# FACADE QUALITY CONTROL MANAGEMENT PLAN

VICTORIA HOUSE

FEBRUARY 2023 REV 4

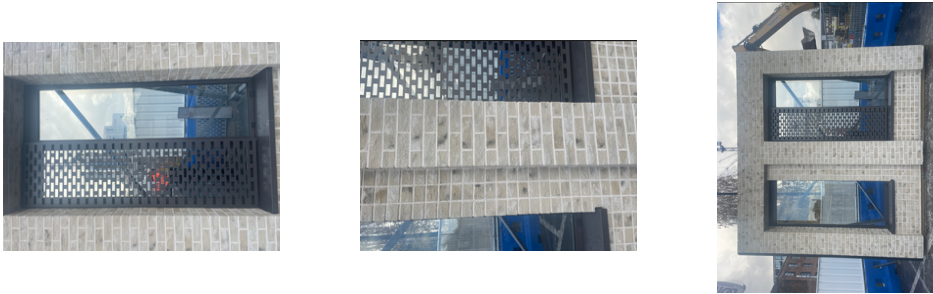
| Number | Title & Date | QC Image | Inspected By | Accepted | Not Accepted | Next Steps |
|---|---|---|---|---|---|---|
| 3 | VMU<br>15/11/2022 | | MCC represented by Angela Leckie & Dave Roscoe. Simpson Haugh Maivi Giang & Nick Owen | <p>Revised solid cill return to facade detail.</p> <p>Reinstalled interface black mastic which provides a consistent finish with no undulation at bed joint.</p> | N/A- All items accepted. | <p>Turley's to submit updated QCMP to MCC enabling condition 3c to be discharged.</p> |

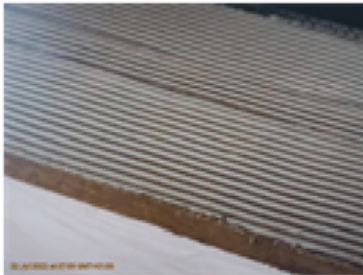
| Insulation | | | | |
|---|---|---|---|---|
| 3 | Has a 10mm x 10mm notch trowel been used to apply the adhesive? | Yes | <br><a href="#">22/07/2022 06:59:05</a> | |

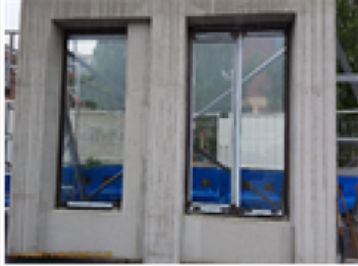
| RENDER COAT | | | | |
|---|---|---|---|---|
| 1 | Is the mesh within the top third of basecoat? | Yes | <br><a href="#">22/07/2022 07:43:16</a> | |

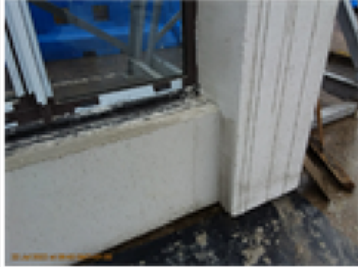
| RENDER COAT | | | | |
|---|---|---|---|---|
| 6 | Corner beads installed correctly? | Yes | <br><a href="#">22/07/2022 07:43:25</a> | |
