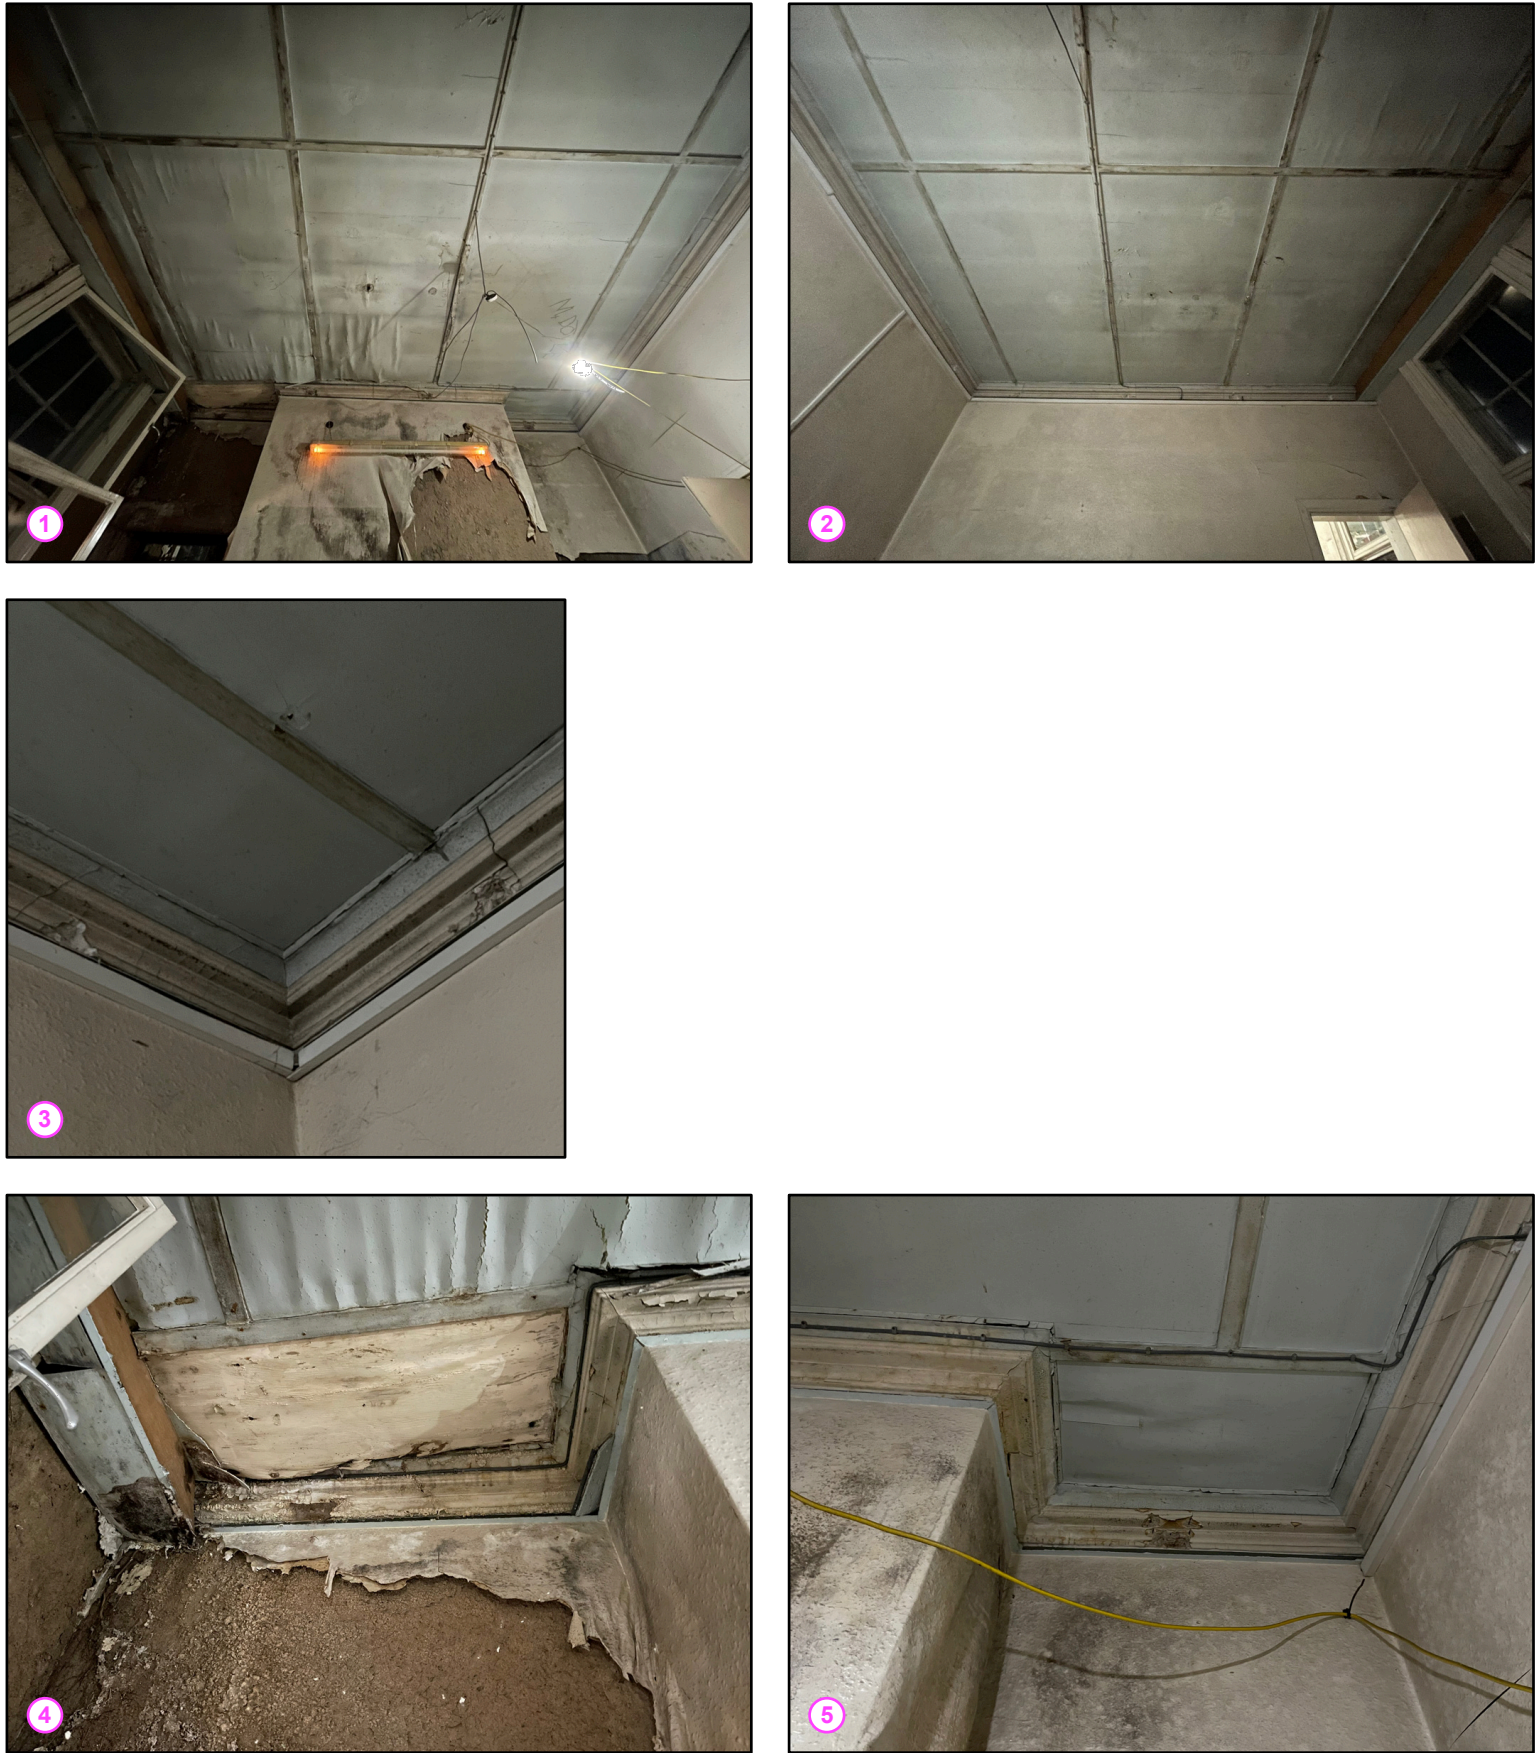
ROOM F.18

- Cornice as noted on the plan
- Water damage to cornice
- Plasterboard ceiling
- Signs of water damage to ceiling

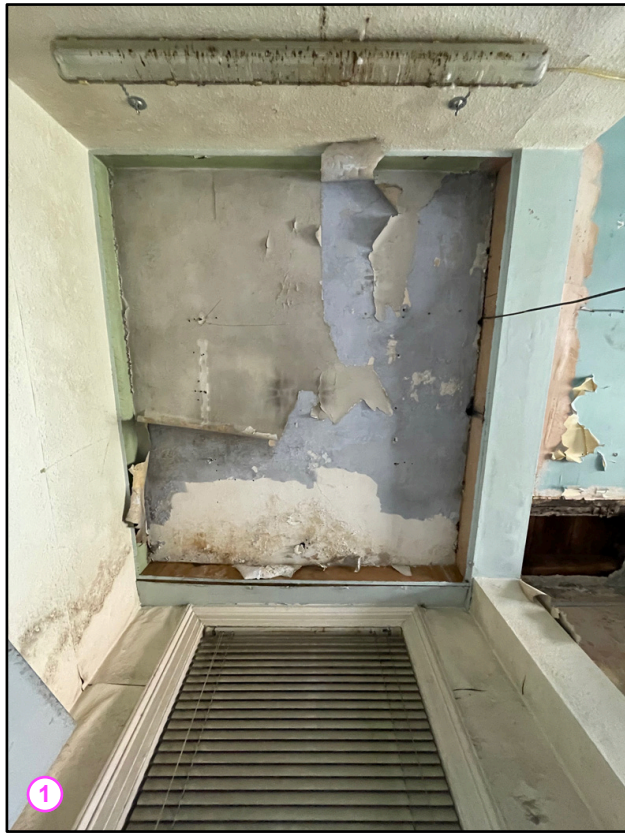
ROOM F.20

- No cornice
- Plasterboard ceiling
- Early signs of water damage to ceiling

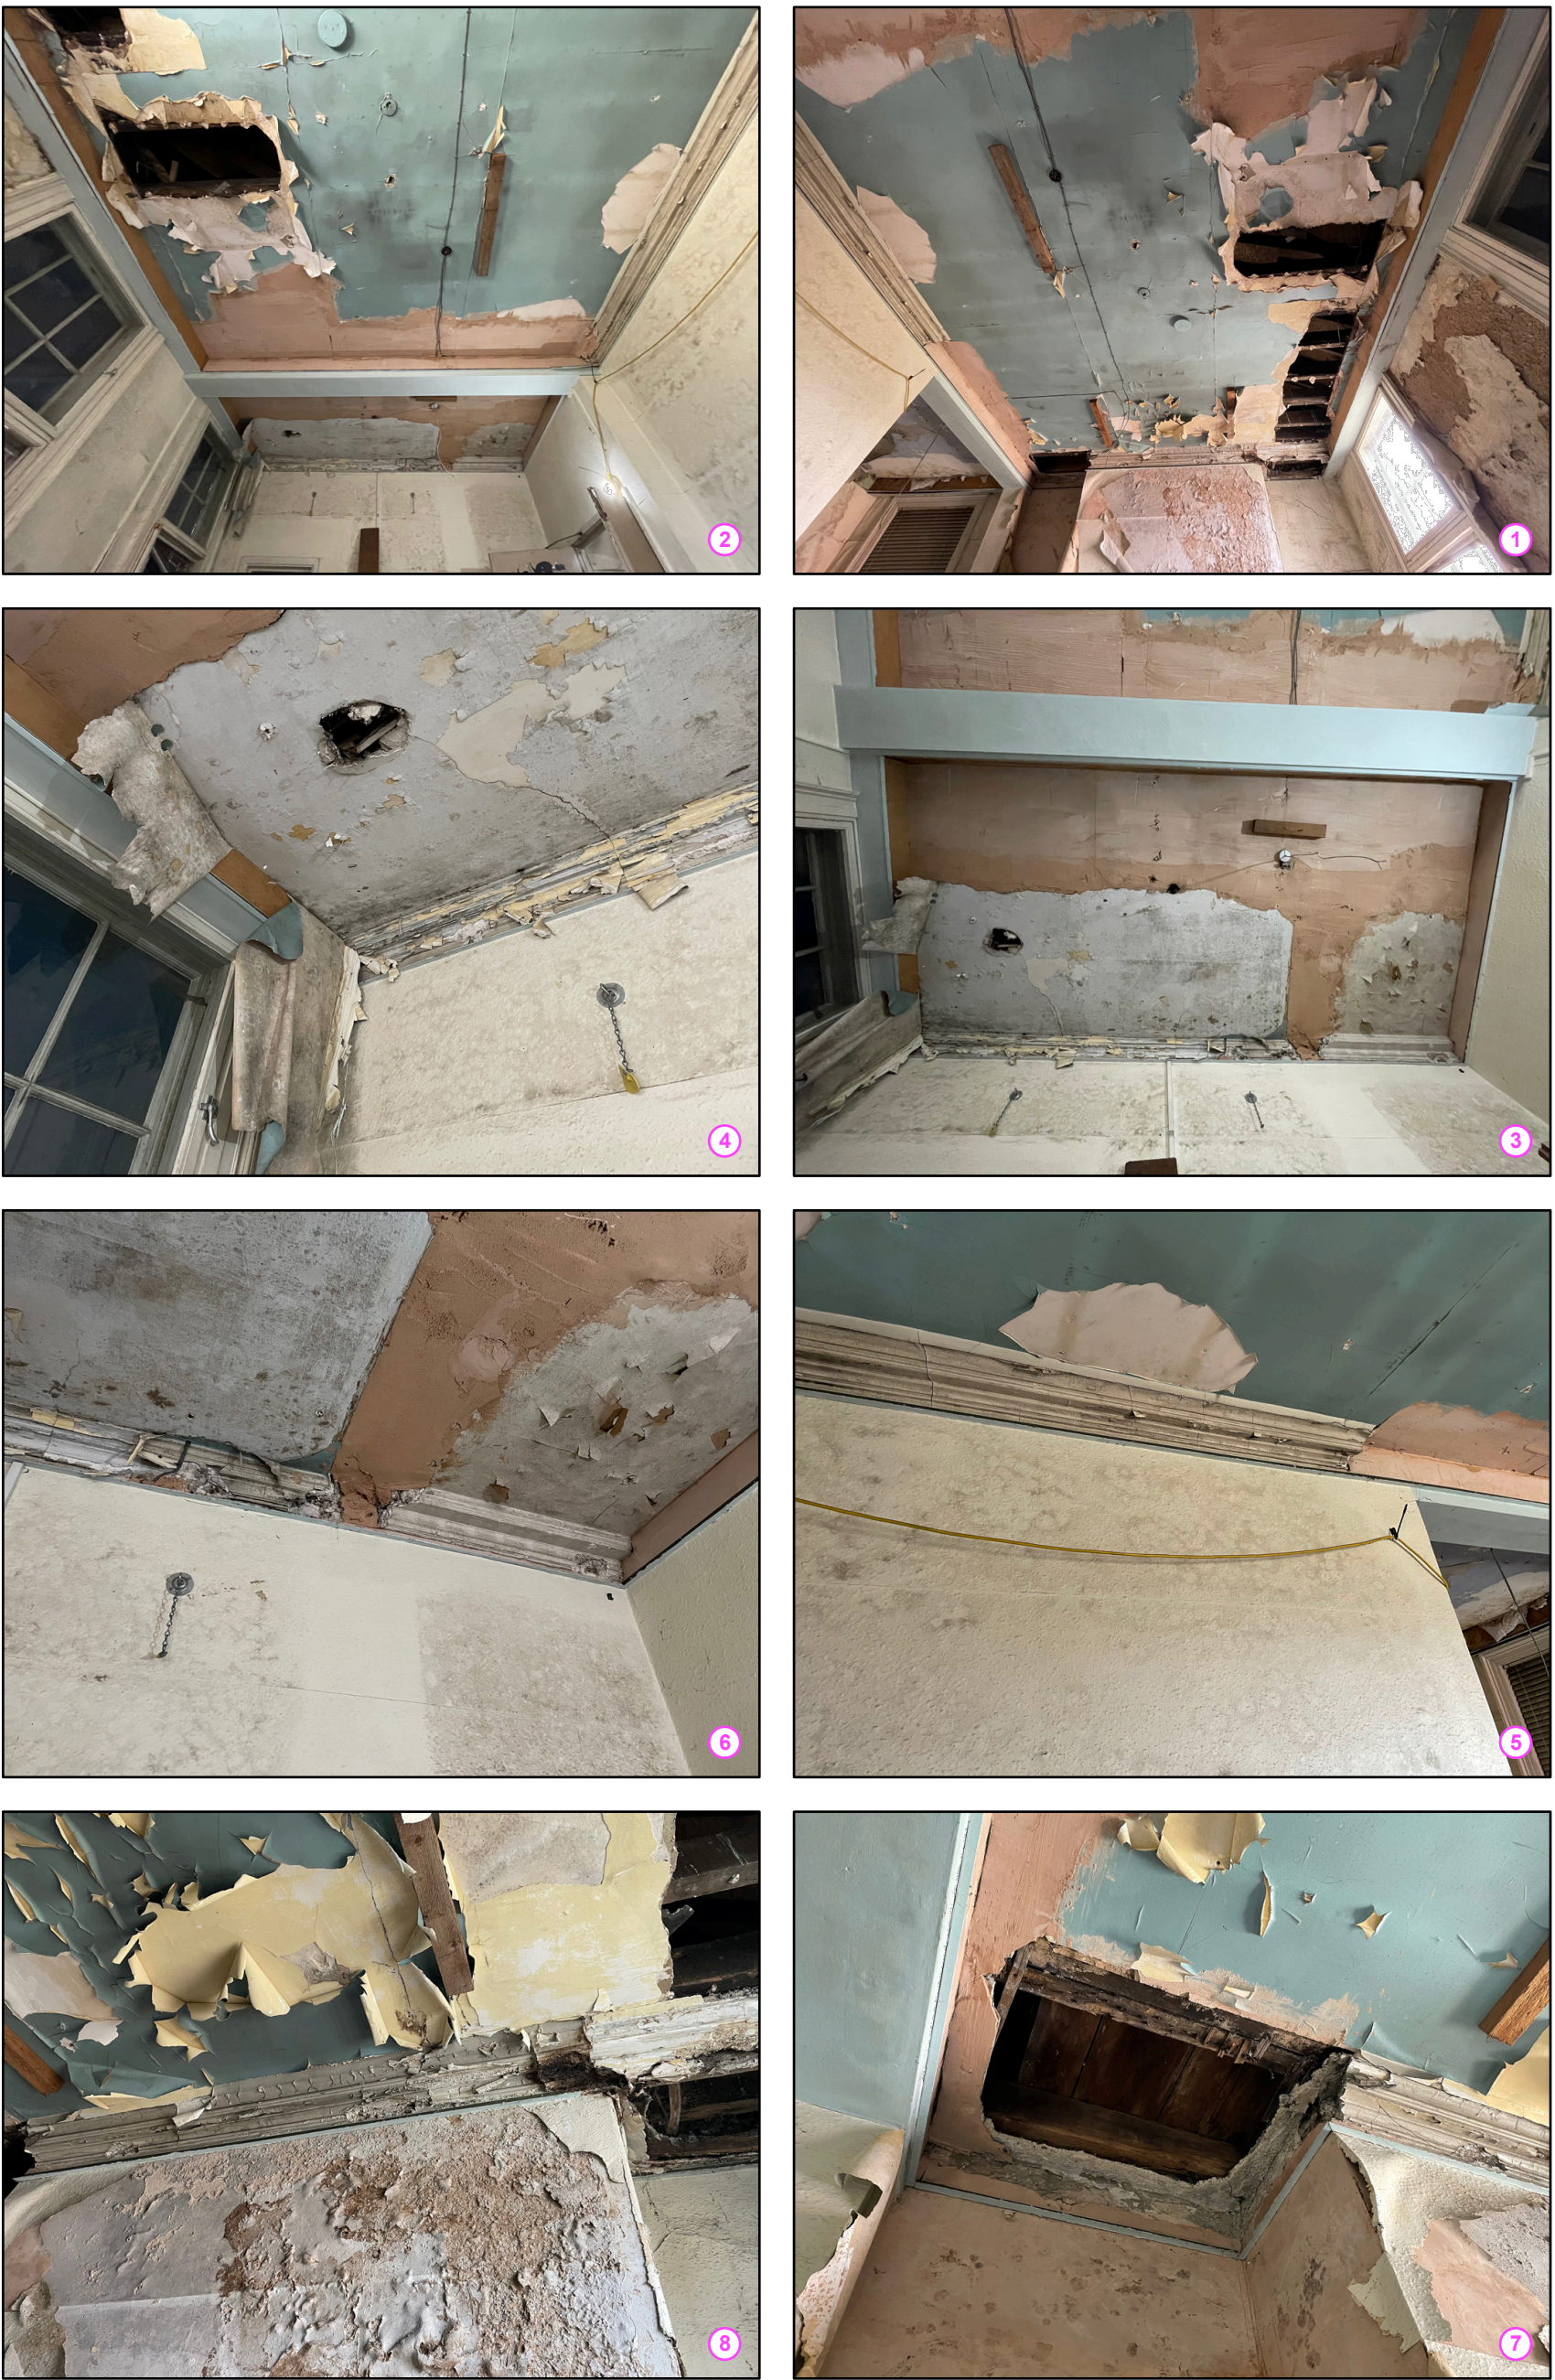
ROOM F.19

- Limited areas of surviving cornice as noted on the plan
- There is some damage to the cornice
- All ceiling is plasterboard
