## **Structural Inspection and Report, 136 Withington Road, Whalley Range, Manchester M16 8EE**

**Report Date:**  
27 May 2020

MH/5056

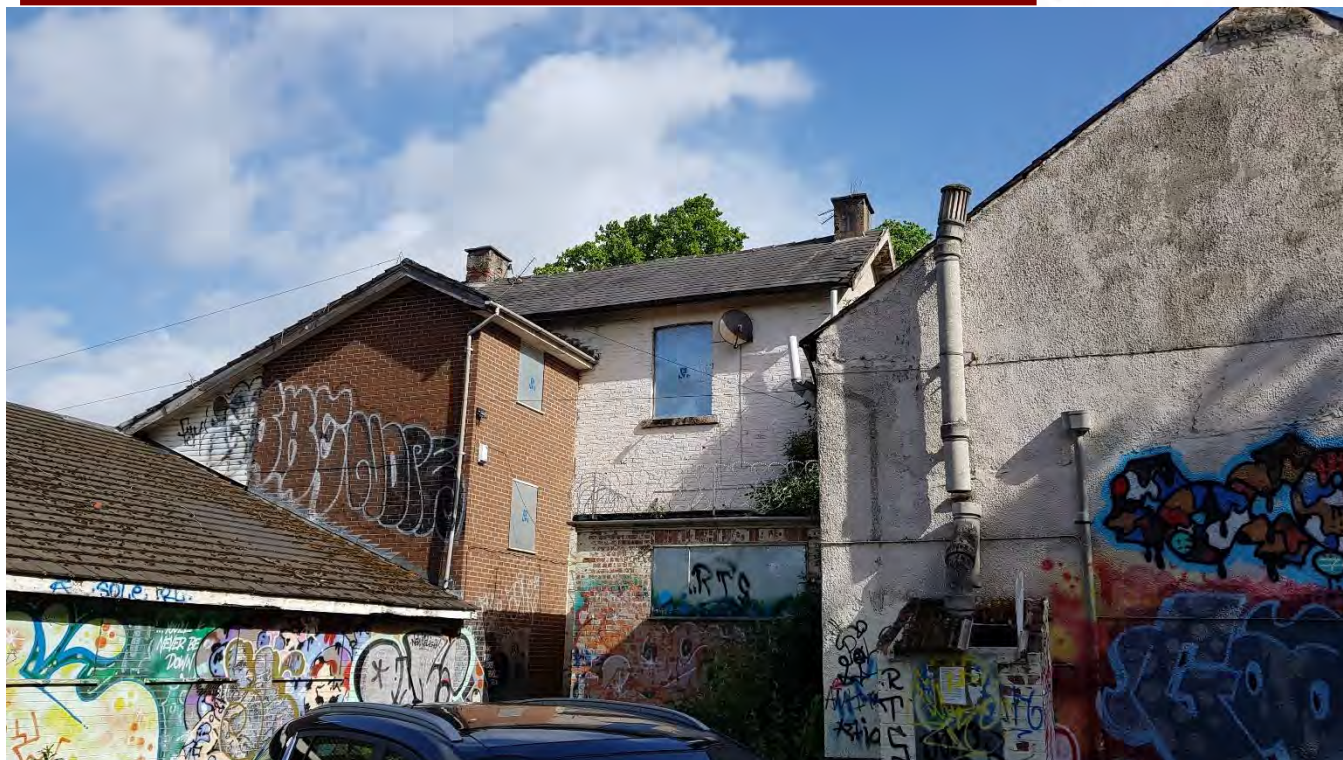
Due to the age of the structure it is possible that asbestos has been used in the construction. One of the external flues appears to be asbestos. Due to the large amount of debris internally it will be very difficult to check this.

Original building to the right and in the background – possible asbestos flue in the foreground

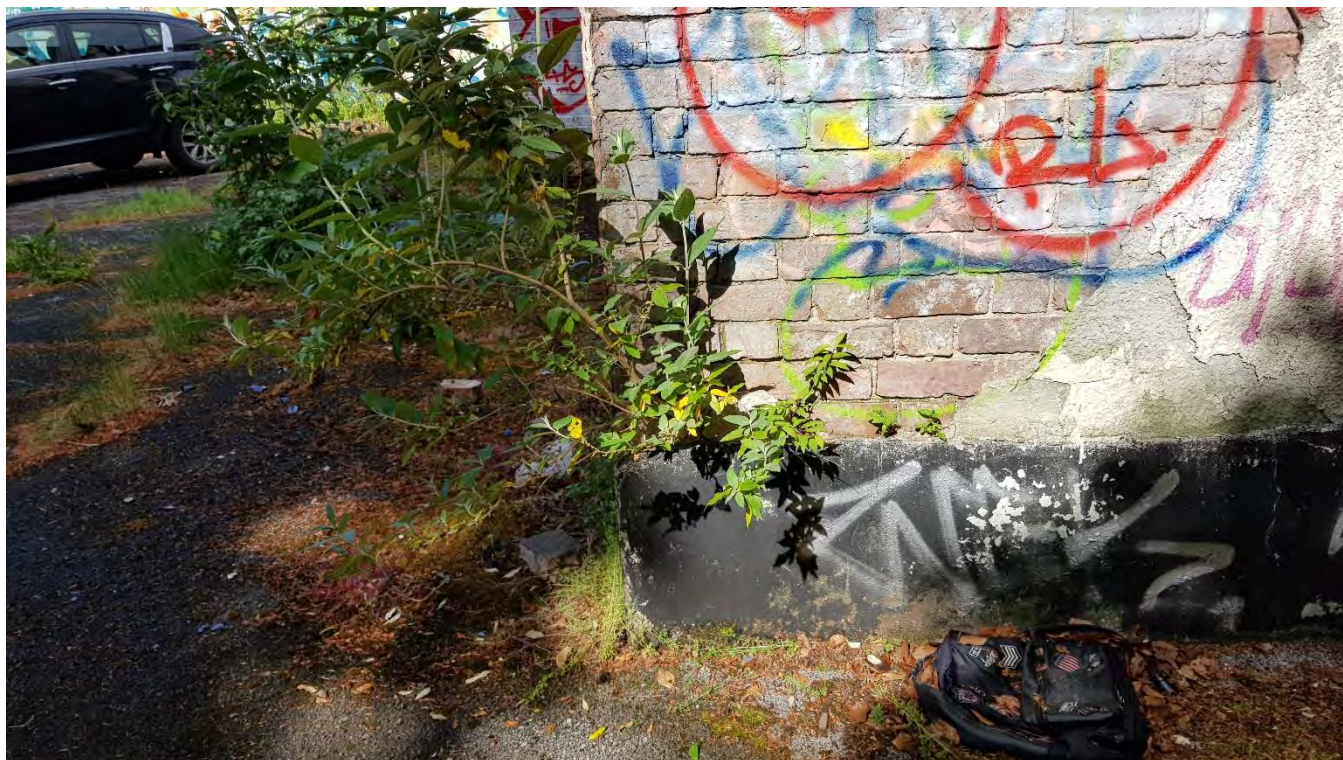
East elevation – vandalism, loose render and vegetation growing out of the wall

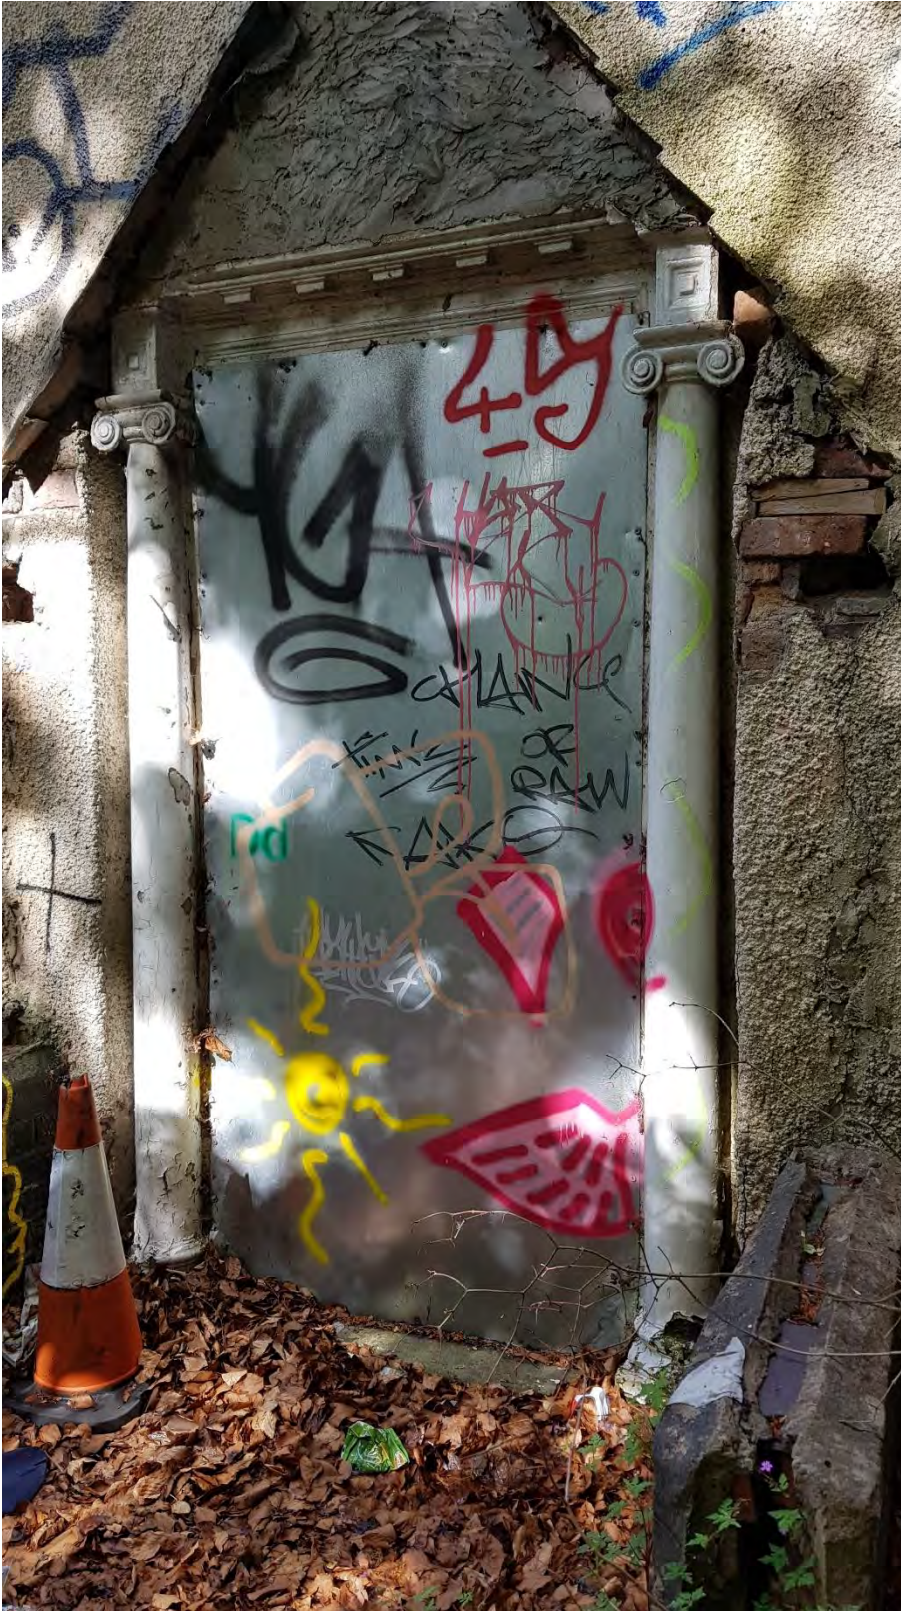
East entrance to original house – vandalised, porch removed, holes through wall

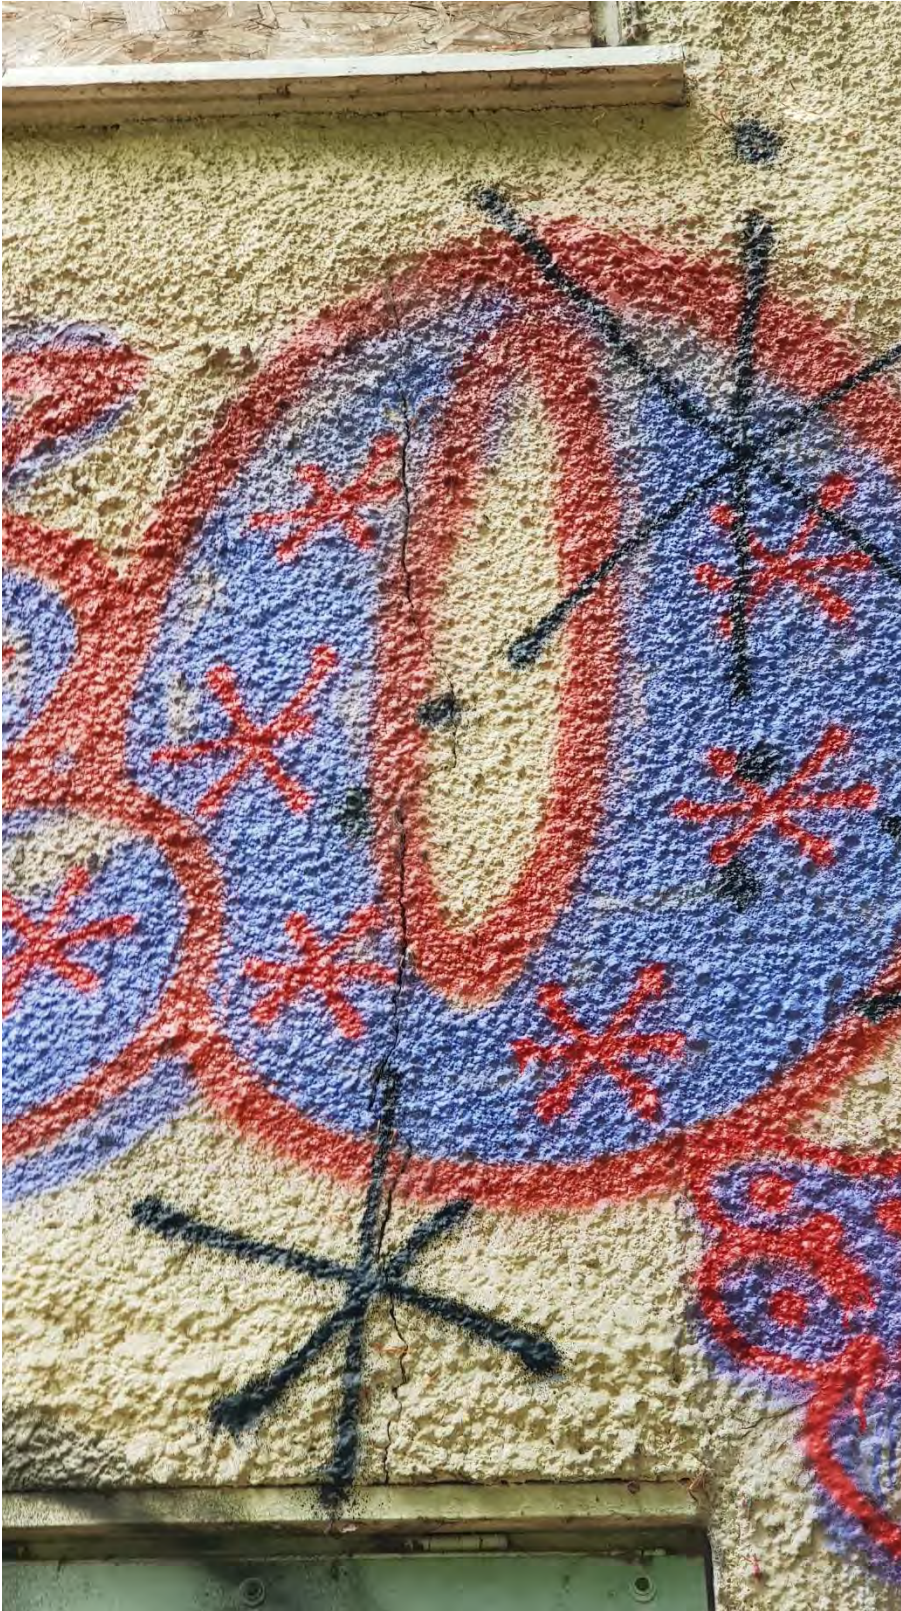
The majority of the walls to the property appear to be in an adequate condition. The external render is coming away in places and there are numerous cracks that appear to be related to thermal movement but also possibly some very minor settlement possibly due to leaking drains.

Cracking to external render – east elevation

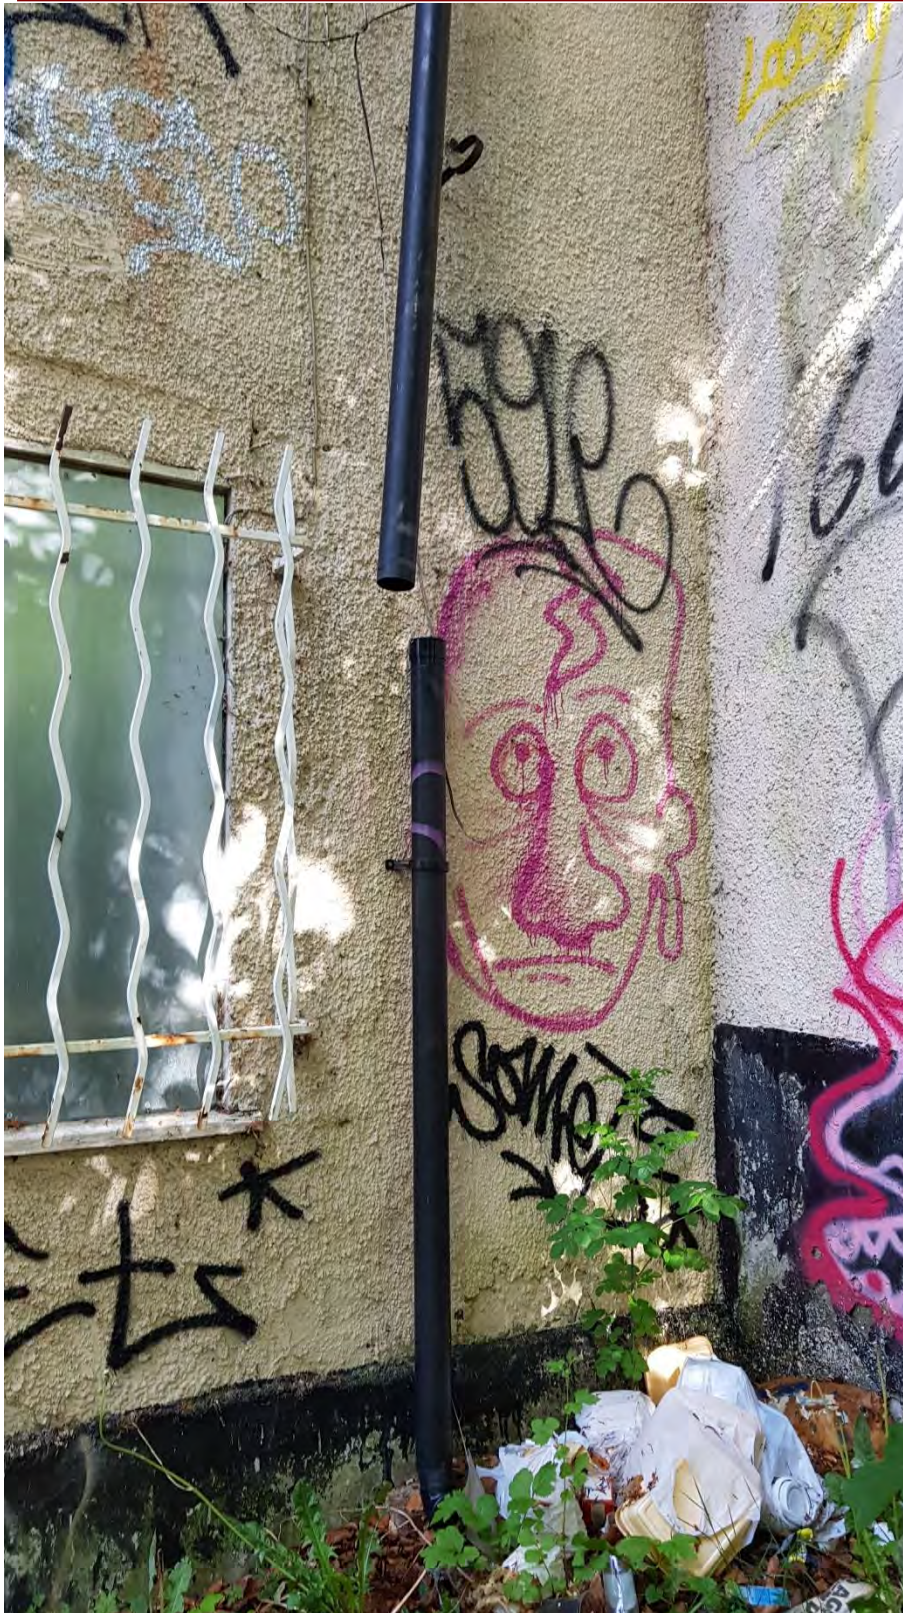
Broken rainwater goods throughout

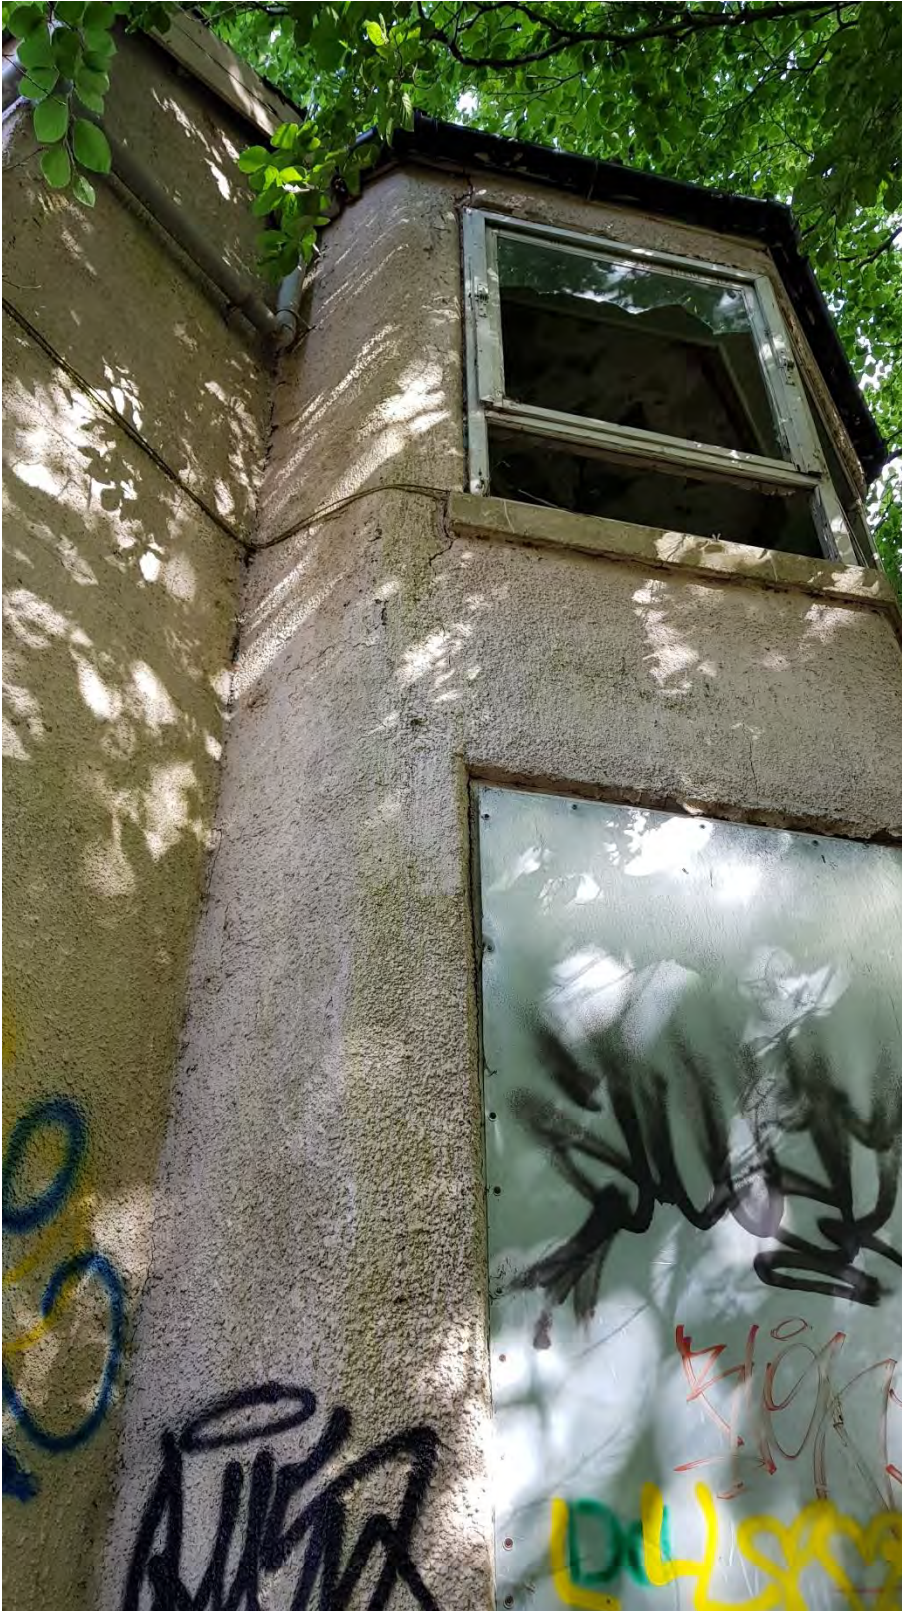
Smashed windows throughout. Minor cracking at the junction of the bay at the main wall. Cracked/ loose render at the corner of the window

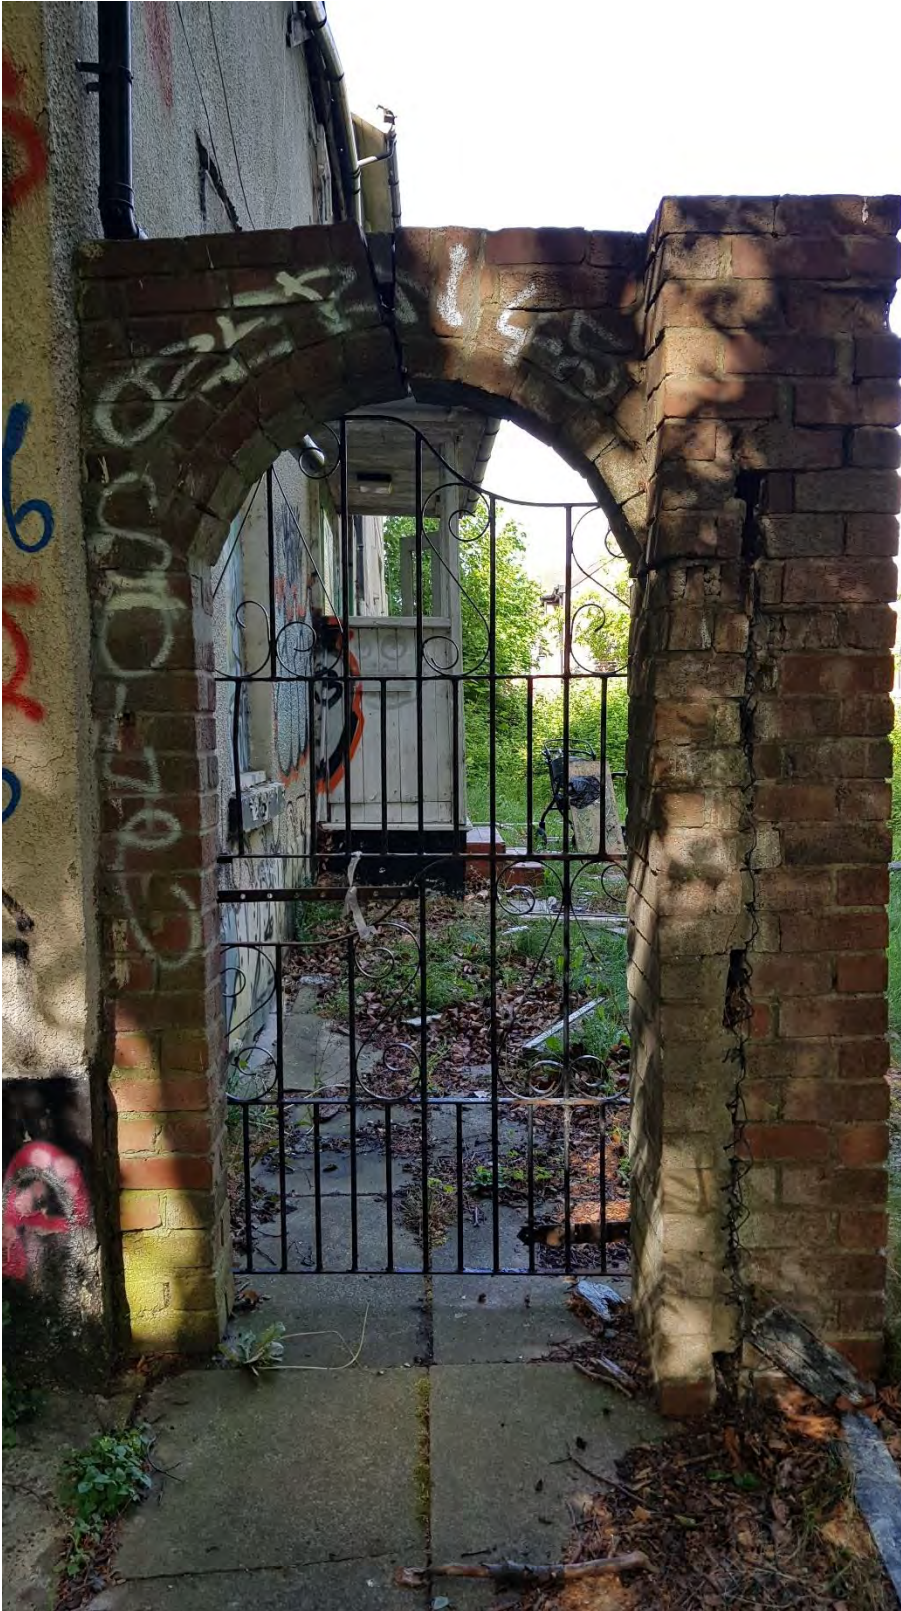
Masonry arched has failed

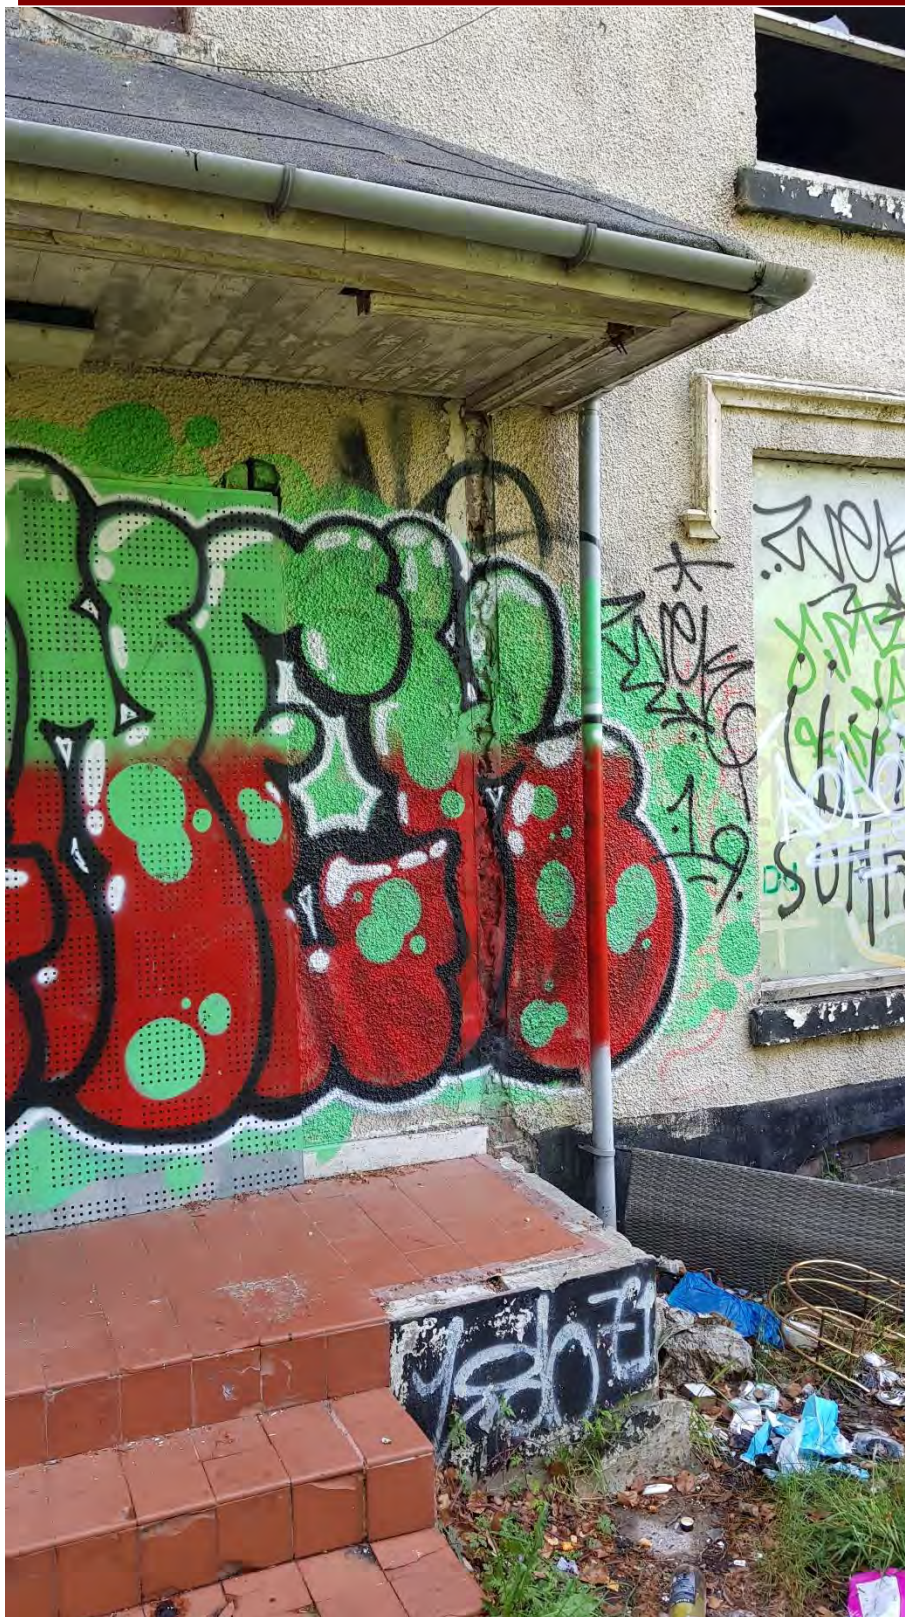
Porch support post missing at north entrance

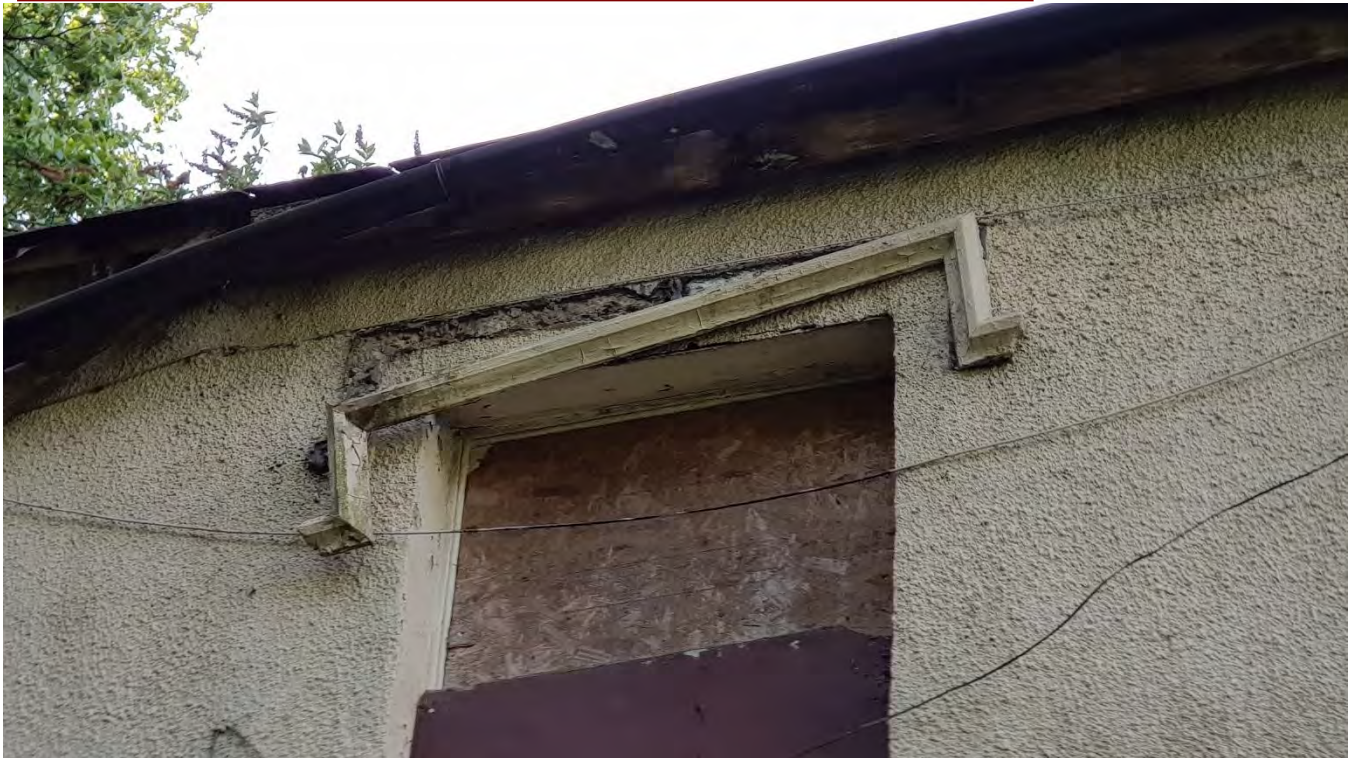
Broken rainwater gutter, rotten timber fascia's, dislodged decorative wall finish

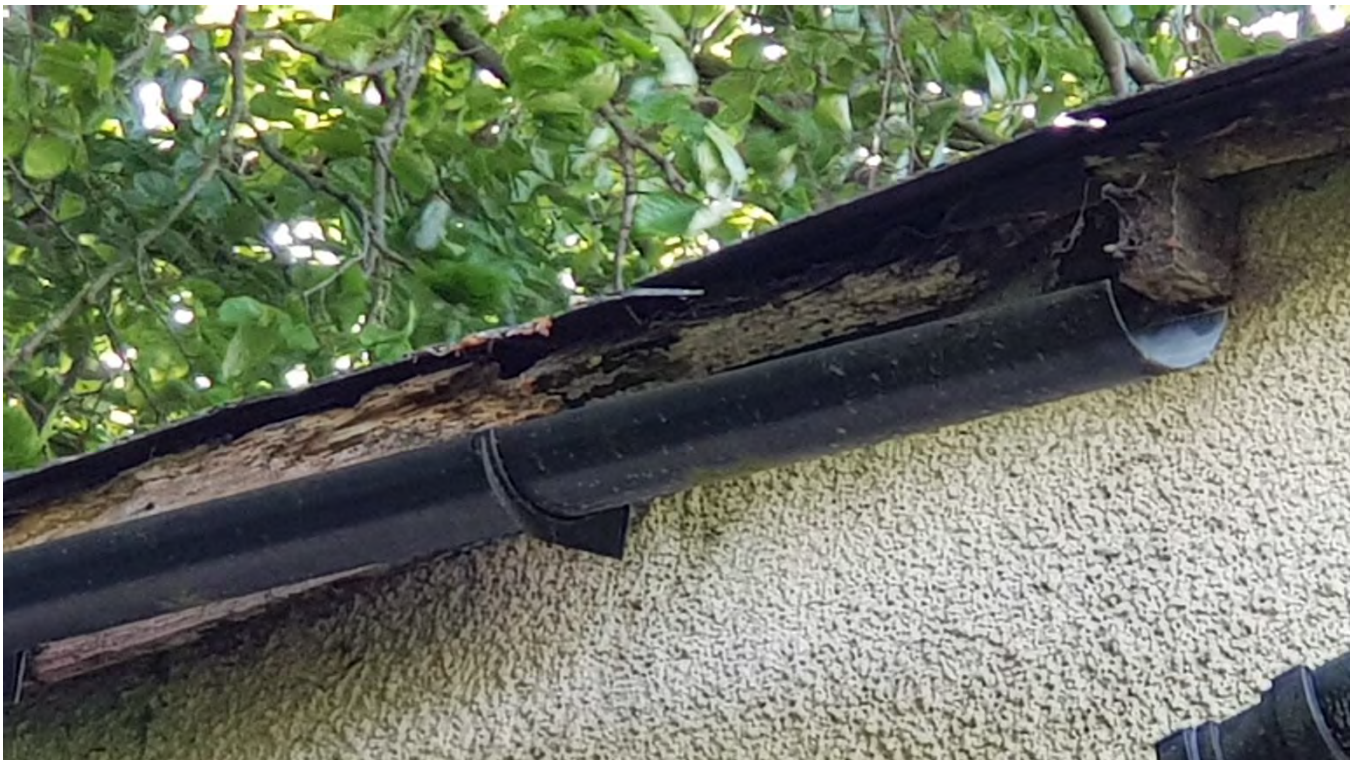
Rotten timber

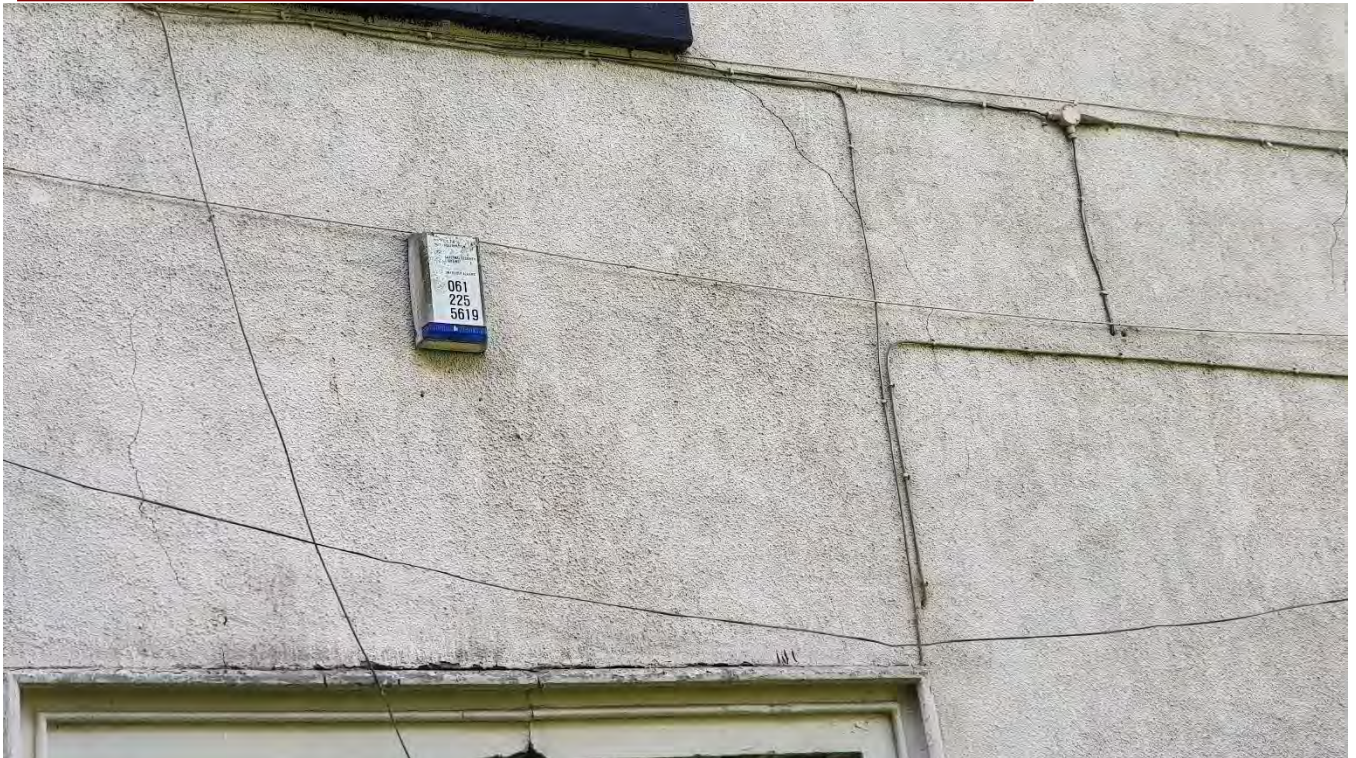
Cracking to render

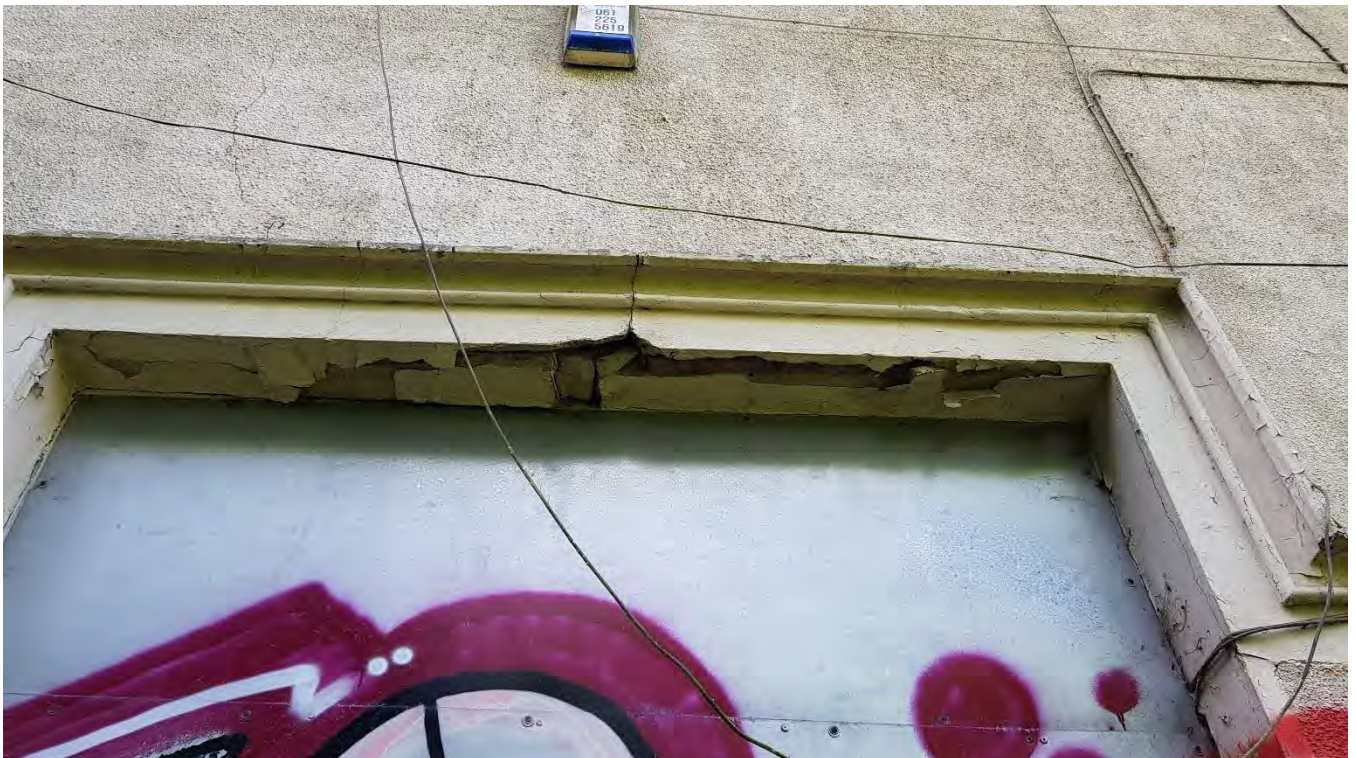
Possible failing lintel to north elevation

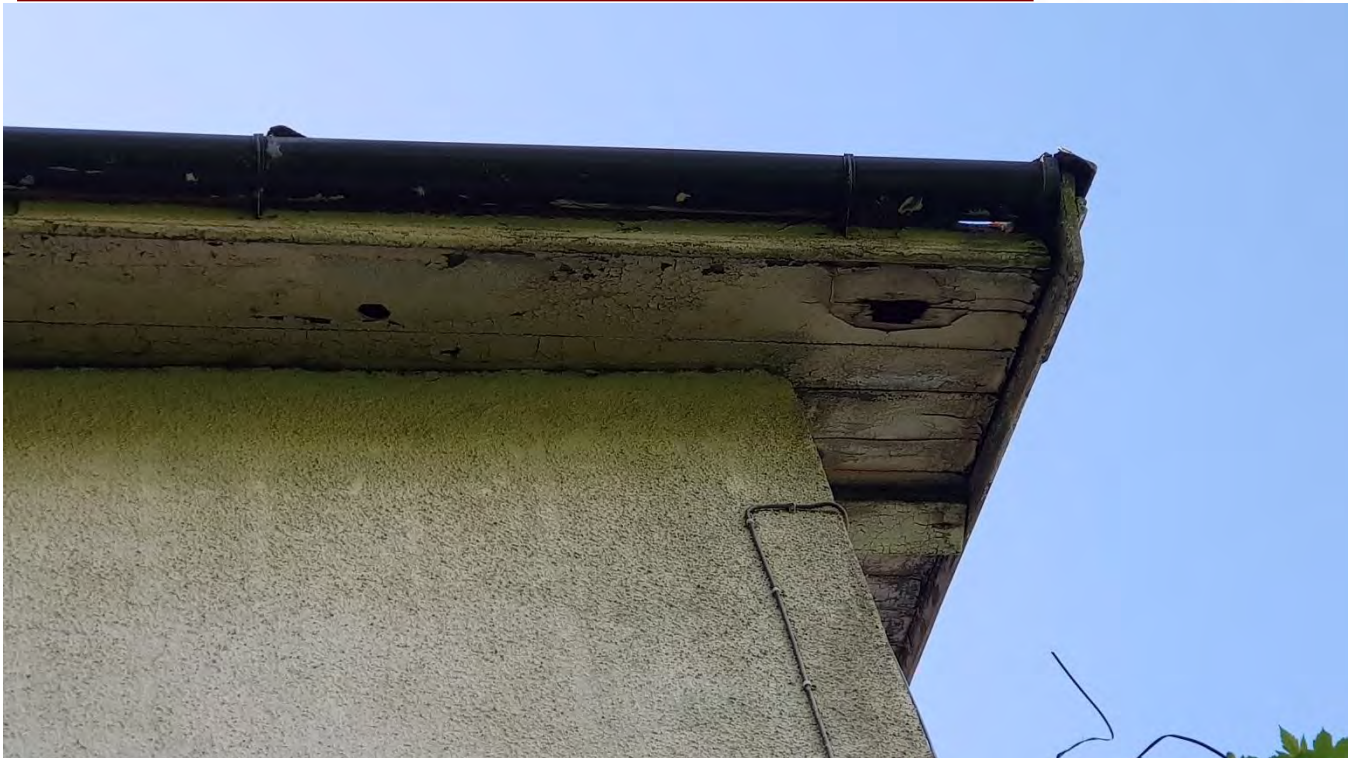
Rotten timbers to roof

- The roofs throughout the property will need to be replaced. Roofs that may be repairable (on the modern extension) could be undersized for modern insulation requirements.

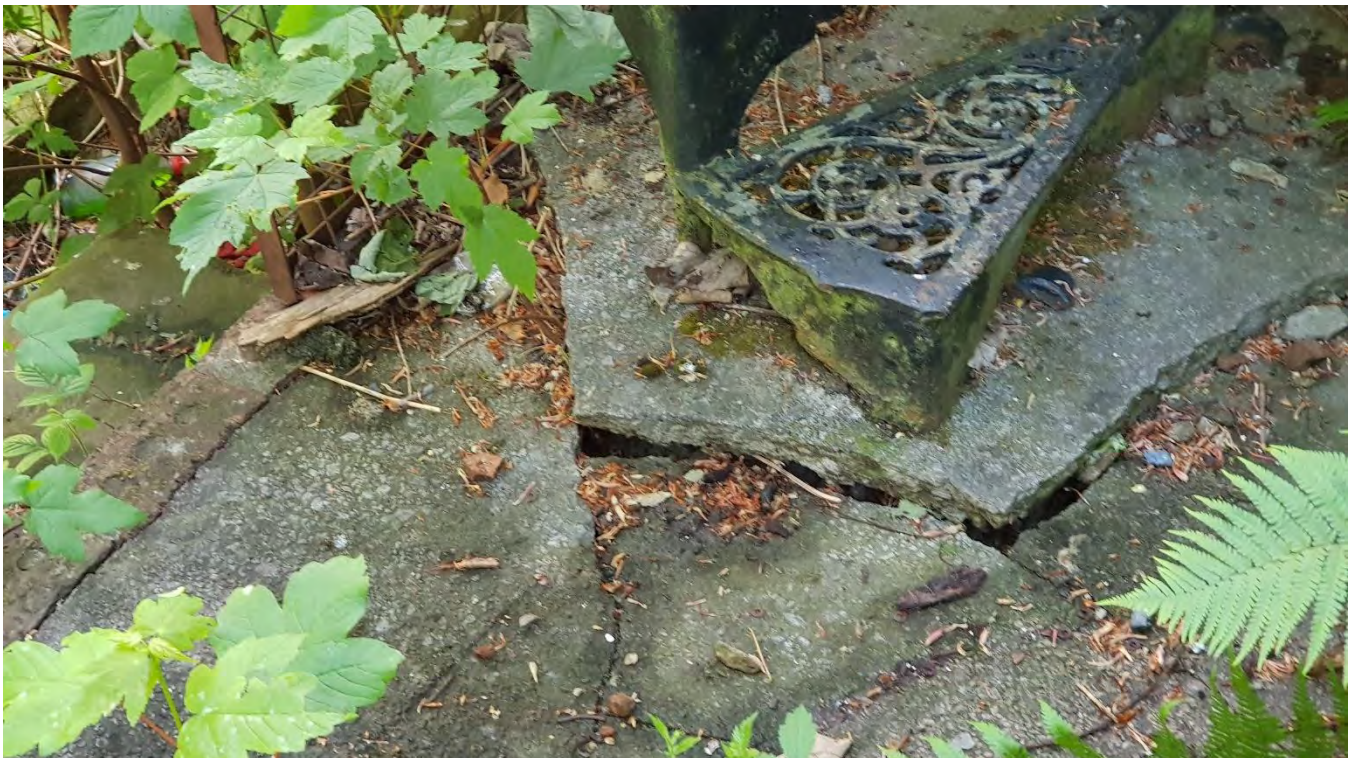
Potential ground movement at rear spiral staircase

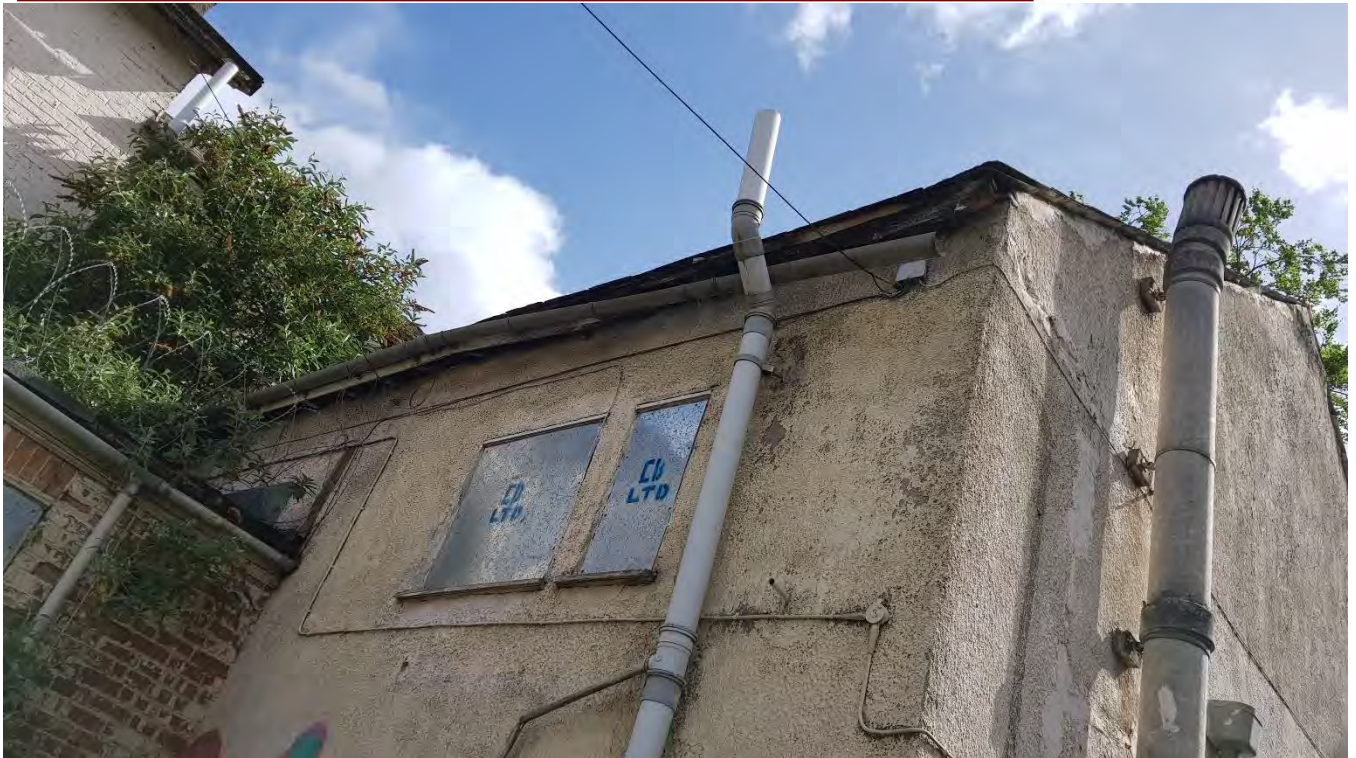
West facing elevation of the south section of the original house. Note vegetation growing out of the roofs

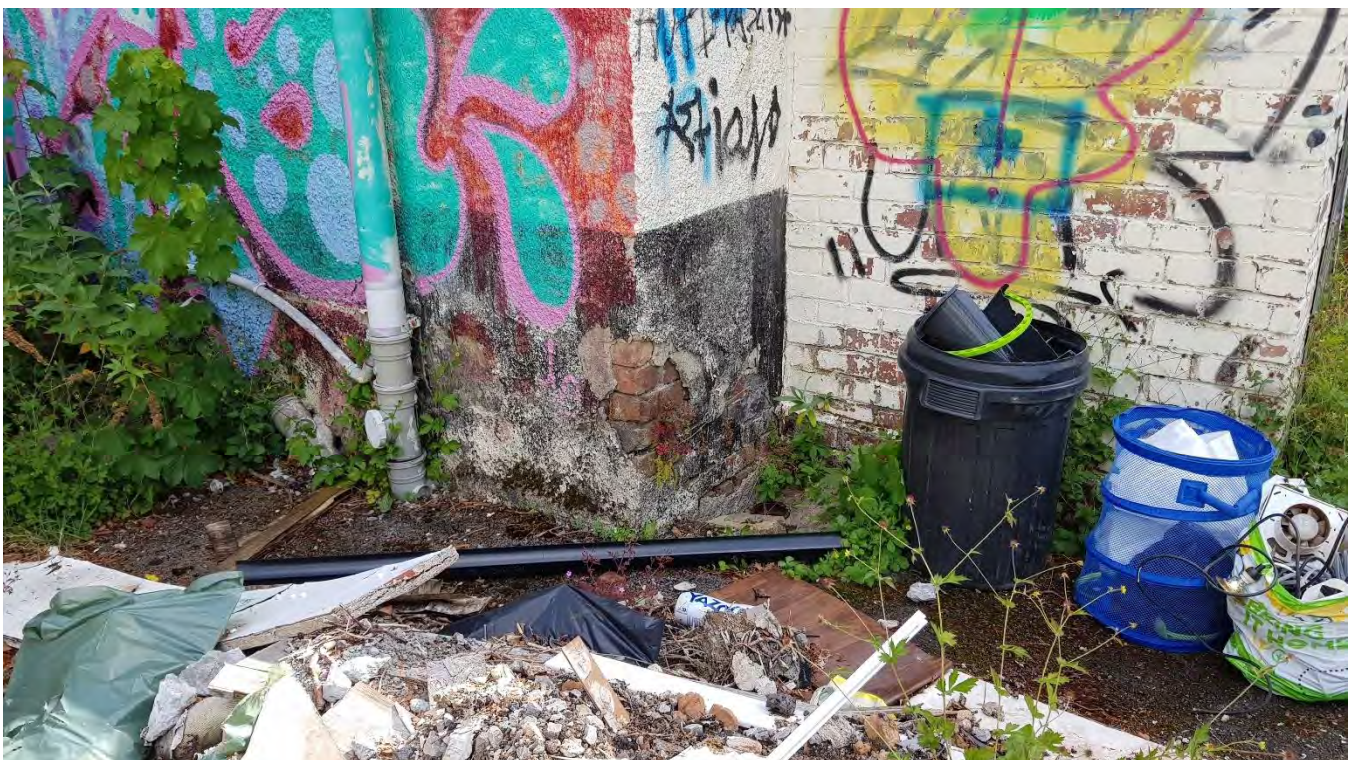
Loose render. Debris externally

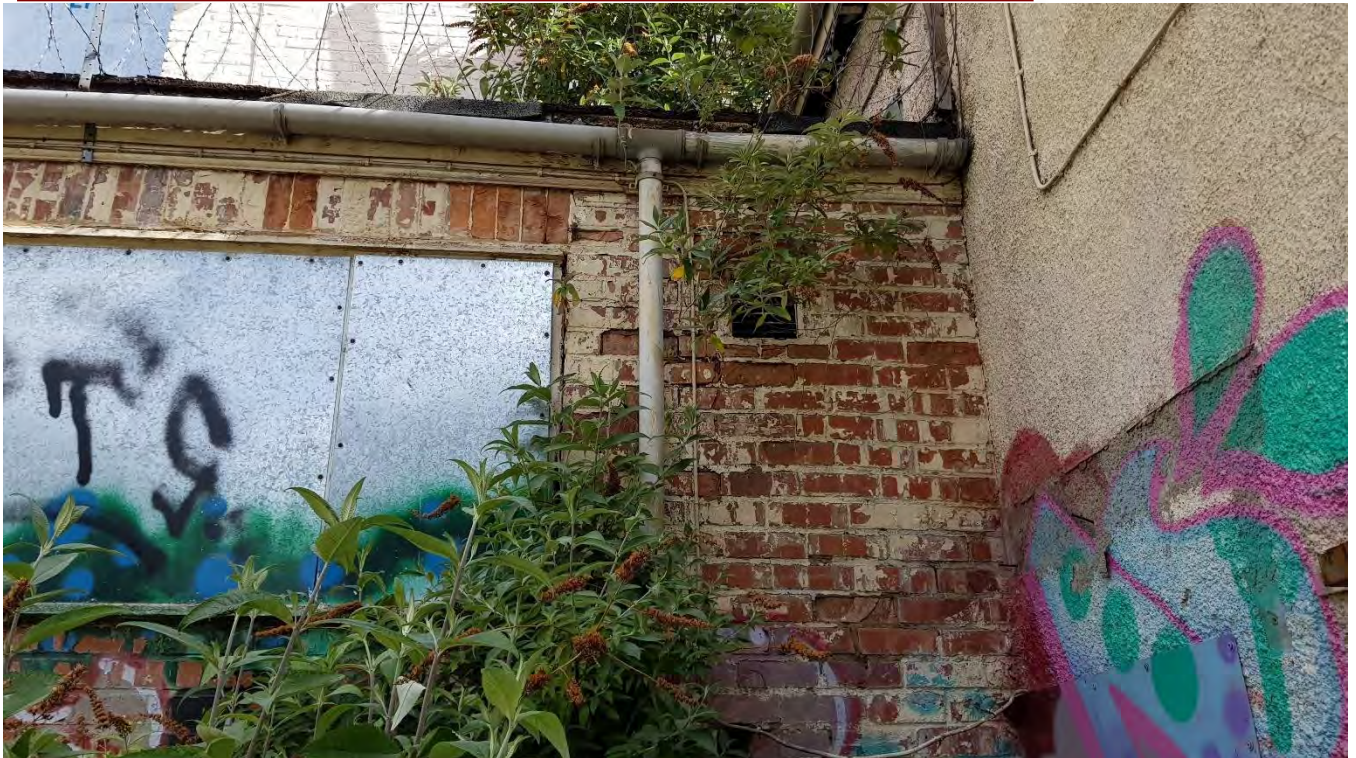
Vegetation growing out of the walls. Spalling masonry where render has been removed (possibly a weak brick that was rendered because of the spalling)

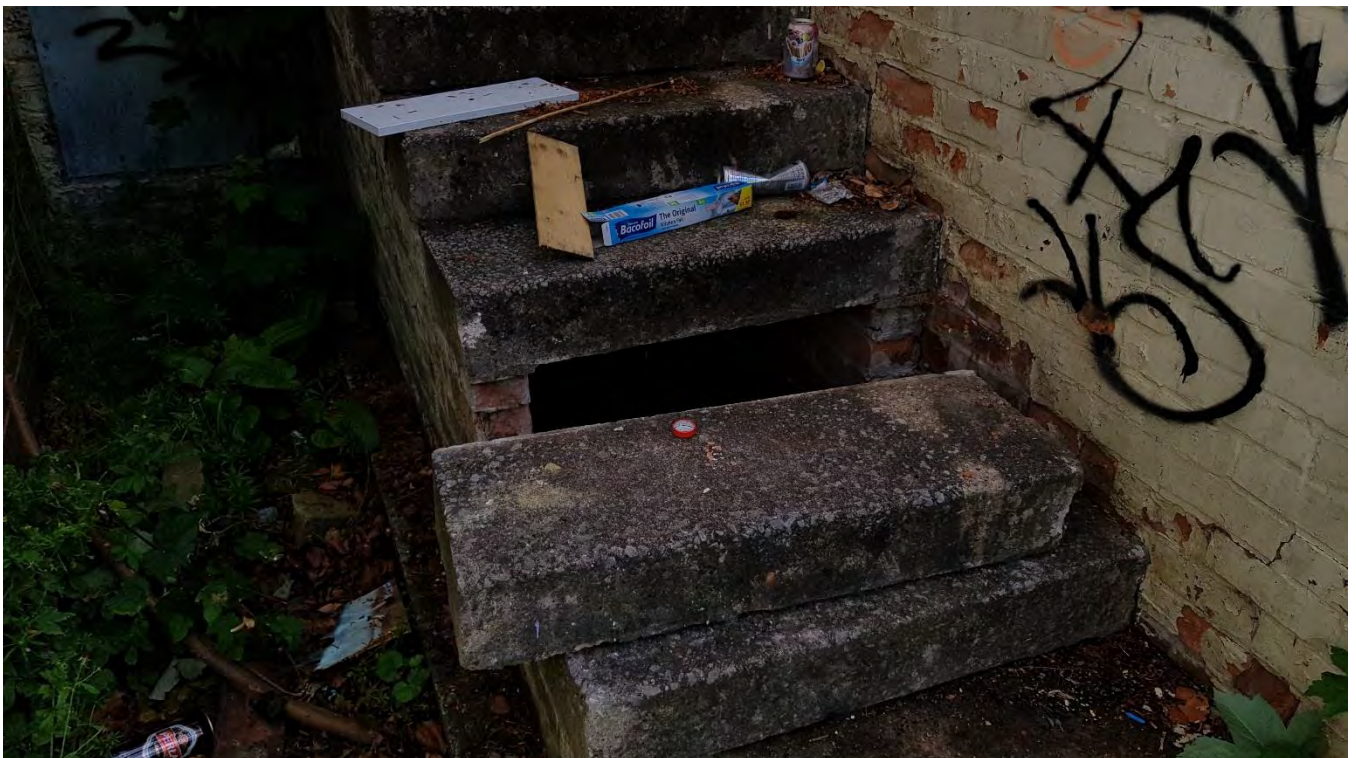
Loose steps

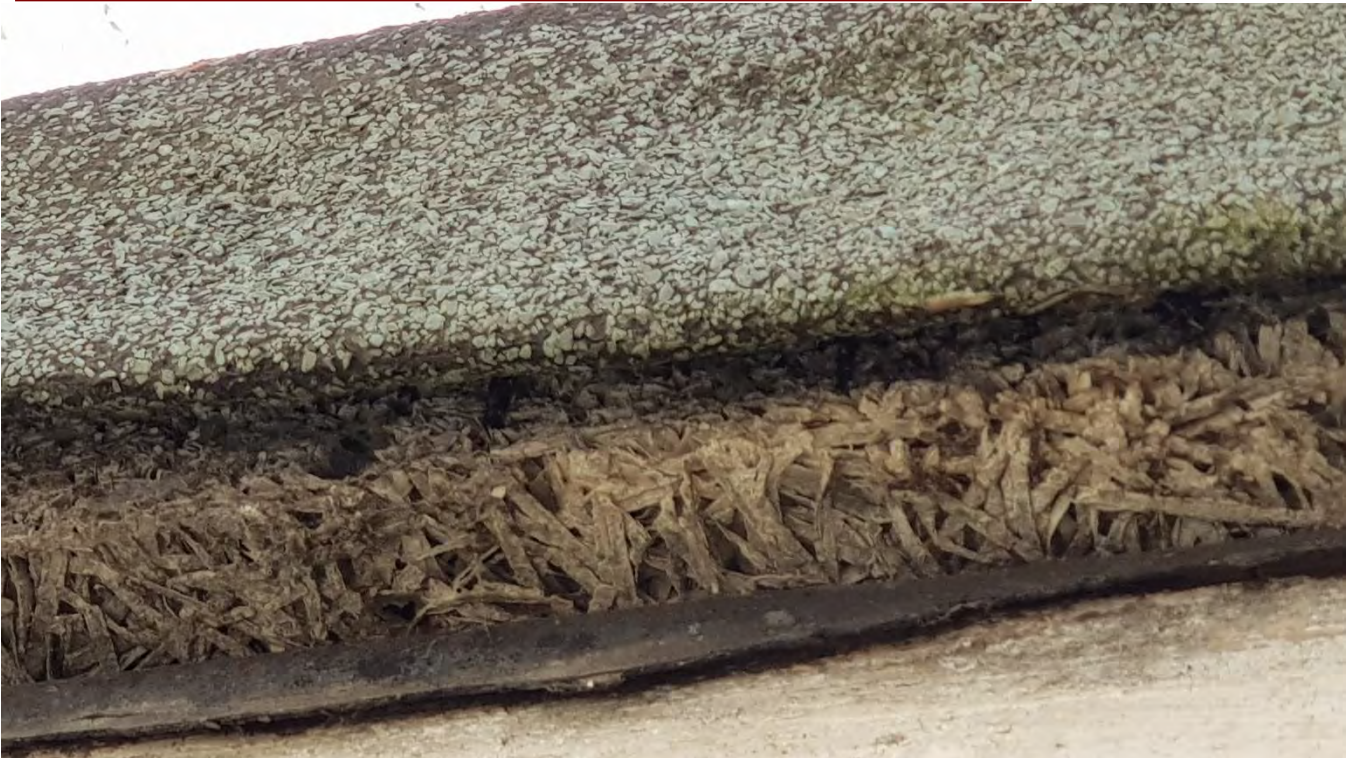
Woodwool slabs used to the flat roof of the original west entrance.
