## **Structural Inspection and Report, 136 Withington Road, Whalley Range, Manchester M16 8EE**

**Report Date:**  
27 May 2020

MH/5056

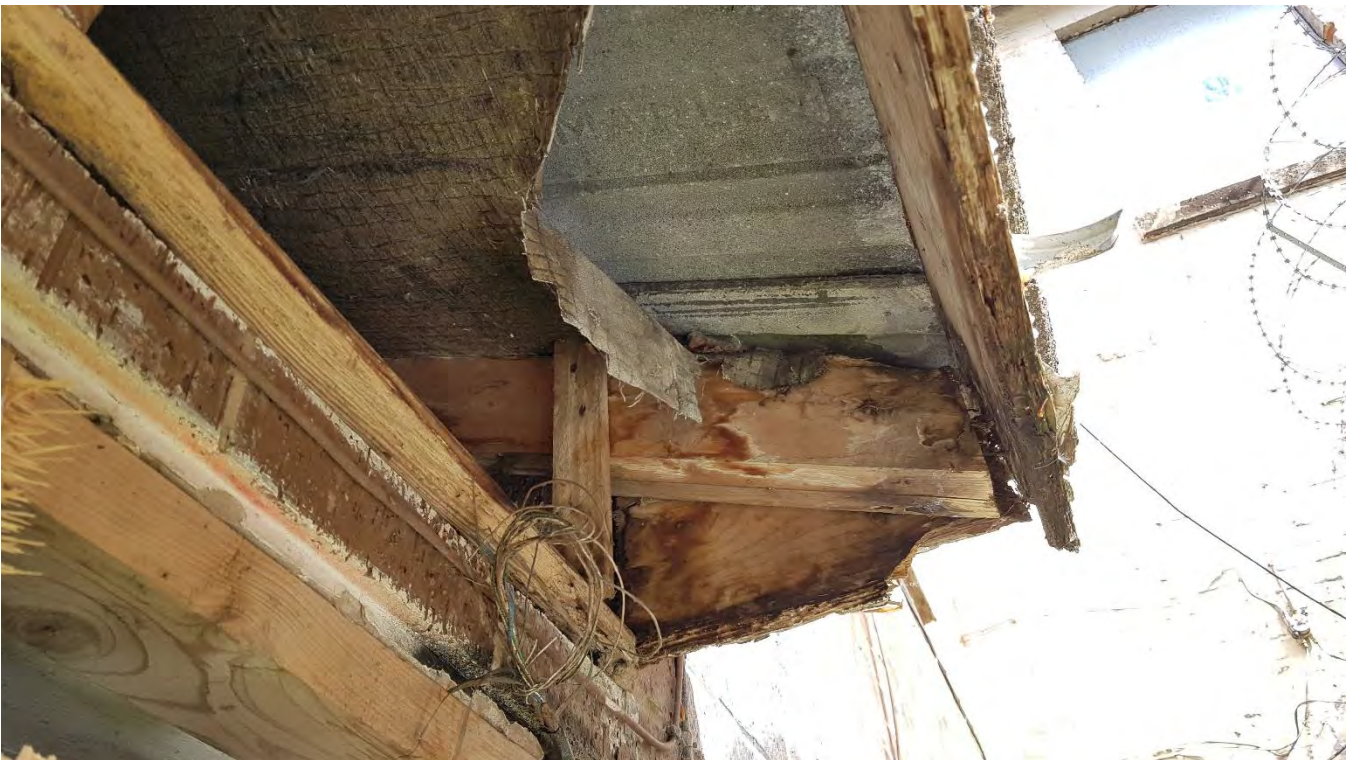
Exposed and water stained timbers to SW extension

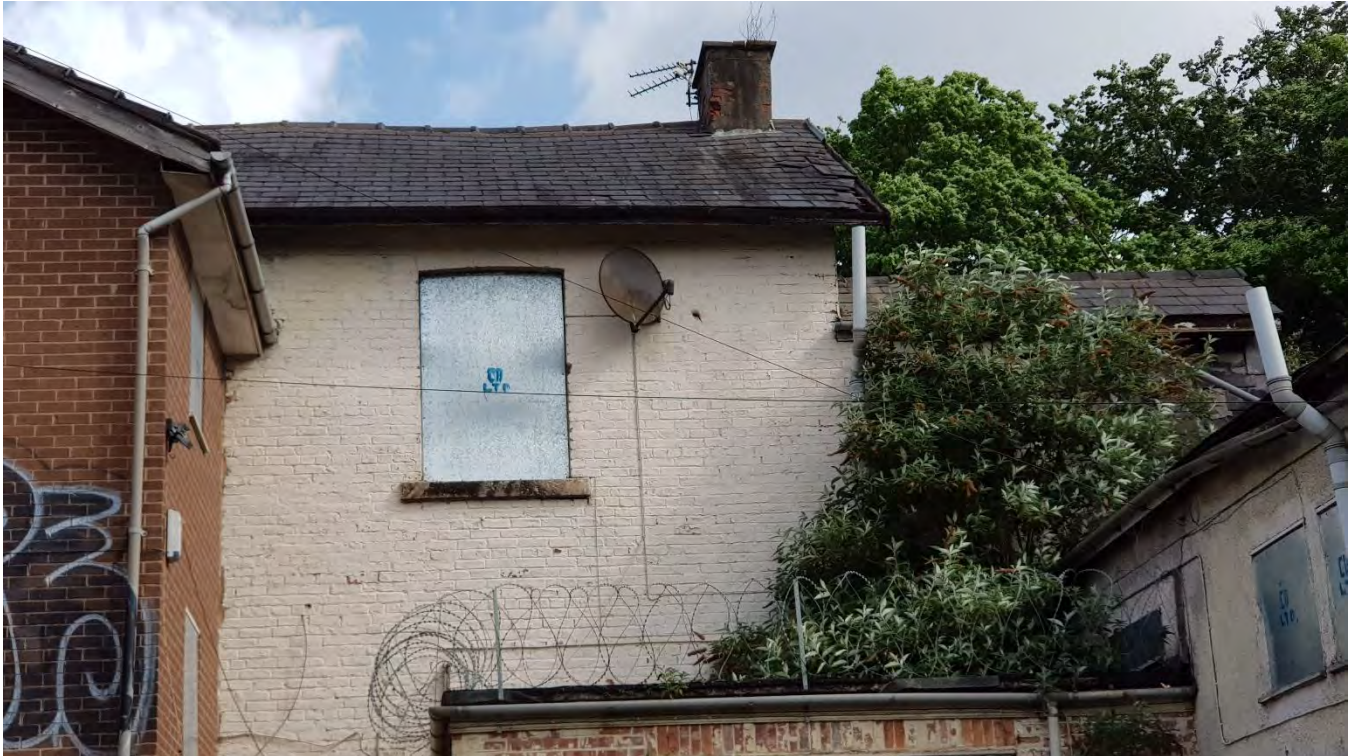
Original roof has settled (partially collapsed in parts). Vegetation growing out of the roof. Chimney in poor state of repair

- The roofs throughout the property will need to be replaced. Roofs that may be repairable (on the modern extension) could be undersized for modern insulation requirements.

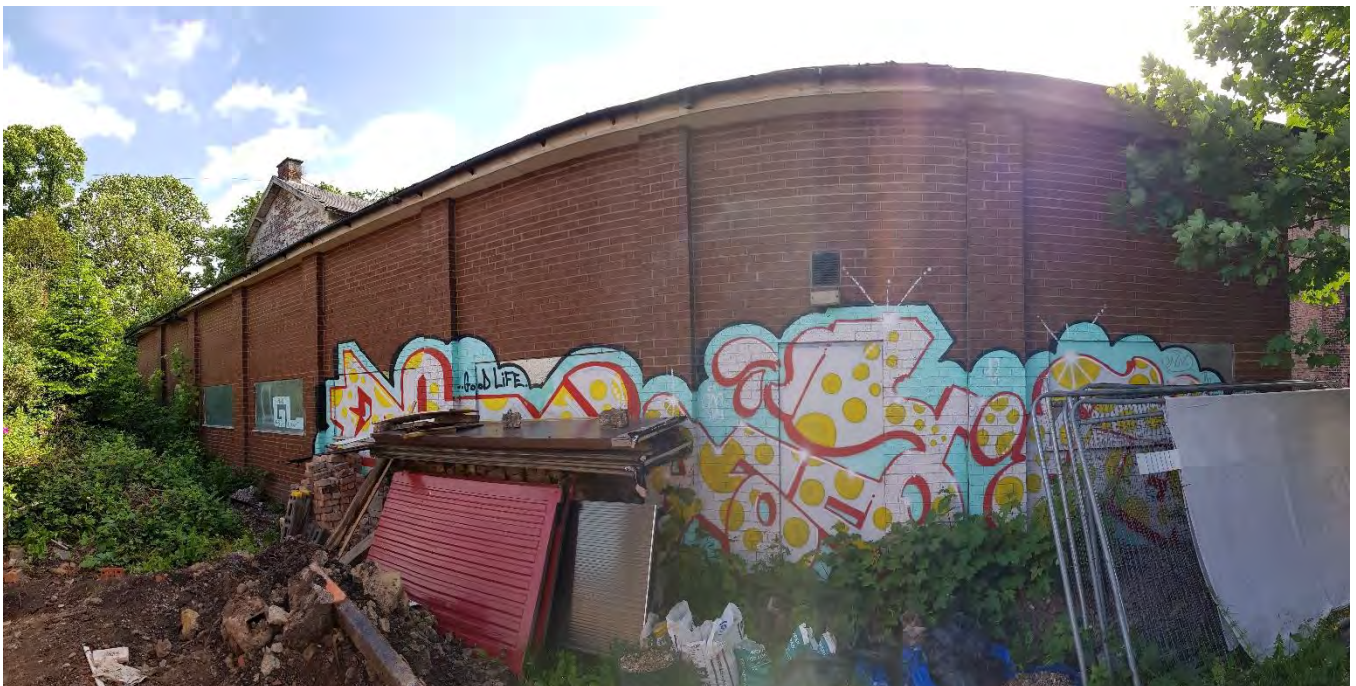
West elevation of single storey extension. Area vandalised and being used to store materials. (Panoramic shot, ignore distortions)

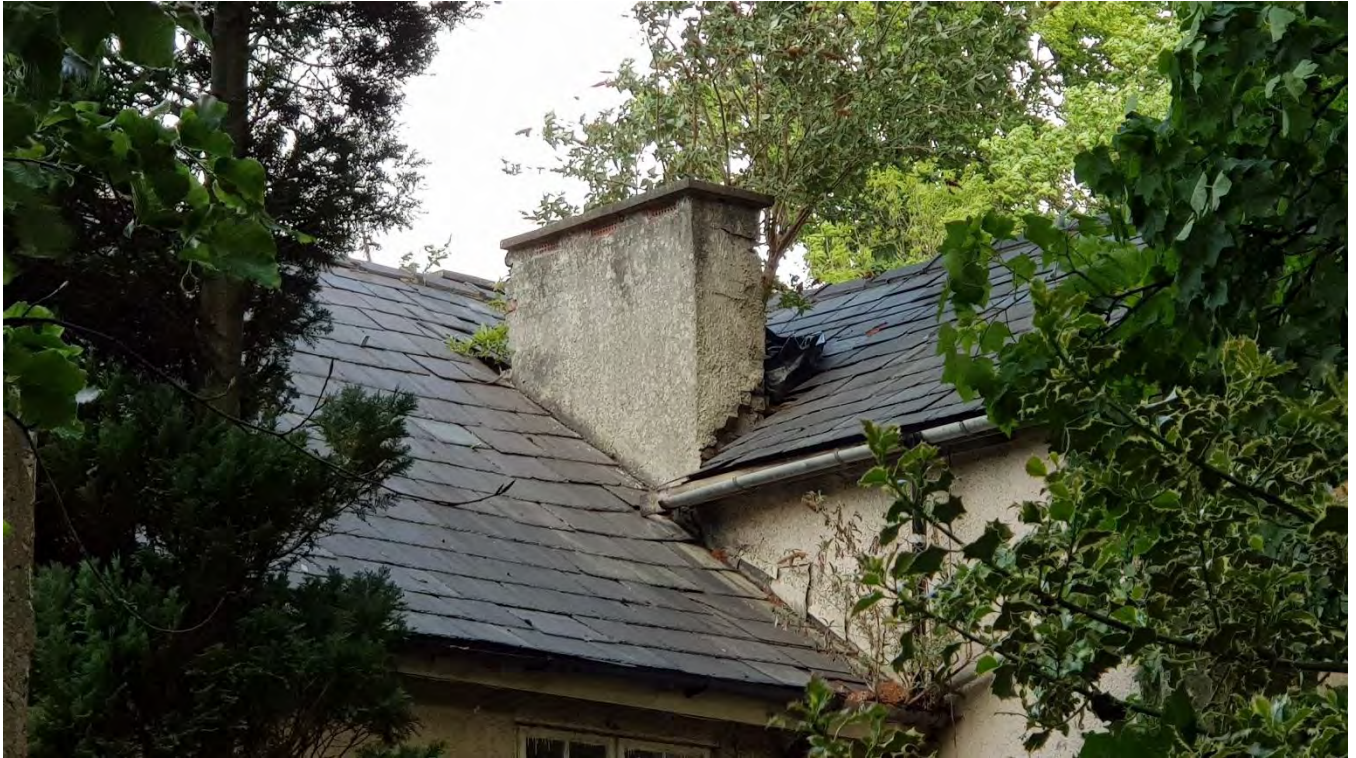
Original roofs in poor condition with numerous holes

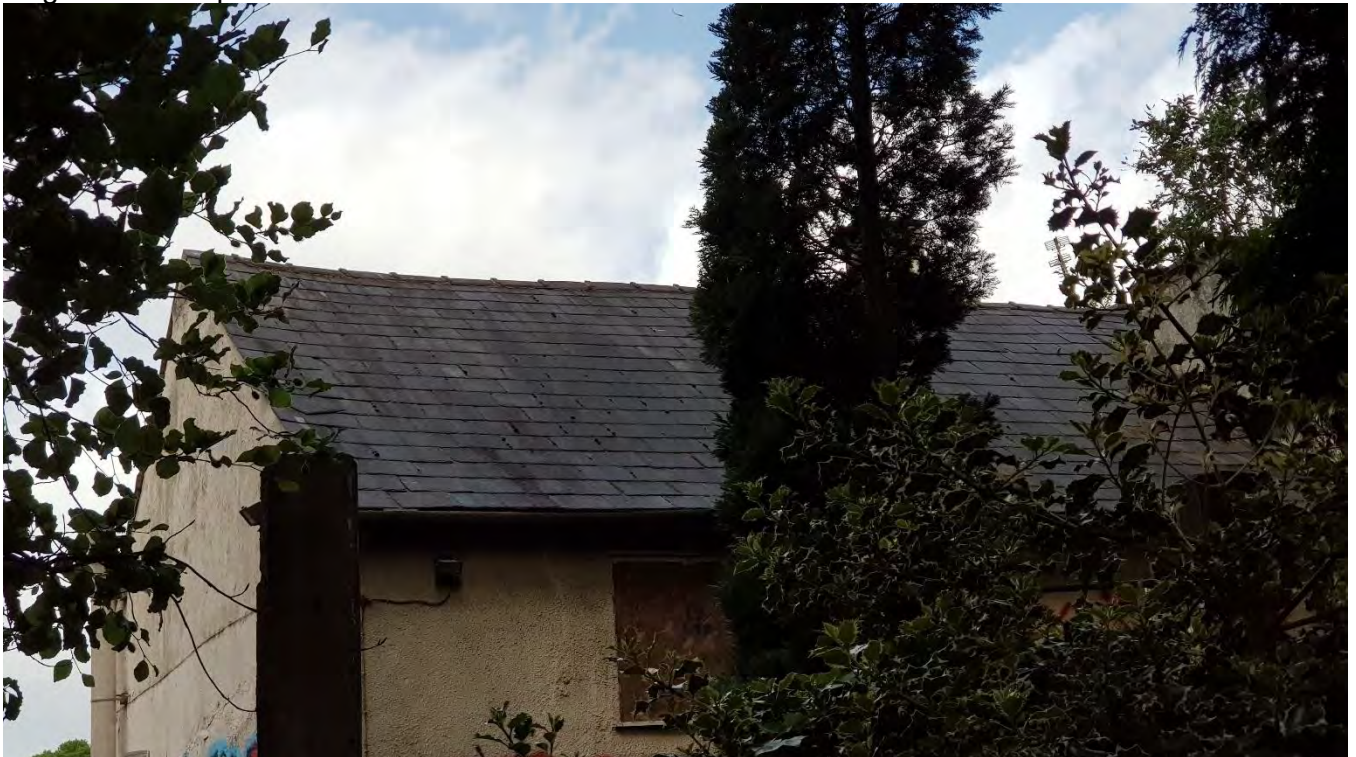
Original roof line distorted where the roof has settled due to rotten timbers, partial collapse

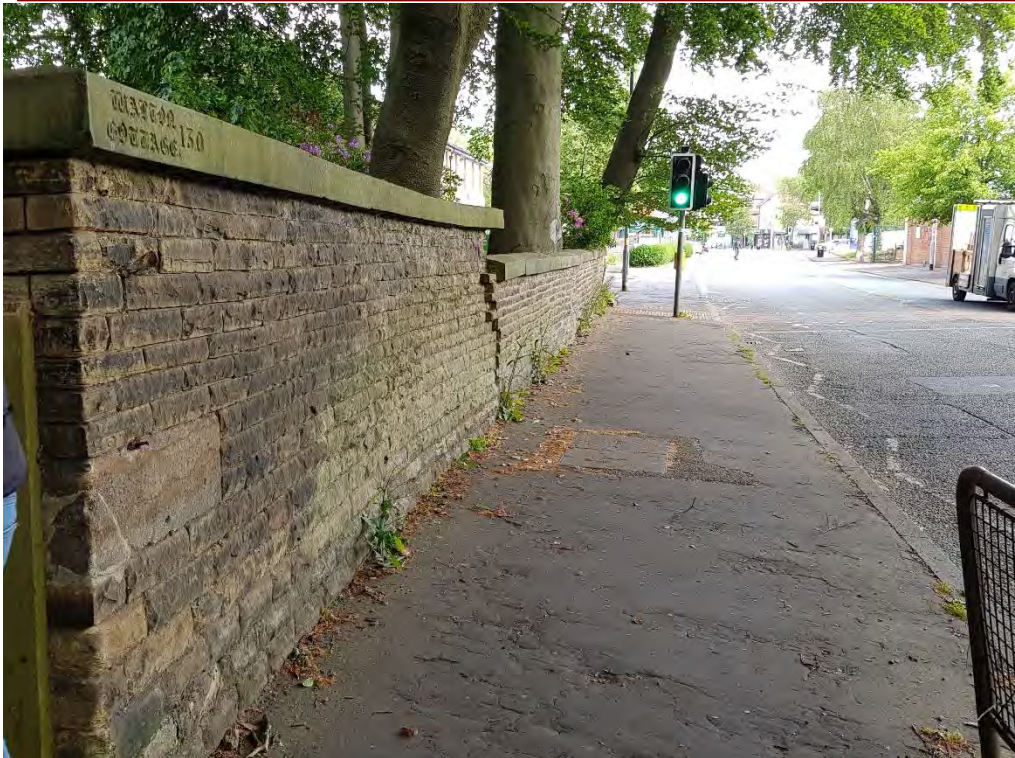
External boundary wall leaning out, damage due to tree growth

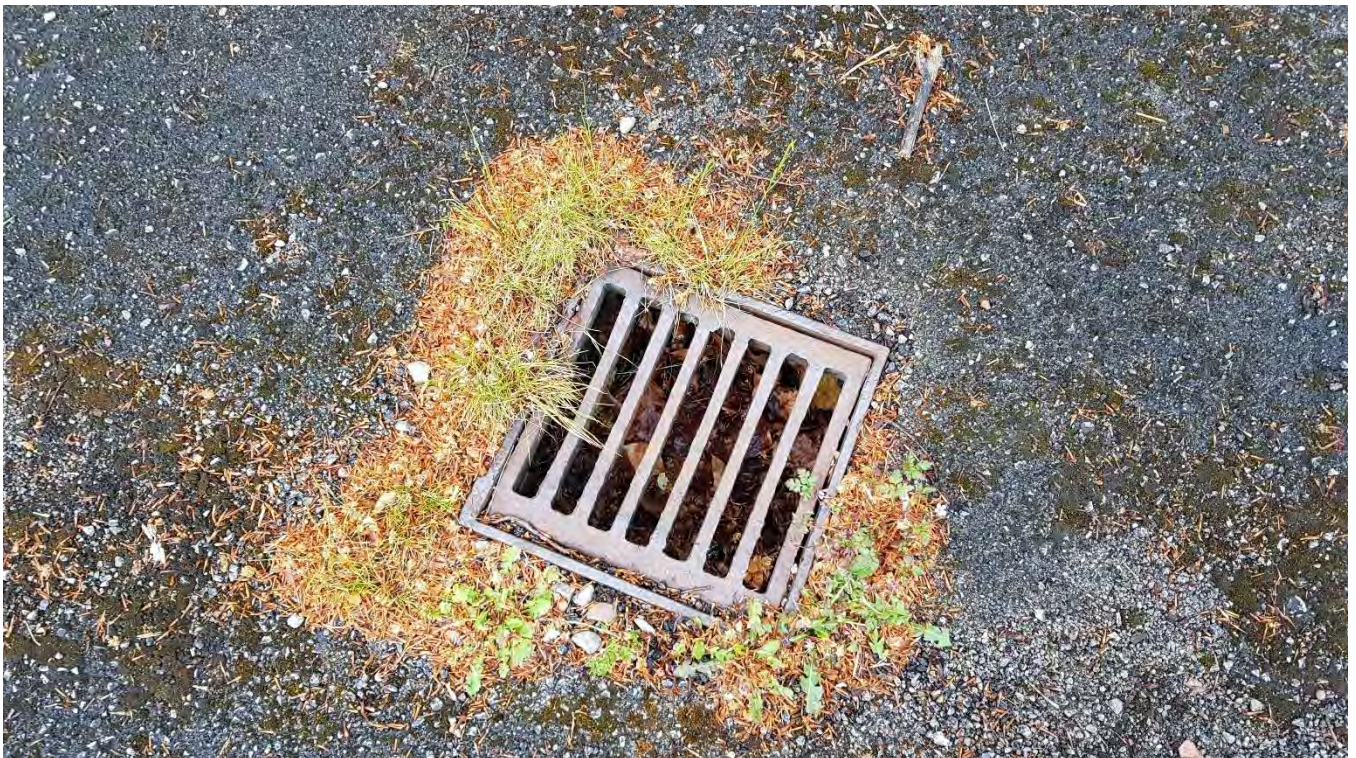
Blocked drains through lack of maintenance. The area around this gully is sunken which could mean further issues with leaking drains.

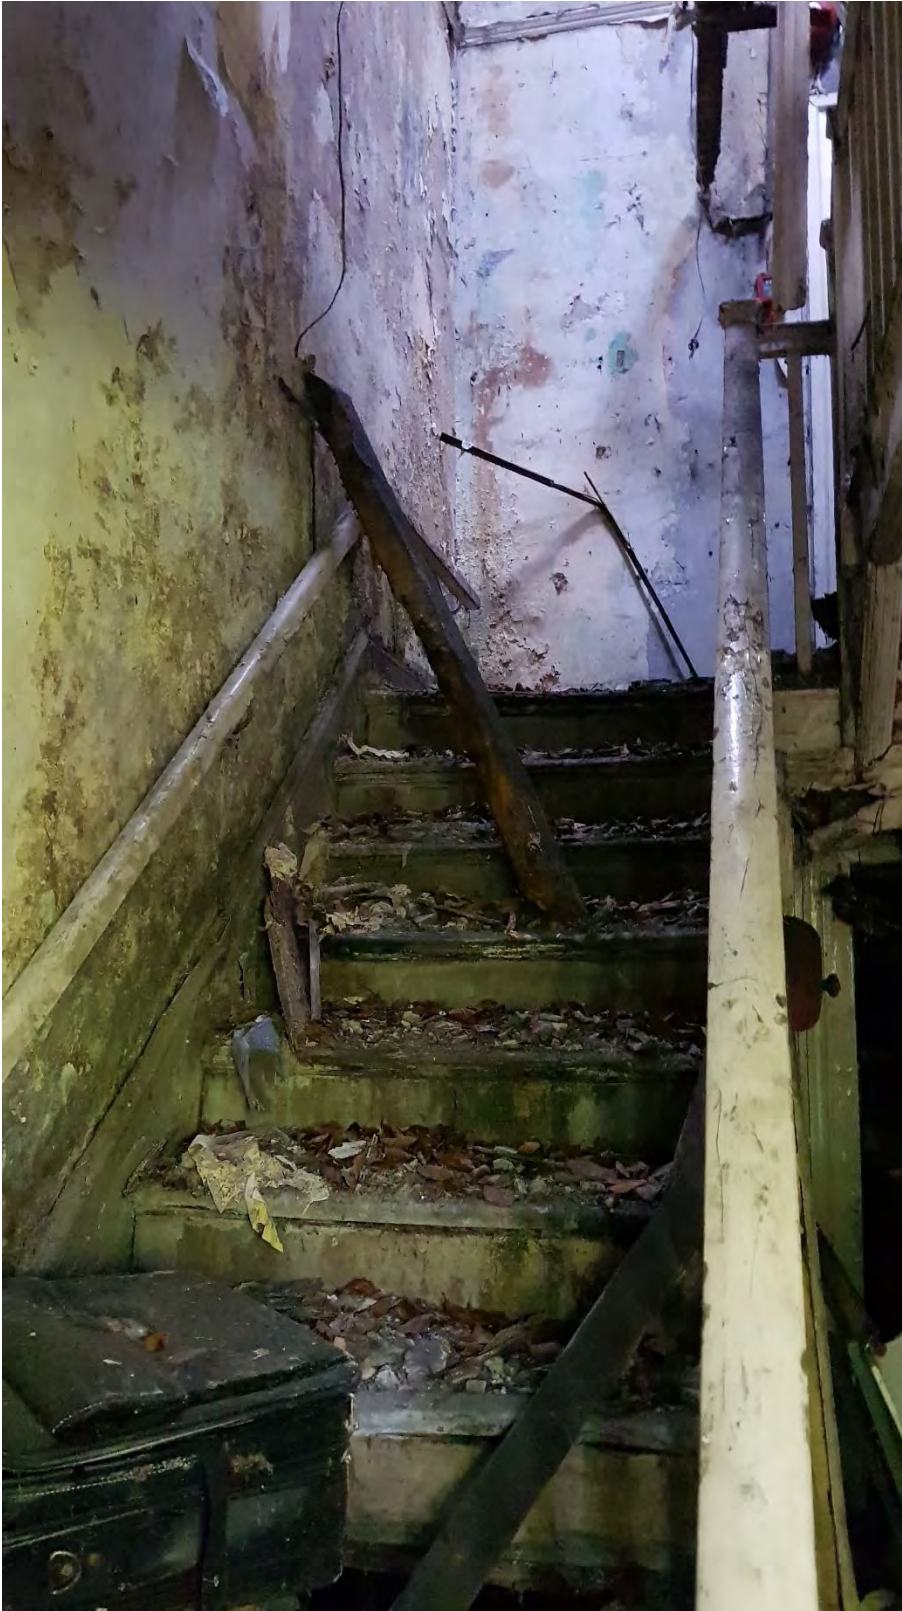
Internal staircase – roof and floor above are partially collapsed. The bottom step and handrail are rotten and no longer connected to anything

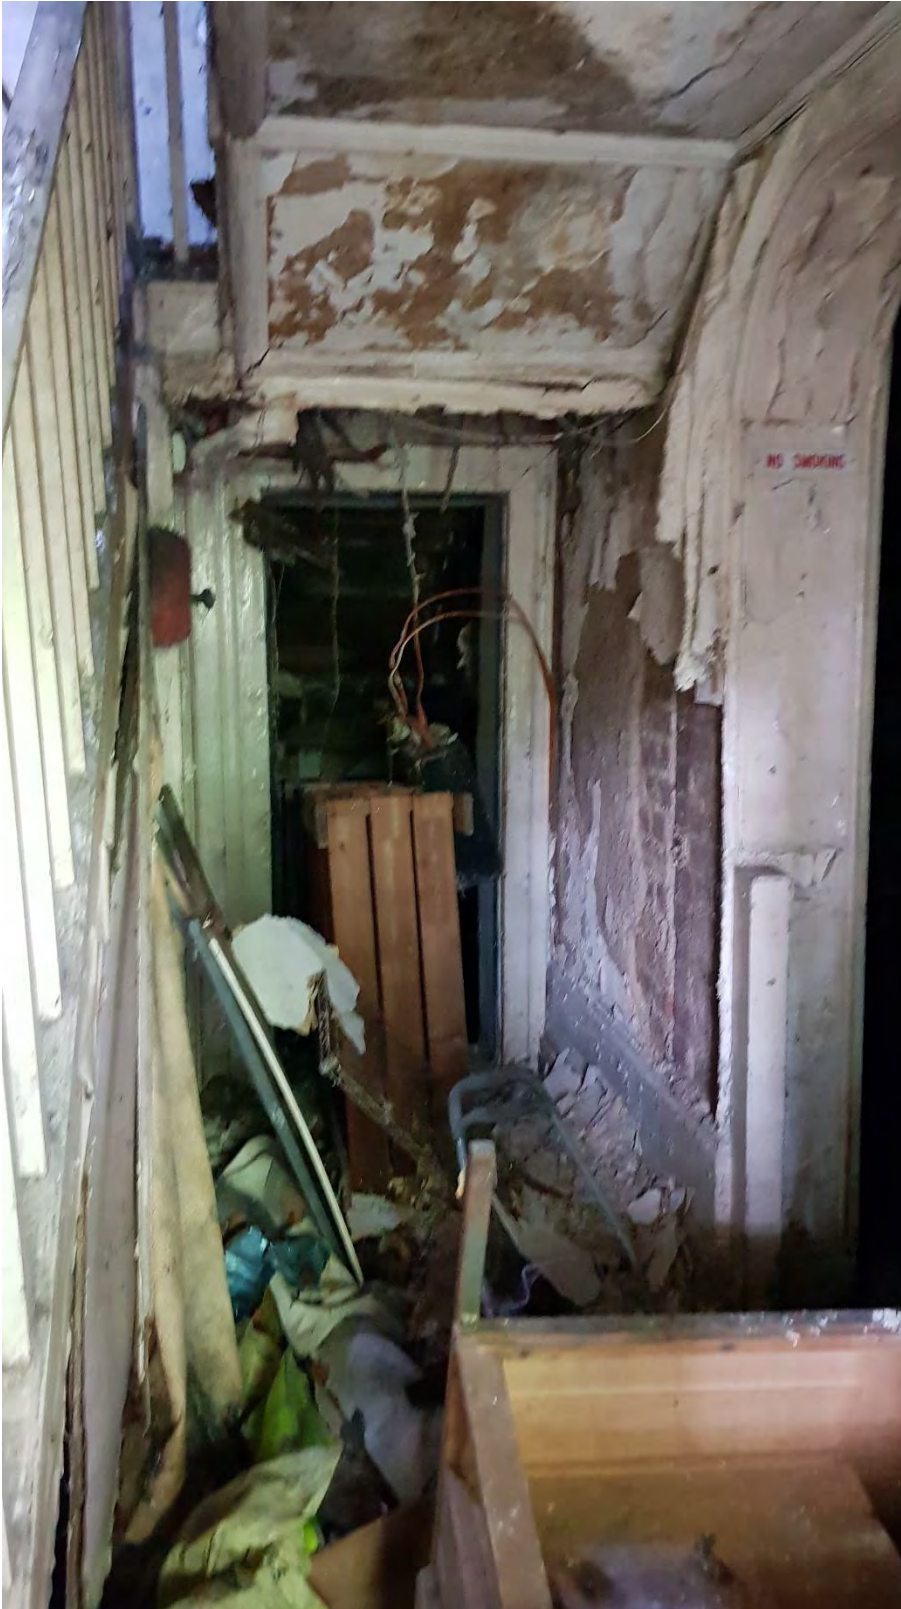
Debris and rubbish scattered throughout

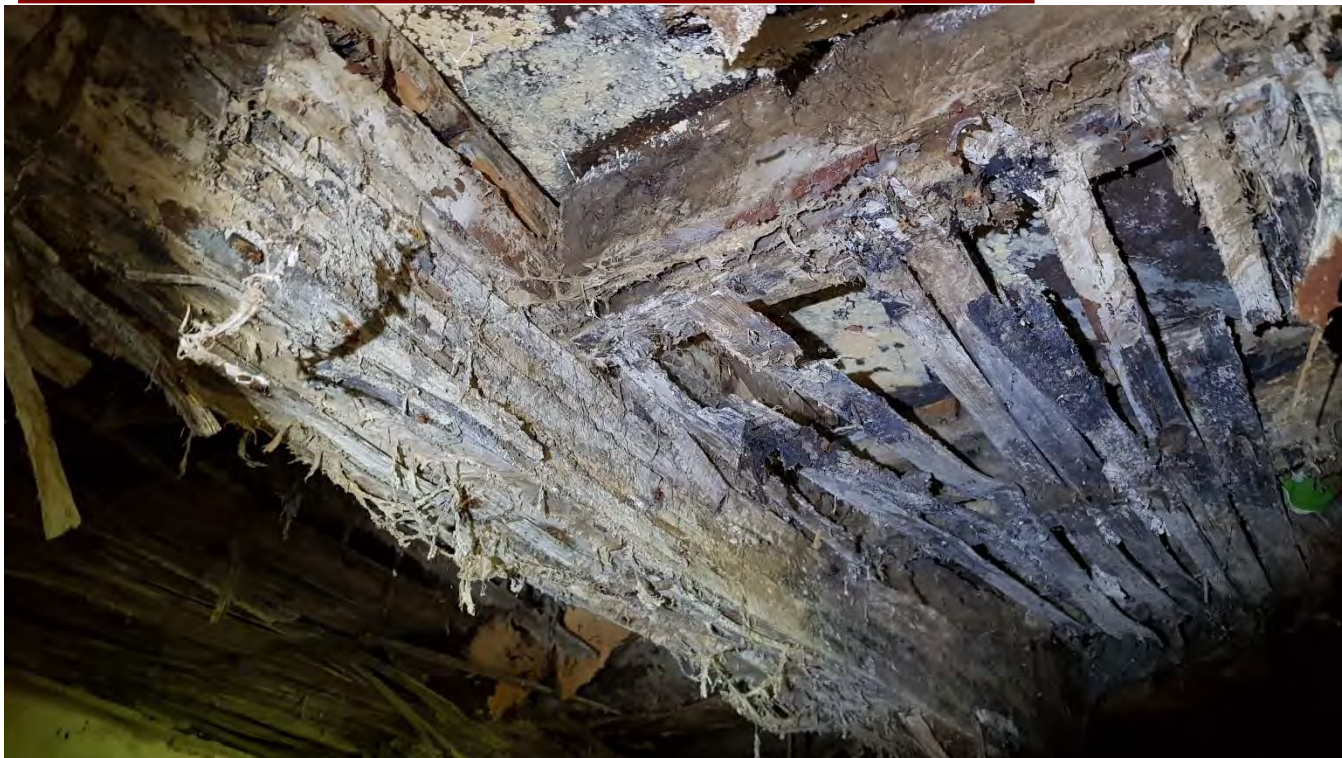
Ceiling over the room in the previous photo. Rotten first floor timbers

- The amount of visibly rotten timber suggests that the majority of the timber in the original house needs to be stripped out completely.
- There is a high probability that wet/dry rot has also spread through the masonry walls of the original property.

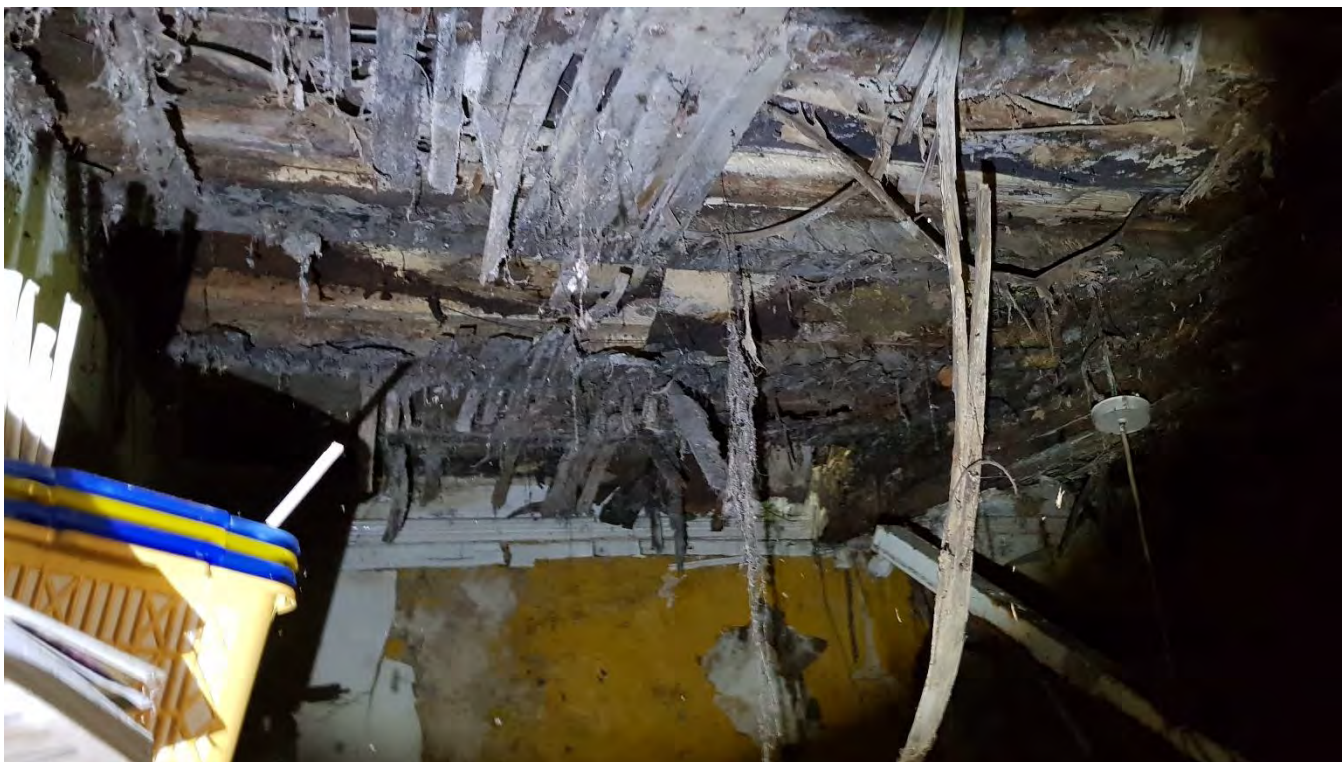
Partially collapsed ceilings. Rotten first floor timbers

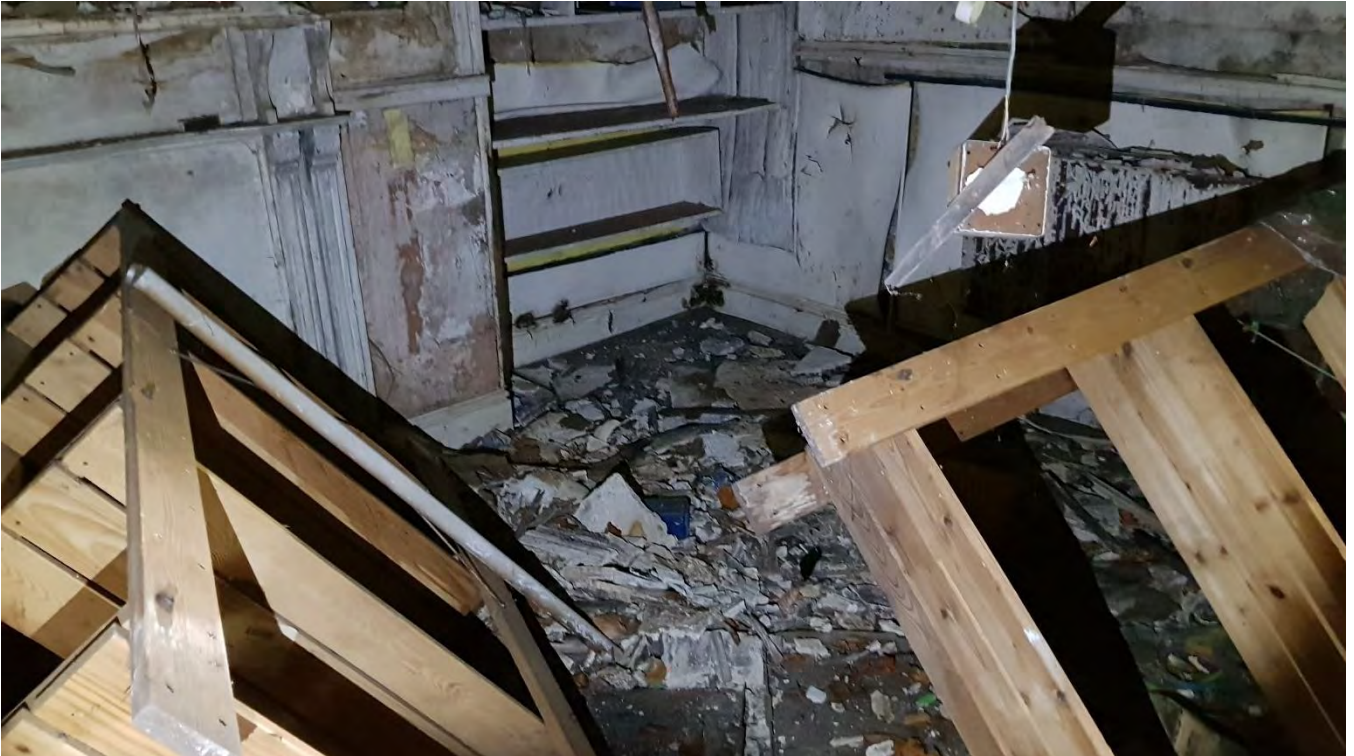
Debris to floors

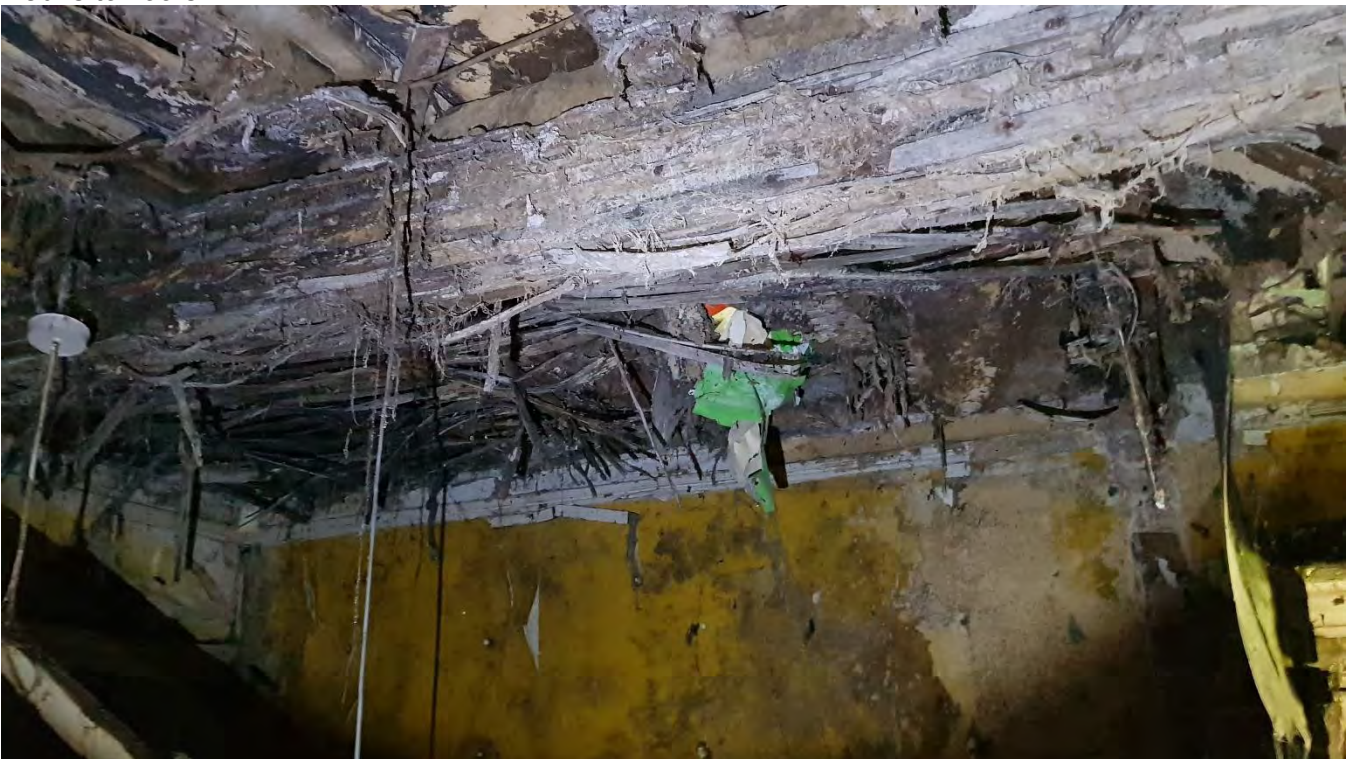
Rotten first floor timbers

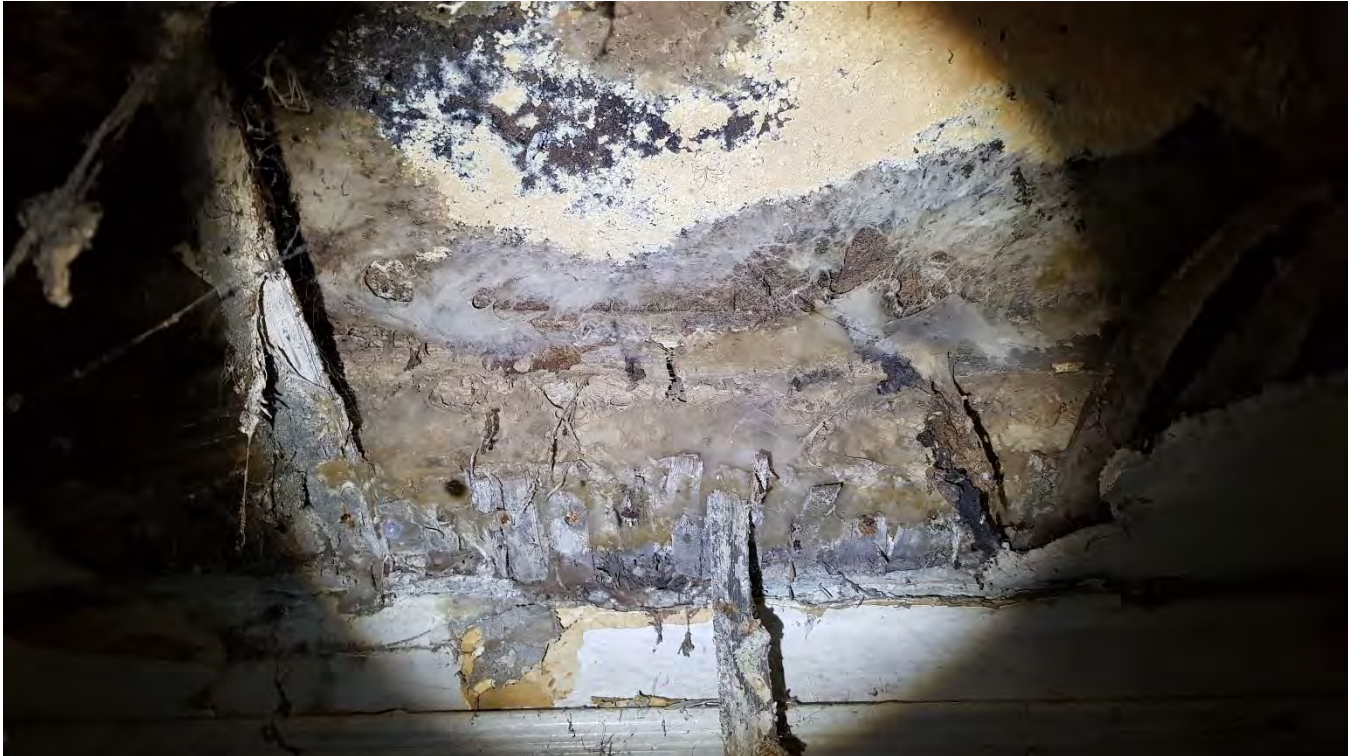
Potential dry/wet rot

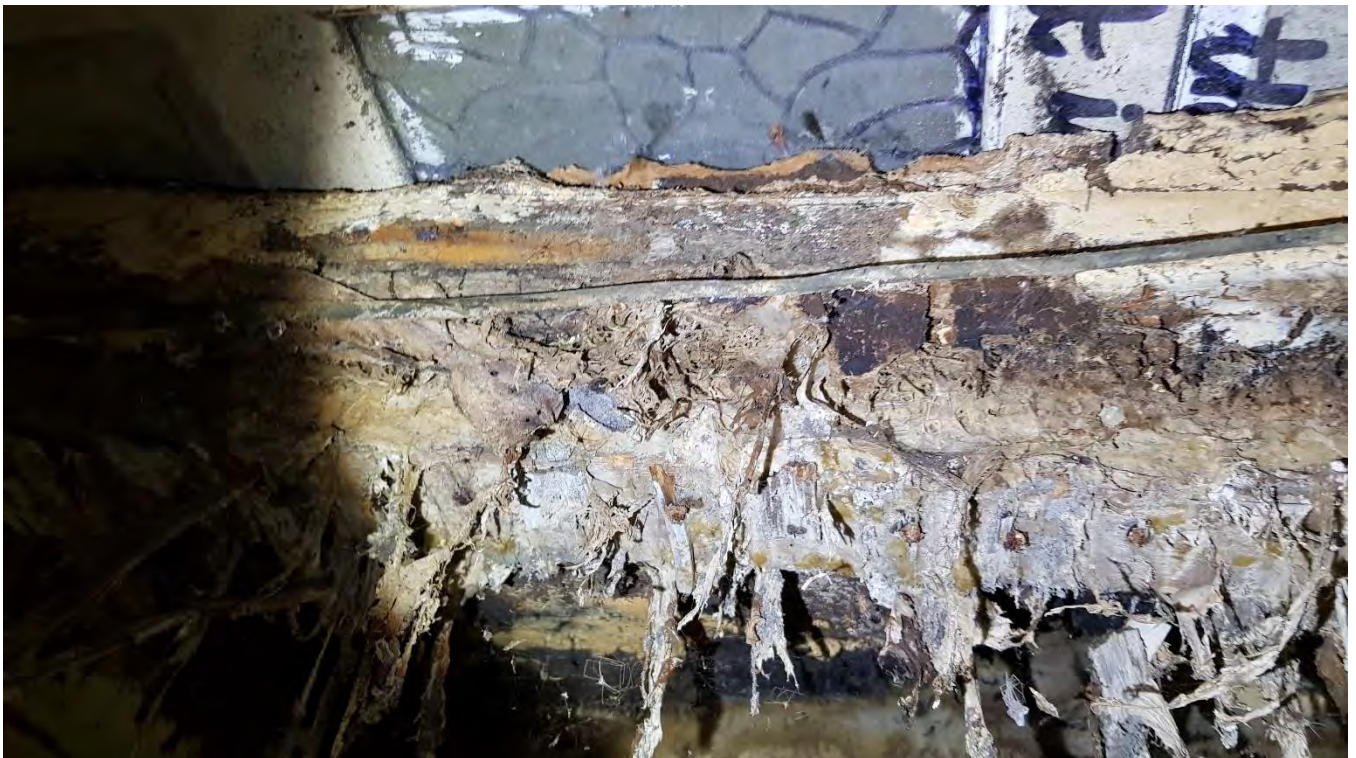
Potential dry/wet rot

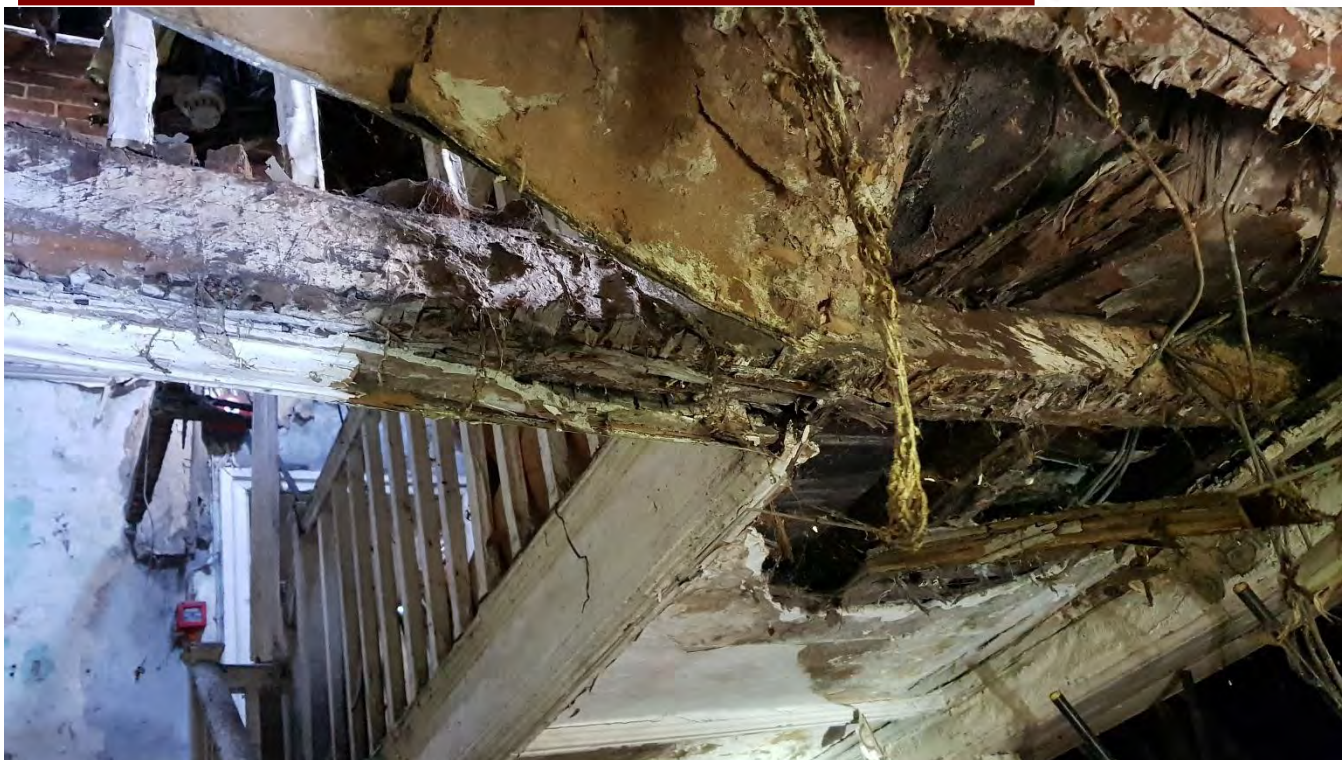
Rotten timbers support stair and landing

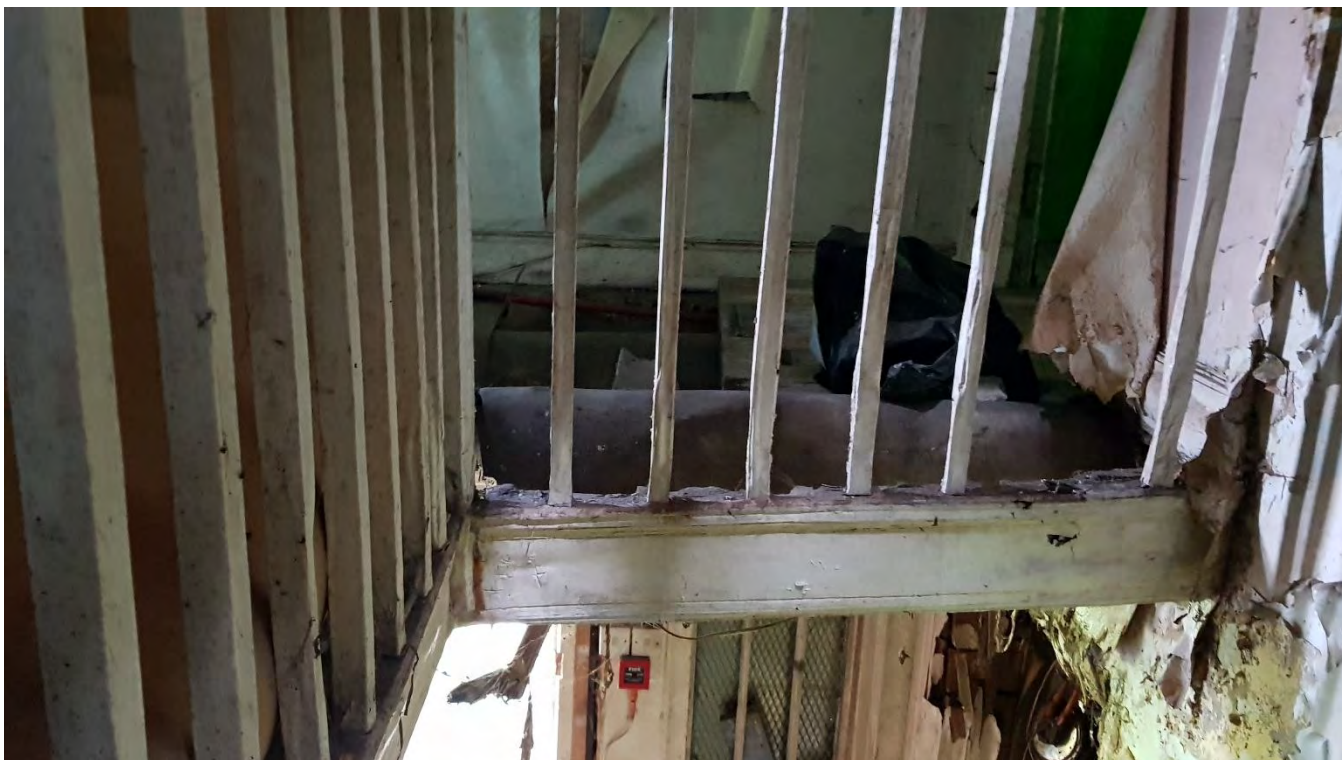
Floorboards missing to first floor

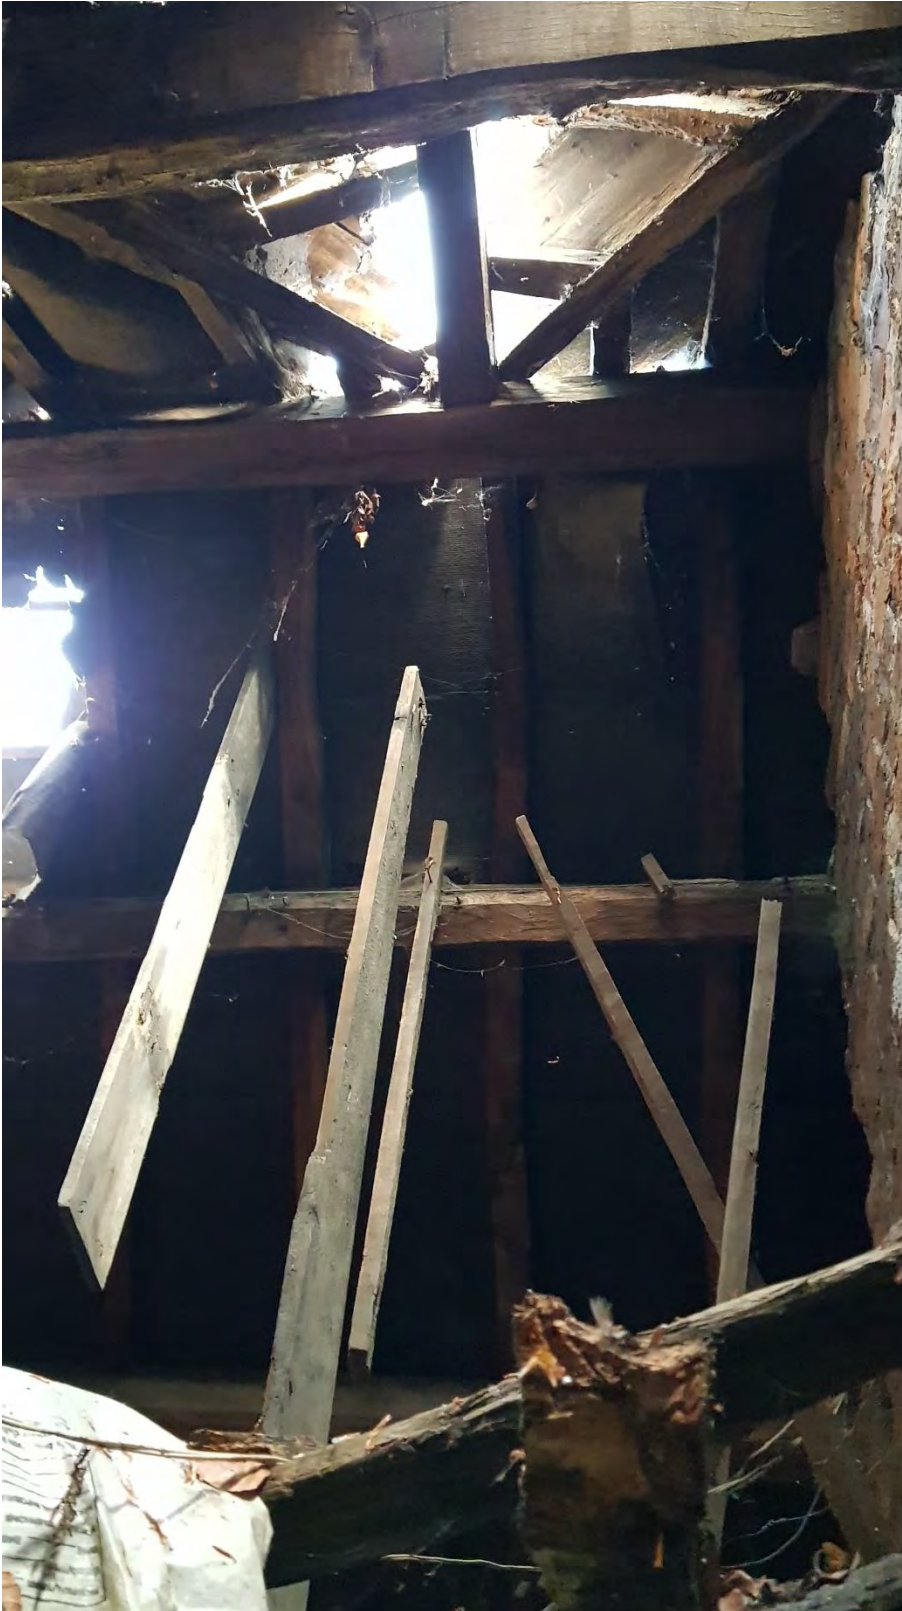
Collapsed roof and ceiling over stair

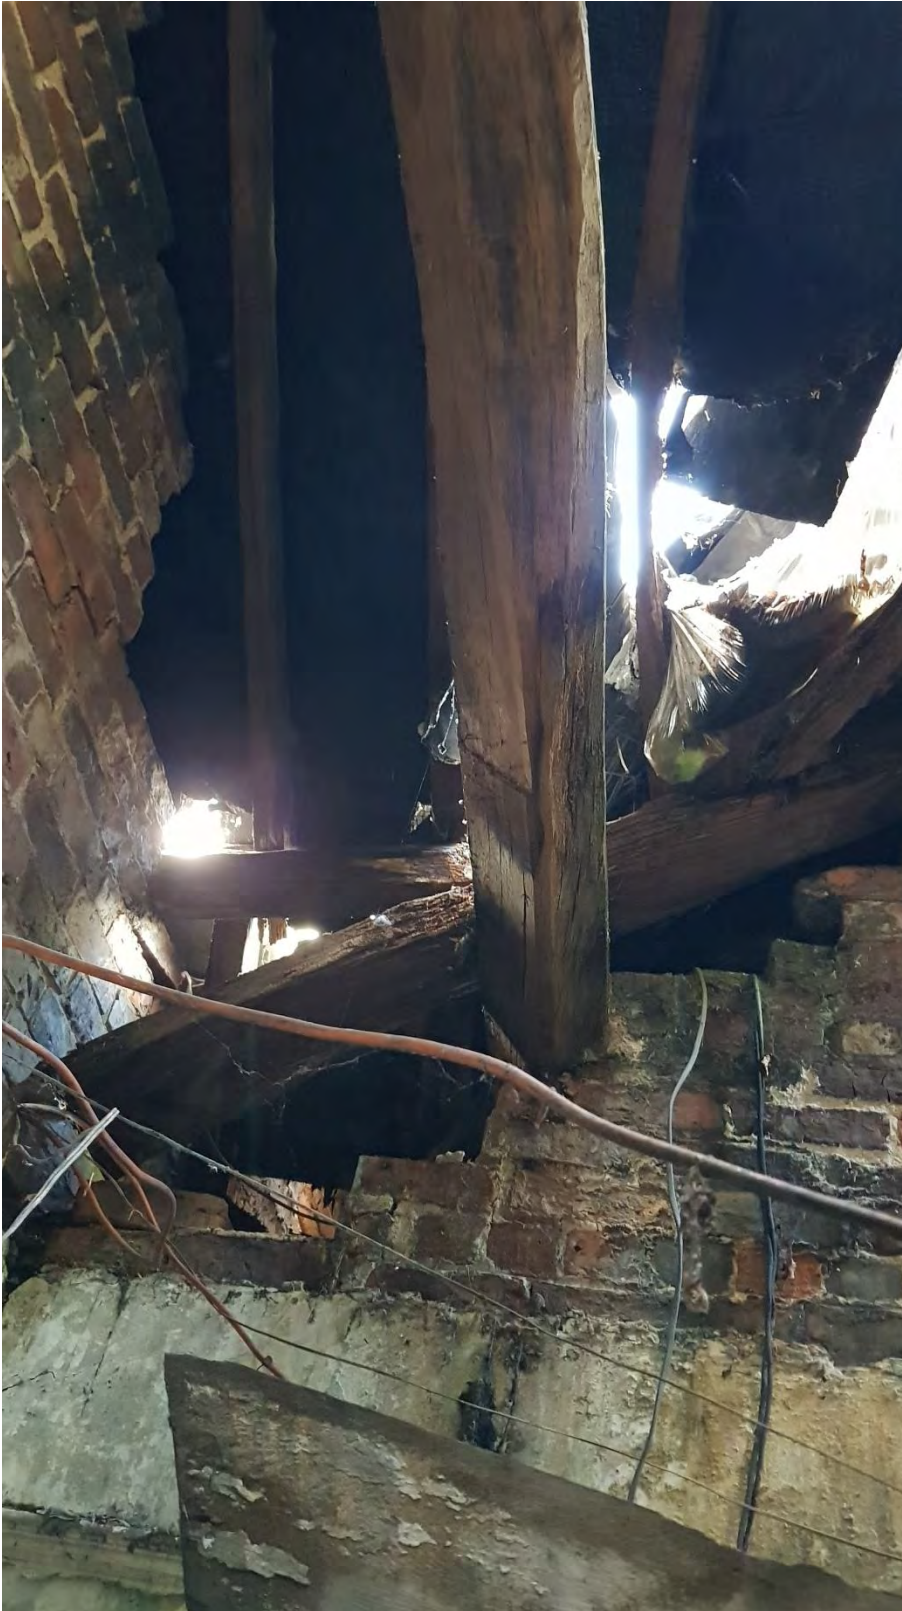
Partial collapse of roof. Purlin support inadequate due to masonry removal

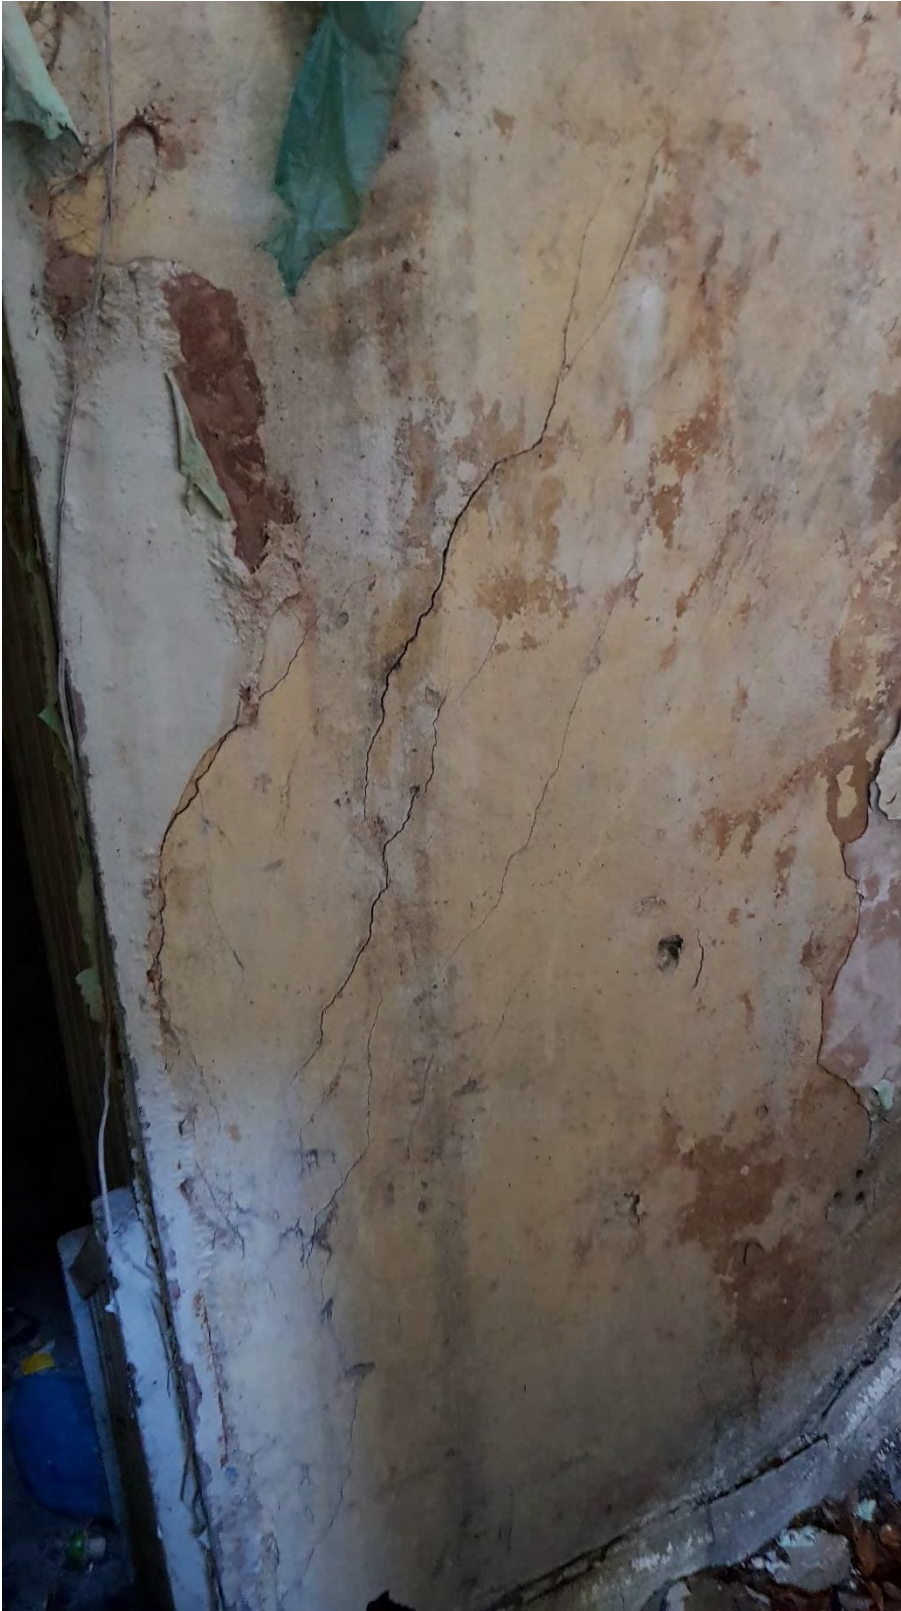
Cracking to internal walls
