## **Structural Inspection and Report, 136 Withington Road, Whalley Range, Manchester M16 8EE**

**Report Date:**  
27 May 2020

MH/5056

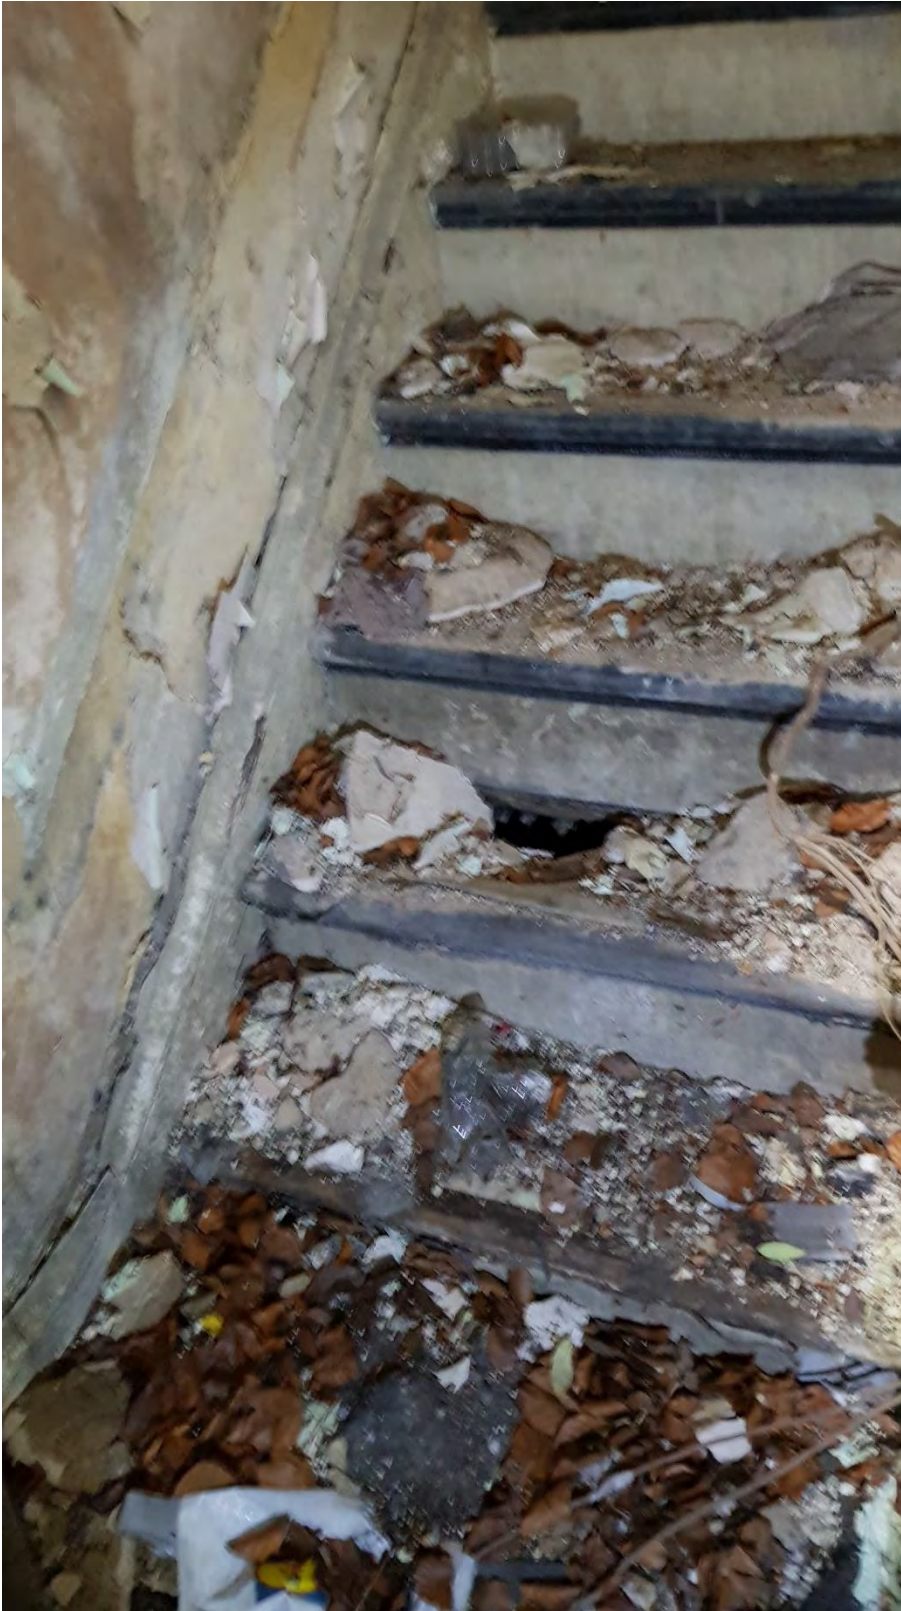
Holes in existing timber stairs (tread partially collapsed) and debris

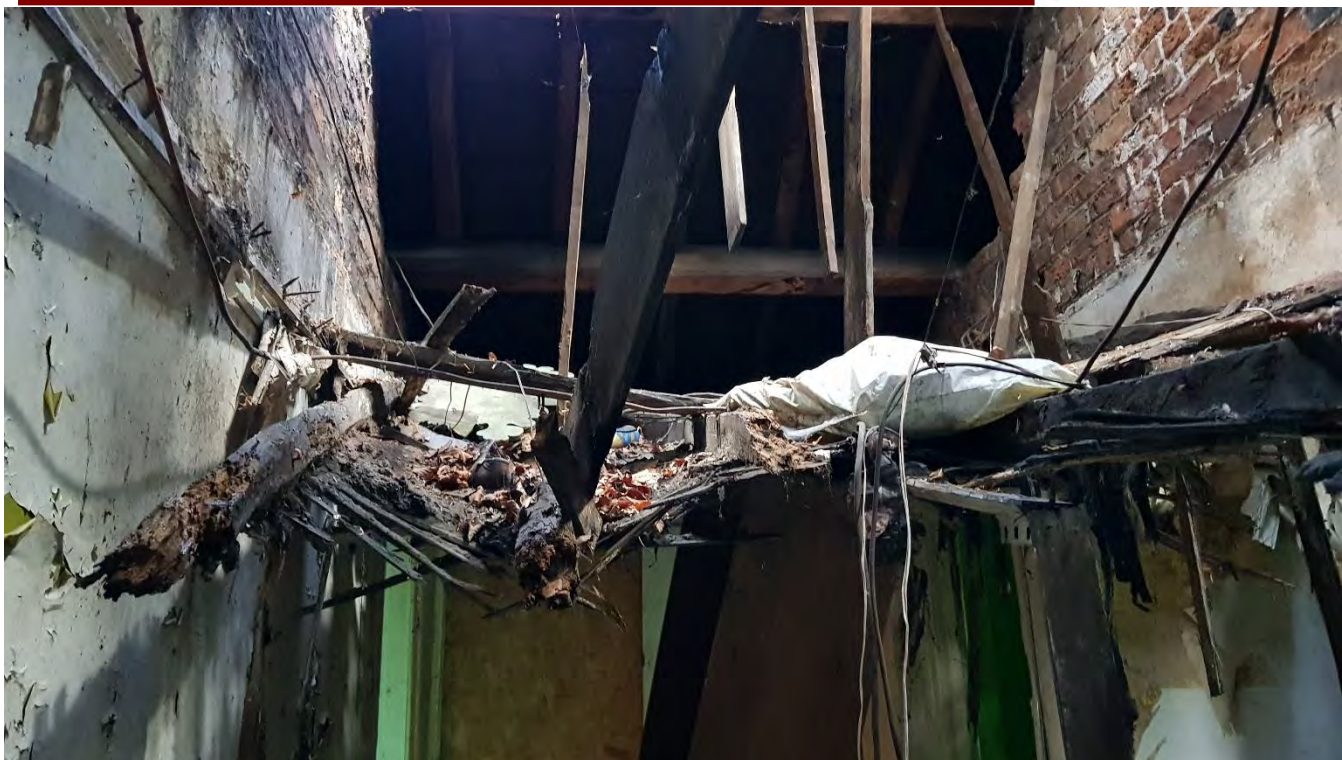
Collapsed ceilings

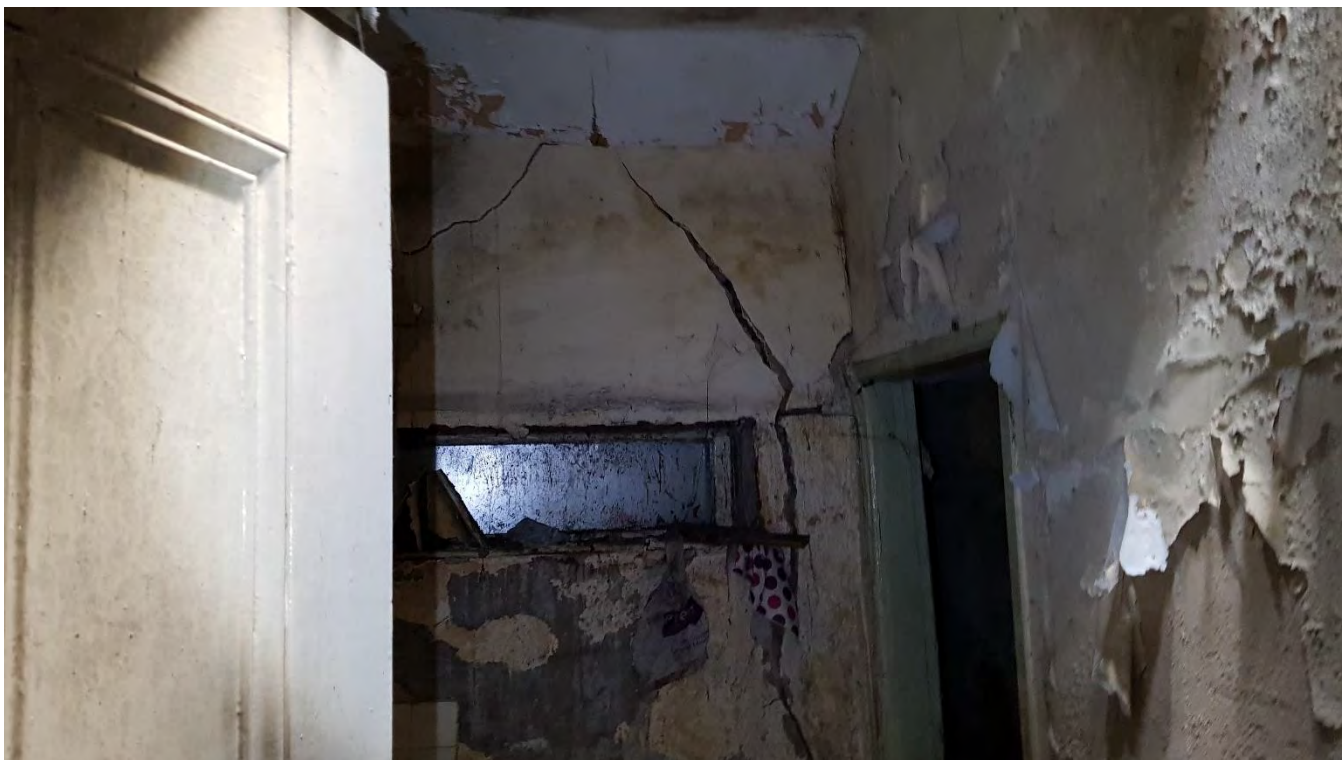
Significant cracking to internal walls

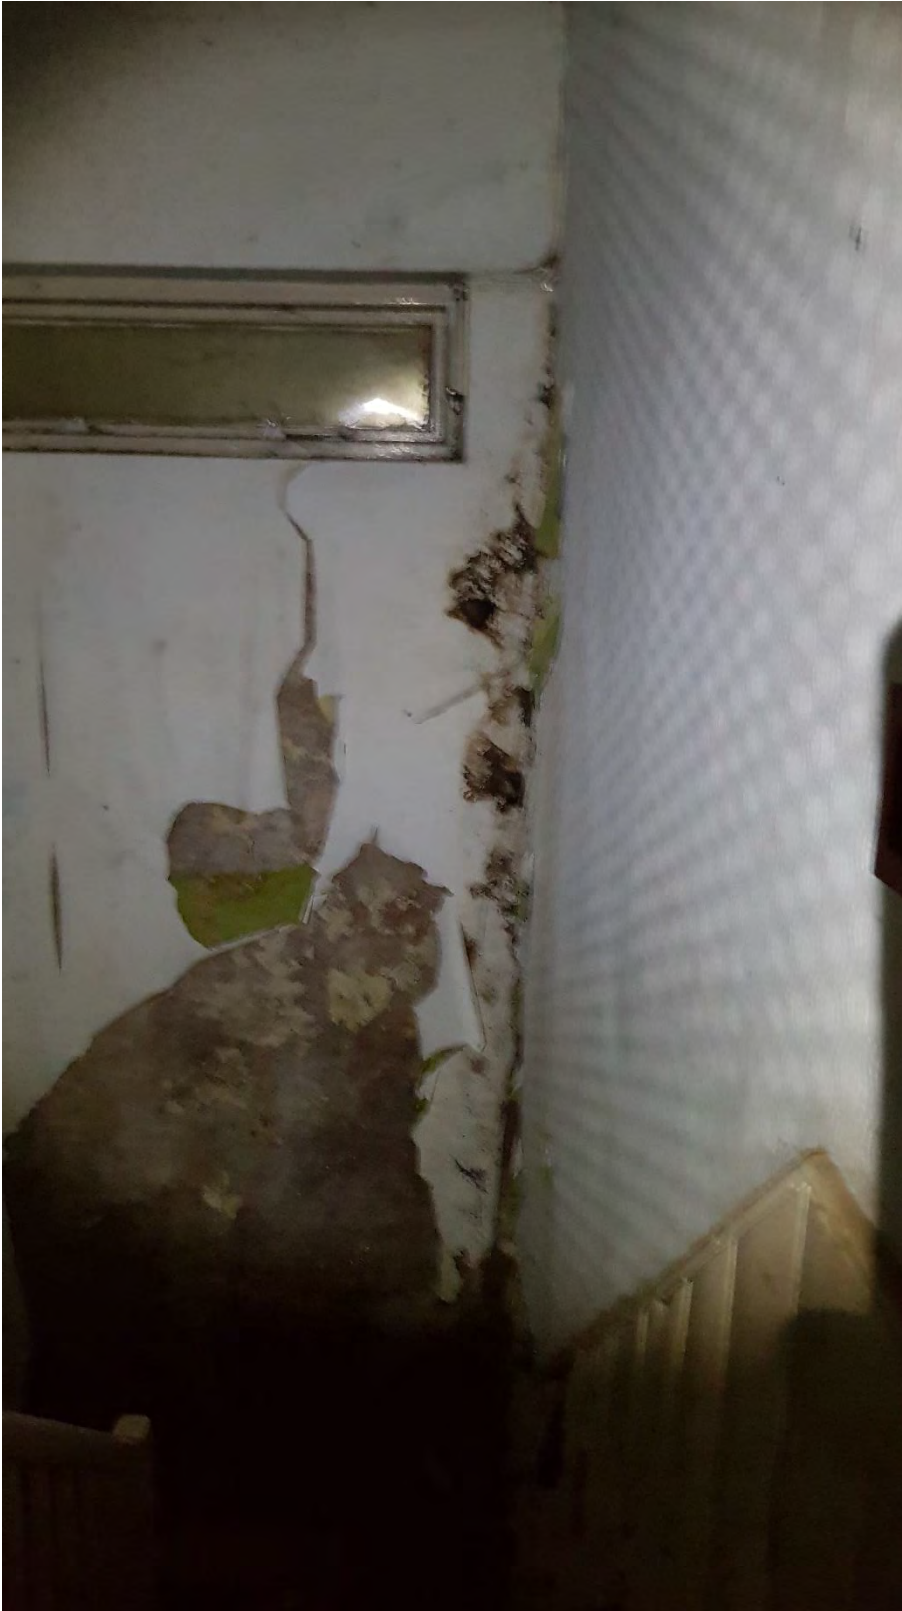
Potential rot in the corners

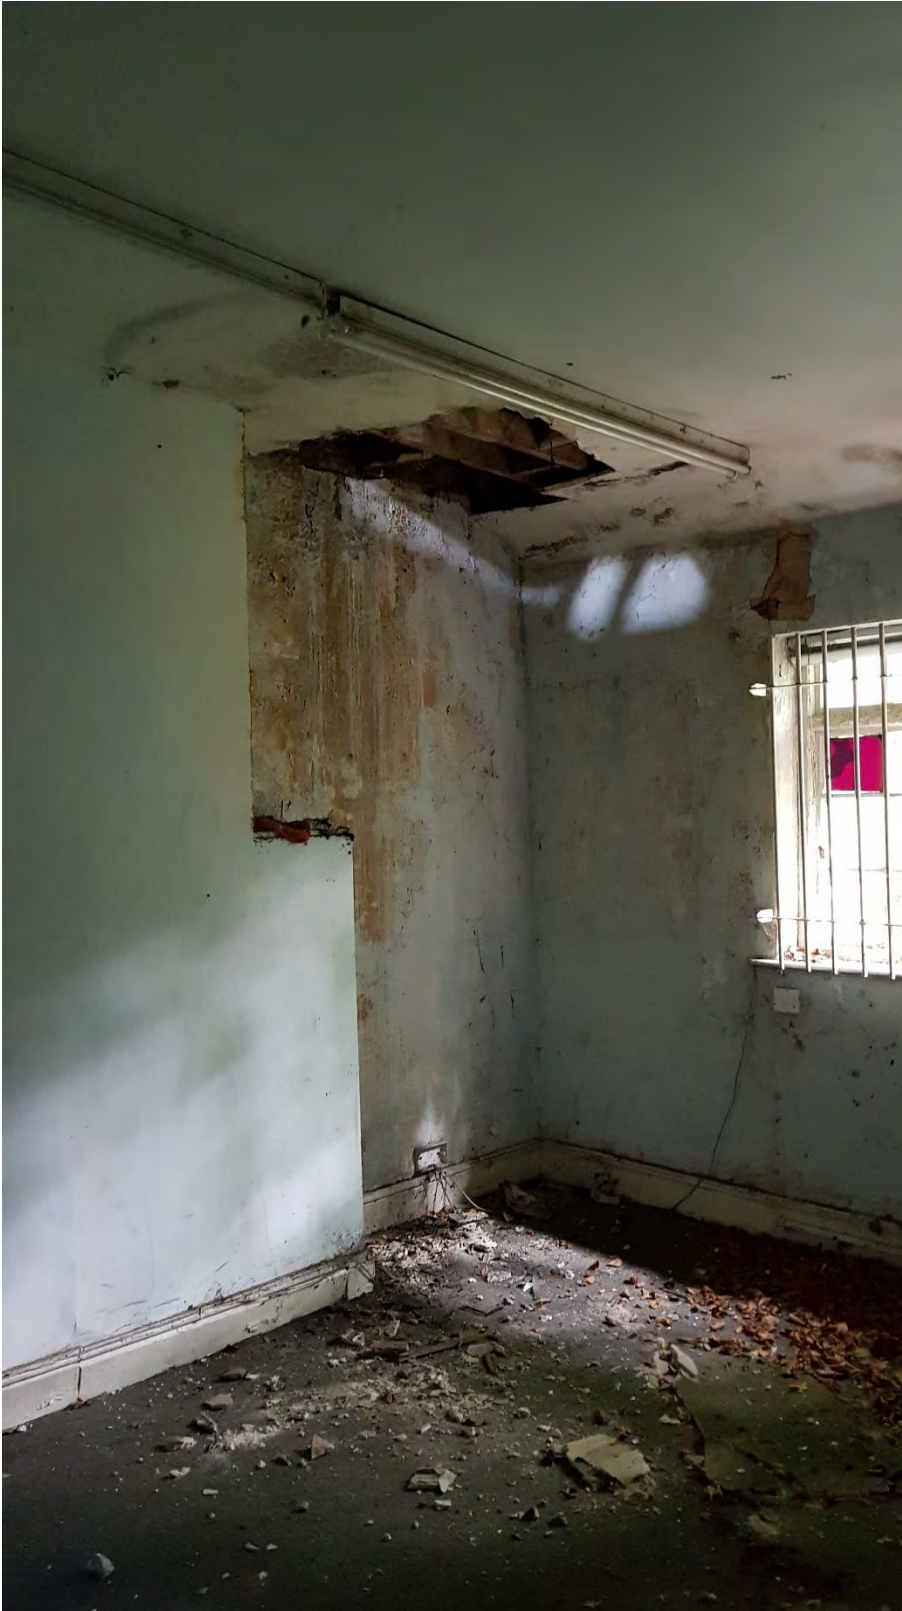
Partially collapsed ceiling above first floor

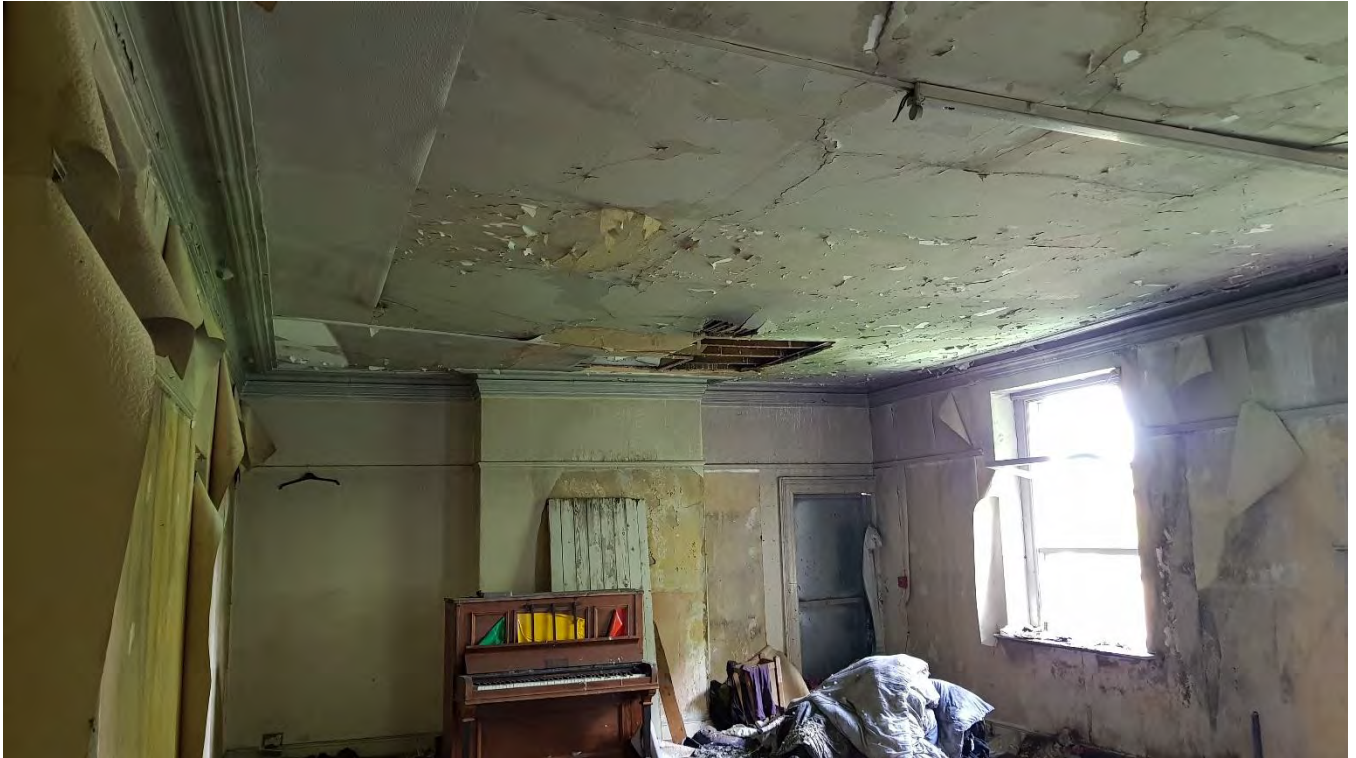
Partial collapsed ceiling in original house (west end of north wing above first floor)

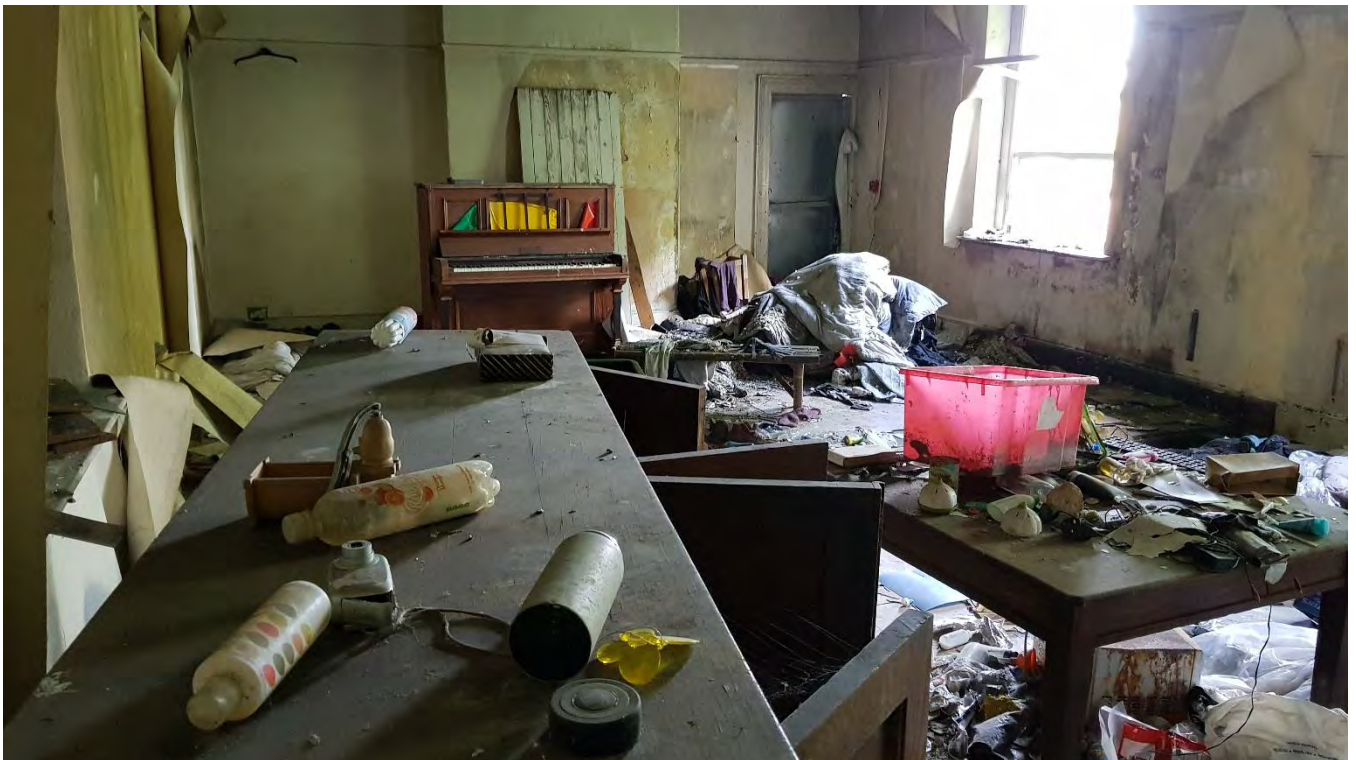
Debris and holes through first floor prevent access

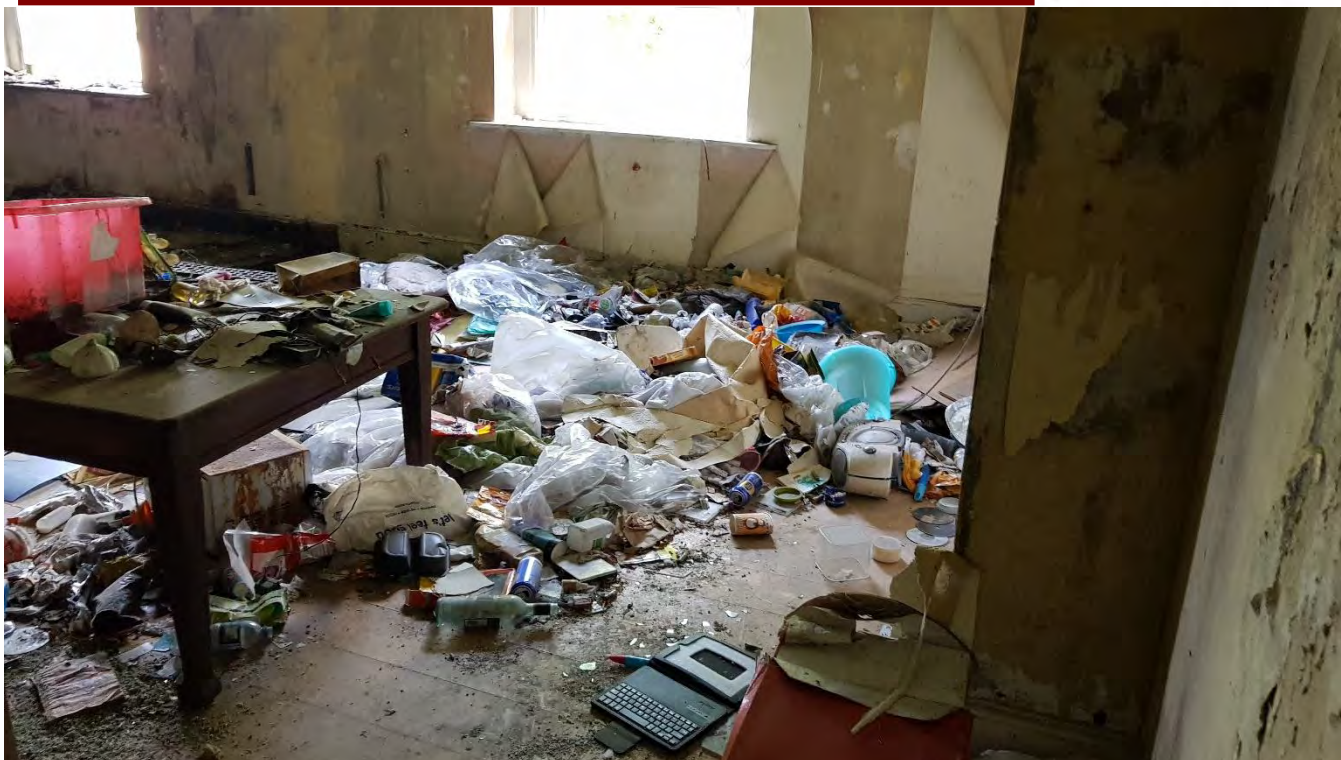
Debris to first floor

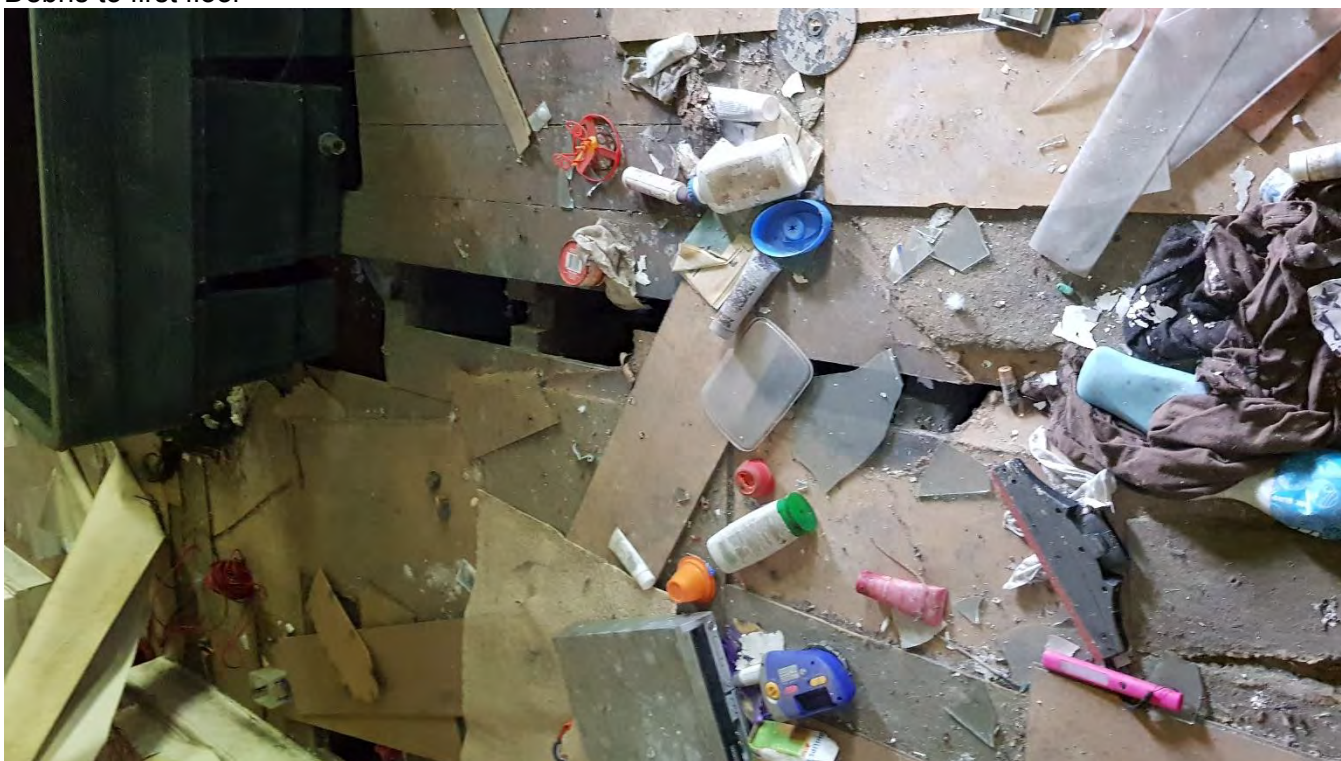
Broken glass and holes through floors prevent better access

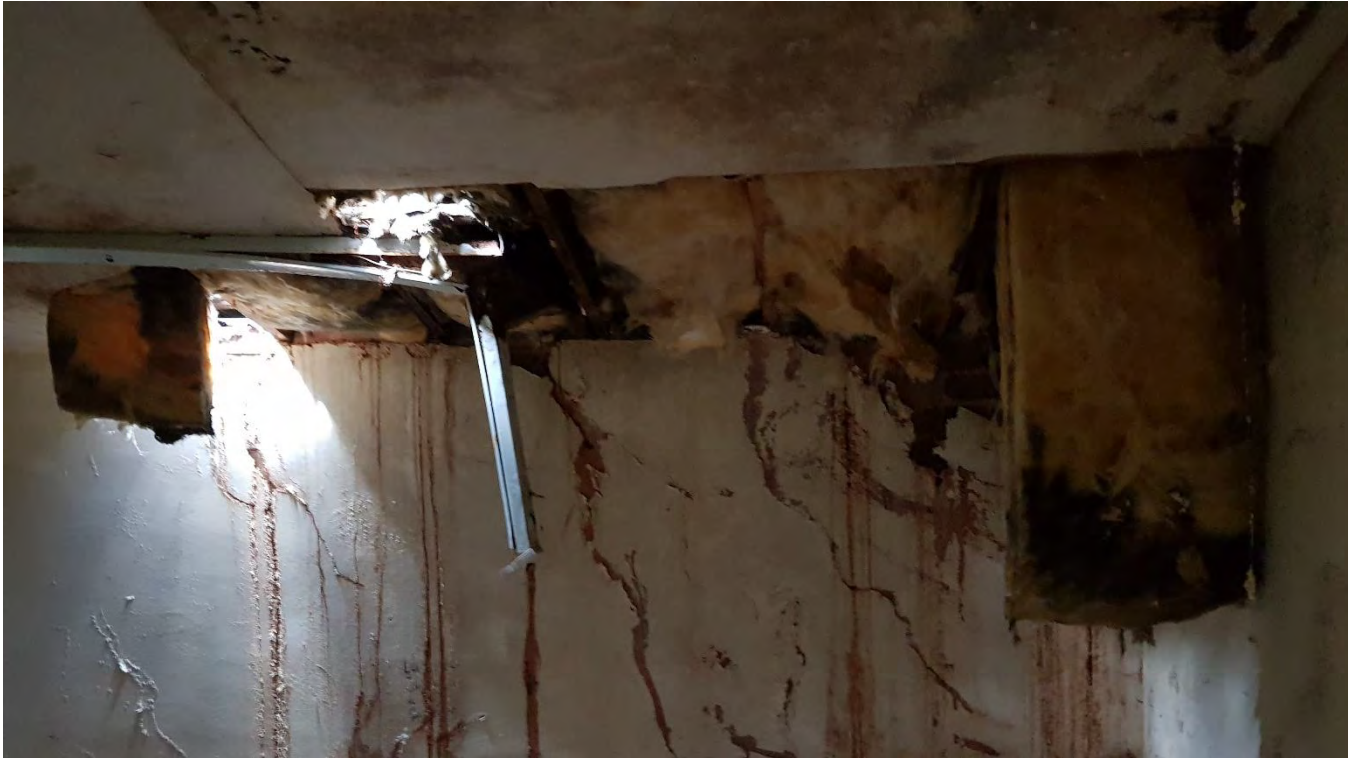
Partially collapsed ceiling and water damage in the two-storey link structure

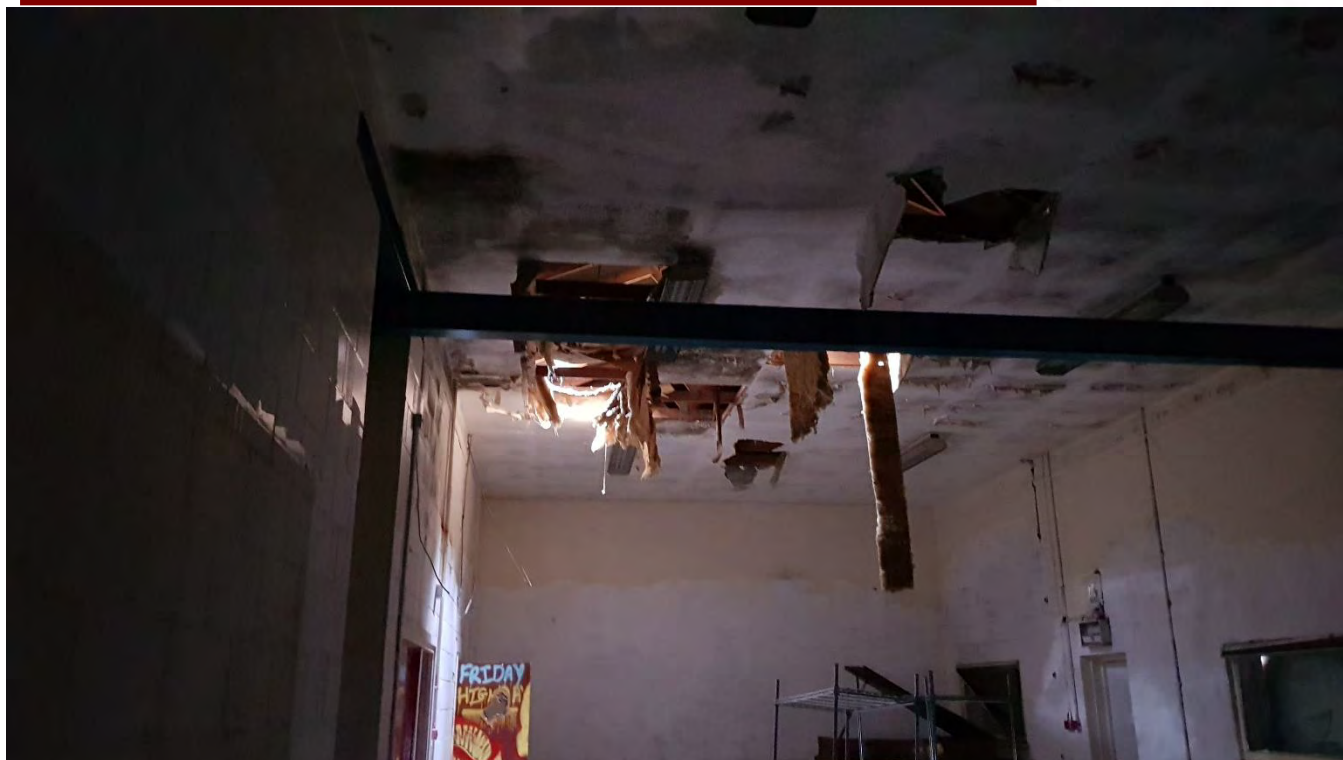
Holes in the ceiling of the single storey extension

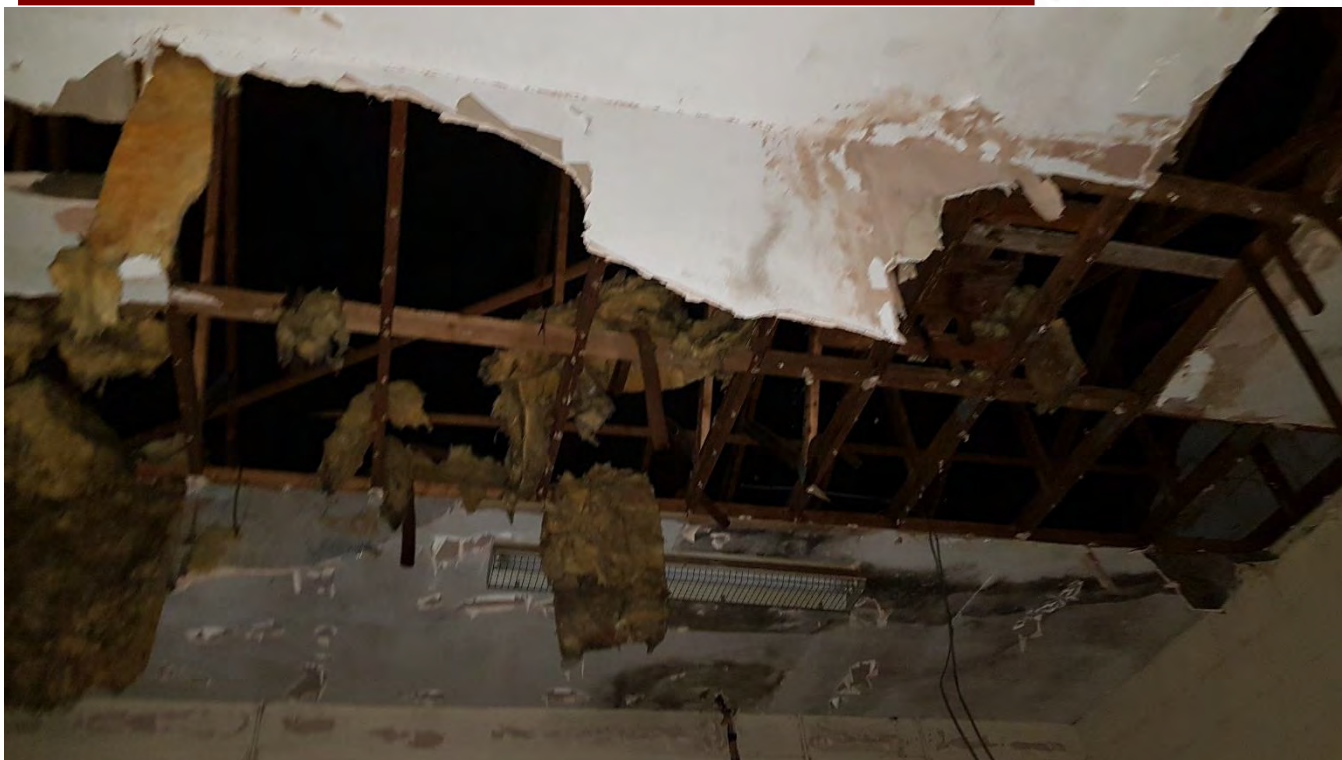
Collapsed ceiling in single storey extension

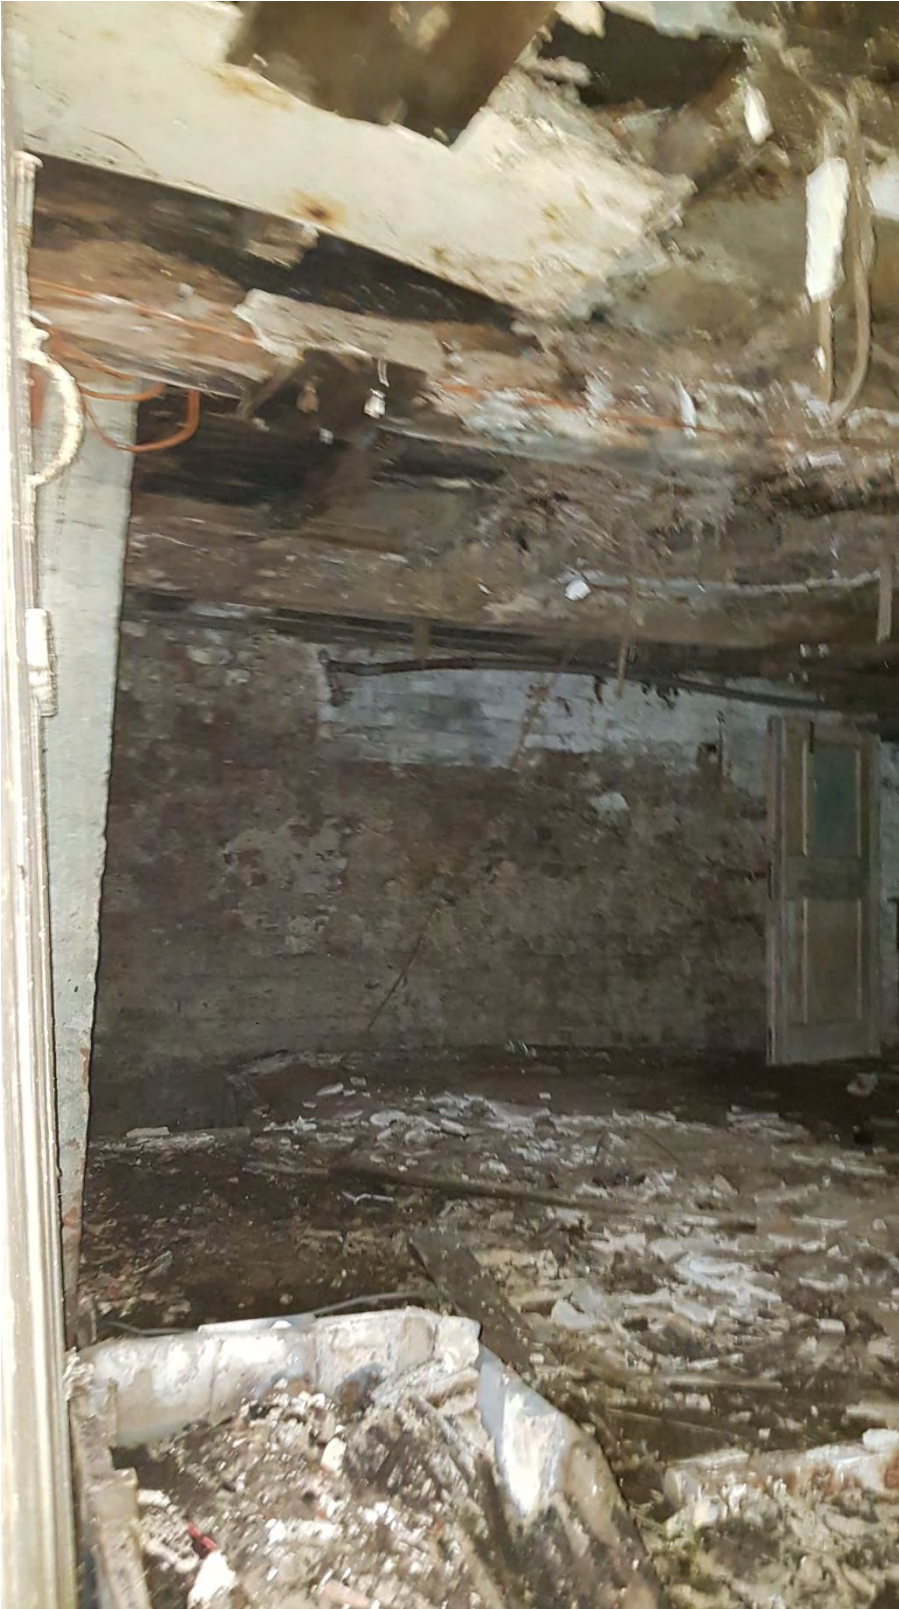
Storage space under ground floor – note rotten timbers and debris

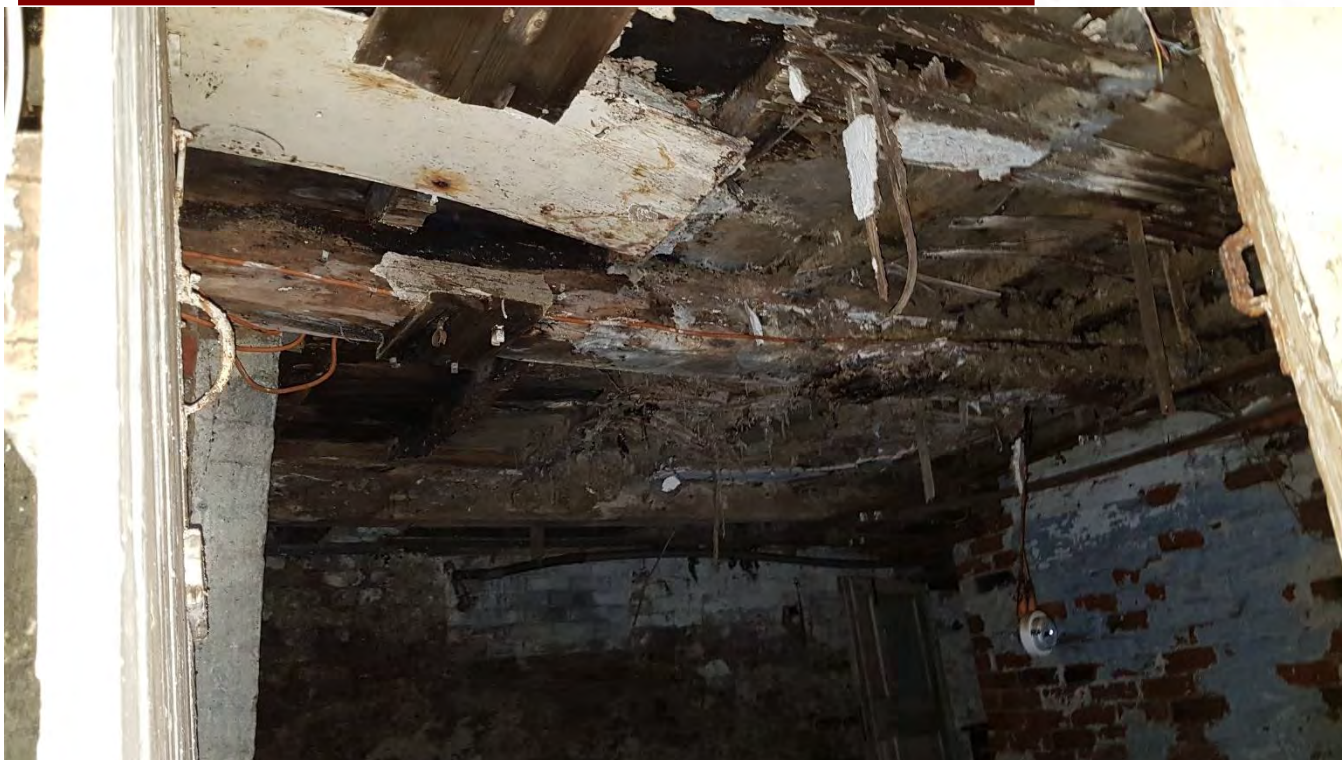
Underside of ground floor – note rotten timbers

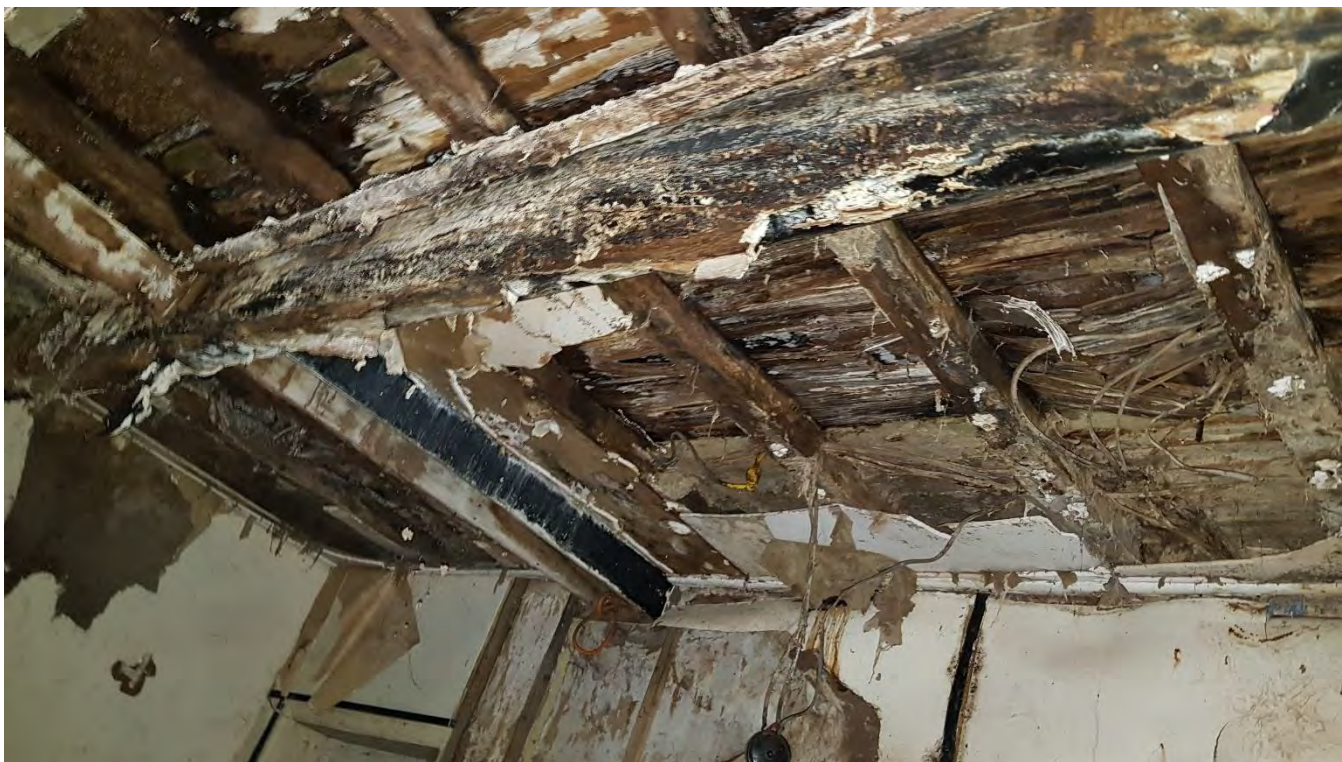
Rotten timbers to underside of ground floor
