## Bituminous Interim Inspection

| <b>PROJECT NUMBER</b> | B190846/1 | <b>AREA MANAGER</b> | John Wilkinson |
| <b>PROJECT NAME</b> | Paterson Building - Christie Hospital | | |

| <b>INSPECTED BY:</b> | Anthony Symondson | <b>Date:</b> | 04-02-2022 |

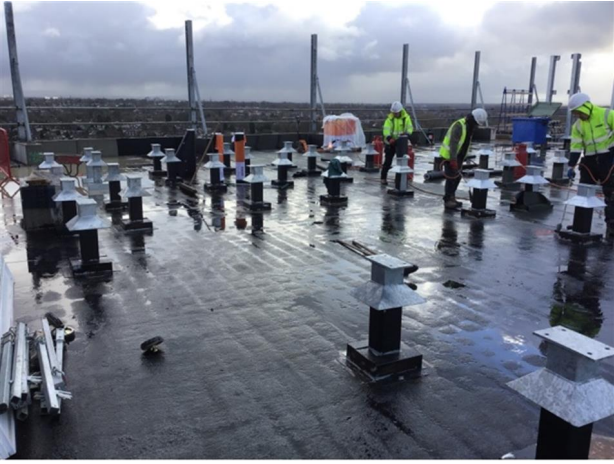
Progress to date as follows, ROOF 9 SECTION 1 is 95% complete with perimeter detail and plinth details to finish. SECTION 2 is 10% AVCL installed. SECTION 3 is approximately 70% AVCL installed

**Photo 1 - View of progress to section 3**

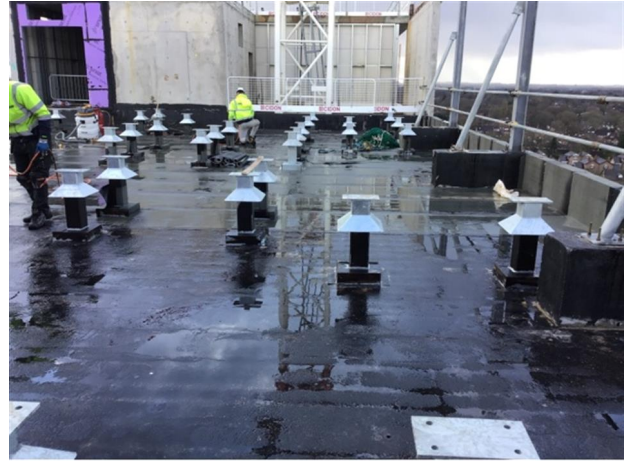
**Photo 2 - View of section 3**

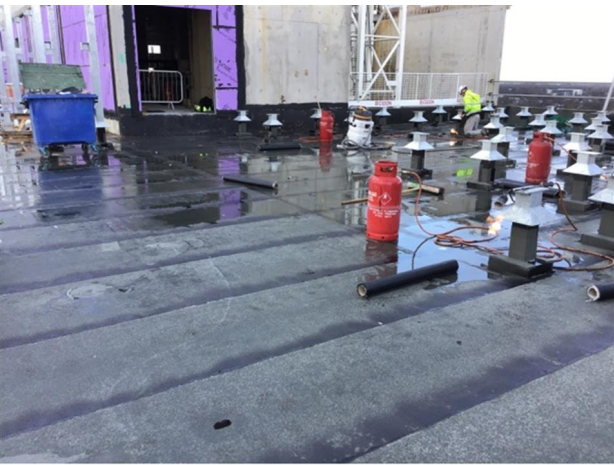
**Photo 3 - View of AVCL to section 3**

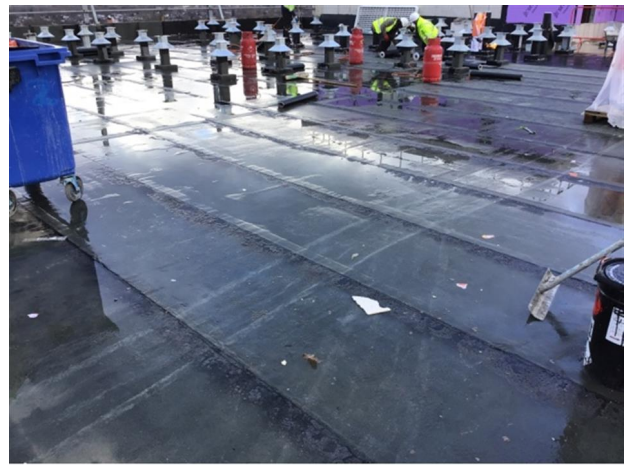
**Photo 4 - View of AVCL to section 3**

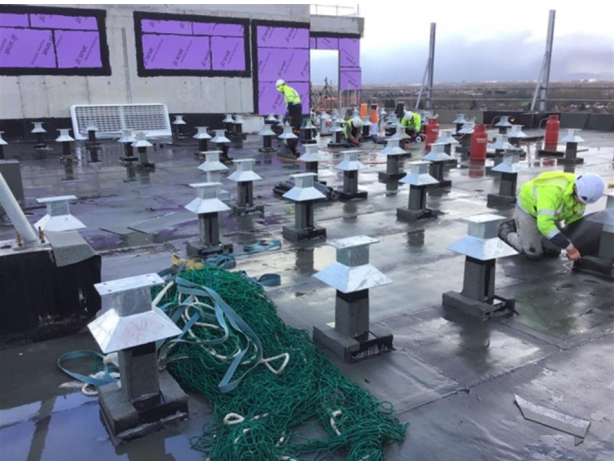
**Photo 5 - View of post details to section 3**

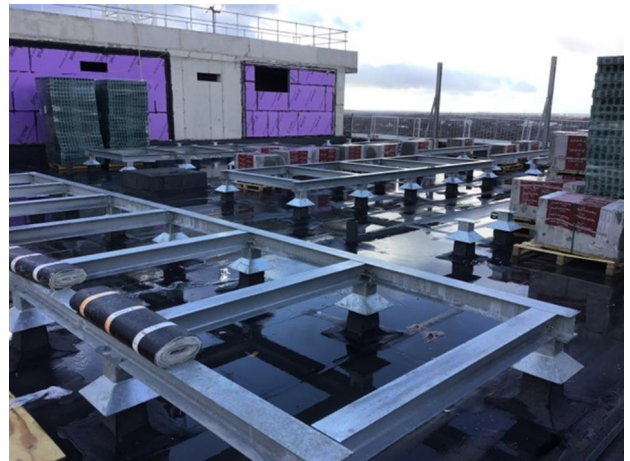
**Photo 6 - Overview of section 1**

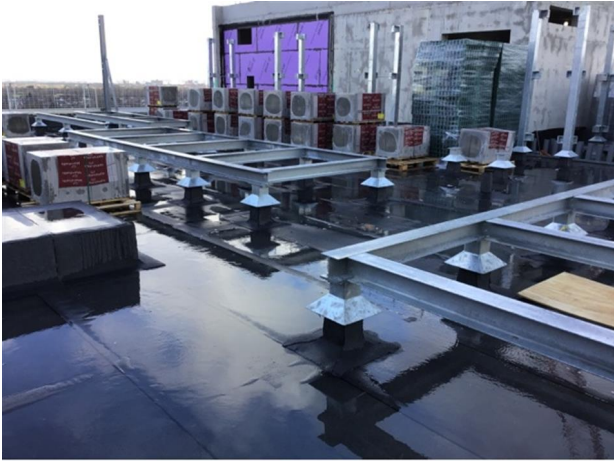
**Photo 7 - View of section 1**

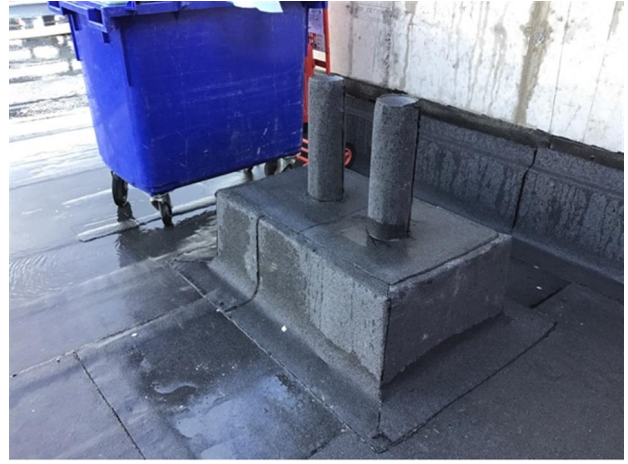
**Photo 8 - View of SVP detail to section 1**

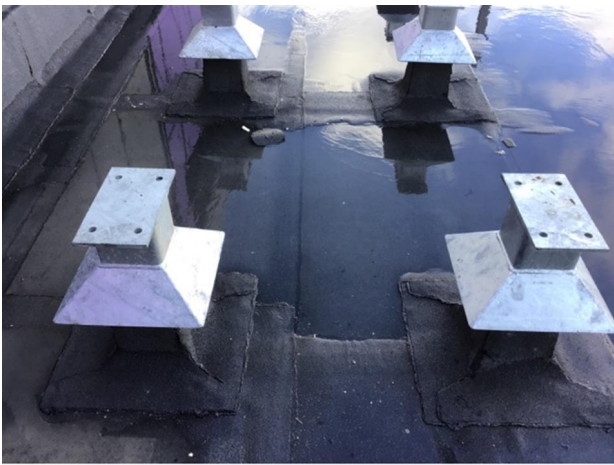
**Photo 9 - View of post details to section 1**

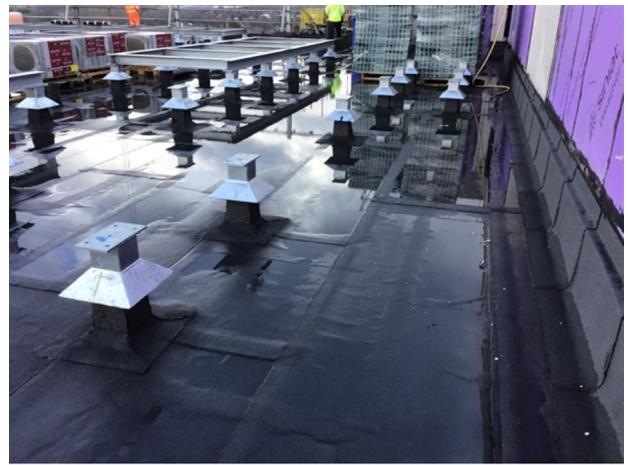
**Photo 10 - View of section 1**

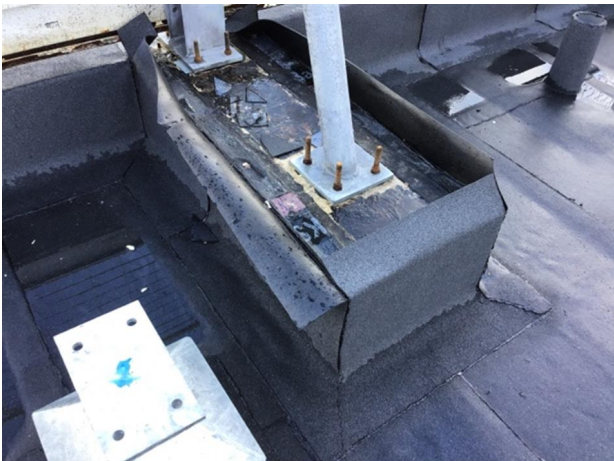
**Photo 11 - View of perimeter plinths to be completed**

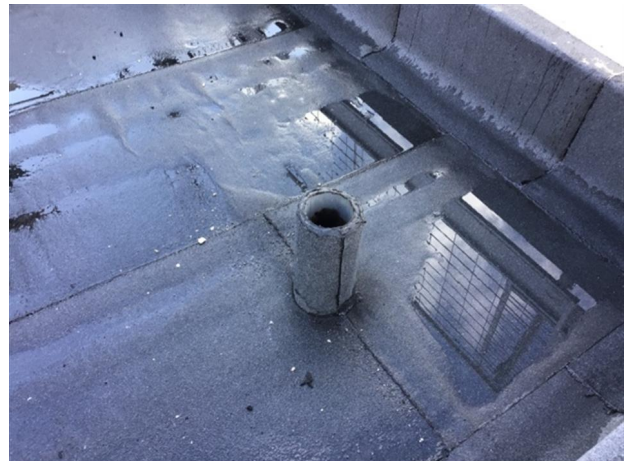
**Photo 12 - View of SVP detail**

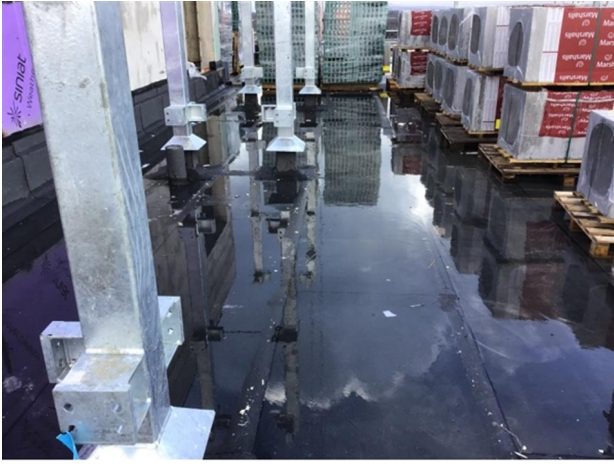
**Photo 13 - View of section 1**

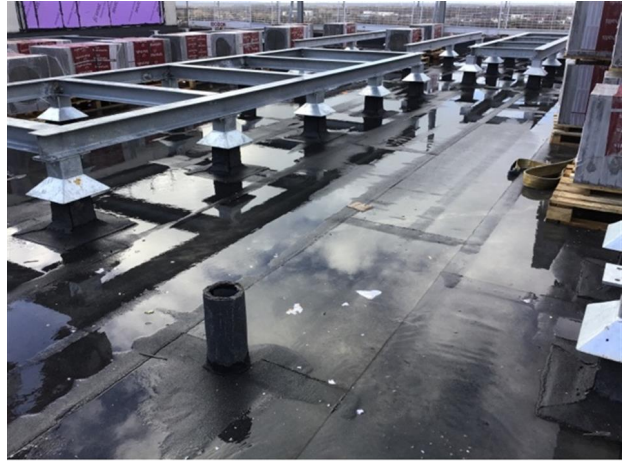
**Photo 14 - View of section 1**

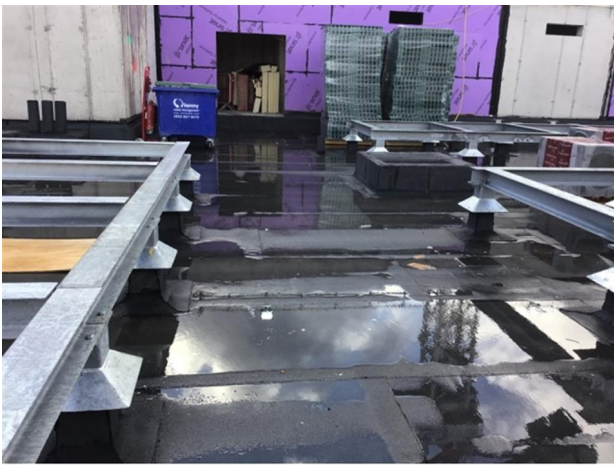
SECTION 1 is passed for landscaping

**Photo 15 - View of section 1 that is passed for landscaping**

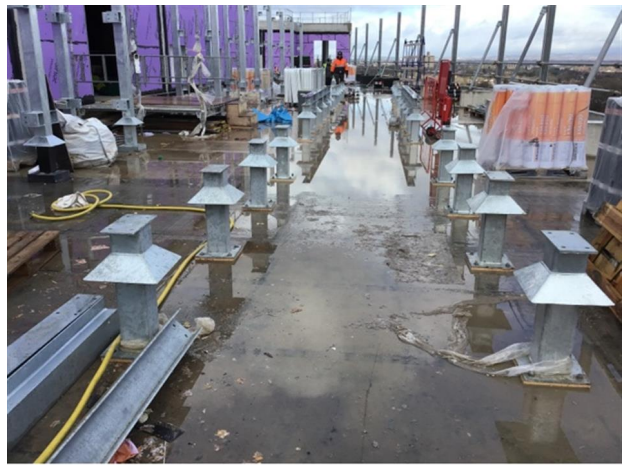
**Photo 16 - View of section 2**
