Doc Ref: **2762**  
Date: **15<sup>th</sup> February 2022**  
Rev: **0**

**51-53 Richmond Street**  
**Manchester**  
**M1 3WB**

**Structural Inspection Report**

- 1.1 Brennan Consult Ltd was appointed by Kieran Hedges of Eminence Development Ltd to carry out a pre-purchase structural inspection of a Grade II listed 3/4-storey textile warehouse.
- 1.2 The principal aim of the structural inspection report is to advise on the general structural condition of the building and its suitability for a proposed change of use to residential occupancy.

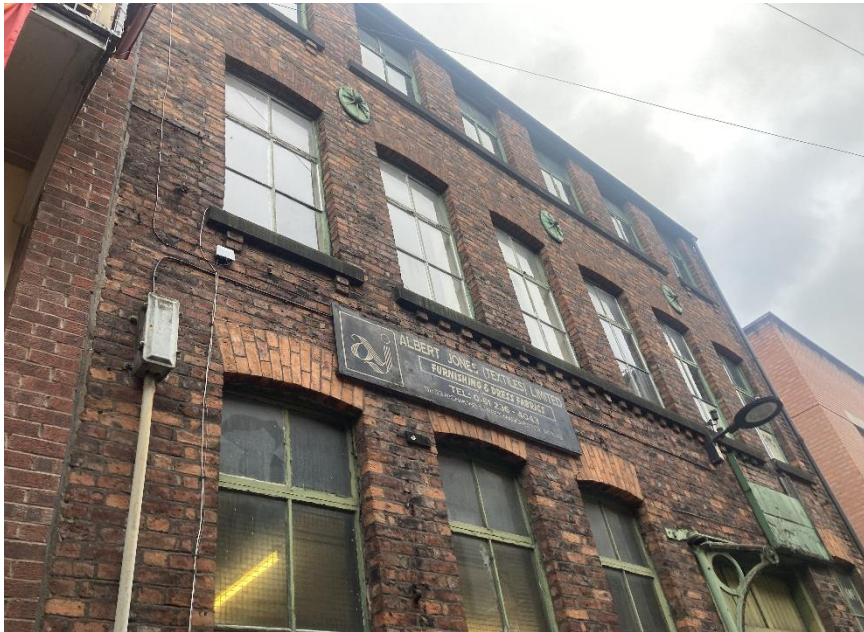
- 4.1.1 The property was 3 / 4-storey high and of traditional loadbearing masonry construction with brick arches over windows and stone cills with corbel brick supports (Photo 2). Pattress plates were present at 2<sup>nd</sup> floor level with tie rods assumed to tie through to the rear elevation.

Photo 2. Front (north) elevation

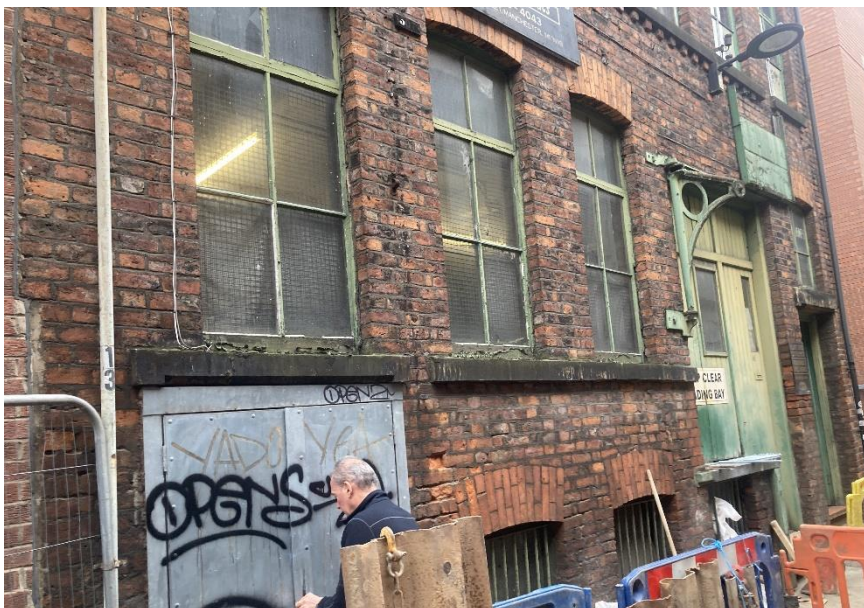
- 4.1.2 The ground-floor storey was raised 1/2 storey above street level, with access to the basement directly off Richmond Street (Photo 3). A loading bay was also present to the front elevation with wall-mounted lifting crane.

Photo 3. Front (north) elevation showing basement access and loading bay

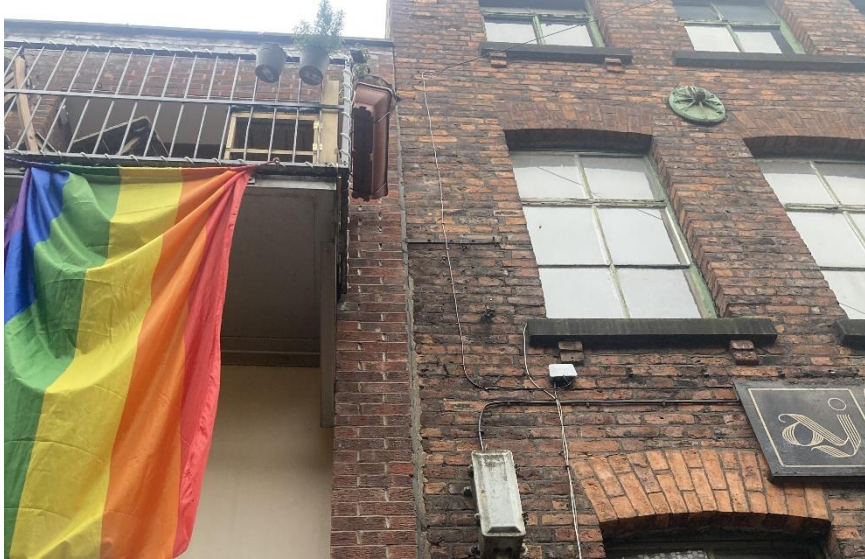
- 4.1.3 To the left-hand (east) gable wall was a full-height movement joint with the adjacent residential building, suggesting each building has an independent external wall (Photo 4).

Photo 4. Full-height movement joint to left-hand party wall

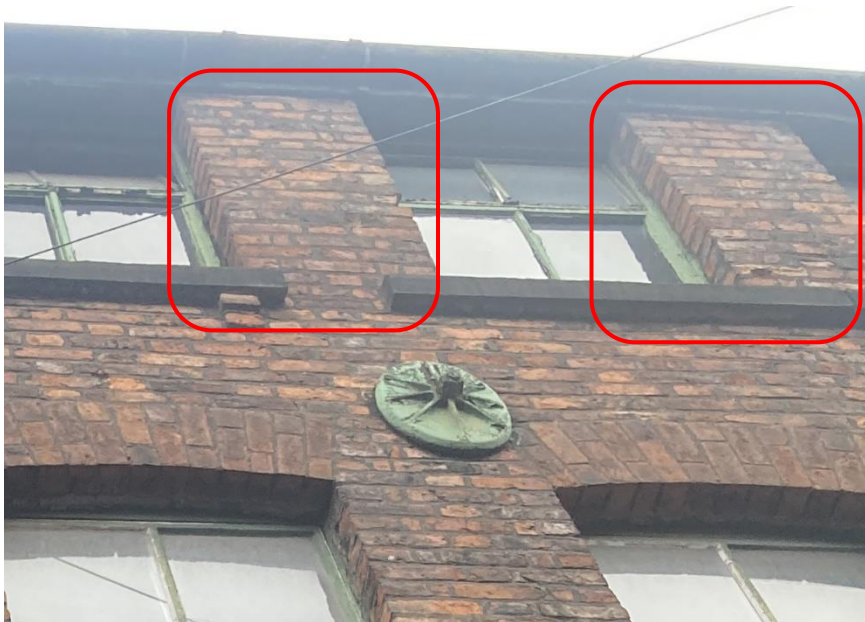
- 4.1.4 Outward rotation of the second-floor piers between the windows was visible from ground level (Photo 5).

Photo 5. Rotation of brickwork piers at second-floor level to front (north) elevation

- 5.6 There were two areas of structural movement that need to be addressed as part of any proposed redevelopment and change-of-use of the building, these are roof spread which has caused outward displacement of the second-floor masonry to the front elevation, and movement and cracking within the west gable wall seen both internally and externally.

- 5.7 The roof spread is due to a lack of restraint at window head level and the lack of continuous masonry on the front elevation compared with the solid masonry on the rear elevation. As the roof has deflected over time, the rafters and truss have spread outwards and have pushed the masonry walls which offer little resistance to this movement.

- 5.8 The worst movement has occurred at the north-east corner and is likely to require locally rebuilding at least one of the masonry piers.
- 5.9 As part of any works to the building it would be suggested that additional plan bracing is installed within the roof to transfer lateral thrust loads and wind loads to the gable walls and prevent horizontal loads being applied to the slender masonry piers. Where cracking is present it will be necessary to carry out crack stitch repairs to reinstate the strength lost as a result of the previous movement.

- 6.3 Roof spread has pushed out the masonry piers to the second-floor front elevation and at least one of these may require locally rebuilding. As part of any proposed works, plan roof bracing should be installed to the front elevation to resist further roof spread and transfer lateral loads to the east and west gable walls.

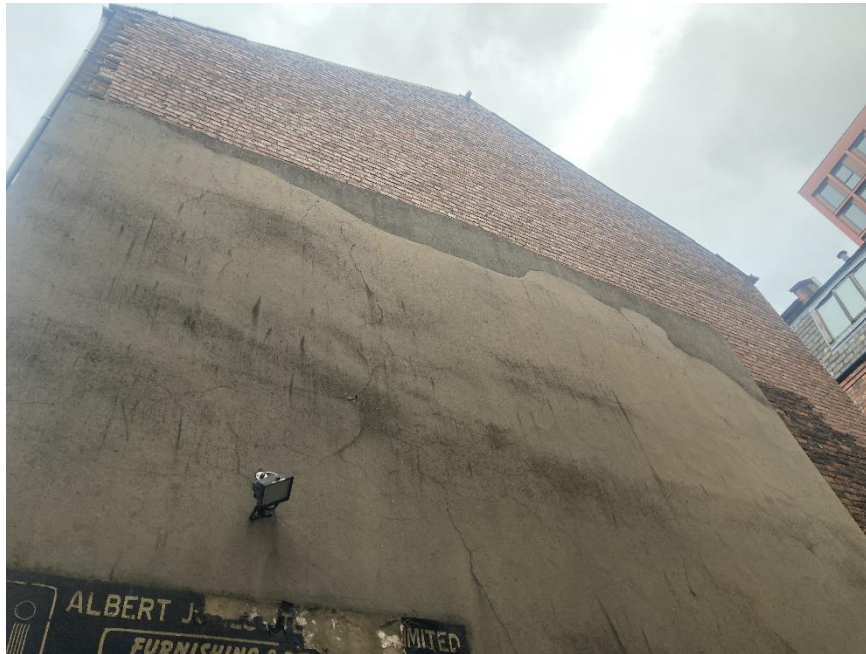
- 4.1.5 The right-hand gable wall was full-height masonry with no fenestration and was rendered up to second floor level (Photo 6). The top storey of the gable wall was newer masonry construction and is understood from discussions with the current owner to have been rebuilt due to damage occurring during WWII. There was crazing of the render, though it had remained largely intact.

Photo 6. Right-hand (west) gable elevation

- 5.3 There is evidence of previous masonry reconstruction at high-level and we understand from discussions with the current owners that this was the result of damage experienced during WWII and not the result of previous structural movement or collapse.

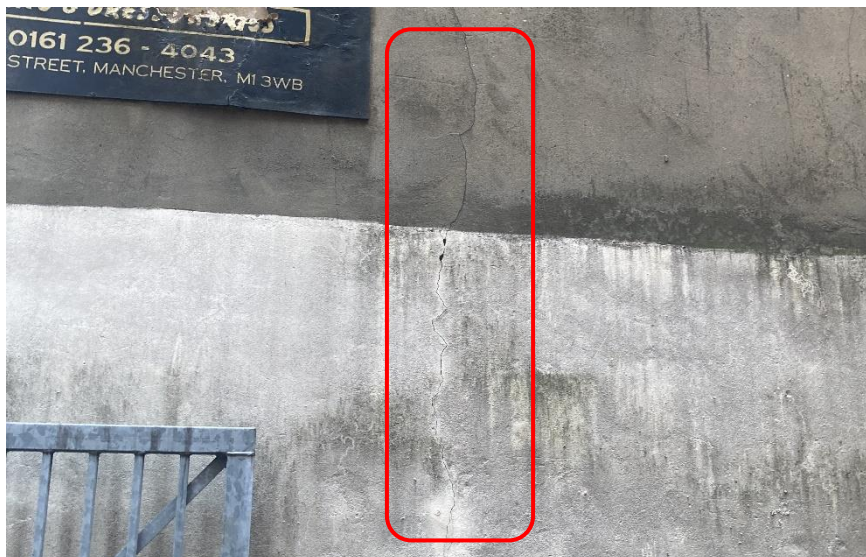
- 4.1.6 At ground-floor level there was vertical cracking to the west gable wall that continued up through first-floor level (Photo 7).

Photo 7. Vertical cracking to right-hand (west) gable wall

- 5.10 Adjacent the west elevation there is a lack of restraint of the large masonry gable wall panel due to the presence of the stairs. This is a common defect in older buildings where restraint of external walls was not installed and was exasperated by the lack of flooring where stairs were present. As part of any proposed works it would be recommended to introduce restraint straps between walls and floors

and between walls and roof structure to ensure the building is suitably tied throughout, in accordance with current Building Regulations recommendations. Where cracking is already present, crack stitch repairs should be carried out using helical bar reinforcement to both internal and external wall faces.

- 6.4 Where cracking is evident, particularly due to the roof spread issues and due to a lack of restraint to the west gable wall, crack stitch repairs should be carried out using helical bar reinforcement so to reintroduce strength to the masonry wall panels.

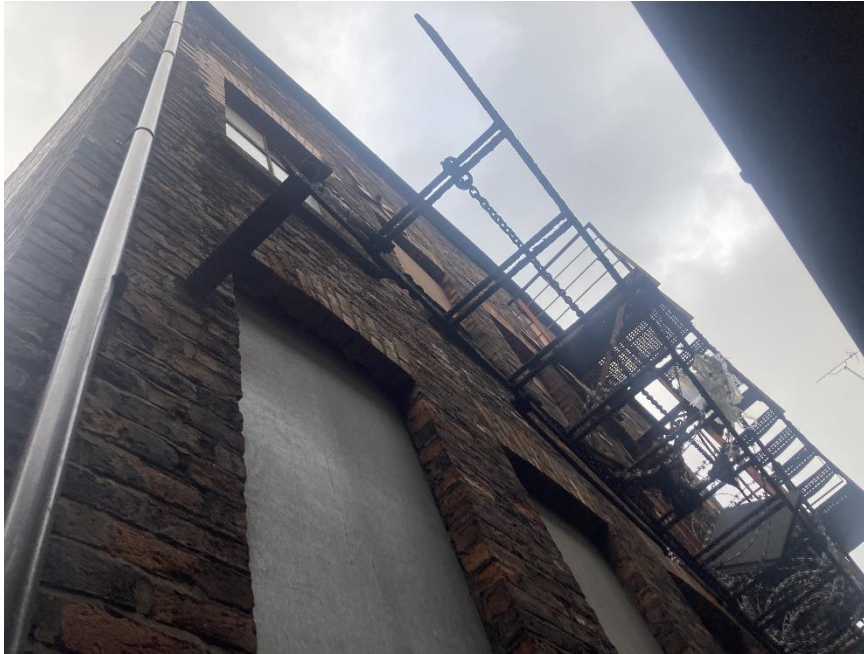
- 4.1.7 To the rear (south) elevation there was a narrow alley that restricted viewing access, however it could be seen the brickwork was in a similar condition to the rest of the building and there were patch repairs at higher levels similar to the newer brickwork on the west elevation (Photo 8). Pattress plates were present at second floor level that reflected those on the front elevation.

Photo 8. Rear (south) elevation

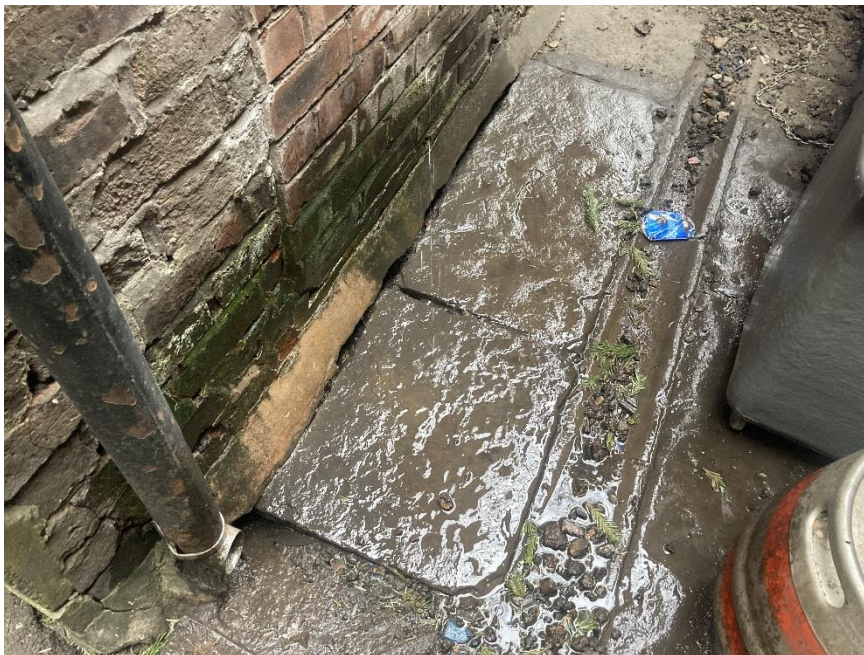
- 4.1.8 At ground level to the rear elevation the windows had been bricked up, however there was evidence of water ingress to the basement resulting from an overflow pipe spilling on to the paving and the discharge of a rainwater pipe (Photo 9).

Photo 9. Saturated ground and RWP discharge adjacent basement corner

- 5.5 In particular there has been excessive water ingress through the rear elevation and this was due to a leaking overflow pipe and a rainwater pipe discharging in to the rear alley and tracking back in to the building. Works should be carried out as soon as possible to prevent water entering the building to allow the basement to dry out, and the timber and damp survey should include the basement structure, with any recommended repairs carried out.

- 6.6 The building was generally dry, however there was evidence of previous water ingress and possible decay of timber elements where they were built into the external walls. It is recommended that a full timber and damp survey be carried out to confirm the extent of any decay. Any recommended repair works should be carried out as part of the proposed redevelopment. Works should also be carried out to prevent water ingress, including renewal of any rainwater goods and particularly diverting water away from the building at the rear alley where an overflow pipe and rainwater pipe discharge.

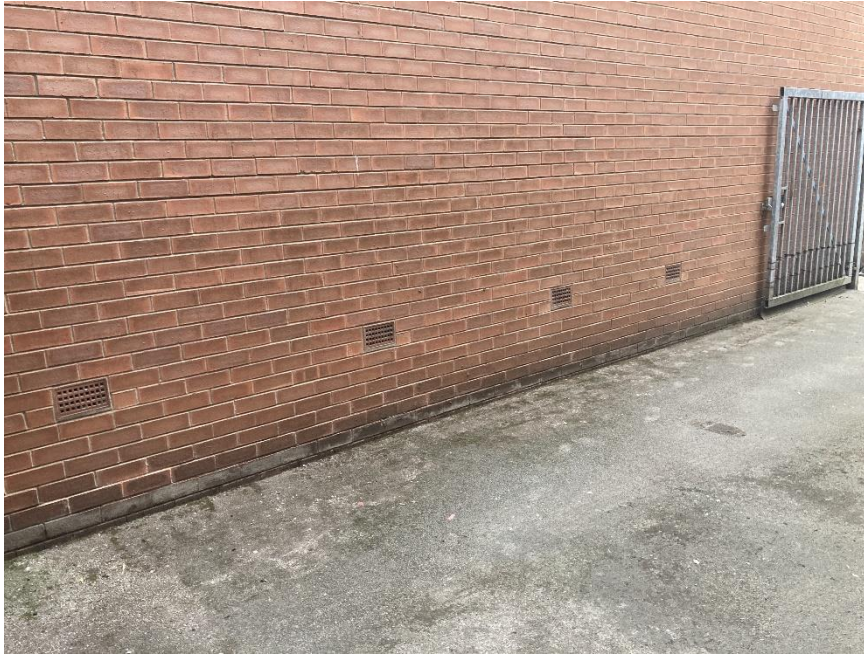
- 4.1.9 The adjacent building to the west was of newer masonry construction with air bricks facing 51-53 Richmond Street (Photo 10). This faces on to where the proposed adjacent development will take place.

Photo 10. Wall of adjacent building to west showing air bricks

- 6.9 With regards the proposed narrow apartment building to be constructed to the west of 51-53 Richmond Street, the design of this should take due account of existing basement structures and the presence of air bricks to the east elevation of the adjoining development that would be closed off by any new building.

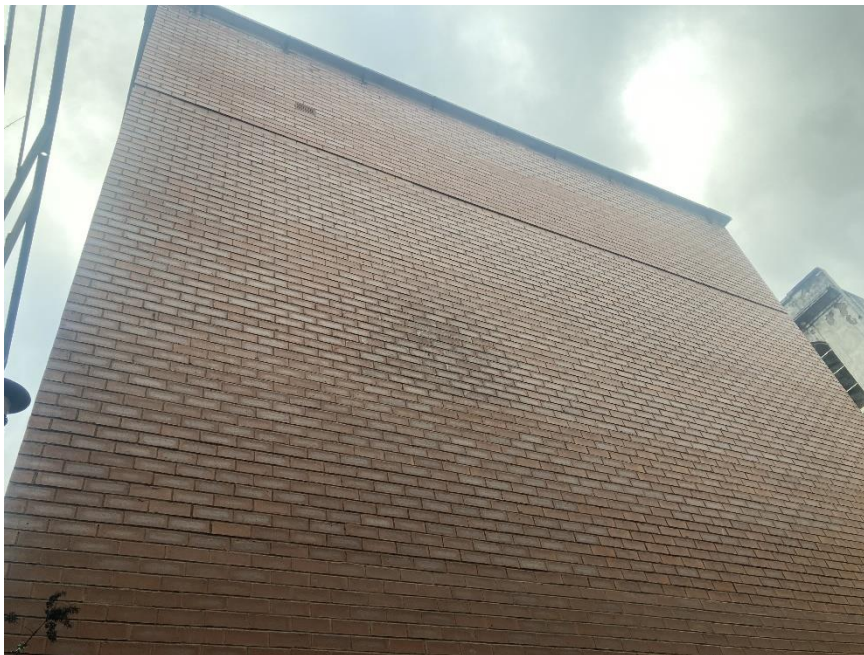
- 4.1.10 At higher level there was a slight overhang of the adjacent building at the eaves position, and a further air brick was present to the side elevation (Photo 11).

Photo 11. Wall of adjacent building showing slight eaves overhang and high-level air brick

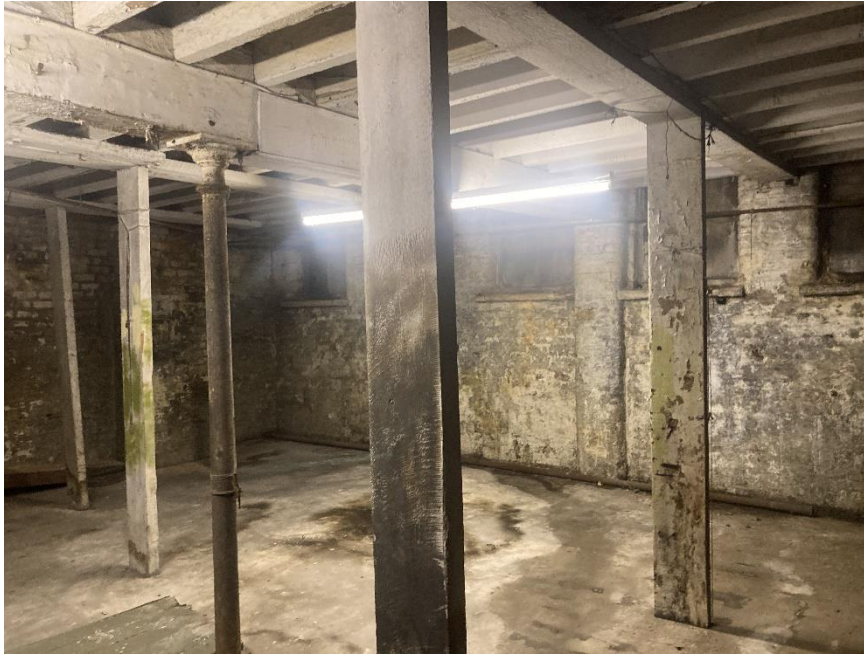
- 4.2.1 Access was gained in to the basement and showed the construction to consist of timber floors spanning left-to-right and supported on a single row of timber beams and a single internal cast-iron column (Photo 12).

Photo 12. Ground floor construction visible within basement

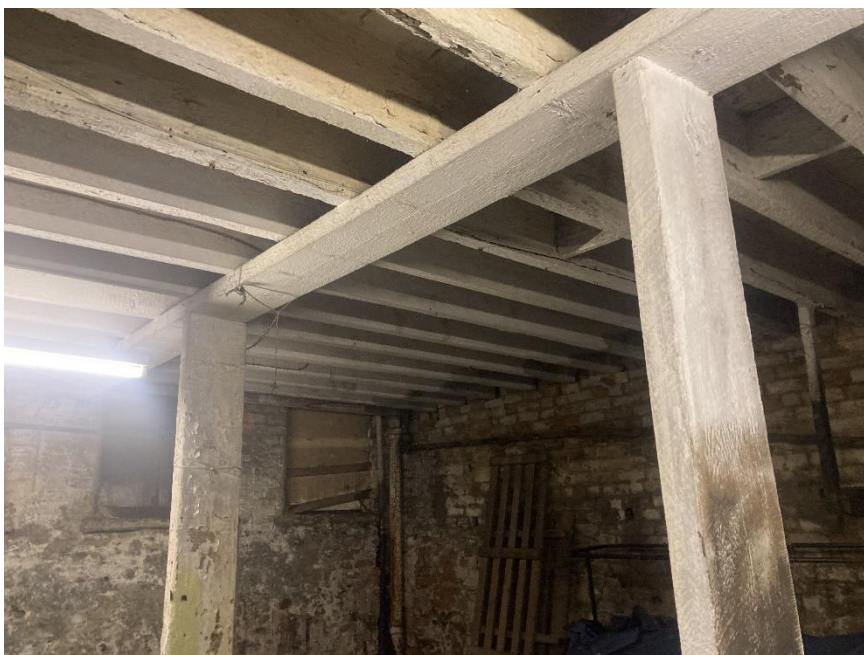
- 4.2.2 The timber floor joists appeared to be a good depth for their span, however had been propped at mid-span with timber framing to provide additional support (Photo 13). We understand from discussions with the current owner this was due to the weight of materials stored on the ground floor.

Photo 13. Historic timber propping to mid-span of ground-floor joists

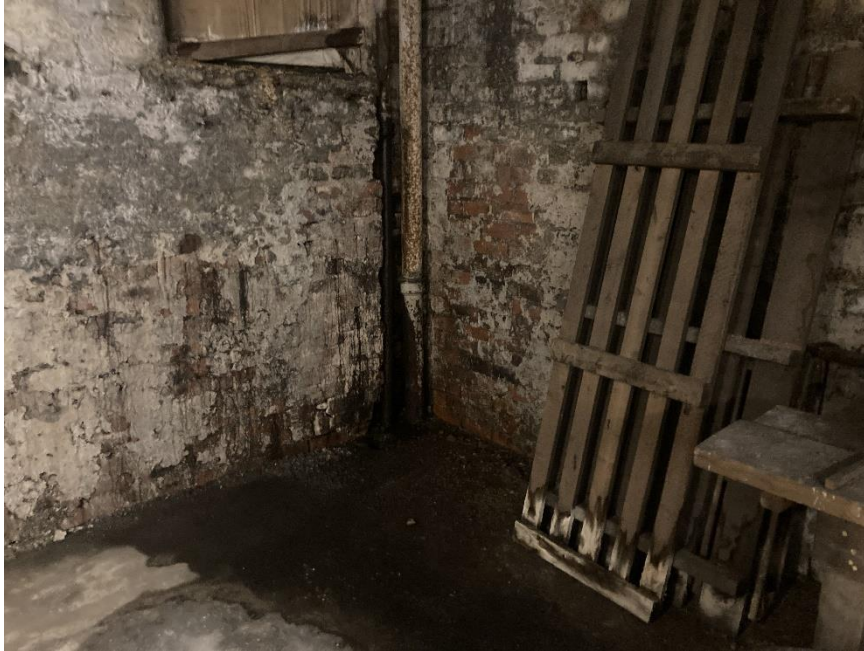
- 4.2.3 In the south-west corner of the basement there had been significant water ingress through the rear elevation (Photo 14), at the location noted in 4.1.8 above.

Photo 14. Basement water ingress through rear elevation

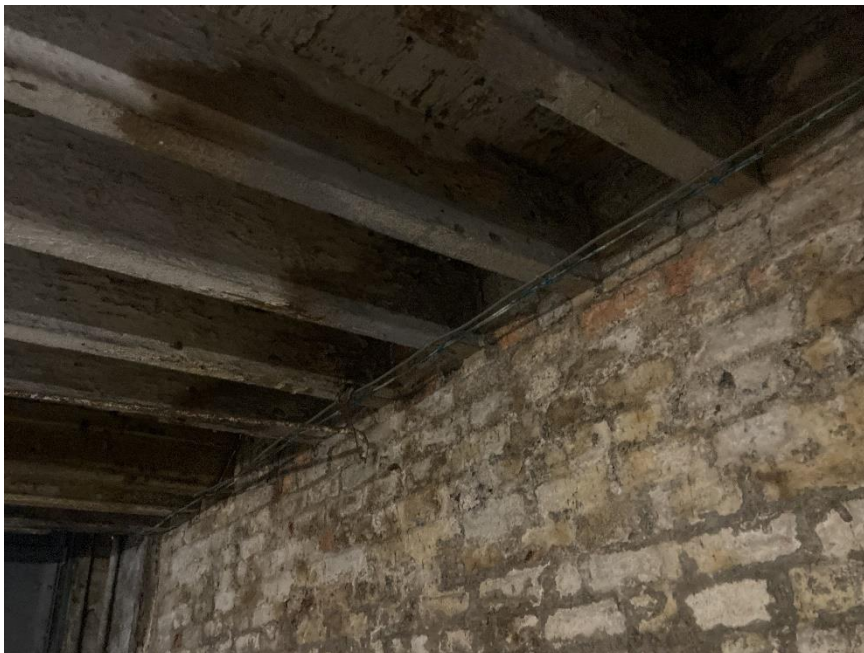
- 4.2.4 The ends of timber joists appeared damp where built in to external walls (Photo 15).

Photo 15. Ground floor joists appeared damp where built in to external walls

- 5.4 The building was reasonably dry at the time of our inspection, however there was evidence of timber decay, particularly where timber beams and joists were built into the external walls. A full timber and damp survey would be recommended to determine the extent and severity of any timber decay and the extent of any timber repairs required.

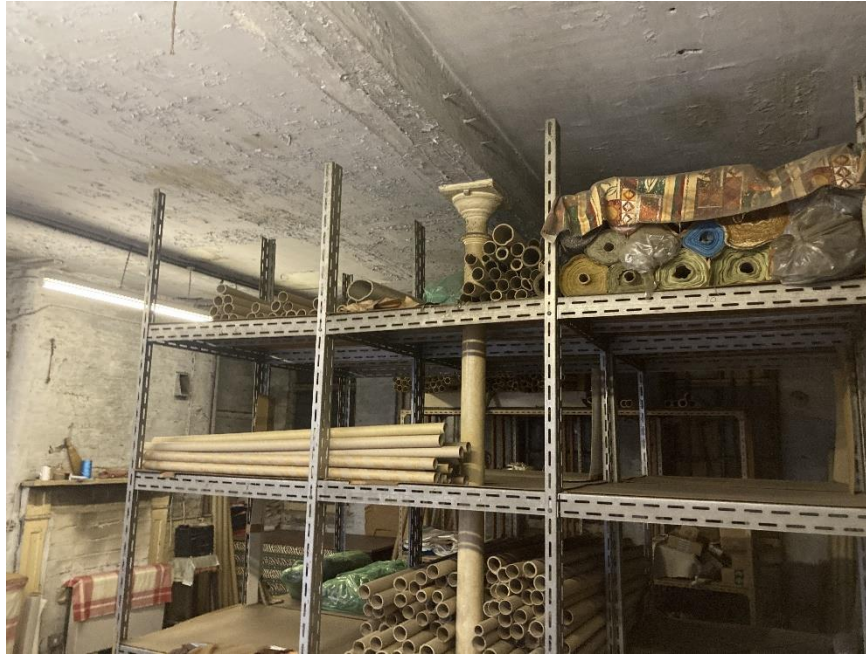
- 4.2.6 The ground floor was being used as a store and had the same form of construction seen within the basement i.e. a single internal cast-iron columns supporting timber beams and timber floor joists that spanned left-to-right (Photo 16).

Photo 16. Ground floor store

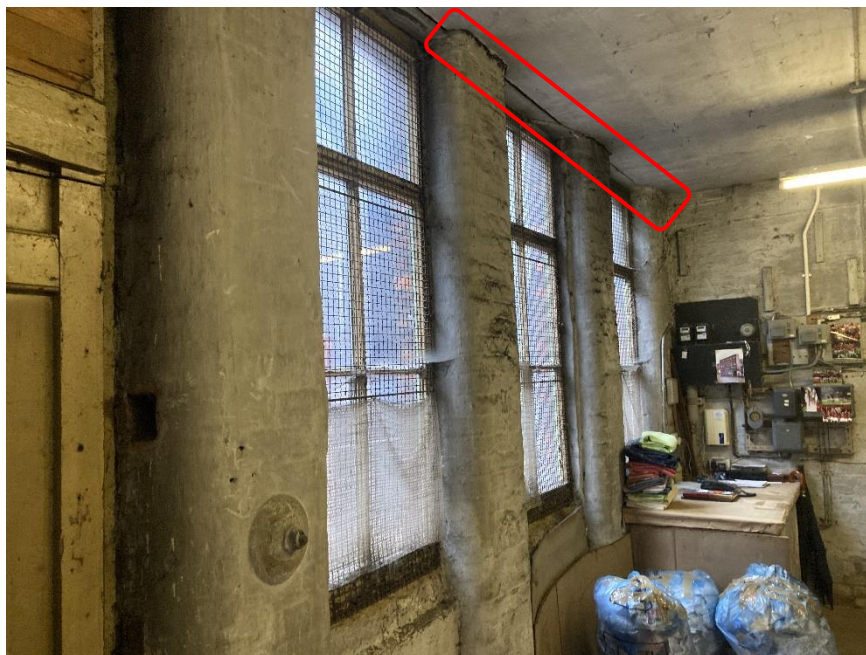
- 4.2.7 Adjacent the front elevation there was a suggestion of slight outward movement of the façade away from the floor plate, as evidenced by a tapering joint between the ceiling and the masonry piers (Photo 17).

Photo 17. Horizontal joint between ceiling and front elevation at ground-floor level

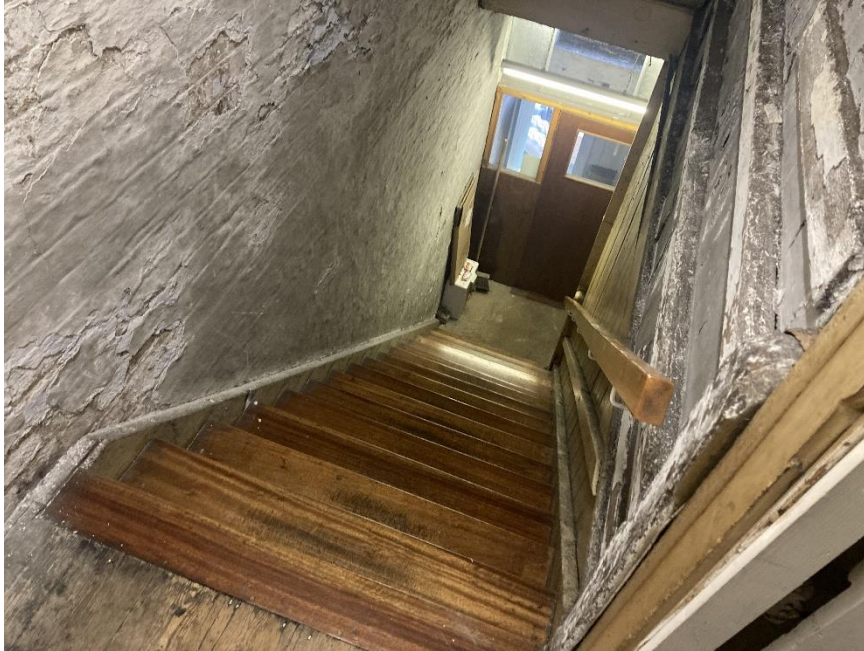
- 4.2.8 The stair ran parallel to the west elevation and created a void that had been trimmed through the floors at each level (Photo 18).

Photo 18. Stair adjacent west elevation

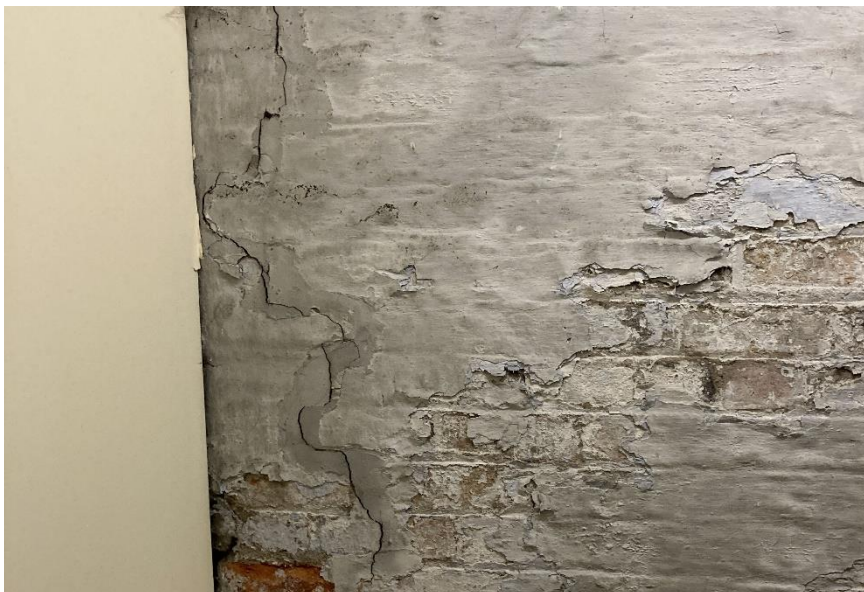
- 4.2.9 Vertical cracking was evident internally to the west gable wall at north-west and south-west corners of the building and reflected the cracking seen externally to the rendered elevation (Photo 19).

Photo 19. Internal cracking to south-west corner at first-floor level

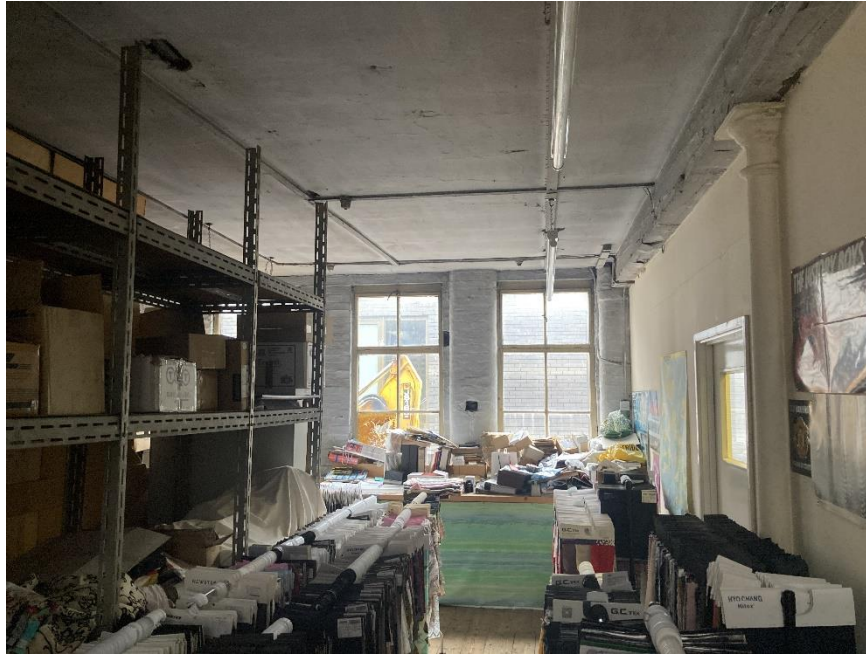
4.2.10 At first-floor level the structure again repeated what had been seen at basement and ground-floor levels (Photo 20). It was noted that there was no continuity of the columns or any clear evidence of direct fixings through each floor level.

Photo 20. First-floor showing single cast-iron column

- 5.11 Historic buildings often suffer from a lack of robustness as this was not a consideration at the time they were built. Robustness provides additional stiffness to the building to provide alternative load paths, redundancy, and provide resistance against accidental events. The building has been built with no continuity of columns between floors and no apparent direct connection between columns and beams.

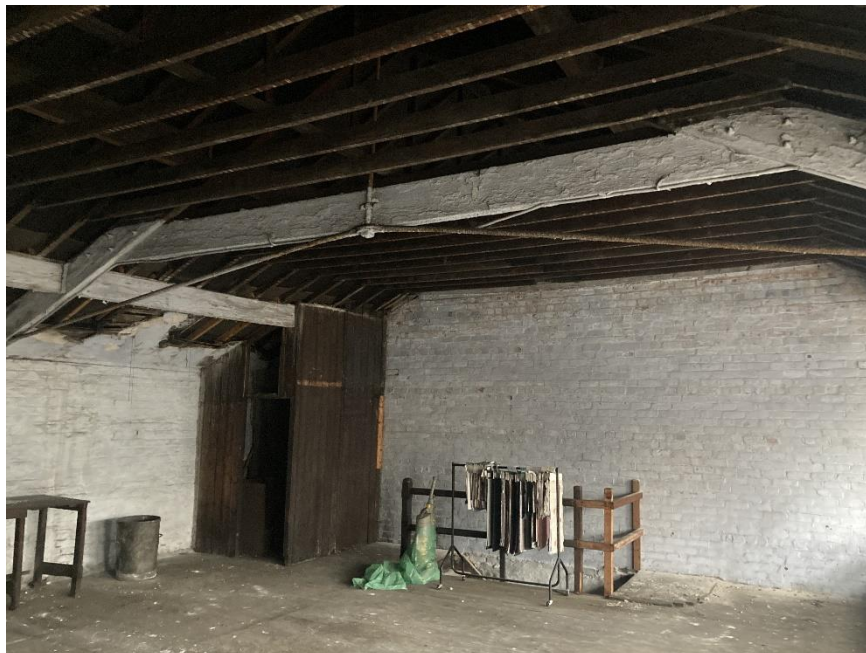
4.2.11 At second-floor level there was no internal column, with a single collar-tied roof truss supporting timber purlins and in turn timber rafters and ceiling joists (Photo 21).

Photo 21. Roof structure visible at second-floor level

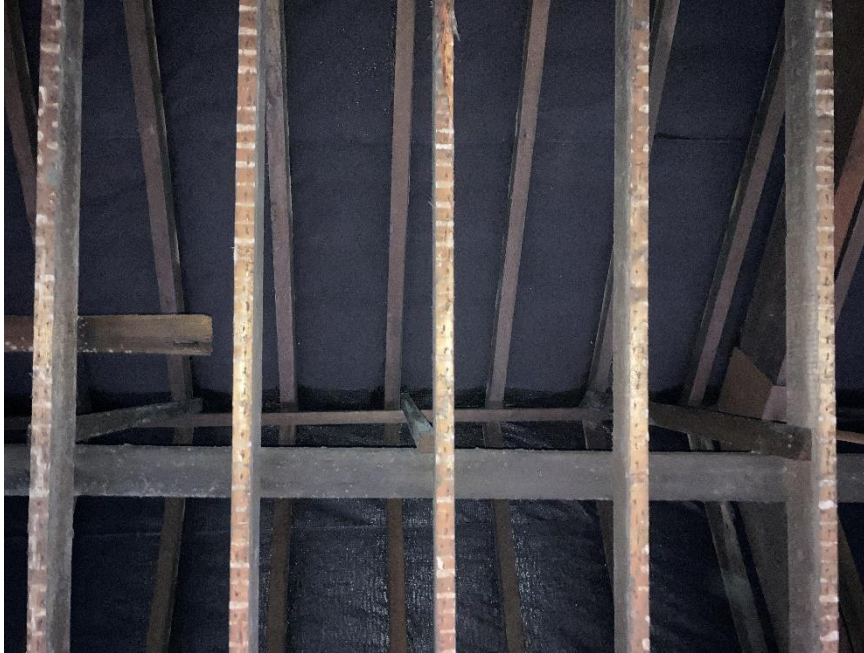
4.2.12 There was some evidence of the roof structure racking, however this was not considered to be excessive (Photo 22).

Photo 22. Timber roof racking to one side

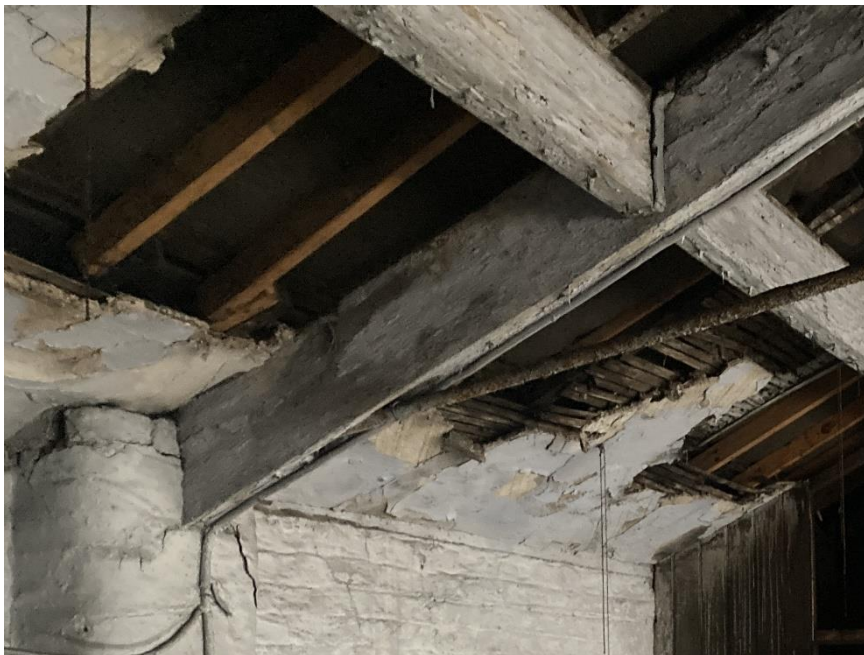
4.2.13 The second-floor level appeared to be reasonably dry at the time of our inspection, however there was evidence of previous decay and collapse of the ceiling, and the timber again appeared to be damp where built in to the external walls (Photo 23).

Photo 23. Previous damp conditions evident

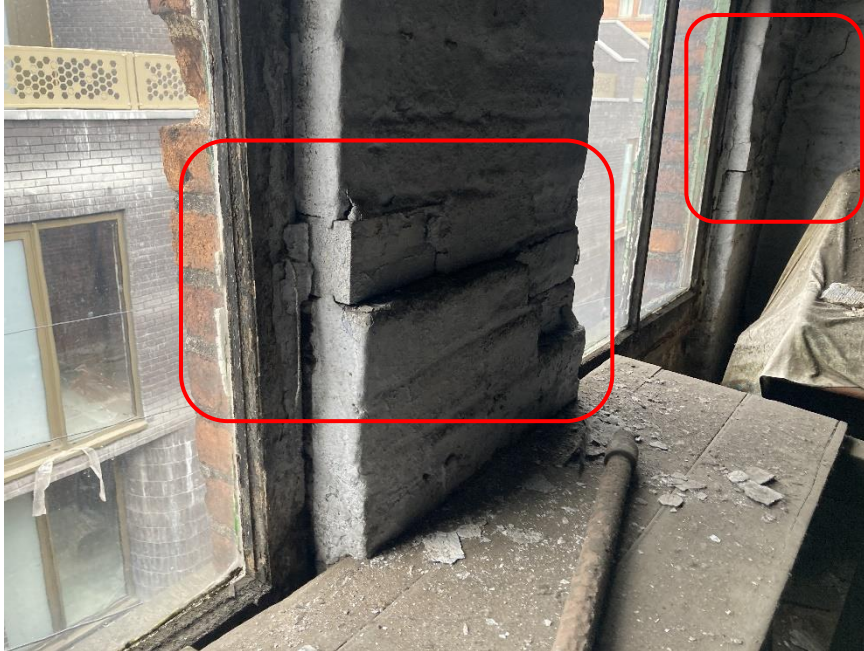
4.2.14 There was evidence of cracking to the masonry walls at the corners of the second floor and there was visible outward movement of the masonry at the pier positions to the front elevation (Photo 24).

Photo 24. Structural movement to masonry piers at second-floor level

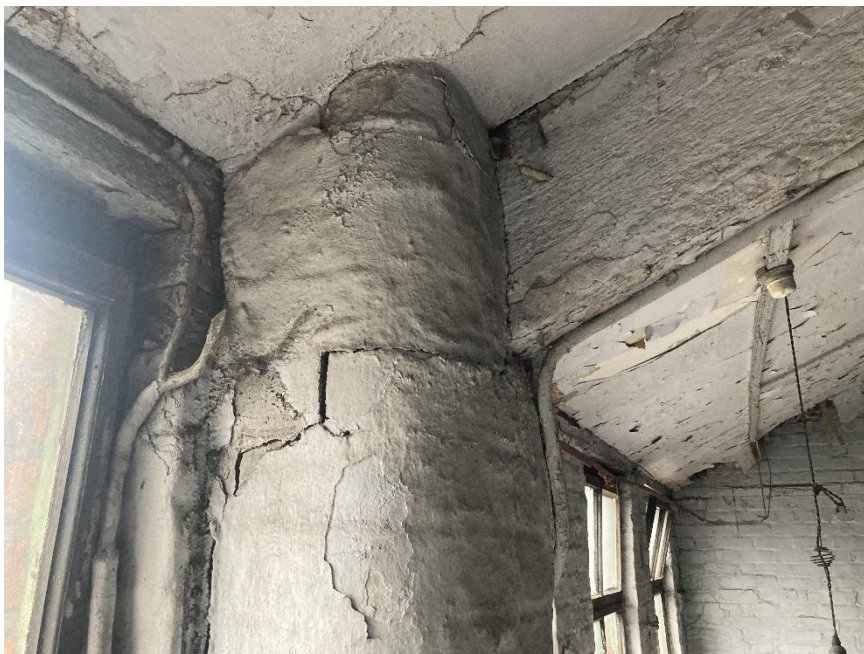
4.2.15 Cracking was also present at the spring point of the roof truss to the front elevation which was also supported off a masonry pier (Photo 25).

Photo 26. Cracking at spring point of roof truss to front elevation
