## **MKCC HIGHWAY DILAPIDATION SURVEY**

**Project: Mawlawi Kurdish Cultural Centre, Hulme, Manchester**

**Date: 18/01/23**

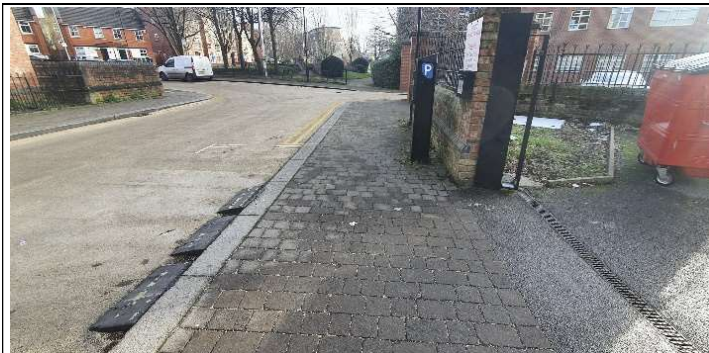
The path up to the entrance of the site is slightly low in places as it's used for vehicle access daily by the users of Mawlawi Kurdish Cultural Centre.

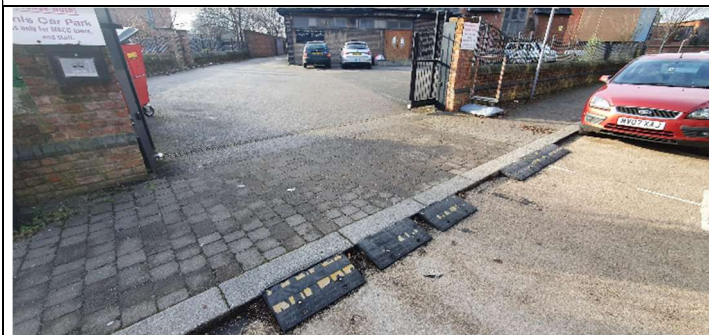
Access ramps to allow vehicles in and out of site.

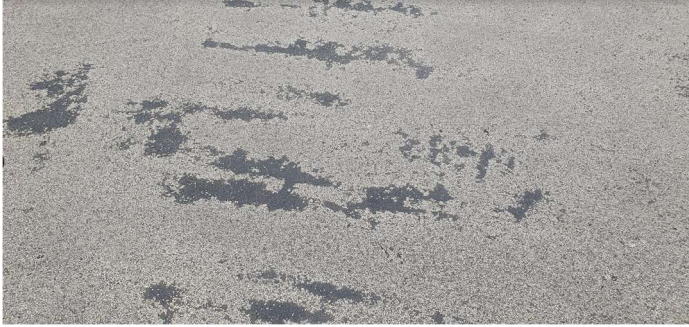
Pebbletex screed removed due to wear and tear in middle of Parsonage St road.

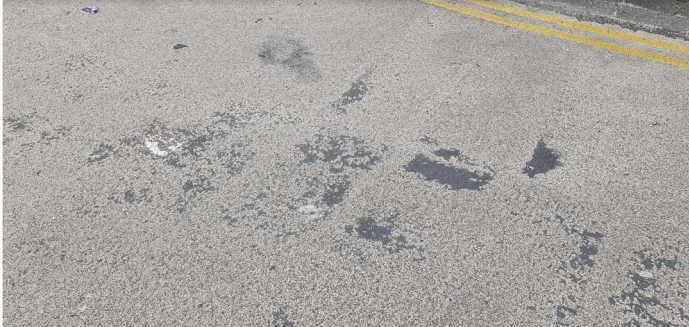
Pebbletex screed removed due to wear and tear in middle of Parsonage St road.

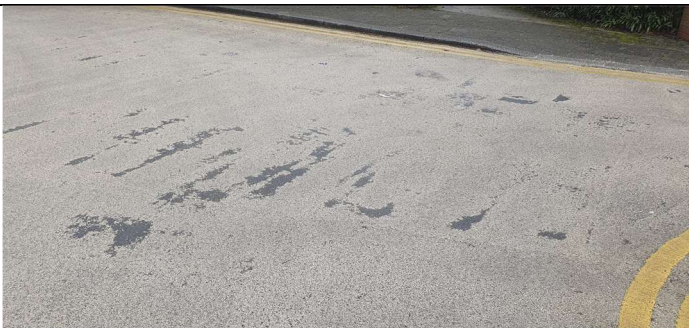
Pebbletex screed removed due to wear and tear in middle of Parsonage St road.

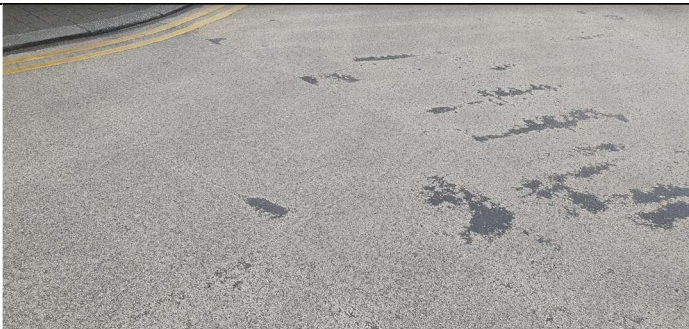
Pebbletex screed removed due to wear and tear in middle of Parsonage St road.

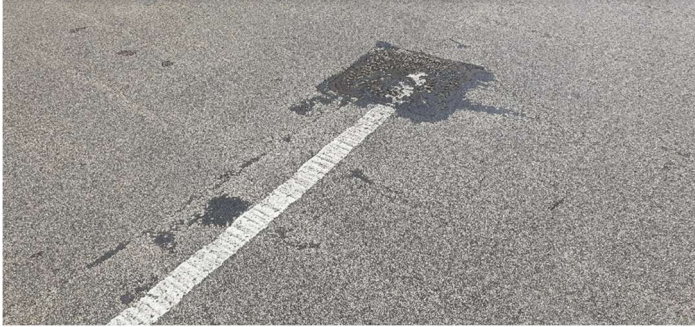
Pebbletex screed removed due to wear and tear in middle of Parsonage St road.

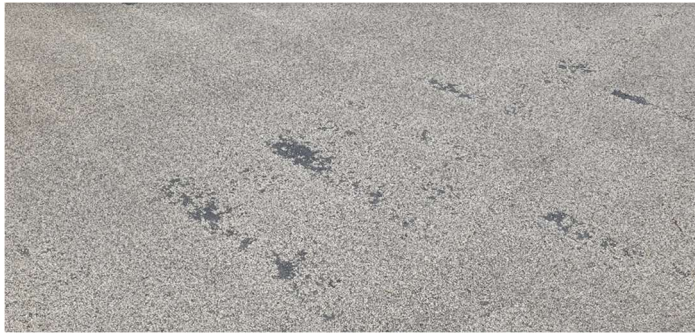
Pebbletex screed removed due to wear and tear in middle of Parsonage St road.

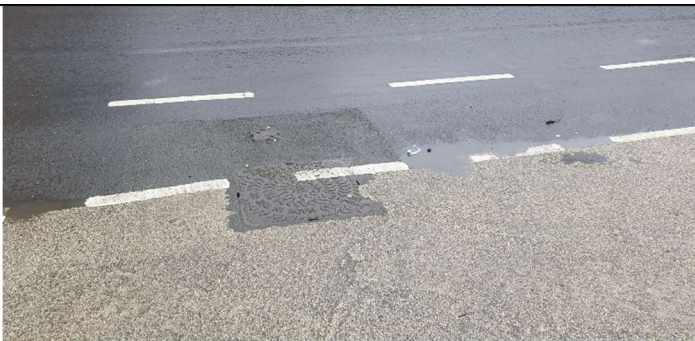
Pebbletex screed removed due to wear and tear in middle of Parsonage St road.

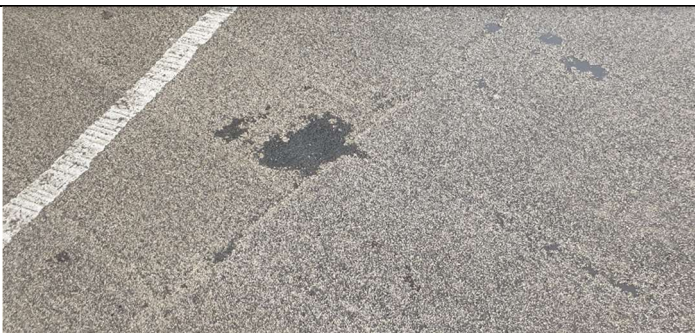
Pebbletex screed removed due to wear and tear in middle of Parsonage St road.

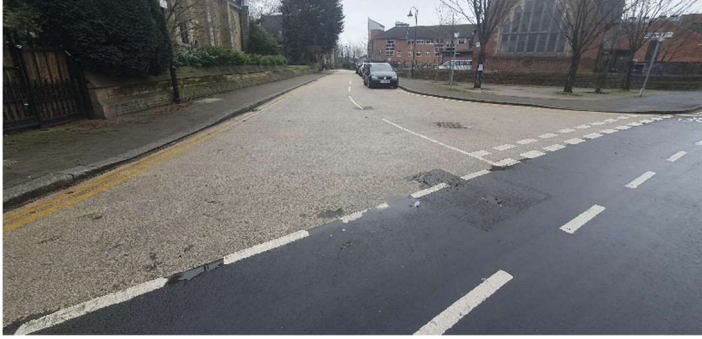
Pebbletex screed removed due to wear and tear in middle of Parsonage St road.

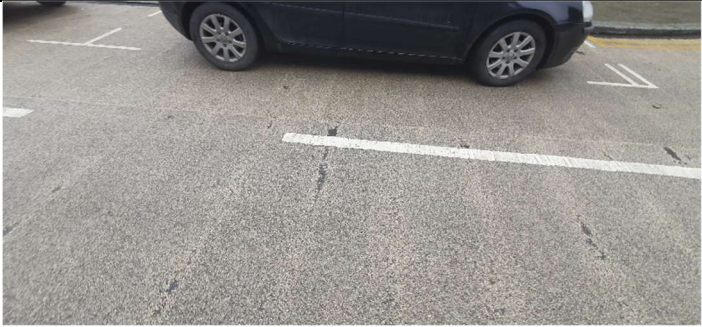
Pebbletex screed removed due to wear and tear in middle of Parsonage St road.

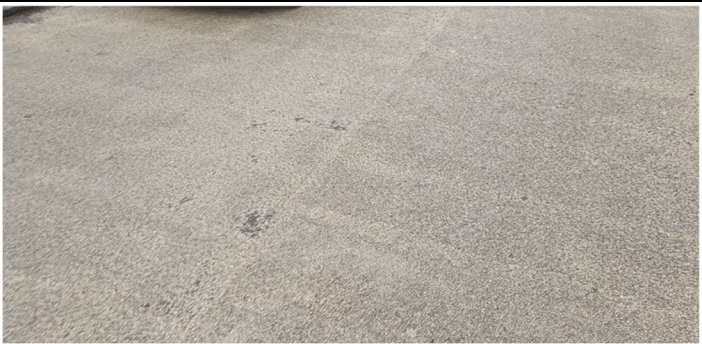
Pebbletex screed removed due to wear and tear in middle of Parsonage St road.

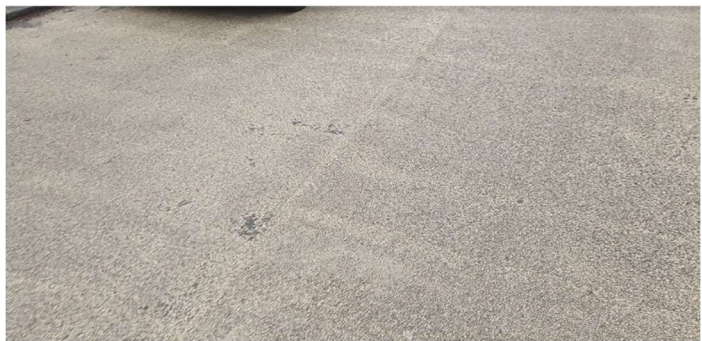
Pebbletex screed removed due to wear and tear in middle of Parsonage St Road.

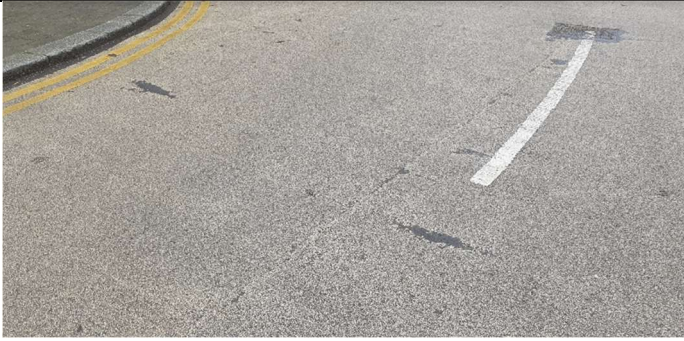
Pebbletex screed removed due to wear and tear in middle of Parsonage St Road.

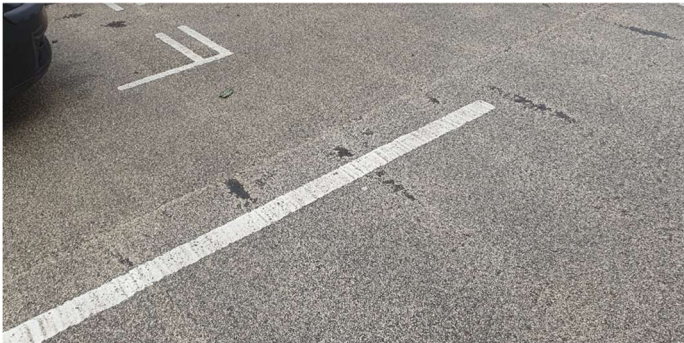
Pebbletex screed removed due to wear and tear in middle of Parsonage St Road.

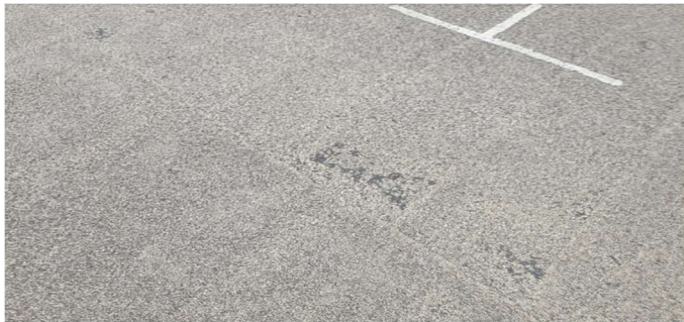
Pebbletex screed removed due to wear and tear in middle of Parsonage St road.
