# crusader photo-report

| crusader mill | 08 02 2022 | Capital & Centric | Crusader<br>70 Chapeltown St<br>Manchester<br>M1 2EW | Manchester City Council | photoreport to discharge planning<br>conditions relating to applications<br>113363/FO/2016<br>113364/LO/201 |
| planning photo report | - | shedkm architects ltd | | | |

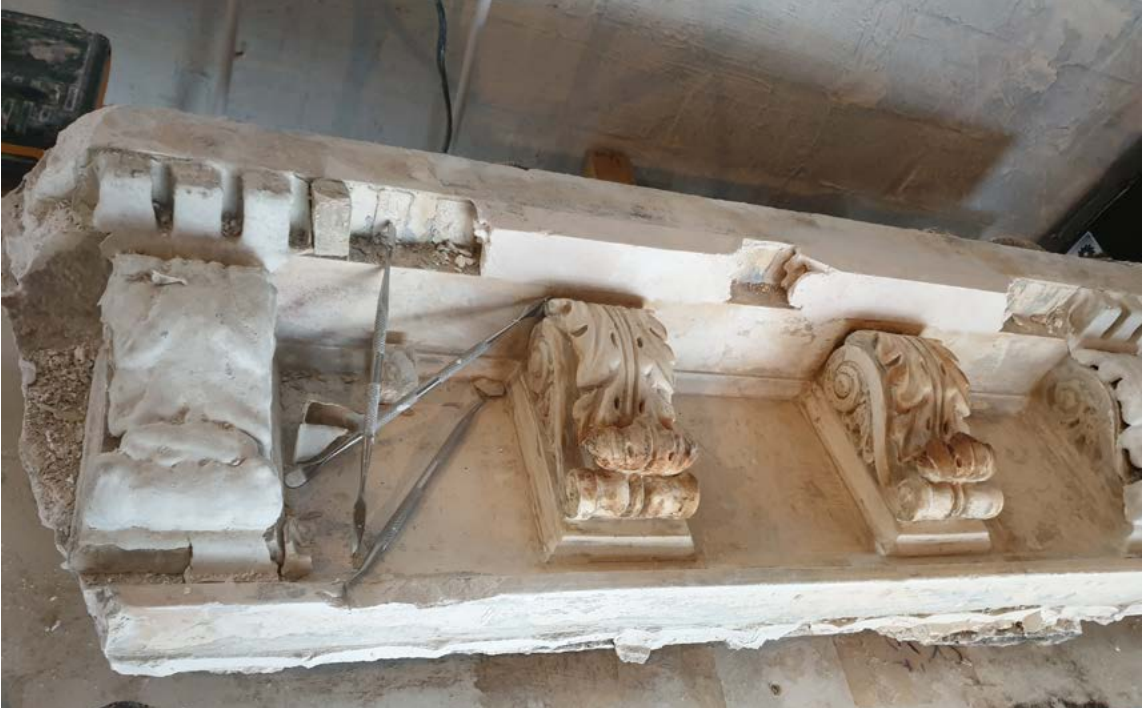
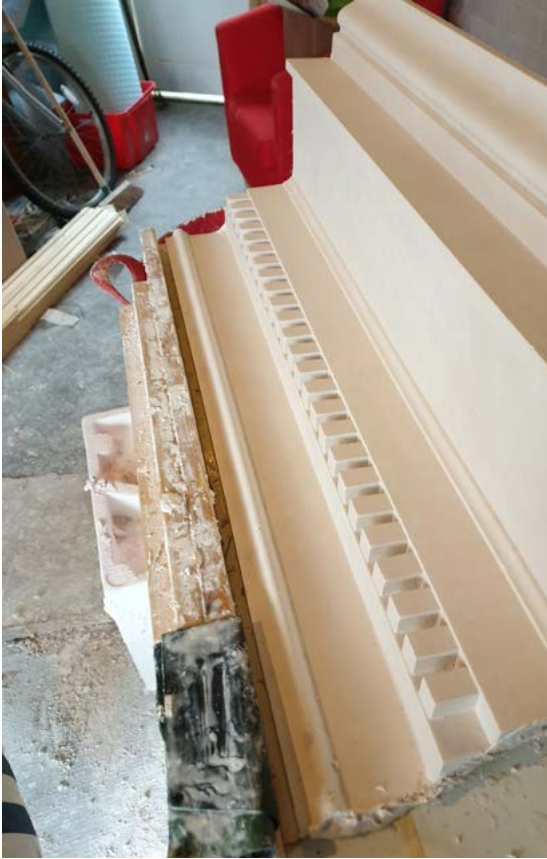
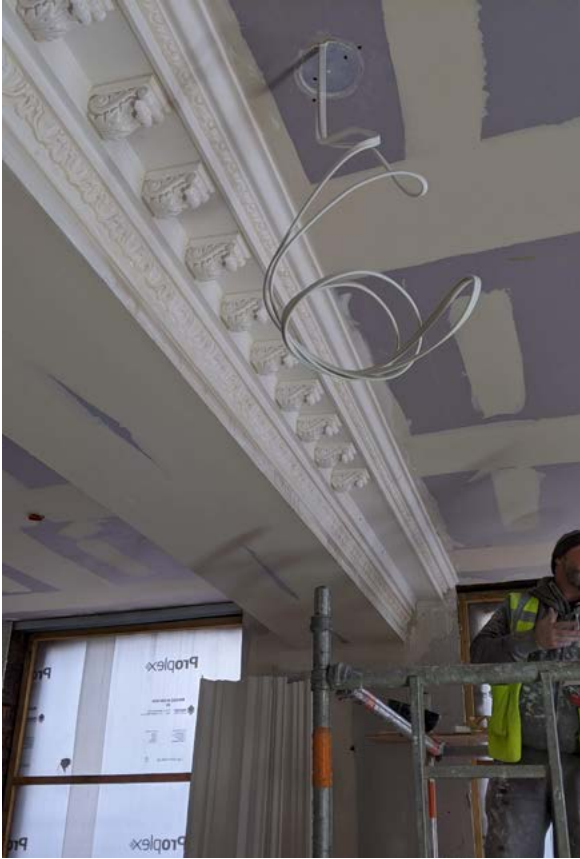
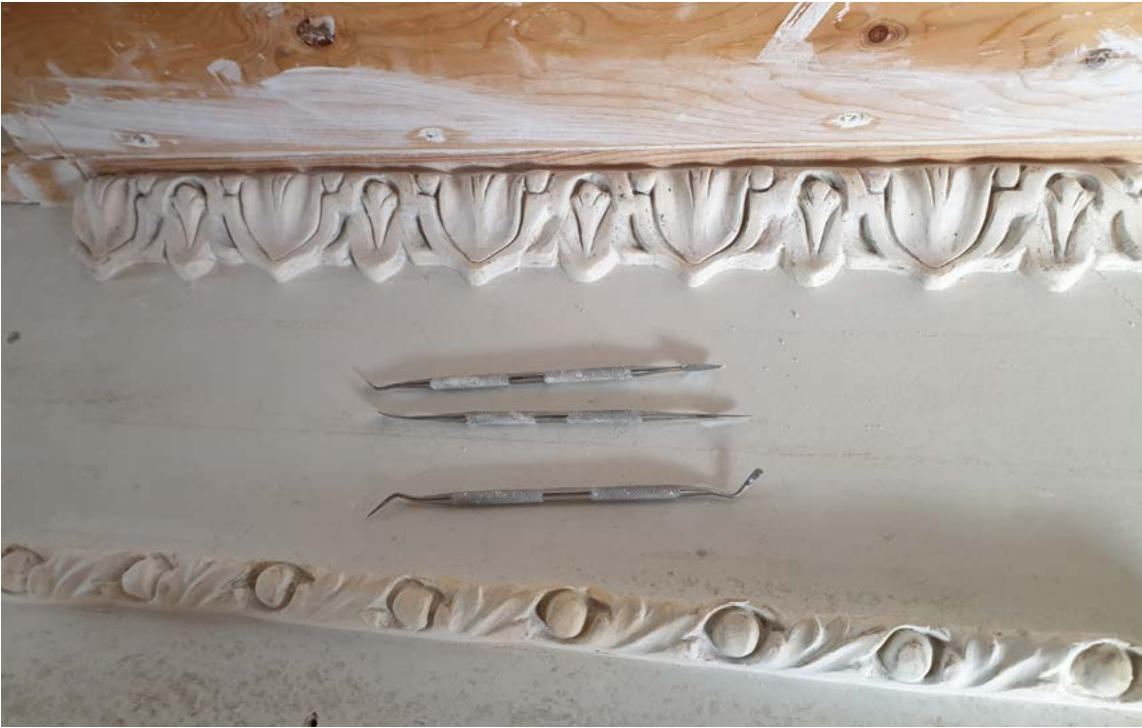
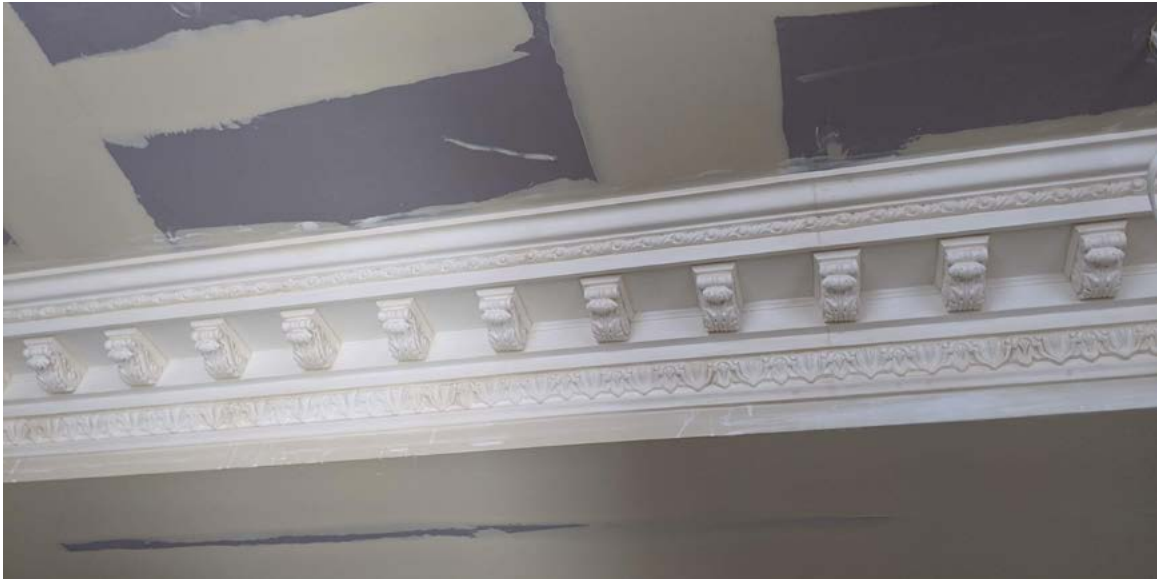
- key** (clockwise from top left)
- 01** repair of existing cornices to create new template
  - 02** section of replacement cornice
  - 03** cornices being installed, with acanthus leaves being individually placed
  - 04** cornice installation
  - 05** section of cornice mould being made in workshop

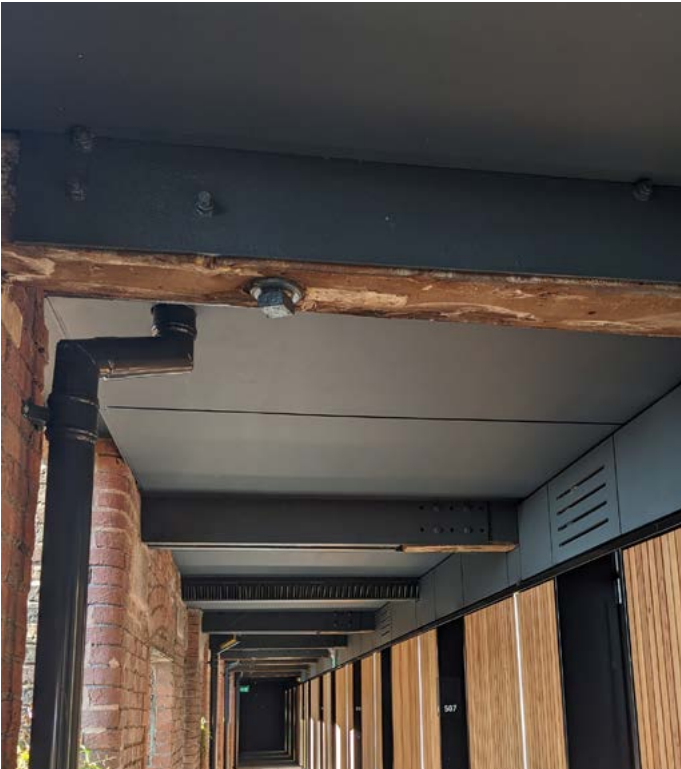
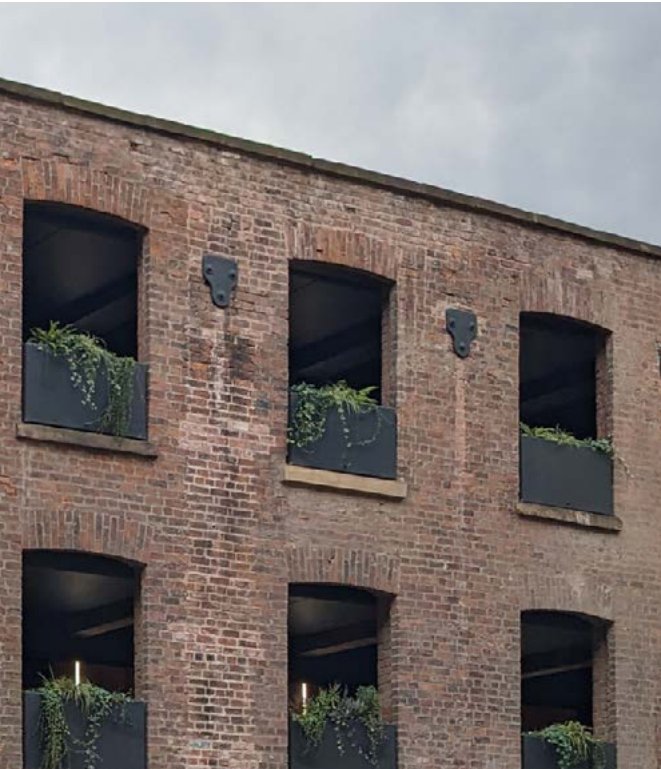
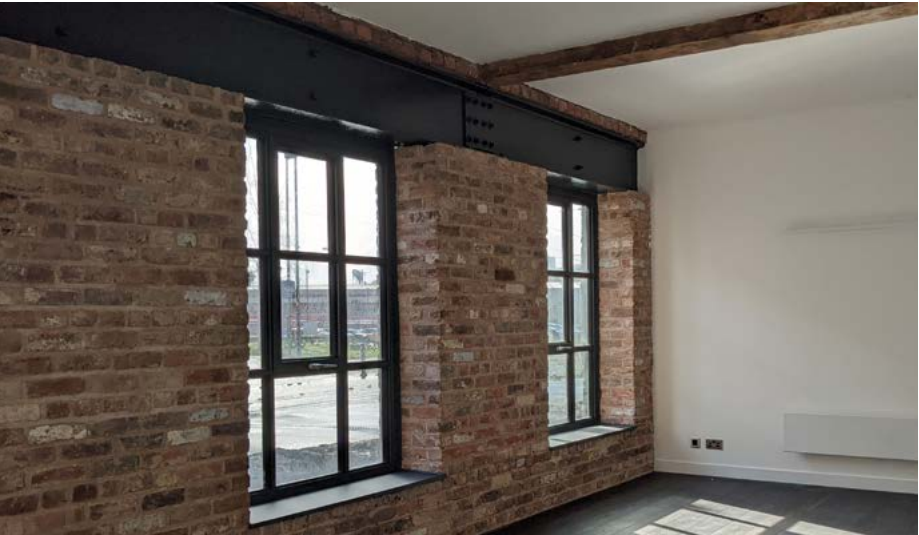
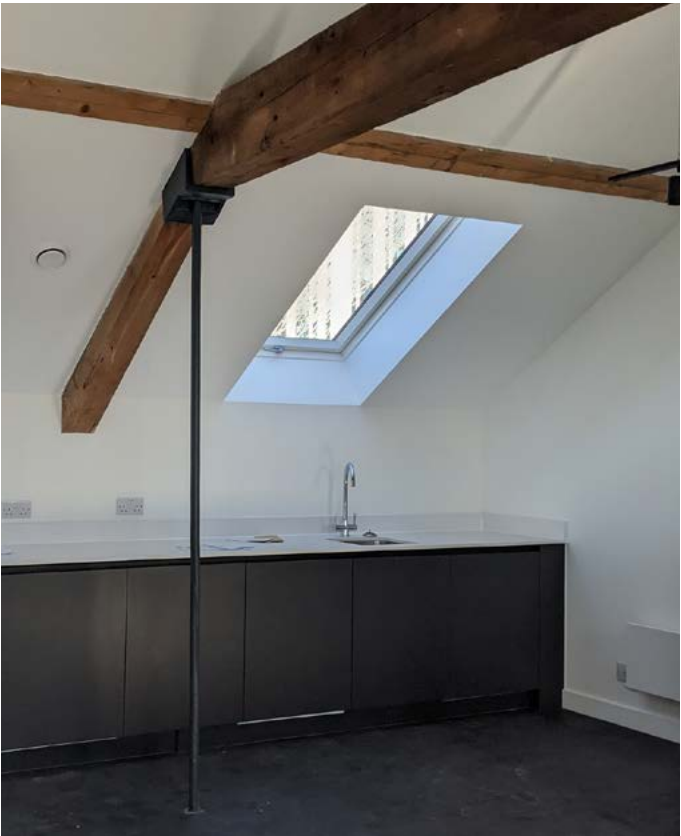
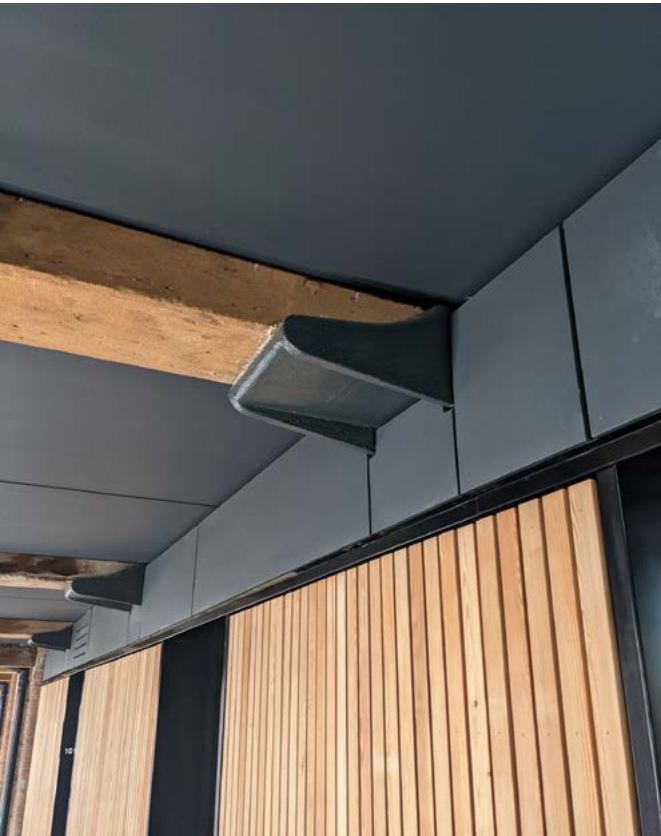
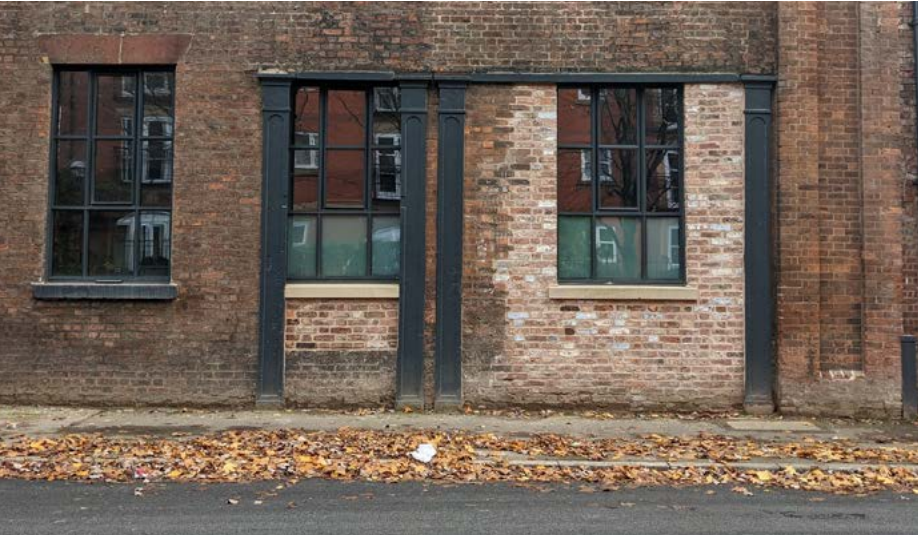
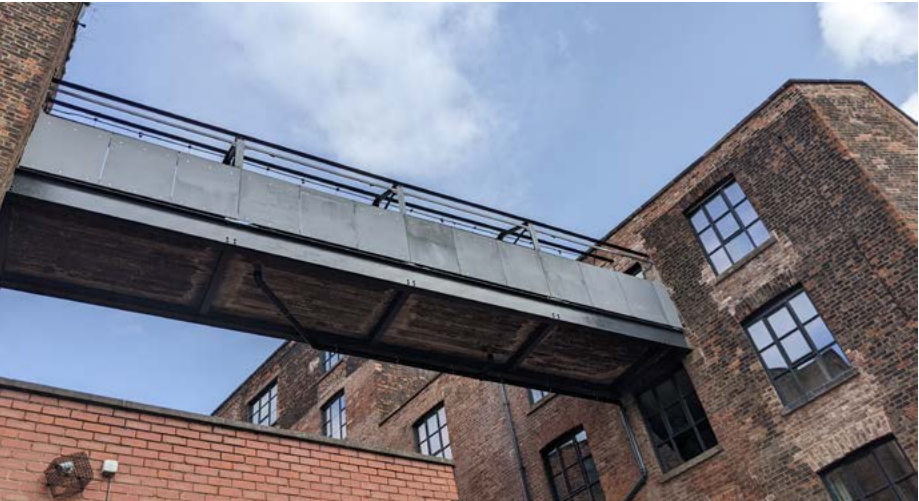
- key** (clockwise from top left)
- 01 existing beams, sandblasted with steel reinforcement
  - 02 steel pattress plates cleaned, repaired and reinstated
  - 03 existing internal steel beam – cleaned, repaired and reinstated
  - 04 existing timber trusses with tie rods – timber sandblasted, steel rods cleaned and painted
  - 05 existing timber beams, sandblasted and retained
  - 06 external cast iron pilasters cleaned, repaired and repainted
  - 07 existing bridgelink repaired with steel plate balustrades added to use as terrace

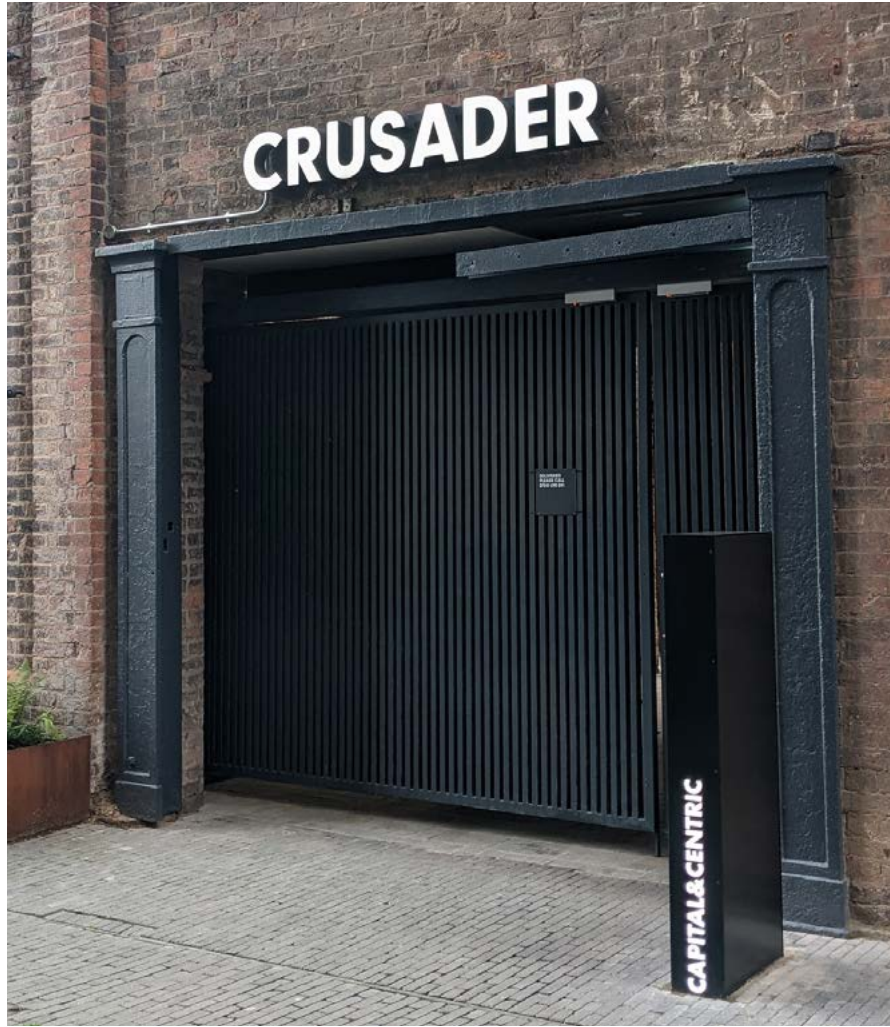
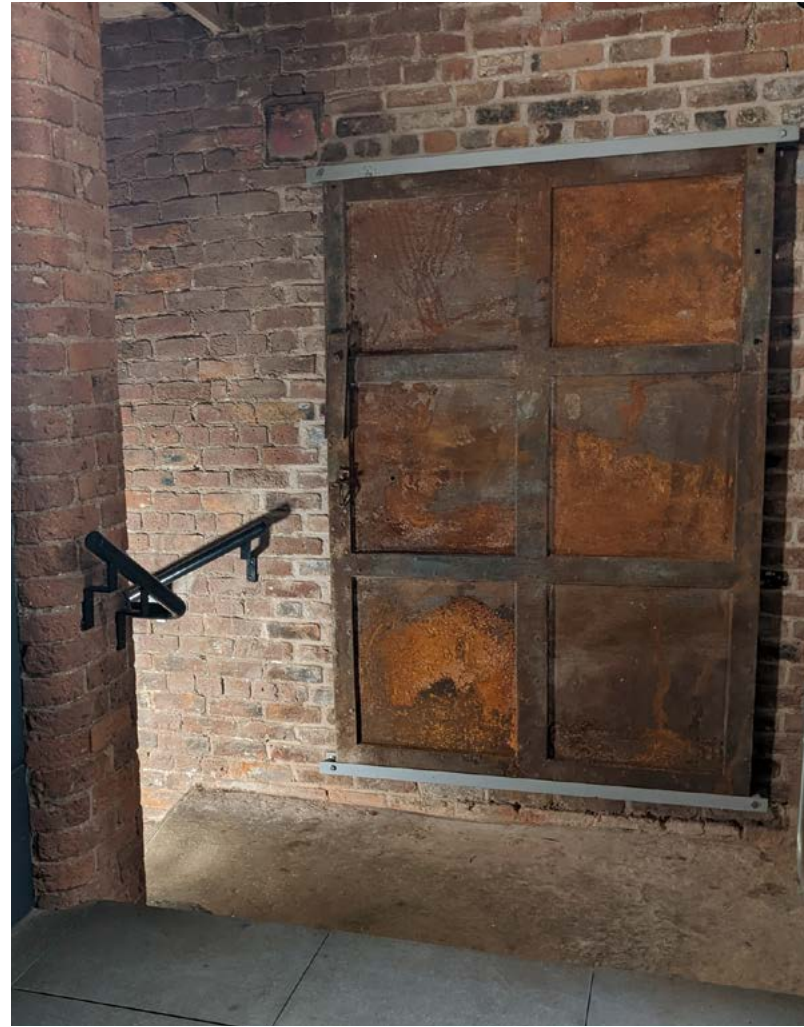
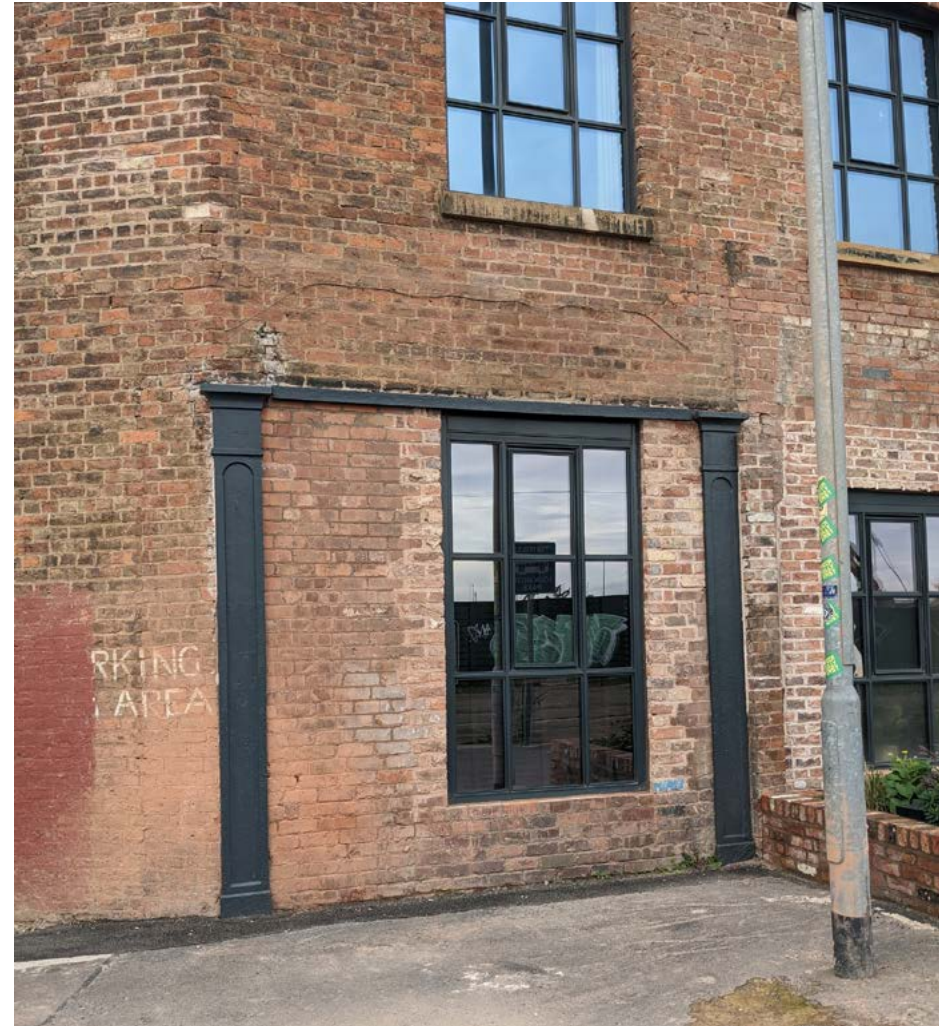
- following page**
- 08 external cast iron pilasters cleaned, repaired and repainted with new metal gates set into undercroft opening
  - 09 castiron doors retained as existing and mounted in existing stairwell
  - 10 external cast iron pilasters cleaned, repaired and repainted

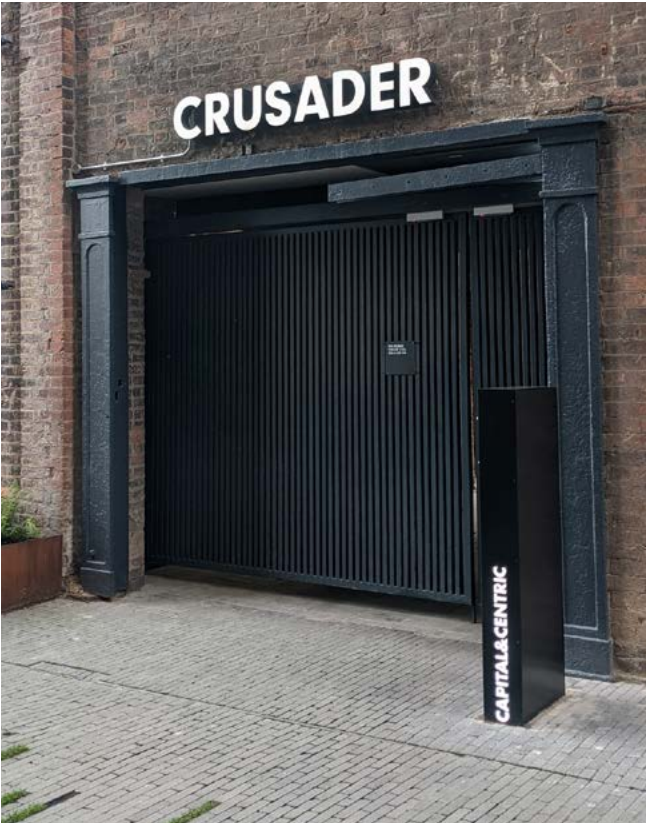
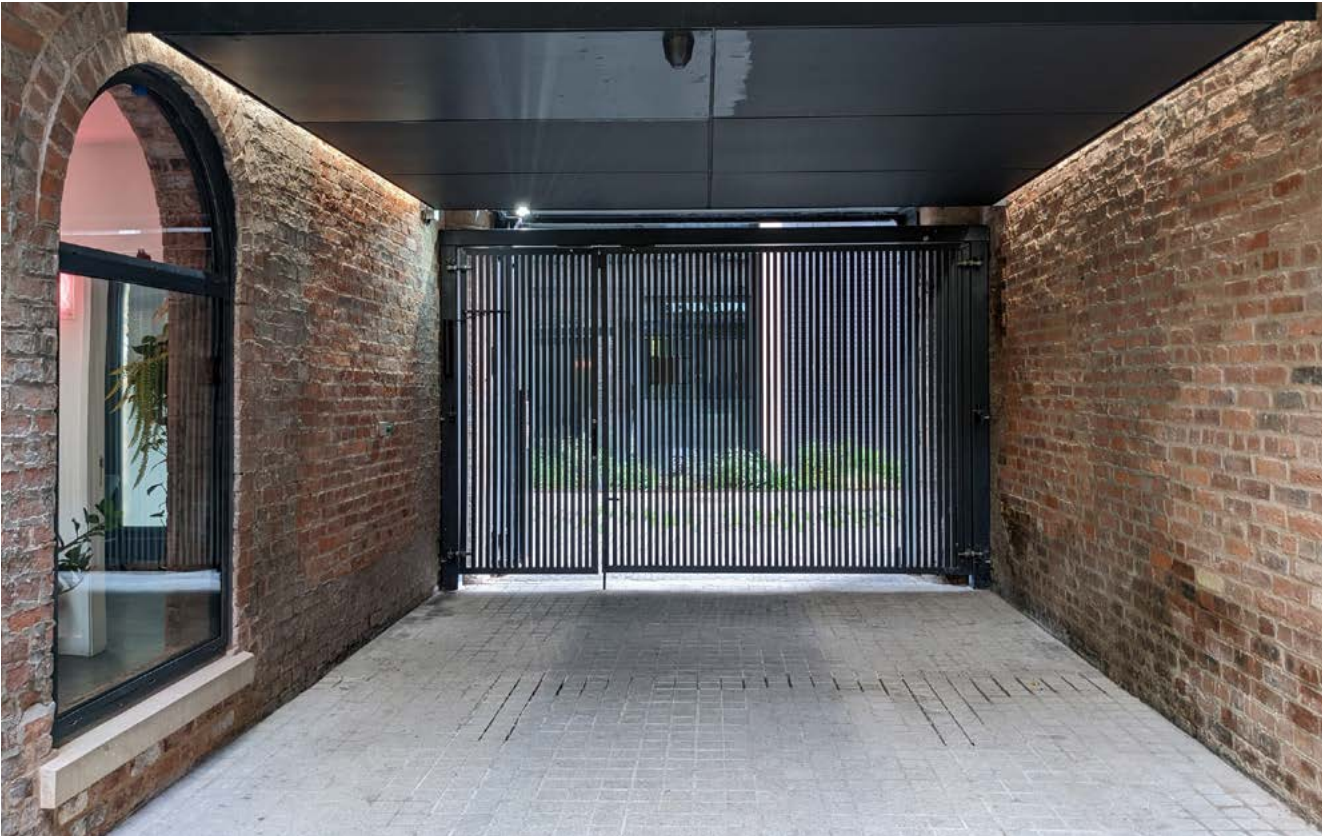
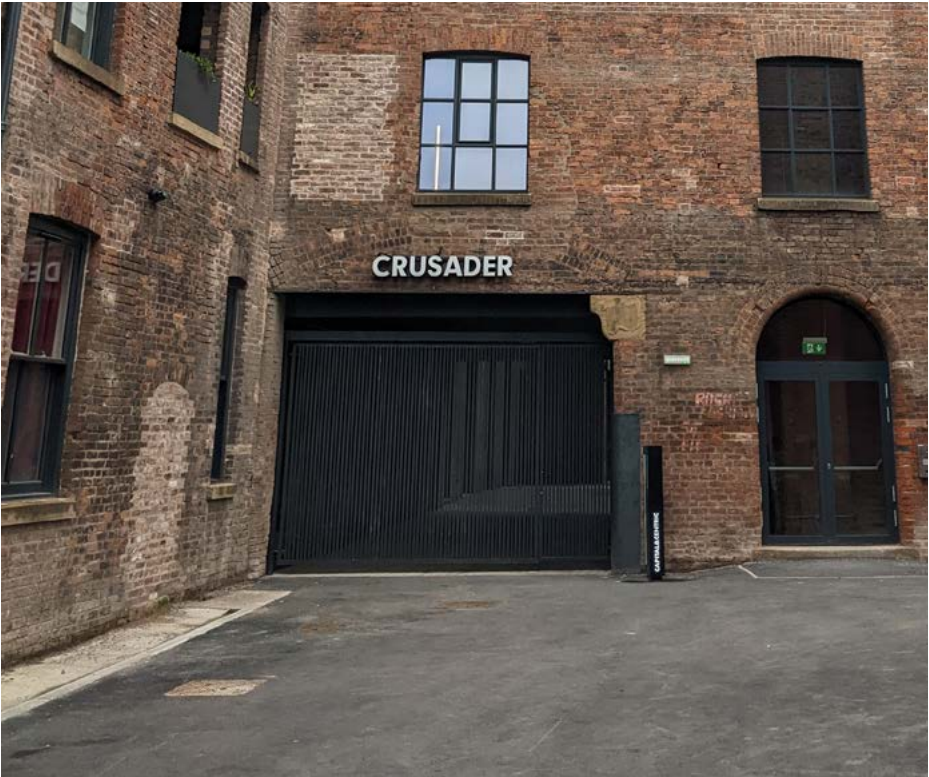
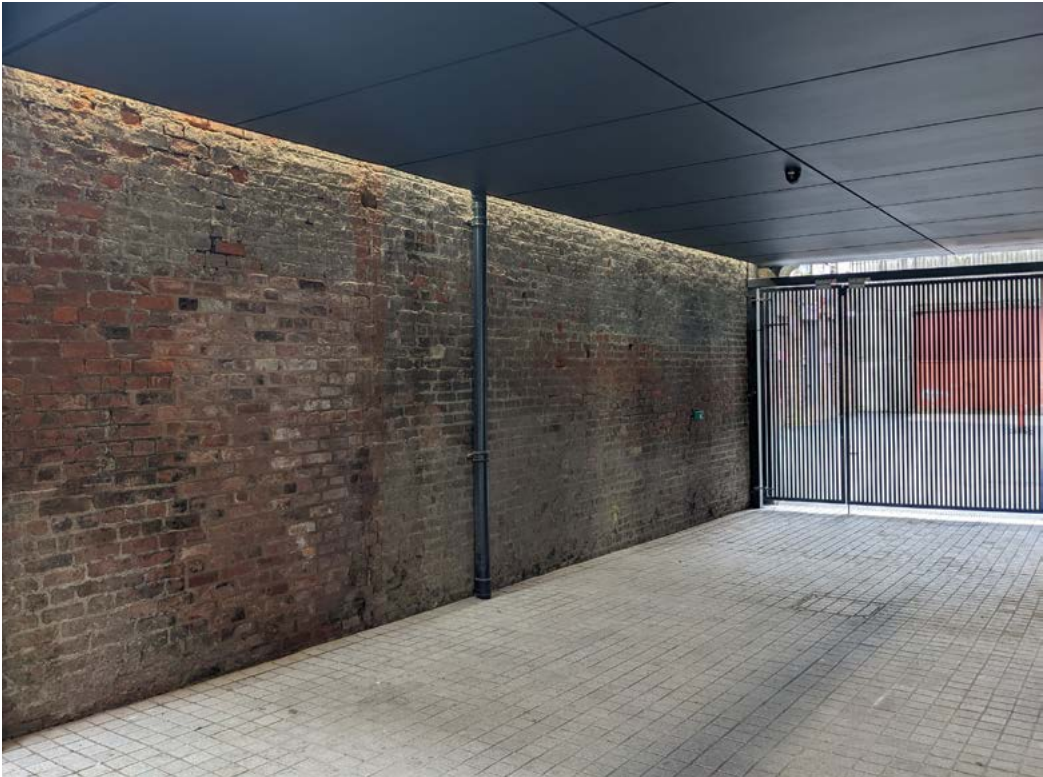
- 01 east entrance gate external view
- 02 east entrance gate internal view
- 03 west entrance gate external view
- 04 west entrance gate internal view

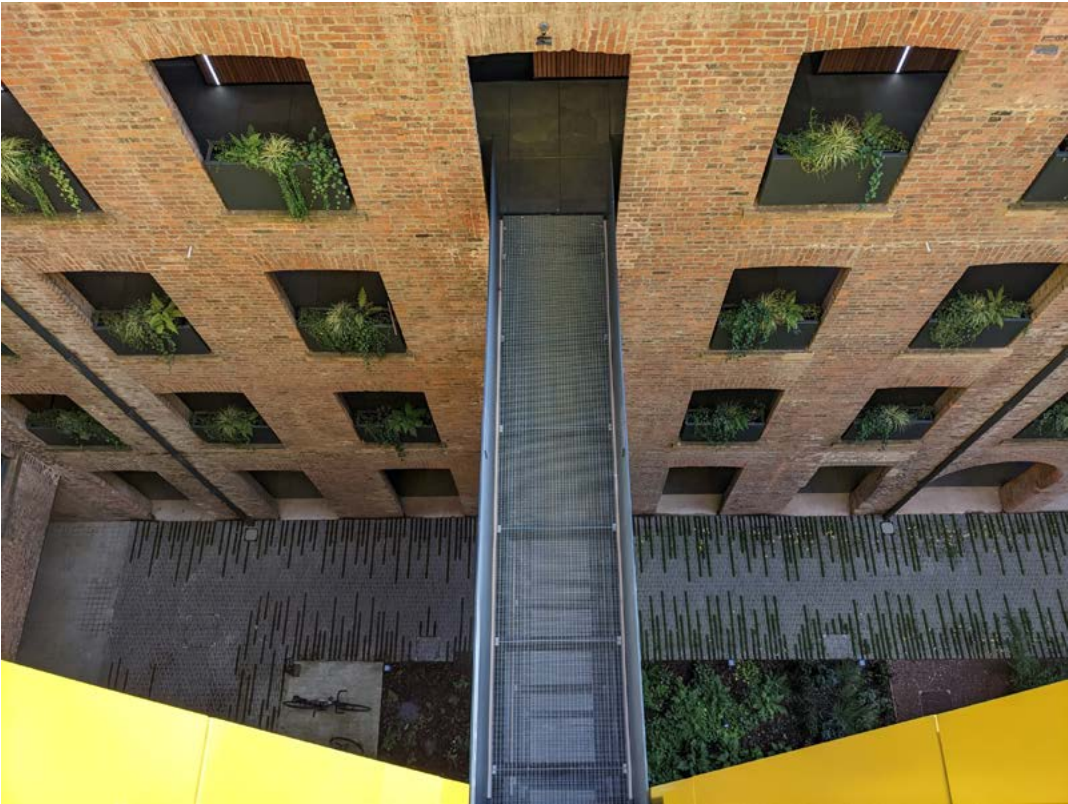
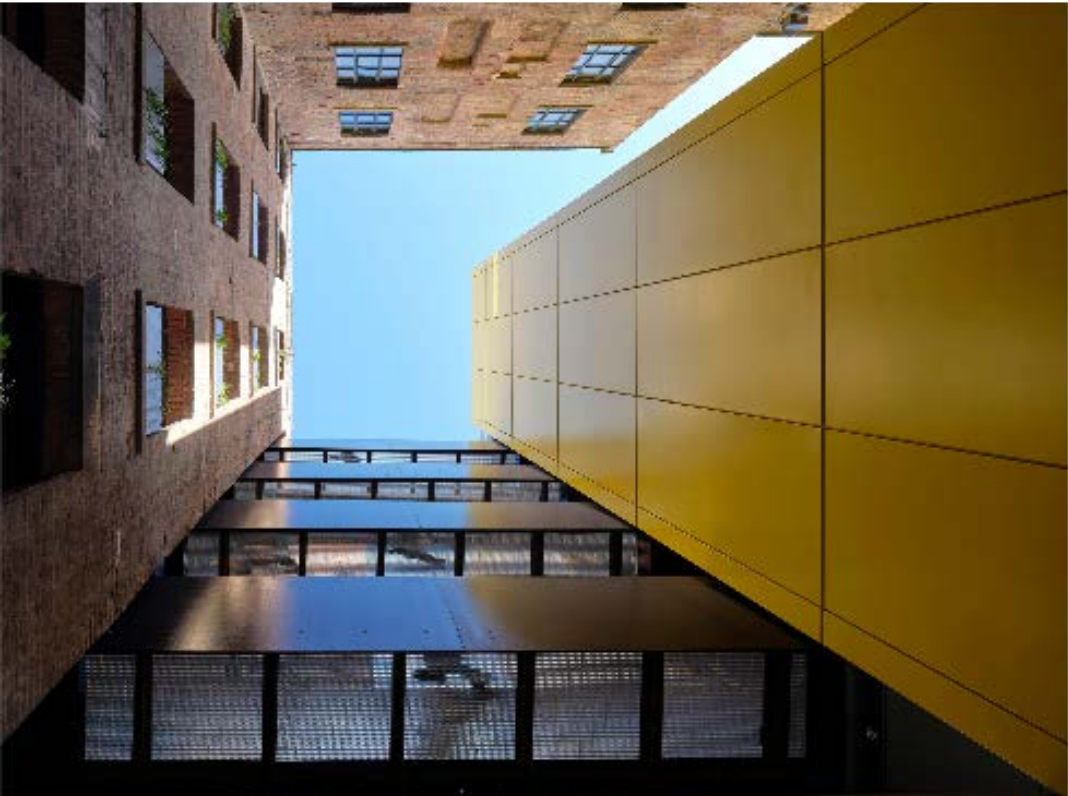
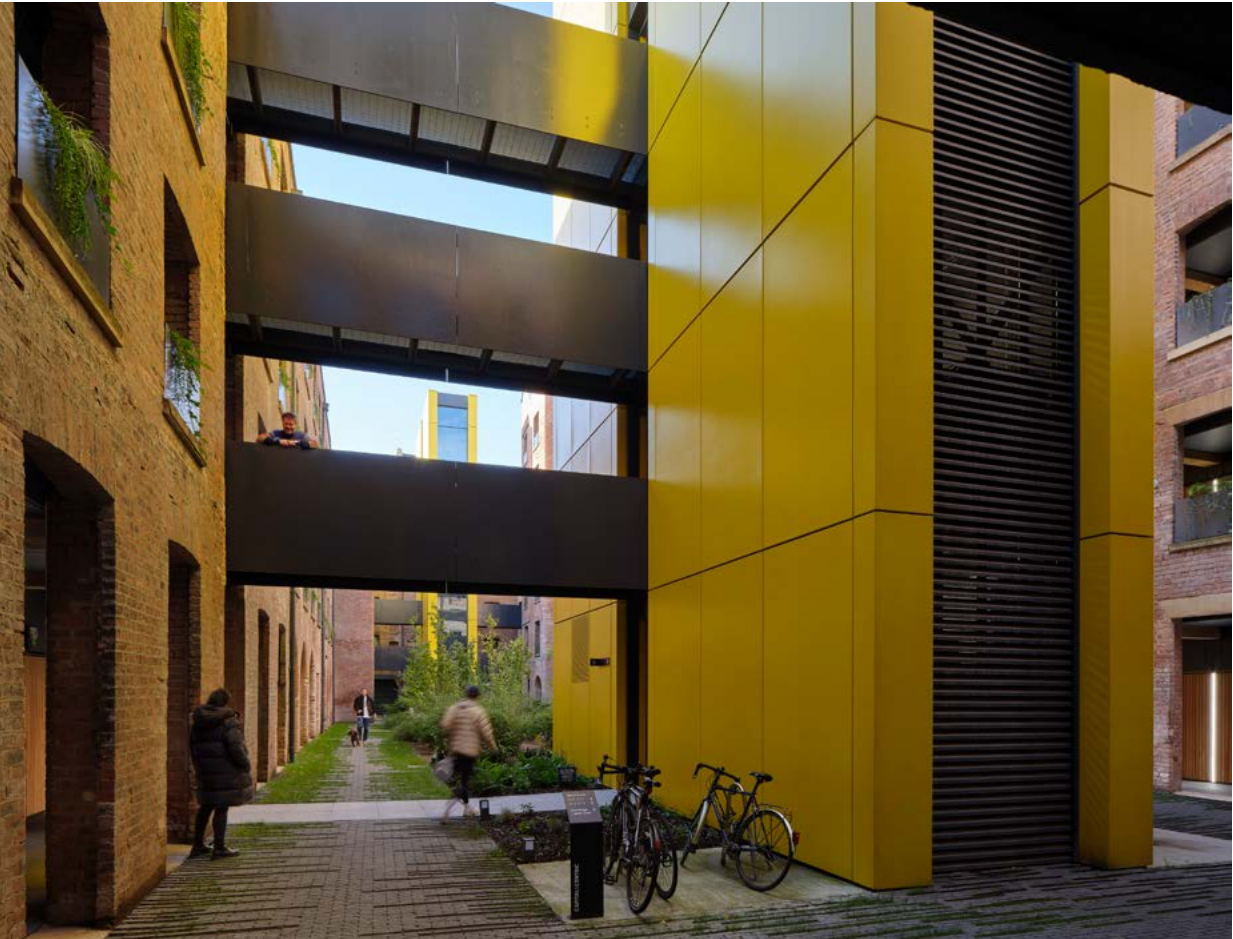
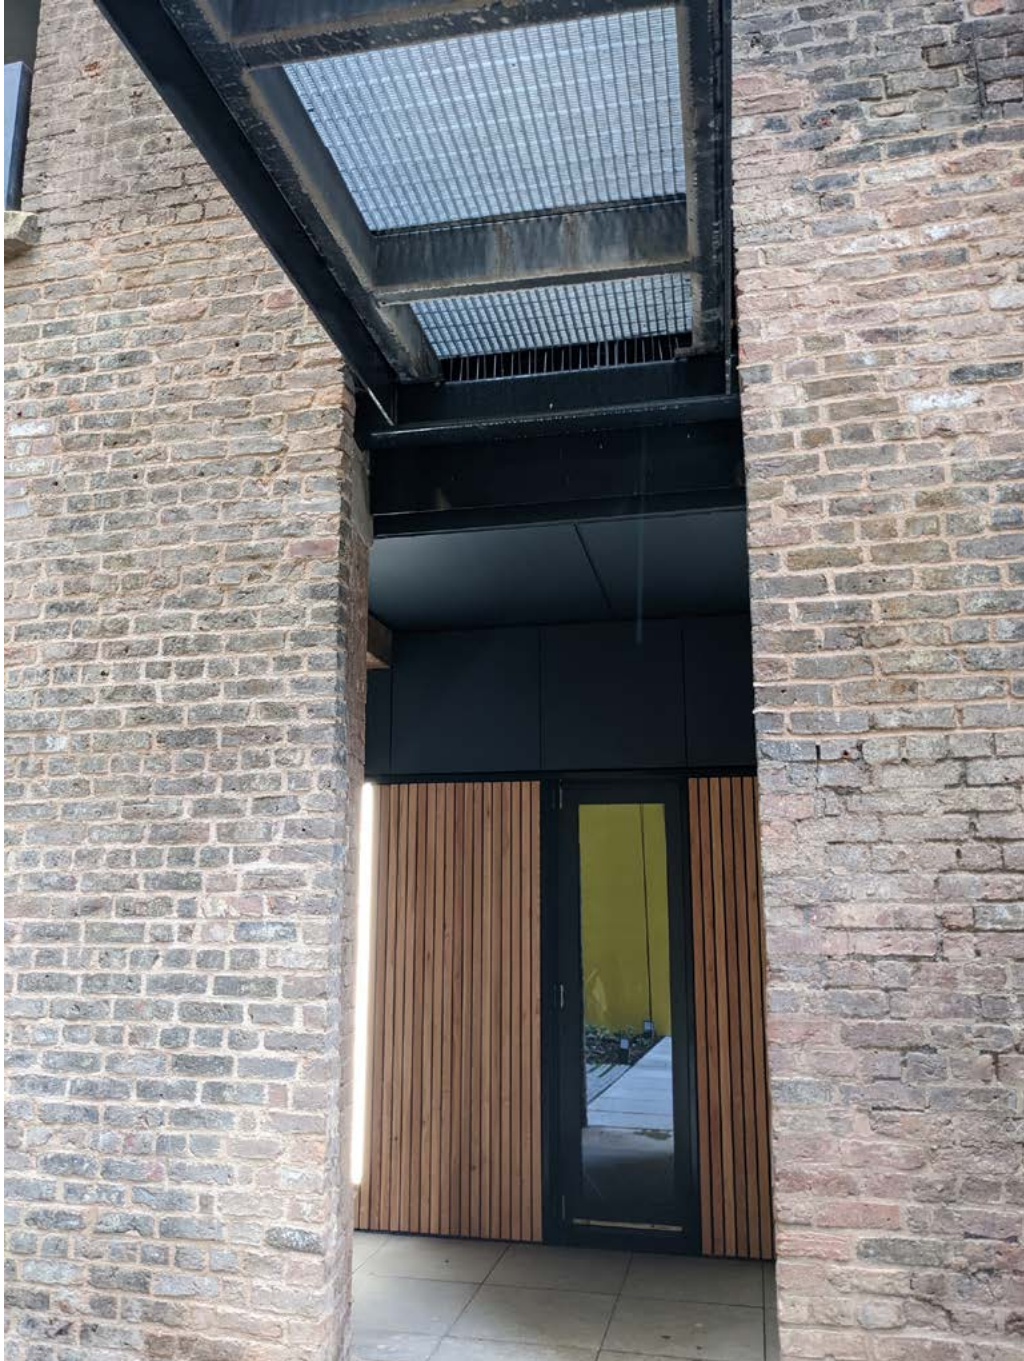
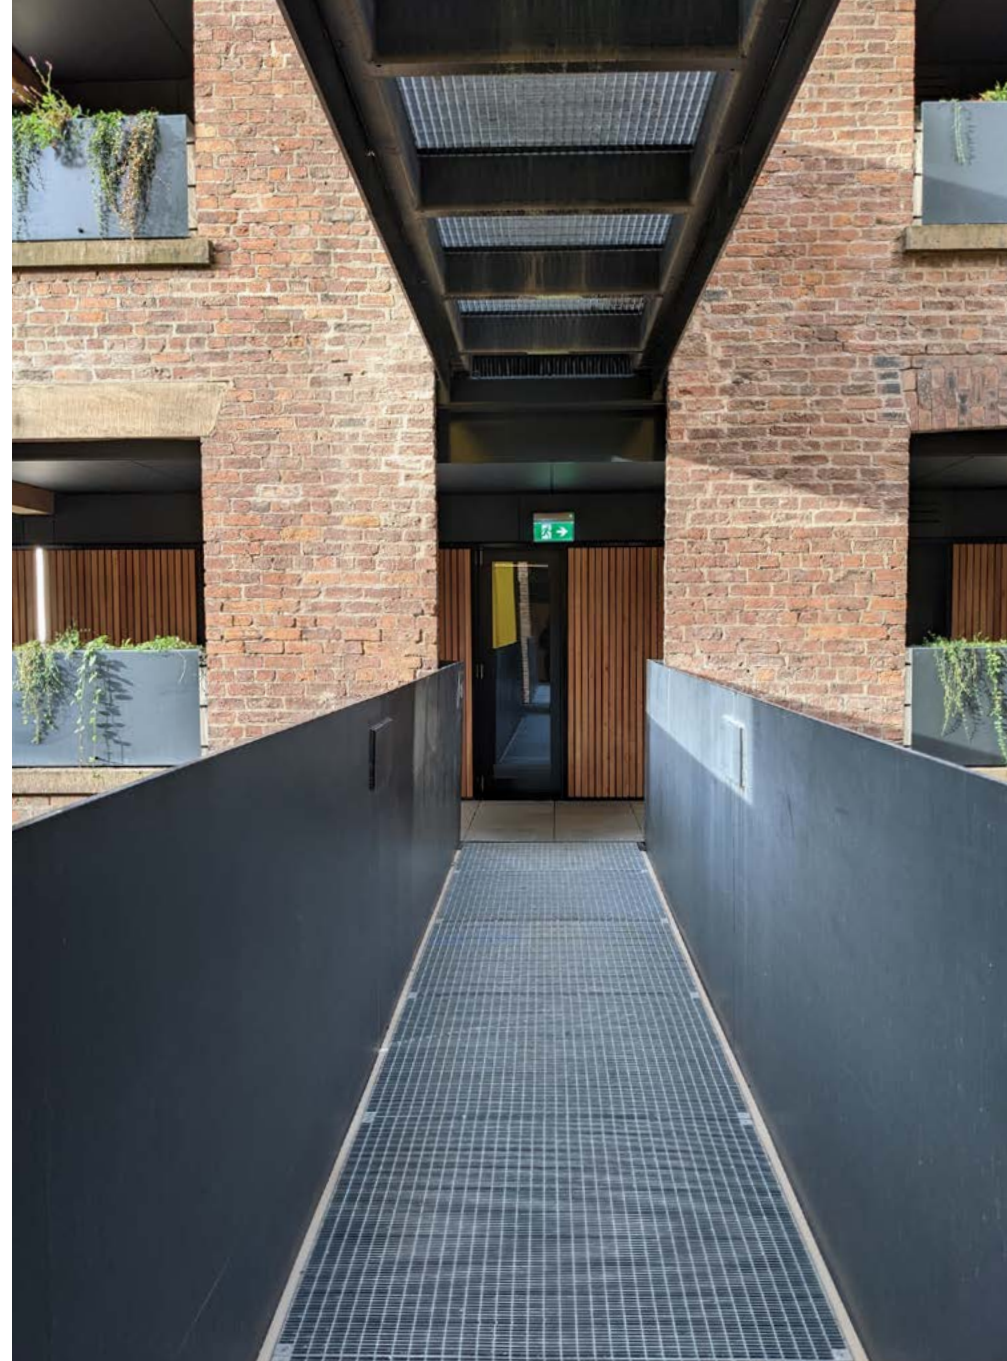
- key** (clockwise from top left)
- 01 bridgelink connection to existing facade
  - 02 core and bridgelink view from the courtyard
  - 03 view looking up at core, bridgelink and masonry
  - following page**
  - 04 interface of bridgelink and existing masonry facade viewed from below
  - 05 interface of bridgelink and existing masonry facade viewed from walkway

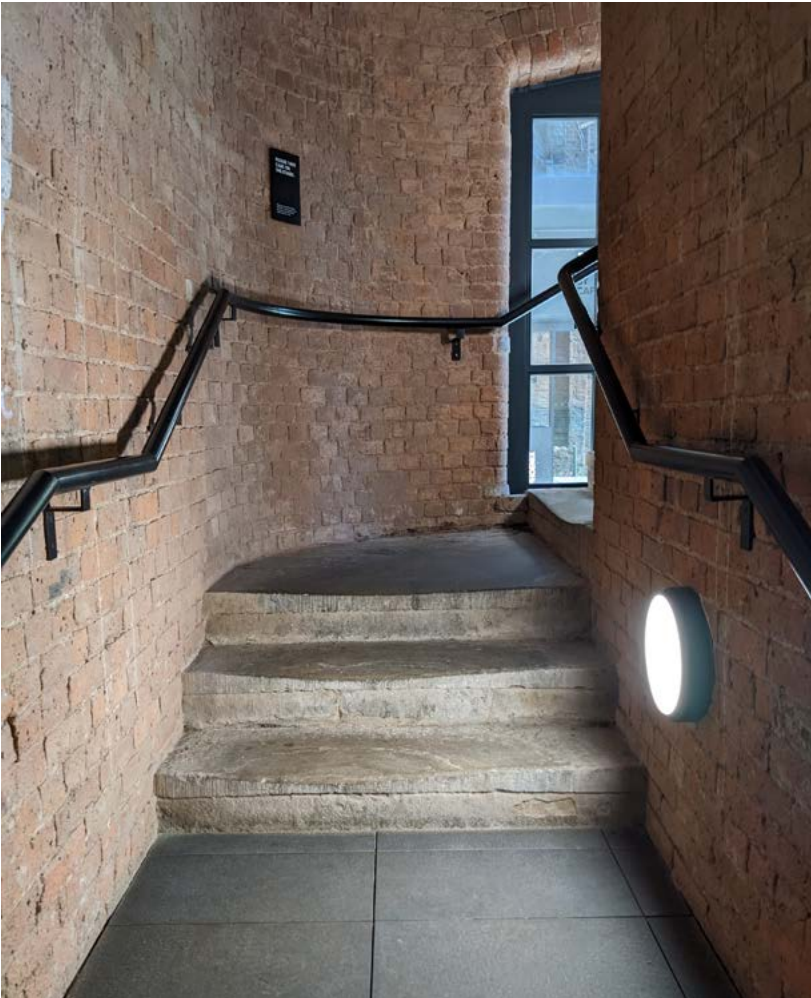
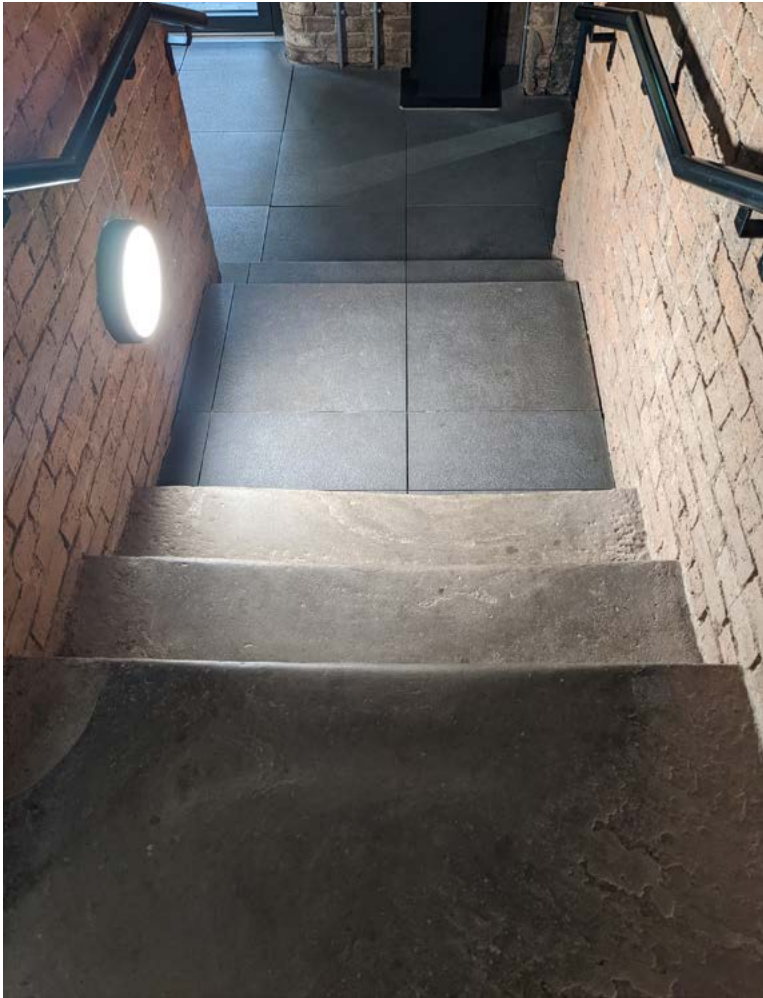
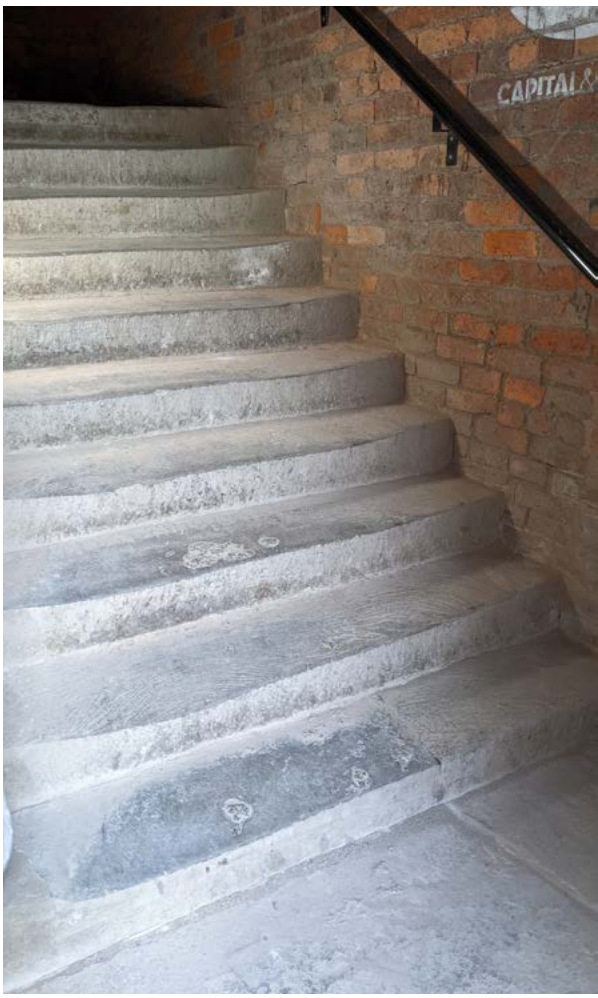
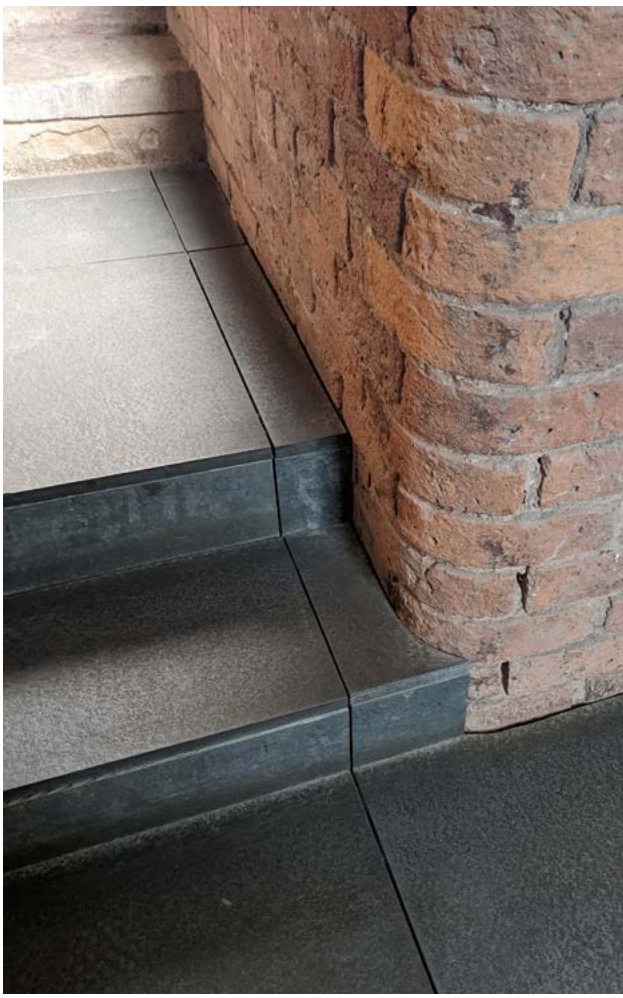
- key** (from left)
- 01** new flooring, existing stone treads, handrails and lighting
  - 02** interface of new flooring and existing stone treads
  - 03** existing stone treads repaired and cleaned
  - 04** new tiles scribed to existing masonry
