# crusader photo-report

| crusader mill | 08 02 2022 | Capital & Centric | Crusader<br>70 Chapeltown St<br>Manchester<br>M1 2EW | Manchester City Council | photoreport to discharge planning<br>conditions relating to applications<br>113363/FO/2016<br>113364/LO/201 |
| planning photo report | - | shedkm architects ltd | | | |

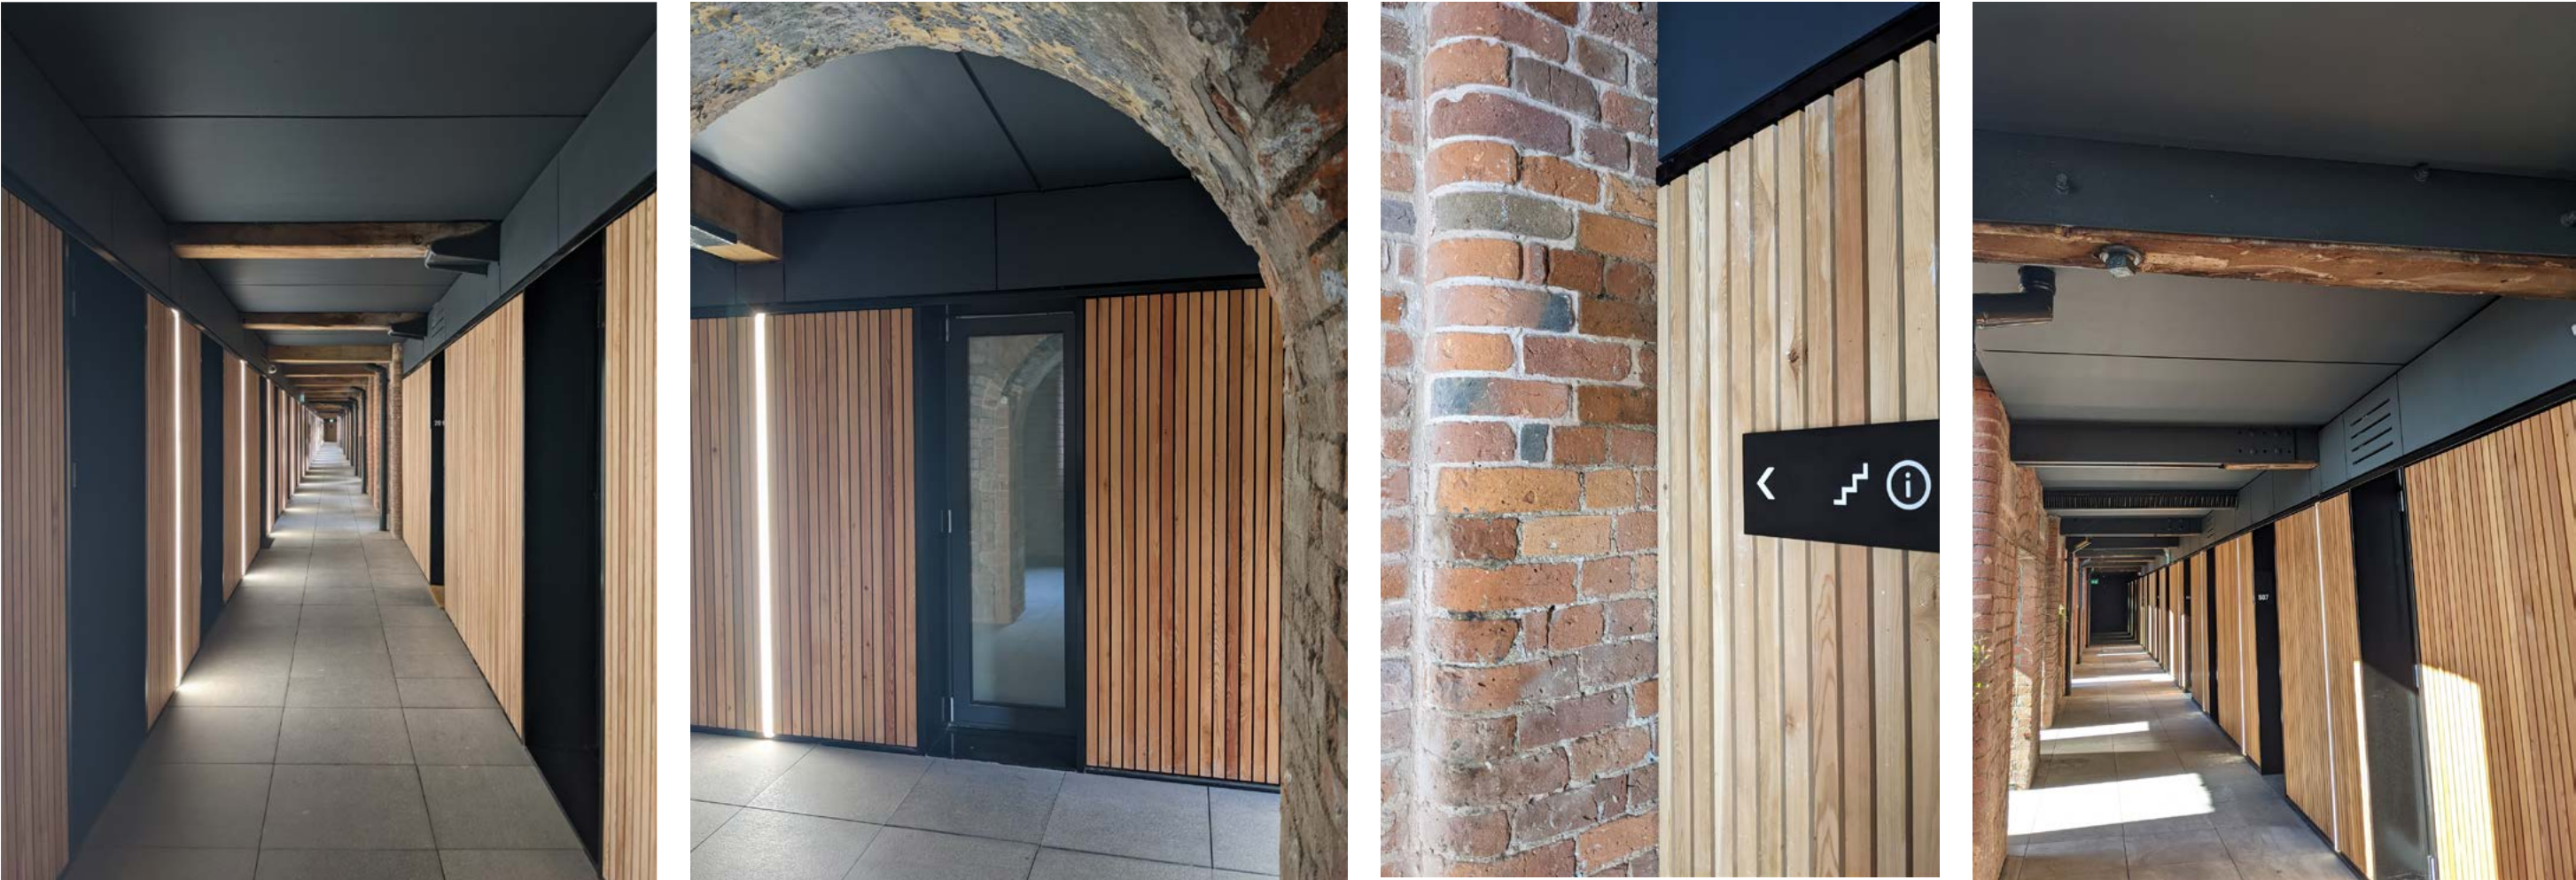
- key** (from left)
- 01** view along cloister showing new coister walls and soffit interface with existing timber beams
  - 02** cloister timber cladding, aluminium window reveals, frieze and soffit
  - 03** interface of new cloister wall with existing masonry
  - 04** interface of new soffit with steel plate to beams

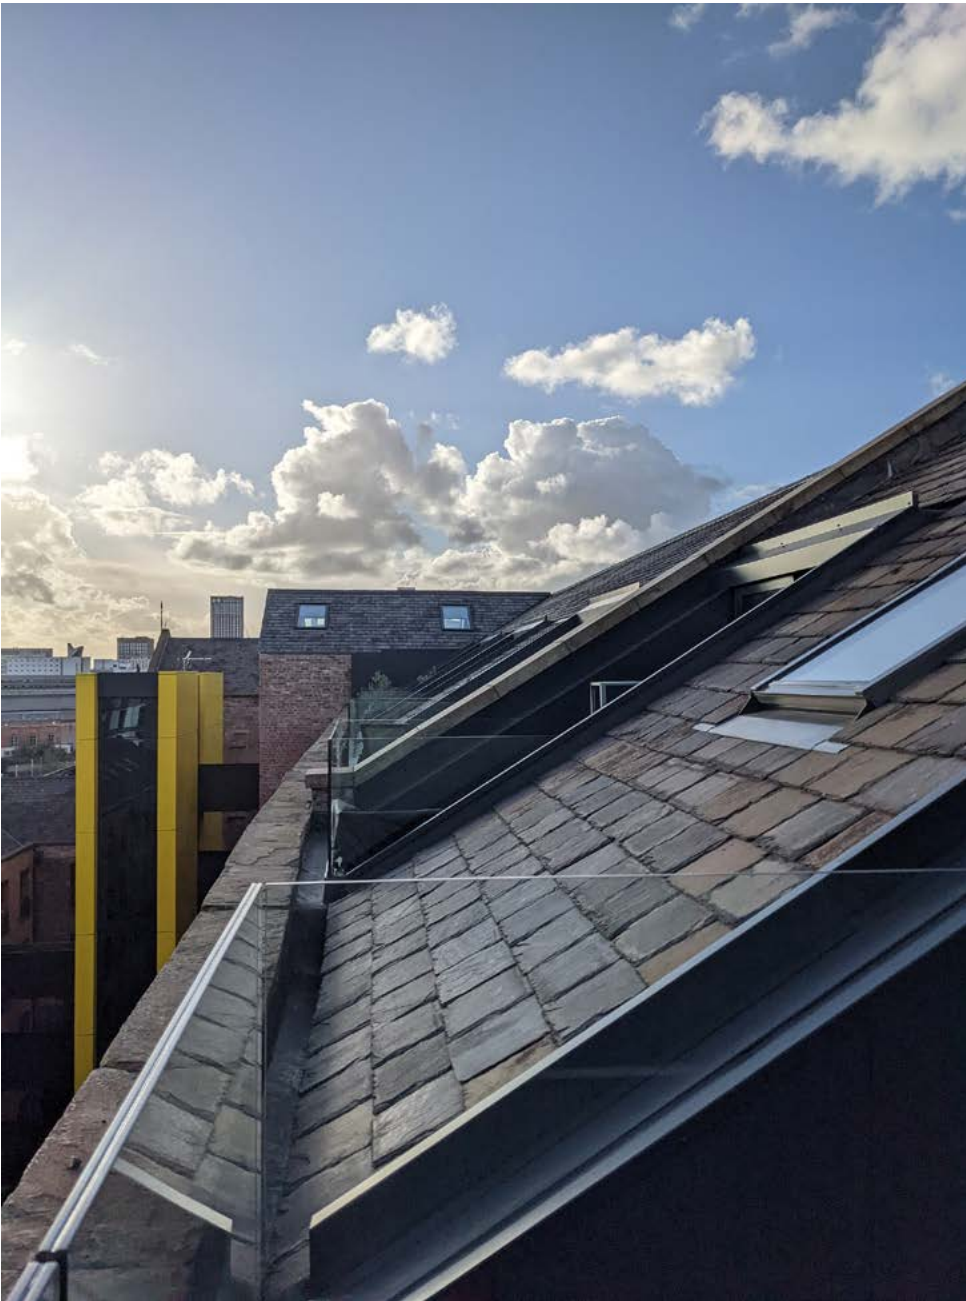
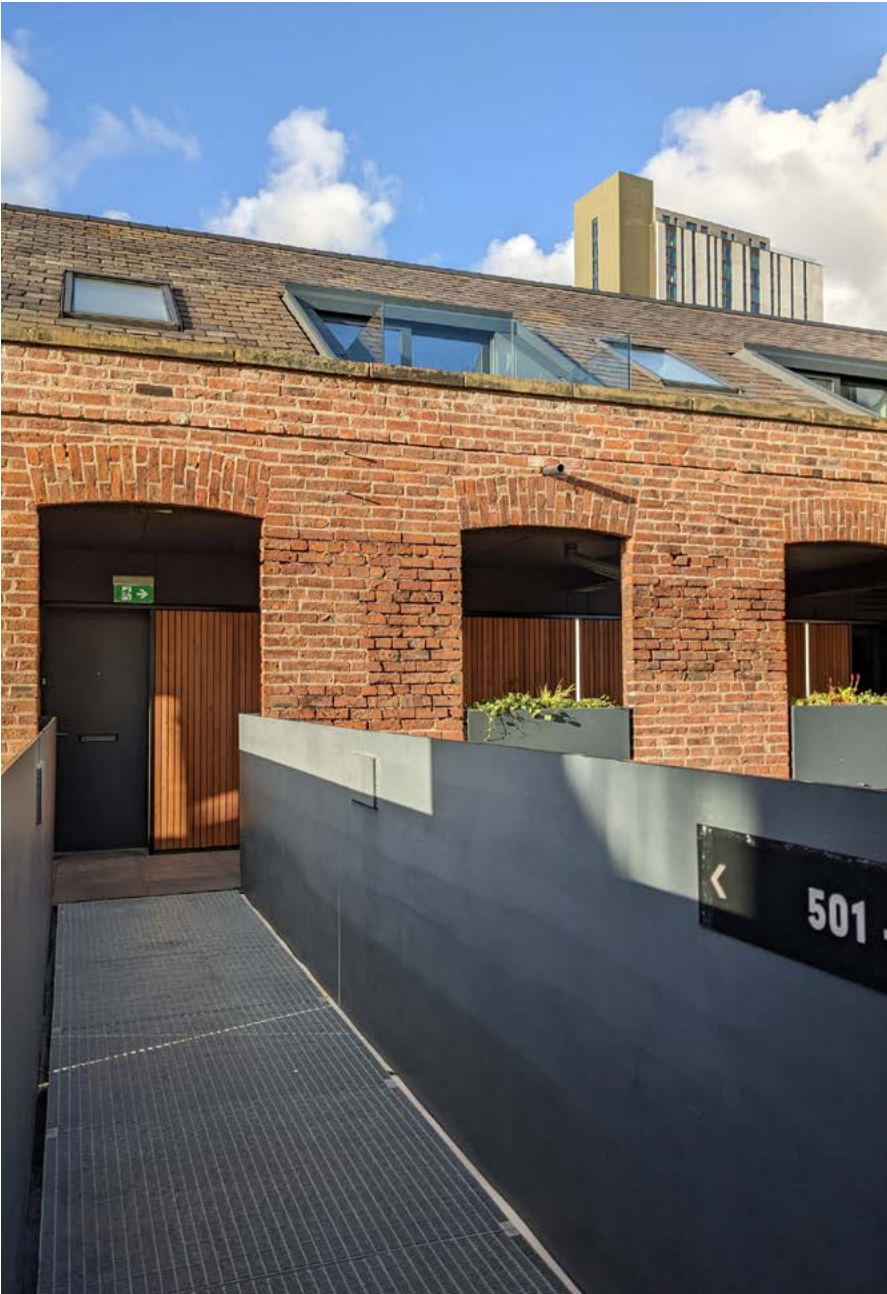
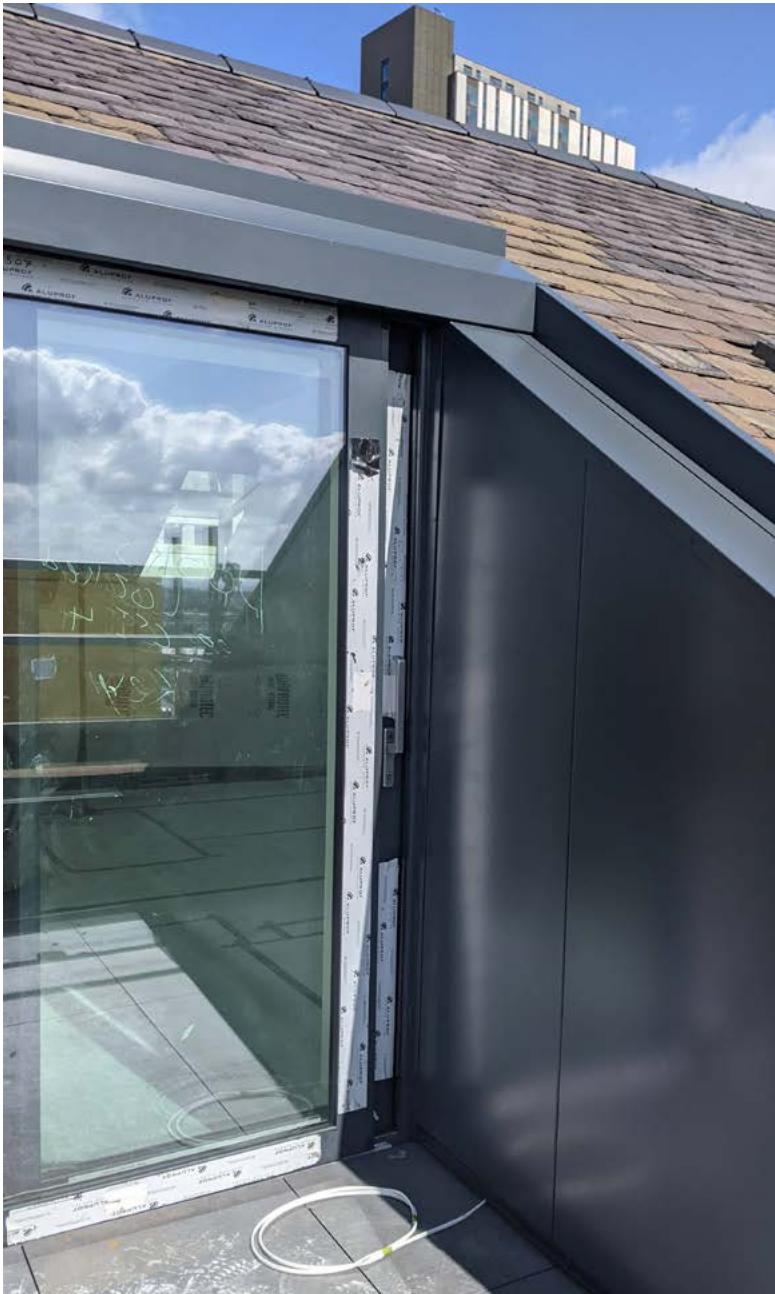
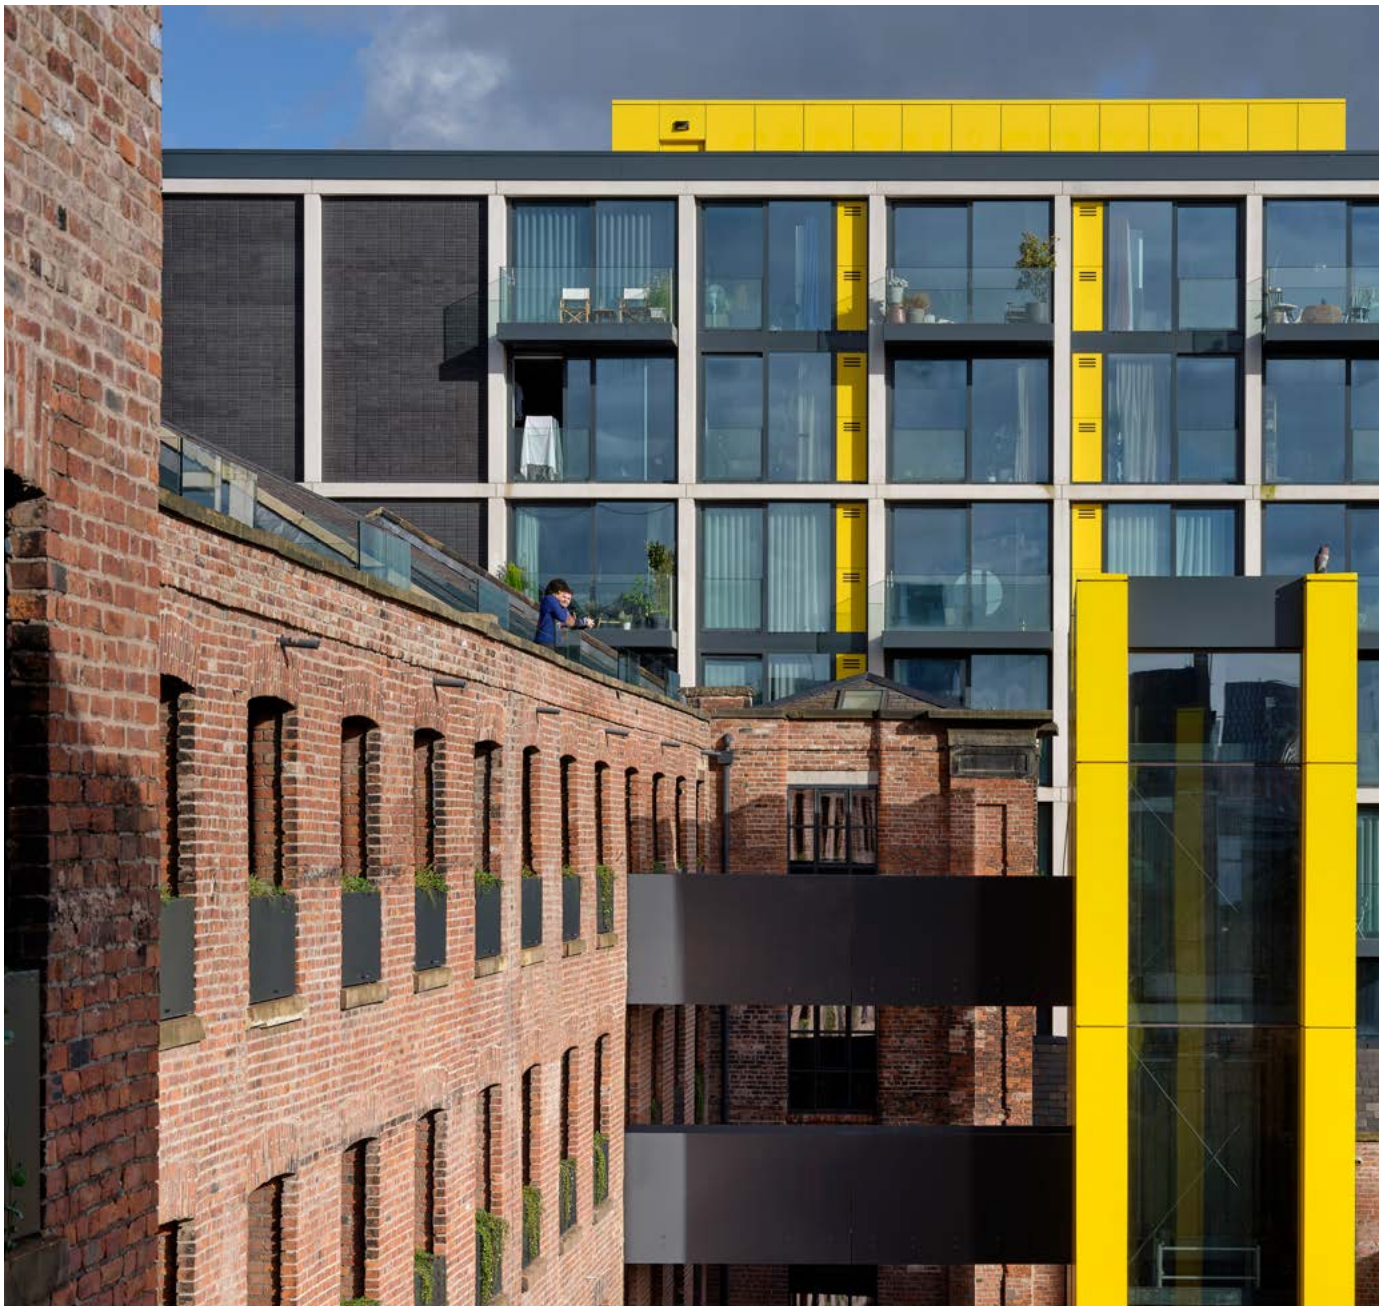
- key** (from left)
- 01** 'cut-out' roof terraces - interface with existing coping and gutter, glazed balustrade and flashing with slate roof shown
  - 02** roof terraces viewed from below
  - 03** aluminium flashing to head of door and cladding to cheeks
  - 04** terraces viewed from bridgelink showing minimal visual impact to roof line

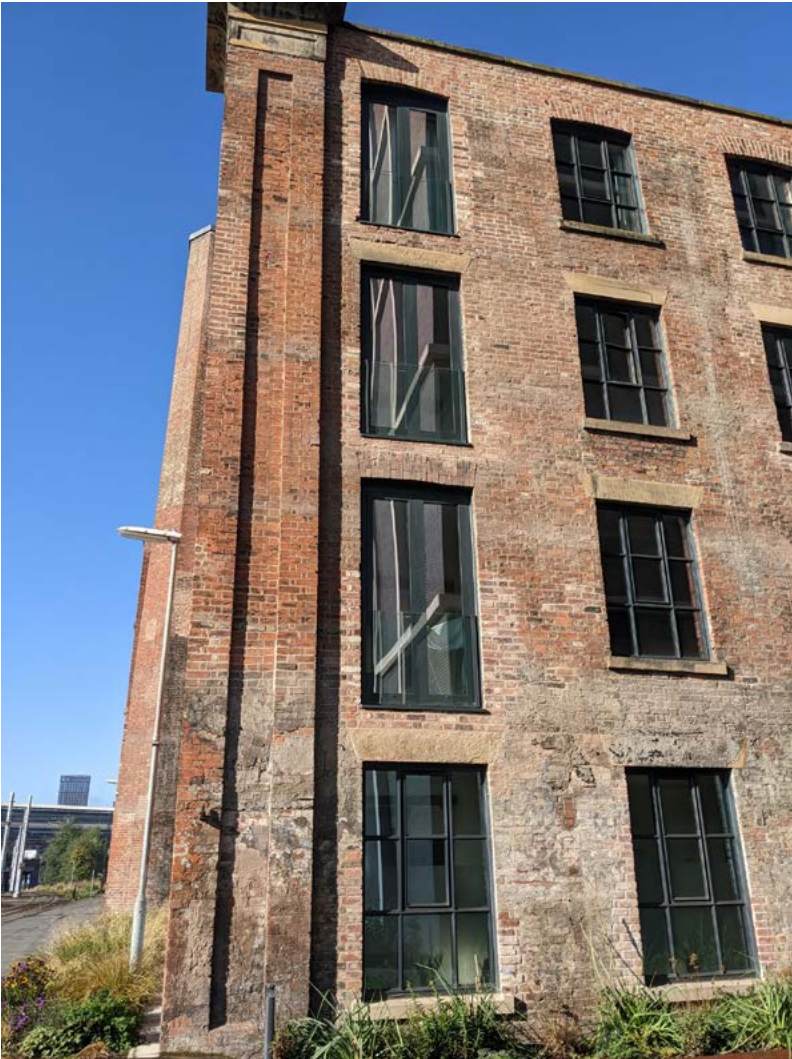
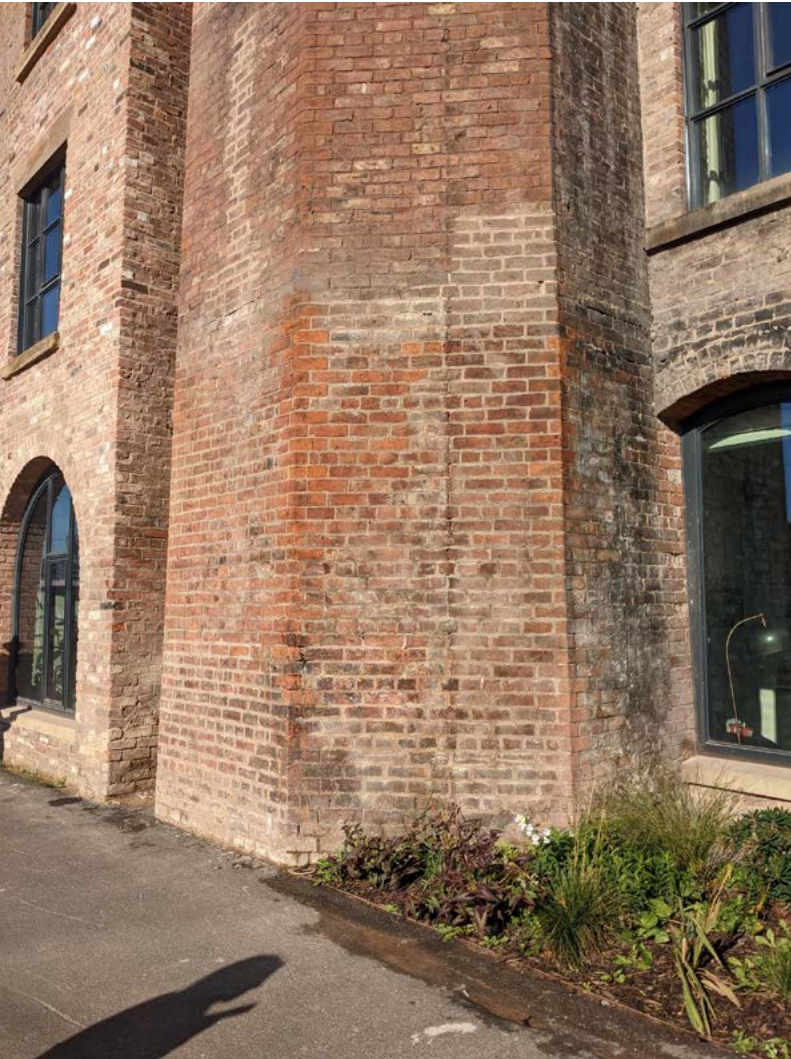
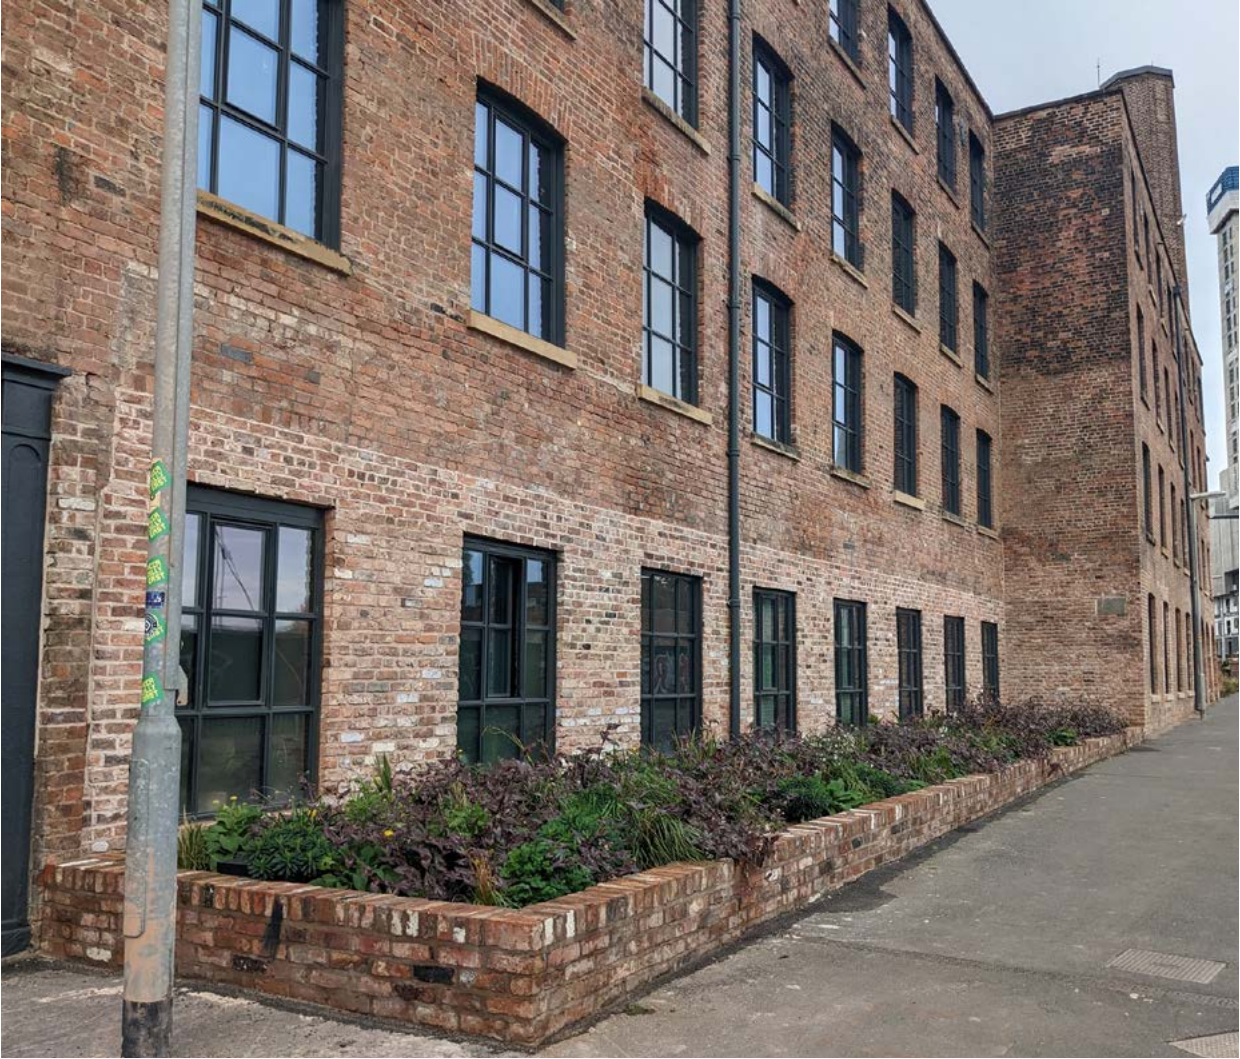
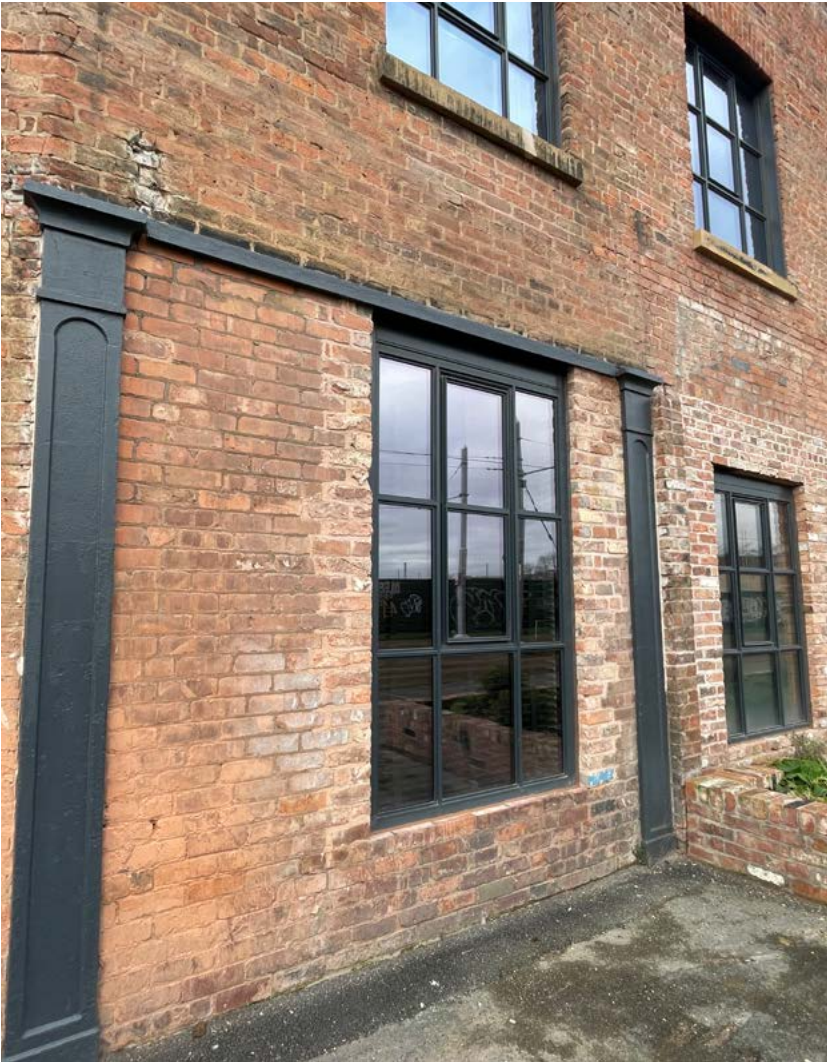
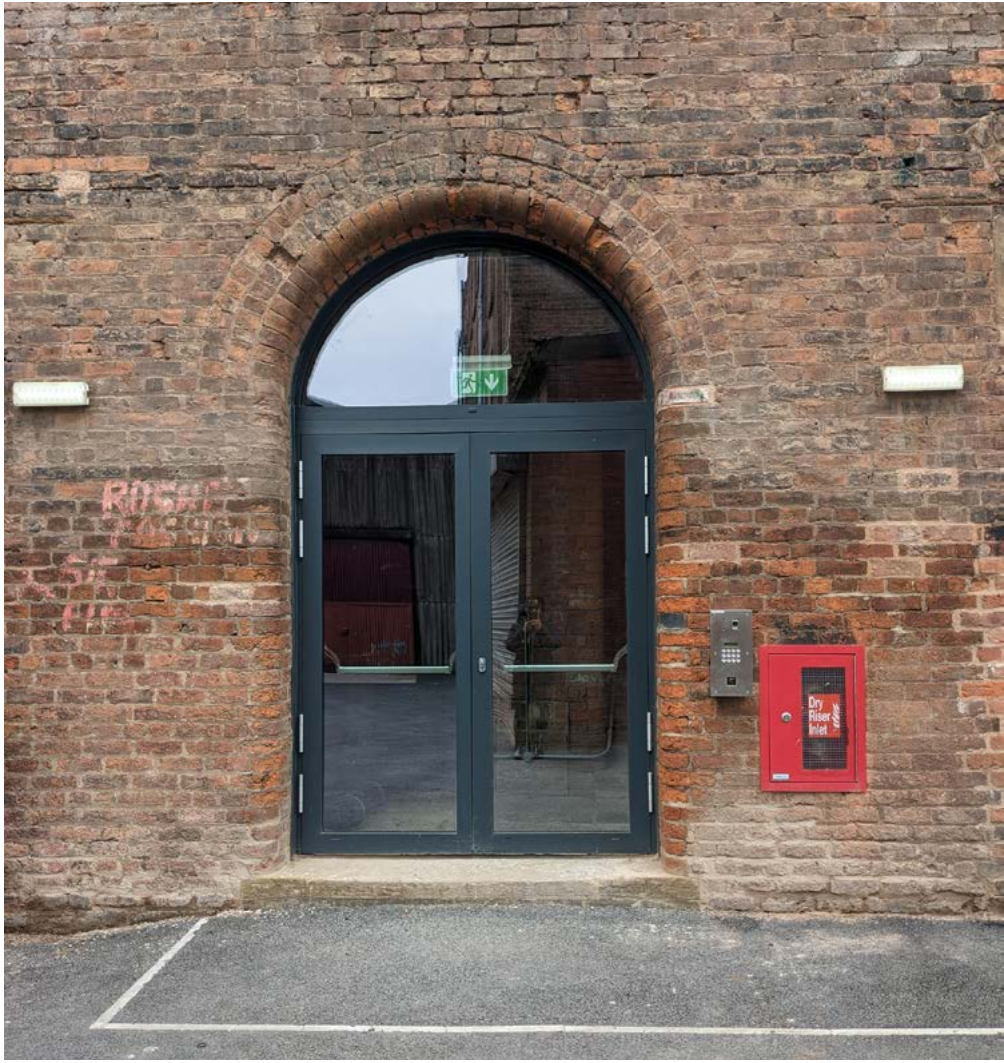
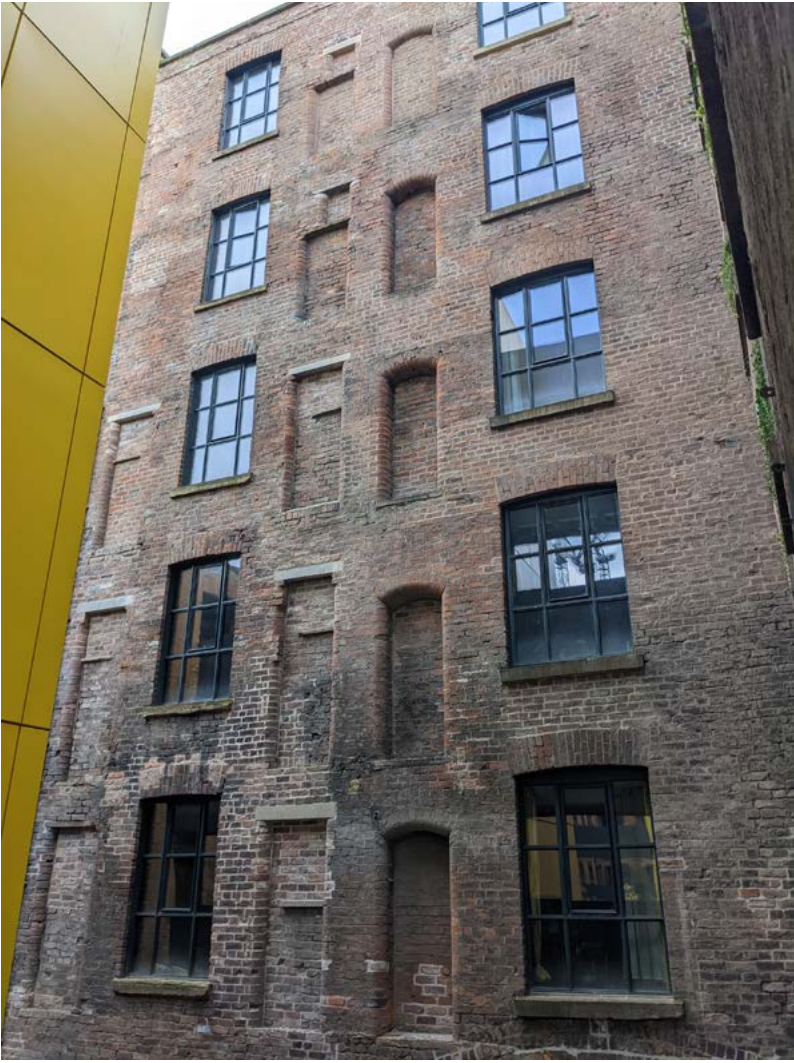
- 01 SE corner - new openings to masonry with double doors and juliette balconies
- 02 chimney brickwork, repointed and cleaned
- 03 tramline elevation – new section of brickwork along full ground floor
- 04 tramline elevation – new section of brickwork between cast-iron pilasters  
(\*redundant wires removed since last visit and low level repointing completed)
- 05 west stair access
- 06 openings reinstated to west courtyard elevation

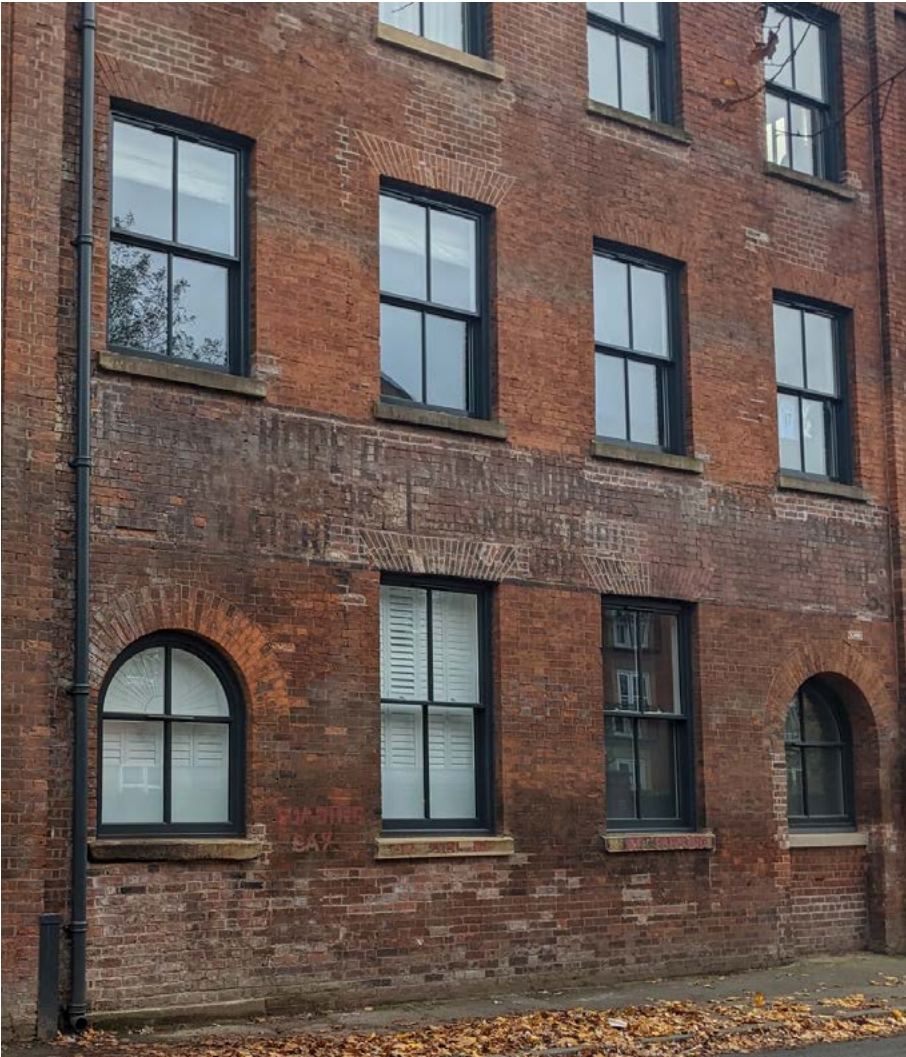
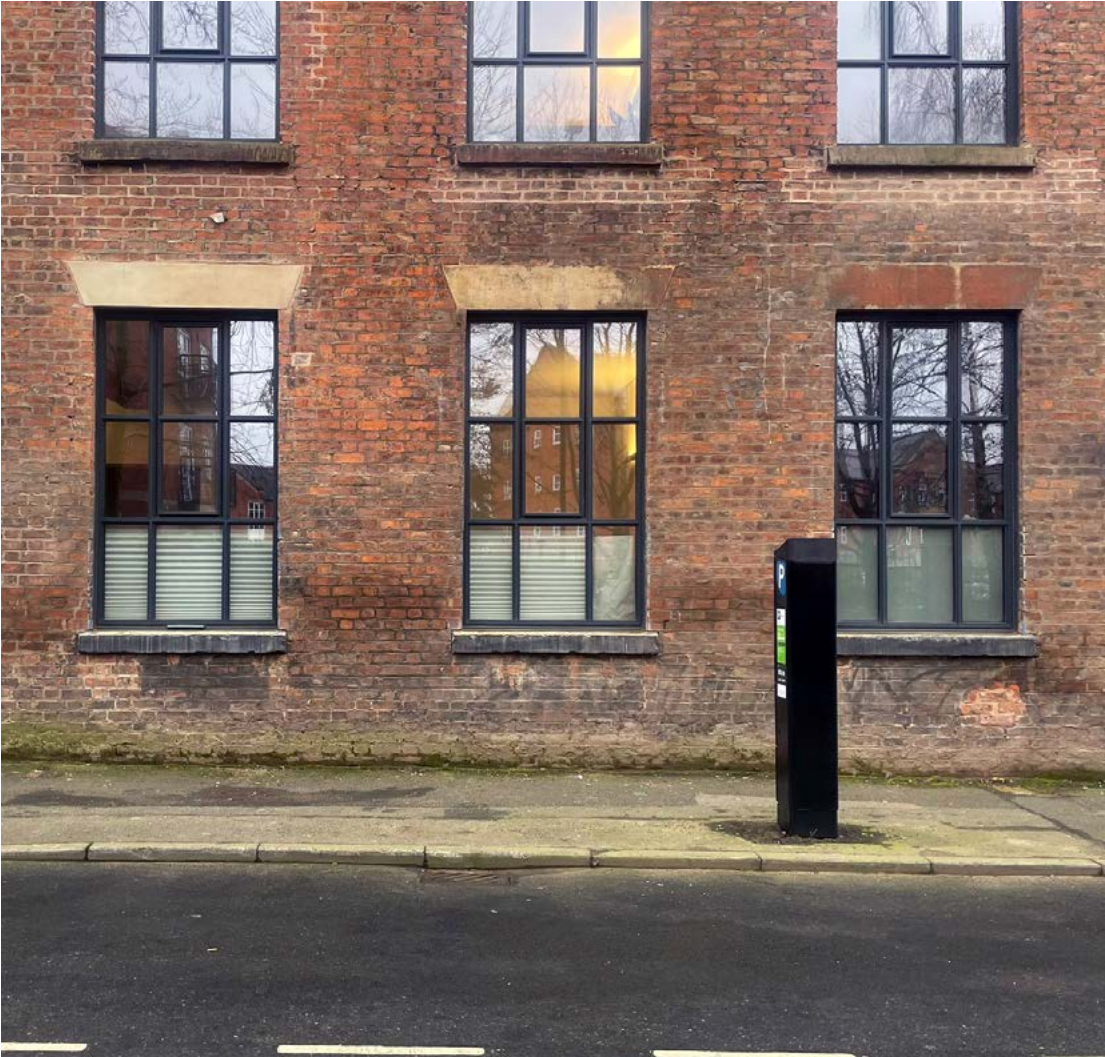
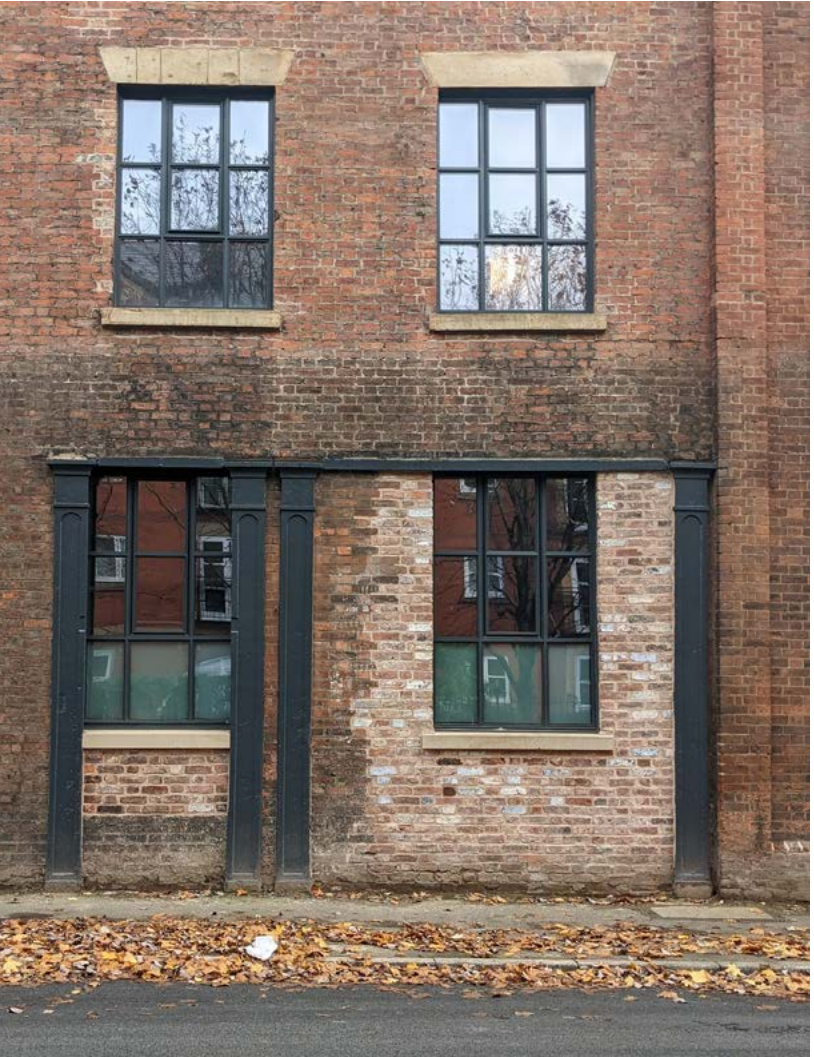
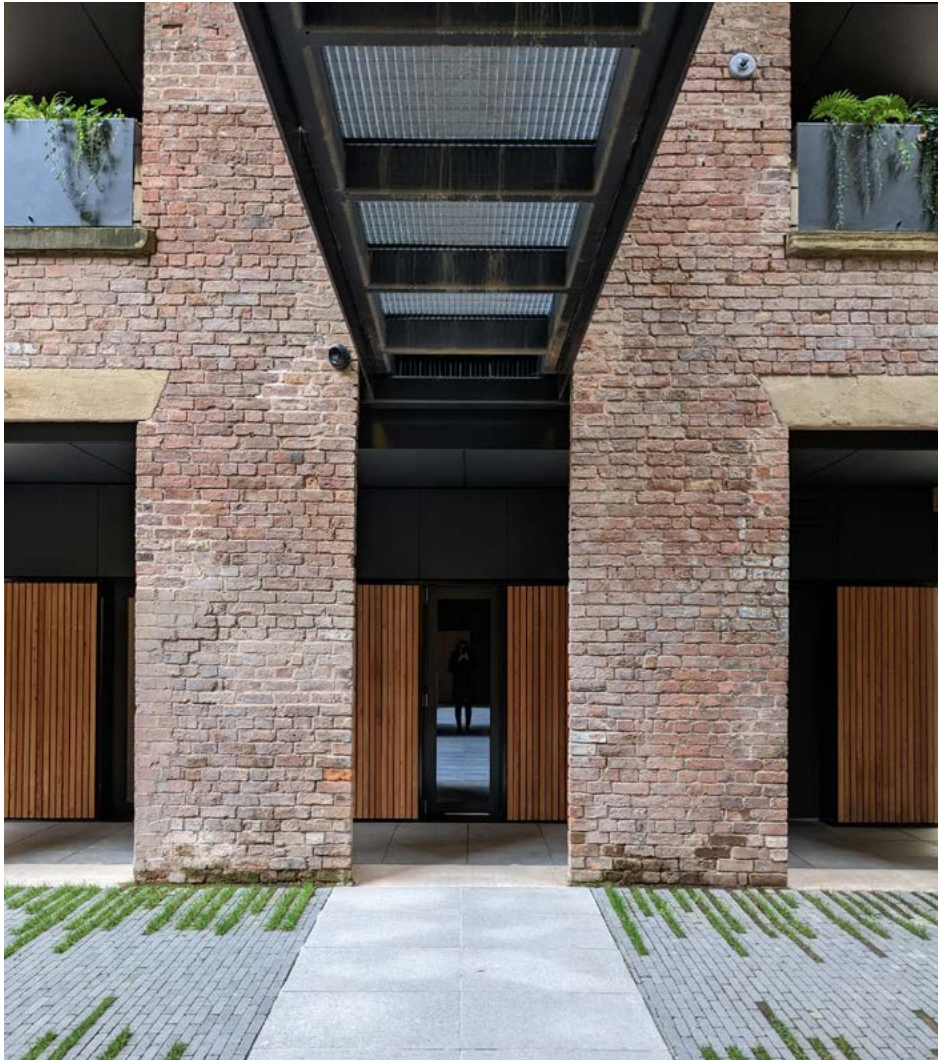
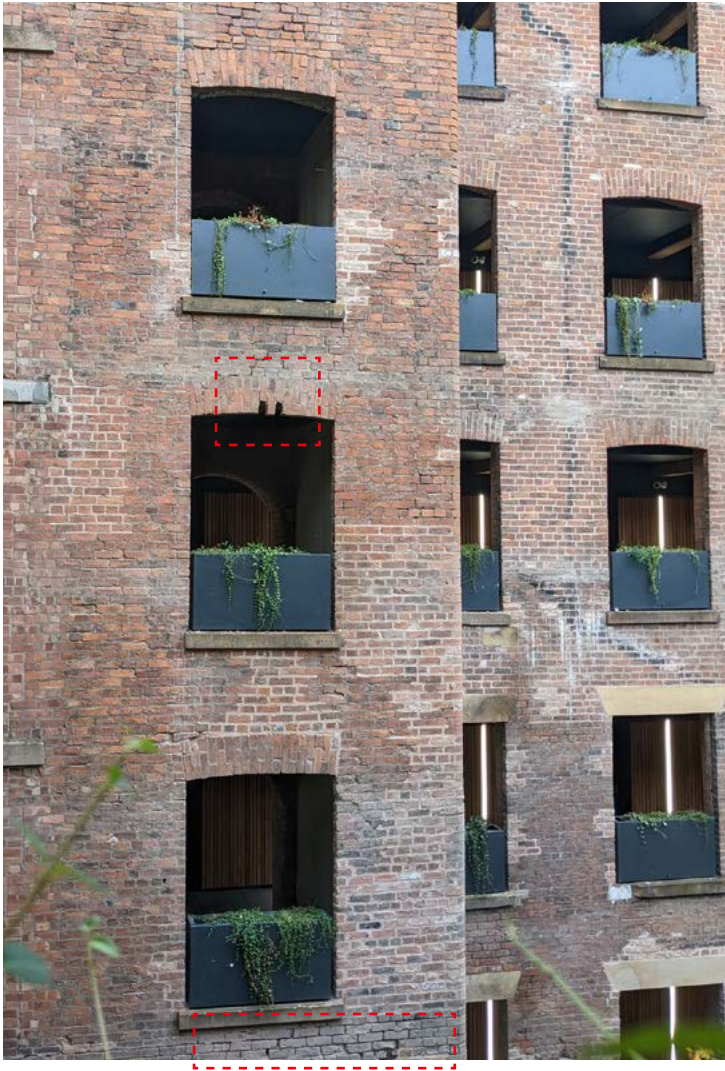
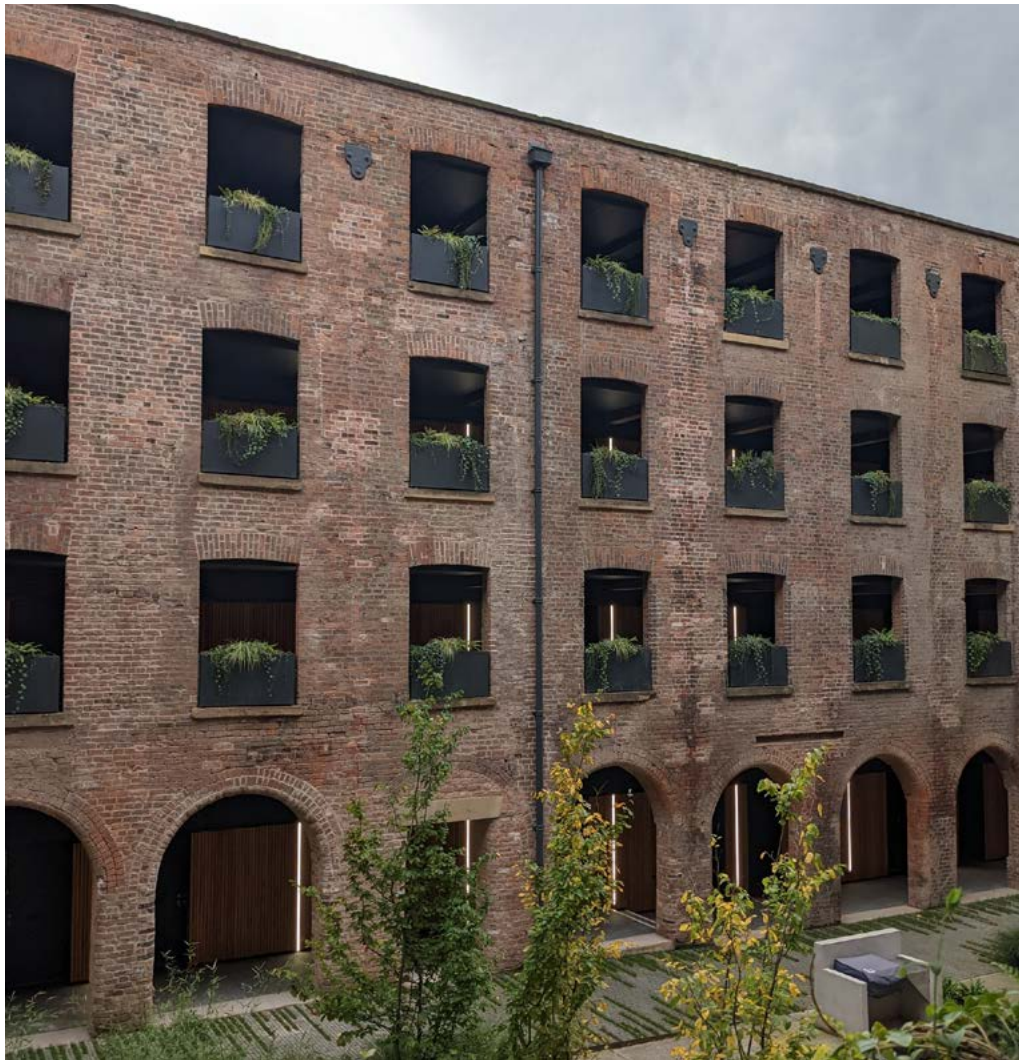
- key** (from left)
- 01 painted signage to B1 retained, new brickwork to reinstated cills and replacement brickwork at low level.
  - 02 brickwork on chapeltown street (\* low level repointed along the full length of elevation completed)
  - 03 section of new brickwork between cast-iron pilasters on chapeltown street
  - 04 cut brickwork at bridgelink junction
  - 05 brickwork to outrigger (\* missing bricks to arch to be replaced, repointing required)
  - 06 repaired and cleaned brockwork to B3 courtyard facade
