# crusader photo-report

| crusader mill | 08 02 2022 | Capital & Centric | Crusader<br>70 Chapeltown St<br>Manchester<br>M1 2EW | Manchester City Council | photoreport to discharge planning<br>conditions relating to applications<br>113363/FO/2016<br>113364/LO/201 |
| planning photo report | - | shedkm architects ltd | | | |

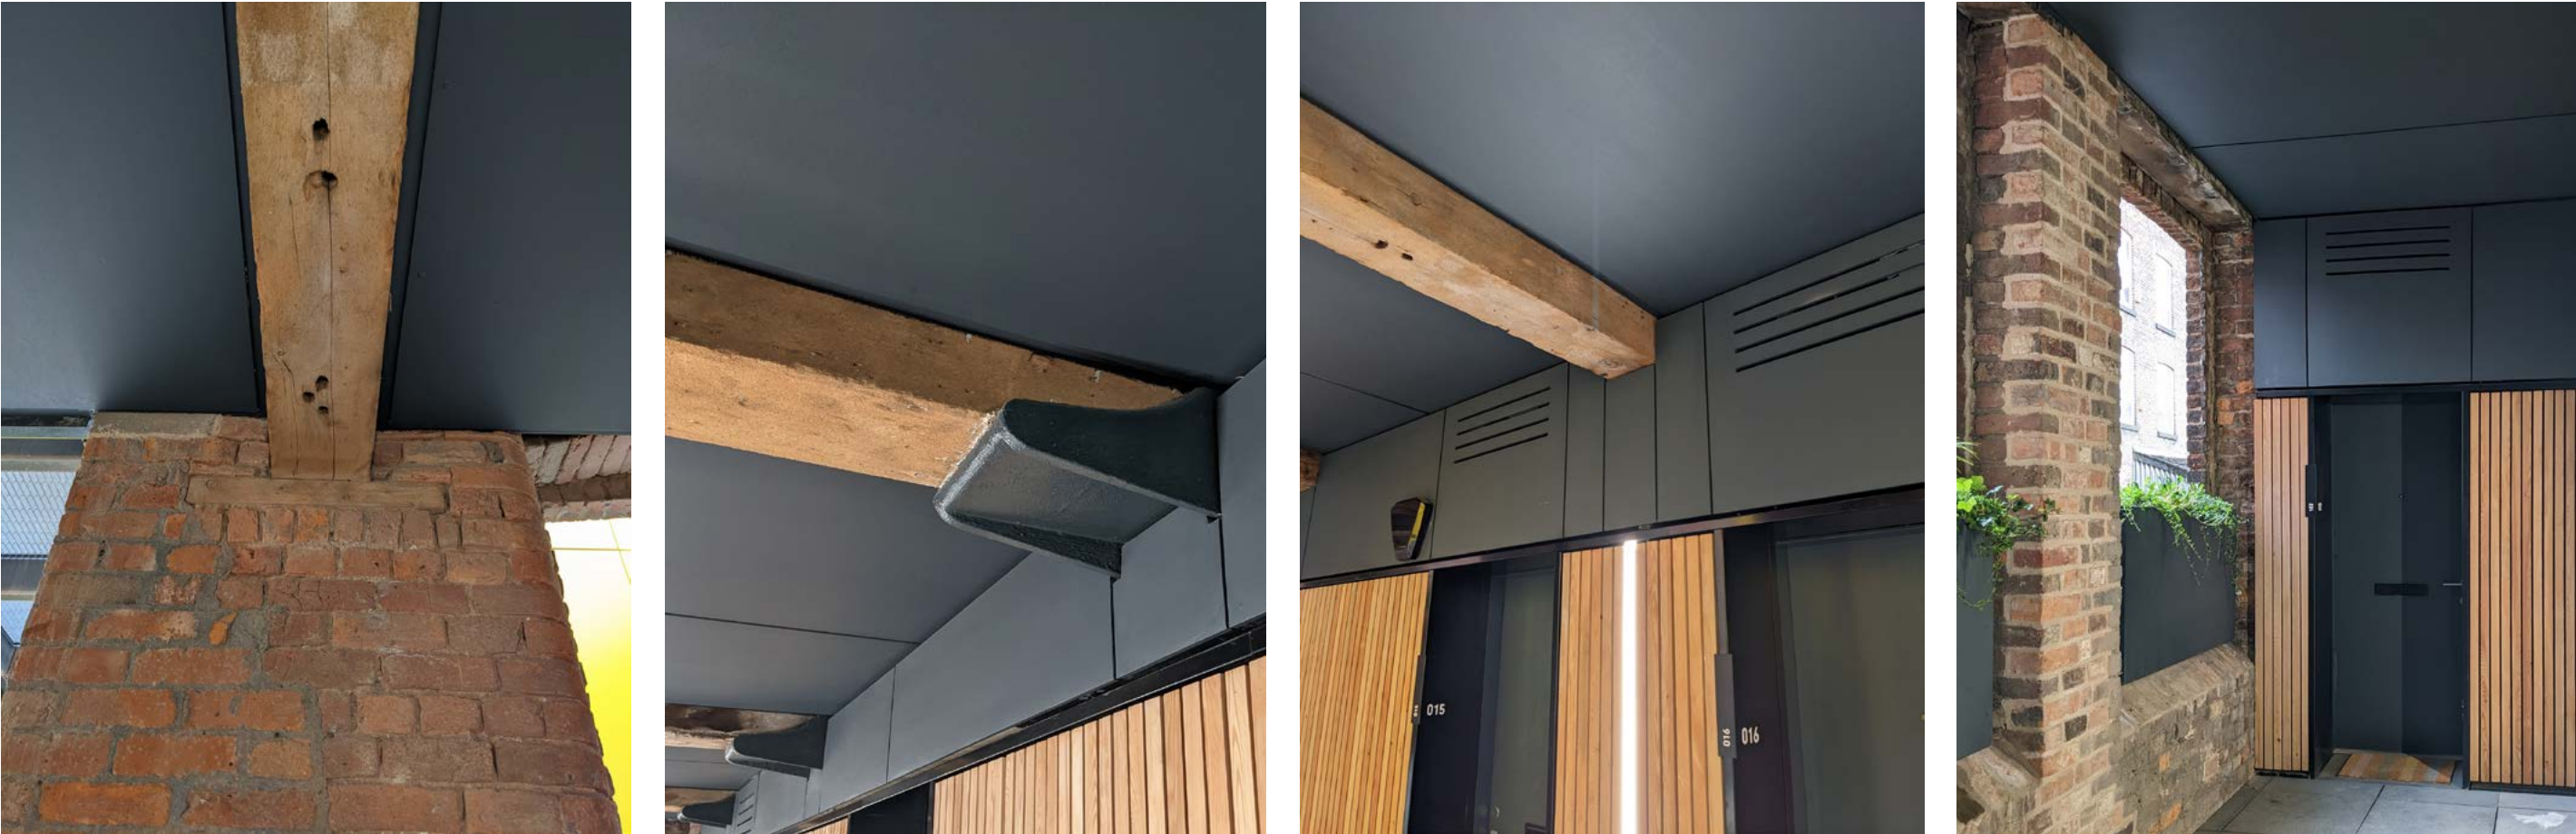
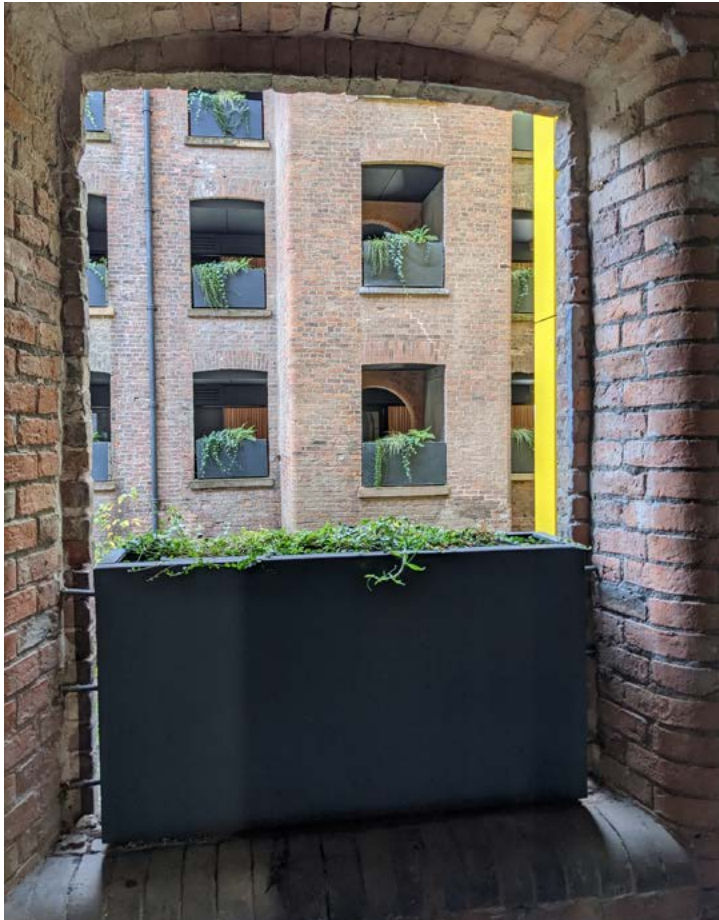
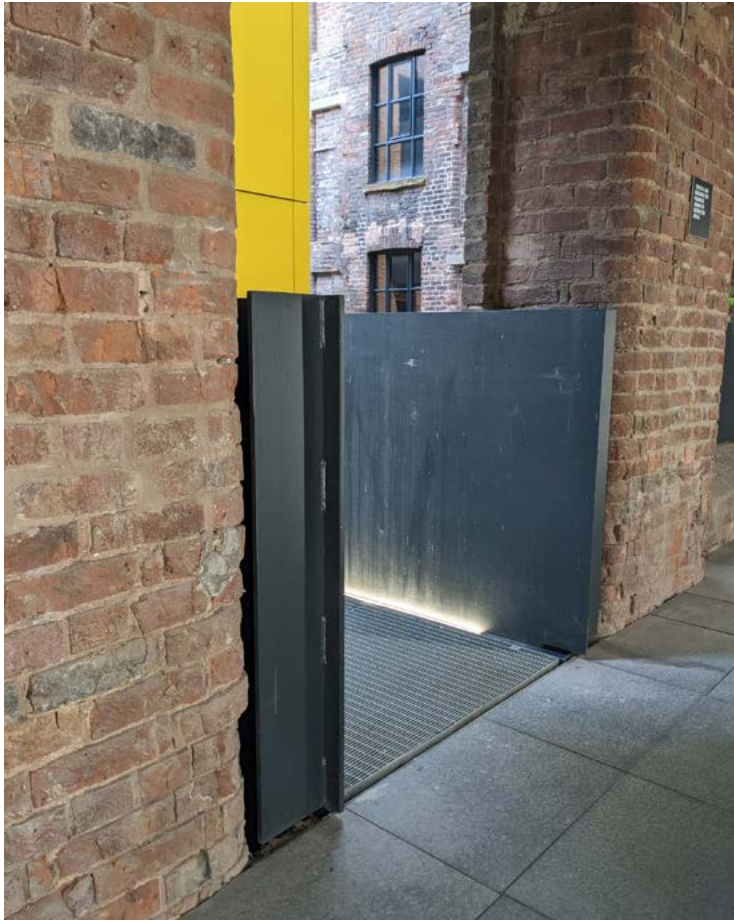
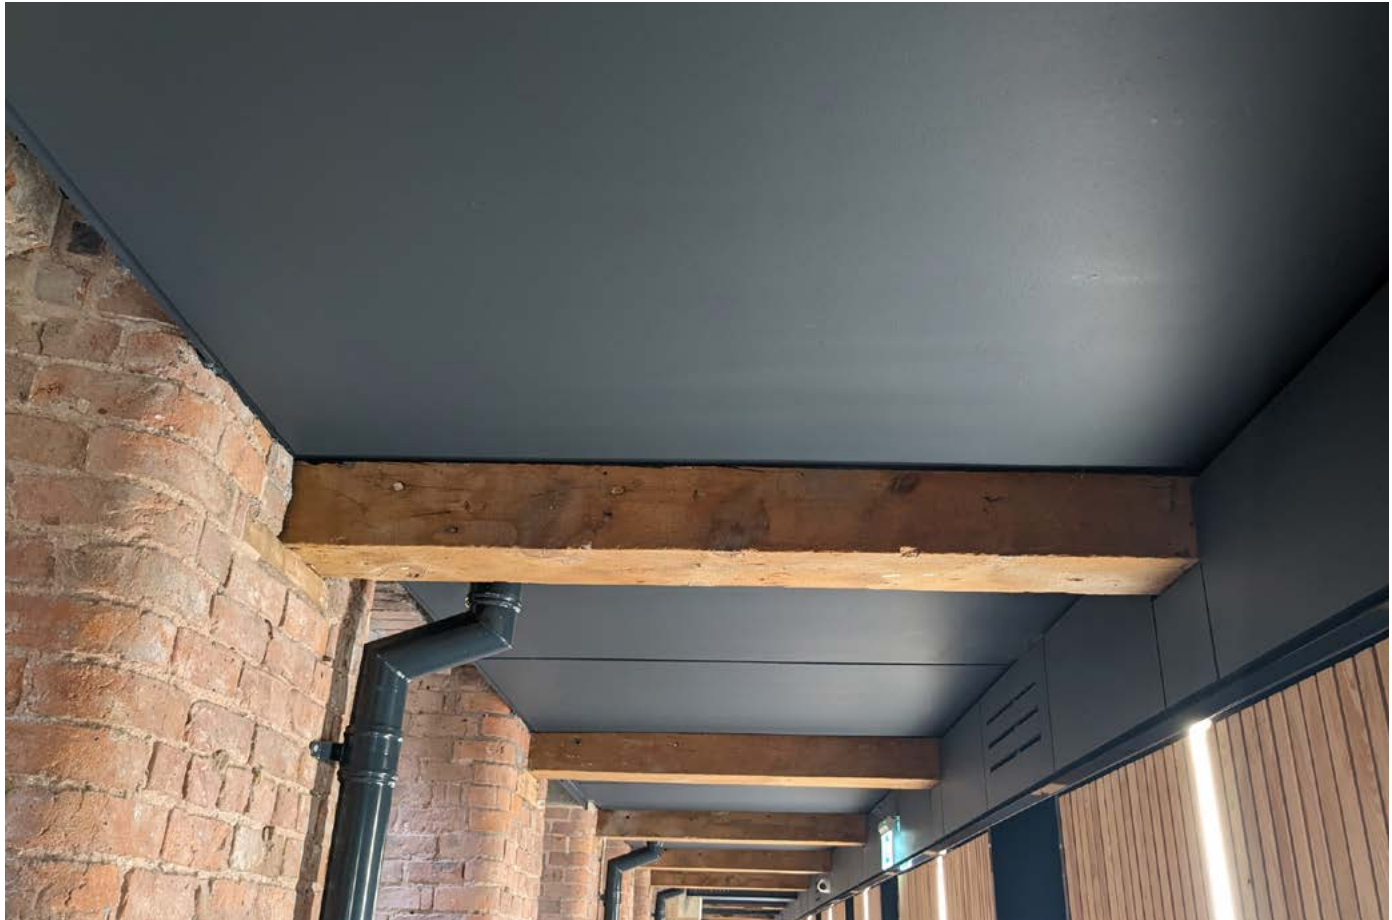
- key** (from left)
- 01 recessed soffit board forming shadow gap between masonry and timber beam
  - 02 recessed soffit board forming shadow gap between beam and beam saddle
  - 03 shadowgaps between each facade cladding element
  - 04 shadow gap between new cloister wall and existing masonry
  - 05 planters set-off existing masonry
  - 06 bridgelink balustrade set-off existing masonry
  - 07 shadow gap between existing timber beam and soffit
