# Essential Repairs including Replacement Wagon Arch Glazing

## 1830 Warehouse

Science & Industry Museum

Design and Access Statement

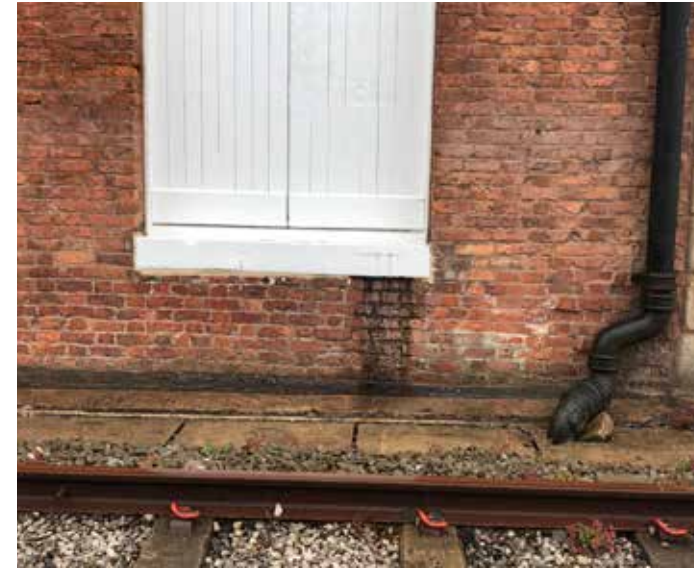
- The existing sills are set flush in the wall with no drip and the square profile means that there is no fall to discharge lying water resulting in ongoing cause of decay to both timber sills and the brickwork below. The existing wood is primarily pine used during the 20th century replacements.

Visible staining to brickwork due to absence of any drip.

- Works will involve carefully cutting out and completely removing the entire wood sill. Specialist craftsman will carefully template the existing and cut a new sill using hardwood/oak matching the profile of the existing section with the adapted profile to include the fall to the top surface and the protruding drip detail with grooved throat to the underside to prevent capillary rainwater tracking under the sill. Lime Putty seals will interface with the brickwork.
- Apply preservative and decorate the new hardwood sills.

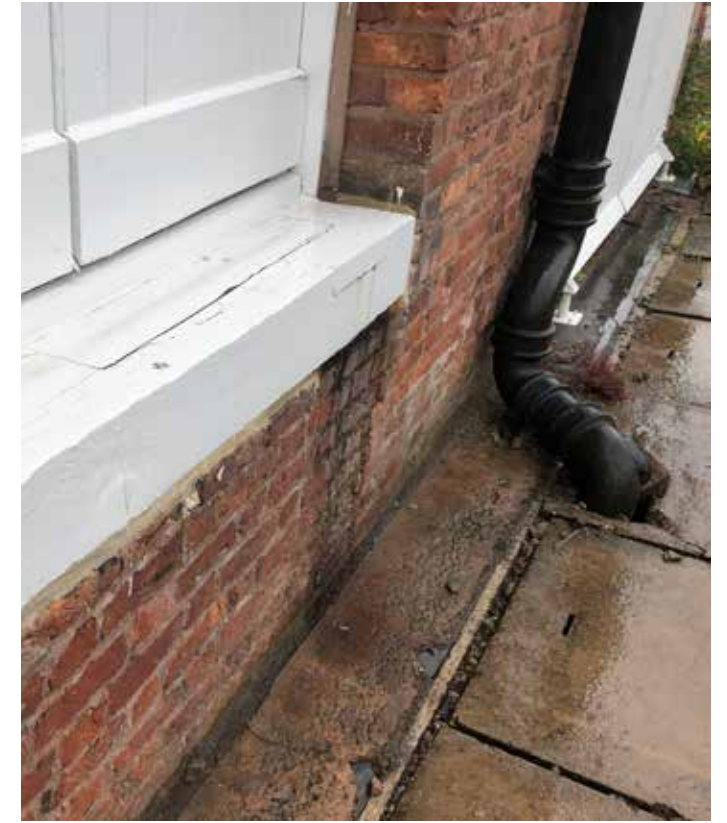
Sitting water as a result of the absence of any fall to the top surface of the sills. The scope is to replace and to reprofile with fall and drip.

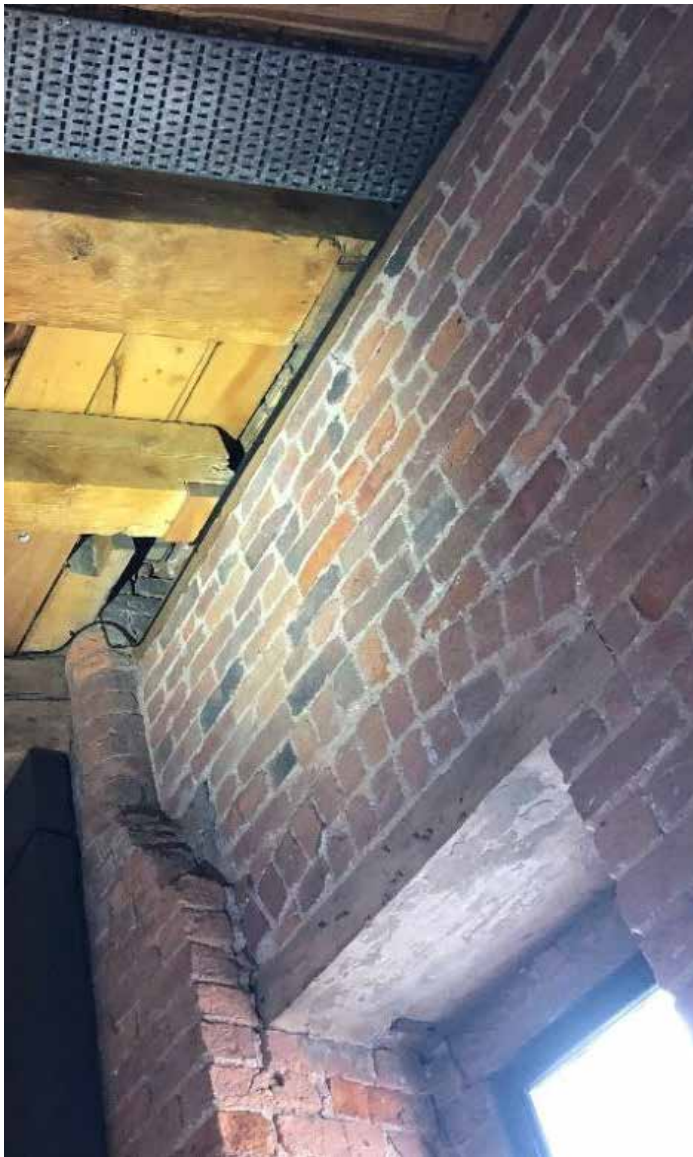
A full height photo of a ground floor pier at the inside of the north elevation, showing the extent of vertical cracking evident through bricks.

- Brick repair or replacement & repoint with lime mortar where repairs undertaken.
- Second floor - Bay 2: Helical bar repair to crack in brickwork.
- Second floor - Bay 2: Helical bar repair to crack in brickwork.
- Ground floor mezzanine - Bay2: Helical bar repair to crack in brickwork.
- Ground + Basement: Grout Cracked Bedjoint. Tie In Pier Using Cemties.
- Ground - Bay 2:
  - Locally rebuild cracked brickwork at corner bearing.
  - Locally rebuild loose brickwork at corner of reveal.
  - Helical bar repair to crack in brickwork.
- Basement - Bay 1:
  - Cut out and replace cracked bricks at beam bearing.
  - Rebuild cracked brickwork at pier top.
  - Tie in separated brickwork panel with helical bars.
  - Dry-pack/grout padstone bedjoint.
  - Grout cracked bedjoint. Tie in pier using cemties
- Install monitoring devices across the cracks.

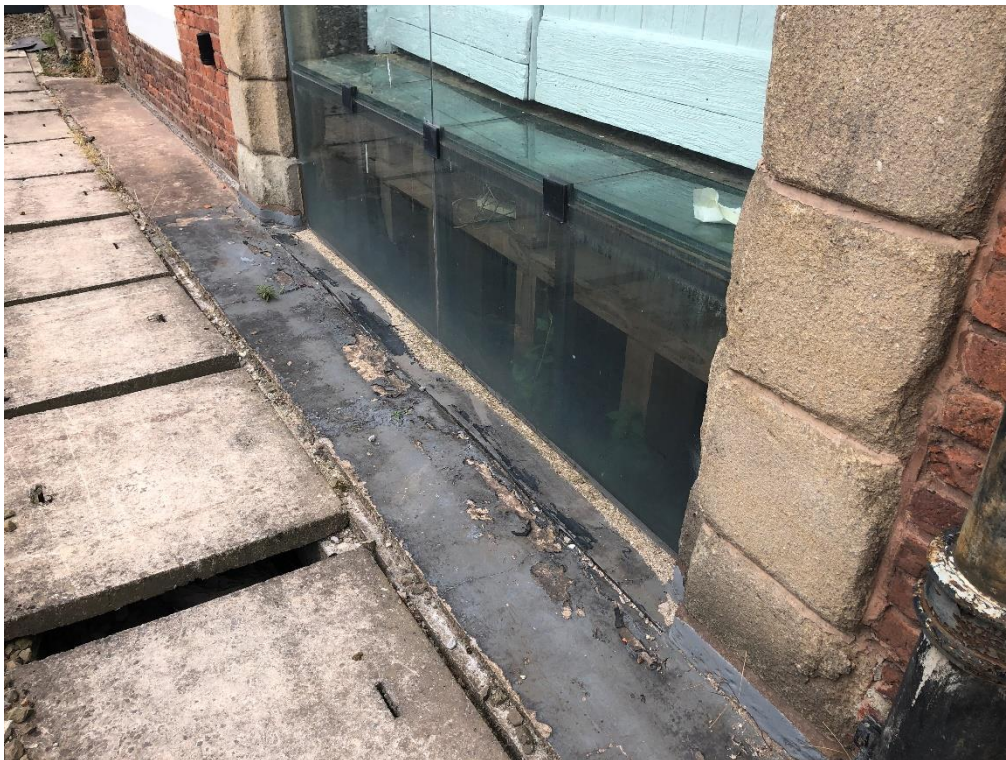
- 3.2 The glazing was supported at the base on a timber 'sill' with brickwork under. The top surface of the sill and the base of the glazing are at or very close to the external ground level (Photograph 1). An external rendered apron is provided directly adjacent to the building with a concrete drainage channel beyond.

**Photograph 1: General view of the lower part of the glazing externally showing sill/base flush with the external ground level.**

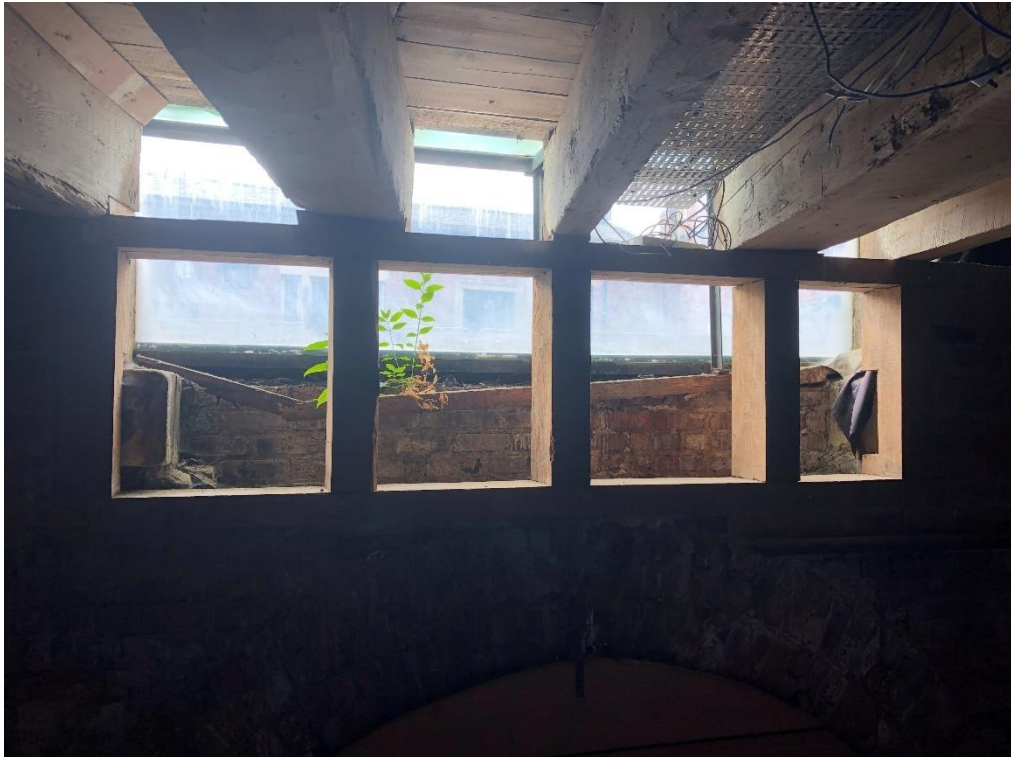
- 3.3 Various attempts have been made at waterproofing this junction using bituminous sheet materials and liquid membranes (Acrypol or similar). These efforts have ultimately been unsuccessful, and the sill has almost completely decayed (Photographs 2 and 3)

**Photograph 2: General internal view showing the floor joists cut back and re-supported on a new sub-frame. The decayed sill is visible beyond.**

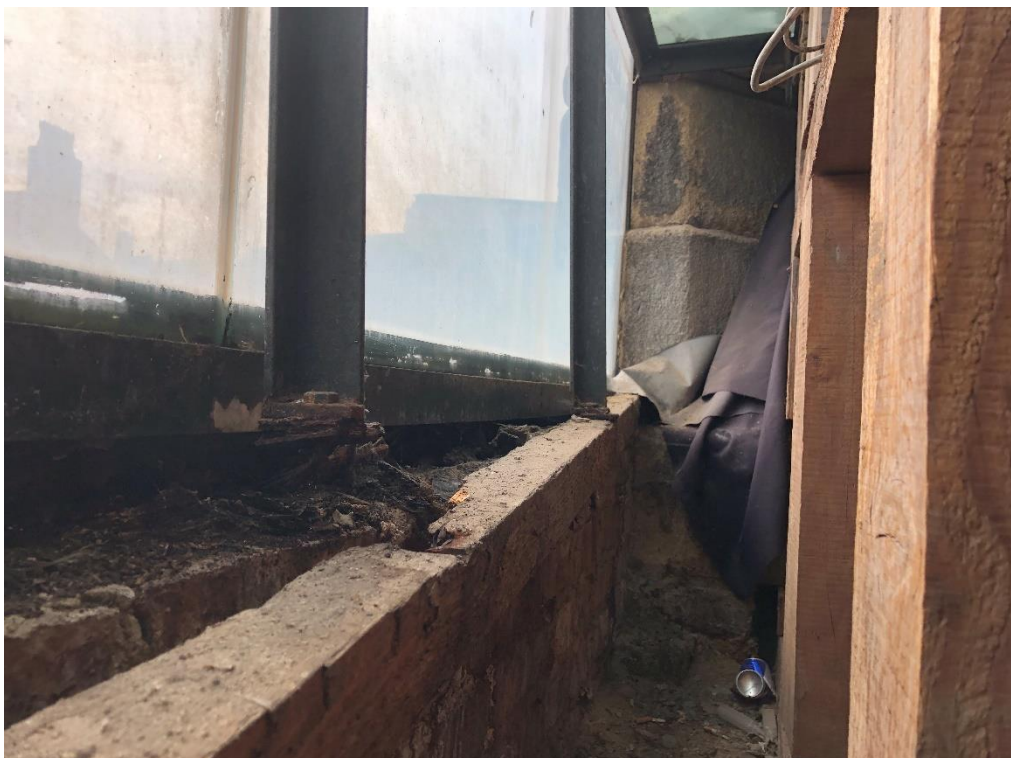
**Photograph 3: Detail view showing severe timber decay to the sill.**

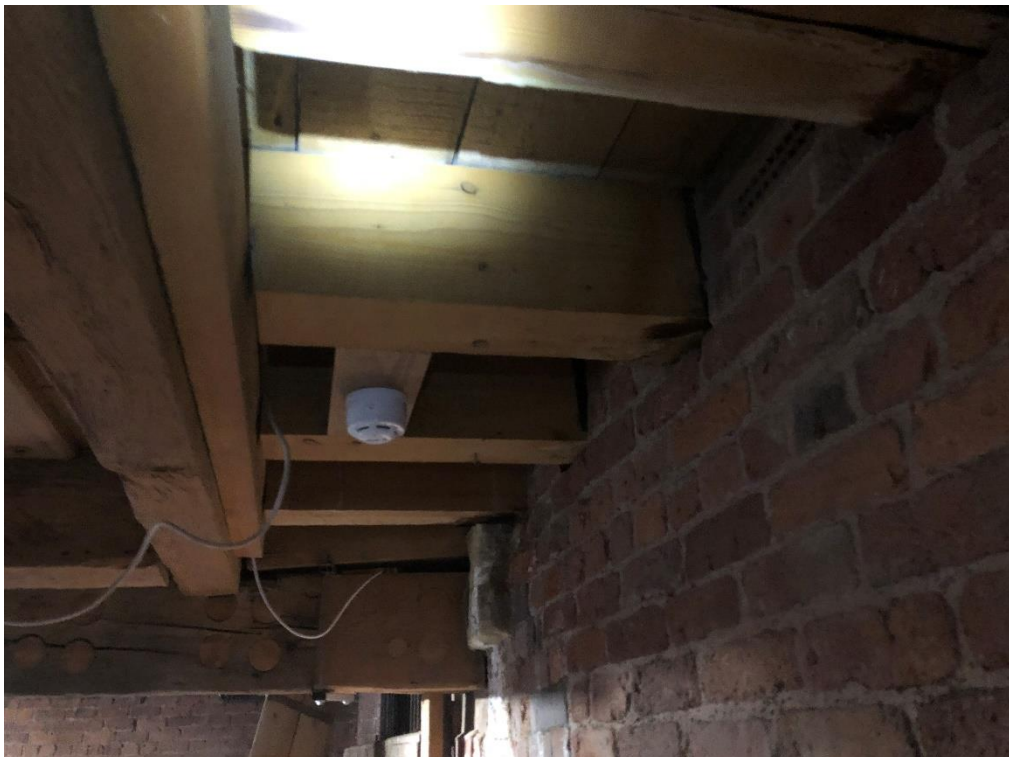
**Photograph 6: Internal view showing the timber framing arrangement and joists passing through the wall.**

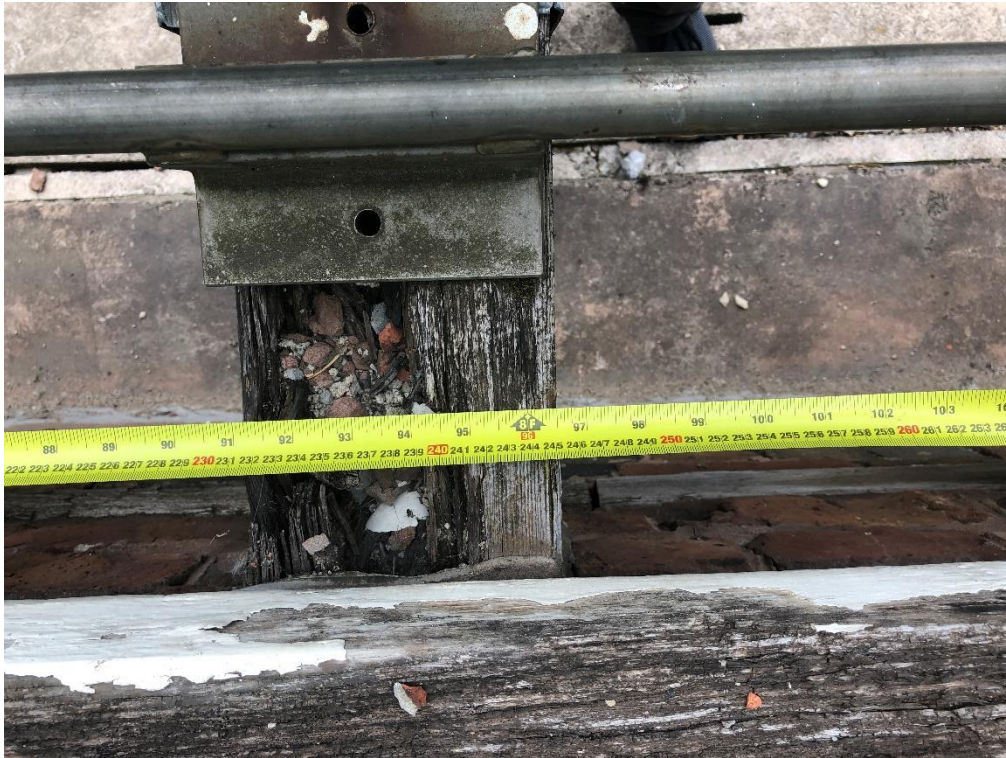
**Photograph 7: Typical example of decay to floor joist projection**

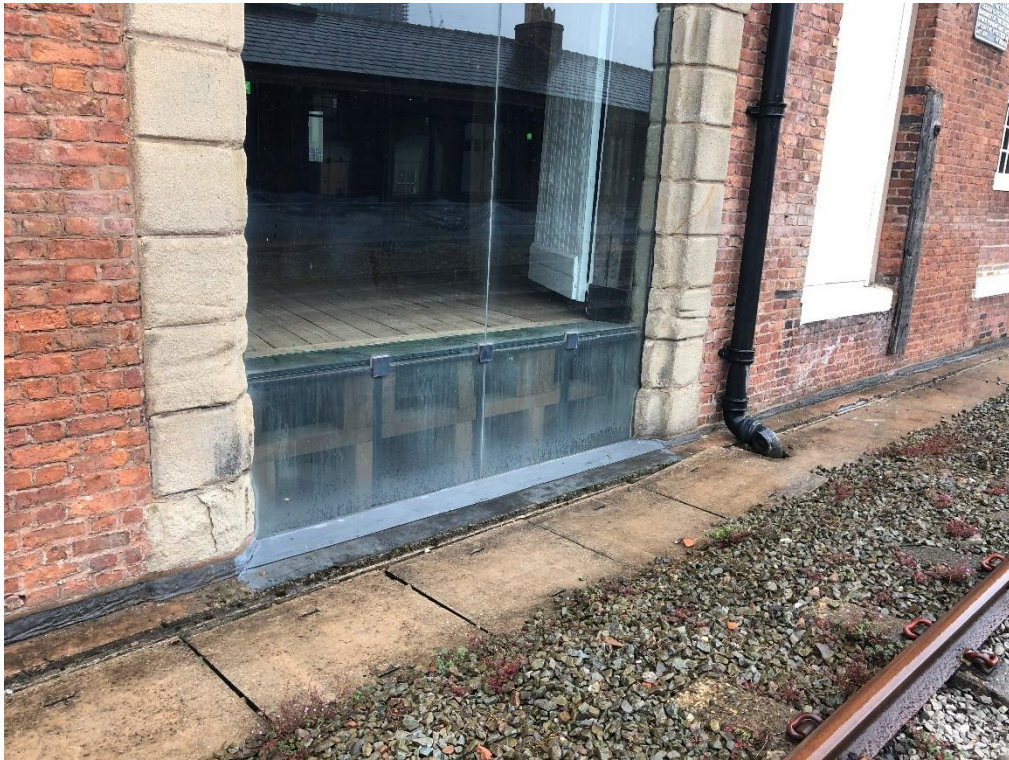
- 5.1 The glazing arrangement at Bay 3 is very similar to that previously described at Bay 1 (Photographs 8 & 9). The waterproofing detail externally is similar in design but is in much better condition and appears to retain some fall away from the building at the base of the glazing to direct water towards the drainage channel.

**Photograph 8: General external view of glazed opening at Bay 3.**

- 5.3 A similar scope of structural repair work to that at Bay 1 could be considered here and either implemented preventatively in the short-term or undertaken in future if and when decay of the supporting timber advances. Due to potential safety issues arising from loss of support to the glazing, there would be a case for preventative action, particularly as no historic fabric would be adversely affected by such works.
- 5.4 The embedded ironwork from the historic door hinges remains in place but has corroded and cracked the architrave stonework (Photograph 10). This is not of structural significance yet but does need to be addressed. Previous project experience at Bay 5 suggests that, although extraction and cleaning would be the best solution, removal without further damage is impractical and in-situ treatment is preferable.

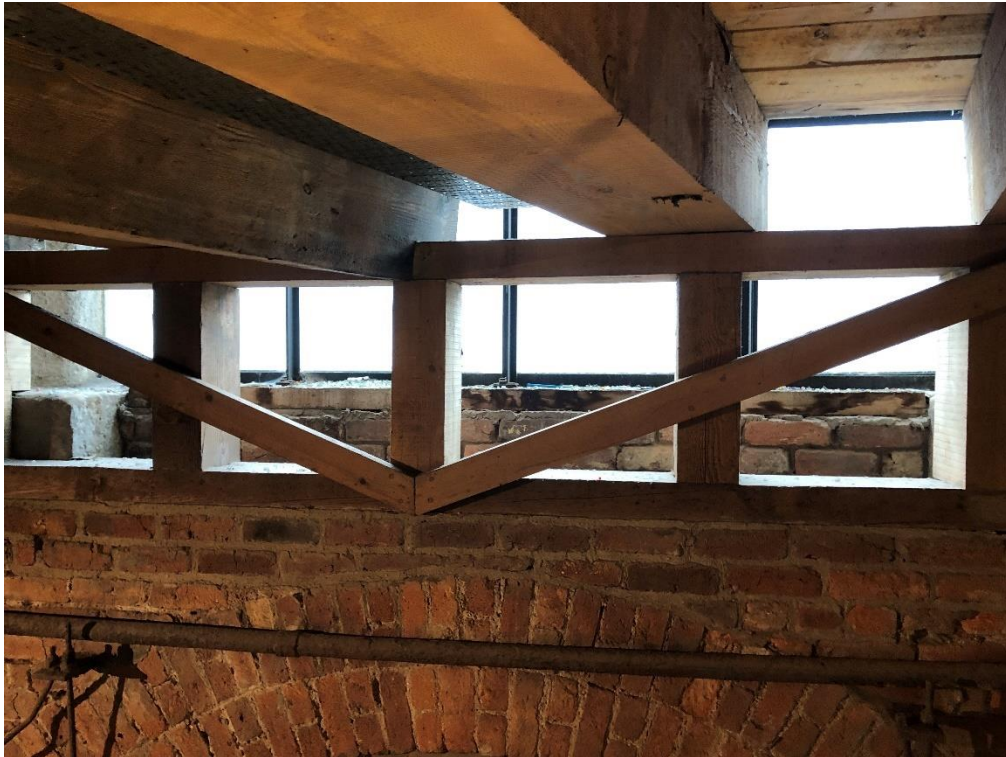
- 5.2 Some water ingress has nonetheless occurred at the base of the glass, as evidenced by staining to the timber bearer internally (Photograph 9). Direct access for 'hands-on' inspection was not possible due to the high level location in the foyer area internally. It is assumed that the supporting timber was in better condition at the time of inspection than the equivalent at Bay 1 as there was no obvious sign of glass slippage due to loss of support. This nonetheless remains a poorly designed structural detail and will have ongoing vulnerability to water ingress and decay of the timber support.

**Photograph 9: General internal view of glazing support and floor framing arrangements at Bay 3 showing water staining to the timber support at the base of the glazing.**

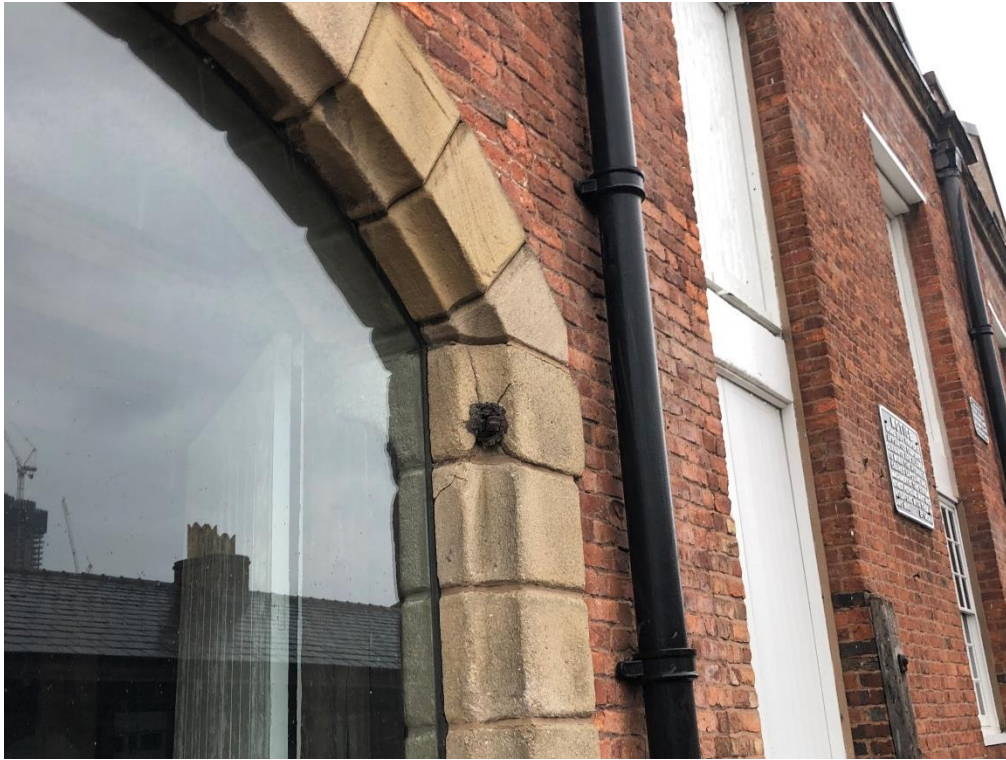
**Photograph 10: Corroded historic hinge ironwork at Bay 3**

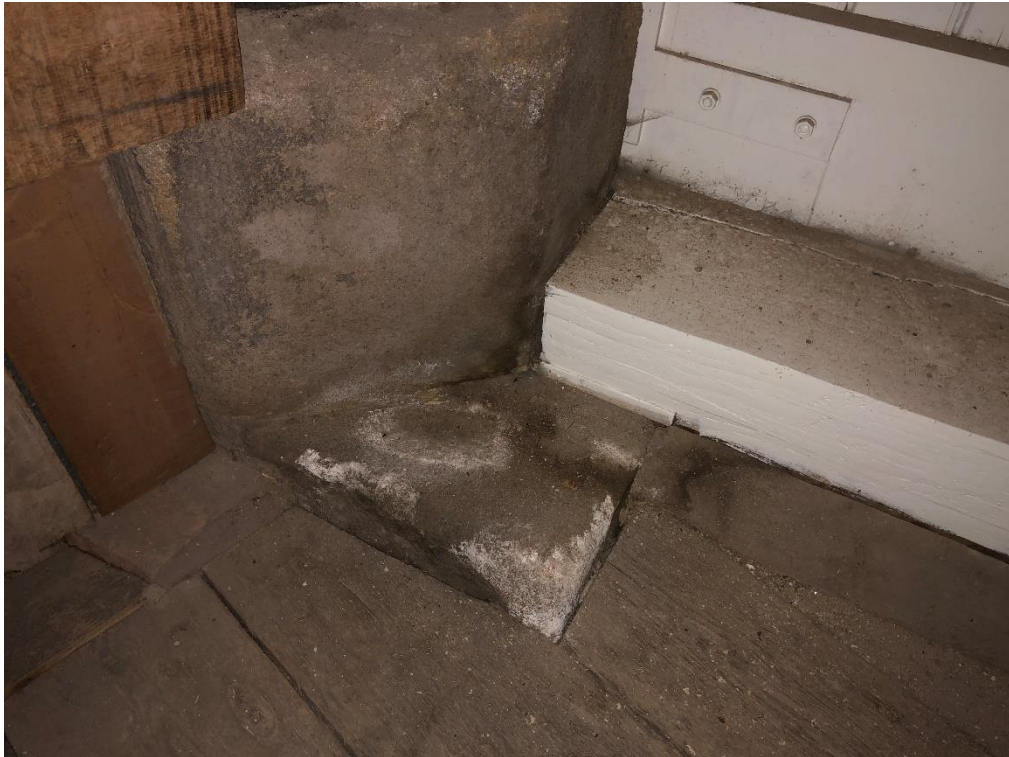
- 6.4 No structurally significant defects were observed around this opening.

**Photograph 12: Water staining internally at the Bay 4 door opening.**

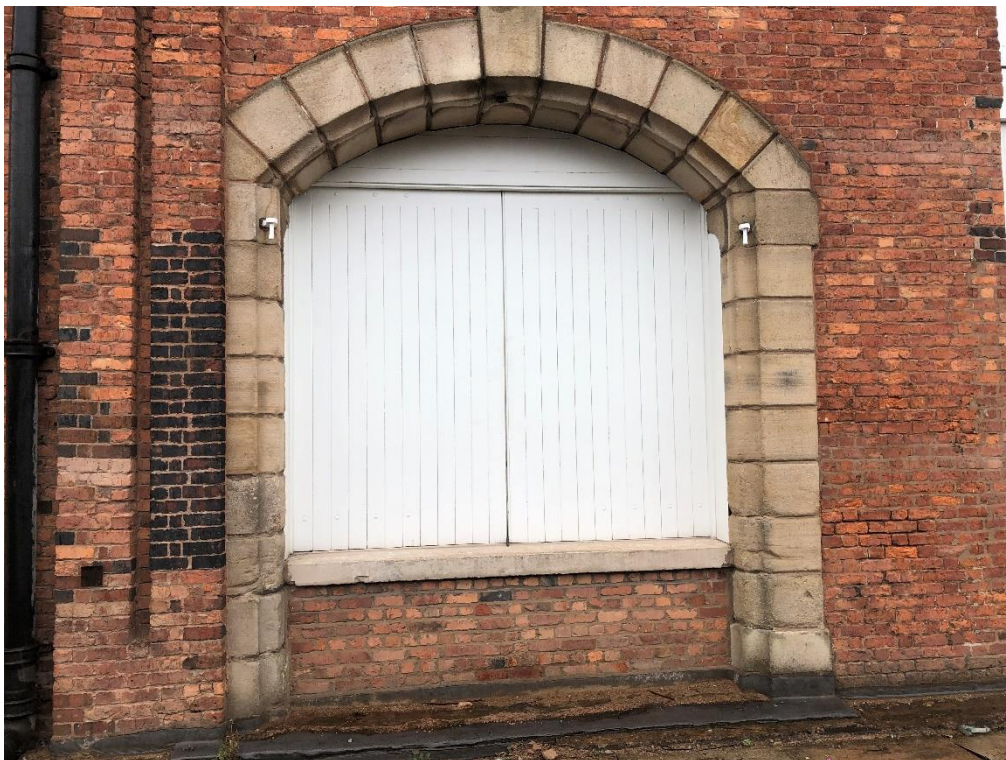
**Photograph 13: Bay 5 – left-hand (west) door opening.**

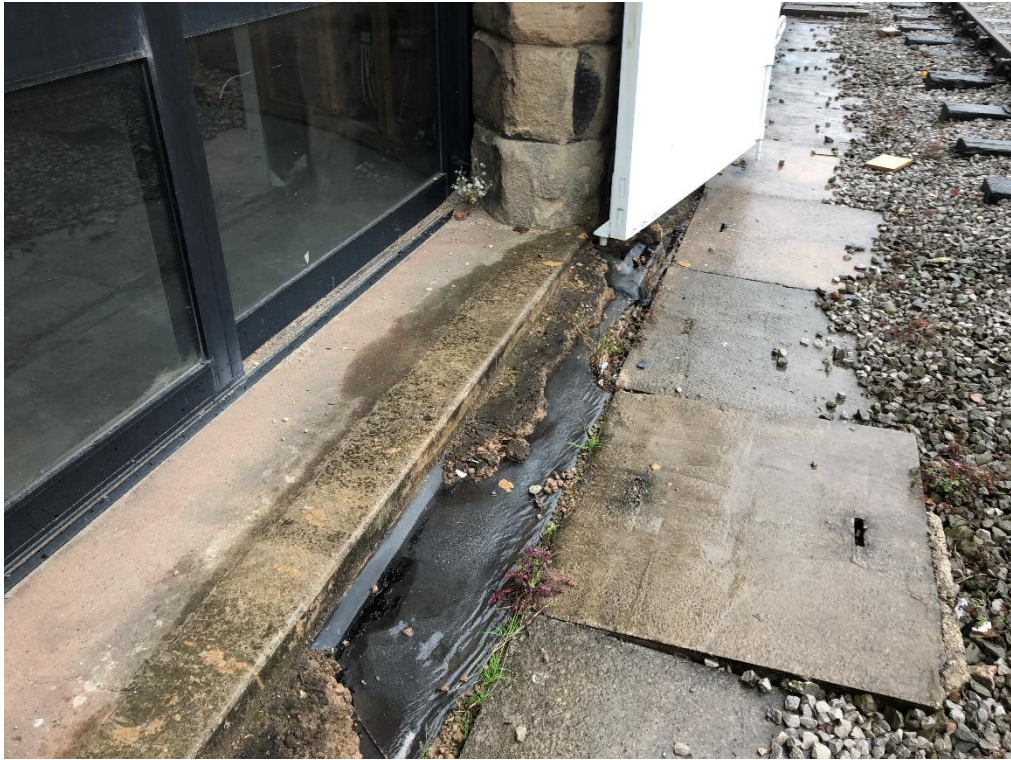
- 7.5 The floor structure directly adjacent to the right-hand door opening is a landing area forming part of a cast in-situ reinforced concrete staircase. The glazing infill bears onto this concrete structure with no timber visible at the base (Photograph 15). An approximate 150mm upstand height is also present here.
- 7.6 No structural defects or water ingress were observed in this location. The doors have been replaced as part of recent external works. The water proofing detailing beyond the concrete slab is noted be in poor condition (as is the case generally along the elevation).

**Photograph 15: Bay 5 – detail view of glazing base area**

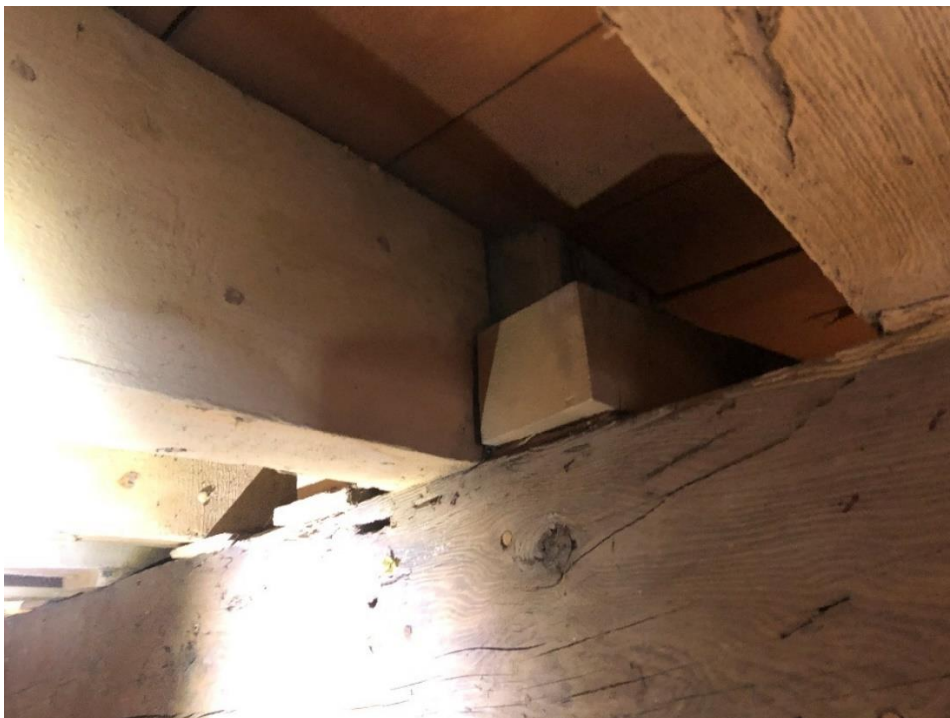
**Photograph 03, 04: limited bearing of timber floor joist.**

**Note base of timber column above floor beam. This limited bearing has been addressed in various areas of the building, however, there remains floor joists which are at increased risk of end bearing / dynamic failure**

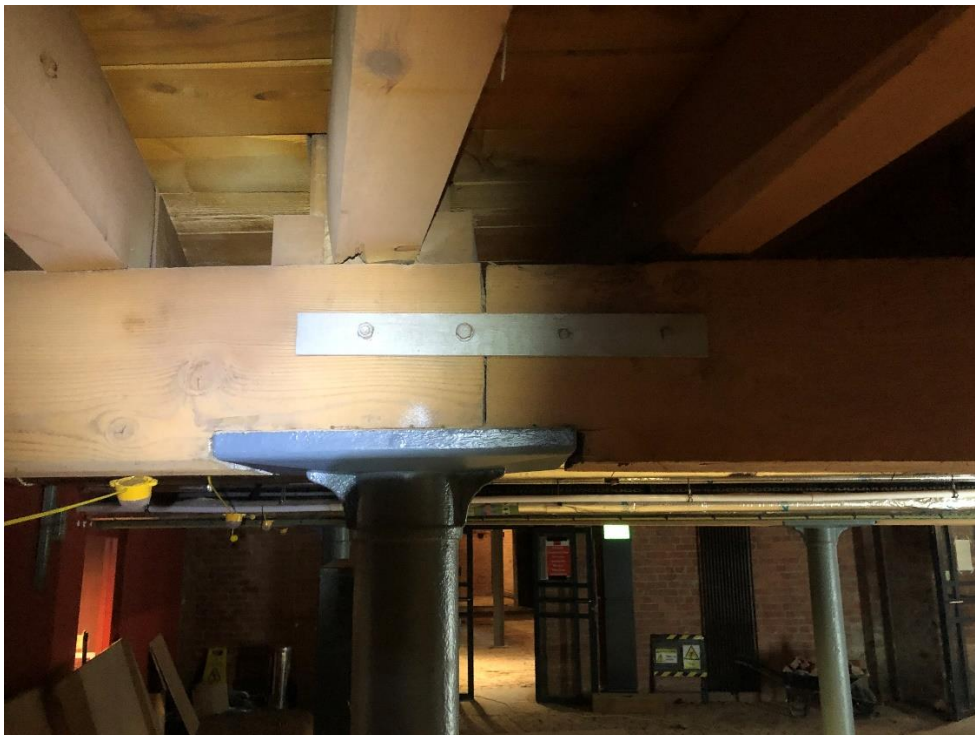
**Photograph 06 - Floor beam 'but' connection off centre overcast iron column. s. floor beam eccentrically loading cast iron plate.**

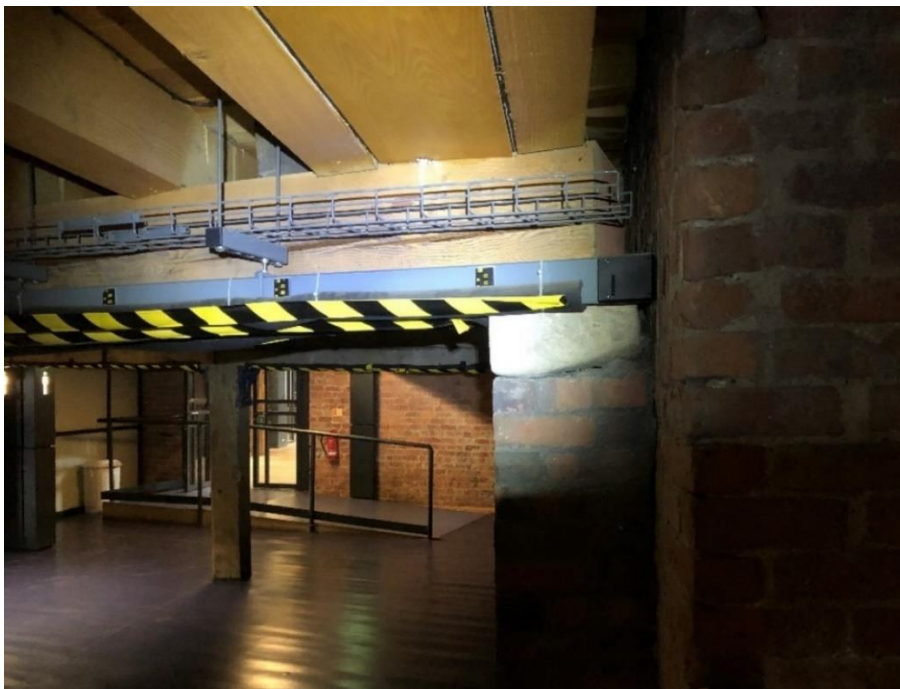
**Photograph 08 – A photo of a ground floor pier at the inside of the Southern elevation, providing limited lateral restraint to the head of the wall.**

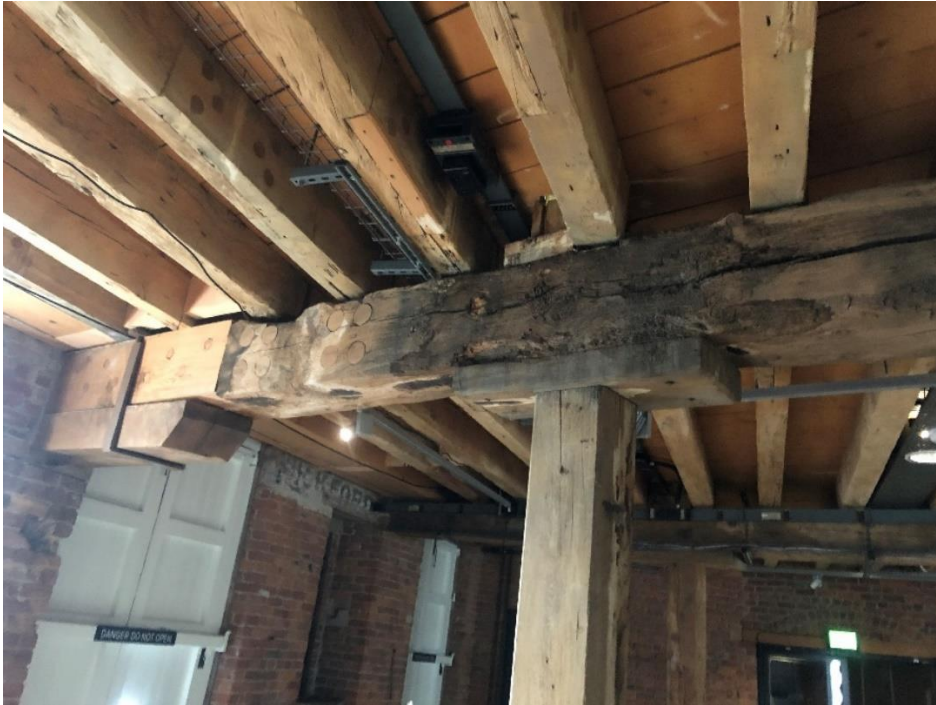
**Photograph 15 – View from first floor level of degraded timber post and beam, H&R to review condition of timber.**

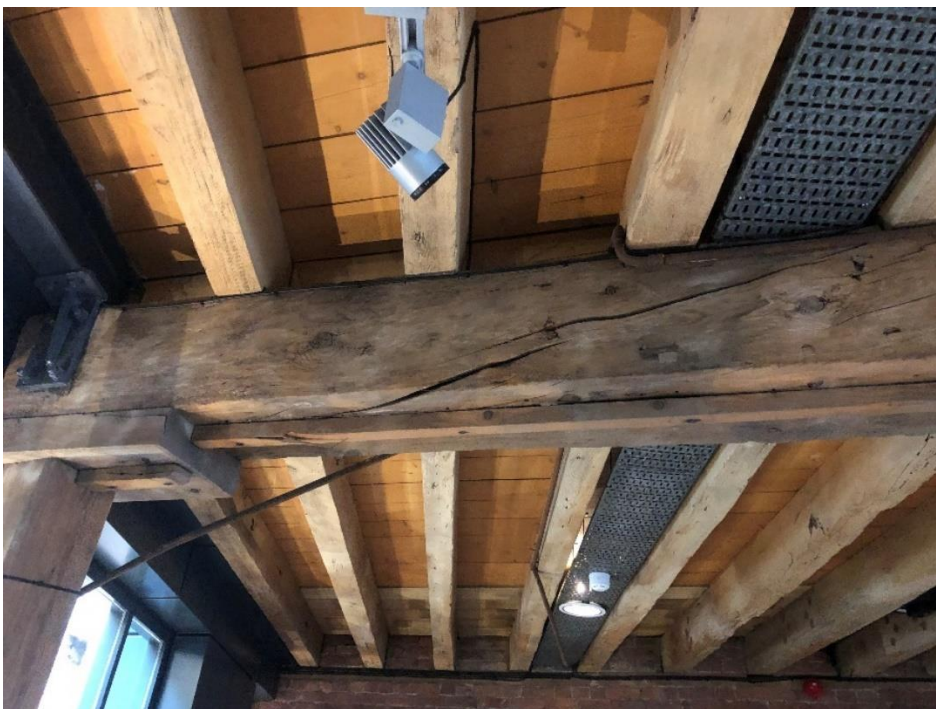
**Photograph 16 – View from first floor level of diagonal cracking in floor beam.**

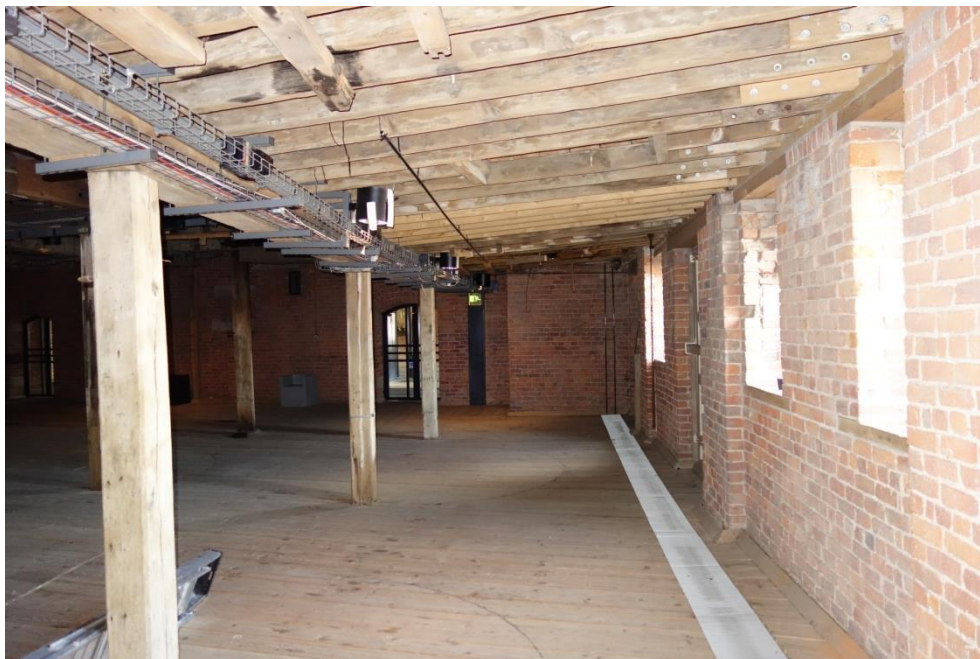
**Photograph 17, 18 – View from first (16) and second (17) floor level of general depression in floor level**

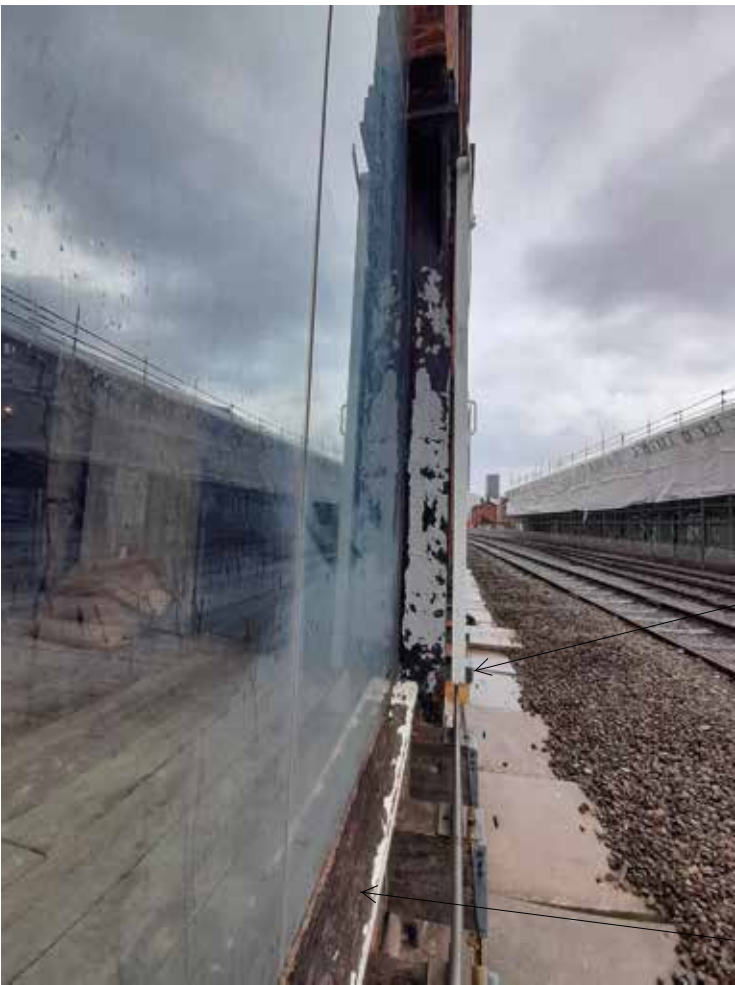
Shoe detail  
(defect to rectify)

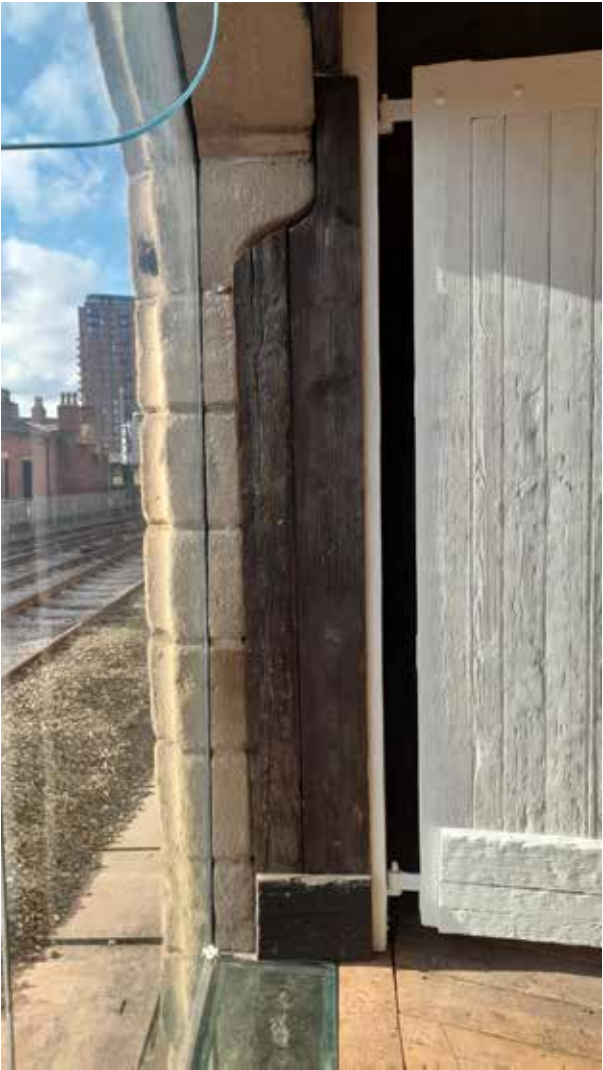
The glazing detail is very similar to the failed detail at Bay 1

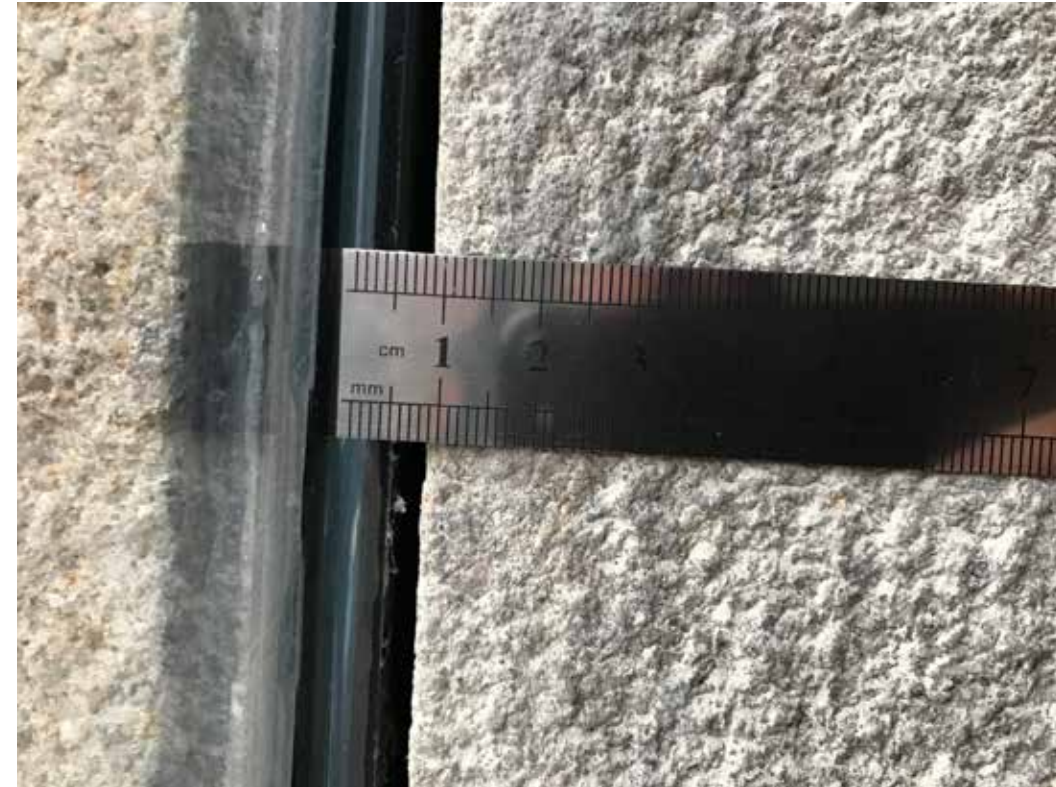
View of existing detail at Bay 3.

- As a result of previous urgent repairs with the benefit of extensive temporary works access, the defects in the glazing system were identified and the installation of anti-shatter film and bracing to the joints was undertaken - but these are only temporary safety measures and a long term detailed solution is required.
