# PRELIMINARY ROOST ASSESSMENT

**June 2022**

**17-47 Eastford Square,**  
Manchester,  
M40 7QT

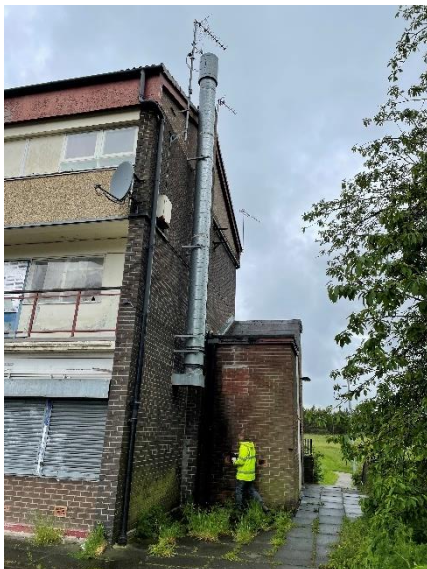
The northern aspect of the building was a gable end, with exposed brickwork. An air extractor vent and multiple tv antenna were present attached to the roof and the wall. A stairwell was present on this aspect which allowed access to the second floor and the residential flats. The stairwell showed signs of arson and vandalism on the exterior and interior walls, however, did not offer any PRF's.

Photograph 1 – Northern Aspect

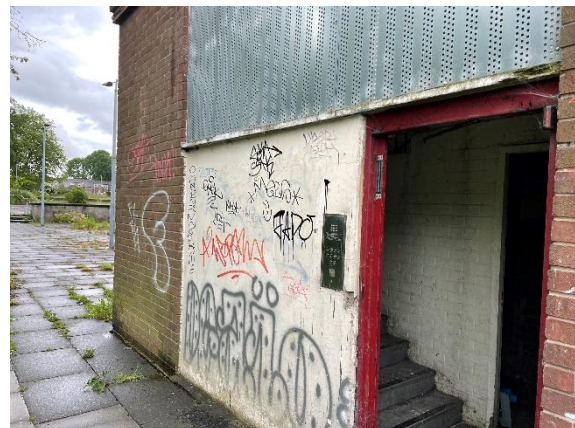
Photograph 2 – Associated stairwell (exterior)

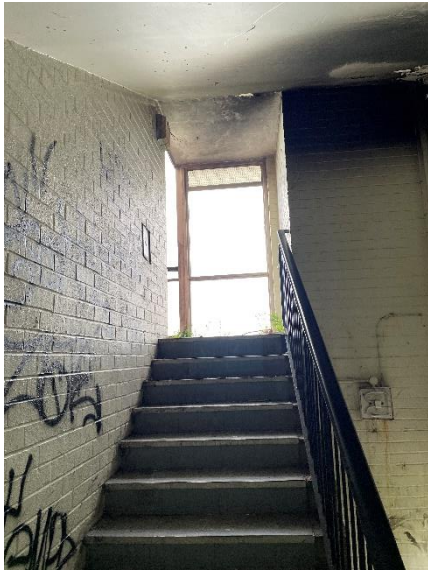
**Photograph 3 – Associated stairwell (interior)**

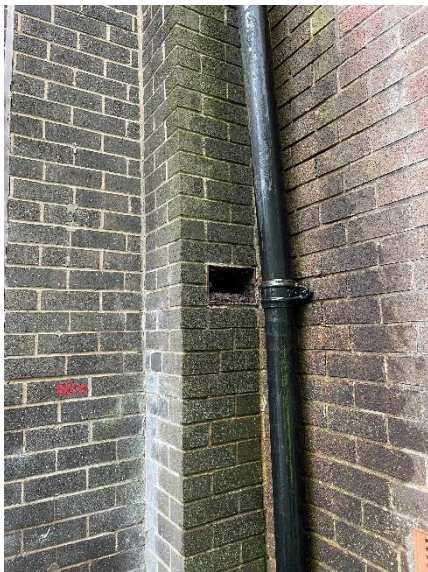
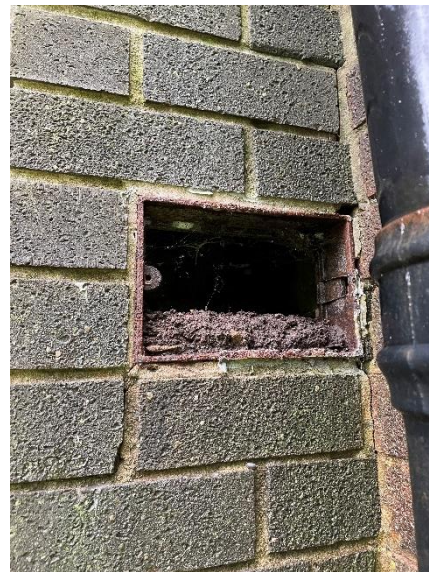
The majority of the brickwork on this aspect was in good condition and well sealed, offering no opportunities to support a possible bat roost. However, an air vent in the brickwork had its cap missing and the opening was exposed. This cavity extended into the building and an inspection with a torch revealed that the cavity extended upwards towards the roof.

**Photograph 4 – Air vent**

**Photograph 5 – Air vent**

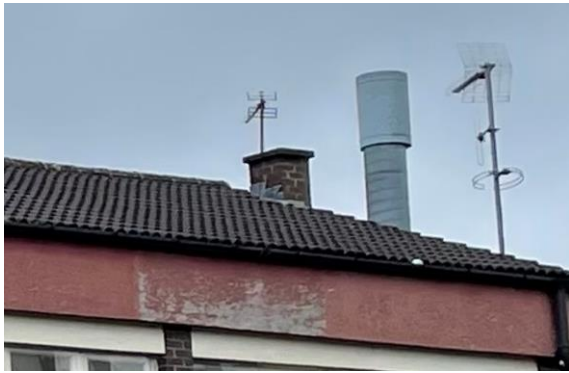
The roof was observed to be in good condition, with no slipped roof tiles or defects present. The chimney stack at the northern extent was coated in lead flashing that had lifted, offering a suitable PRF for crevice dwelling species.

**Photograph 6 – Lifted lead flashing around chimney stack**

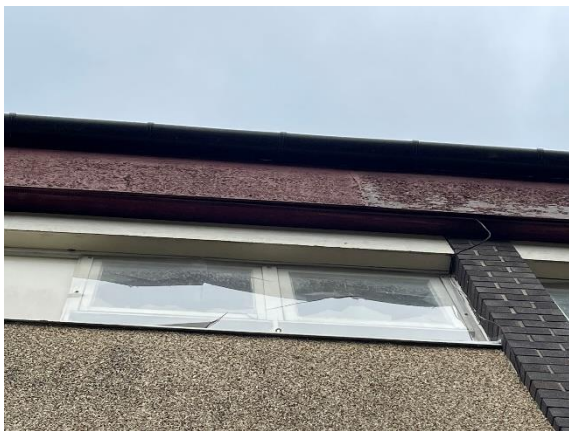
The fascia on this aspect had also begun to lift in places, providing a suitable PRF between the fascia boarding and the building.

**Photograph 7 – Lifting fascia board**

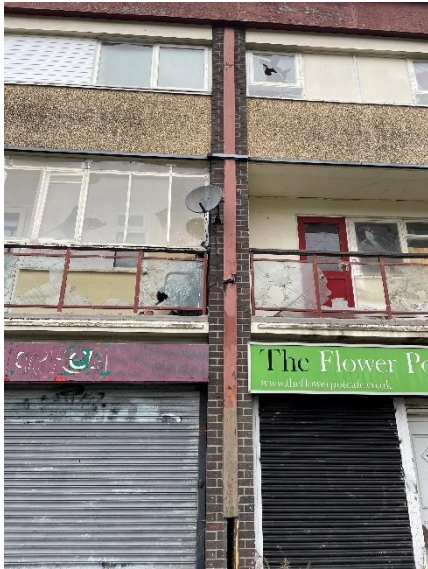
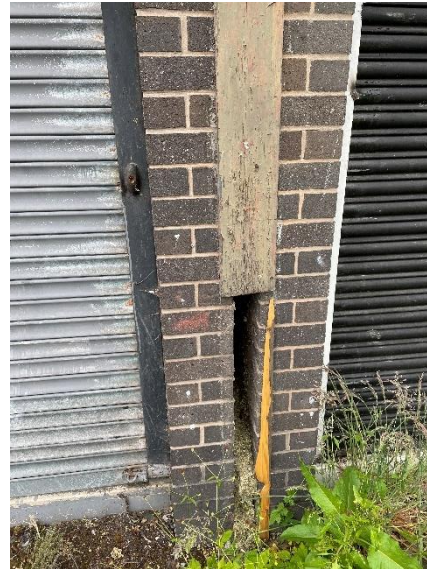
The brick work on this aspect was in good condition and was well sealed. Brick work pillars were present dividing each compartment. These pillars had a void present between them that was once filled with insulation and covered by a wood panel. These panels had become damaged in places or had been removed all together and formed access into the void between the pillars. The insulation appeared to have been lost in some places and the void appeared to extend the further into the building and up to the upper floors. Access to each void was available via gaps and defects within the wooden panels that covered the front of each void. An inspection with a torch revealed that the insulation did not fully fill each void and also contained wooden support structures that would provide suitable features to support crevice dwelling species.

**Photograph 8 – Brickwork pillar covered by wooden panel**

**Photograph 9 – Brickwork pillar covered by wooden panel**

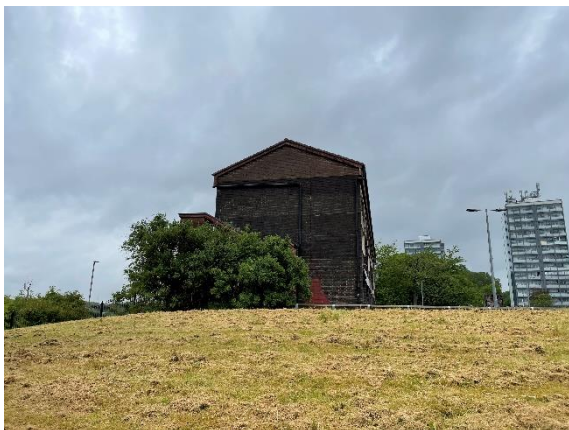
The southern aspect of the building formed another gable end with an associated stairwell. The stairwell is inaccessible and there were no features present that could provide PRF's

**Photograph 10 – Southern aspect**

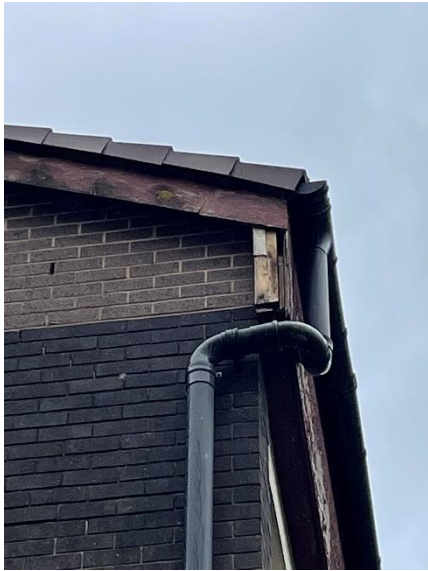
The fascia boarding that meets with the corner of the eastern aspect fascia, and the corner of the western aspect fascia were damaged and provided access into a cavity between the fascia and the wall, again providing suitable roosting opportunities for crevice dwelling species.

**Photograph 11 – Damaged fascia (south-eastern corner)**

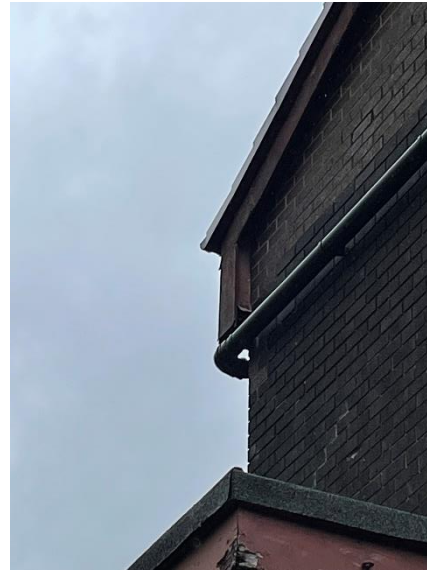
**Photograph 12 – Damaged fascia (south-western corner)**

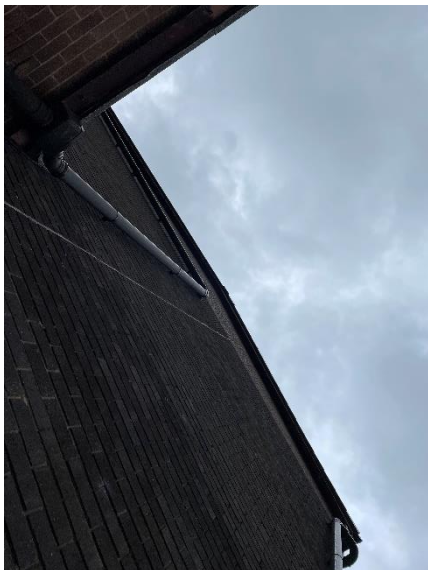
The fascia on the roof ridge had begun to lift also forming another PRF.

**Photograph 13 – Lifted fascia**

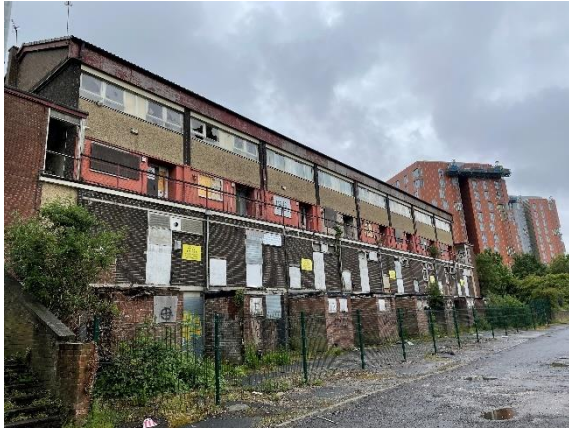
**Photograph 14 – Eastern aspect**

This aspect was in poor condition throughout, with multiple features forming PRFs or access points to possible PRFs. Some of the windows present and windows around the front doors to the apartments were smashed and would allow access internally for bats. Many of the windows were also boarded over which form suitable PRFs for crevice dwelling species. A blue tit (*Cyanistes caeruleus*) was also observed nesting behind boarded window at the southern extent.

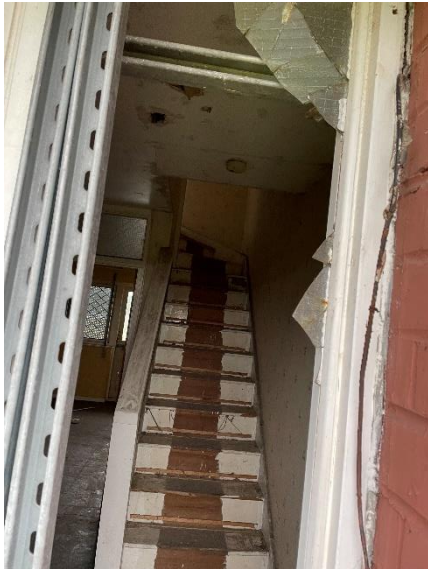
**Photograph 15 – Broken window around door**

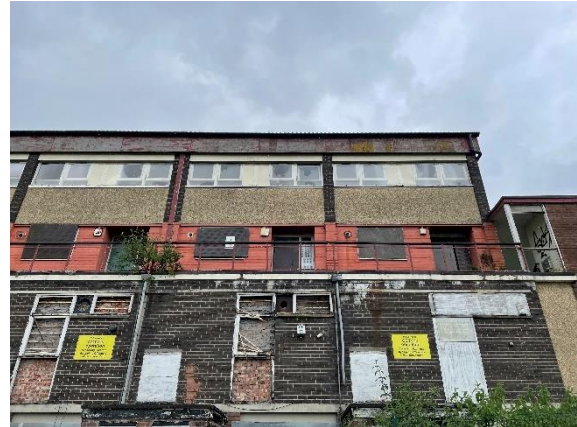
**Photograph 16 – Boarded up windows**

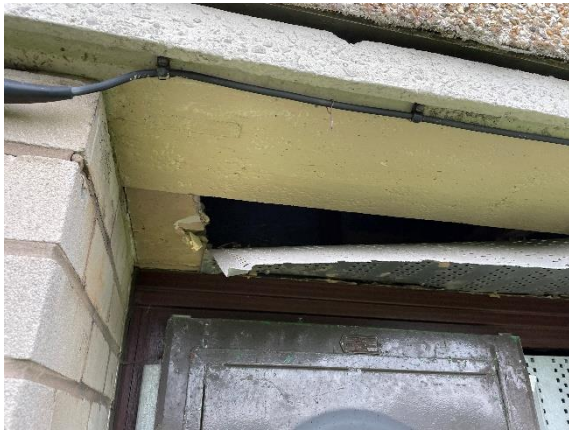
The entrance ways to each individual property were also in poor condition with major defects in metal sheeting above the doorway that provided access into a cavity that appeared to run the length of each apartment. It's likely that this cavity is highly exposed and will not retain its temperature limiting the potential of a PRF but more suitable PRFs maybe present further within the cavity.

**Photograph 17 – Metal sheeting peeling**

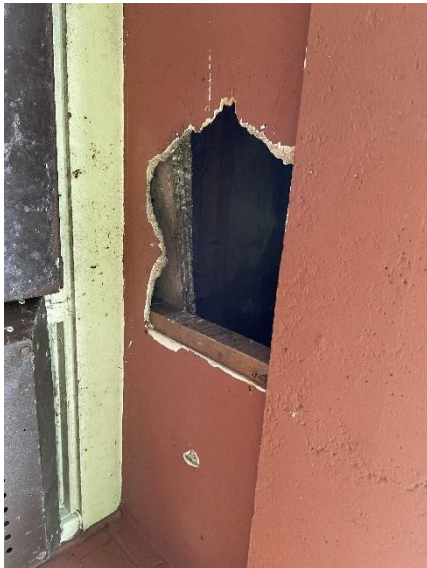
Wooden boards were present around the window cases of the residential apartments, these were damaged in places that provided access into a cavity that could provide a potential PRF. The brick pillars described in Section 3.2.3 were also present on this aspect that were also damaged in places providing suitable PRFs.

**Photograph 18 – Damaged window casing**

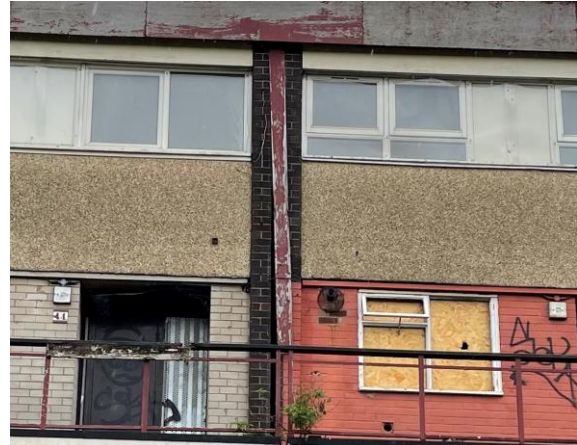
**Photograph 19 – Damaged wooden board over brick pillar**
