## Bituminous Interim Inspection

| <b>PROJECT NUMBER</b> | B190846/1 | <b>AREA MANAGER</b> | John Wilkinson |
| <b>PROJECT NAME</b> | Paterson Building - Christie Hospital | | |

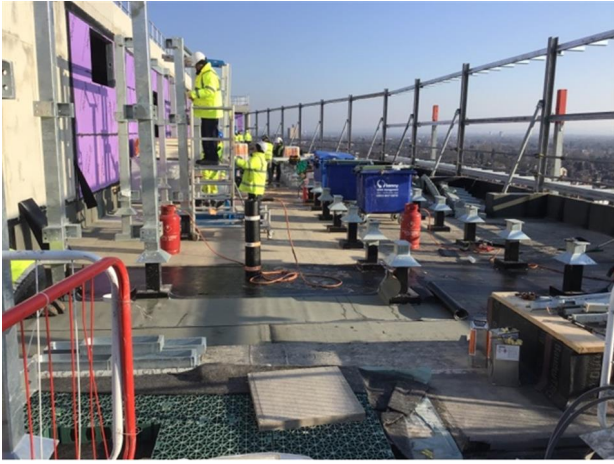
**Photo 1 - Overview of level 9 section 2**

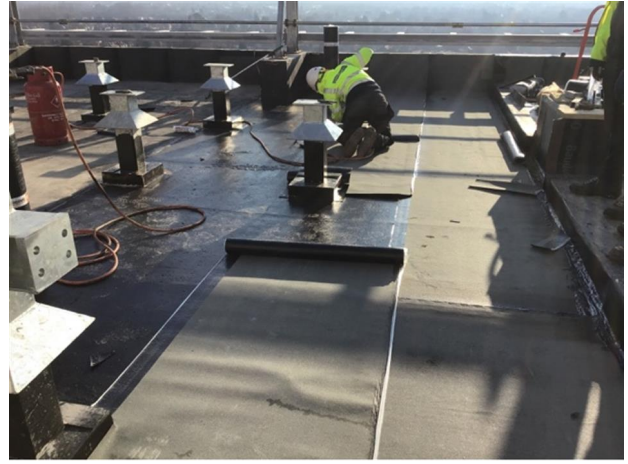
**Photo 2 - View of AVCL being installed**

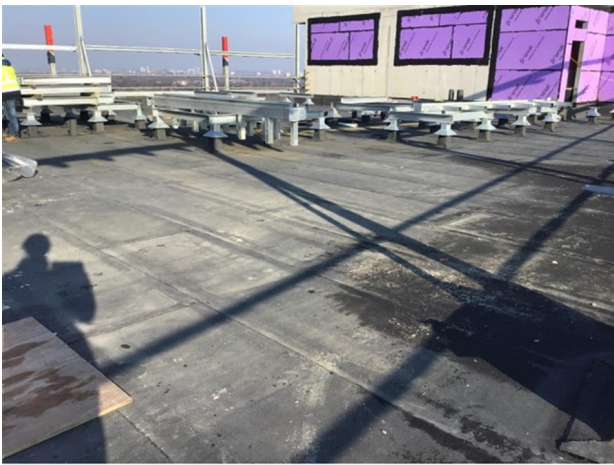
**Photo 3 - Overview of level 9 section 3**

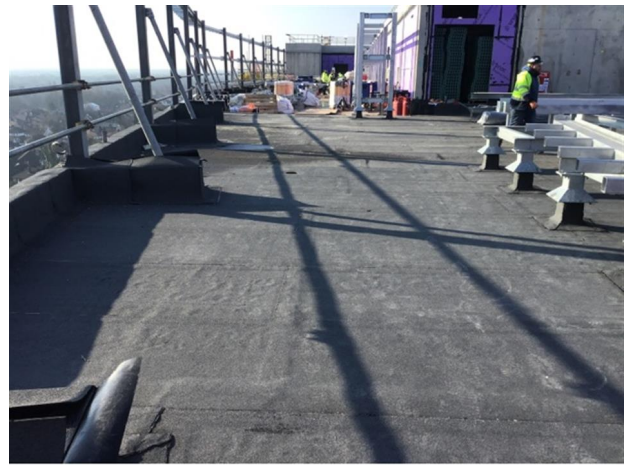
**Photo 4 - View of cap sheet to section 3**

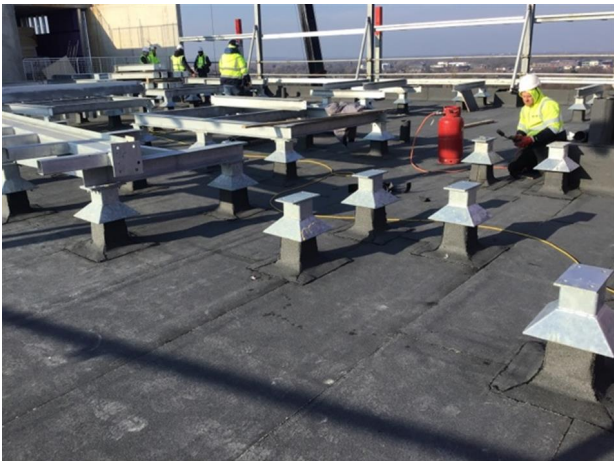
**Photo 5 - View of post details to section 3**

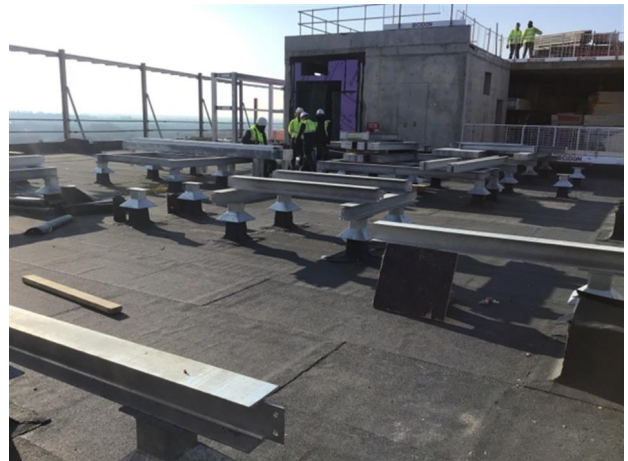
**Photo 6 - Overview of section 3**

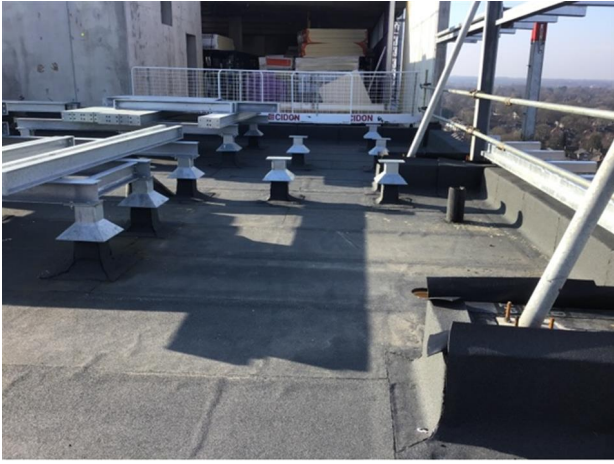
**Photo 7 - View of cap sheet to section 3**

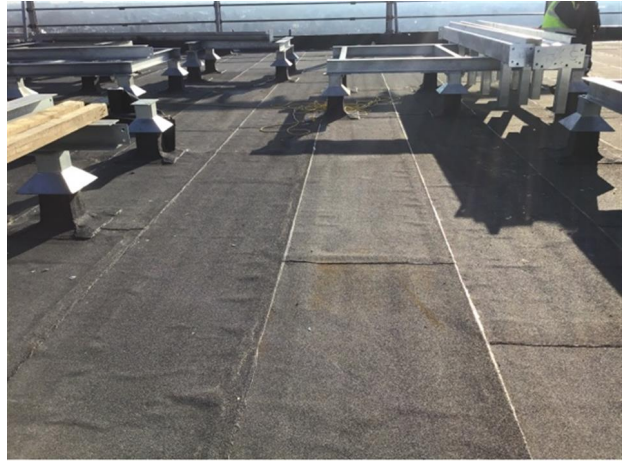
**Photo 8 - View of cap sheet to section 3**

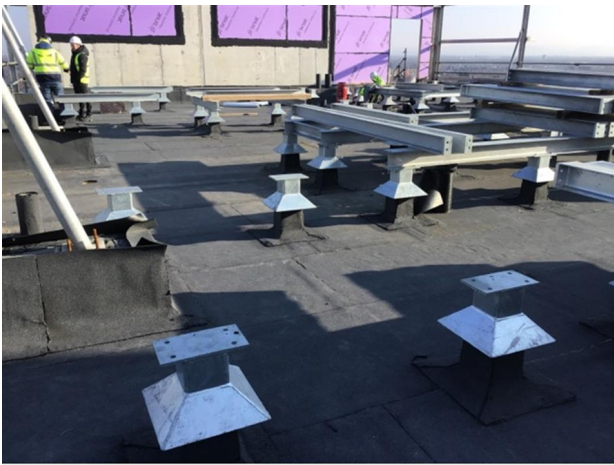
Level section 3 has been passed for landscaping

**Photo 9 - Overview of section 3 and passed for landscaping**

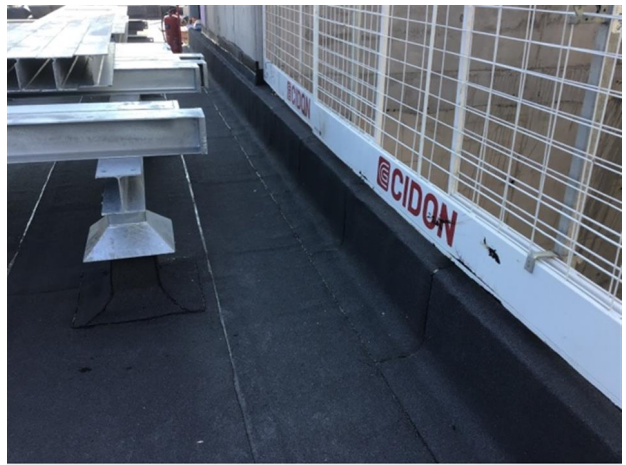
**Photo 10 - View of up stand to section 3**
