# Apex Arb Consultancy

**Tree Decay Inspection for Tariq Munif at 11a Cresswell Grove, Didsbury,  
Manchester, M20 2NH**

**Mr T Crick, APEX ARB Training Ltd  
L4 Dip Arb (ABC), Certified Arborist (ISA)**

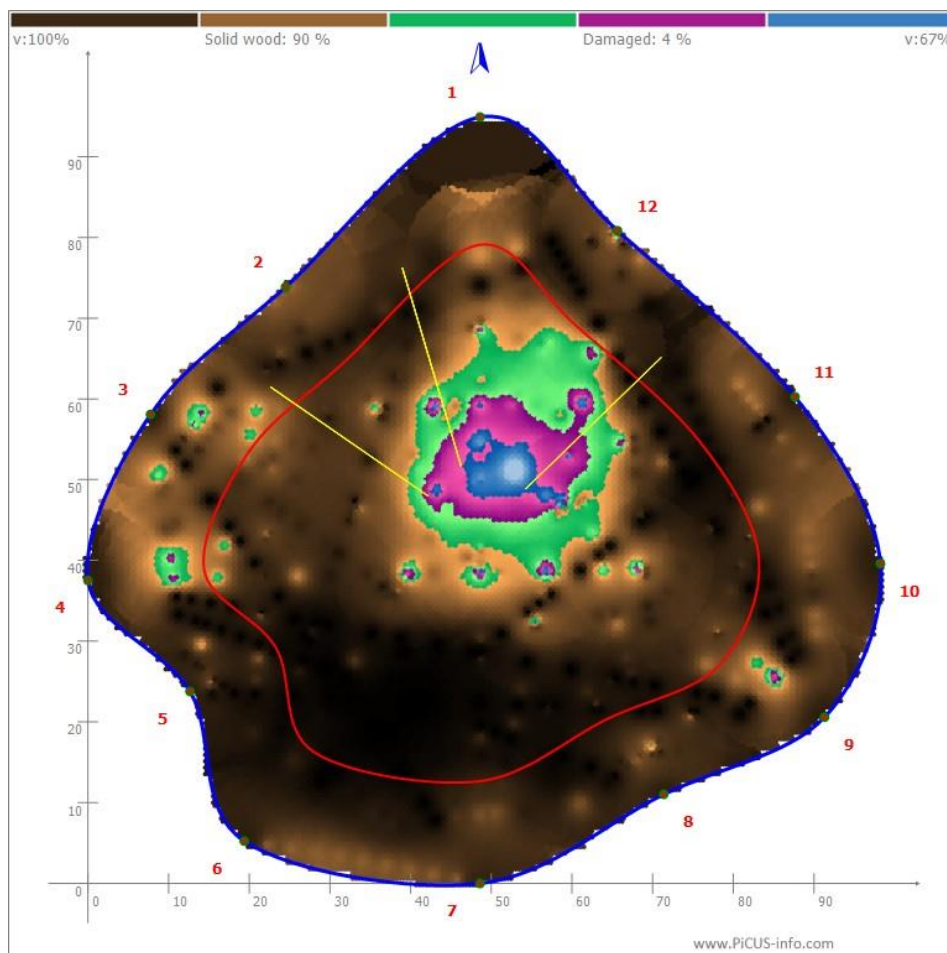
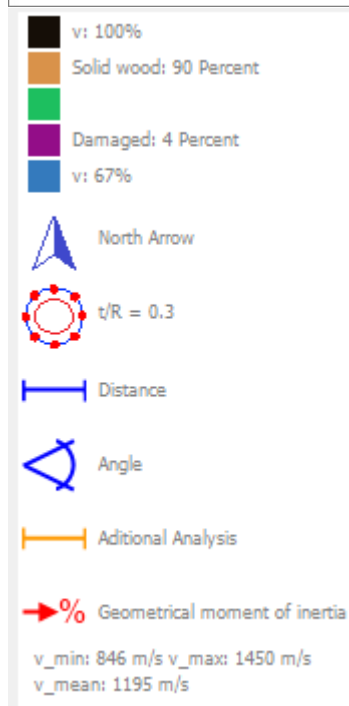
### Tomogram 1.

Showing only 4% decayed wood. The red line demarks the area of sound wood needed to meet the requirement of the thickness in relation to radius calculation, generally excepted as the standard.

The tree should be re inspected biennially for the spread of internal decay.

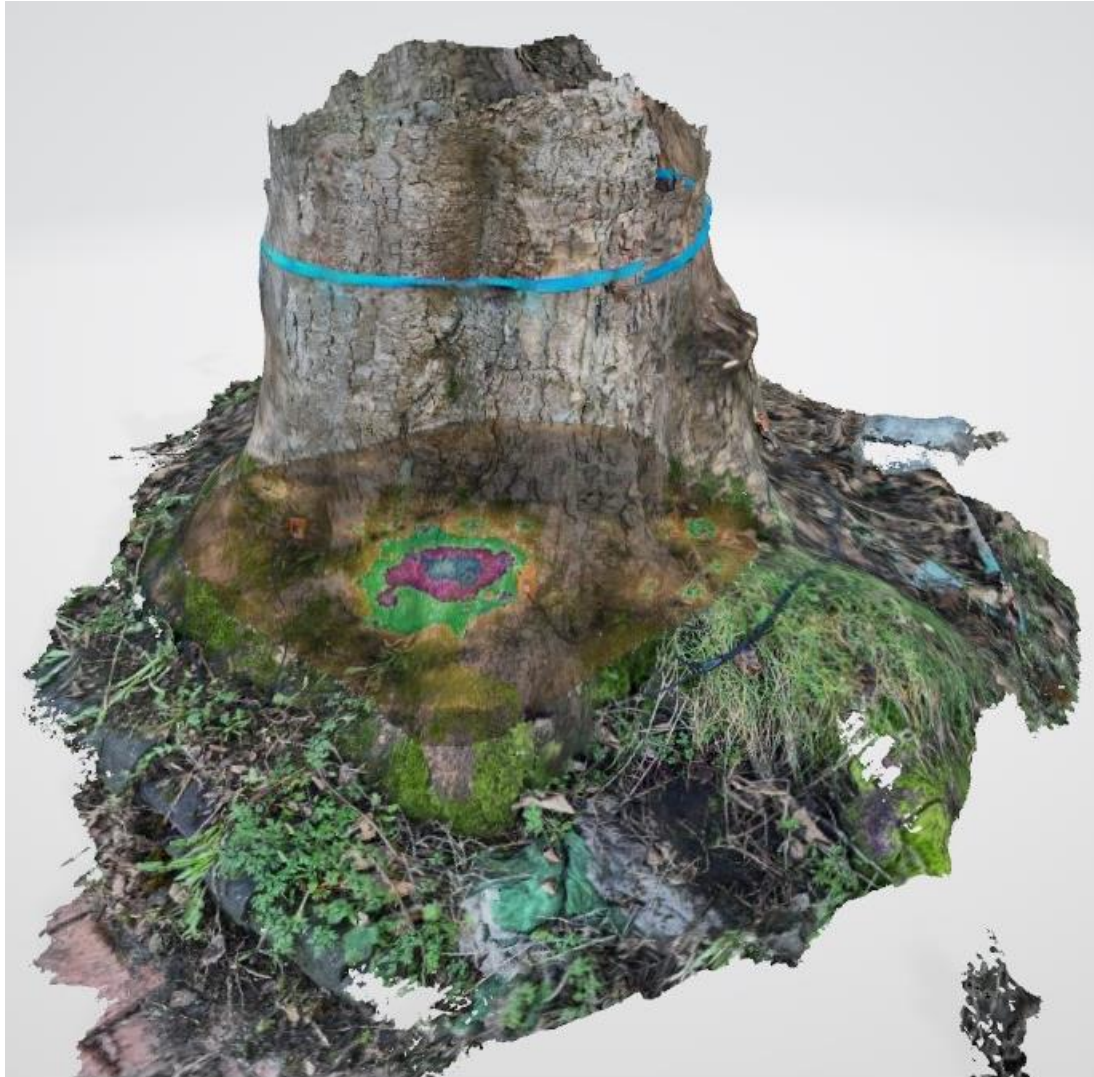
Tomogram in tree from north.

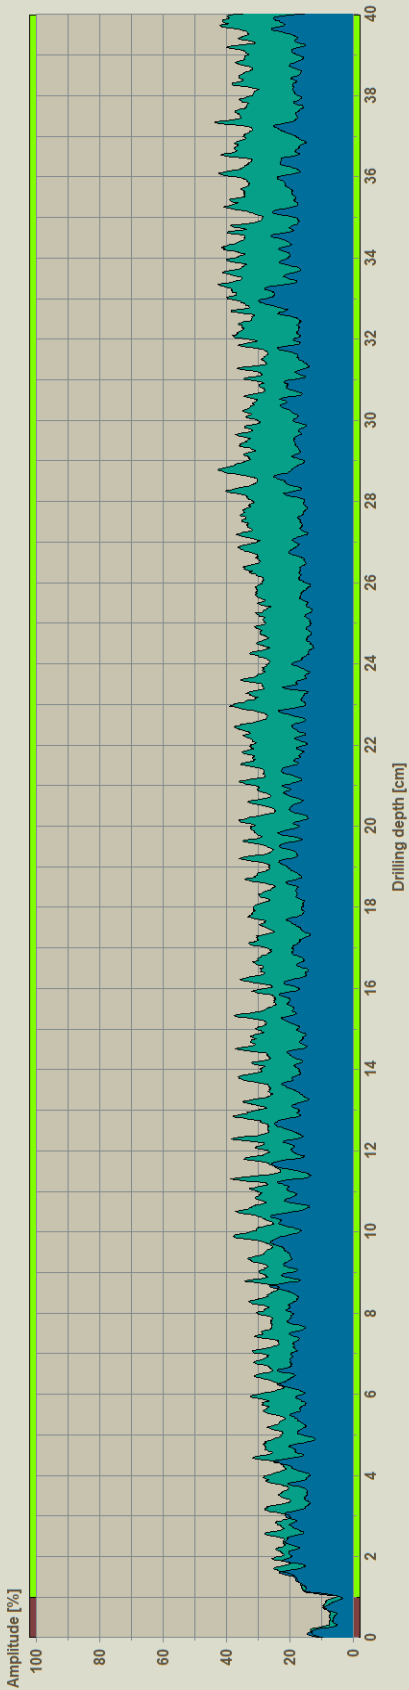
# Resistograph South

This drilling from the South shows good resistance for 40cm.

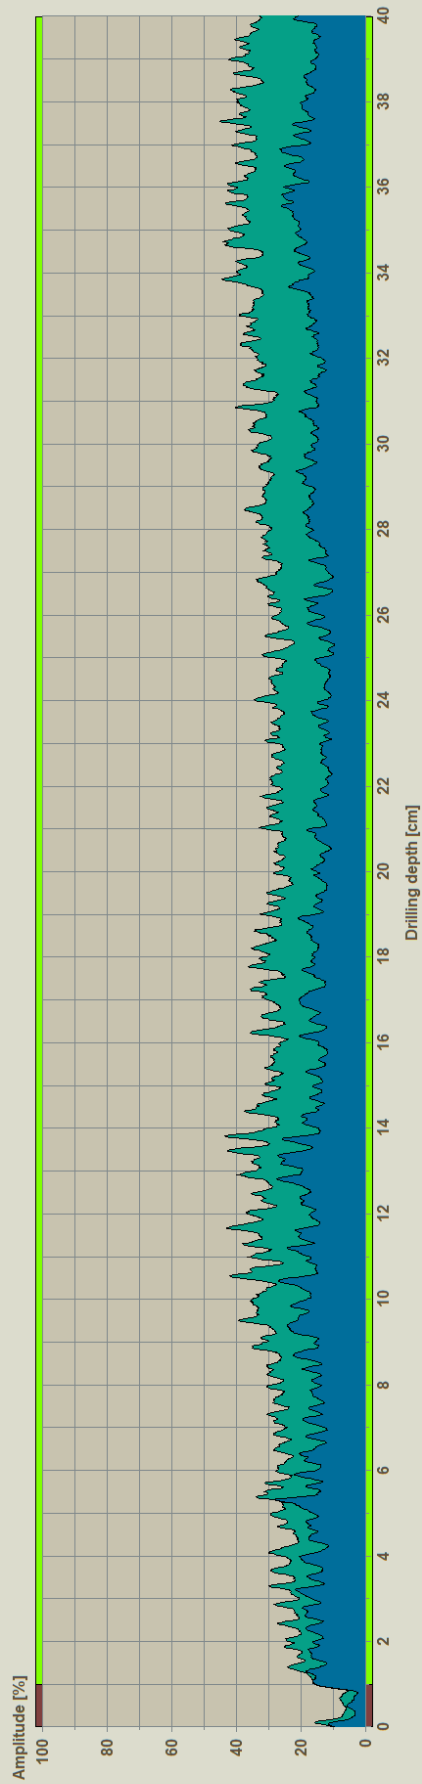
Resistograph West

This drilling from the West shows good resistance for 40cm.

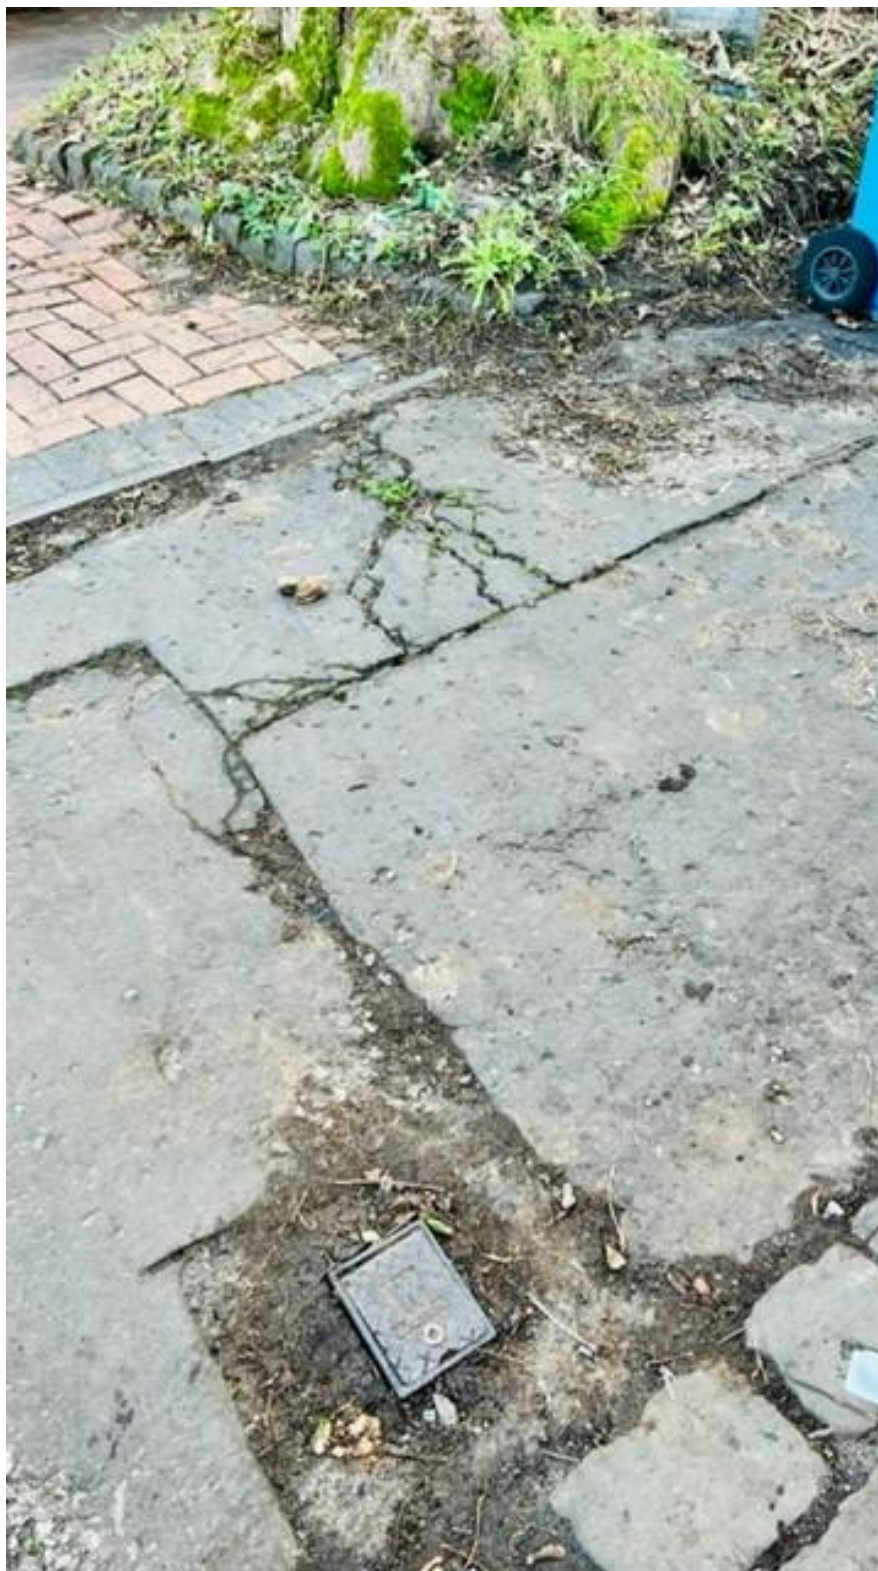
**Photograph 1**

Although my investigations were to measure the extent of any internal decay, I did observe substantial ground heave to the North side of the tree (***see photographs 1 & 2***), approximately 2M from the trunk, this may warrant a further inspection of the trees roots for damage to structures.
