Heaton Park Horticultural Centre Wall  
Conservation Accredited Architect's Report on Proposals for  
Rebuilding with Recommendations  
October 2022

## HEATON PARK HORTICULTURAL CENTRE WALL

### CONSERVATION ACCREDITED ARCHITECT'S REPORT ON REBUILDING PROPOSALS WITH RECOMMENDATIONS

OCTOBER 2022

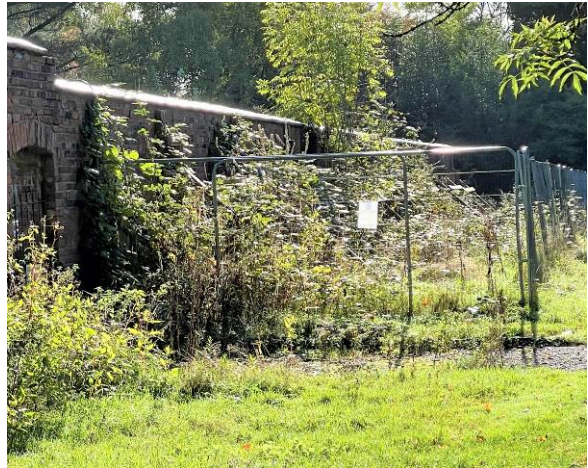
A section of the south garden wall, approximately 16m long to the west of an opening through to the area around the gardener's house collapsed some time ago. The displaced bricks and copings were salvaged, put onto pallets, and stored in the grounds of the gardener's house ready for rebuilding back into the wall. In addition to this a c47m section south of the opening through the west boundary wall is unstable and is currently supported by timber raking shores.

*Area of the west boundary wall fenced off and supported by raking timber shores.*

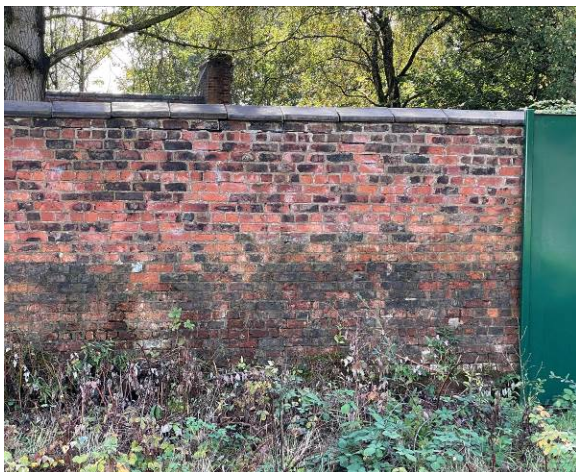
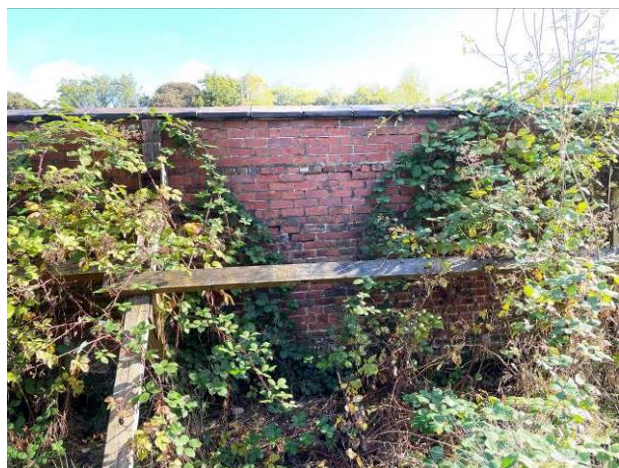
*Differing bonding patterns to south (L) and west (R) walls. Note engineering bricks in upper area of west wall.*

- Local areas of wall have been rebuilt in hard engineering brick pointed in cement over the original, lime mortar pointed, 'softer' clay commons. Stresses are introduced in the wall where materials of differing rates of expansion meet, resulting in local cracking

- Cut back / remove all vegetation encroaching on the base of the wall and taking hold on the surfaces of the brickwork
- Replace all Engineering bricks with commons to unify the appearance of the walls
- Cut back trees where canopies and roots are likely to endanger the walls
- Ensure all copings are in place to prevent water penetrating the core of the wall (Section missing over the south side of the opening in the west wall, immediately before the change in level)

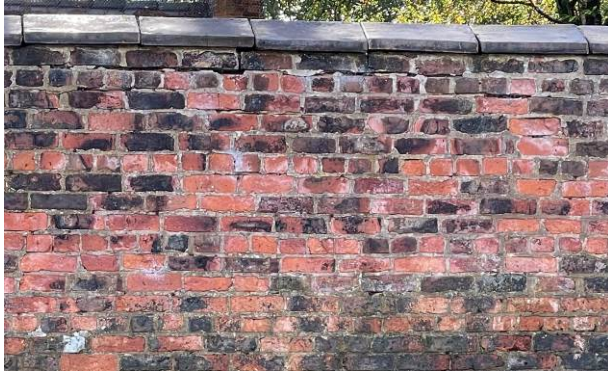
Originally the wall would have been bedded and pointed in lime mortar, but later repointing regimes have been undertaken in cement. Whilst the use of this has had little effect on the later inserted red engineering bricks, it is responsible for the accelerated decay and loss of face of many of the original, softer, clay common bricks. This mortar will also restrict thermal expansion of the wall, and may be, in part responsible for cracking noted locally.

*Effects of cement pointing seen on the softer, common brickwork (blown faces).*

It should, however, be remembered that regular maintenance is essential to keeping the wall in good condition, including regular repointing regimes to the brickwork and copings using lime mortars, and ensuring that vegetation is not allowed to encroach and collect on the surfaces of the walls.

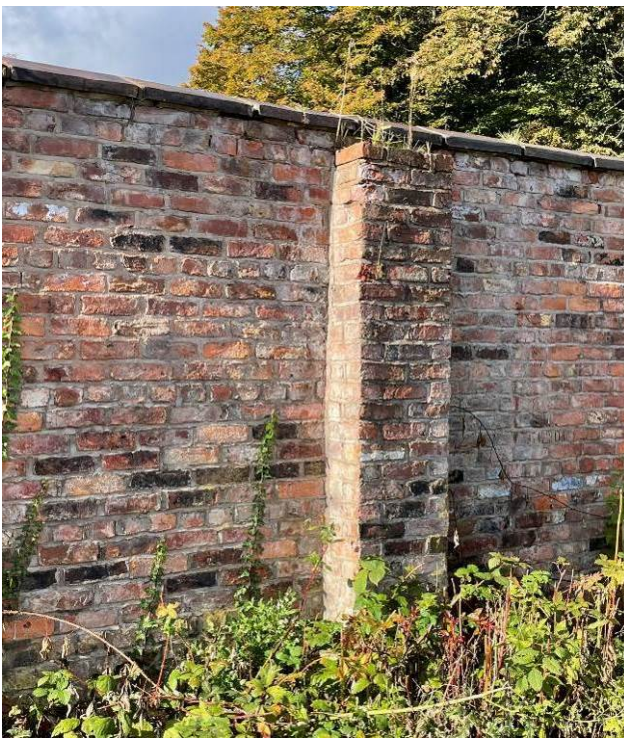
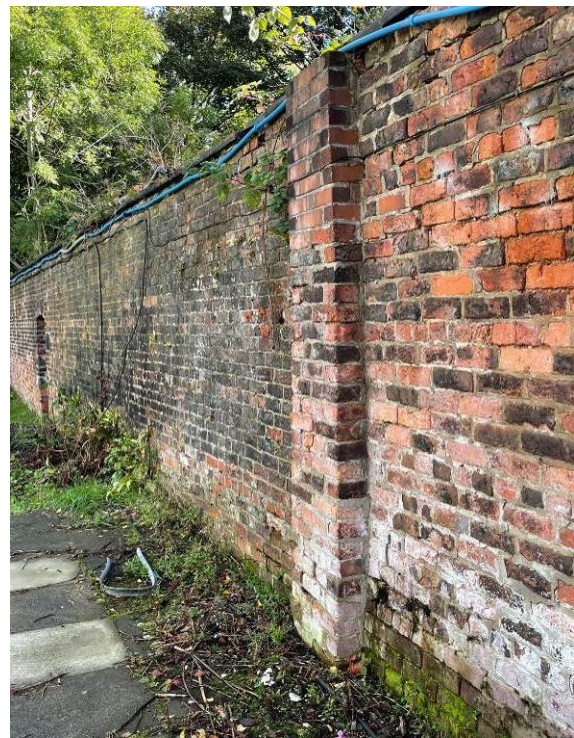
*Brick piers to west (L) and south (R) walls. Difference in coursing (see left image) suggests later additions.*

Both walls subject to the application have brick piers on the garden side only. The west wall has 2 no. brick length which projects 1 no. brick from the face of the wall, whilst the south wall has a single half brick thick pier, 2 no. bricks long. The fact that all of these have no copings, are irregularly spaced, and in some sections don't appear to course in with the main area of the wall, suggests that these are later additions introduced as remedial measures. Confirmation of this is not possible as mortar fillets introduced at the junction of pier and wall masks the area where the pier brickwork would be bonded into the wall, and further investigation (by local removal of the fillet) should be undertaken to determine whether the piers are original features.

- The buttresses, which appear to have been retrospectively introduced, may be contributing to the outward lean of the west wall by applying pressure

Taking all observations made in Section 2.00 into account the walls should be rebuilt in what we believe to be their original configuration of 1.5 bricks thick, without piers (unless further investigation reveals the piers are likely to be original), in salvaged brickwork supplemented with new commons to match (where required) and capped by the existing terracotta saddleback copings. All rebuilding should be bedded and pointed in 1:3 lime (NHL 3.5) / sand mortar, or similar subject to analysis of the original binding material, and no expansion joints are considered necessary.

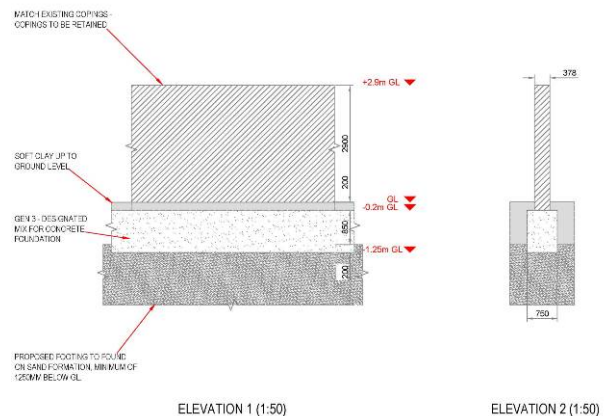
You might expect to find this information on drawing no. 001, 'New Wall and Foundations – Wall Elevations', but this comprises a 'typical' elevation and section of a short section of the wall only, lacking an overall layout indicating the position and spacing of the expansion joints or the areas of foundation renewal (unless this is intended for the complete length of the rebuilt sections of the walls).

The drawing also lacks information likely to be required by the Local Authority Conservation Officer, such as coping profile, brick coursing and bonding, and the existing nature of the footings (brick spreaders?).

*Extract from drawing no. 001, further detail would give more clarity to the submission.*

- Elevations of the walls to be rebuilt as proposed, with the rebuilt sections and expansion joint positions highlighted, together with the extent of any foundation renewal
- Add detail to drawing no. 001 to show brick coursing and bonding in elevation and section, coping profile, and add notes detailing brick sizes (for any replacements required), and mortar specification for bedding and pointing (to avoid any confusion regarding the use of cement)

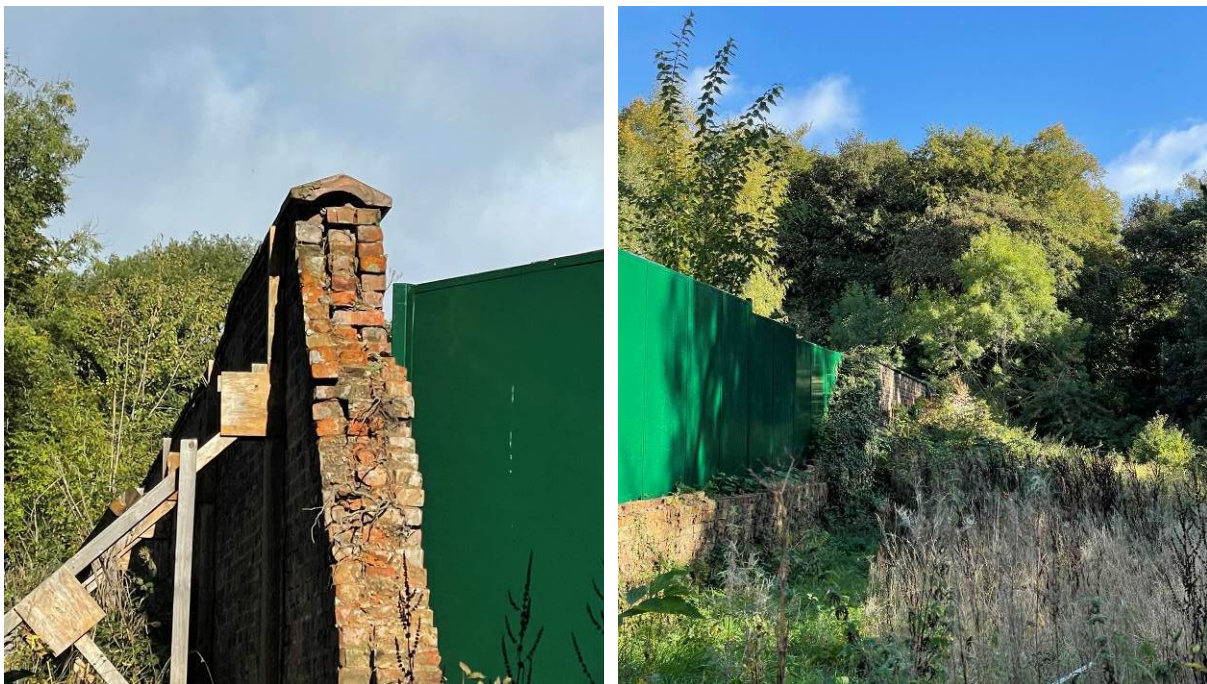
- In all areas the wall is under considerable pressure from encroaching vegetation, largely from self-seeded bushes and trees, which have not been cut back or removed. This has resulted in both pressure being applied to the walls, and root growth being present in the depth of the masonry (as seen at the collapsed south end of the west wall)

- Invasive vegetation, particularly the likes of Buddleia, will displace the walling brickwork and foundations
- Past patch pointing regimes have been undertaken in cement mortar, which will restrict the ability of the walls to accommodate thermal movement, and lead to accelerated decay of the brickwork

- Some larger trees are also quite close to the walls, which their canopies overhang. This suggests their roots may be undermining the footings locally

*Root growth in the core of the west wall (L), vegetation taking hold on / trees overhanging south wall (R)*

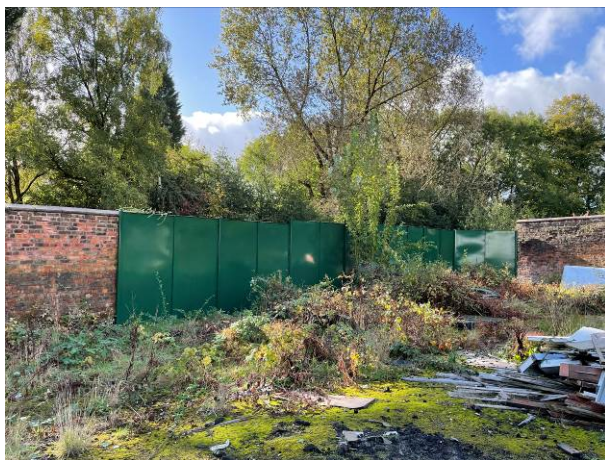
*Vegetation build up, collapsed section of south wall.*
