# **Site Tree Appraisal**

***8 Meadow Bank, Chorlton-Cum-Hardy, Manchester M21 8FP***

**“BS 5837 2012: Trees in Relation to Design, Demolition and Construction – Recommendations”**

Ref: RTS/02012023

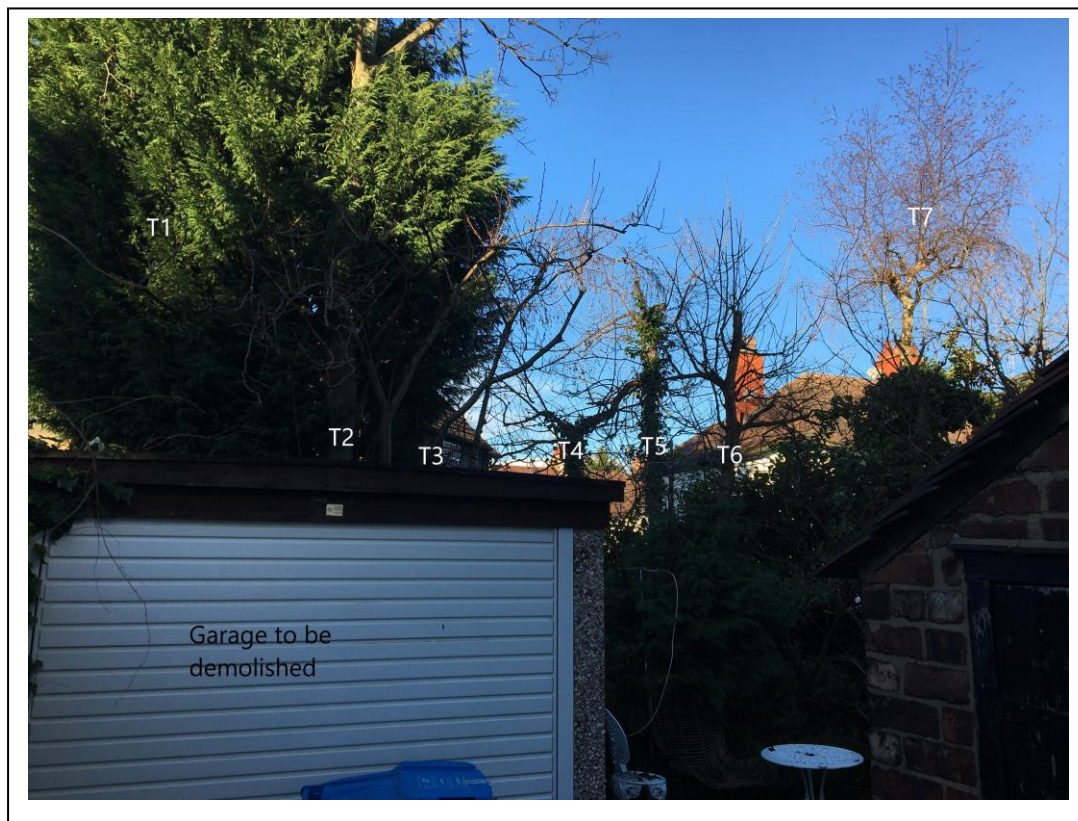
Photo 02:

**3.4** All the trees in the rear garden are relatively small and of poor to only fair quality, many being covered with ivy climber and most having been topped (photo 02). Also, given its location (butted up to the existing boundary fence and behind the garage), it is somewhat surprising that the sycamore T2 is purported to have TPO status (photo 03). Its long-term visual amenity in this location is anticipated to be limited, irrespective of the proposed garden landscaping. There is also a need to thoroughly dig out all the roots of the invasive bamboo plants. Given that one bamboo is close to sycamore T2, removing it will undoubtedly damage the tree roots (photo 04).
