Lucky Cat Restaurant

100 King Street Manchester

MARBLE FLOOR CONDITION AND RENOVATION REPORT 09/01/23

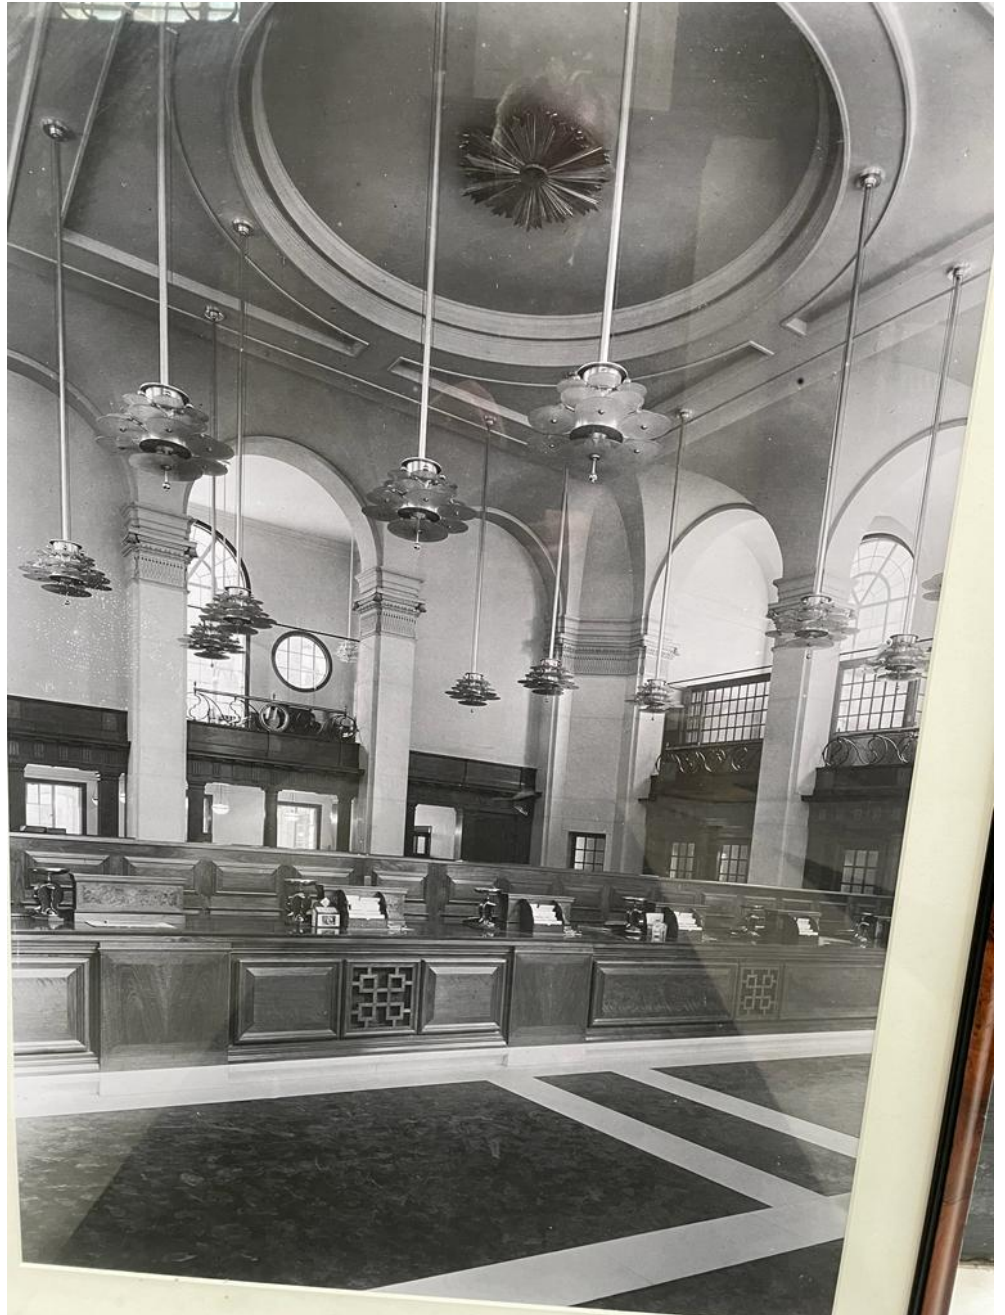
It is clear from the historic photo and a current photo taken during the survey , that the original counter location has been moved. It is harder to see from the original photo the extent of vinyl , as there are foot marks , but there are not the white veins that are present in the current photo. It is only an assumption but some of these black vinyl panels may have been swapped out for marble at some stage, in the history of this floor.

The current bar location has moved from the original counter location which is evident from historical photos of the original counter. In addition the new location has also had a footrail installed which, if moved, will require repair of the fixing holes.

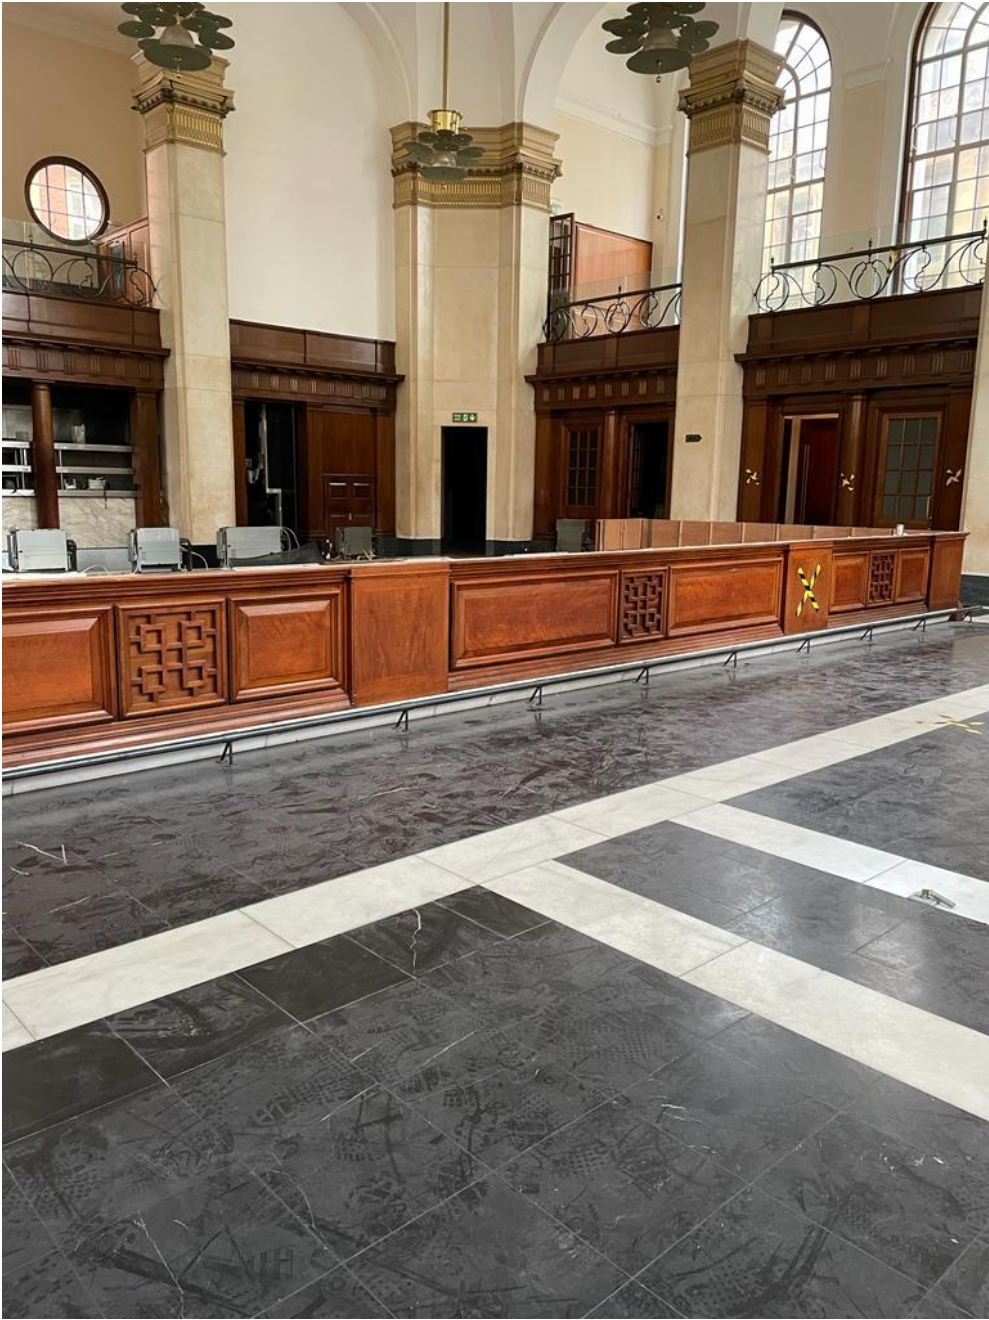
The marked up drawing has been adjusted from the original to reflect the existing make up of each vinyl or marble area along with a record of various faults and conditions that are either historic movement, damage, or current conditions.

These include but are not limited to cracked or missing stones, holes and apertures, or historic repairs that are unsightly, etc
