## Bituminous Interim Inspection

| <b>PROJECT NUMBER</b> | B190846/1 | <b>AREA MANAGER</b> | John Wilkinson |
| <b>PROJECT NAME</b> | Paterson Building - Christie Hospital | | |

| <b>INSPECTED BY:</b> | Anthony Symondson | <b>Date:</b> | 07-01-2022 |

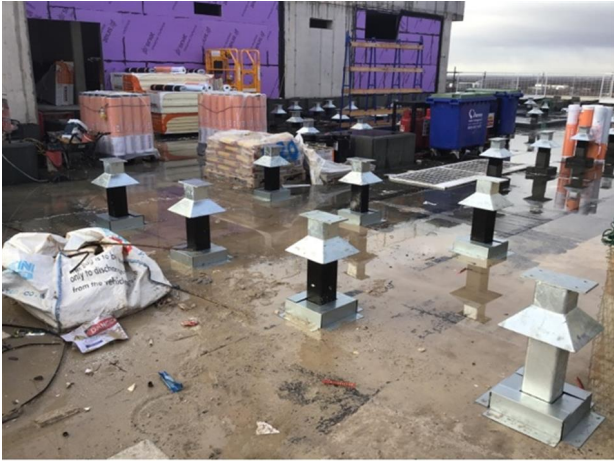
**Photo 1 - View of progress to level 9**

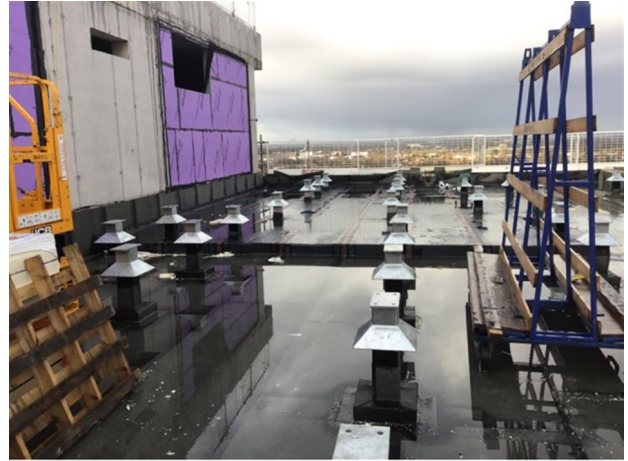
**Photo 2 - View of progress to level 9**

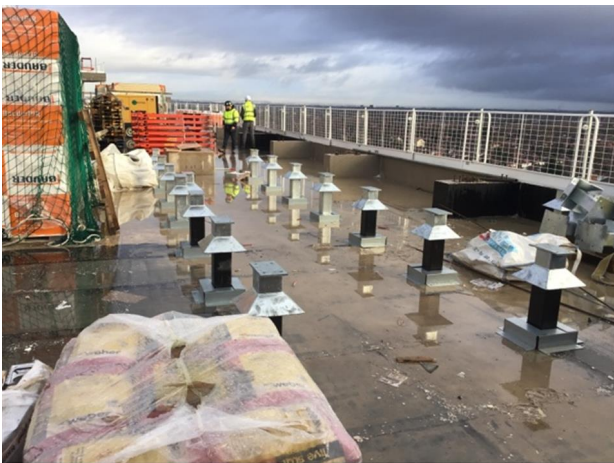
**Photo 3 - View of level 9**

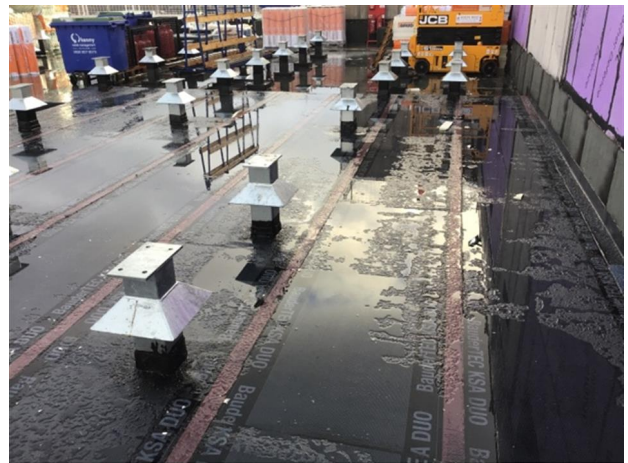
**Photo 4 - View of insulation and underlay**

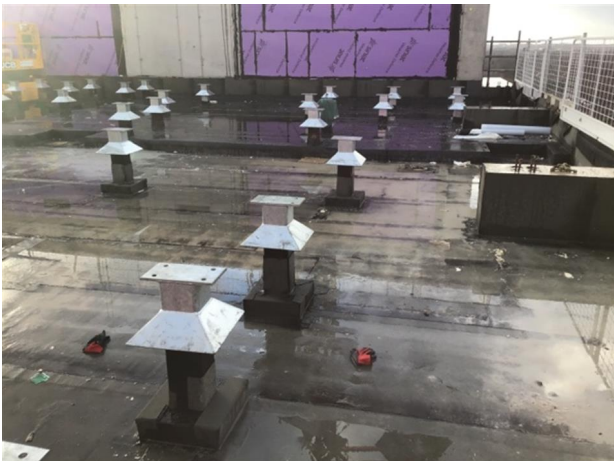
**Photo 5 - View of progress to level 9**

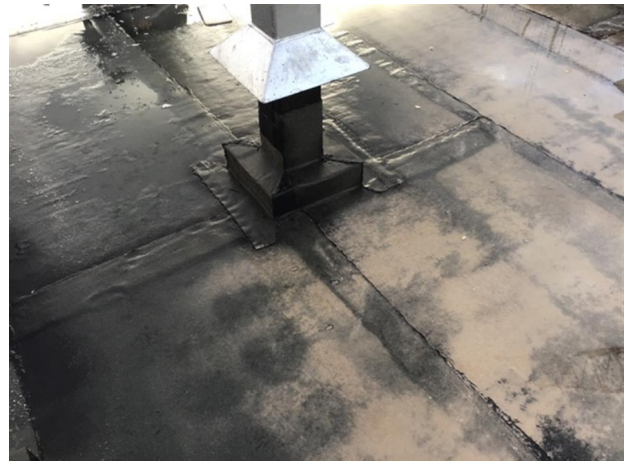
It was discussed that to help continuity of work that the steel support posts can be detailed in AVCL before main area is installed, but once insulated it will be detailed after area membranes are installed.

**Photo 6 - View of AVCL to steel supports**

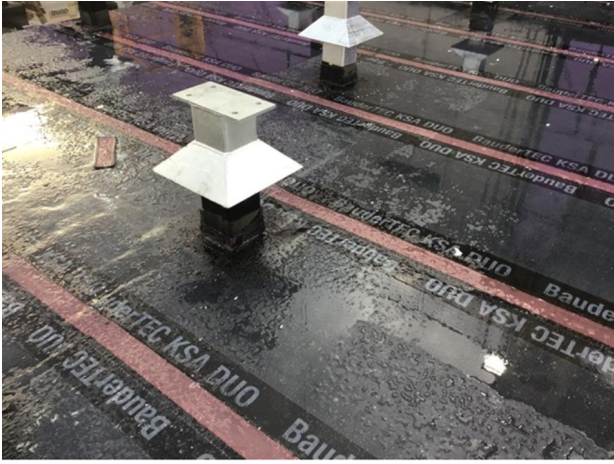
**Photo 7 - View of steel supports**

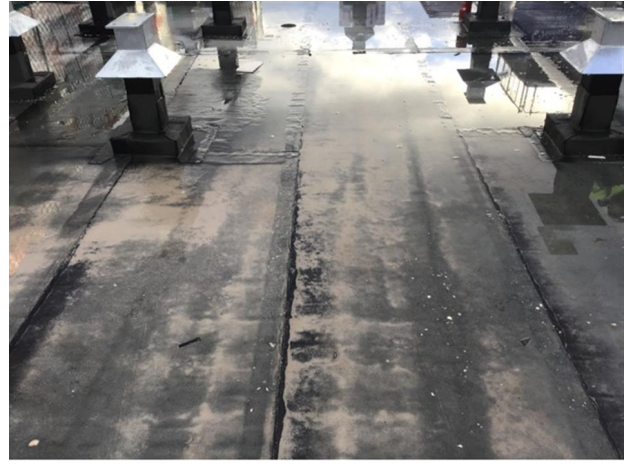
**Photo 8 - View of AVCL to level 9**
