## Site Photographs

**Project:** The Wentwood, 72-76 Newton Street M1 1EE

**Document:** Site Photographs

**Document Ref:** KVA/2170/TW-SP001

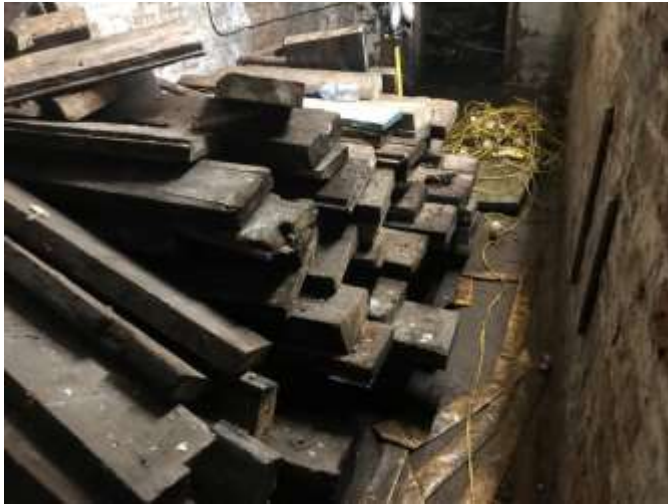
**Photograph no.1:** Stock Pile of existing rafters.

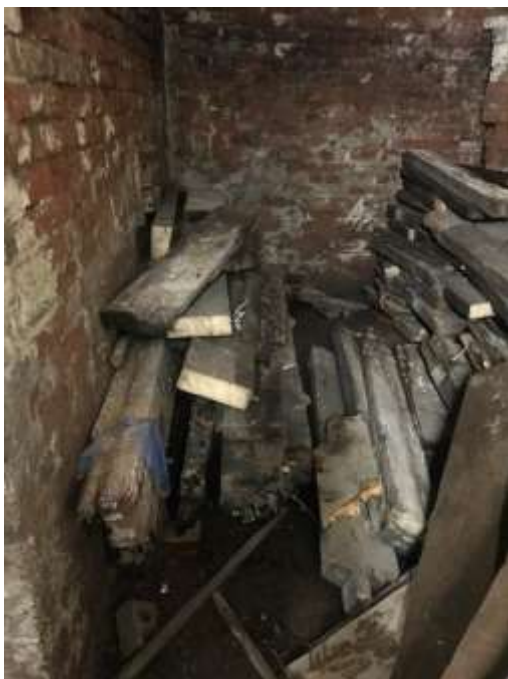
**Photograph no.2:** Stock Pile of existing rafters.

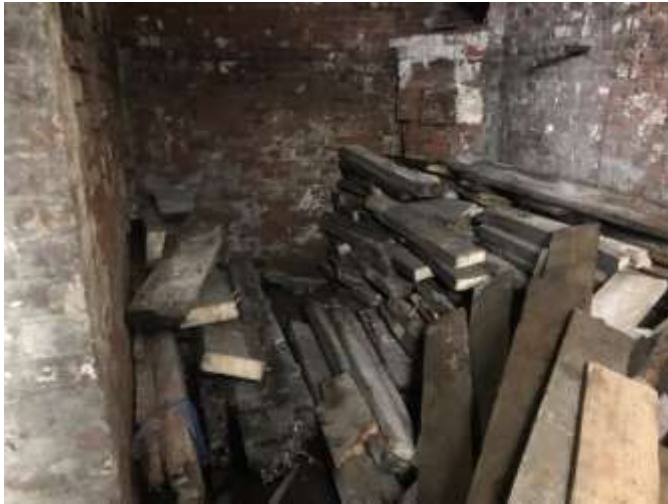
**Photograph no.3:** Stock Pile of existing rafters.

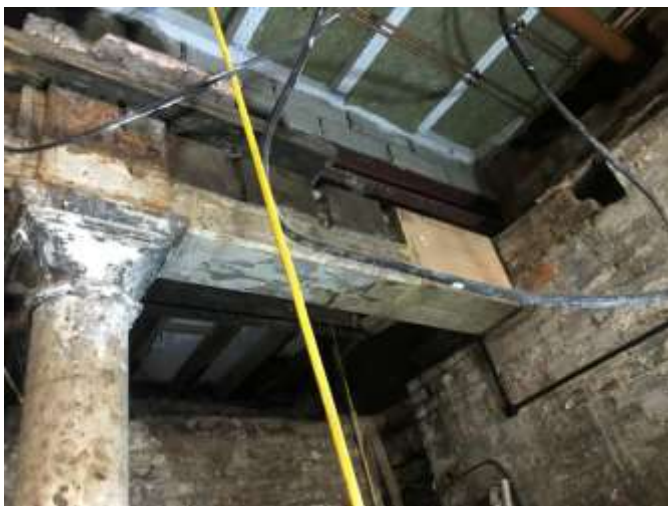
**Photograph no.4:** Splice Repair no.1.

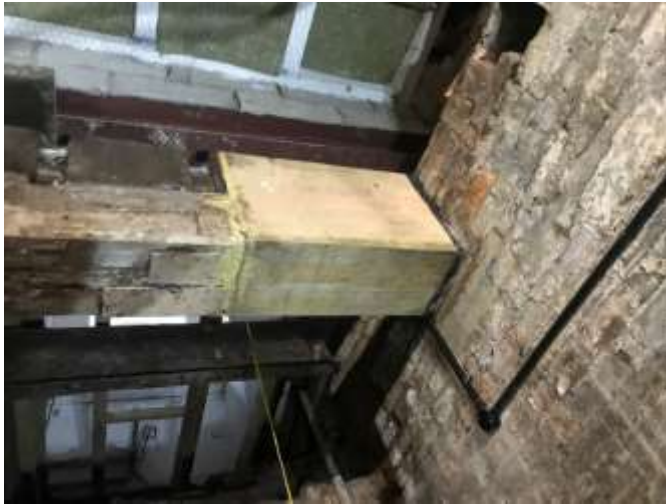
**Photograph no.5: Splice Repair no.1.**

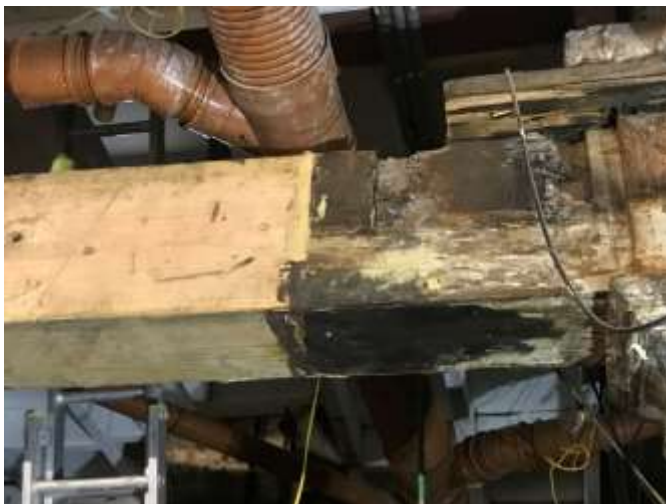
**Photograph no.6: Splice Repair no.2.**

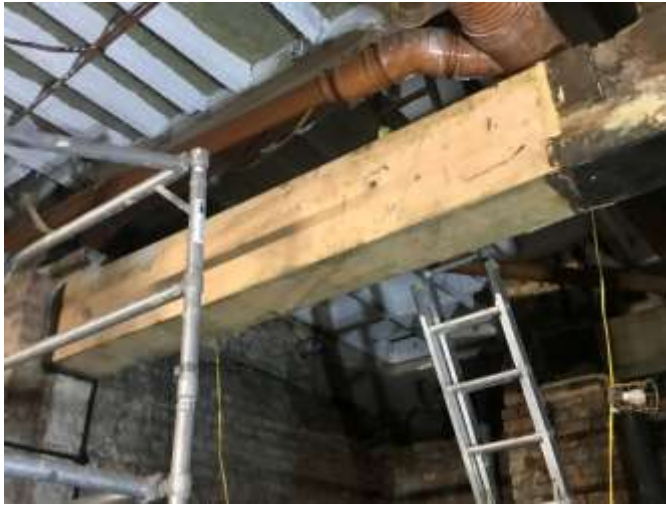
**Photograph no.7 : Splice Repair no.2.**

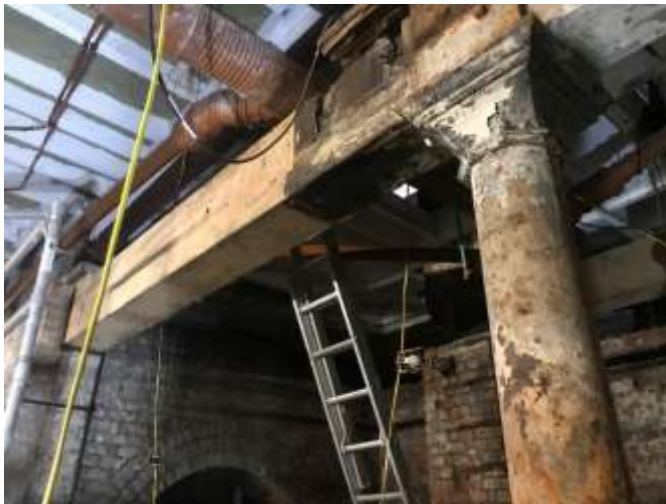
**Photograph no.8 : Splice Repair no.2.**

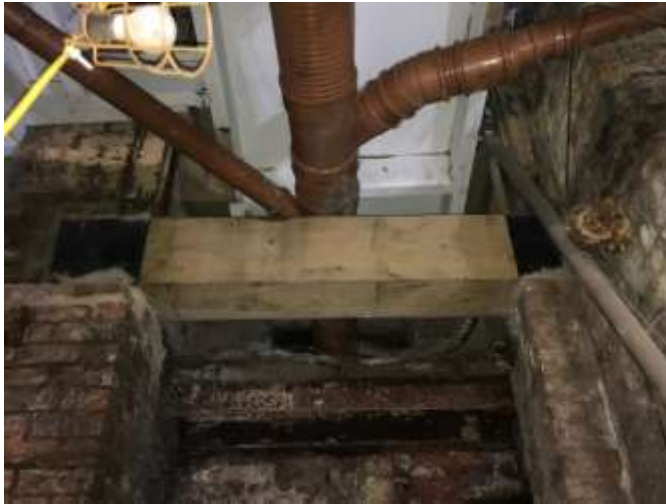
**Photograph no.9:** Complete beam Replacement with like for like `Douglas Fir`  
 Refer to Highlighted Section of drawing Ref: LK.01-102: Extents of Remedial Works to Existing Ground Floor Construction and also drawing ref: LK.01-101: Remedial Works to Existing Ground Floor Construction.

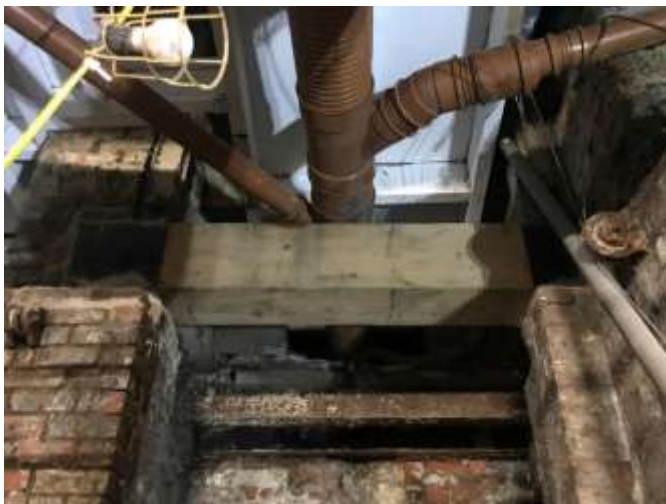
**Photograph no.10:** Complete beam Replacement with like for like `Douglas Fir`.  
 Refer to Highlighted Section of drawing Ref: LK.01-102: Extents of Remedial Works to Existing Ground Floor Construction and also drawing ref: LK.01-101: Remedial Works to Existing Ground Floor Construction.

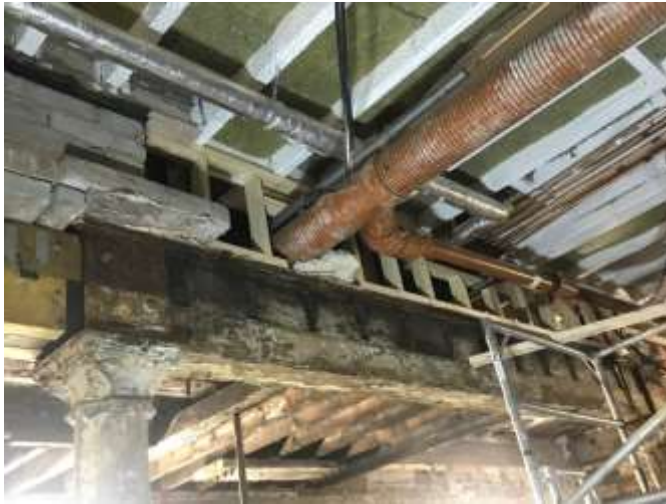
**Photograph no.11:** Existing beam and floor deck with new floor construction above.

New Floor construction coated with intumescent paint and void between joists packed with 150mm Rockwool RW45 insulation batts supported by chicken wire fixed to underside of joists in preparation for 35mm Actis Triso Super 10+, 25mm counter battens and 2no. layers of 12.5mm plasterboard.

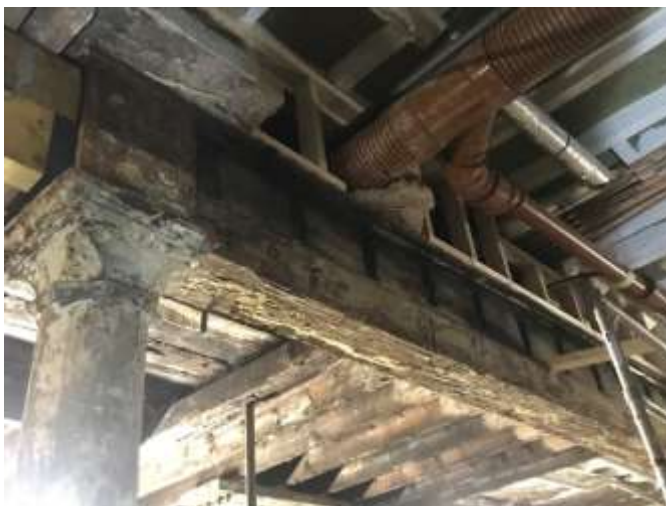
**Photograph no.12:** Existing beam and floor deck with new floor construction above.

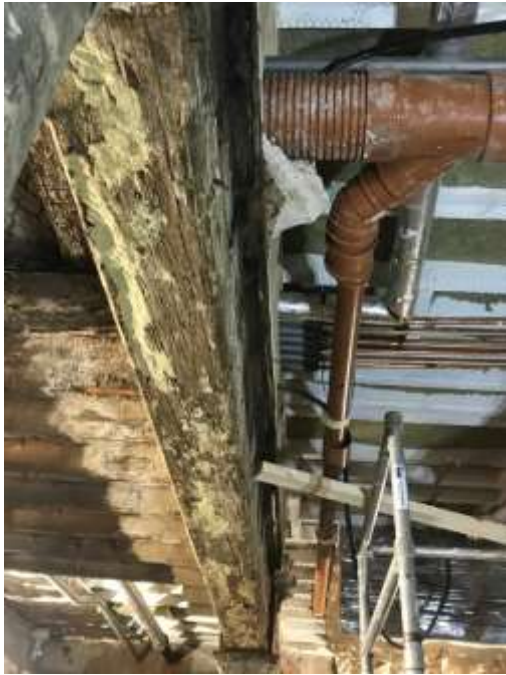
**Photograph no.13:** Existing beam ref A with putty treatment as installed by PRS.

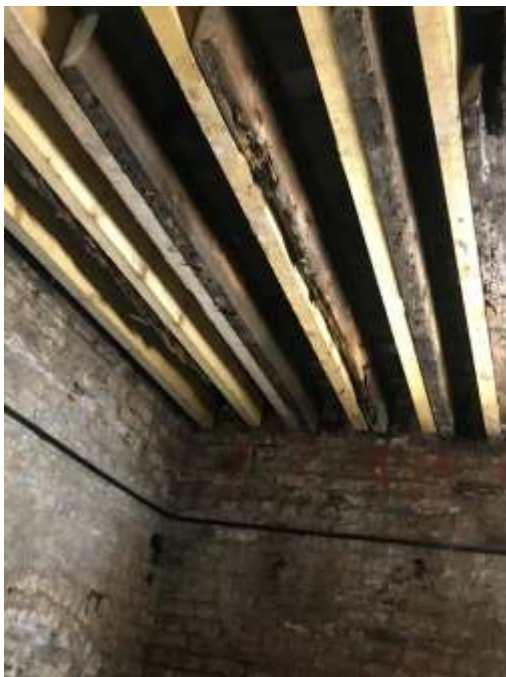
**Photograph no.14 :** Existing floor joists retained and spliced with new timber for support.

Note: New Floor joists installed historically and as part of original conversion.

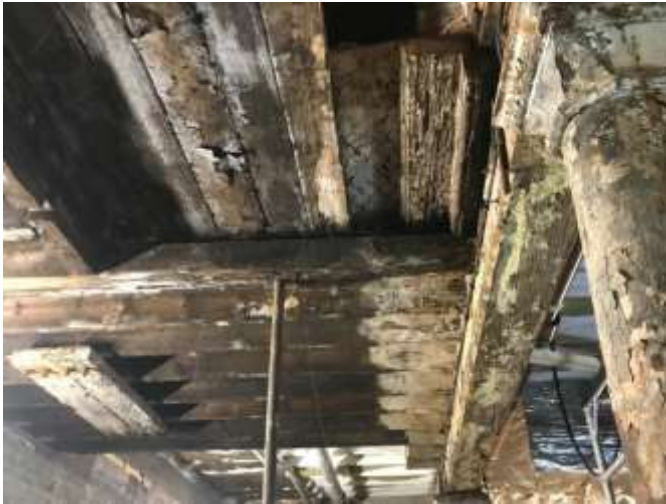
**Photograph no.15:** Existing floor beams and joists retained.

Note: Existing reinforced concrete floor slab visible between joists.

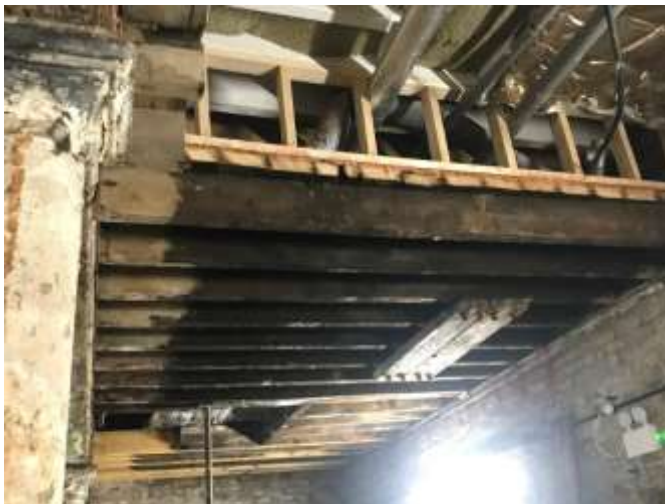
**Photograph no.16:** Existing floor beams and joists retained.

Note: This section of flooring is to be underdrawn with 2no. layers of 12.5mm plasterboard to provide basic fire protections.

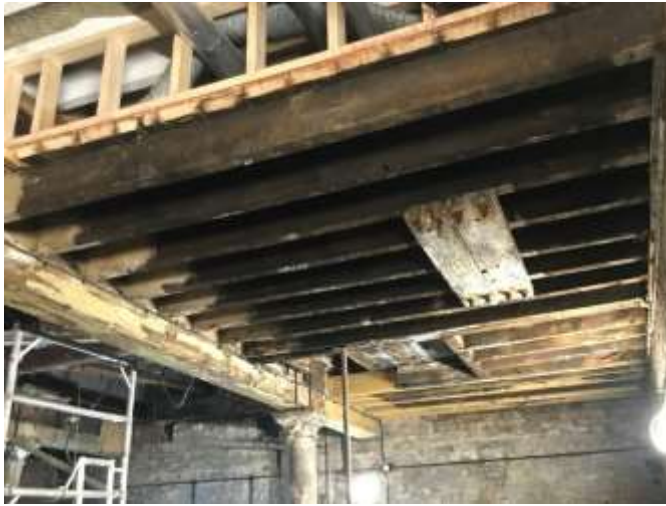
**Photograph no.17:** Existing floor beams and joists retained.

Note: This section of flooring is to be underdrawn with 2no. layers of 12.5mm plasterboard to provide basic fire protections.

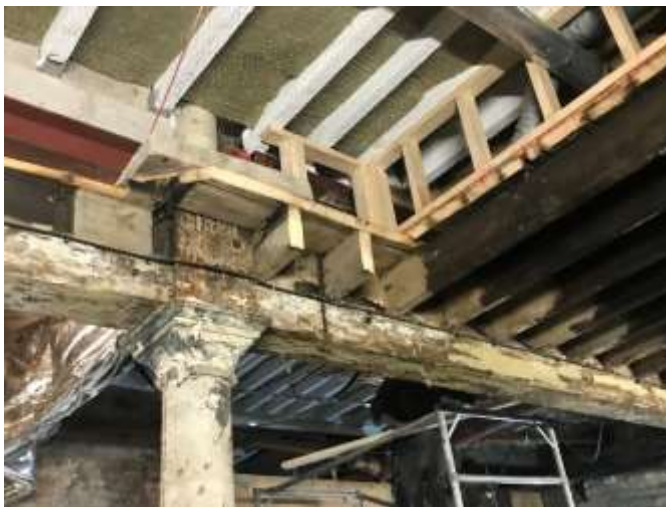
**Photograph no.18:** Showing Existing floor beams and joists that are to be retained and to be underdrawn with 2no. layers of 12.5mm plasterboard to provide basic fire protection.

The photograph also displays a section of the existing floor structure that has been removed to allow the new floor structure above to be coated with intumescent paint and the void between joists packed with 150mm Rockwool RW45 insulation batts supported by chicken wire fixed to underside of joists in preparation for 35mm Actis Triso Super 10+, 25mm counter battens and 2no. layers of 12.5mm plasterboard.

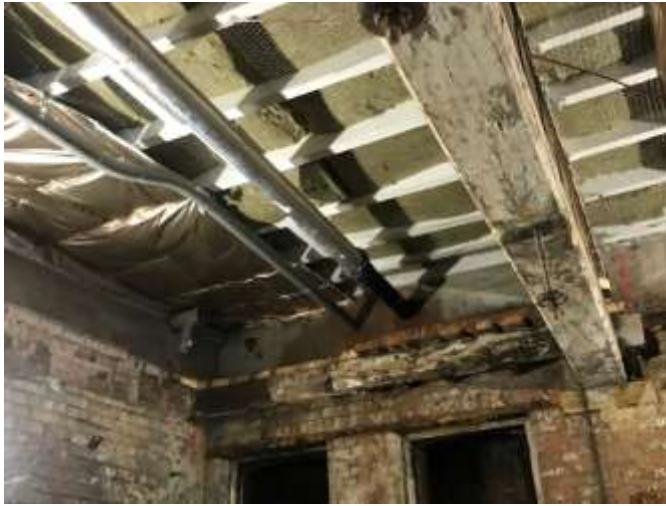
**Photograph no.19:** Showing Existing floor beam retained and the existing horizontal floor deck removed to allow access to the new floor structure.

The photograph displays a section of the new floor structure coated with intumescent paint and the void between joists packed with 150mm Rockwool RW45 insulation batts supported by chicken wire fixed to underside of joists. A section of the 35mm Actis Triso Super 10+ has been applied ready for the 25mm counter battens and 2no. layers of 12.5mm plasterboard to be installed.

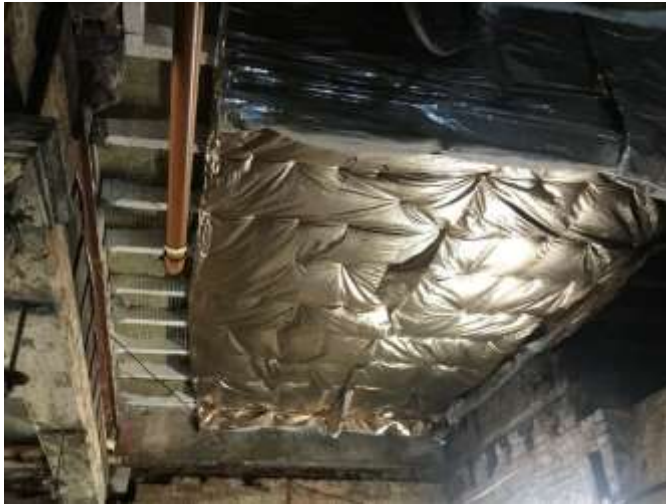
**Photograph no.20:** Showing Existing floor beam retained and the existing horizontal floor deck removed to allow access to the new floor structure.

The photograph displays a section of the new floor structure coated with intumescent paint and the void between joists packed with 150mm Rockwool RW45 insulation batts supported by chicken wire fixed to underside of joists. A section of the 35mm Actis Triso Super 10+ has been applied ready for the 25mm counter battens and 2no. layers of 12.5mm plasterboard to be installed.

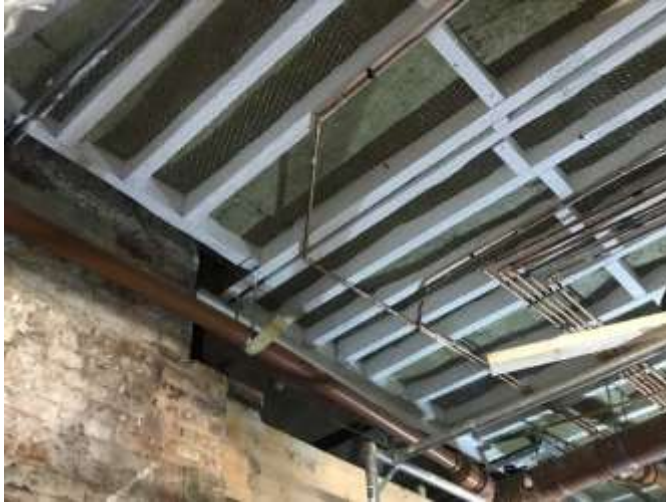
**Photograph no.21:** This photograph displays a section of the new floor structure coated with intumescent paint and the void between joists packed with 150mm Rockwool RW45 insulation batts supported by chicken wire fixed to underside of joists. A section of the 35mm Actis Triso Super 10+ has been applied ready for the 25mm counter battens and 2no. layers of 12.5mm plasterboard to be installed.

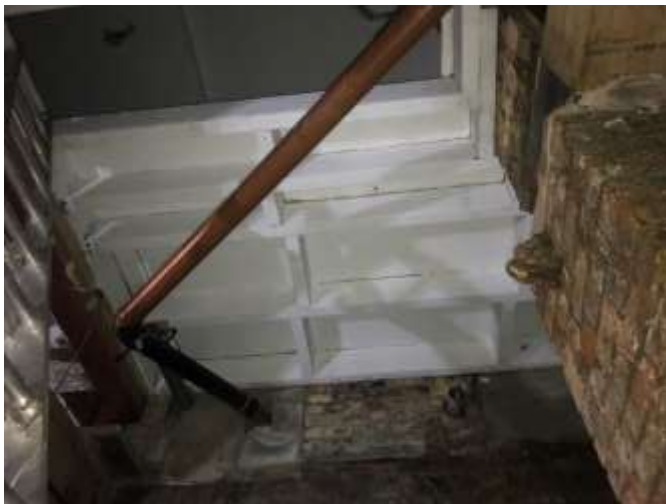
**Photograph no.22:** The photograph displays a section of the new floor structure coated with intumescent paint.
