**FENTON HOUSE, HIGHER ARDWICK, MANCHESTER**

**CONDITION COMPLIANCE:**

**Room by Room Schedule of Works  
(Condition 5)**

*Peter Jones-Hughes and Huw Davies  
MIHBC; BSc Hons Town Planning; PG Dip Blg Cons [RICS]  
Prepared November 2021*

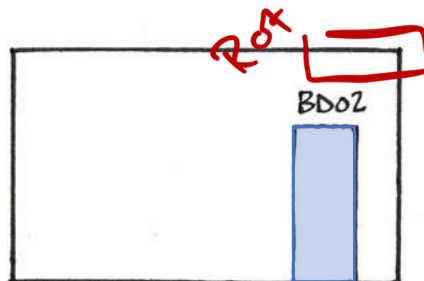
## NORTH

North elevation- Existing: Plain plaster wall – no coving. Low Torus skirting board (6”), existing door opening no door or architrave-

Proposed: Retain existing Torus board. Door blocked with new masonry partition?

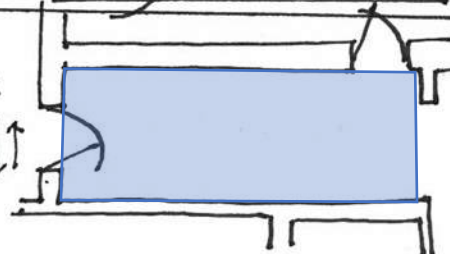
## FLOOR

Floor Plan - Existing: Laminate covering on solid concrete (?) floor

Proposed: Remove damaged laminate covering and replace with better quality laminate or solid boards or carpets

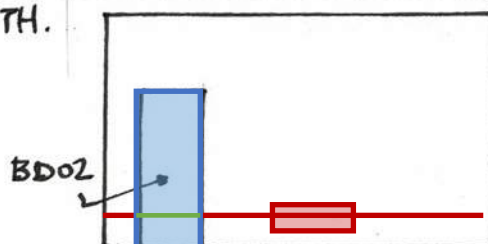
SOUTH.

| <p><u>South elevation- Existing:</u> Modern coving and Torus skirting – door opening to east (no door or architrave). Dry rot fungal growth to centre of skirting.</p> <p><u>Proposed:</u> Retain coving – replace skirting, like for like. Treat all dry rot. Block door and plaster</p> |

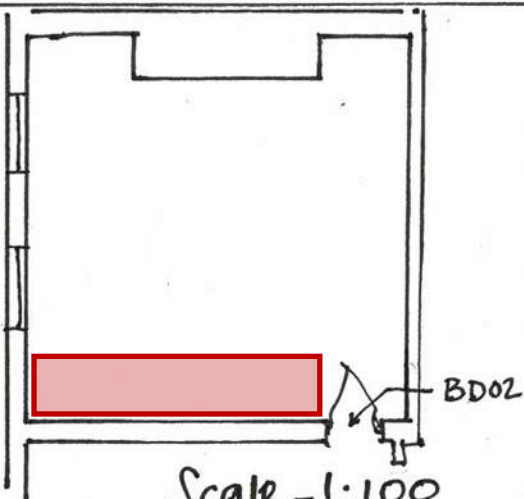
FLOOR

| <p><u>Floor Plan - Existing:</u> Laminate over solid floor. Dry rot/fungus to west of door in south wall.</p> <p><u>Proposed</u> Remove laminate board over or carpet. Treat dry rot</p> |

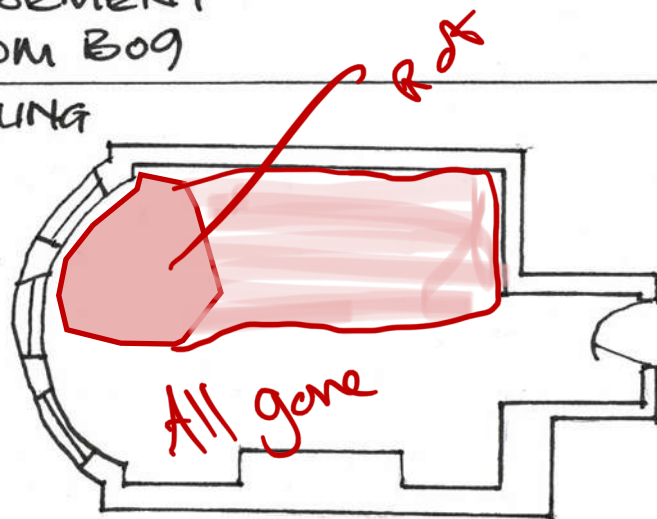
### CEILING

Ceiling Existing: Plain ceiling – plaster board?  
Missing area to northwest – joists exposed, dry rot to north end of 6 exposed joists. No coving.  
Further additional partitioning for lobby (off B01) WC and bedroom to apartment 1. All partitions to have modern skirtings – no coving

Proposed: Treat dry rot – remove infected timber and splice in new like for like joists. Recover with plasterboard. Do not instal coving. Four new doors to lobby with modern architrave (see door and window schedule)

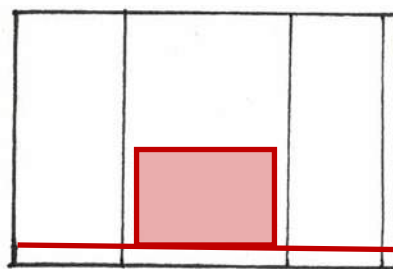
### SOUTH

South elevation- Existing: Chimney breast – damaged opening in breast, no covering and skirting.

Proposed: Repair and plaster existing opening, retain skirting boards – replace where damaged. No coving.

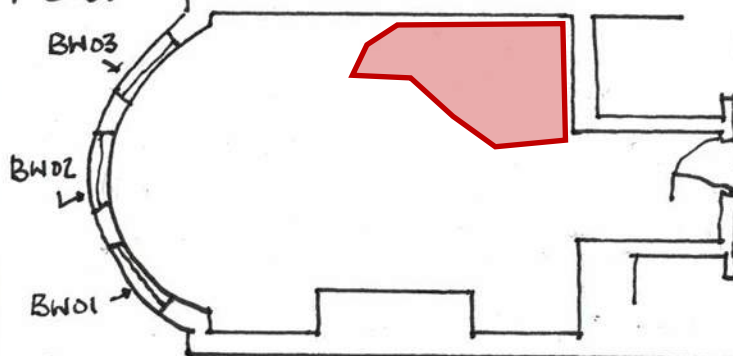
### FLOOR

Floor Plan - Existing: Laminate covering over solid floor. Dry rot in northeast corner of main room

Proposed Investigate and treat dry rot in northeast corner, replace any removed skirtings, like for like. Remove laminate floor and board or carpet.

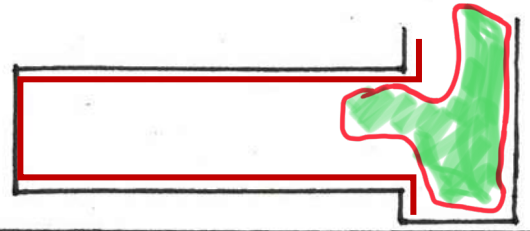
### CEILING

Room GF01 -Main entrance lobby.  
Ceiling Plan - Existing: Original coving remains, but small section missing to the north east of the room. The ceiling has been plaster-boarded over.

Proposed: Reinstate missing section of coving to match original. Remove plasterboard from ceiling and assess underlying structure. Repair as needed as per schedule for Lath and Plaster. New lightweight stud or glazed wall inserted to form inner lobby.

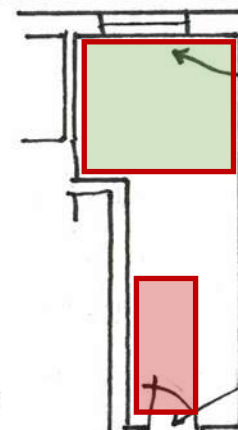
FLOOR

Floor Plan - Existing: Timber boarded floor, changed to the north of the room. Water damage and removal of boards has occurred

Proposed raise floor, repair and relay using reclaimed boards to reinstate modern floor and damaged areas

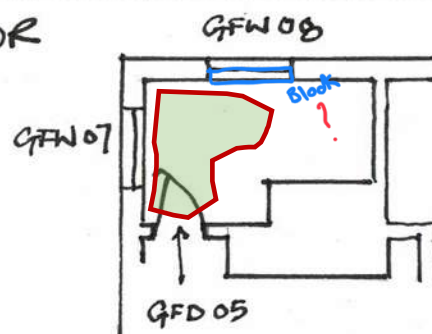
### FLOOR

Floor Plan - Existing: Timber floorboard, with large section of damage.

Proposed carry out repairs to the floor, using reclaimed boards to match existing.

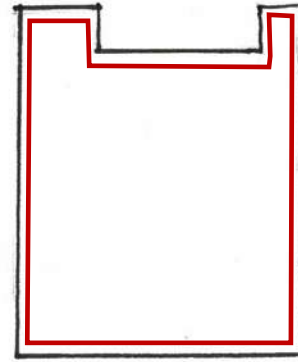
### CEILING

Ceiling Plan - Existing: Original cornice in situ, but ceiling has been plaster-boarded over, sections of failure and damage.

Proposed: Reinstate missing section of coving to match original. Remove plasterboard from ceiling and assess underlying structure. Repair as needed as per schedule for Lath and Plaster.

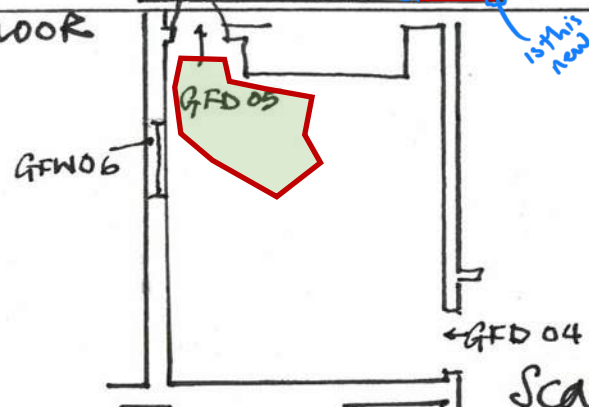
### FLOOR

Floor Plan - Existing: Timber floorboard, with large section of damage.

Proposed carry out repairs to the floor, using reclaimed boards to match existing.

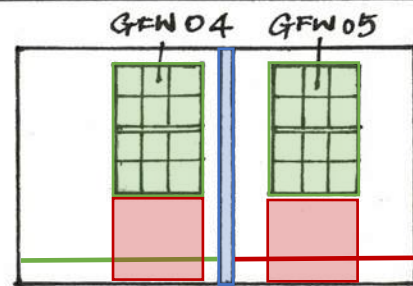
WEST

West elevation- Existing: Modern replacement sashes in lower section of both windows. Original case/frames and panelling. Shutters remain. Skirtings remain in RHS only

Proposed: Carry out repairs to both windows, and remove modern replica sashes. New lower sashes to match the originals. Reinstate skirting board to room GF07

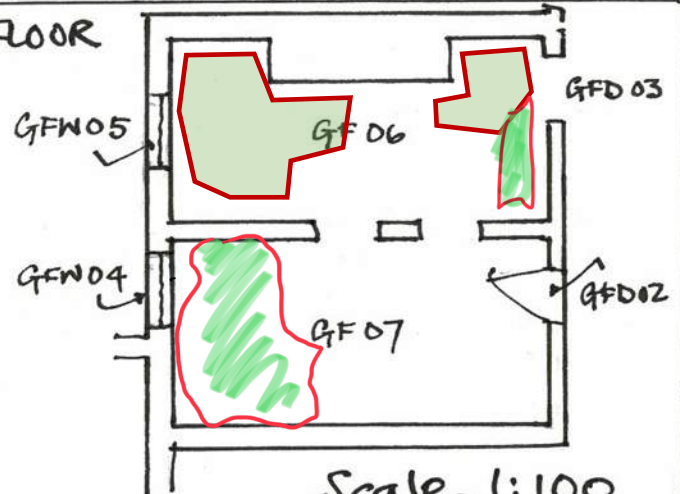
FLOOR

Floor Plan - Existing: Floor has been damaged due to investigations. Hearth remains.

Proposed carry out repairs to the floor, using reclaimed boards to match existing.

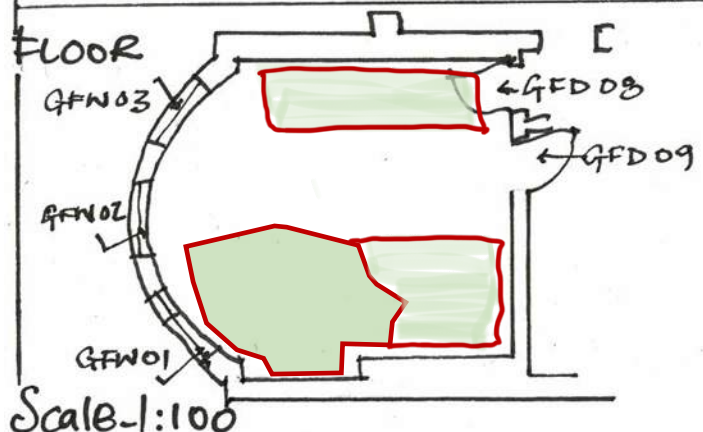
### FLOOR

Floor Plan - Existing: Wooden floorboards, damage to the East and West of room.

Proposed: reinstate missing / damaged timber floor with reclaimed boards to match the originals.

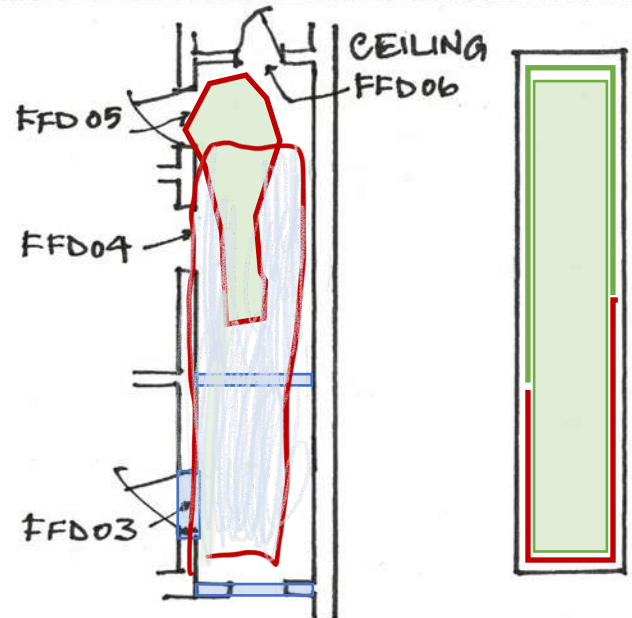
FLOOR

Floor Plan - Existing: Timber floorboard, with large section of damage and missing – tongue and groove.

Proposed: Replace missing boards after installation of fire protection/noise attenuation measures. Ensure skirtings are safeguarded.

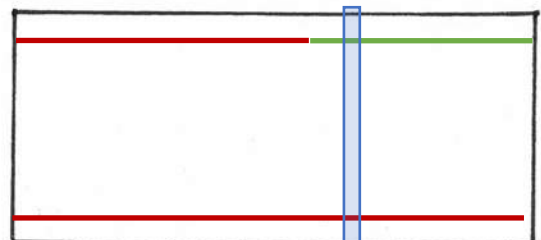
EAST

East elevation- Existing: Plaster – moisture damaged. Early 9" Torus skirting. Remnants of early coving

Proposed Repair and replace coving and skirting where damaged, like for like.
