# Fraser House Outline Structural Engineering Proposals

Ref: LM21346-DYSE-XX-ZZ-RP-S-0002

Rev: P02

Date: 13/12/2022

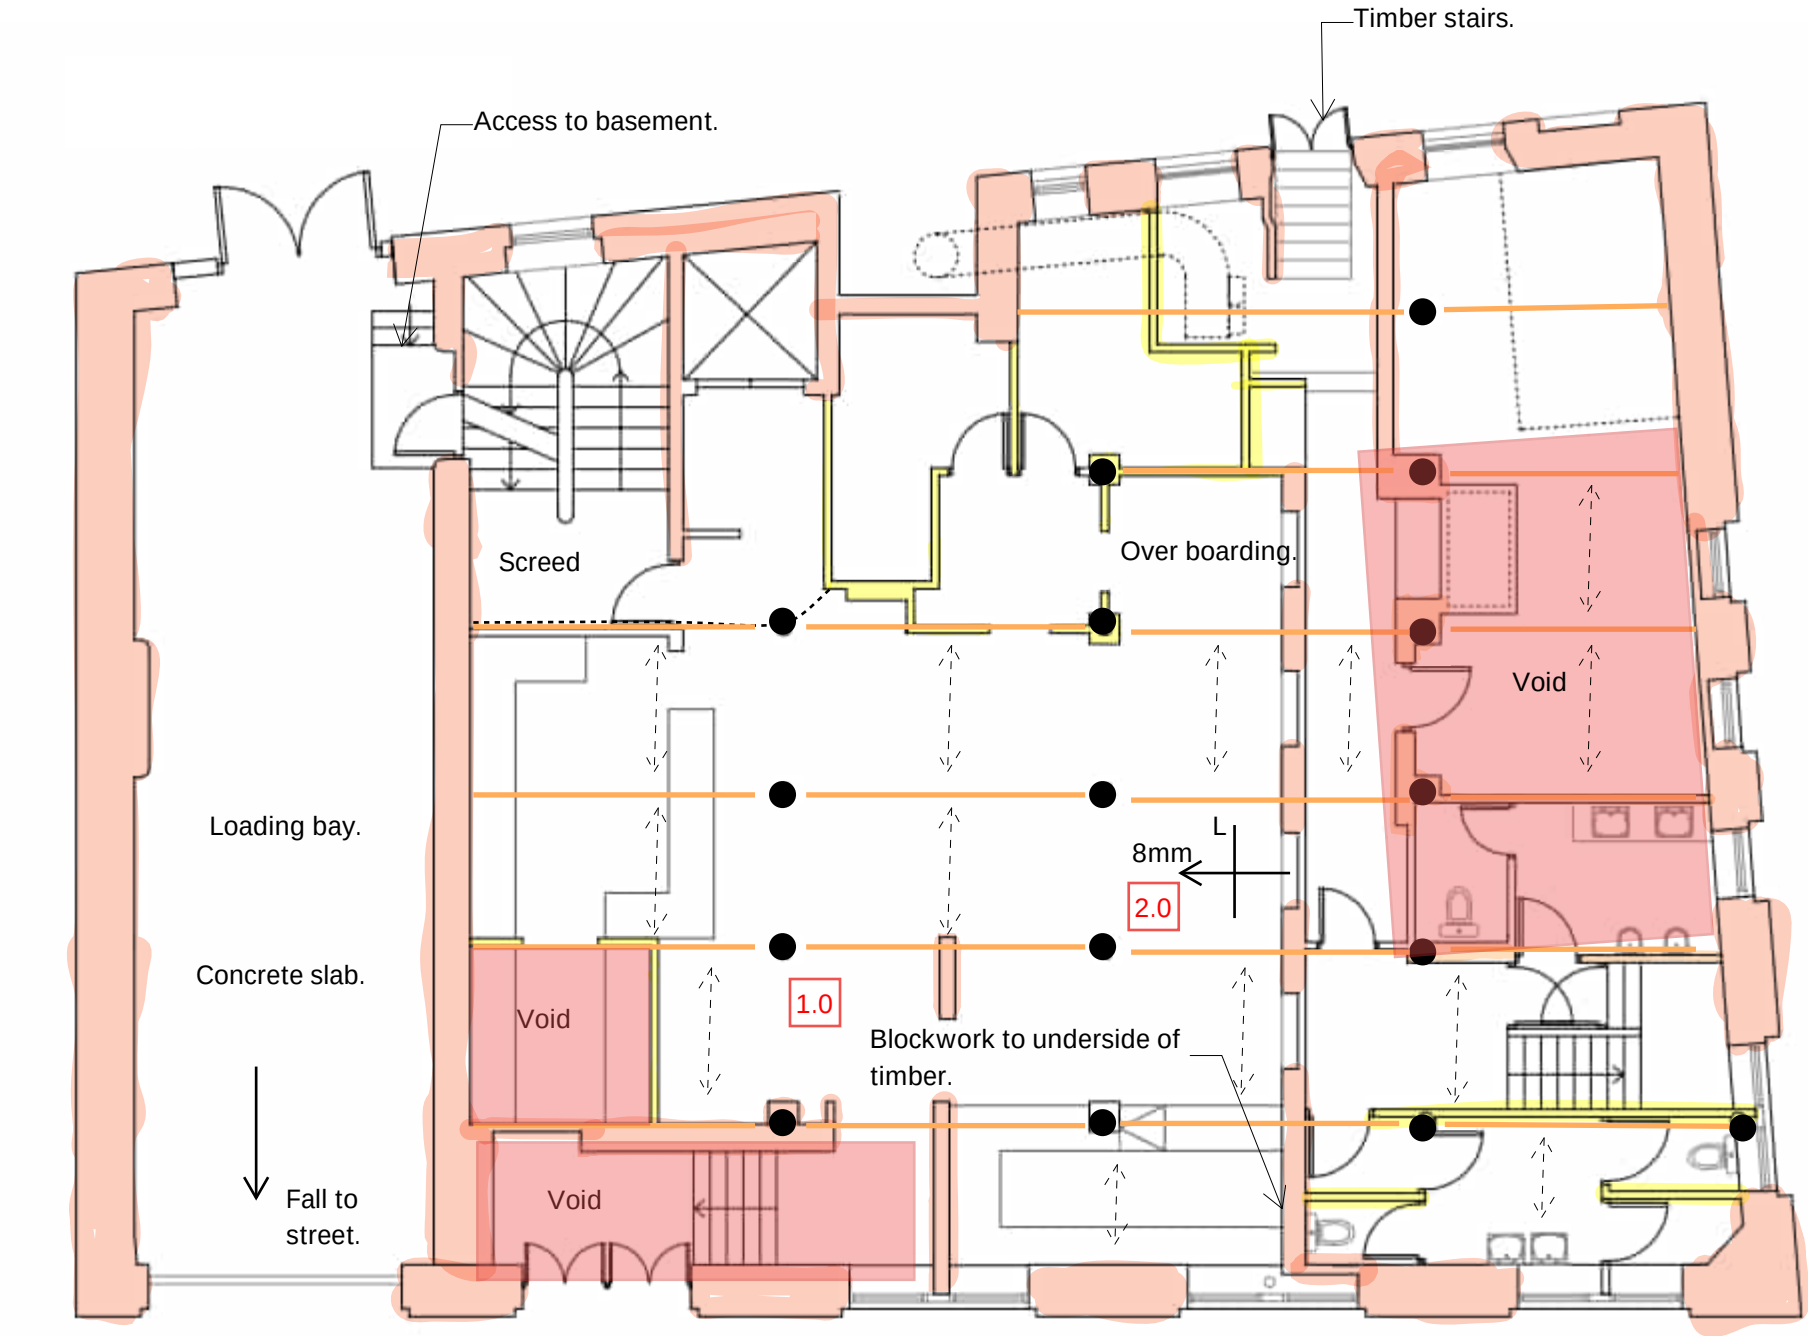
Existing Lower Ground Floor Layout Indicating Ground Floor Structure Over

- Defects Reference
- 1.0 - Debris pile preventing access.
  - 2.0 - Fall to existing floor (mm)

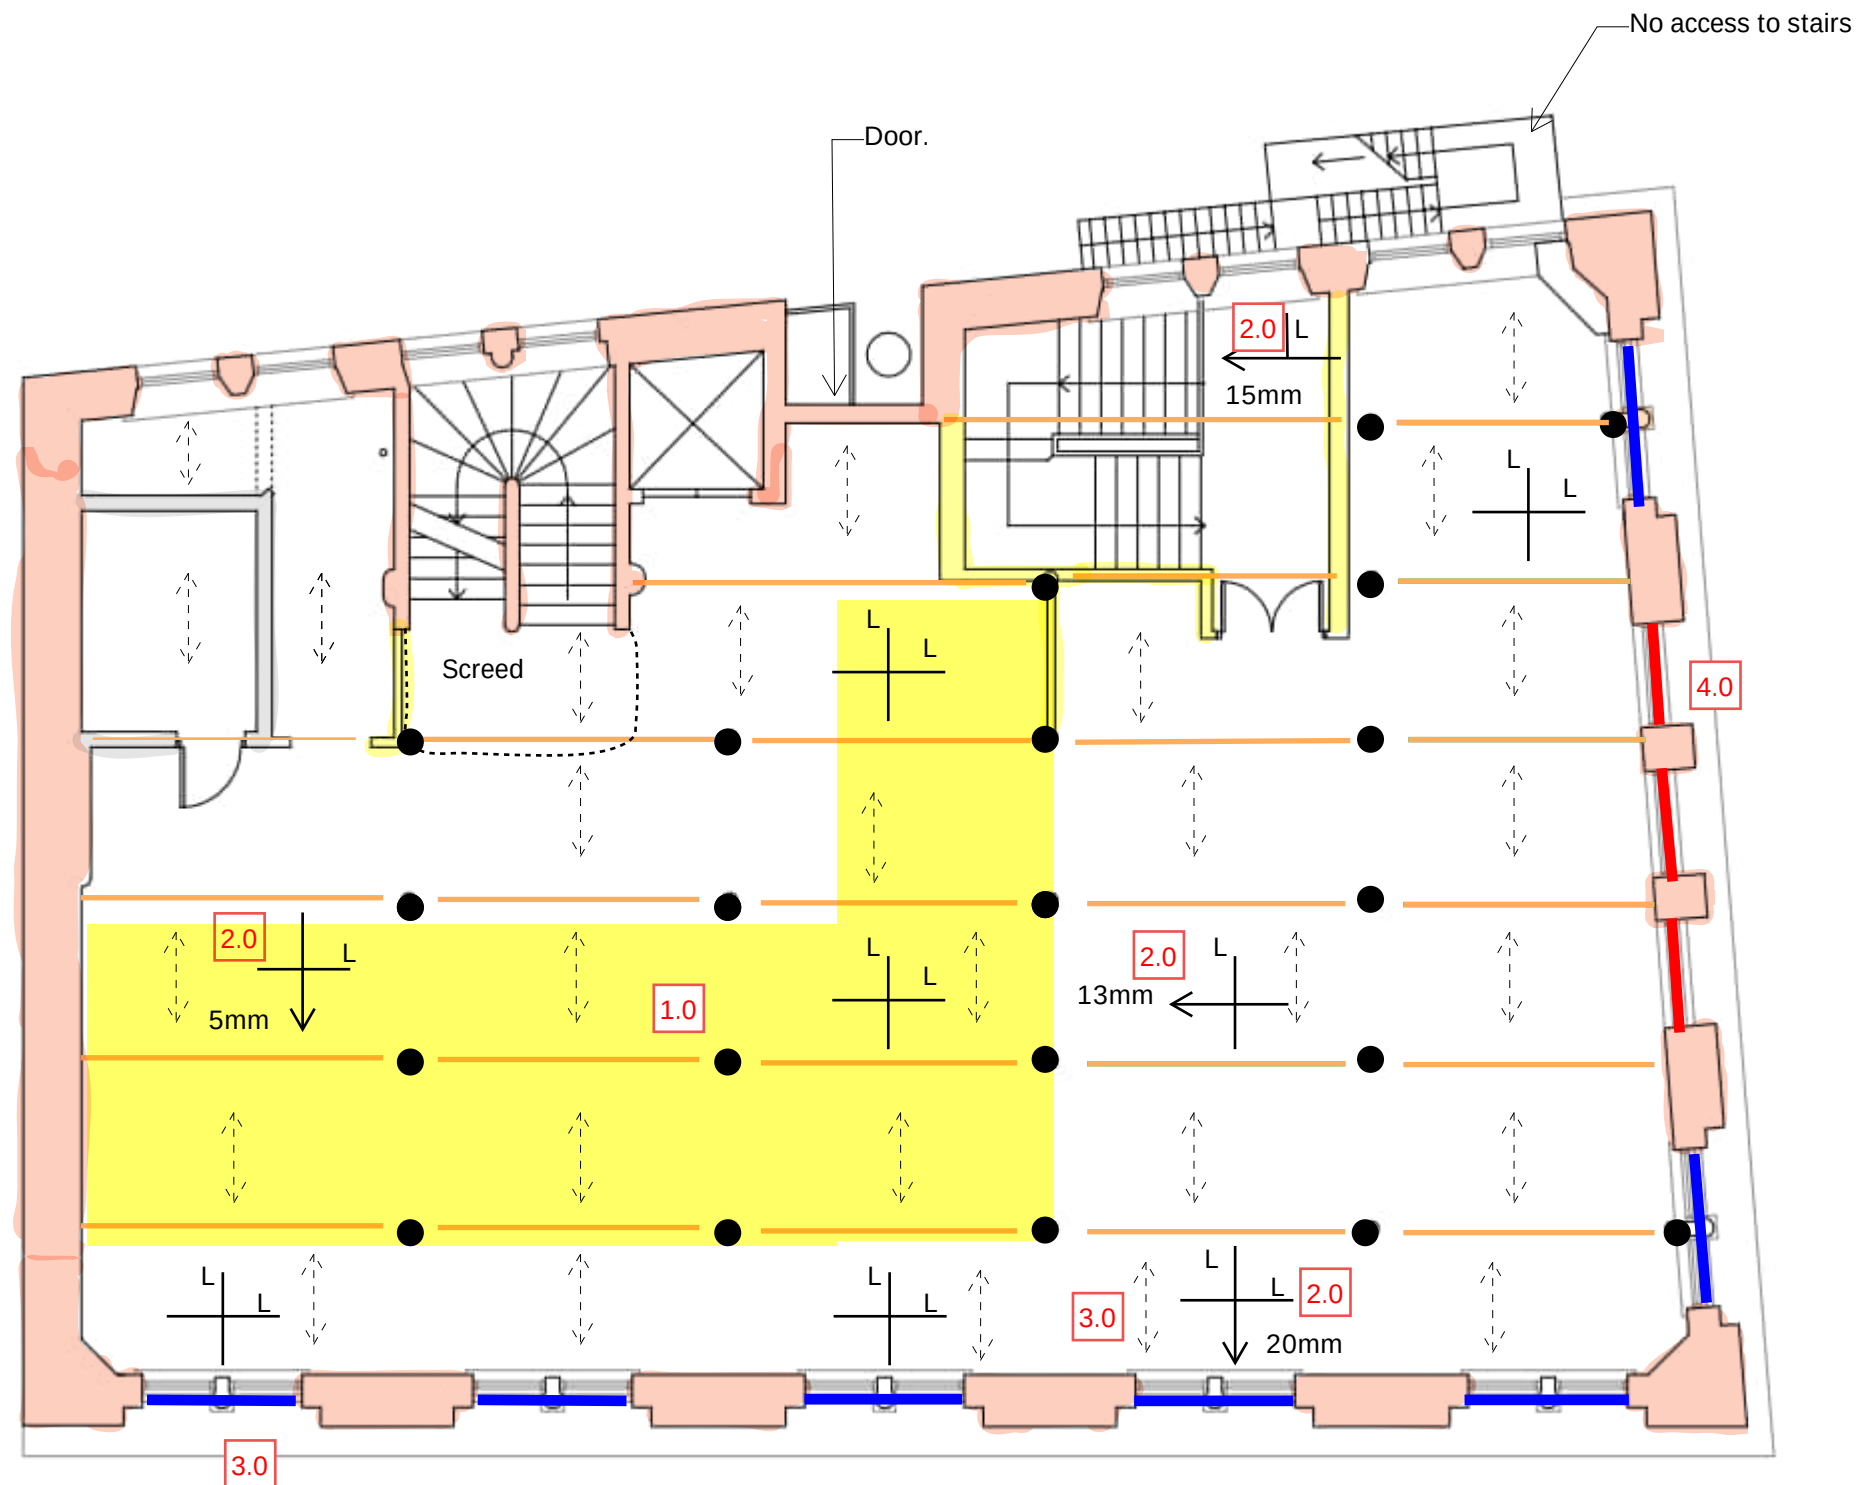
- 1.0 - Undulation to flooring (yellow hatch).
- 2.0 - Fall to existing floor (mm)
- 3.0 - New timber lintel.
- 4.0 - Steel lintel, fair condition.

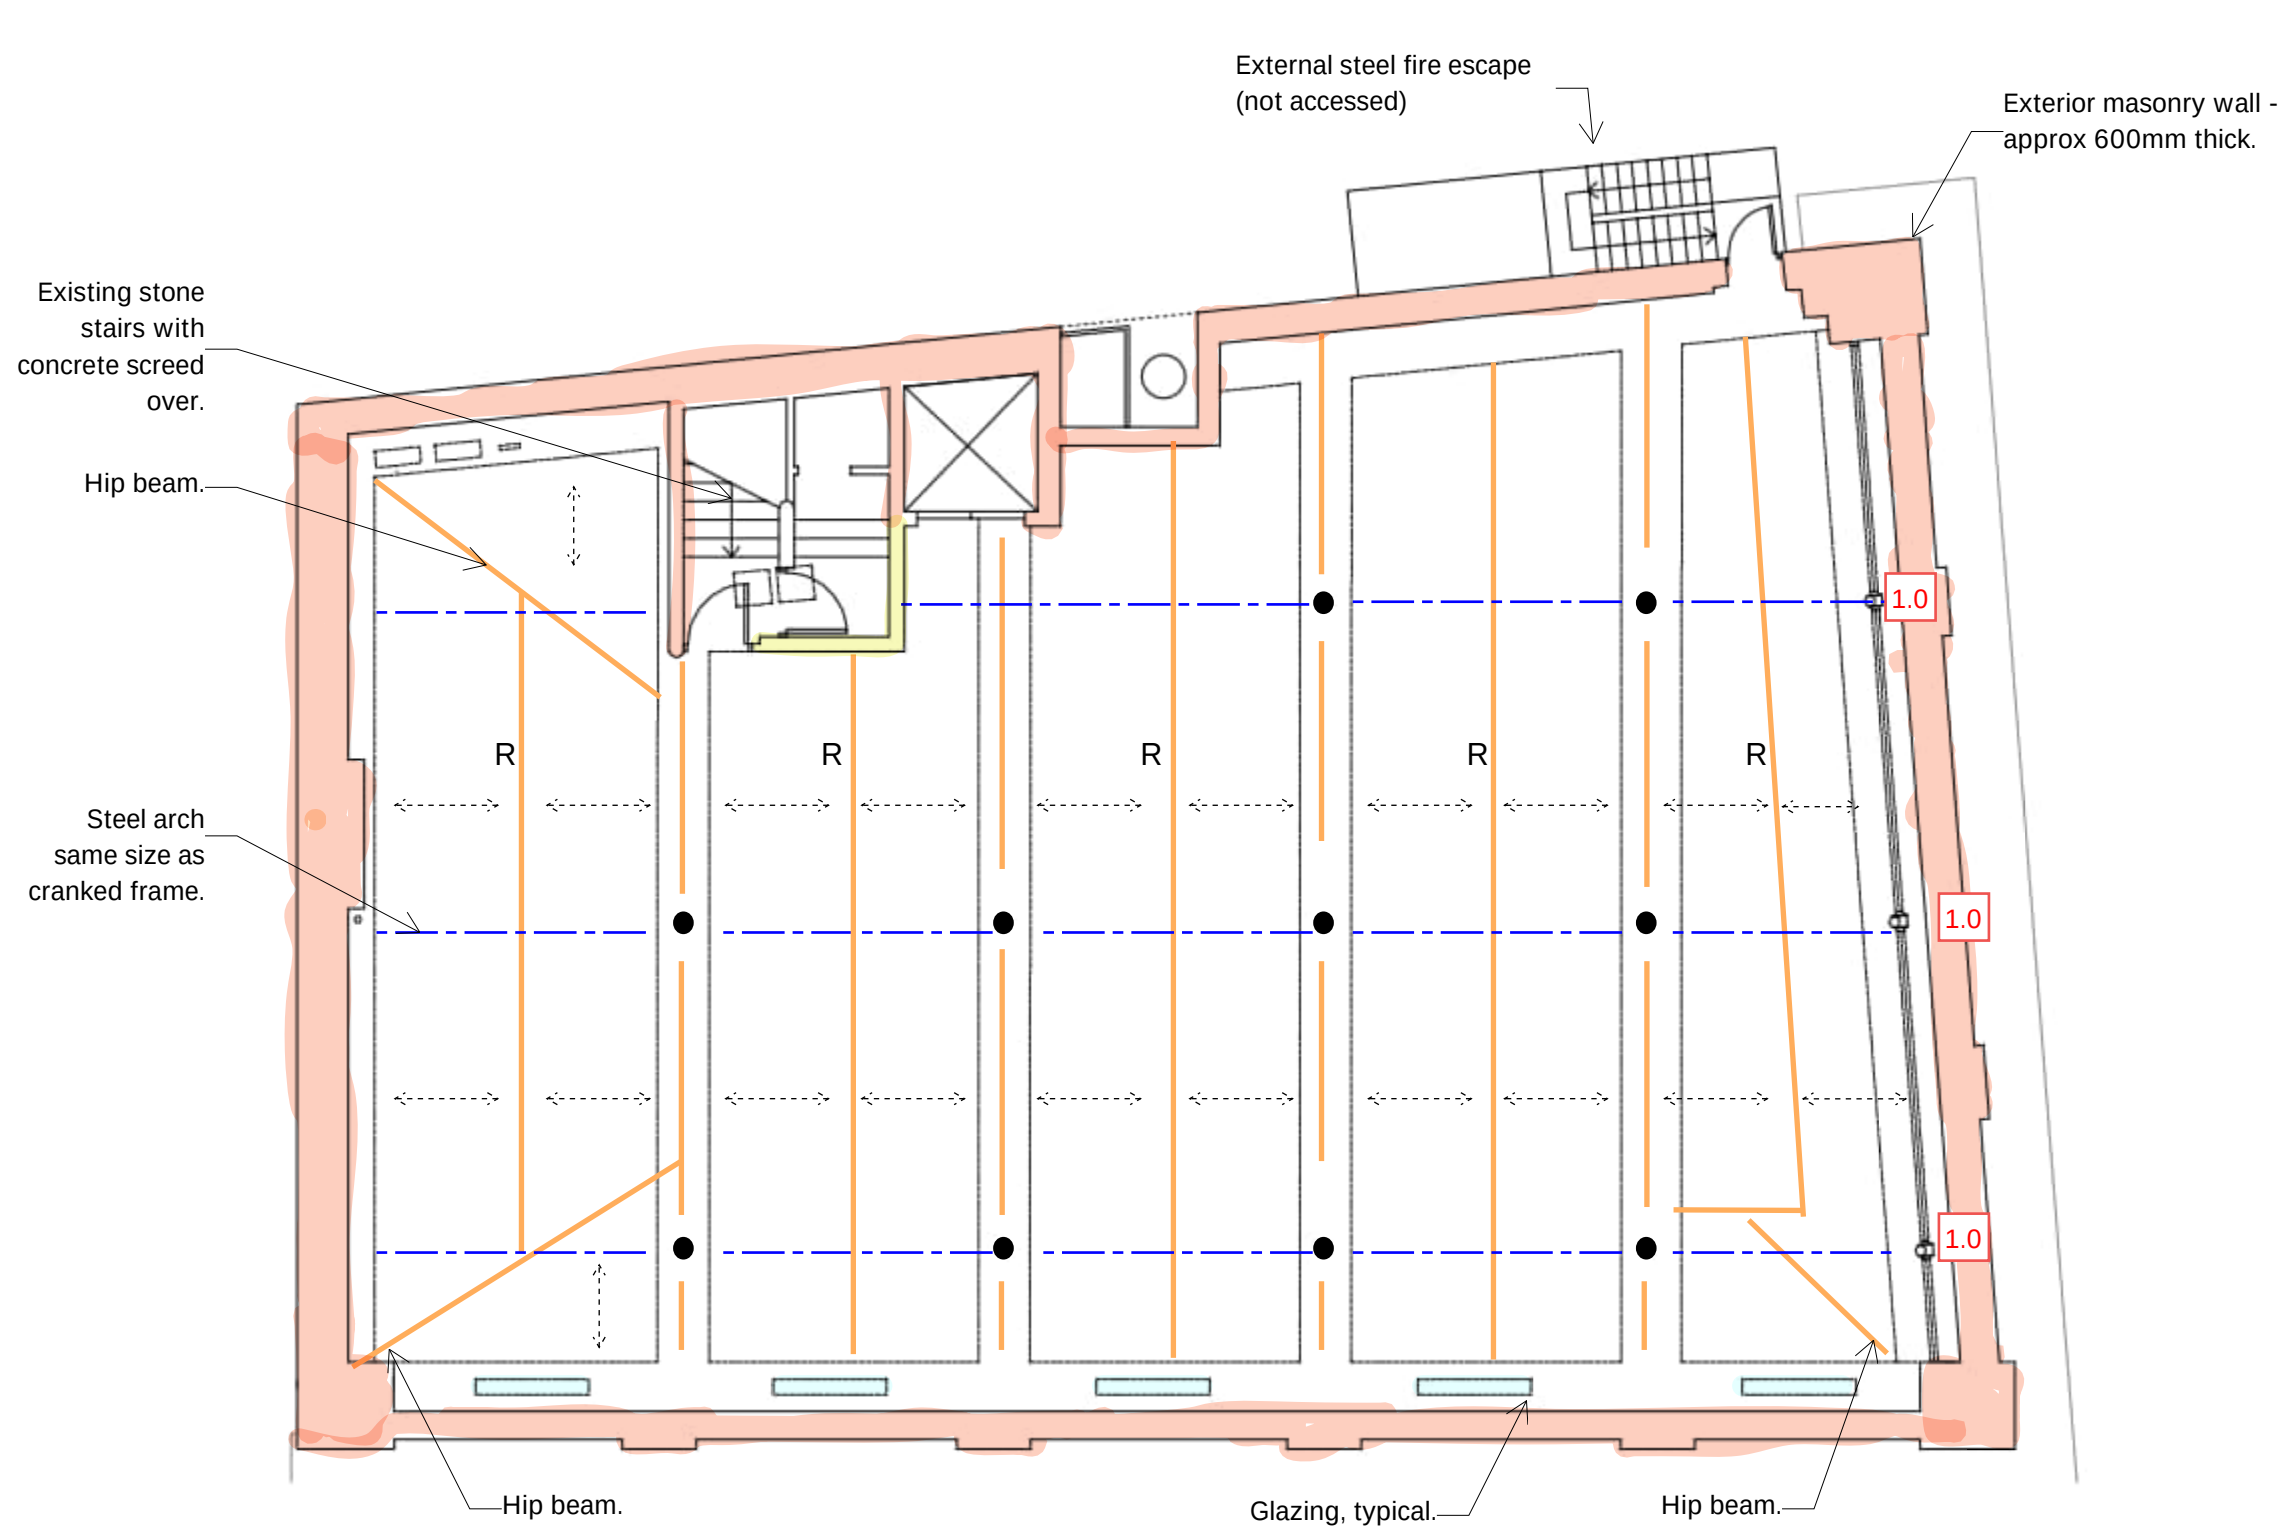
1.0 Cranked frame with minor rusting at bearing end with contact to masonry wall.

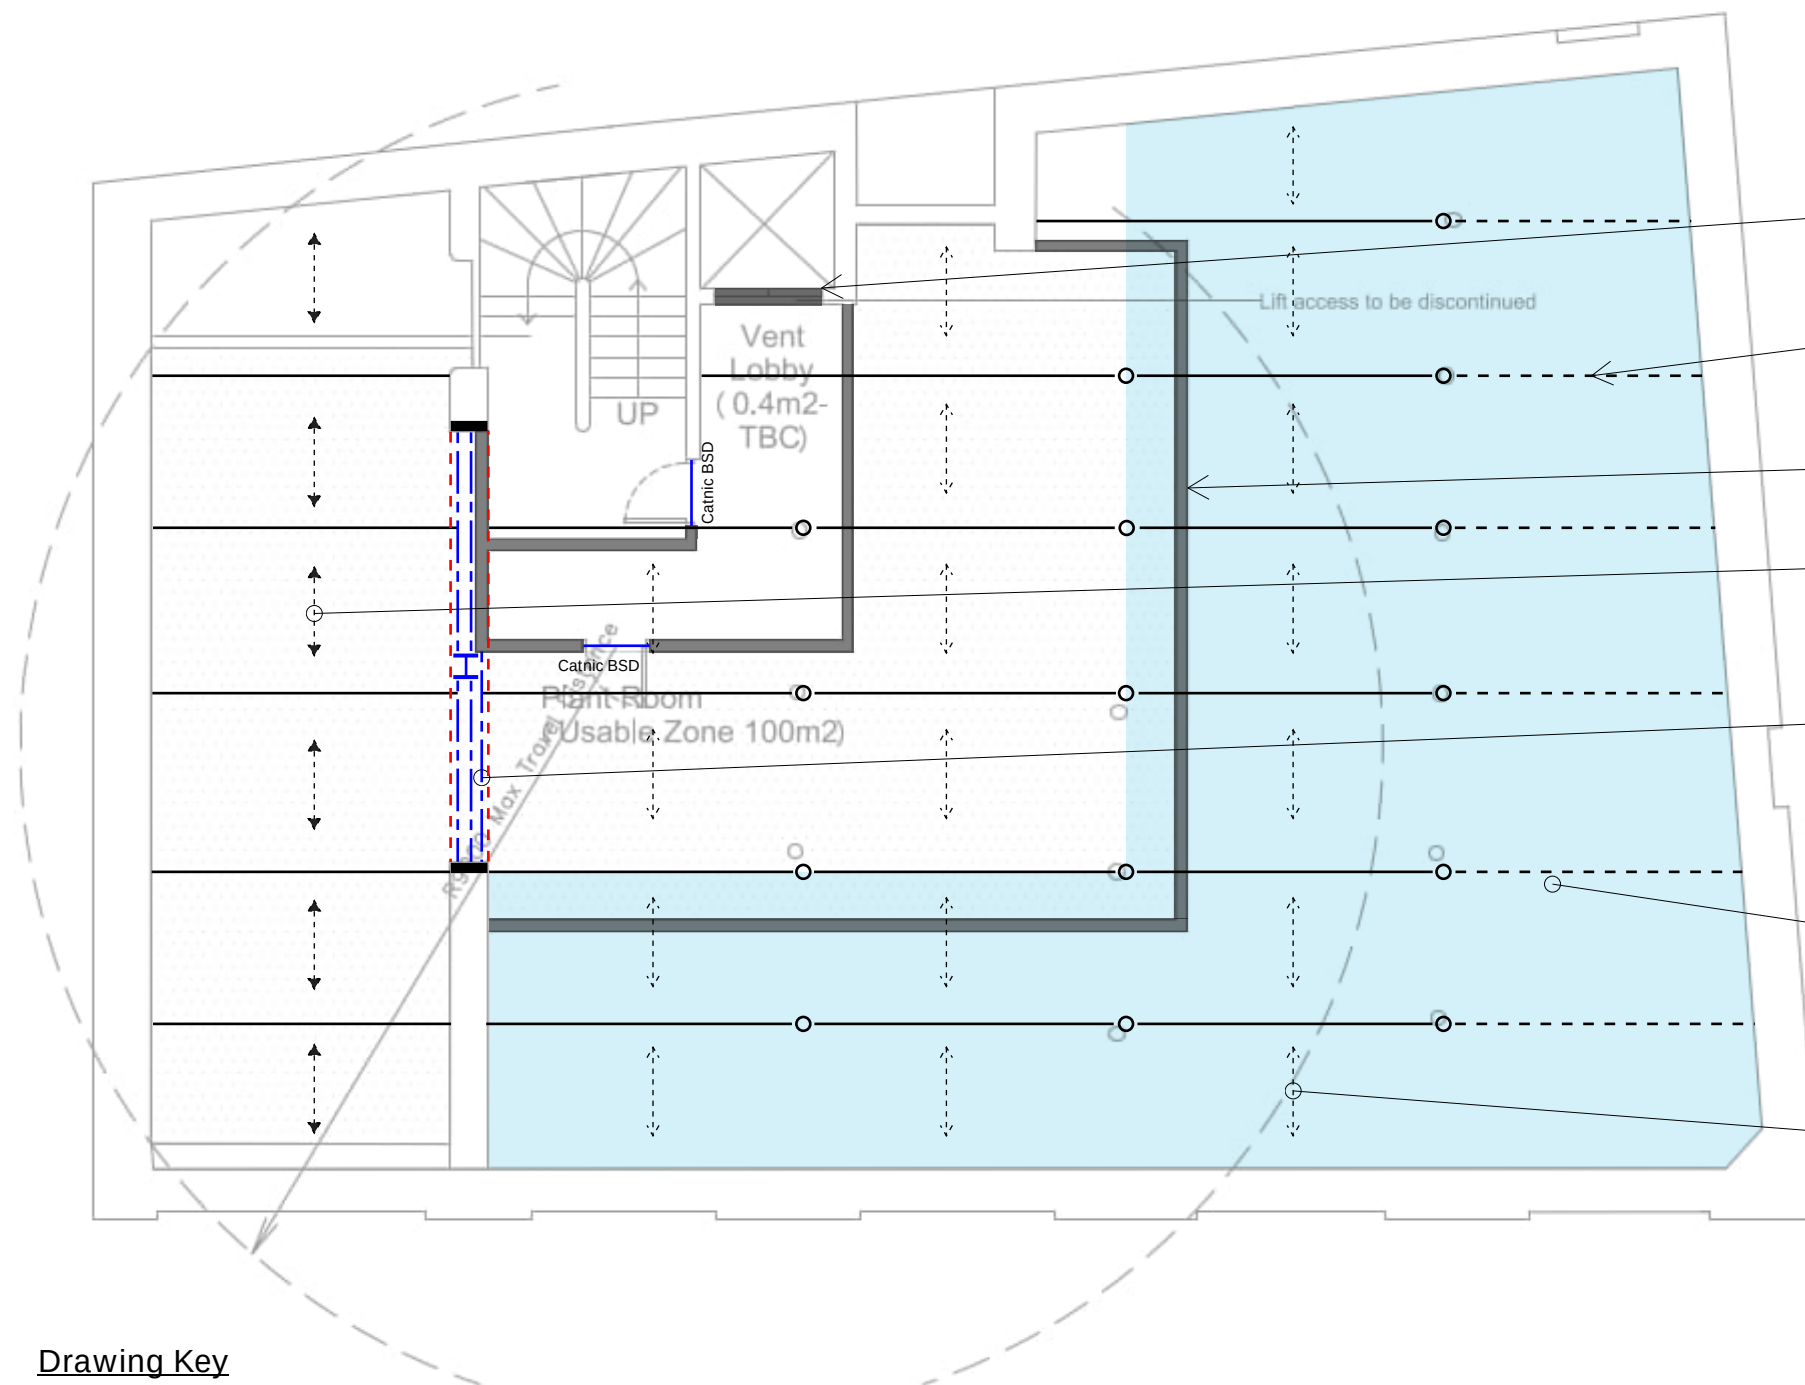
Assumed location of the existing structure. To be confirmed once access is available.

New blockwork infill to existing lift shaft opening. New infill to be fully toothed and bonded into the original masonry.

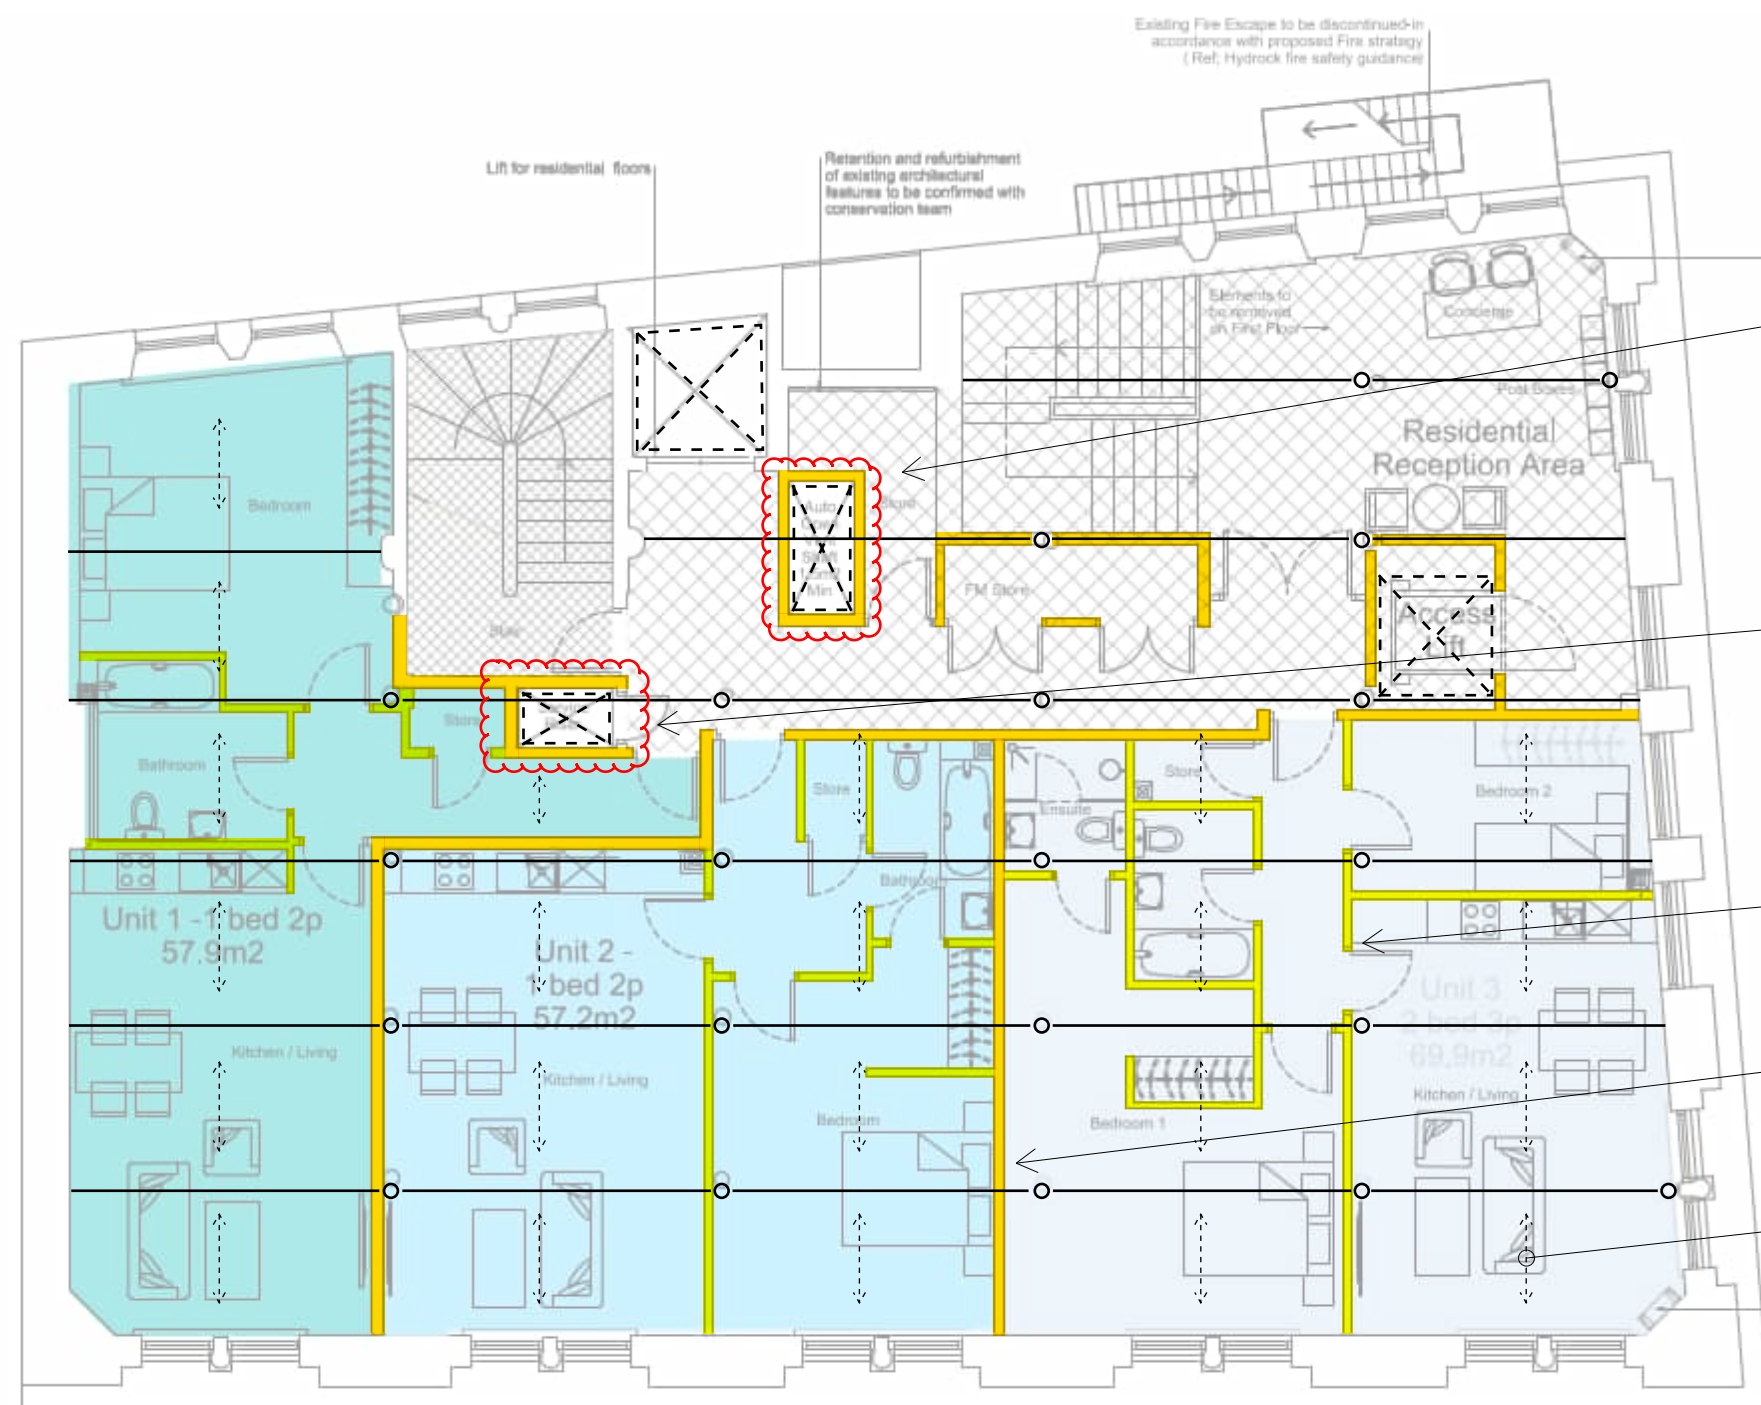
Location of smoke vent cuts through existing primary timber floor beam. Can smoke vent be moved to avoid additional significant structural framing to trim out void for smoke vent. Architects to confirm acceptance.

Location of service riser cuts through existing primary timber floor beam. Can beam continue to pass through service riser to avoid additional significant structural framing to trim out void for smoke vent. Architects & M&E consultants to confirm acceptance.

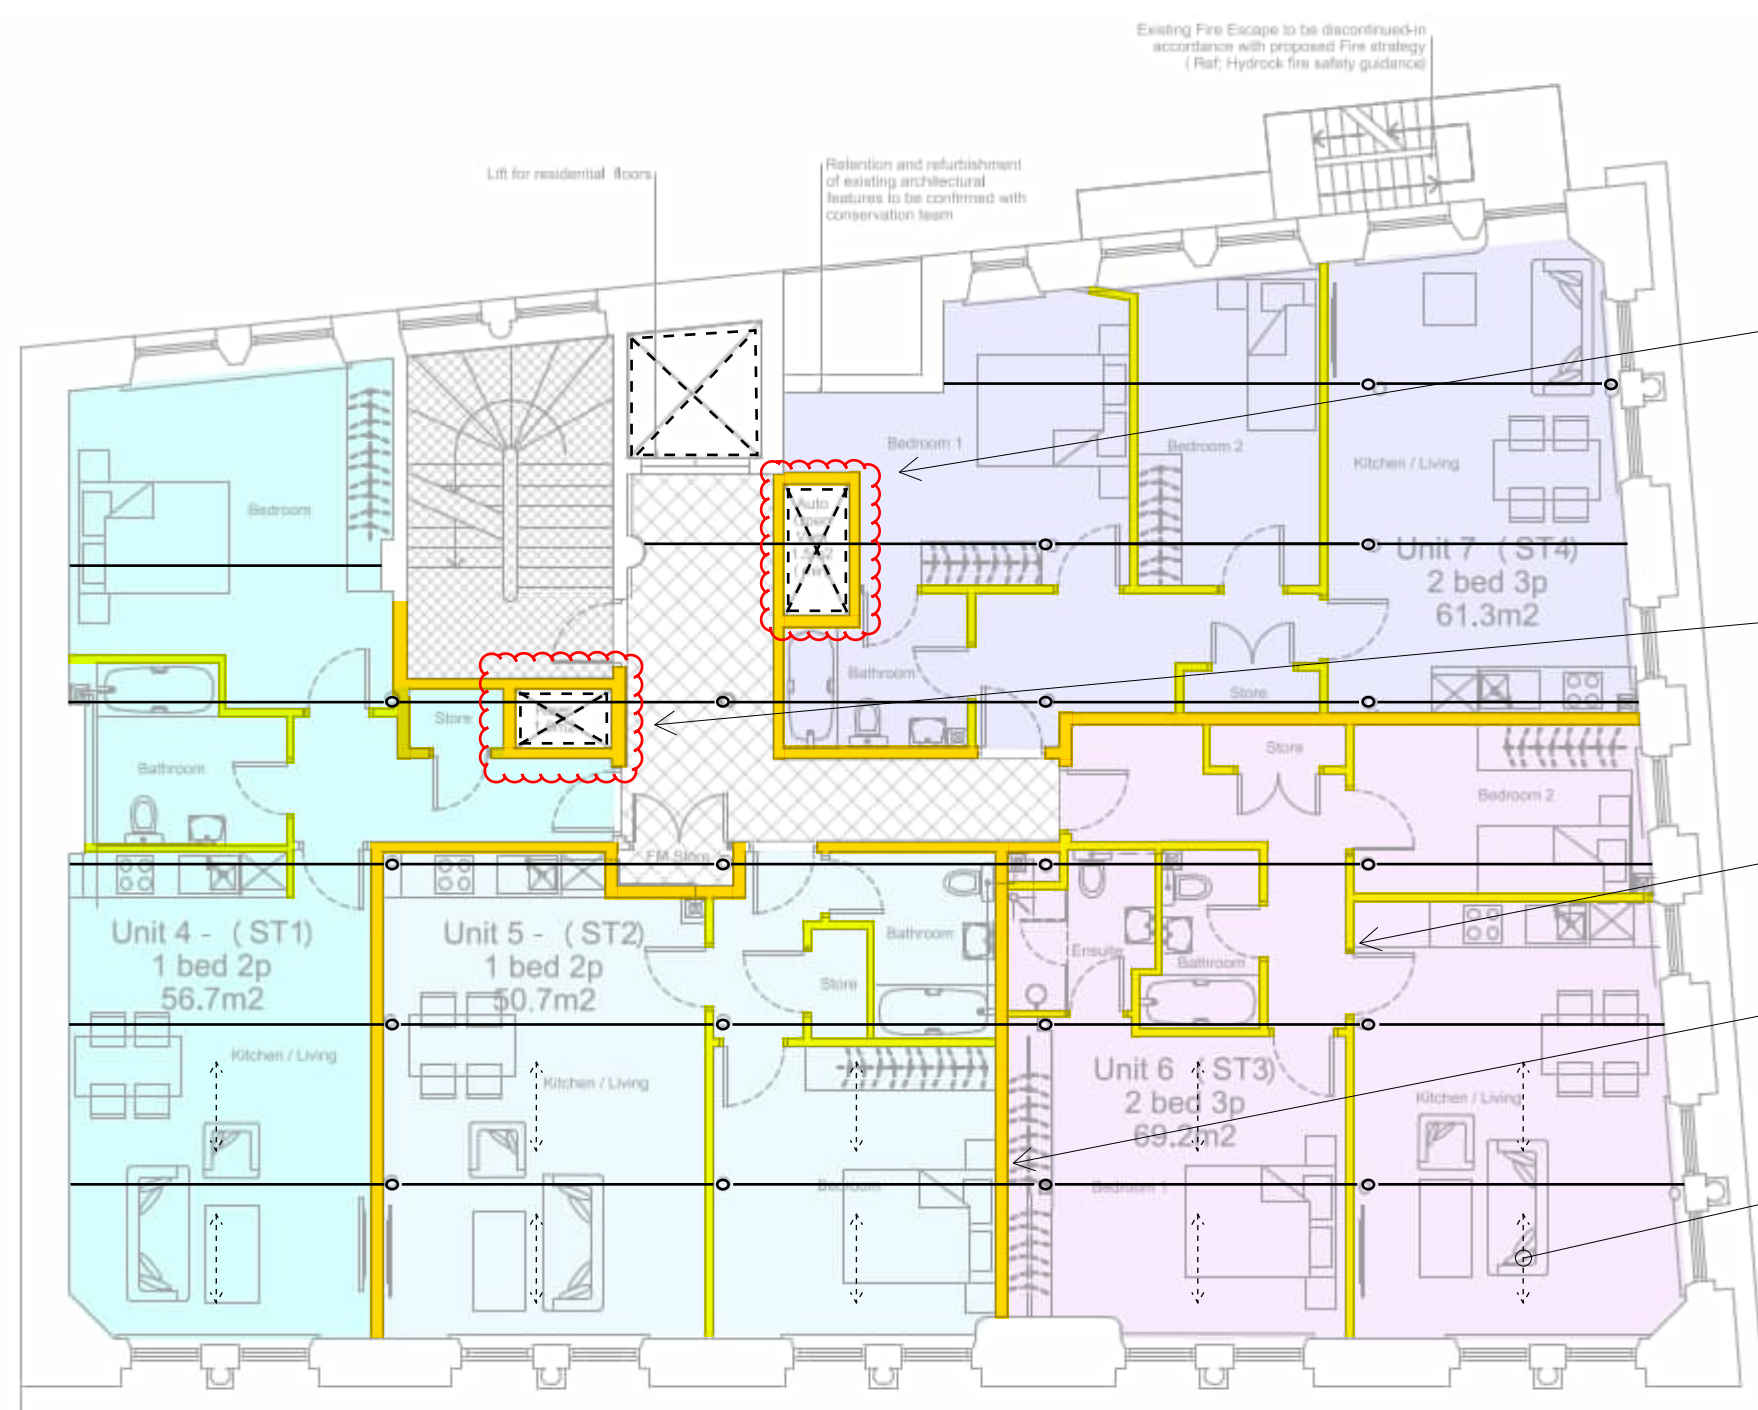
Location of smoke vent cuts through existing primary timber floor beam. Can smoke vent be moved to avoid additional significant structural framing to trim out void for smoke vent. Architects to confirm acceptance.

Location of service riser cuts through existing primary timber floor beam. Can beam continue to pass through service riser to avoid additional significant structural framing to trim out void for smoke vent. Architects & M&E consultants to confirm acceptance.

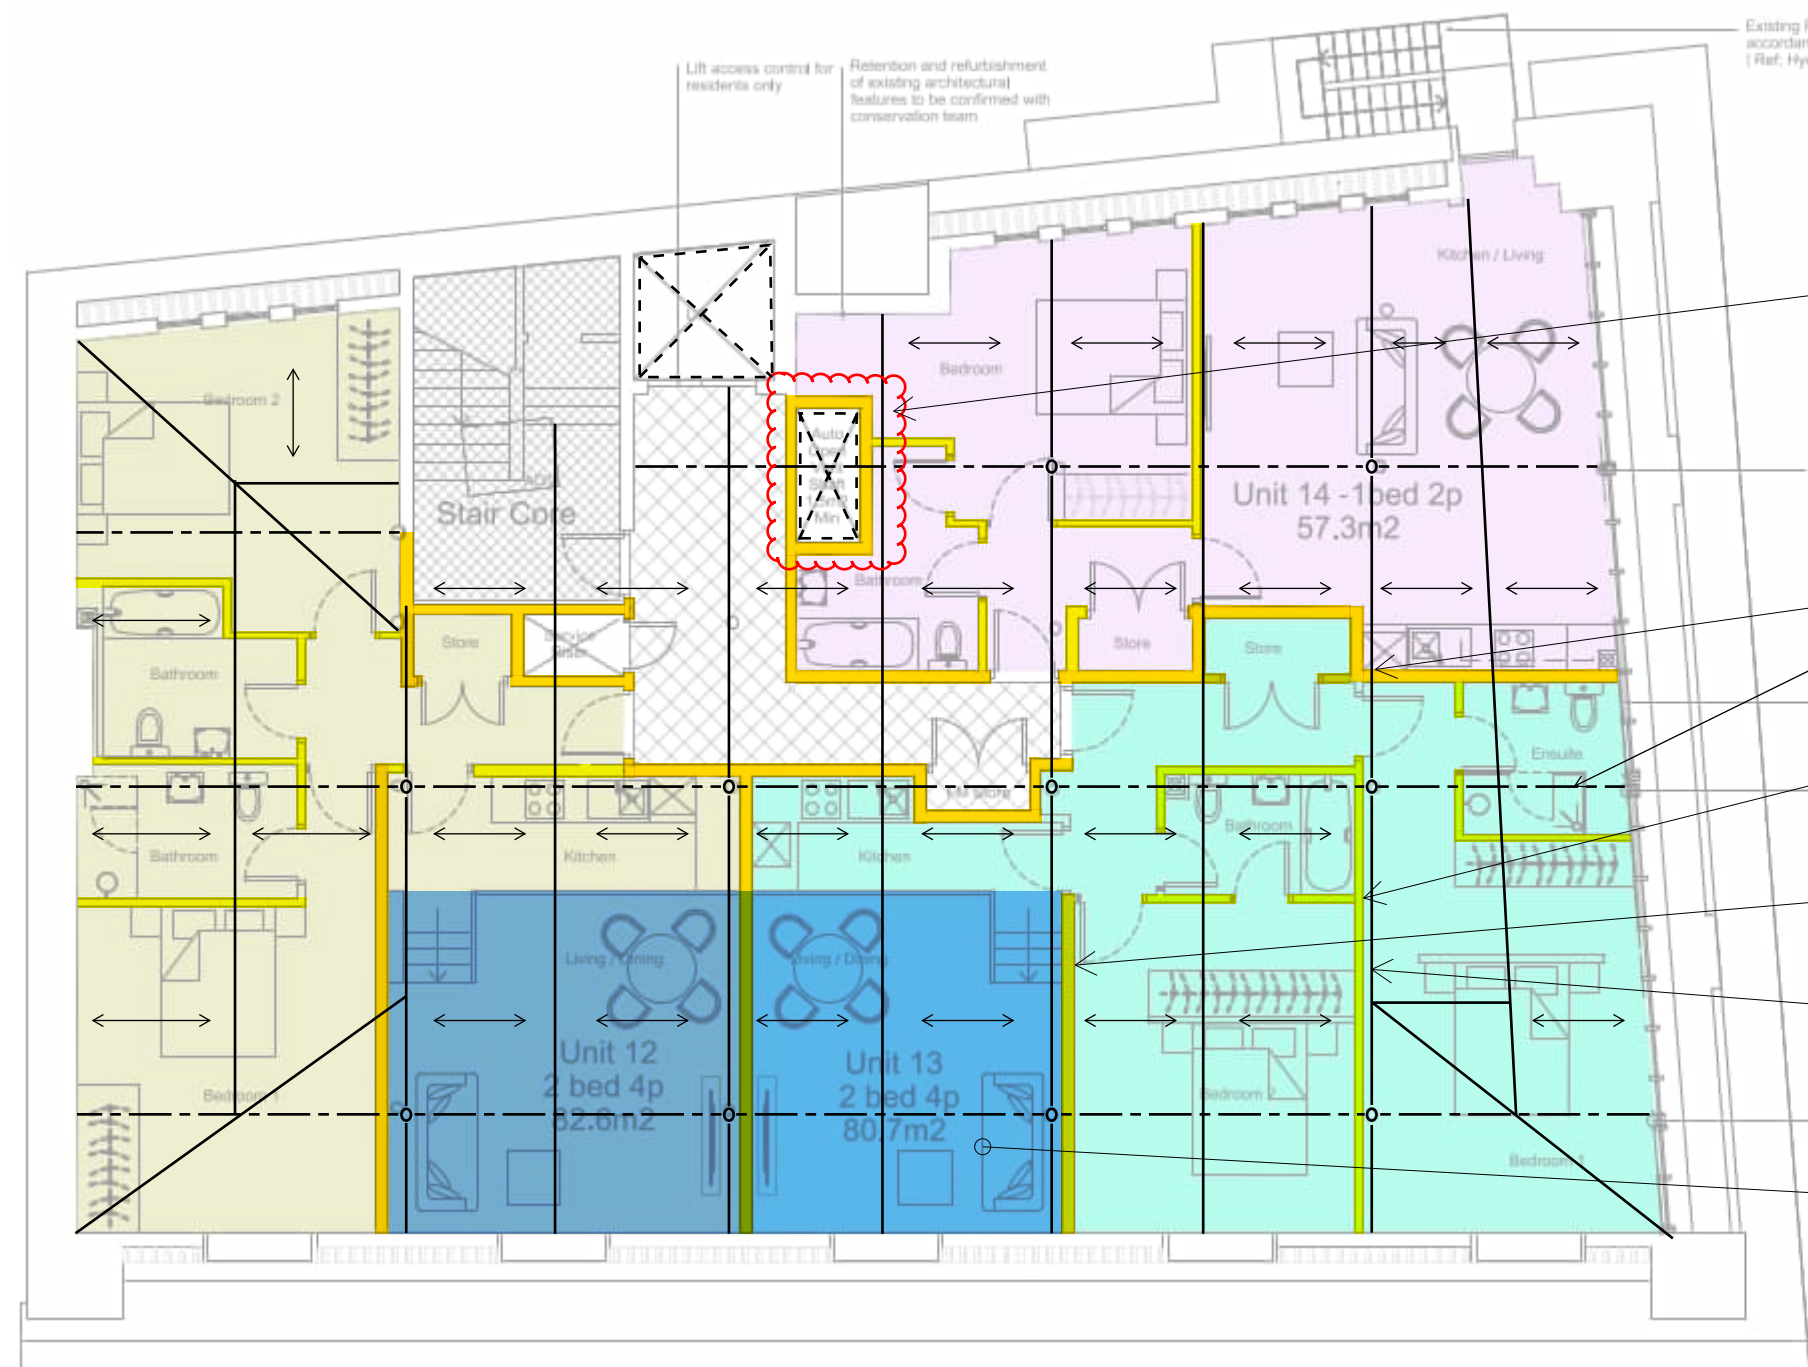
Location of smoke vent cuts through existing roof purlin. Can smoke vent be moved to avoid additional significant structural framing to trim out void for smoke vent. Vent within roof to be trimmed out with new structural timber. Architects to confirm acceptance.

Existing timber ridge beams and supporting steel frames to be retained as part of the proposed refurbishment works.
