## CCTV SURVEY INSPECTION REPORT

| <b>Client:</b> | Kellen Homes Limited |
| <b>Location:</b> | Bennett St, Manchester |

**Project Name:** KELLEN\_HOMES\_BENNETT\_STREET\_MANCHESTER\_14\_07\_2022  
**Project Date:** 14/07/2022  
**Inspection Standard:** MSCC5 Sewers & Drainage GB (SRM5 Scoring)

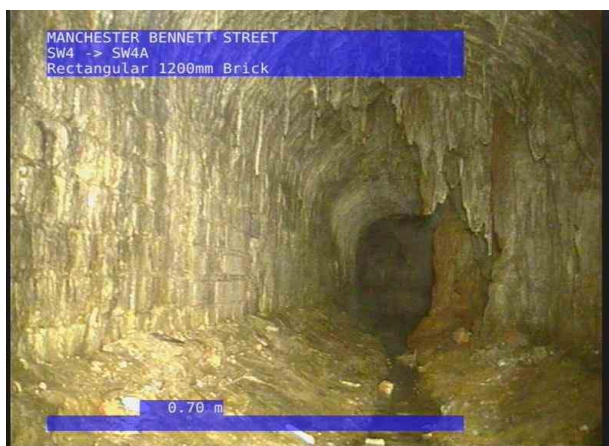
SW4X\_0699012d-c2af-438c-9a92-8f499360e6f1\_20220714\_1  
00105\_086.jpg, 00:00:05, 0.00 m  
Water level, 5% of the vertical dimension

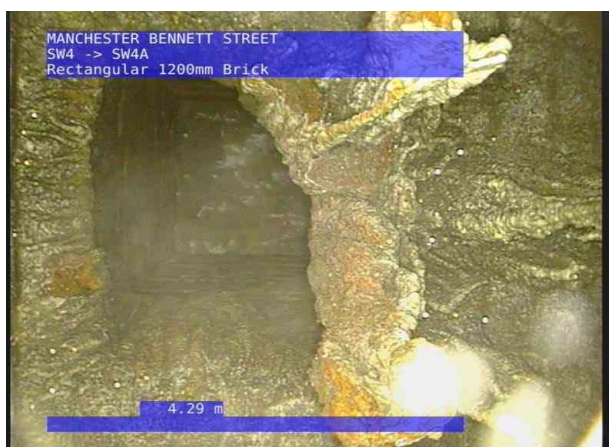
SW4X\_f82995f1-0c30-4031-b276-b723afe879cc\_20220714\_1  
00152\_117.jpg, 00:00:44, 4.29 m  
Finish node, manhole, reference: SW4A

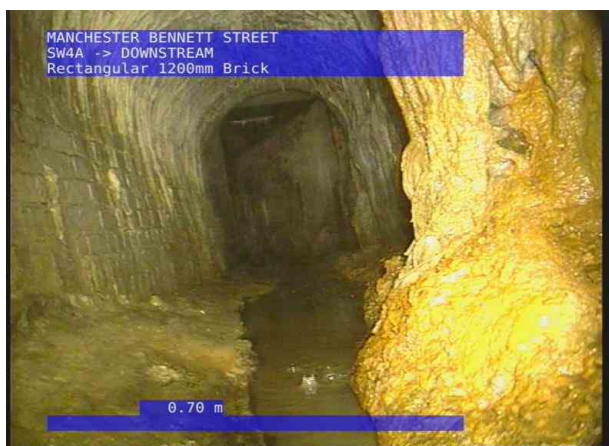
SW4AX\_d7a7f437-fa09-4c72-9474-685f673f149a\_20220714\_100311\_226.jpg, 00:00:14, 0.00 m  
Water level, 5% of the vertical dimension

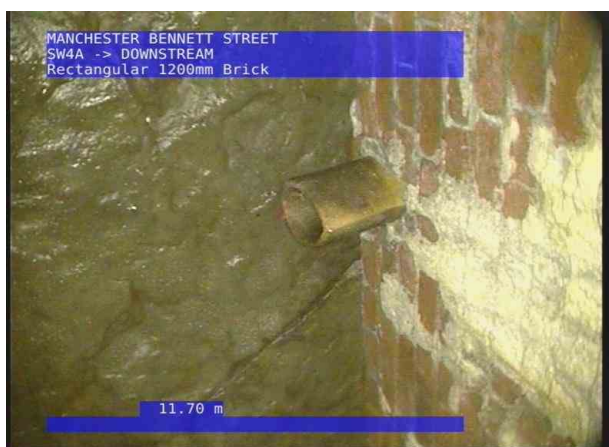
| Scale: 1:279 | Position [m] | Code | Observation | MPEG | Photo | Grade |
|---|---|---|---|---|---|---|
| | 11.69 | CXI | Connection defective, connecting pipe is intruding at 1 o'clock, 150mm dia, intrusion: 5% | 00:02:15 | SW4AX_5<br>ae7b2b5-6<br>6d7-4b22- | 3 |

SW4AX\_5ae7b2b5-66d7-4b22-b059-5b9f368d99a0\_20220714\_100536\_352.jpg, 00:02:15, 11.69 m  
Connection defective, connecting pipe is intruding at 1 o'clock, 150mm dia, intrusion: 5%

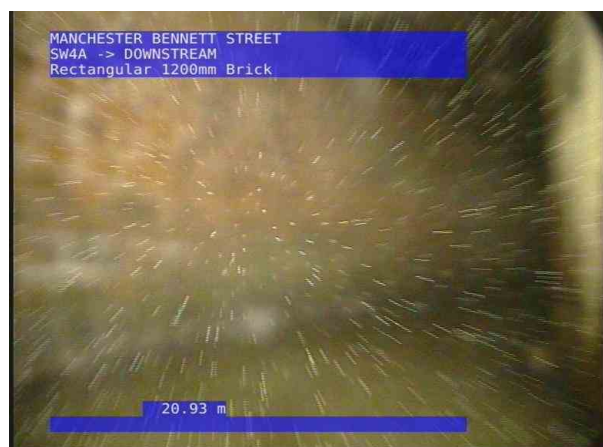
SW4AX\_c84c1016-437e-471c-9877-f595c03dc179\_20220714\_100647\_964.jpg, 00:03:21, 20.93 m  
Line deviates right

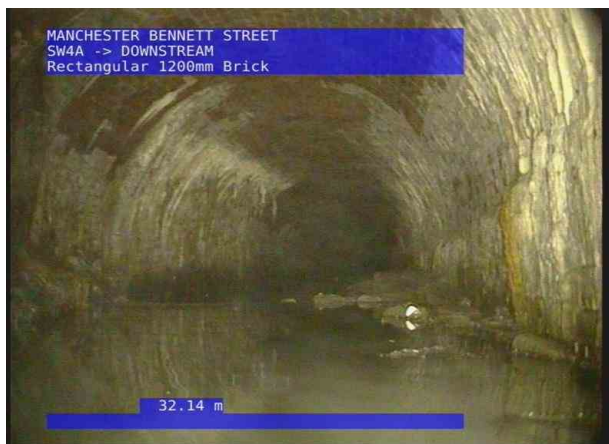
SW4AX\_13e2b733-7b1f-4afc-997a-a5fdcf8bd8a1\_20220714\_100929\_571.jpg, 00:05:47, 32.14 m  
General remark, JOINTS UP WITH THE D/S FROM MH SW1

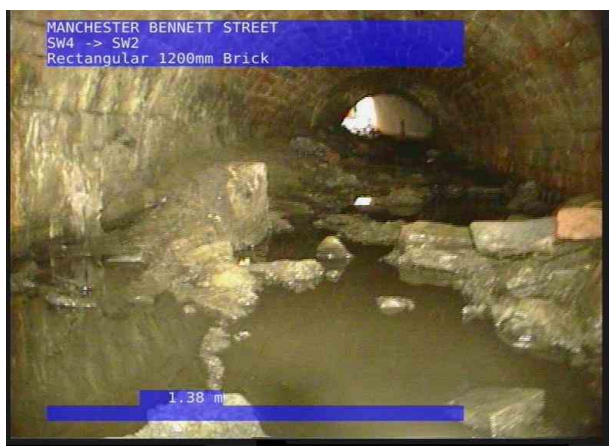
| Scale: 1:752 | Position [m] | Code | Observation | MPEG | Photo | Grade |
|---|---|---|---|---|---|---|
| | 0.89 | DES | Settled deposits, fine, 10% cross-sectional area loss | 00:00:10 | SW2X_b4<br>adb64d-9b<br>77-4045-8 | 3 |

SW2X\_b4adb64d-9b77-4045-81e2-e264cd73f99f\_20220715\_100039\_278.jpg, 00:00:10, 0.89 m  
Settled deposits, fine, 10% cross-sectional area loss

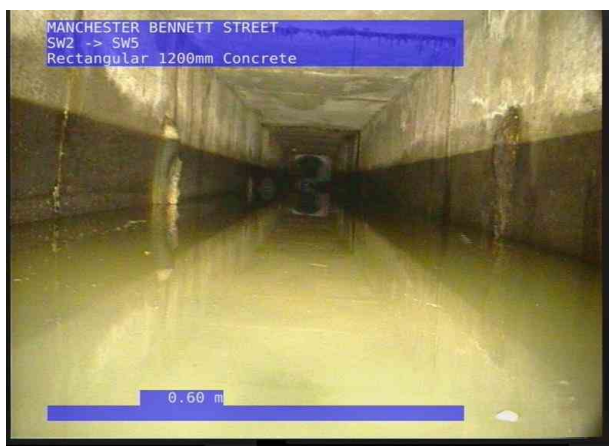
SW5X\_9b1566c9-dd26-4eca-9d5e-56e5bd2f8793\_20220715\_100950\_742.jpg, 00:00:05, 0.00 m  
Water level, 10% of the vertical dimension

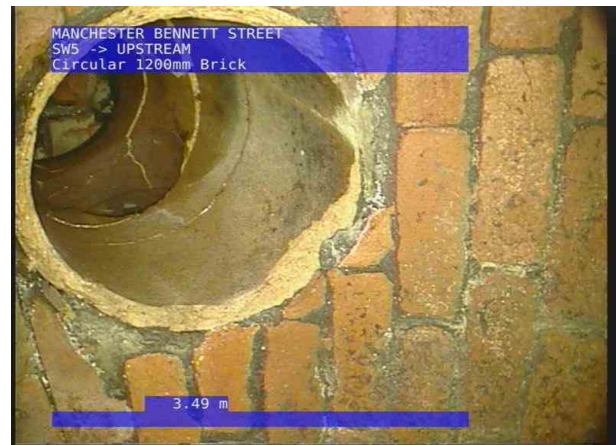
UPSTREAMX\_dcff5fe2-aeff-490b-995b-ba493665b4b6\_20220  
715\_102025\_082.jpg, 00:00:29, 3.49 m  
Connection other than junction at 10 o'clock, 150mm dia

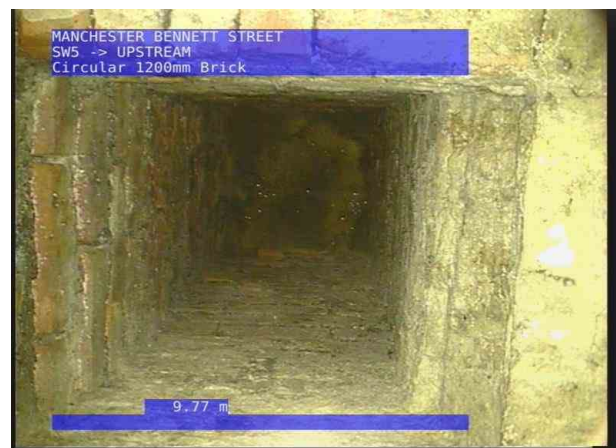
UPSTREAMX\_d1bb645d-c35e-4a0e-9bdf-6efff4b8fb1d\_20220  
715\_102205\_405.jpg, 00:01:53, 9.77 m  
General remark, UNCHARTED BURIED MH

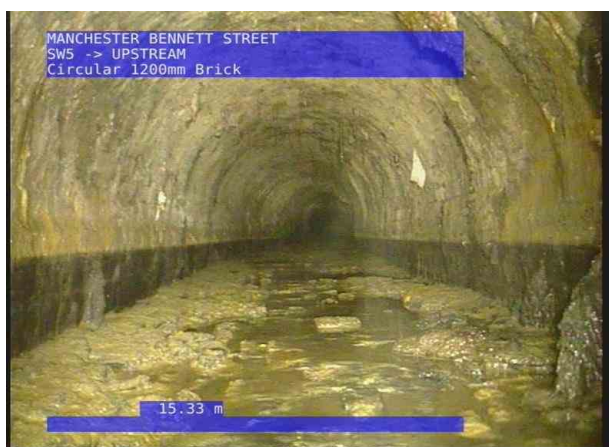
UPSTREAMX\_6f20c8d0-bca2-4553-87b5-30119180304b\_202  
20715\_102623\_179.jpg, 00:05:48, 15.33 m  
Attached deposits, encrustation from 12 o'clock to 12 o'clock,  
5% cross-sectional area loss, start

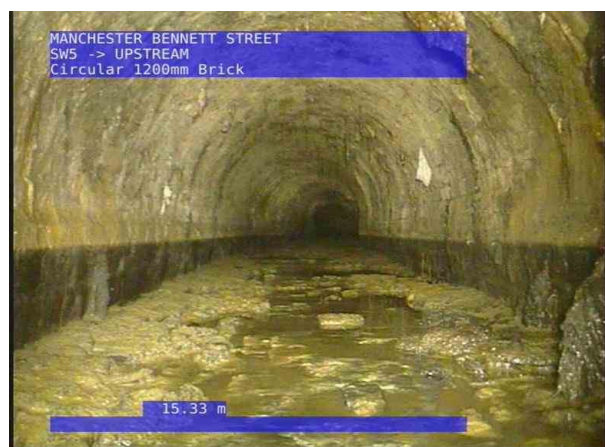
UPSTREAMX\_116c7368-fcb8-46bb-ac8c-c52e9c534ca7\_202  
20715\_102632\_146.jpg, 00:05:53, 15.33 m  
Settled deposits, fine, 10% cross-sectional area loss

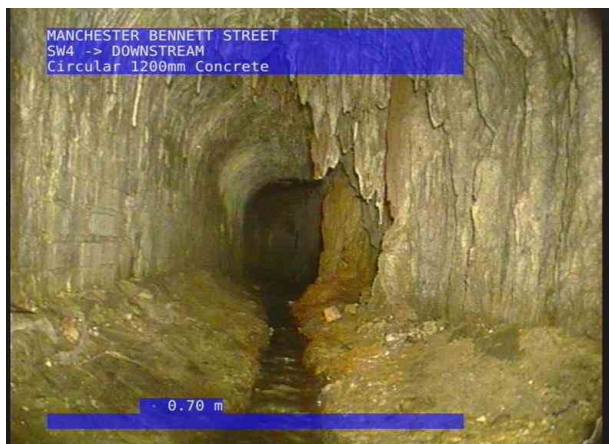
SW4X\_c77be944-c213-405d-9b54-fc652ab781be\_20220715\_105917\_832.jpg, 00:00:07, 0.70 m  
Attached deposits, encrustation from 12 o'clock to 12 o'clock, 10% cross-sectional area loss

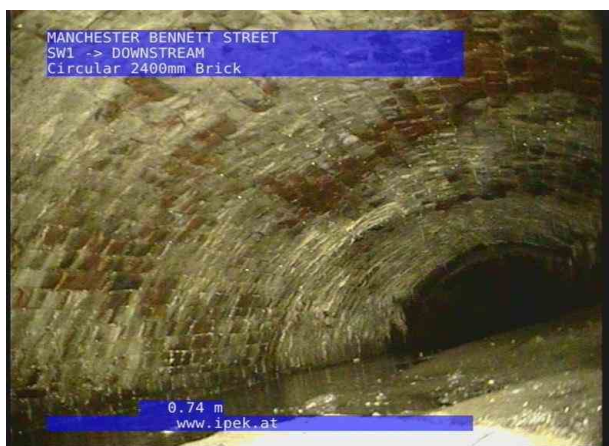
SW1X\_1ed9bc55-95c4-4458-8aa1-46cdaa95485a\_20220715\_112934\_534.jpg, 00:00:02, 0.00 m  
Water level, 20% of the vertical dimension

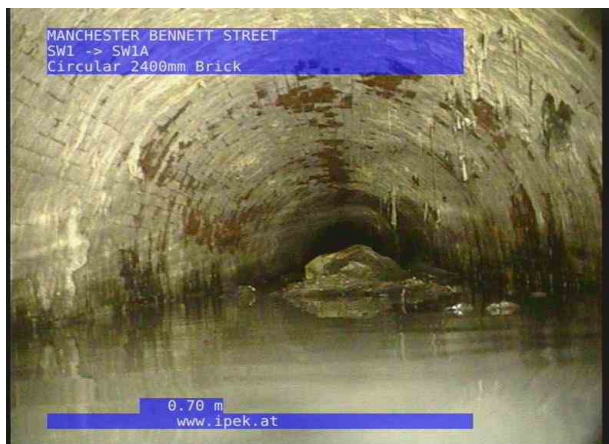
SW1AX\_155f3a27-8aa1-45a0-927f-f0e2eea2c30f\_20220715\_115227\_911.jpg, 00:00:07, 0.00 m  
Water level, 20% of the vertical dimension

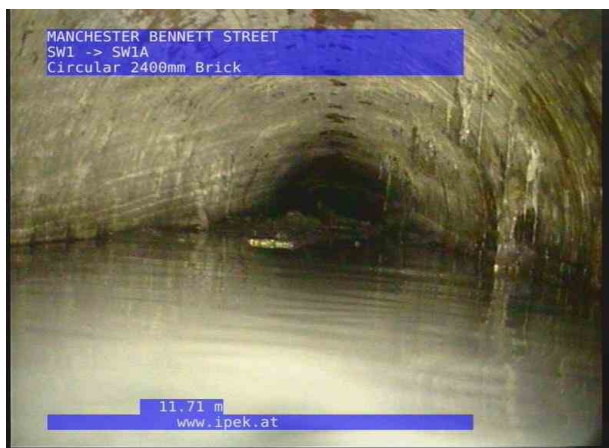
SW1AX\_a6df3ce6-3909-4ee5-a819-268de26b1f8f\_20220715\_115405\_753.jpg, 00:01:45, 6.23 m  
Settled deposits, fine, 20% cross-sectional area loss

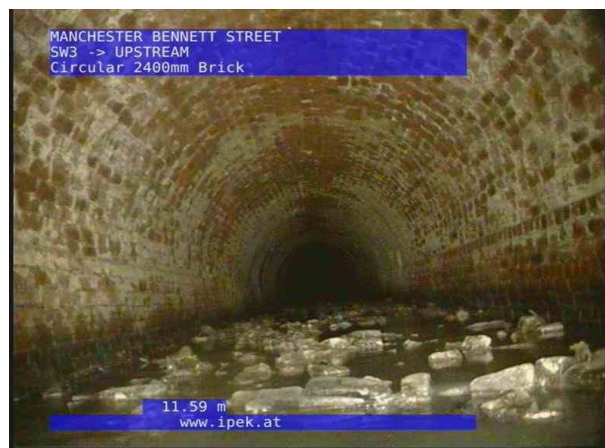
UPSTREAMX\_91c249c5-307e-4052-b8ed-c9b6c93fcde2\_202  
20715\_121920\_482.jpg, 00:00:36, 11.59 m  
Settled deposits, fine, 15% cross-sectional area loss, start

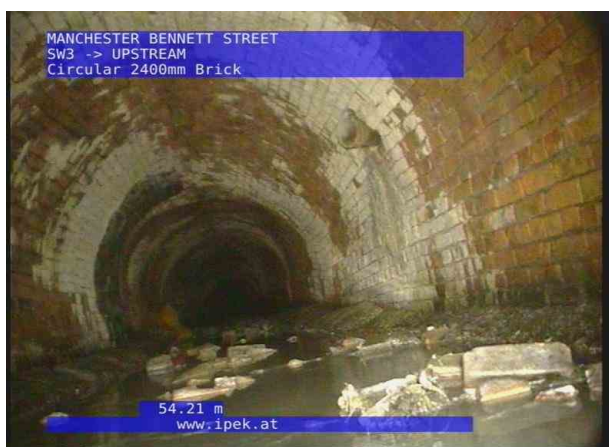
UPSTREAMX\_991564bf-0861-4d4b-a1df-d86103db70fa\_202  
20715\_122425\_384.jpg, 00:05:16, 54.21 m  
Connection other than junction at 2 o'clock, 150mm dia
