# CONDITION REPORT

University of Manchester  
Presidents Residence - Conservatory  
Broomcroft Hall, Ford Lane, Manchester

NOVEMBER 2018

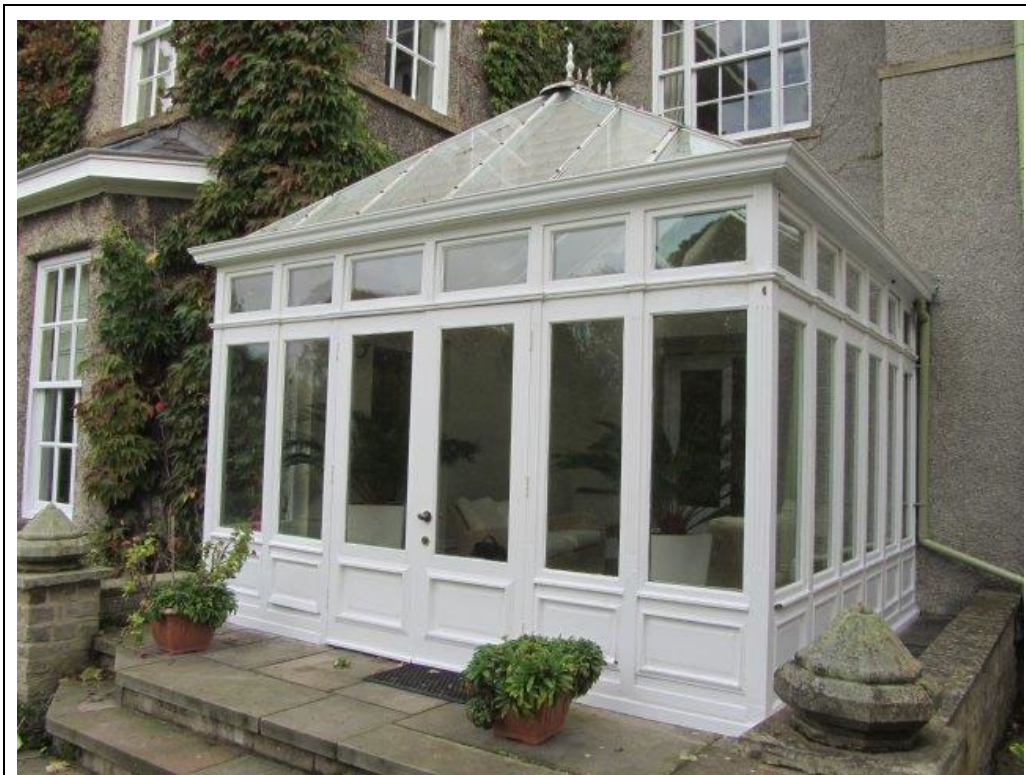
Image 1: Rear Elevation

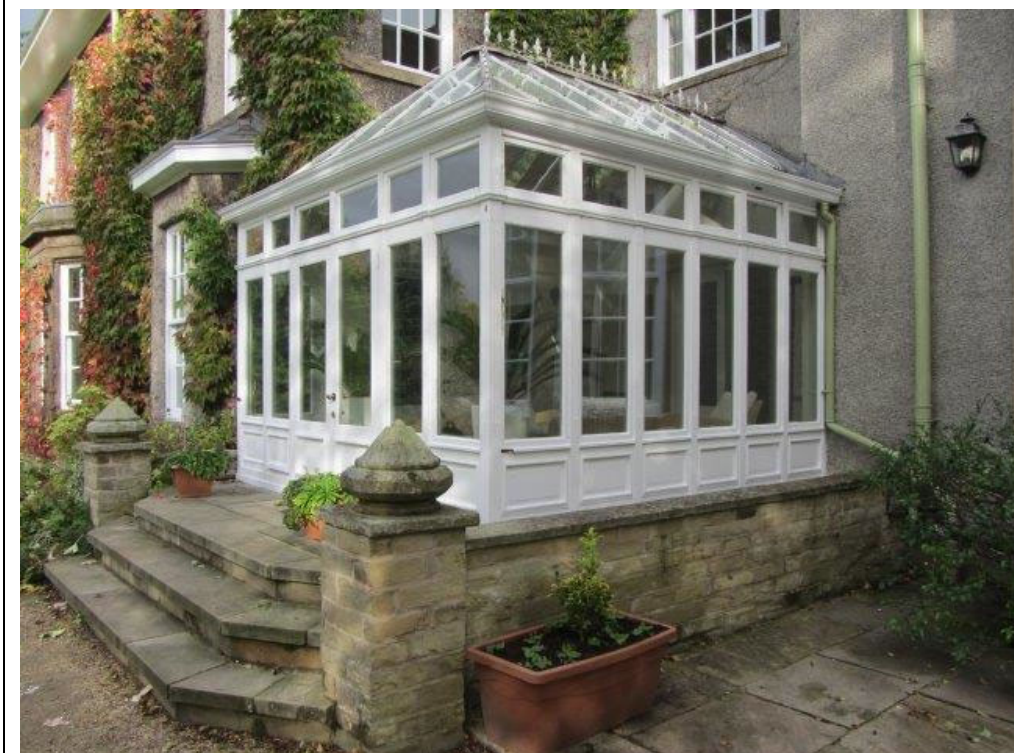
Image 2: RHS Elevation

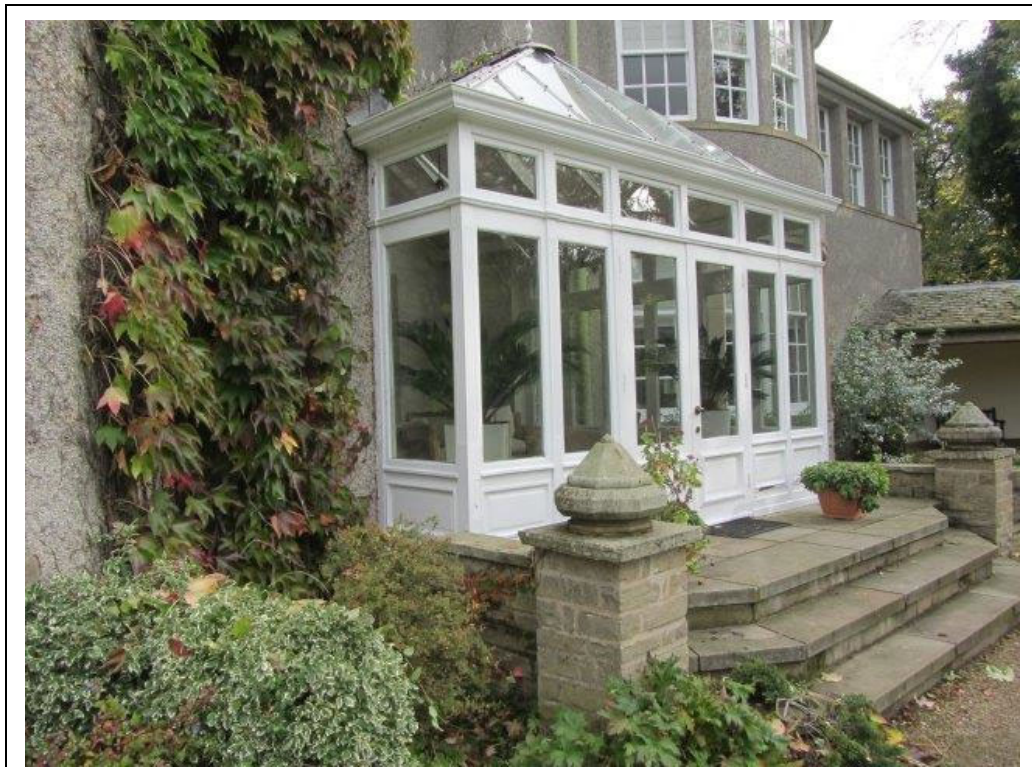
Image 3: LHS Elevation

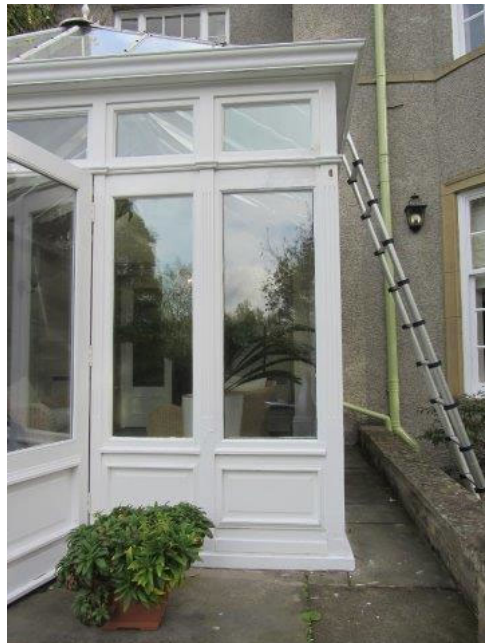
2. A damaged pane of the single glazed roof was noted at eaves/gutter level at the abutment with the main building.
3. No internal bracing or purlins are present to the roof structure as part of the original construction of the building. This is likely to be a contributory factor to the structural movement that was found, through the process of 'eaves spread' due to the presence of an unrestrained roof structure.

1. Evidence of historical structural movement was found to the rear of the conservatory. The timber corner post which acts as a structural support to the roof was found to be bowed and the lower infill panels to the rear elevation were found to have moved away from the tiled floor finishes. We were unable to determine if this is historical movement or if movement is still occurring, we would recommend that this is monitored over a period of time to confirm.

Image 4: Bowing to corner post

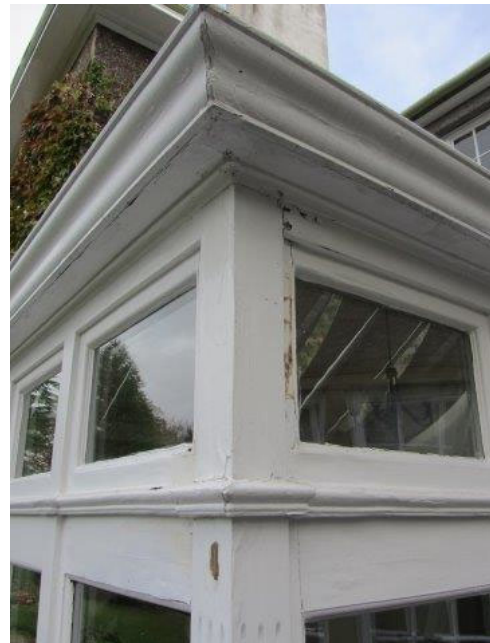
6. Numerous areas of wet rot affected timbers were found to the external areas of the building envelope. High moisture readings were recorded in various locations, particularly to the lower infill panels, glazing beads and roof supporting posts.

Image 5: Wet rot affected timber

3. Remove the existing fibreglass and inspect and reline gutters with liquid applied waterproof coating if required.
4. Undertake short term localised cosmetic repairs or replacement of wet rot affected timbers and decorative finishes. **Note:** These are unlikely to prevent further wet rot decay occurring to the building but will enable the building to 'appear' serviceable until full replacement is possible.

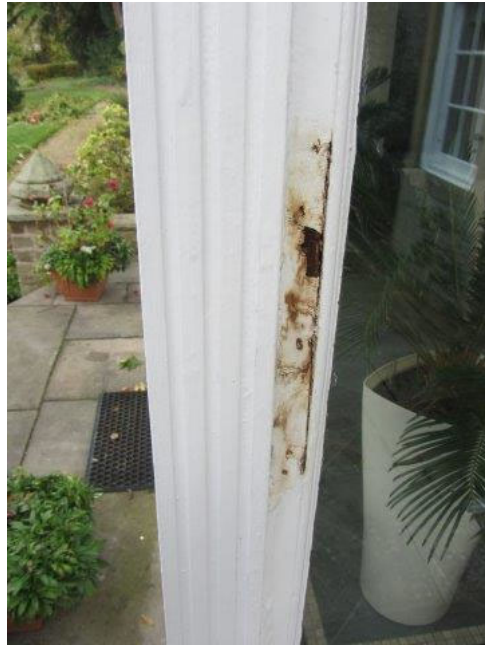
Image 6: Wet rot affected timber

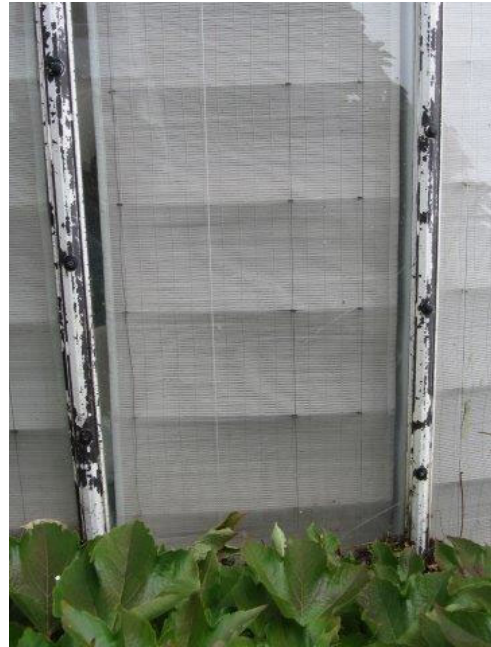
Image 7: Damaged glazed roof panel

5. If leaking (as this was not possible to evidence at the time of inspection), replacement of the damaged single glazed roof sheet.
6. Introduce a second rainwater outlet to the LHS corner.

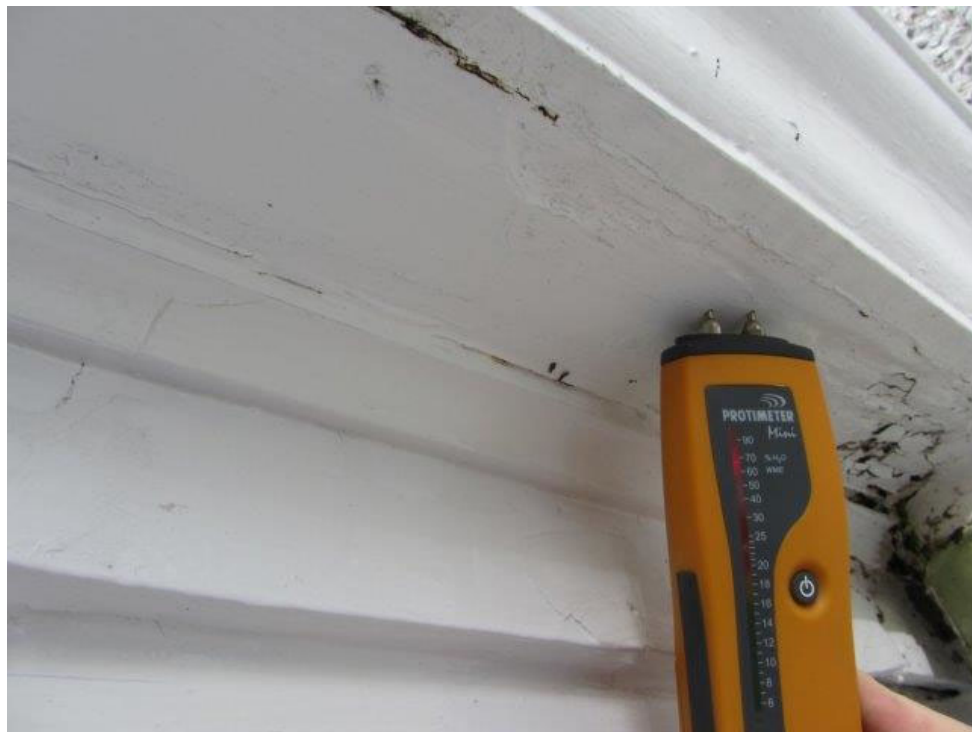
7. Rainwater overflows the gutters and is being trapped between the fibreglass gutter and the timber moulded decorative dressings where this has delaminated from the timber. This is then finding its way back into the head of the timber window frames and external timber soffits. The external timber soffits between the head of the window frame and the external gutters were found to be saturated in a number of locations and some areas are affected by wet rot. Medium to high moisture readings ranging from 28-67% WME were recorded within the external timber soffits.

Image 8: Wet rot affected timber soffits to u/s of gutter

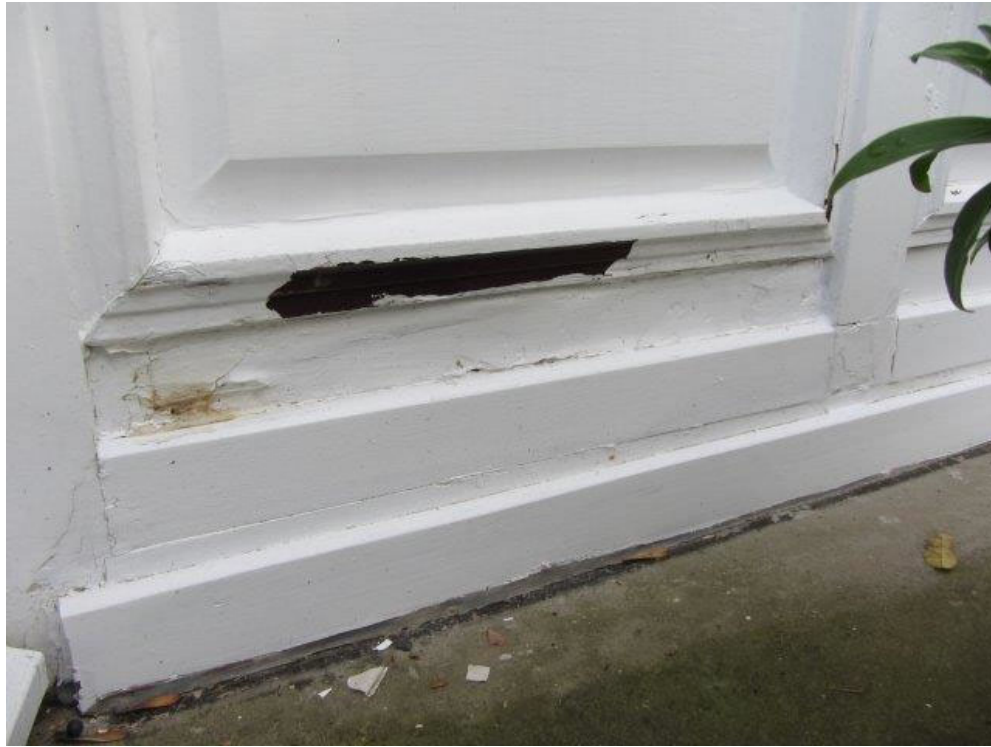
2. A poor standard of decorative finish was noted to the external envelope. Differing depths of coverage to painted finishes were present and the original varnished finishes were visible under the newer gloss decorations.

3. Use of a non-breathable surface finish such as gloss paint and the possible absence of suitable drying out times at the time of the previous repairs and redecorations, has increased the rate of decay within the timber structure. This appears to have occurred as a result of moisture having been trapped within the timber without sufficient drying out prior to decorations being undertaken.

Image 9: Wet rot affected timber, varnished finish exposed

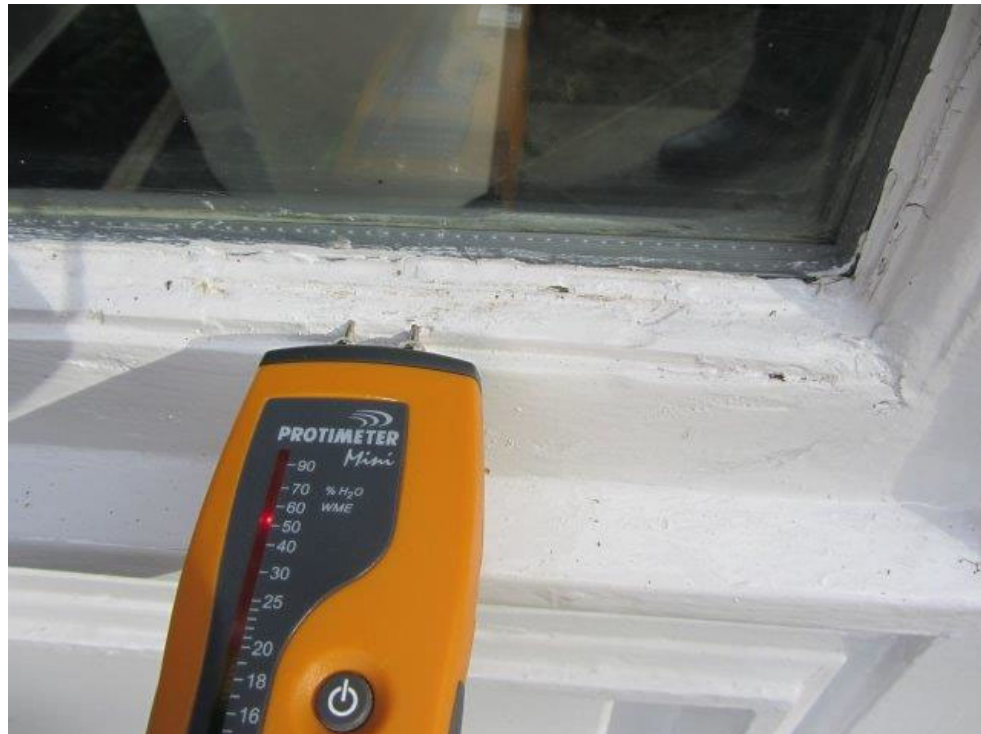
Image 10: High moisture content within glazing beads

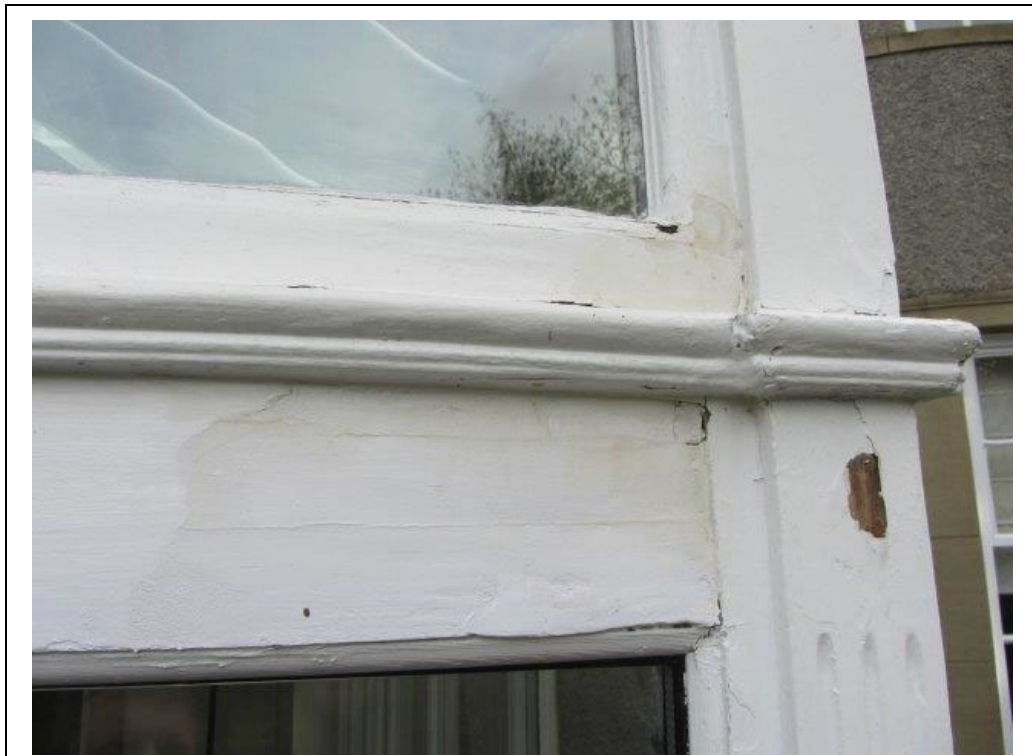
Image 11: Deterioration of decorative finishes

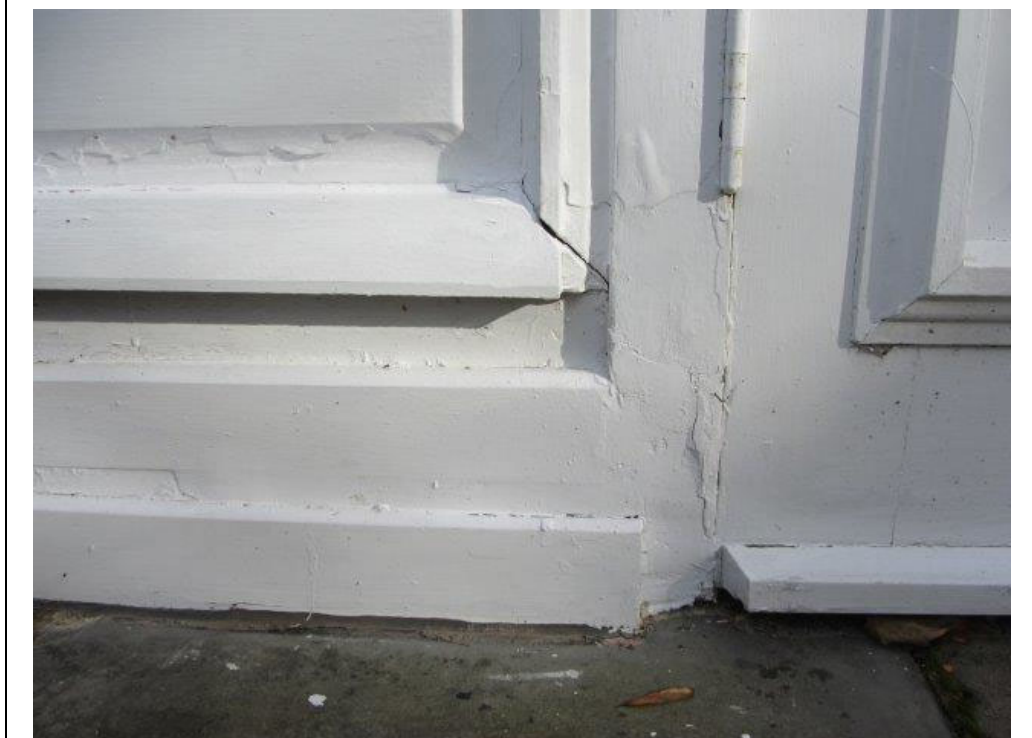
4. A poor standard of previous timber repairs was evident, which consisted of a significant but unquantifiable number of timber splice repairs, timber replacement and resin repairs. It was evident that a number of repairs have been undertaken to the base of the structural timber posts which act as window mullions but also as the main supporting structure to the roof.

Image 12: General standard of previous timber repairs

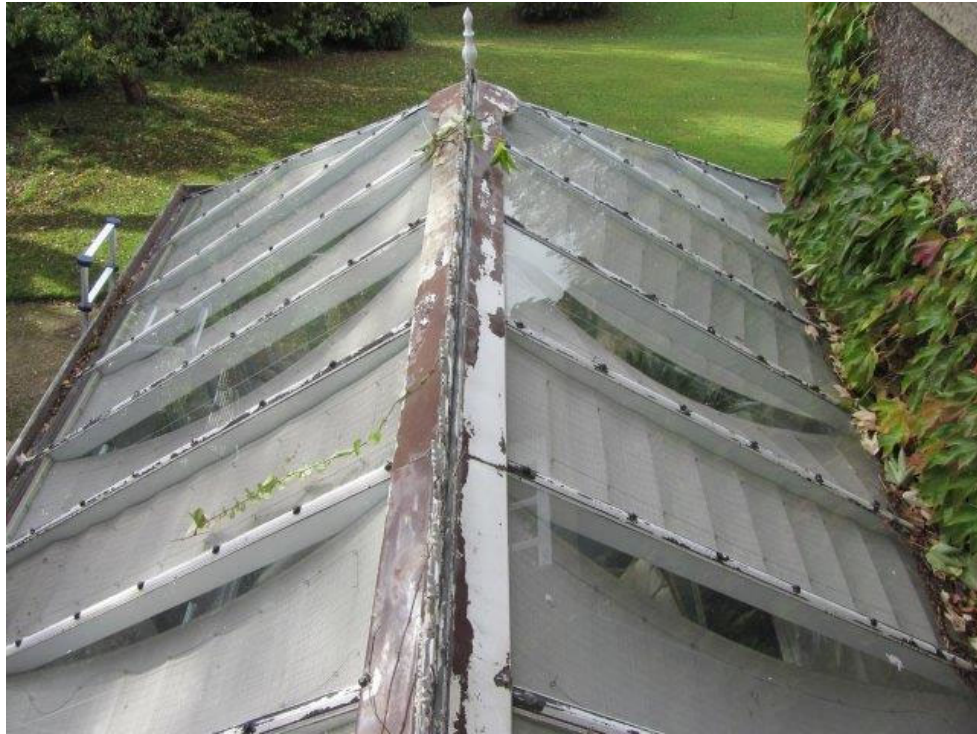
4. A single glazed, non wired, roof is provided with prefinished aluminium glazing bars and ornate roof capping's over timber rafters. Roof detailing has been retrospectively painted and the ultimate decorative finish of these have significantly deteriorated. Due to the nature of its original construction, this is a fragile roof and no suitable access has been provided to enable maintenance of the roof and rainwater goods.

Image 13: Pitched roof in poor condition

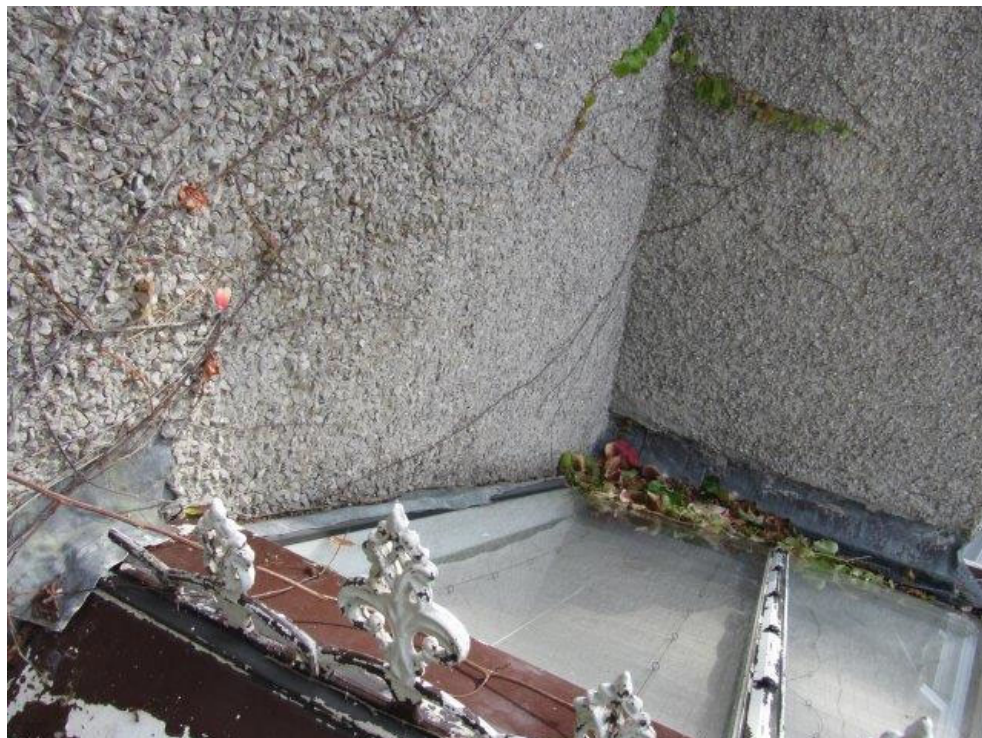
1. Pitched lead flashings at the abutment with the main building are not installed in accordance with the guidance provided by the lead sheet association, as they do not provide a minimum upstand of 150mm to the finished roof. We were unable to fully inspect the gutters or flashed dressing to the side elevation abutting the main building as there was no safe access and also due to a significant build up of leaves.

Image 14: Low dressed lead flashings at abutment to main building

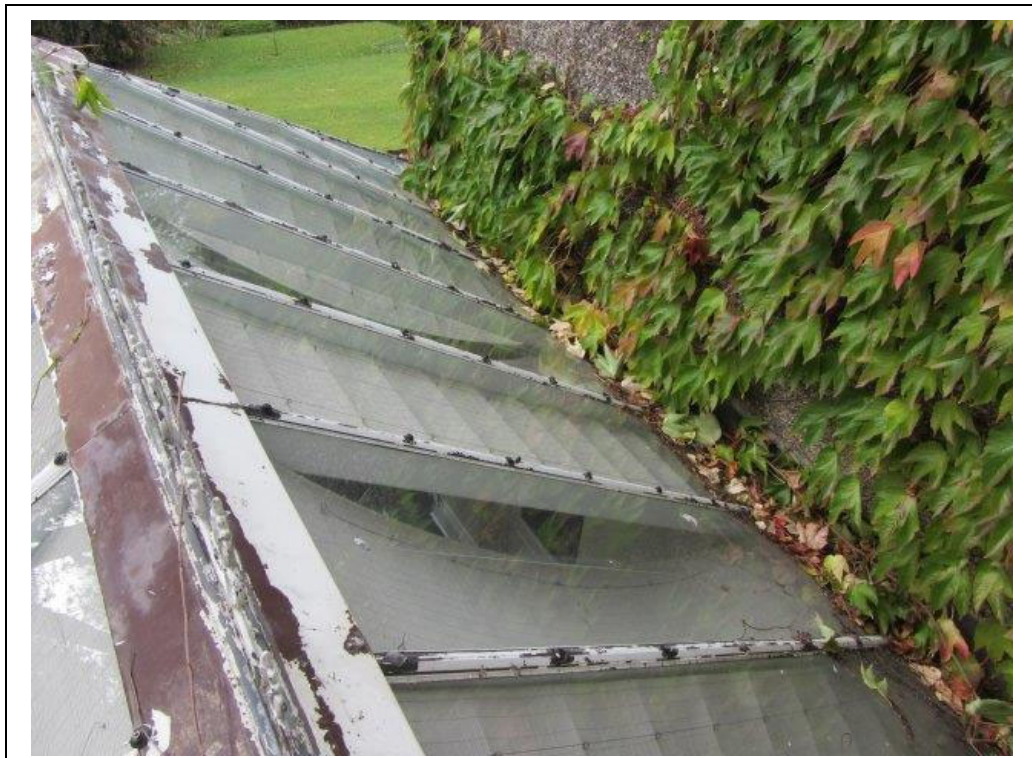
8. The first floor of the building immediately above the roof of the conservatory is covered with vegetation which has been trained to grow against the building. This has resulted in considerable leaf and associated debris being deposited within the gutters, this was particularly evident within the trough gutter located at the abutment with the glazed pitched roof.

9. Wire mesh has previously been installed into the trough gutter to the LHS abutment with the main building to aid issues with fallen leaves and debris entering the gutter. This has proved to be ineffective as a large build-up of moss and leaves were found to be present within the perimeter gutters, restricting the rainwater goods from performing correctly.

Image 15: Vegetation within trough gutter at abutment to main building

1. Removal of vegetation growth from the rear of the main property to reduce debris and vegetation build up within the roof drainage systems.
2. Clear all moss and other debris from within the existing gutters to enable greater rainwater bearing capacity within the existing gutters.

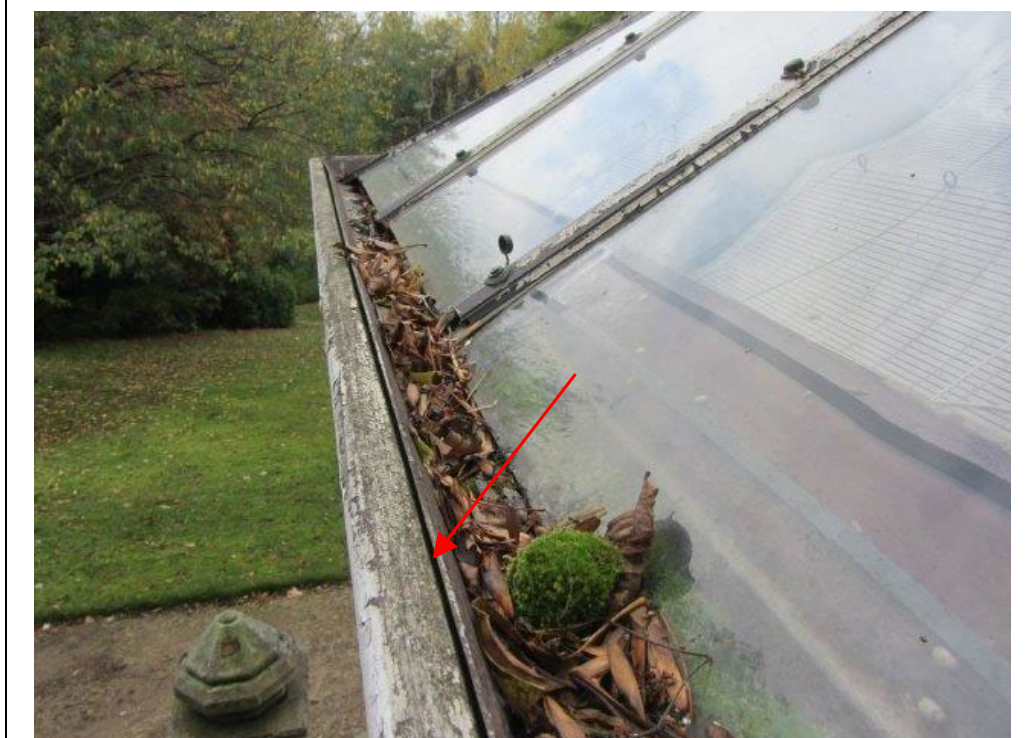
Image 16: Fibreglass liner delaminating with moss and vegetation to gutter under glazing

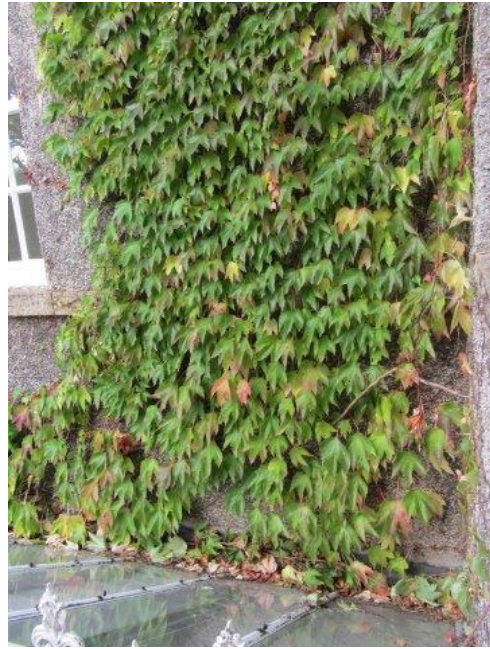
Image 17: Vegetation to rear of property

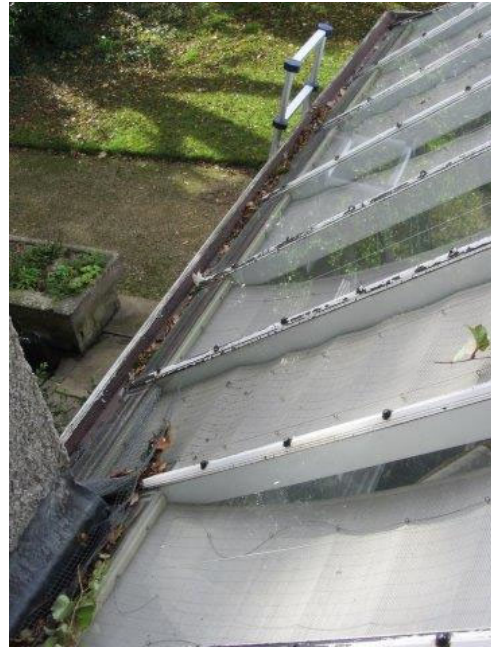
Image 18: Steep pitch to glazed roof

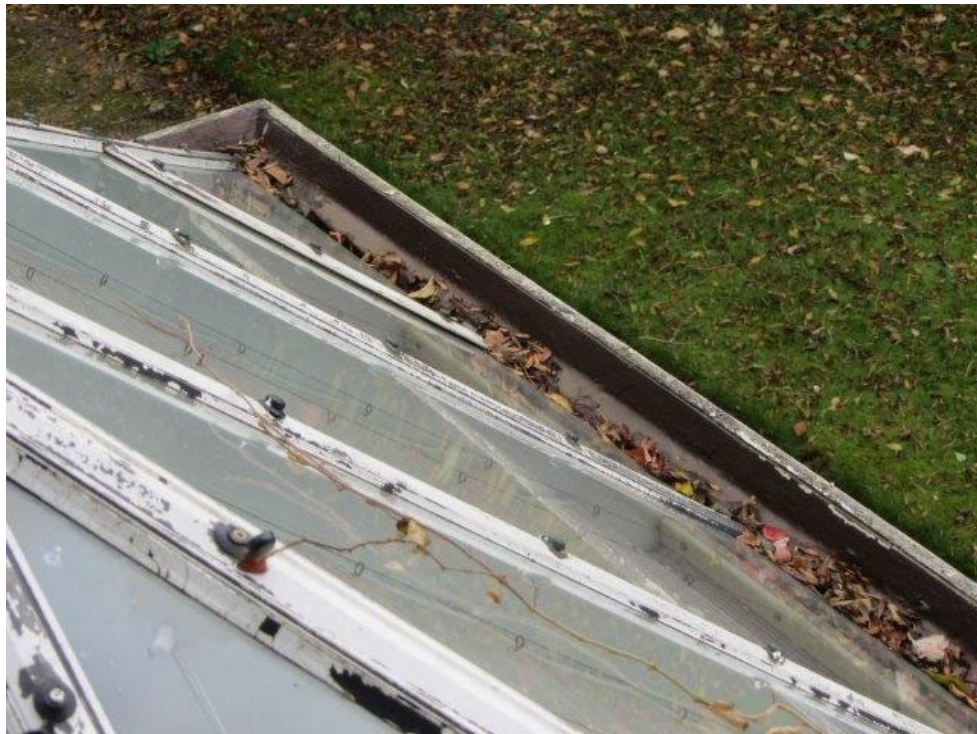
Image 19: Timber faced fibreglass gutters to perimeter

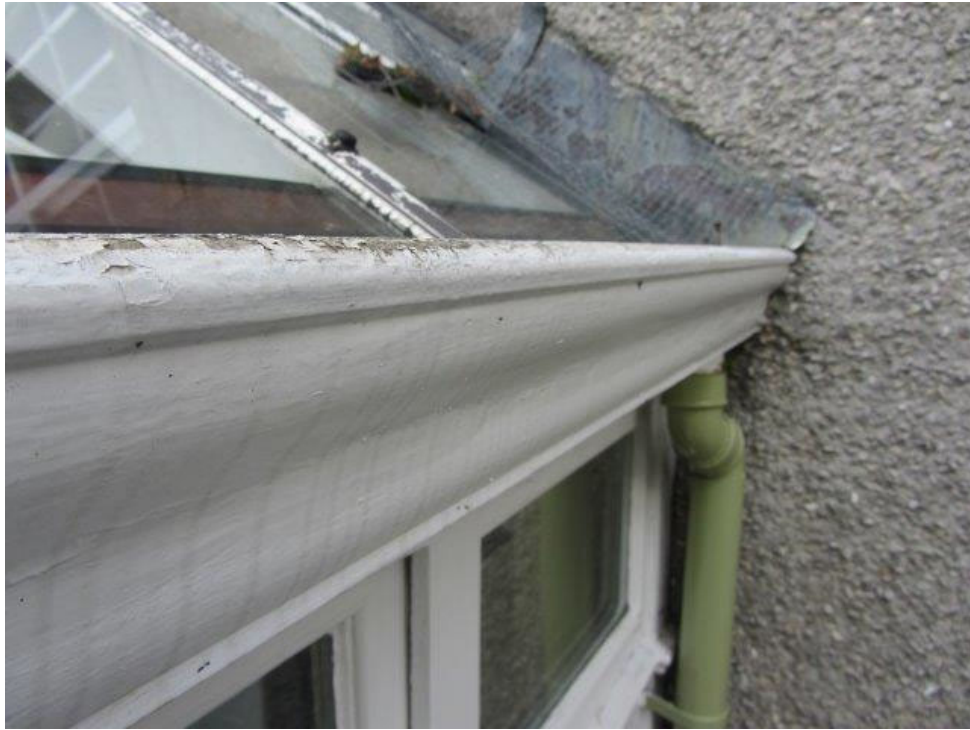
6. Water staining was evident to the outer face of the timber dressed linings to the external gutters. The pitched roof is fairly steep and the gutters are relatively shallow. The water staining indicates that the gutters are, at times, unable to cope with the amount of rainfall. This is exacerbated by the presence of moss and debris within the fibreglass lined gutters, which further reduce the capacity and flow of the rainwater goods.

Image 20: Water staining to timber gutter linings

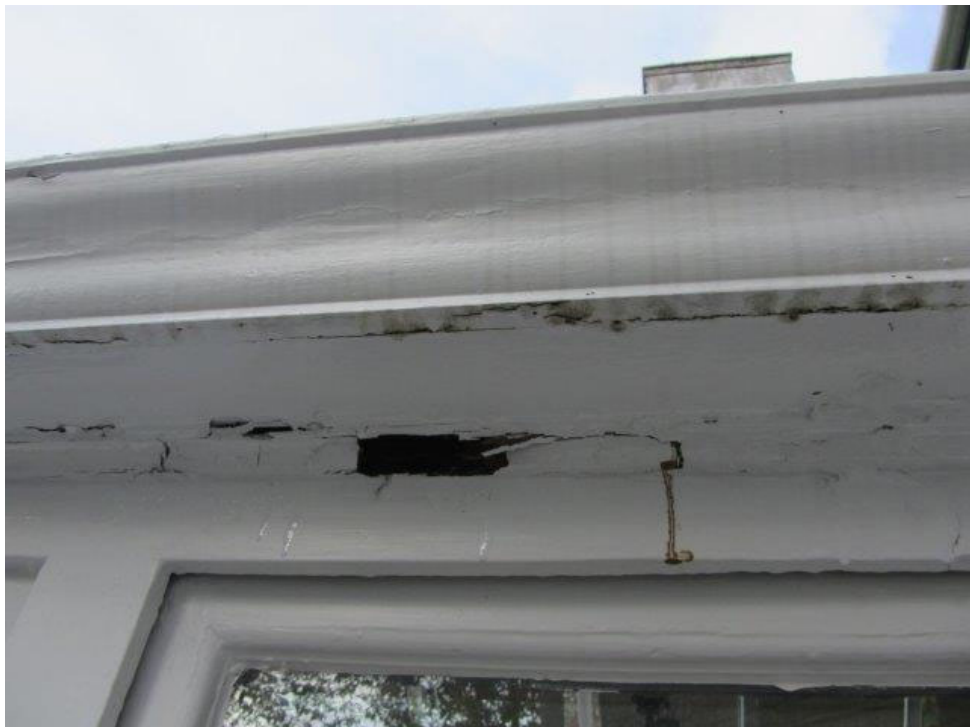
Image 21: Water staining to gutter and wet rot affected timber linings

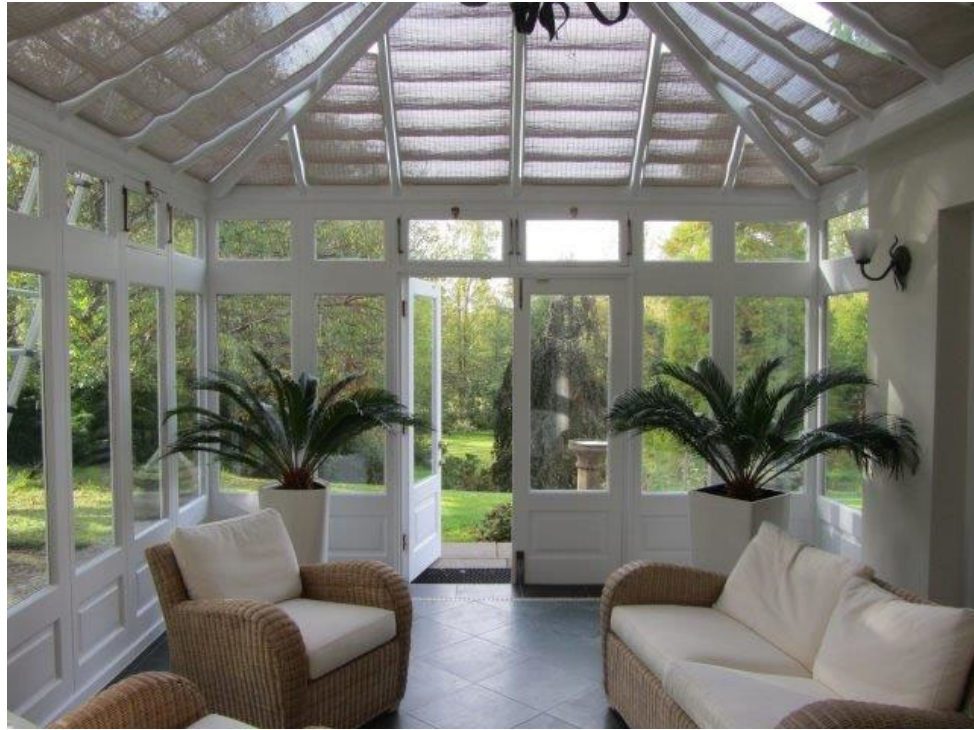
Image 22: Good internal condition generally

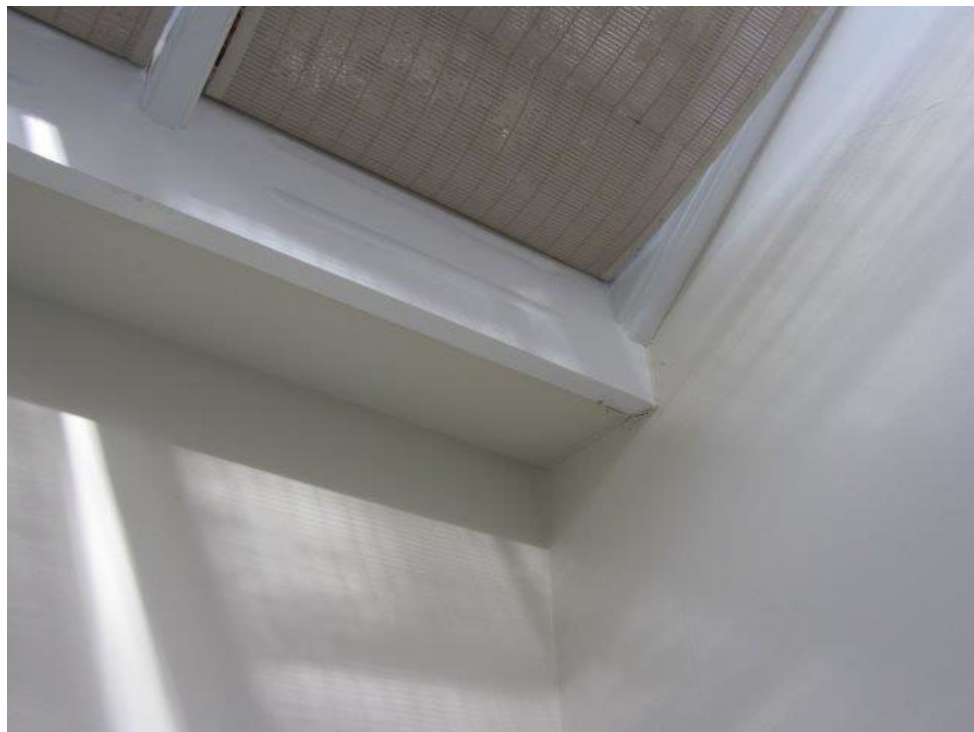
1. Water staining to painted plaster finishes as a result of water ingress to the LHS corner at the abutment with the main building. Likely cause for this is water tracking back under the glazing as a result of poorly maintained gutters.
2. Wet rot affected timbers and were found to the low level infill panels under the windows within the corner on the short return wall.
3. Historical movement has occurred to both sides of the doors leading into the conservatory within the rear elevation of the main building.

Image 23: Location of reported internal water ingress, under trough gutter

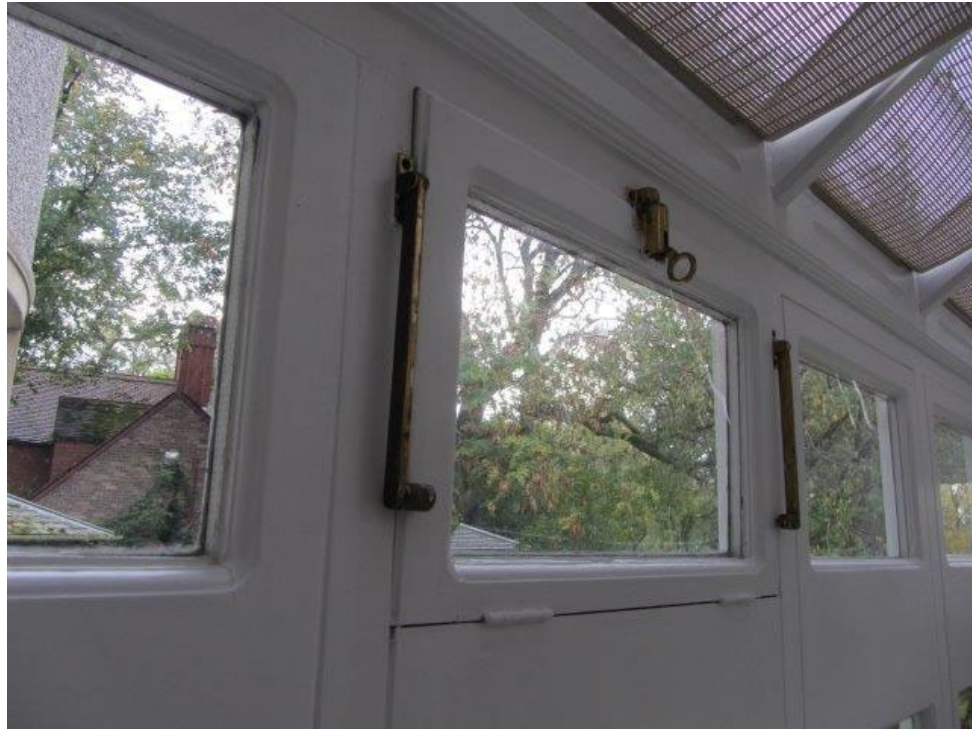
8. A poorly fitting opening casement was present to one of the windows rendering the ironmongery latch almost inoperable.

Image 24: Poorly fitting opening casement

7. Ease and adjust poorly fitting opening window casements.

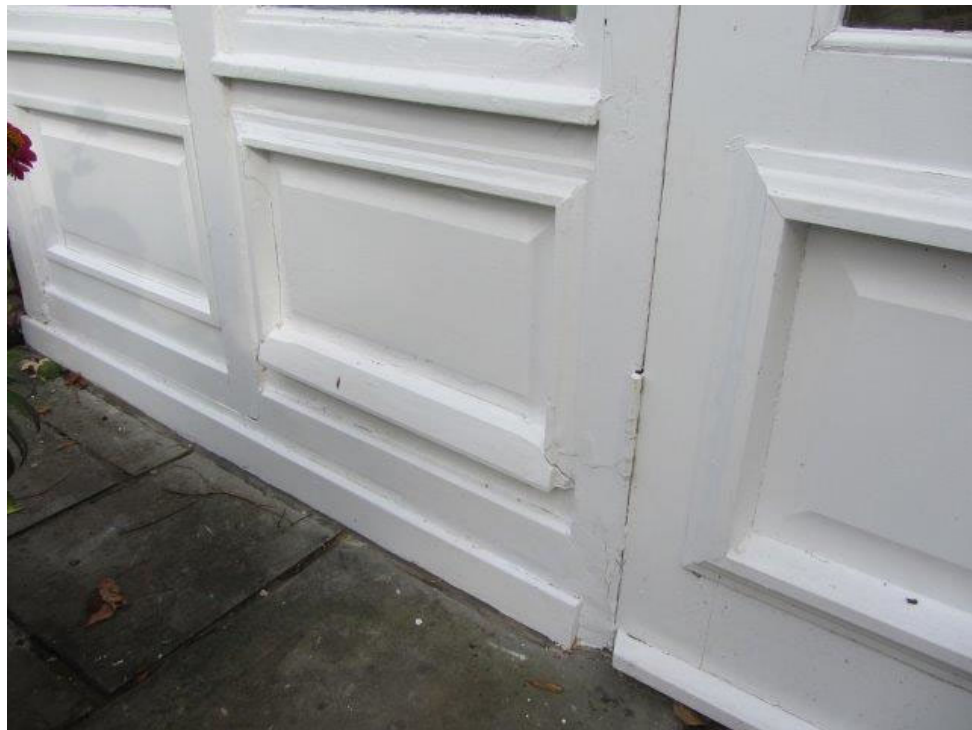
7. New sections of timber have been previously fitted as part of a repair programme, such as a skirting detail that has been provided. It was found that not all of the timbers used were hardwood and are of poorly matched profiles in some instances.

Image 25: Poorly matched timber replacement moulding to infill panel
