DOMIS CONSTRUCTION

# FACADE QUALITY CONTROL MANAGEMENT PLAN

VICTORIA HOUSE

SEPTEMBER 2022 REV 3

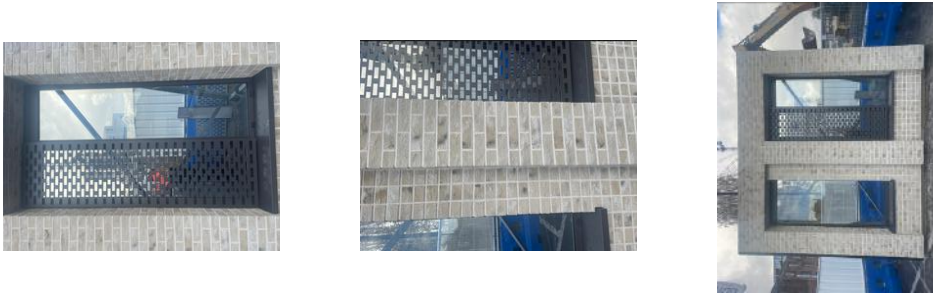
| Number | Title & Date | QC Image | Inspected By | Accepted | Not Accepted | Next Steps |
|---|---|---|---|---|---|---|
| 3 | VMU<br>15/11/2022 | | MCC represented by Angela Lecke & Dave Roscoe. Simpson Haugh Maivi Giang & Nick Owen | <p>Revised solid cill return to facade detail.</p> <p>Reinstalled interface black mastic which provides a consistent finish with no undulation at bed joint.</p> | N/A- All items accepted. | <p>Turley's to submit updated QCM to MCC enabling condition 3c to be discharged.</p> |

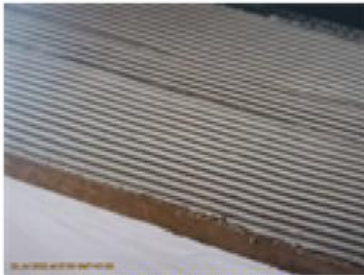
| Insulation | | | | |
|---|---|---|---|---|
| 3 | Has a 10mm x 10mm notch trowel been used to apply the adhesive? | Yes | <br><a href="#">22/07/2022 06:59:05</a> | |

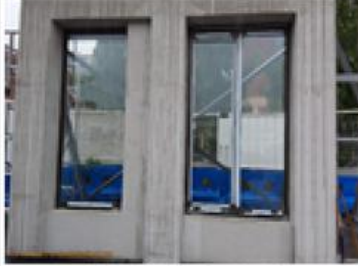
| # | Check Item | Present & Correct | Photos | Photo Location G/L |
|---|---|---|---|---|
| 1 | Is the mesh within the top third of basecoat? | Yes | <br><a href="#">22/07/2022 07:43:16</a> | |

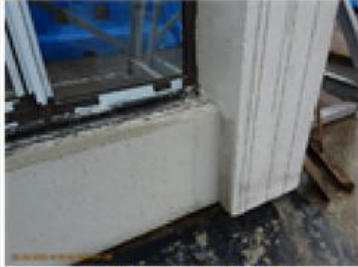
| # | Check Item | Present & Correct | Photos | Photo Location G/L |
|---|---|---|---|---|
| 6 | Corner beads installed correctly? | Yes | <br><a href="#">22/07/2022 07:43:25</a> | |
