# Hutton + Rostron Environmental Investigations Limited

## Mindel House, Manchester: Plaster condition survey

Site note 4 for 8 April and 27 July 2021, job no. 212.57  
REVISION B - 25.04.22

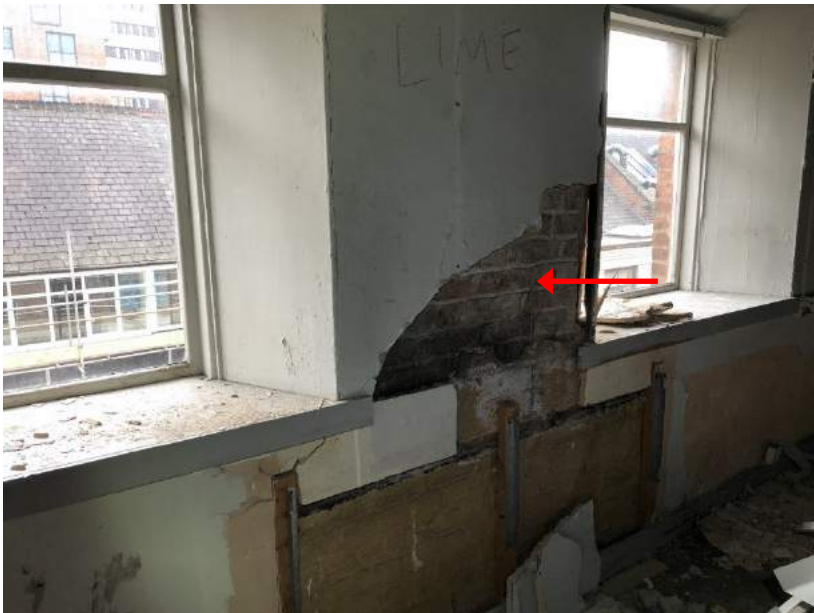
**Fig 9:**

Fourth Floor, MS-402; showing a typical example of debonded lime plaster caused by historical water penetration between MS-4W19 and MS-4W20

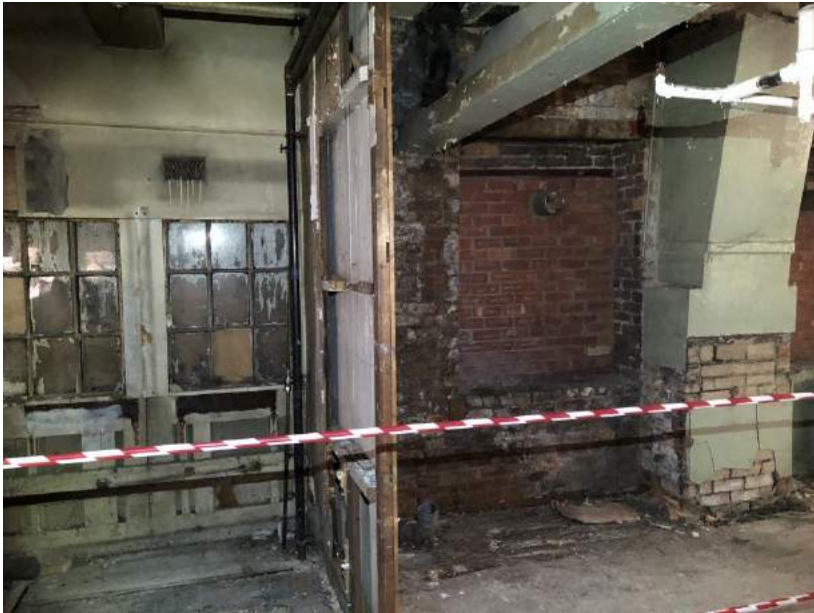
**Fig 13:**

Fourth Floor, MS-406-MS-411;  
showing extensive deterioration of the  
plaster finished in the area of ongoing  
water penetration

- 3 Areas of ongoing water penetration: The lime plaster to the external walls subject to ongoing water penetration should be removed back to the brick substrate. Ideally, at this stage, any damp masonry should be left exposed as long as necessary to allow adequate drying before re-plastering. Lath and plaster in these areas should be carefully cut back to sound material. Allowance should be made for additional decay in the laths and the softwood studwork whilst water penetration continues and whilst residual moisture remains in the structure. Lime plaster should only be reinstated to these areas following drying. H+R can undertake drying monitoring at an appropriate stage in the redevelopment, if instructed. Alternatively, ventilated dry-linings could be considered

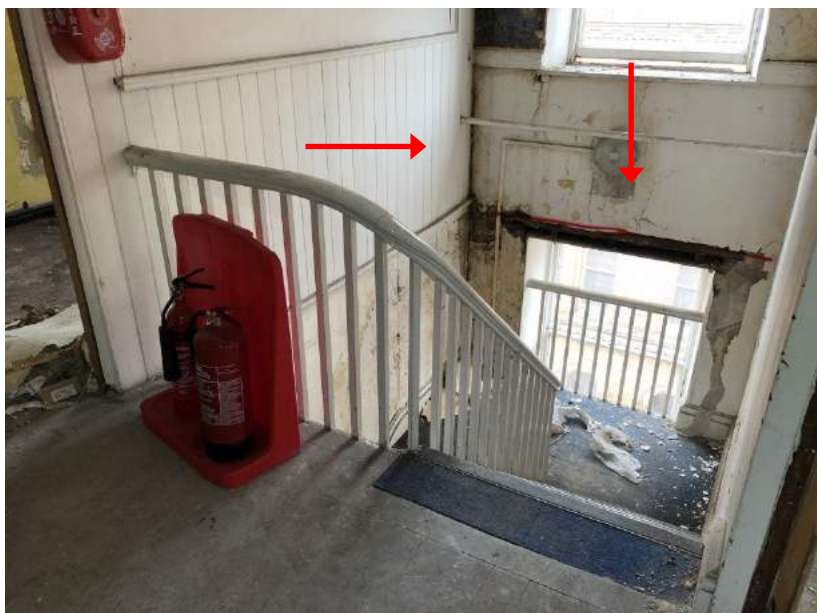
**Fig 21:**

Fourth Floor, MS-414; showing an area of water penetration. All wall finishes were damp and decayed. The timber panelling to the stud partitions were also damp and partially decayed where abutting the external wall

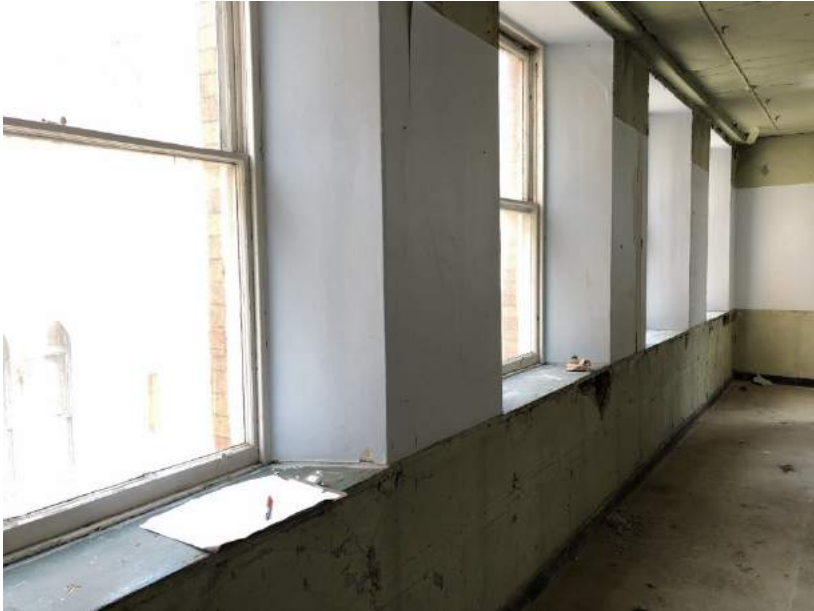
**Fig 25:**

Third Floor, MS-305-MS-308; showing early/original lime plaster to the external wall. Plaster was generally in fair condition with localised areas of debonding at low-level

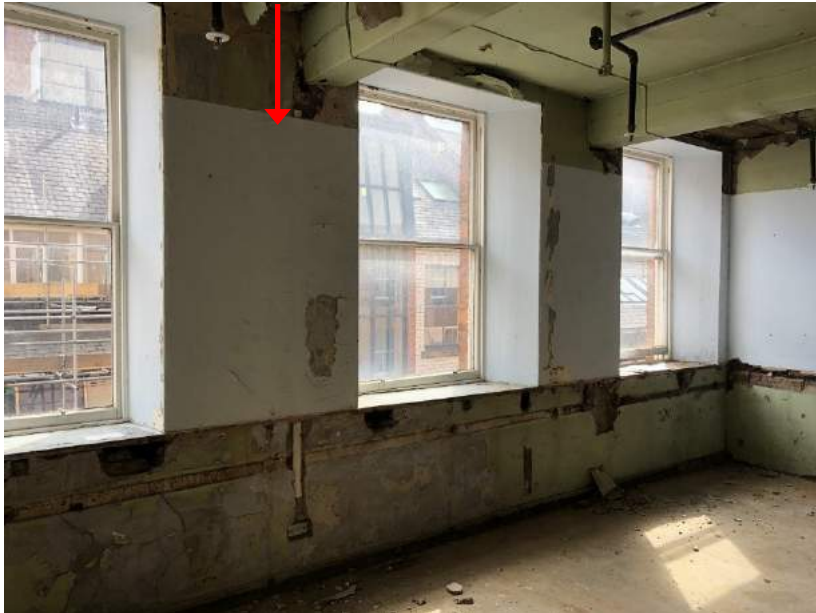
**Fig 27:**

Third Floor, MS-309; showing an area of significant debonding of the plaster caused by historical water penetration

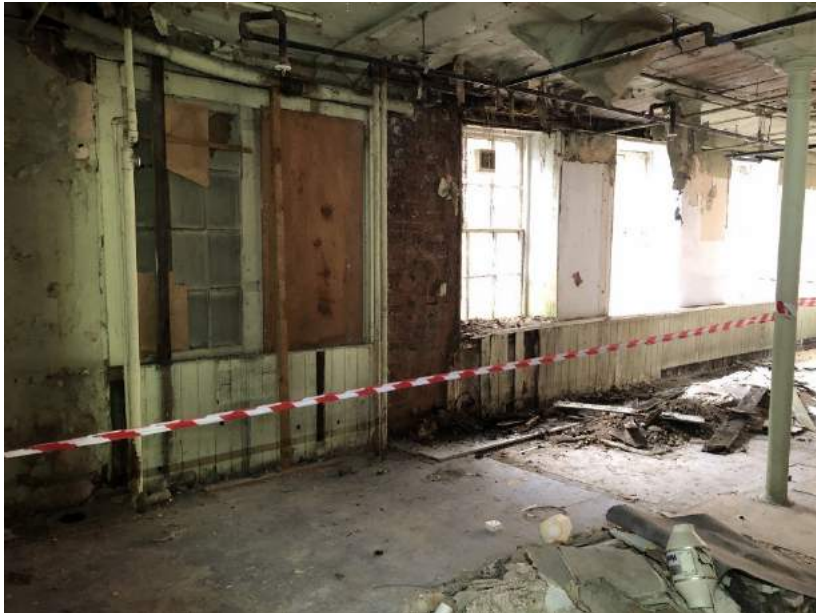
**Fig 29:**

Third Floor, MS-312-MS-320; showing deterioration of the wall finishes in the area of water penetration

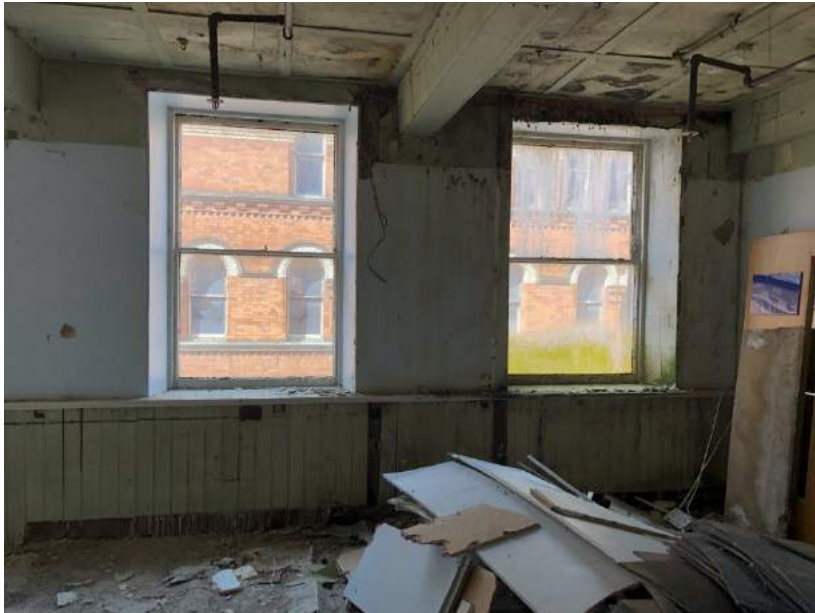
**Fig 33:**

Third Floor, MS-320; showing an area of water penetration and deterioration of the wall finishes

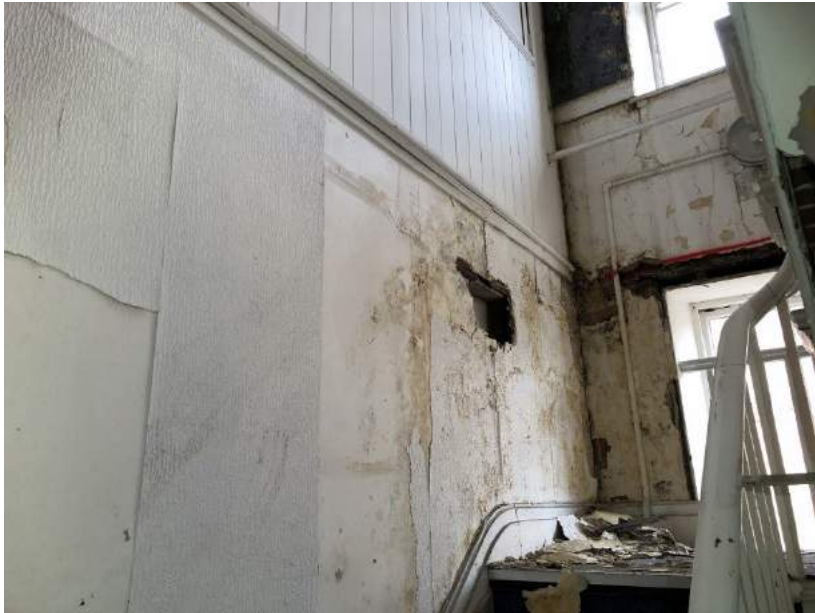
**Fig 37:**

Third Floor, MS-302; showing deterioration of the external and internal wall finishes in the area of water penetration

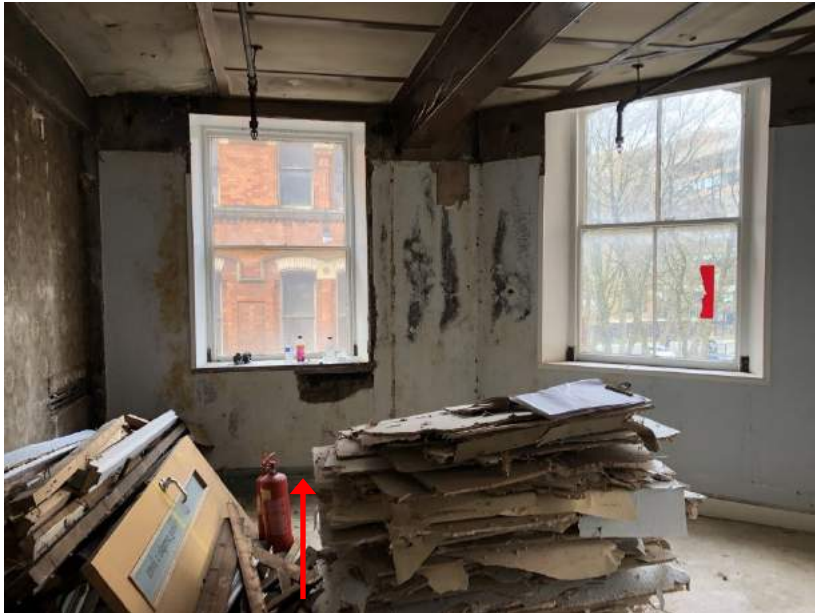
**Fig 41:**

Second Floor, MS-201; showing deterioration of the lime plaster in the area of ongoing water penetration. The softwood square-edge skirting board was also damp and partially decayed in this area

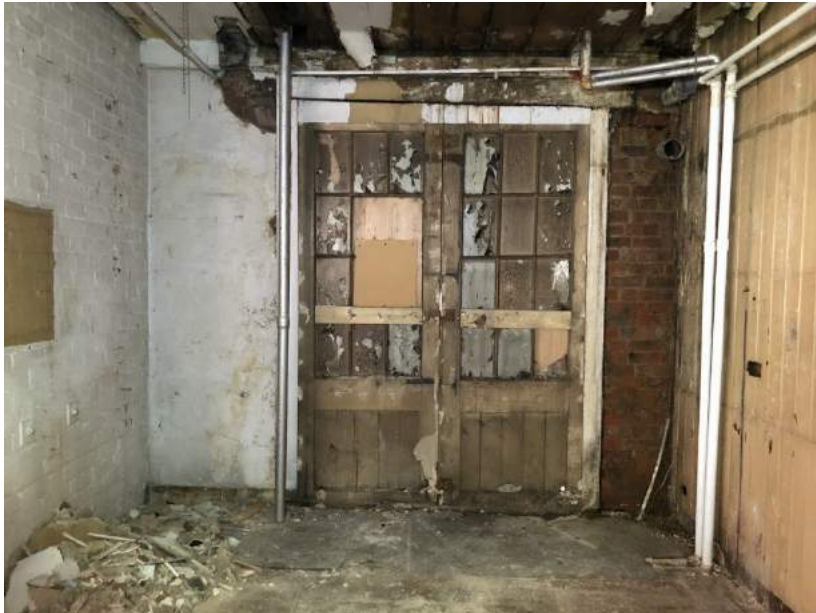
**Fig 47:**

Second Floor, MS-213; showing deterioration of the lime plaster in an area of ongoing water penetration

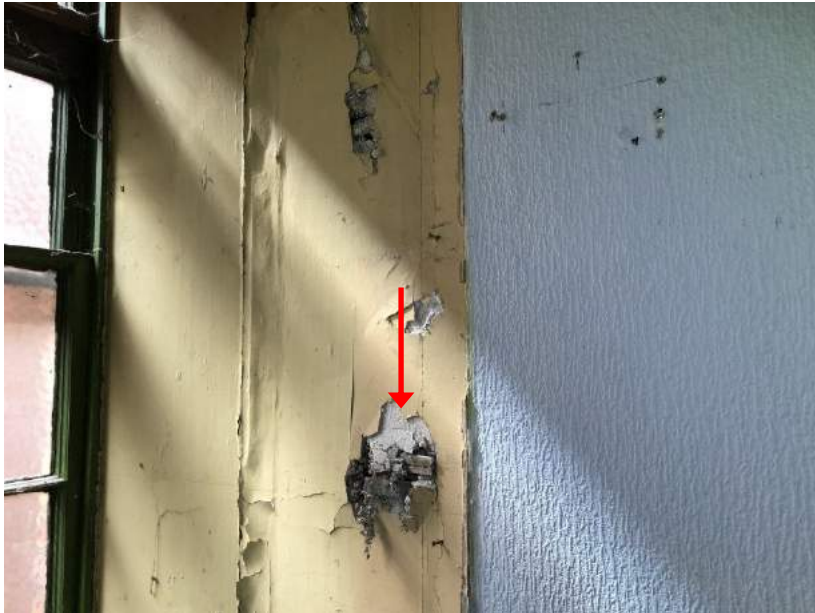
**Fig 49:**

Second Floor, MS-216; showing an area of lath and lime plaster used behind the cupboard of MS-218. The lath and plaster was damp and partially decayed where abutting the external wall

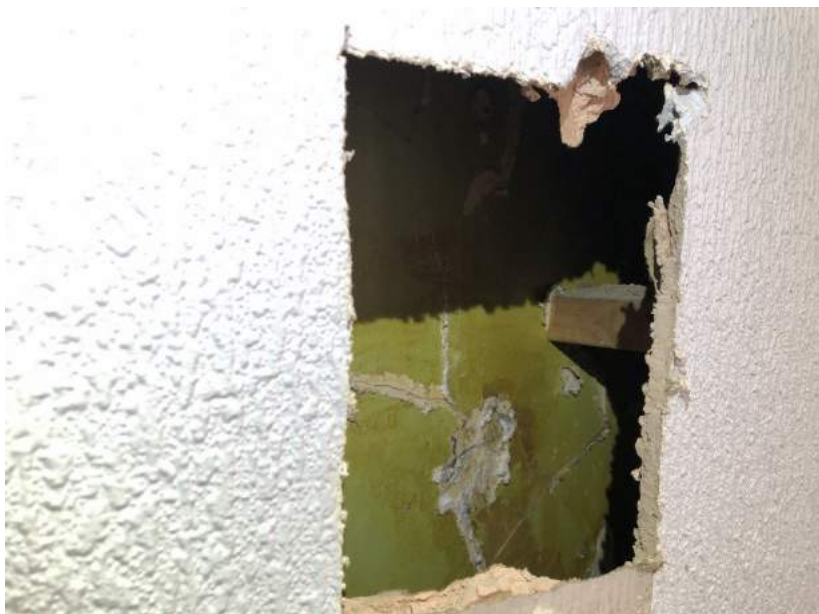
**Fig 51:**

Second Floor, MS-218; showing lime plaster with an earlier paint scheme behind the plasterboard. Note cracking of the plaster associated with salt

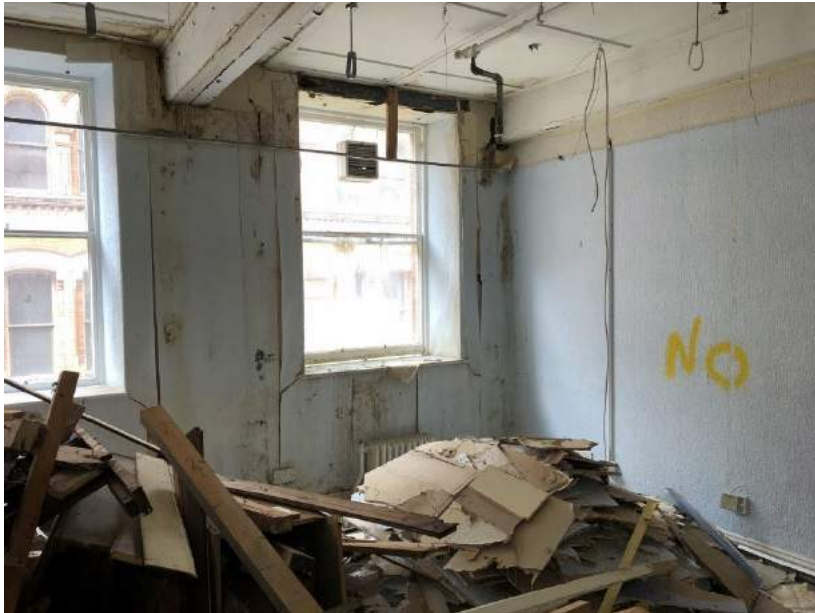
**Fig 53:**

Second Floor, MS-218; showing an area of ongoing water penetration that had caused deterioration of the lime plaster

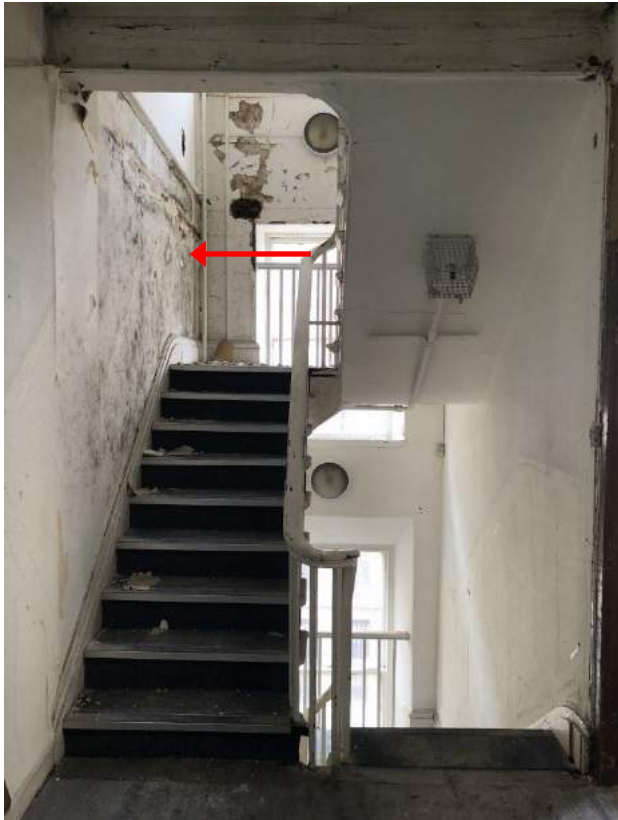
**Fig 55:**

Second Floor, MS-202; showing deterioration of the wall plaster and lath and plaster in the area of ongoing water penetration

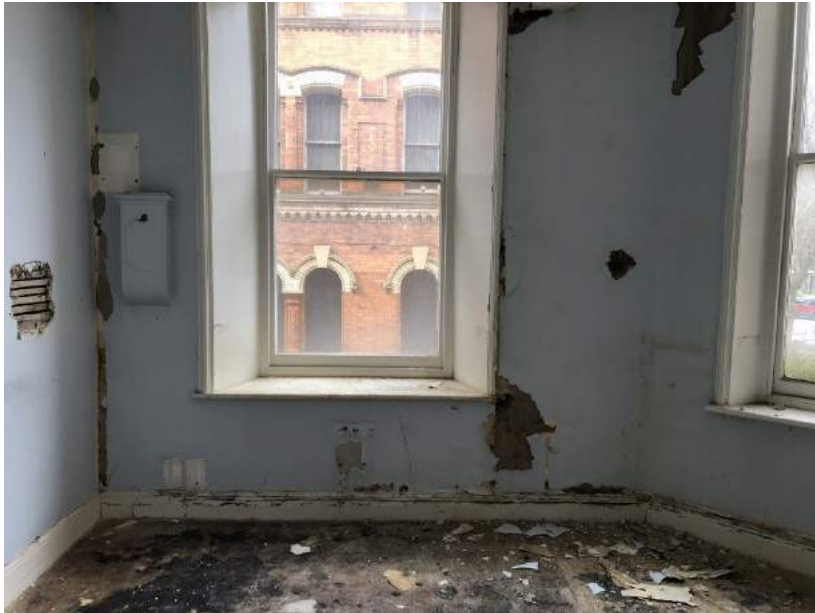
**Fig 57:**

First Floor, MS-101; showing deterioration of the lime plaster and partial decay of the softwood skirting board in the area of ongoing water penetration

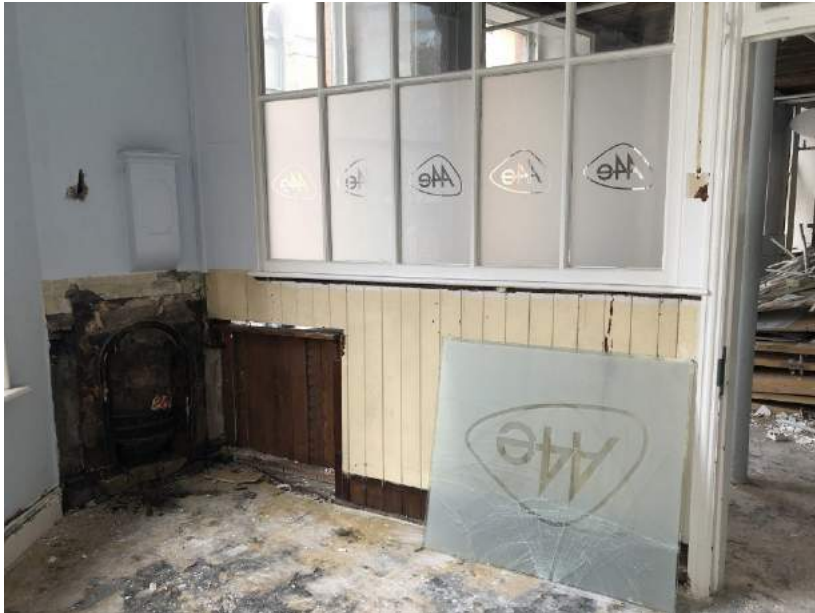
**Fig 59:**

First Floor, MS-101; showing the non-original timber and glazing partition. There was localised mechanical damage but the timbers were free from significant damp and decay

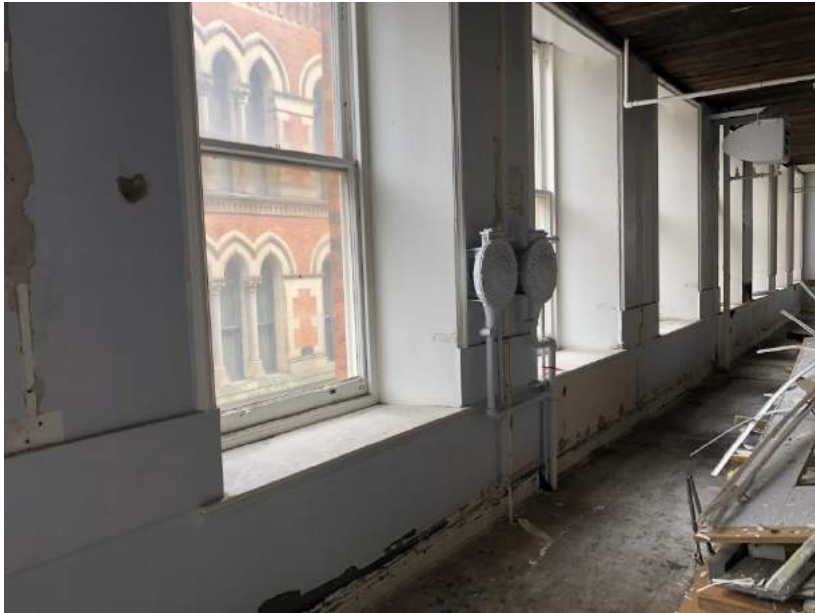
**Fig 61:**

First Floor, MS-102; showing lime plaster with a softwood skirting board. The plaster was generally in fair condition with localised areas of debonding

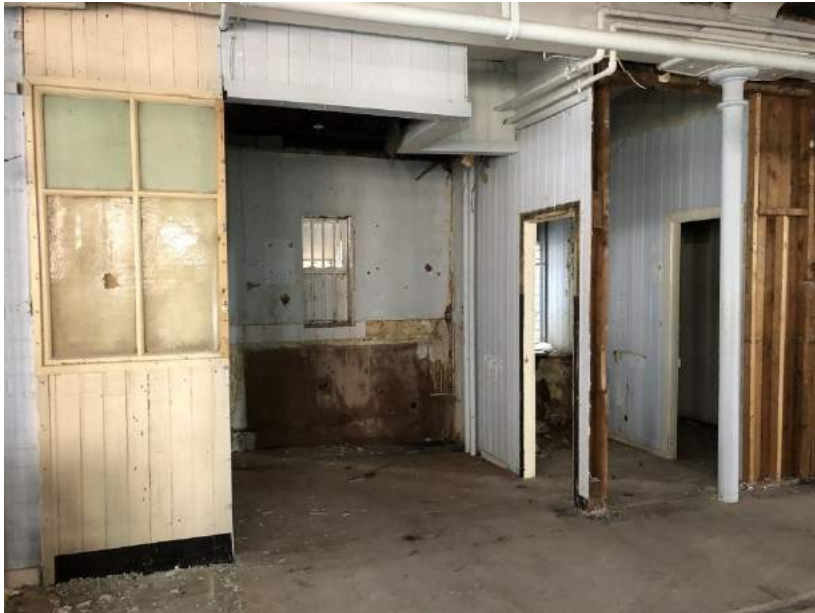
**Fig 63:**

First Floor, MS-1110 to MS115;  
showing the area of ongoing water  
penetration that had caused significant  
deterioration of the plaster finishes

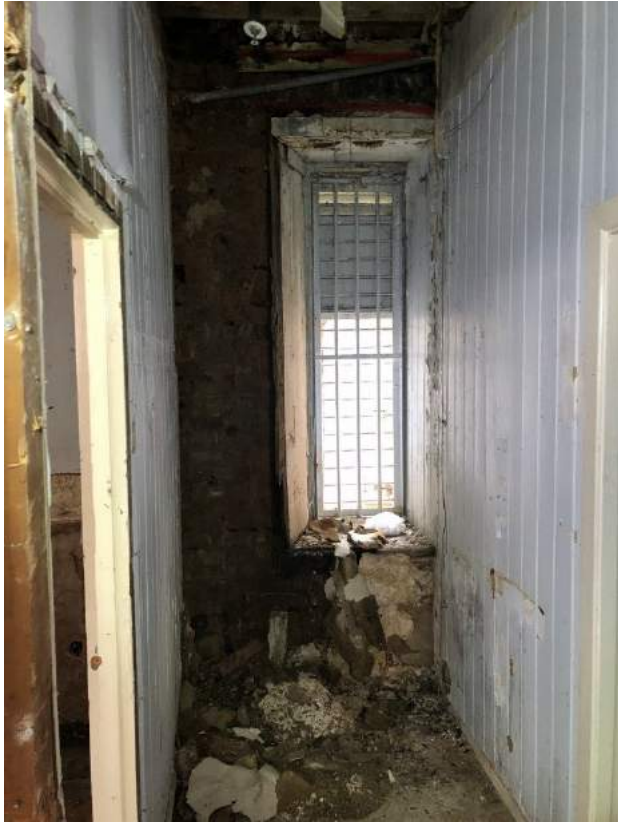
**Fig 65:**

First Floor, MS-116; showing an area of debonded lime plaster

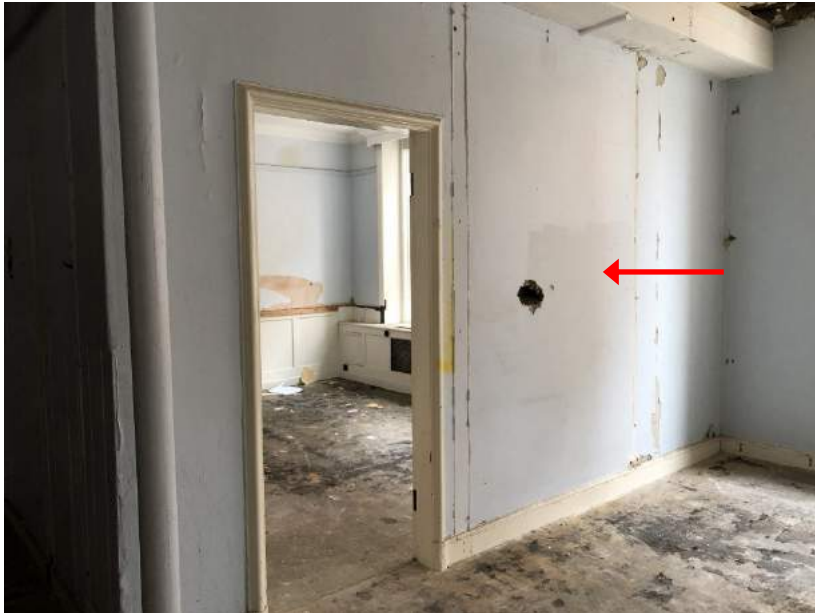
**Fig 71:**

First Floor, MS-118; showing lath and lime plaster finish to the stud partition. There was no significant damp or decay in this area

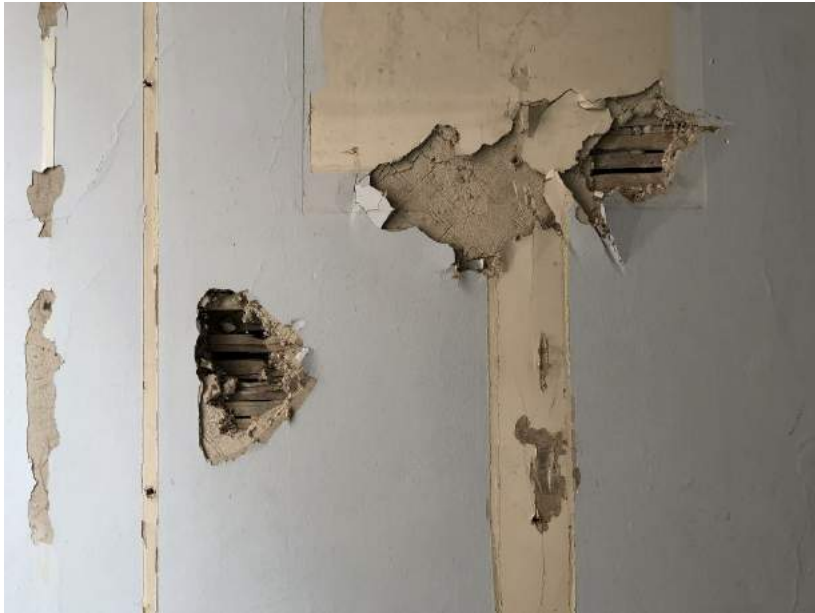
**Fig 73:**

First Floor, MS-118; showing a close-up of the lath and plaster applied to the partition. The lath and plaster was generally free from significant defect

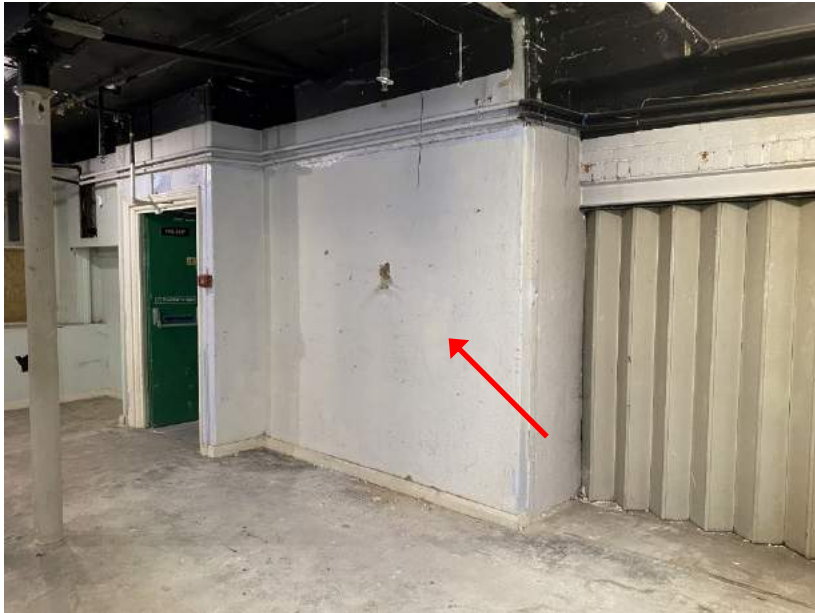
**Fig 81:**

Upper Ground Floor; showing lime plaster applied to the non-original internal wall around the southern stairwell. Plaster here was generally in fair condition

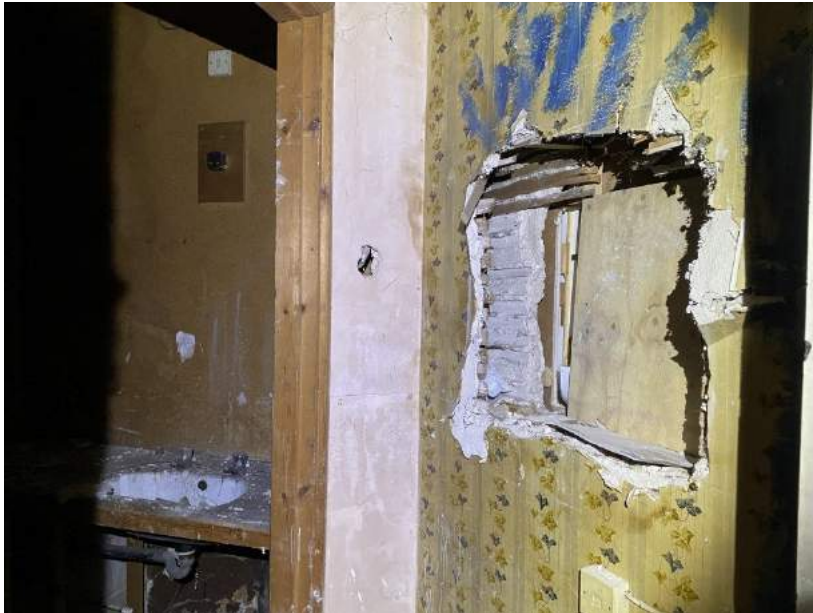
**Fig 87:**

Upper Ground Floor, MS-UG23; showing remnants of early wallpapered lath and plaster to the small store room. The plaster was largely mechanically damaged and partially decayed where abutting the external wall

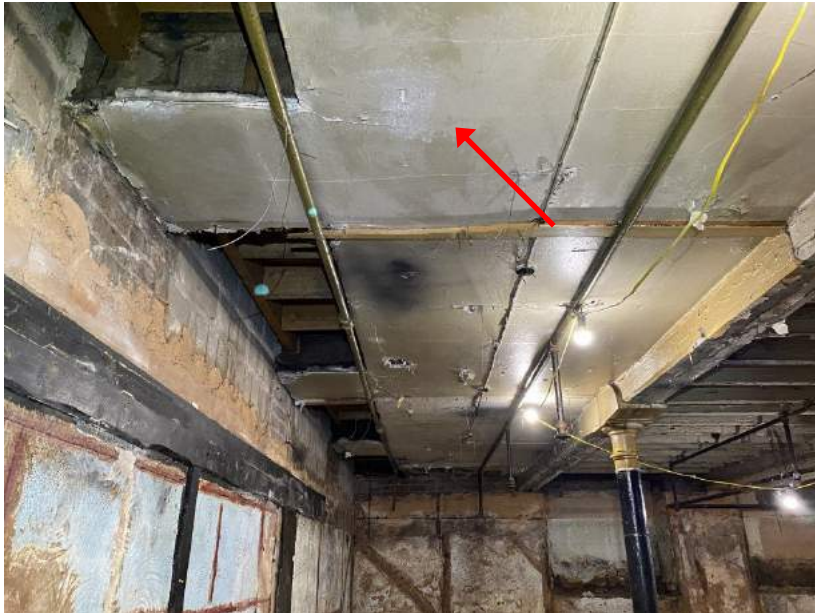
**Fig 93:**

Lower Ground Floor; showing lath and plaster applied to the underside of the floor joists to the north-east bay. The addition of services had caused widespread mechanical damage to the lime plaster resulting in widespread cracking
