# ASBESTOS DEMOLITION SURVEY

110 Brunswick Street, Manchester, M13 9ST

PR-102

| Site Description | Former Community Centre |

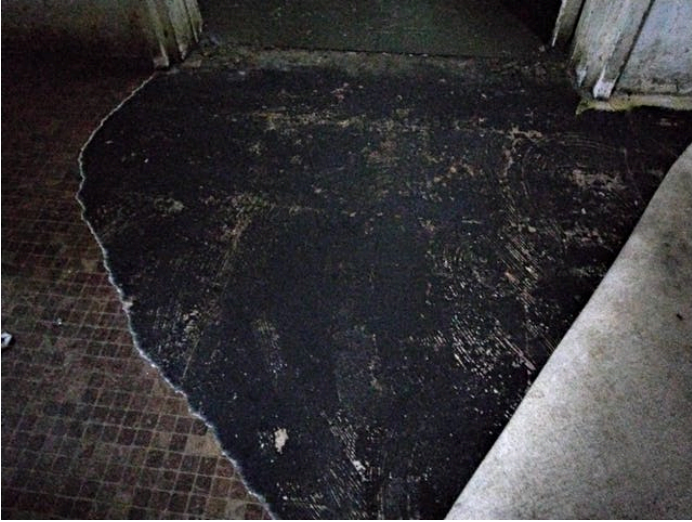
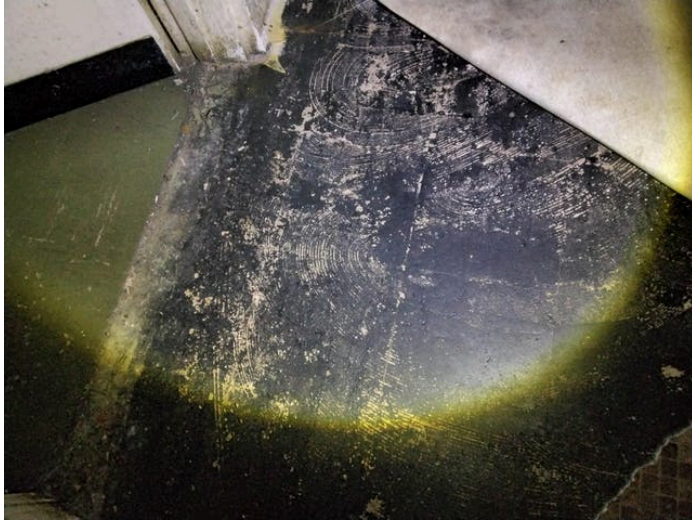
| Material | Adhesive | Extent | 16 m. sq. |
| Strategy / Sample Id | Sample / 001 | Fibre Type | Chrysotile |

| Product Type (or Debris from Product) | 1 | Extent of Damage / Deterioration | 0 |

| Recommendation | Remove | | |

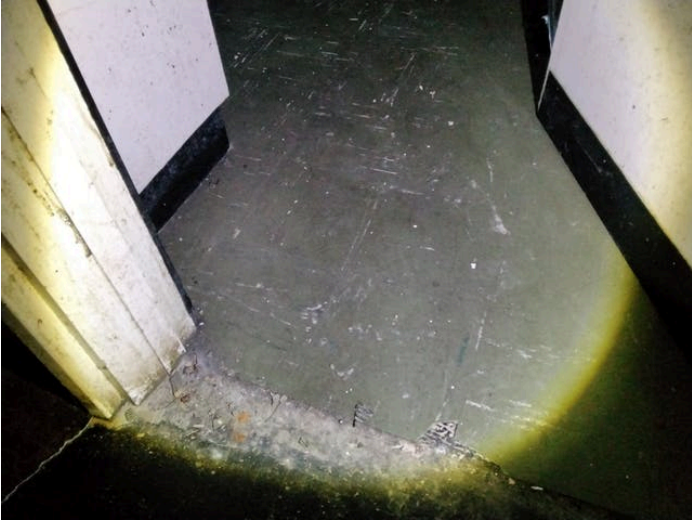
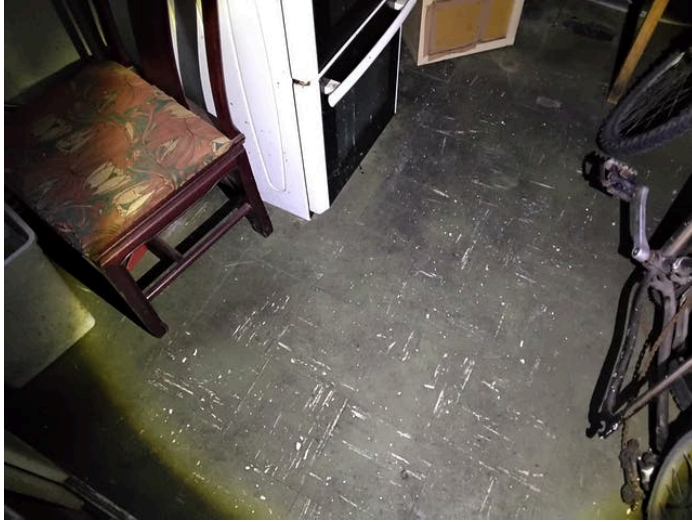
## Community Centre Building > 0 > 002 - Kitchen > Green Floor tiles

| Material | Vinyl Tile & Adhesive | Extent | 4 m. sq. |
| Strategy / Sample Id | Sample / 002 | Fibre Type | Chrysotile |

| Product Type (or Debris from Product) | 1 | Extent of Damage / Deterioration | 0 |

| Recommendation | Remove | | |

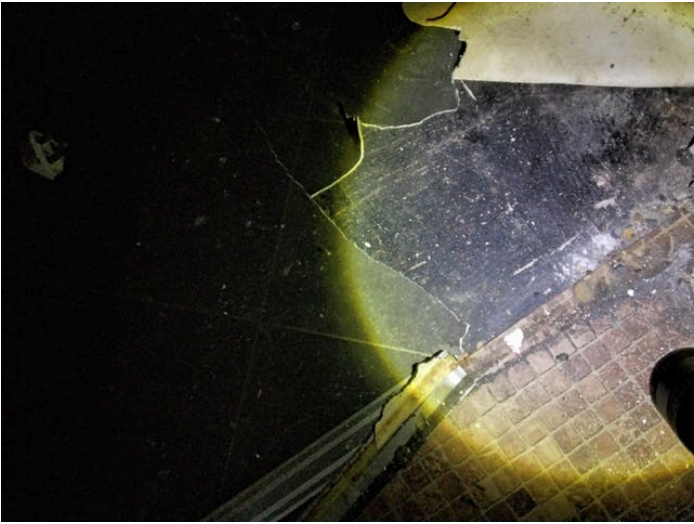
## Community Centre Building > 0 > 003 - Circulation > Bitumen

| Material | Adhesive | Extent | 5 m. sq. |
| | | Strategy / Sample Id | Strongly Presume / 001 |
| | | Presumed Fibre Type | Chrysotile |

| Product Type (or Debris from Product) | 1 | Extent of Damage / Deterioration | 0 |

| Recommendation | Remove | | |

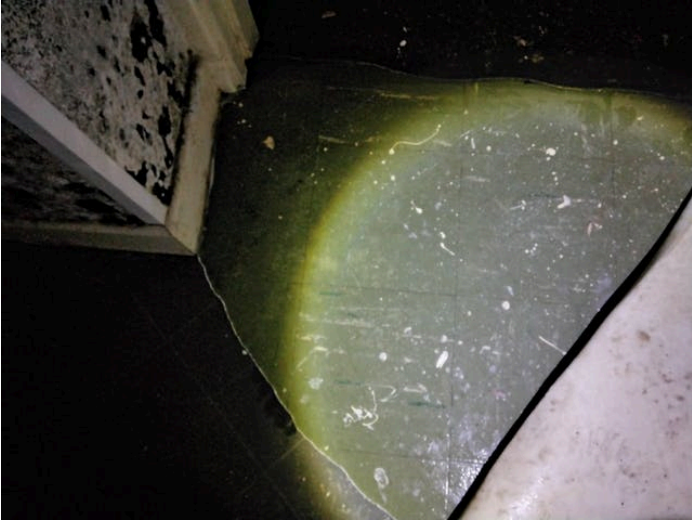
## Community Centre Building > 0 > 004 - Bedroom > Green Floor tiles

| Material | Vinyl Tile & Adhesive | Extent | 6 m. sq. |
| Strategy / Sample Id | Strongly Presume / 002 | Presumed Fibre Type | Chrysotile |

| Product Type (or Debris from Product) | 1 | Extent of Damage / Deterioration | 0 |

| Recommendation | Remove | | |

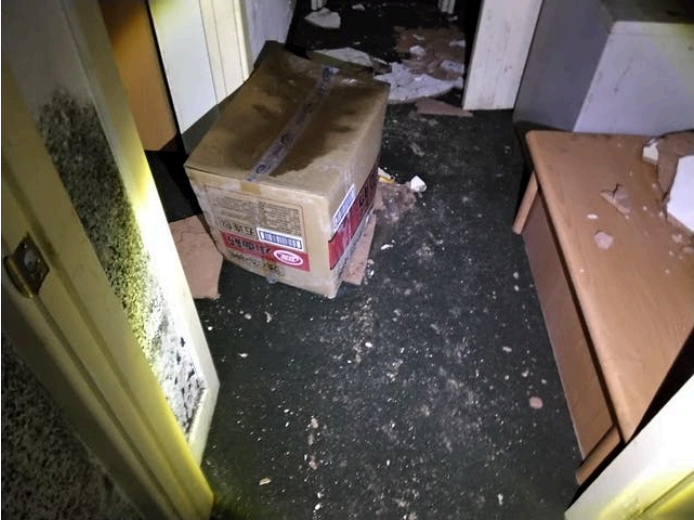
## Community Centre Building > 0 > 005 - Circulation > Green Floor tiles

| Material | Vinyl Tile & Adhesive | Extent | 3 m. sq. |
| Strategy / Sample Id | Strongly Presume / 002 | Presumed Fibre Type | Chrysotile |

| Product Type (or Debris from Product) | 1 | Extent of Damage / Deterioration | 0 |

| Recommendation | Remove | | |

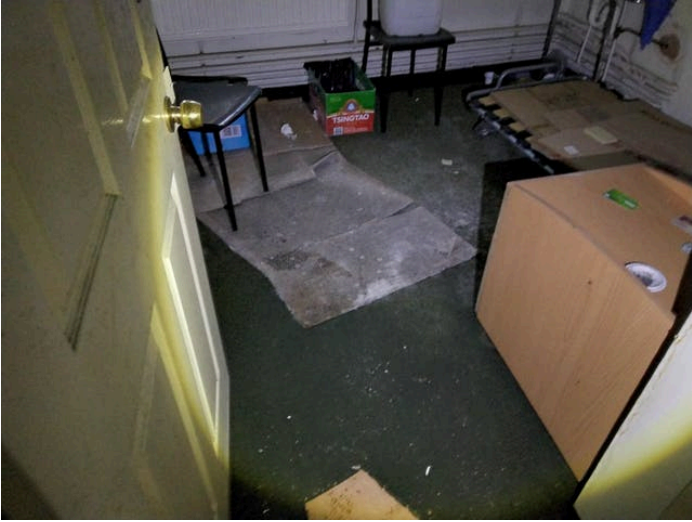
## Community Centre Building > 0 > 006 - Bedroom > Green Floor tiles

| Material | Vinyl Tile & Adhesive | Extent | 6 m. sq. |
| Strategy / Sample Id | Strongly Presume / 002 | Presumed Fibre Type | Chrysotile |

| Product Type (or Debris from Product) | 1 | Extent of Damage / Deterioration | 0 |

| Recommendation | Remove | | |

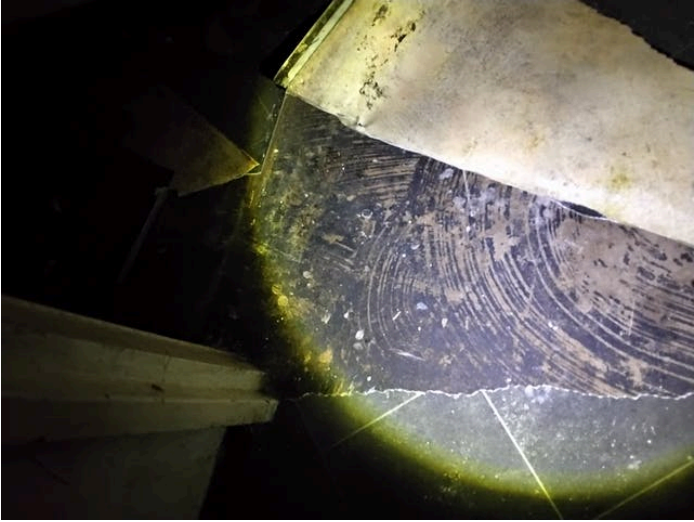
## Community Centre Building > 0 > 007 - Circulation > Bitumen

| Material | Adhesive | Extent | 3 m. sq. |
| | | Strategy / Sample Id | Strongly Presume / 001 |
| | | Presumed Fibre Type | Chrysotile |

| Product Type (or Debris from Product) | 1 | Extent of Damage / Deterioration | 0 |

| Recommendation | Remove | | |

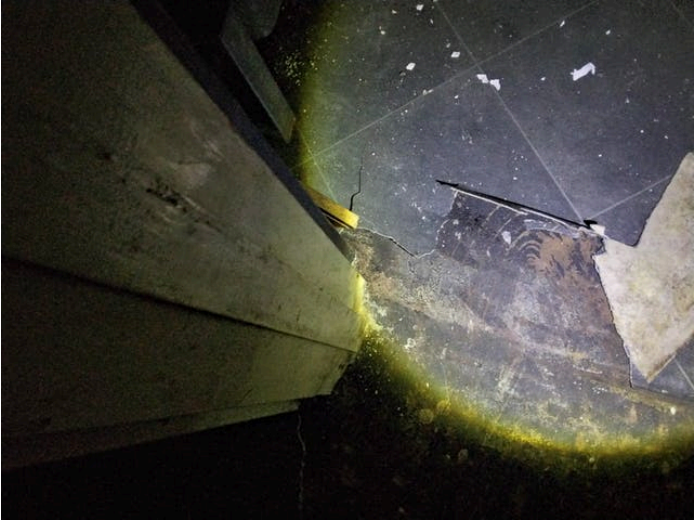
## Community Centre Building > 0 > 008 - Shower Room > Bitumen

| Material | Adhesive | Extent | 3 m. sq. |
| | | Strategy / Sample Id | Strongly Presume / 001 |
| | | Presumed Fibre Type | Chrysotile |

| Product Type (or Debris from Product) | 1 | Extent of Damage / Deterioration | 0 |

| Recommendation | Remove | | |

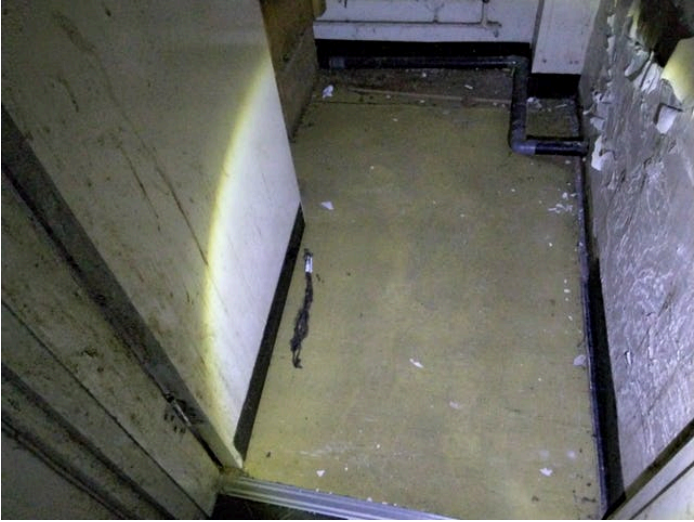
## Community Centre Building > 0 > 010 - W.C > Bitumen

| Material | Adhesive | Extent | 5 m. sq. |
| Strategy / Sample Id | Strongly Presume / 001 | Presumed Fibre Type | Chrysotile |

| Product Type (or Debris from Product) | 1 | Extent of Damage / Deterioration | 0 |

| Recommendation | Remove | | |

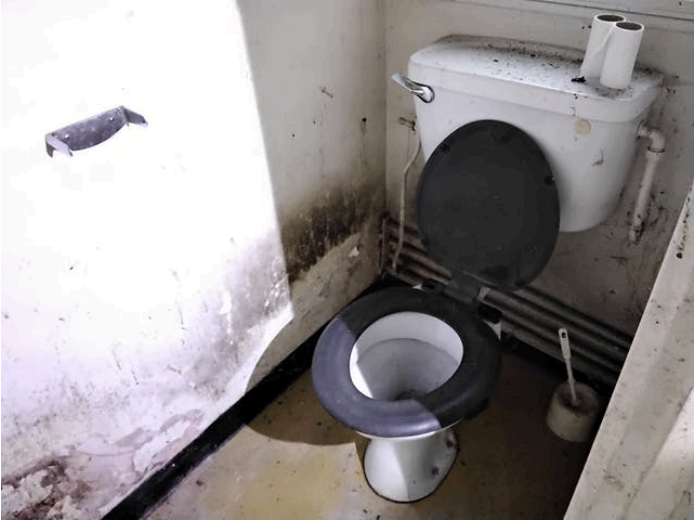
| Material | Composite Bakerlite | Extent | 1 No. |
| Strategy / Sample Id | Sample / 003 | Fibre Type | NADIS |

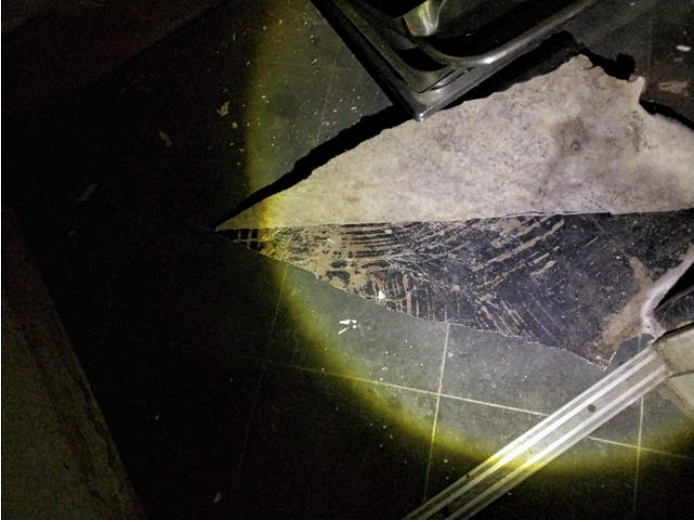
## Community Centre Building > 0 > 011 - Shower Room > Bitumen

| Material | Adhesive | Extent | 3 m. sq. |
| | | Strategy / Sample Id | Strongly Presume / 001 |
| | | Presumed Fibre Type | Chrysotile |

| Product Type (or Debris from Product) | 1 | Extent of Damage / Deterioration | 0 |

| Recommendation | Remove | | |

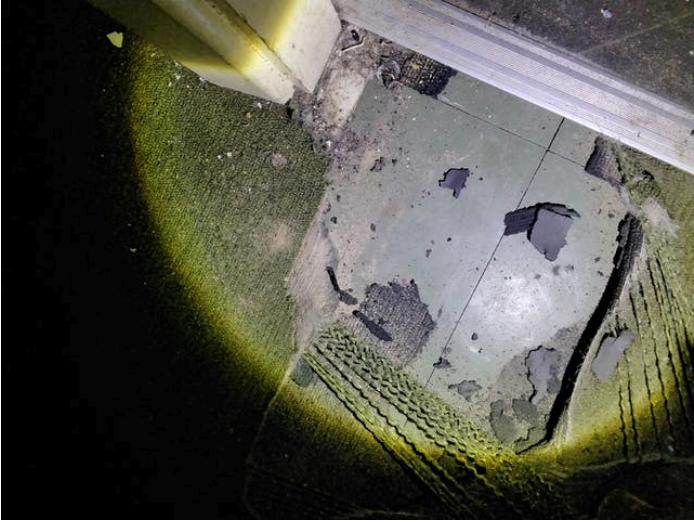
## Community Centre Building > 0 > 012 - Circulation > Green Floor tiles

| Material | Vinyl Tile & Adhesive | Extent | 2 m. sq. |
| Strategy / Sample Id | Strongly Presume / 002 | Presumed Fibre Type | Chrysotile |

| Product Type (or Debris from Product) | 1 | Extent of Damage / Deterioration | 0 |

| Recommendation | Remove | | |

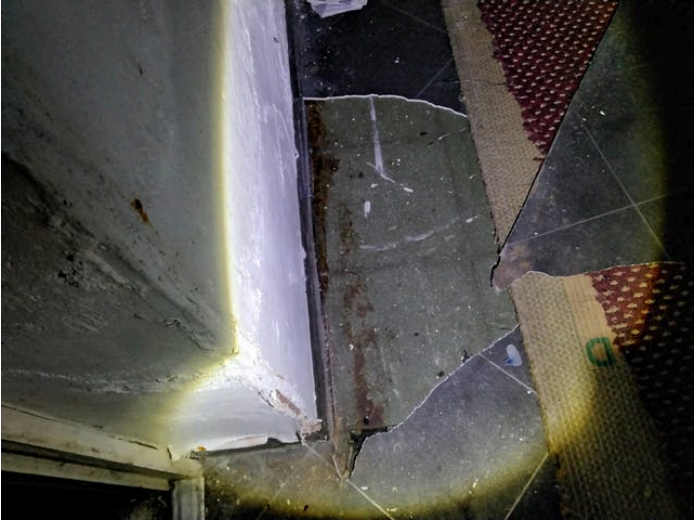
## Community Centre Building > 0 > 013 - Bedroom > Green Floor tiles

| Material | Vinyl Tile & Adhesive | Extent | 6 m. sq. |
| Strategy / Sample Id | Strongly Presume / 002 | Presumed Fibre Type | Chrysotile |

| Product Type (or Debris from Product) | 1 | Extent of Damage / Deterioration | 0 |

| Recommendation | Remove | | |

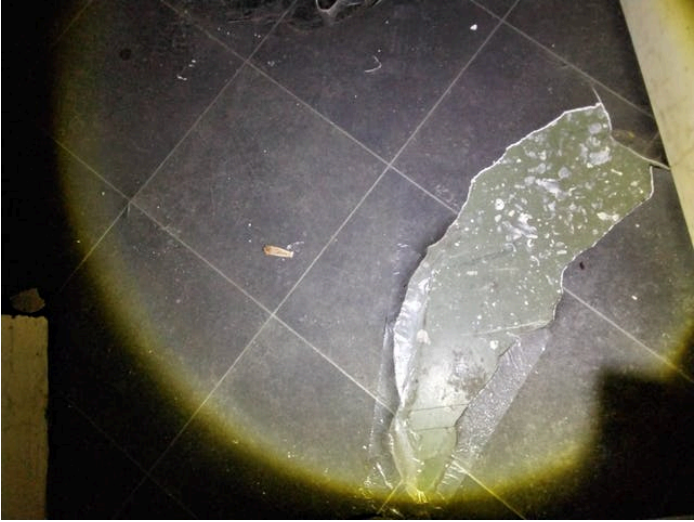
## Community Centre Building > 0 > 014 - Bedroom > Green Floor tiles

| Material | Vinyl Tile & Adhesive | Extent | 8 m. sq. |
| | | Strategy / Sample Id | Strongly Presume / 002 |
| | | Presumed Fibre Type | Chrysotile |

| Product Type (or Debris from Product) | 1 | Extent of Damage / Deterioration | 0 |

| Recommendation | Remove | | |

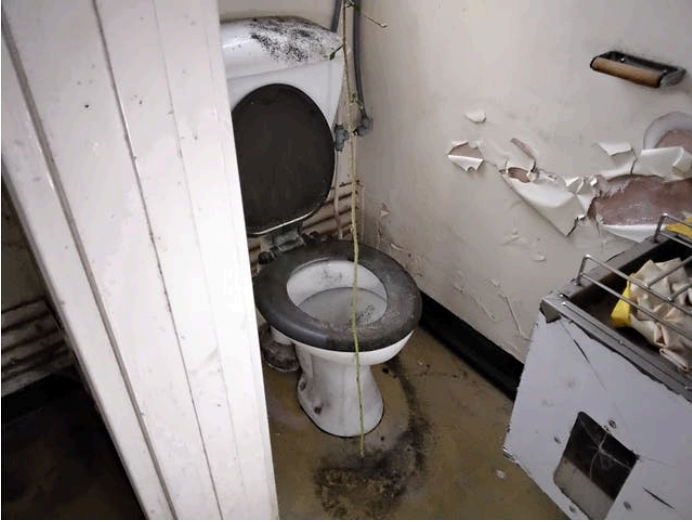
## Community Centre Building > 0 > 015 - W.C > Toilet seat

| Material | Composite Bakerlite | Extent | 1 No. |
| Strategy / Sample Id | Strongly Presume / 003 | Presumed Fibre Type | NADIS |

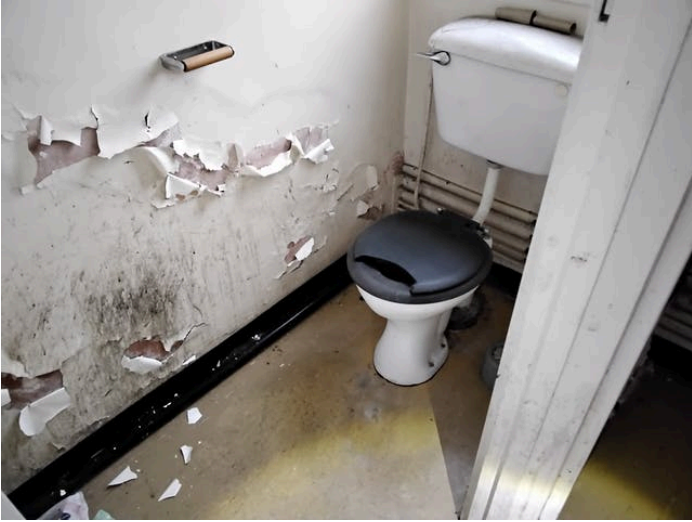
## Community Centre Building > 0 > 017 - W.C > Toilet seat

| Material | Composite Bakerlite | Extent | 1 No. |
| Strategy / Sample Id | Strongly Presume / 003 | Presumed Fibre Type | NADIS |

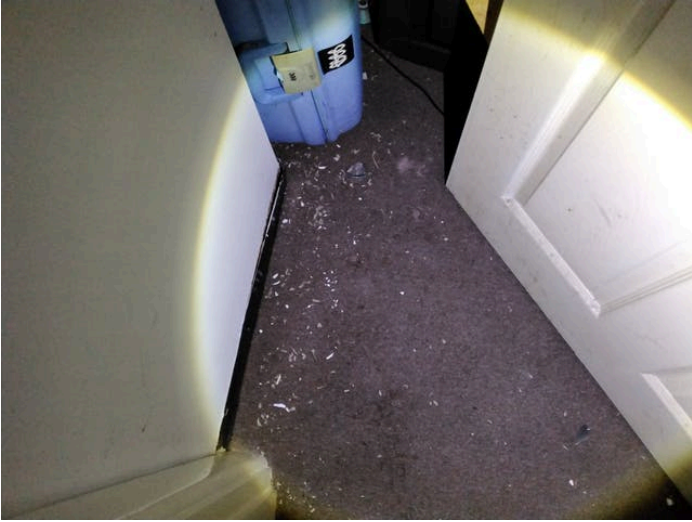
## Community Centre Building > 0 > 018 - Store Room > Green Floor tiles

| Material | Vinyl Tile & Adhesive | Extent | 8 m. sq. |
| Strategy / Sample Id | Strongly Presume / 002 | Presumed Fibre Type | Chrysotile |

| Product Type (or Debris from Product) | 1 | Extent of Damage / Deterioration | 0 |

| Recommendation | Remove | | |

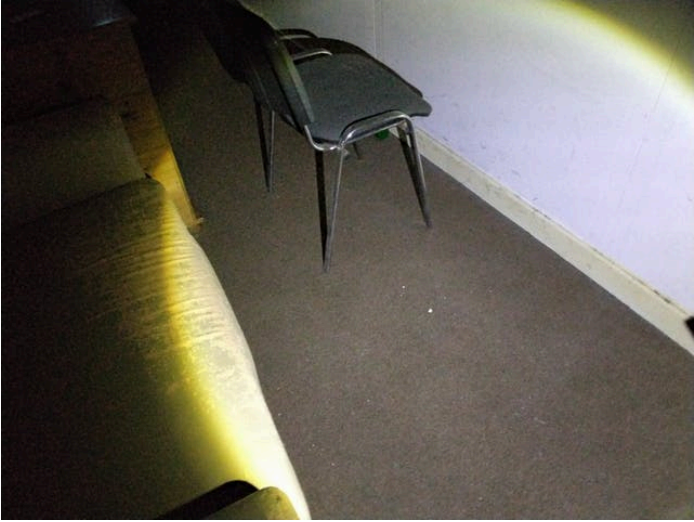
| Material | Vinyl Tile & Adhesive | Extent | 10 m. sq. |
| Strategy / Sample Id | Strongly Presume / 002 | Presumed Fibre Type | Chrysotile |

| Product Type (or Debris from Product) | 1 | Extent of Damage / Deterioration | 0 |

| Recommendation | Remove | | |

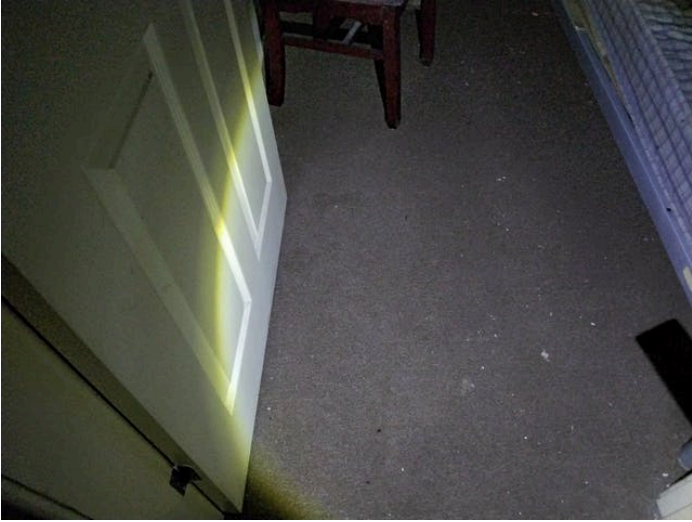
| Material | Vinyl Tile & Adhesive | Extent | 10 m. sq. |
| Strategy / Sample Id | Strongly Presume / 002 | Presumed Fibre Type | Chrysotile |

| Product Type (or Debris from Product) | 1 | Extent of Damage / Deterioration | 0 |

| Recommendation | Remove | | |

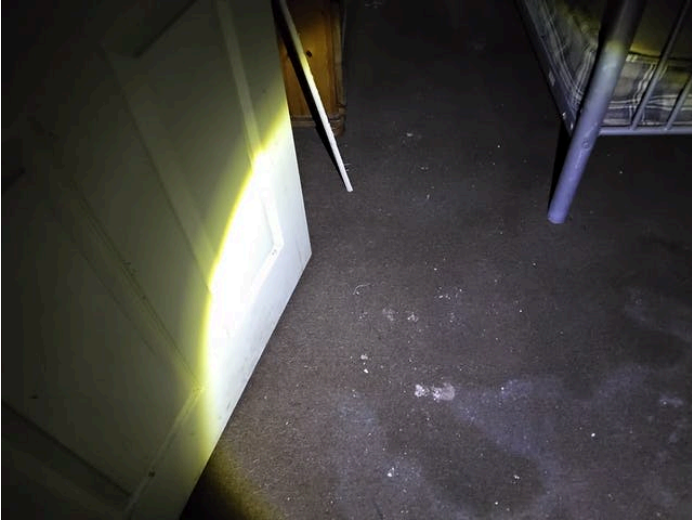
| Material | Vinyl Tile & Adhesive | Extent | 10 m. sq. |
| Strategy / Sample Id | Strongly Presume / 002 | Presumed Fibre Type | Chrysotile |

| Product Type (or Debris from Product) | 1 | Extent of Damage / Deterioration | 0 |

| Recommendation | Remove | | |

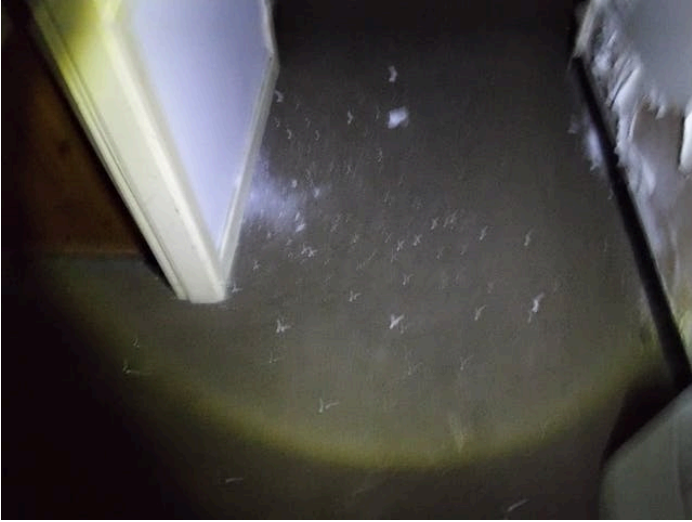
| Material | Vinyl Tile & Adhesive | Extent | 3 m. sq. |
| Strategy / Sample Id | Strongly Presume / 002 | Presumed Fibre Type | Chrysotile |

| Product Type (or Debris from Product) | 1 | Extent of Damage / Deterioration | 0 |

| Recommendation | Remove | | |

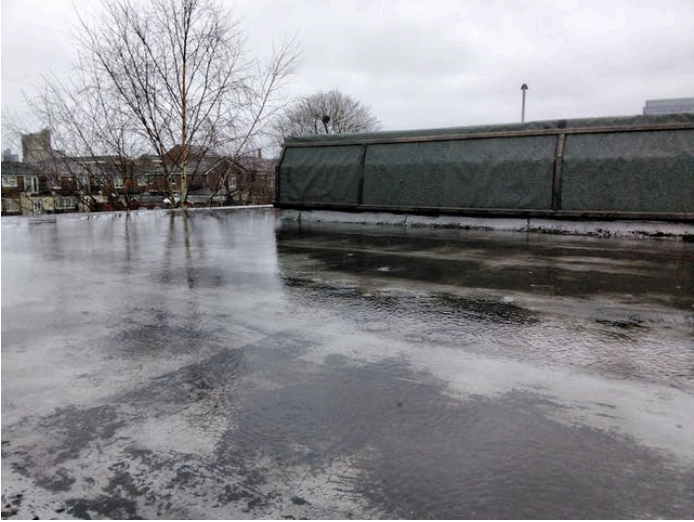
| Material | Bituminous Felt | Extent | 150 msq |
| Strategy / Sample Id | Sample / 005 | Fibre Type | NADIS |

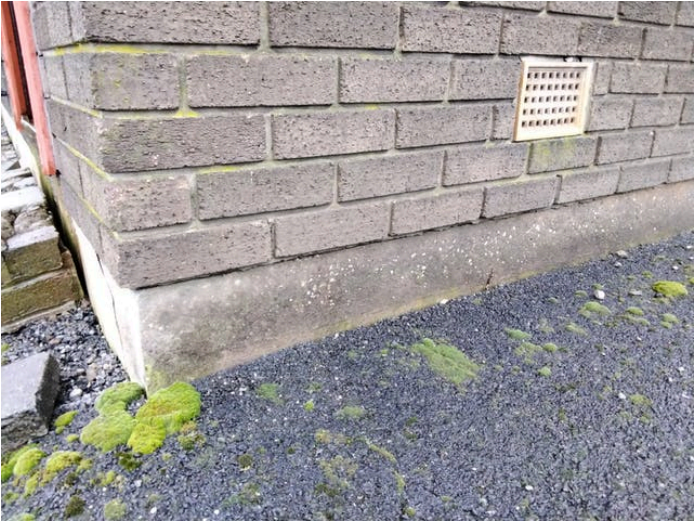
| Material | Bituminous Product | Extent | 60 lm |
| Strategy / Sample Id | Sample / 006 | Fibre Type | NADIS |

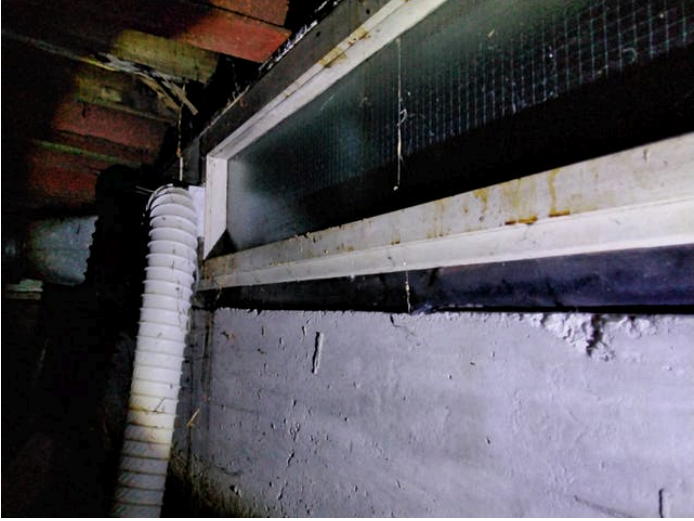
| Material | Bituminous Product | Extent | 10 lm |
| Strategy / Sample Id | Sample / 004 | Fibre Type | NADIS |
