## **WHITECHAPEL ART PLASTER SURVEY**

**Piccadilly Warehouse, 11 Bloom Street &  
Mindel House, Manchester**

3<sup>rd</sup> September 2021

Manchester Design & Build

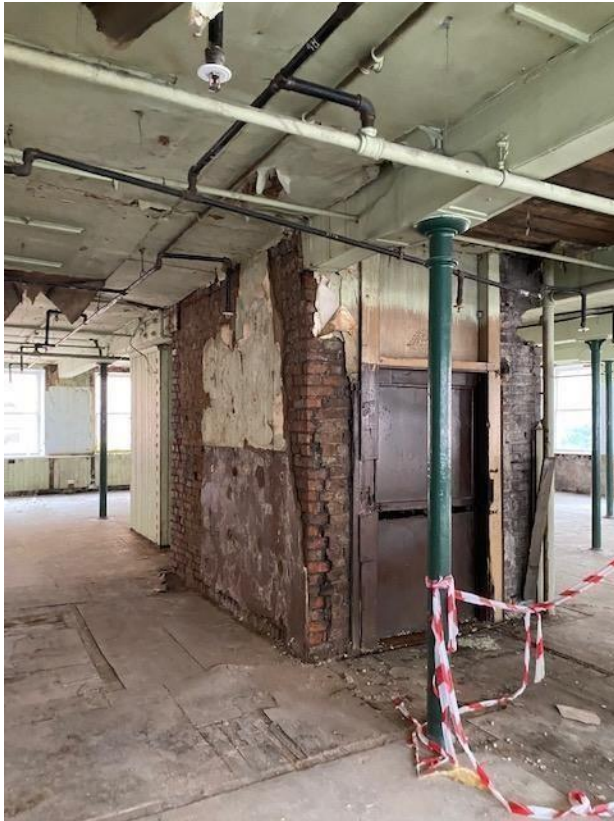
There are damaged timber window reveals to the fourth floor with a bull nose finish rather than a sharp arris which are set out to work with the finished plaster lines. Where these window liners are damaged or missing new timber liners should be made and fixed in place and set to work with new solid plaster work. A mix of materials can be found used in the surface wall finishes. There are areas of original solid lime plaster, areas of lath and plaster and contemporary gypsum base coats and plaster boards, with other areas bonded and over

Mindel House Fourth Floor wall lime plaster

On the fourth floor all the original lime plaster should be removed and replaced. Because of historical moisture ingress and channels cut into plaster work, an allowance of up to sixty percent of the wall plaster finishes should be made. On the access to the stair ways an allowance of up to thirty five percent of the lath and plasterwork should be made. In the basement all wall, ceiling plaster and wall plaster should be removed and either a tanking system or water controlling drained cavity system should be installed to manage and control this below external ground level environment, together with adequate ventilation in this area.

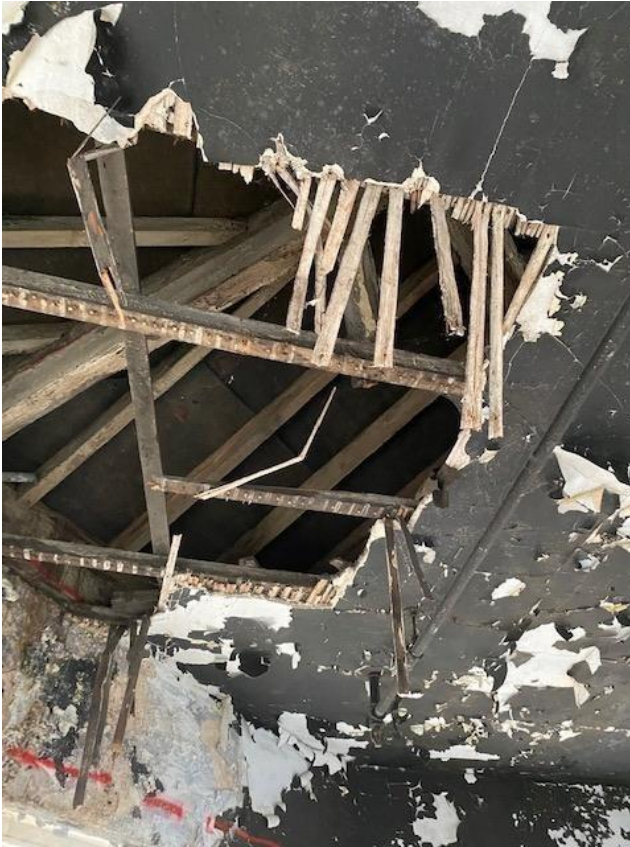
The fourth floor of the building has a lath and plaster ceiling which is in a poor state of repair and with de-bonded (live) lime plaster work in three coats; scratch, float and setting. The plaster work is falling away from the ceiling joist and lath substrate to which it should adhere.

There is some water damage, perished plaster and what possibly may be past fire damage. The building also looks as though it has been subject to structural movement as lateral restraint bars run through the building and are anchored on external brickwork surfaces with steel round plates. This movement may have caused some cracking and distortion of plasterwork, substrates and grounds, but a bigger problem is that the ceiling joists are under sized and over stressed and do not appear to be fit for purpose. As a consequence, much of the timber work supporting the plaster ceilings is bowing, splitting and has in some areas snapped right through the ceiling joists which are not strong enough or sufficiently hung or braced to support the ceiling. The full ceiling should be replaced.

Mindel House Fourth Floor Lath and Plaster Ceiling

**Mindel House** requires extensive plaster removal and reinstatement. The lath and plaster ceiling on the fourth floor is not fit for purpose either now or when it was installed and should be removed and replaced.

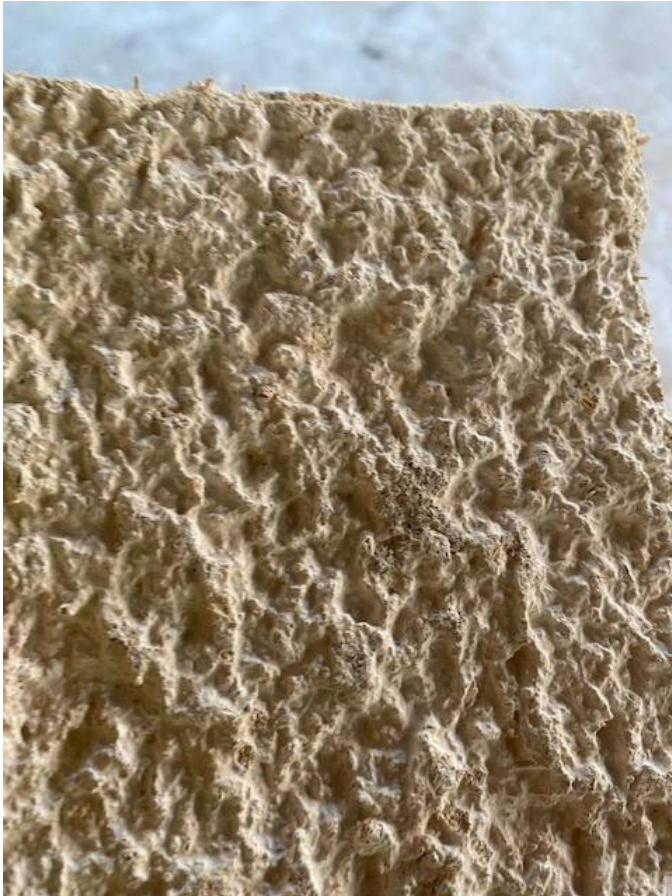
**Third floor fibrous plain face work from third floor partition**

5. To machine and set in place each damaged or decayed window reveal £
6. To repair the front entrance ornamental ceiling to Mindel House £
7. To manufacture fix and finish fibrous plain faced partition finishes £

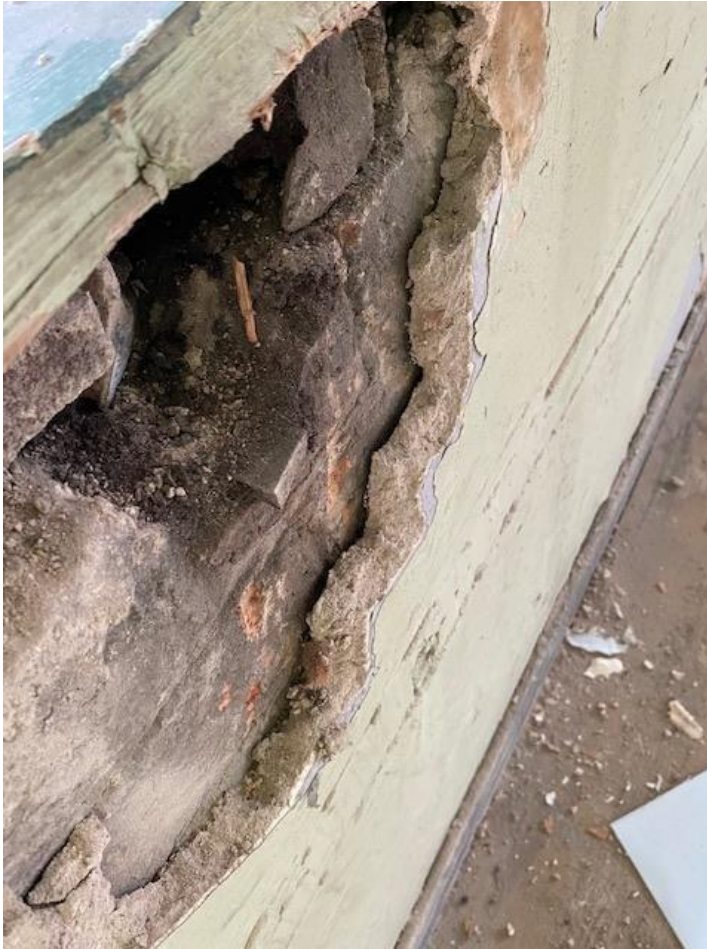
Lime plaster losing its adhesive bond to the brick substrate

All areas of de-bonded plaster marked on the drawings or identified as beyond repair and requiring removal to be stripped back to the substrate and re-plastered in a compatible traditional lime plaster mix. The plaster mixes are to be assessed on a floor by floor basis, and area by area basis, on each floor, as the existing perished and de-bonded plasters are stripped back, and removed from site. New lime plaster mixes to be as near to the petrographic analysis of original plaster as is reasonably practicable, in accordance with results obtained by Hutton and Rostron; see plaster specification in item 4 on page 13 of this report.

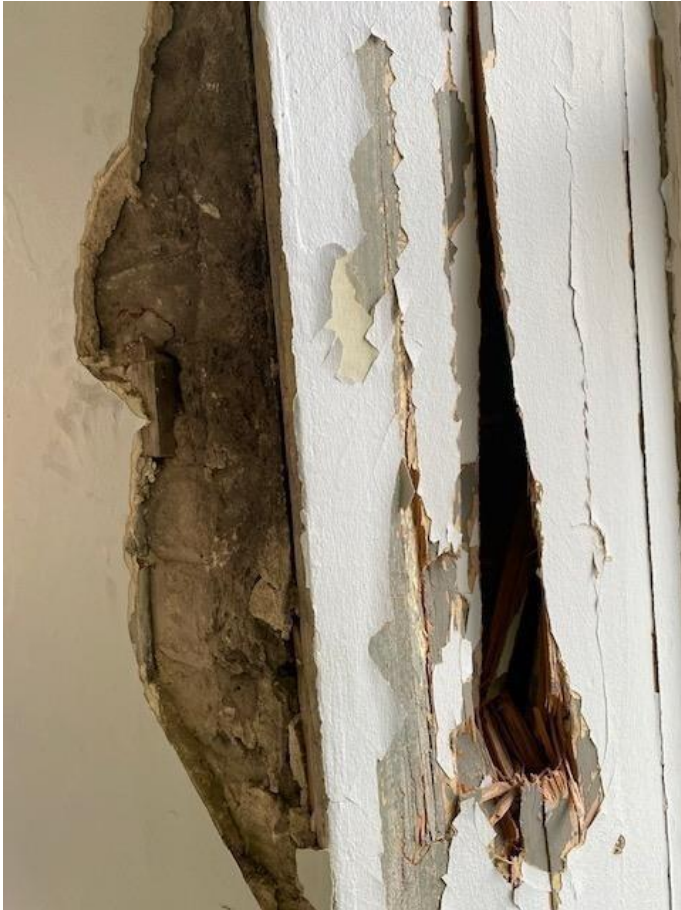
**Damaged timber window reveals**

Where timber window reveals are missing or decayed on the floors of Mindel House bespoke sections should be made and fixed in place prior to re-plastering works.

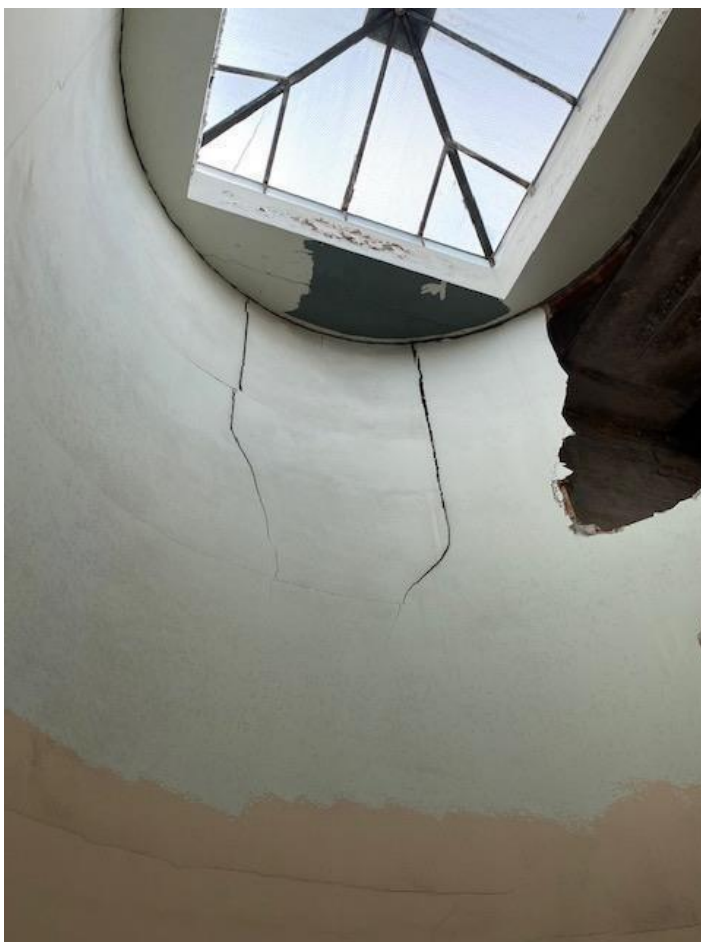
Mindel cracking modern to upper plaster work around staircase

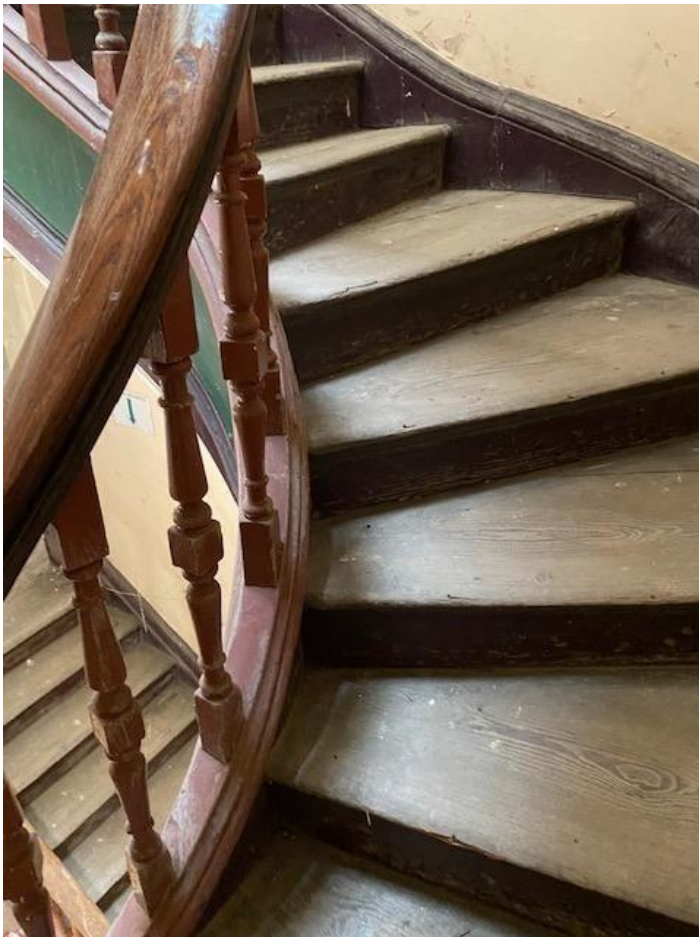
This is a complex structure which shows signs of movement, cracking and some distortion. For this reason a surveyors endoscope was used to look behind the plaster work to look at the grounds and support for the staircase behind the underside plaster soffit enclosing the staircase. We found, where the scope was put through the staircase soffit, that some contemporary gypsum plasters have been used to over skim this soffit and that the walls enclosing the stair case have also been subject to bond, board and over skim. In line with the specification for Mindel House these sections of plaster work should be removed, including the stair soffit, this will allow for an engineer to access the component parts of the staircase and to make recommendations to strengthen where necessary to ensure adequate support when it is in use and to prevent further movement, prior to re-forming and plastering the staircase soffit and walls.

**Above: Staircase treads above cracking falling in to central stair sections and as a consequence out of level**

The soffit of the geometric staircase appears to have been bonded and over skimmed so this should be stripped back and replaced. At the same time this will allow engineers to make an assessment of existing support for the staircase which at present is inadequate as the treads to the middle section of the staircase are out of level and moving in and down on the stair central sections. The plaster work, (including curved wall enclosing the staircase) has boards, bonding and over skim which is also moving with the staircase and is cracking quite severely at higher levels on the stair case. These areas of board and plaster work should also be removed and replaced.

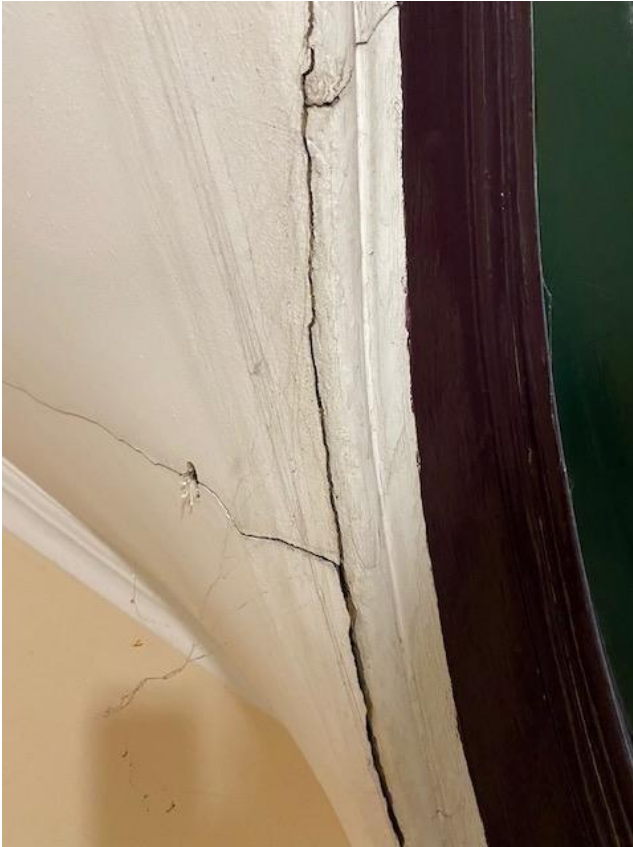
**Above: Cracked and deboned geometric stair soffit**

- 3 To remove soffit from geometric stair case £
- 4 To reinstate soffit to geometric staircase £
- 5 To remove plaster from stair walls £
- 6 To apply lath and lime plaster finishes to stair walls in Bloom House £ (where these walls are partitions the studs and grounds to be fixed by others).
- 7 To template, mould, match and fix missing sections to ornamental plaster ceiling in Bloom House, and make good in situ cracked sections £.
- 8 Scaffold tower hire up to three metre height £ per week each individual tower.

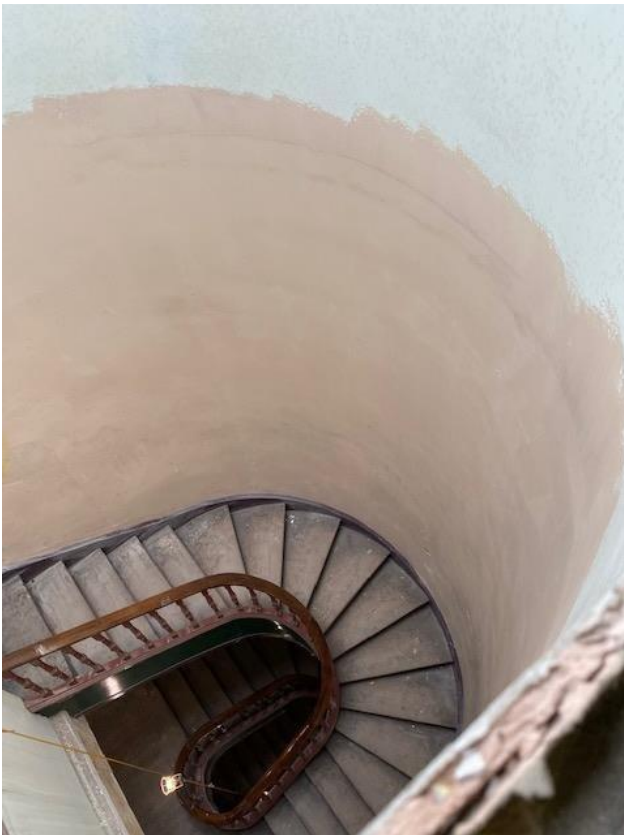
Gypsum plaster enclosing geometric staircase
