# Fraser House Calculations 0001 Preliminary load appraisal

Ref: LM21346-DYSE-XX-ZZ-CA-S-0001

DYSE  
Fraser House  
Manchester

CCTV DRAINAGE SURVEY REPORT

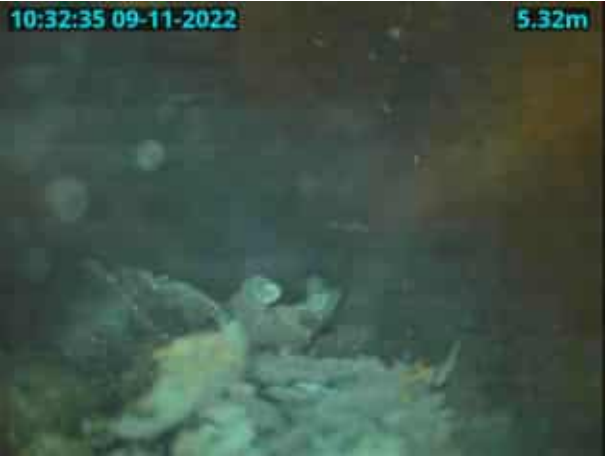
RE  
1X\_529feaf0-5f7e-4972-b3bc-b78d09d2556a\_20221126\_103453\_712.jpg, 00:00:38, 5.32 m  
Settled deposits, fine, 10% cross-sectional area loss

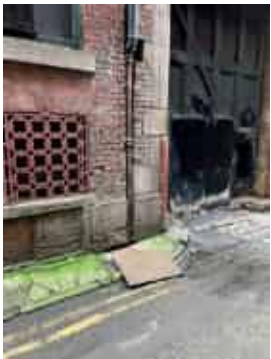
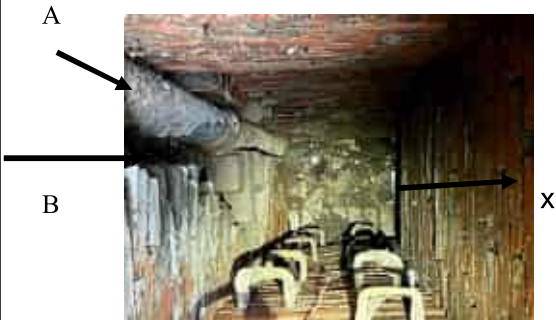
Remarks: Cover broken Step irons poor  
Chamber full of debris– requires cleaning

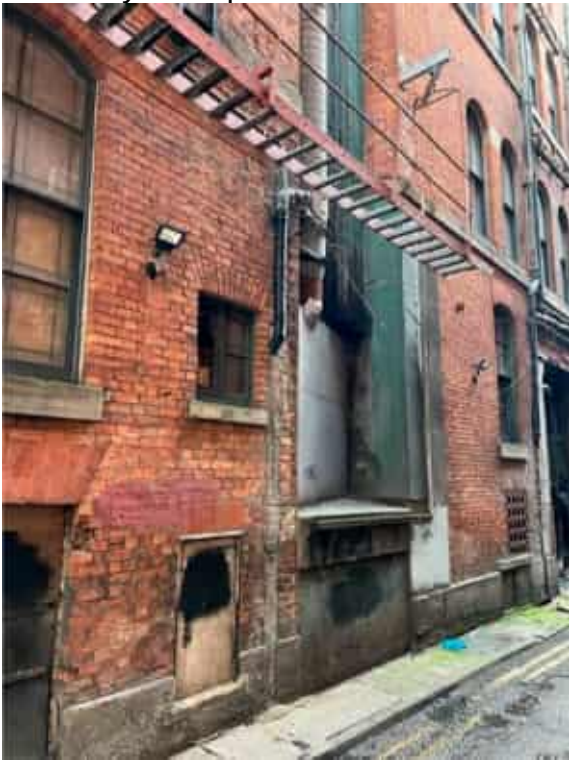
Photo 1, A number of external pipes located to the side of the building, ultimately end up in MH01 and MH02

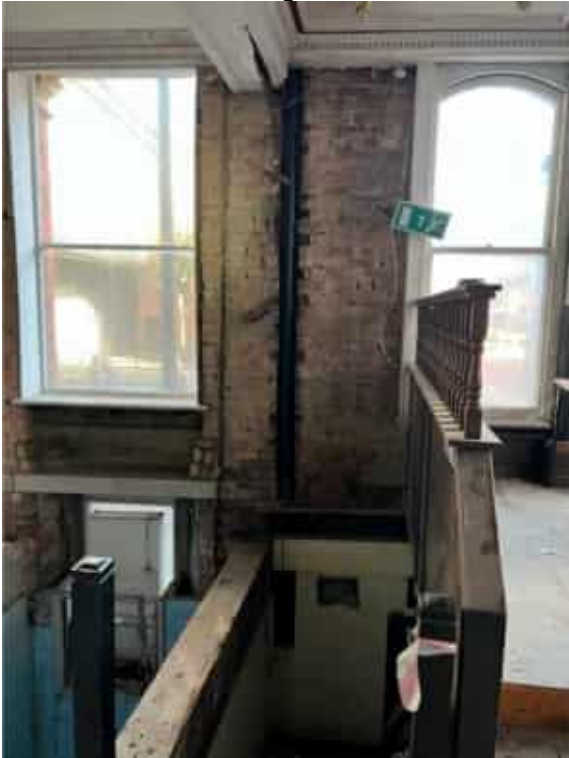
Photo 2, A number of rainwater pipes have been exposed in the wall - assumed to discharge to MH02 and MH01

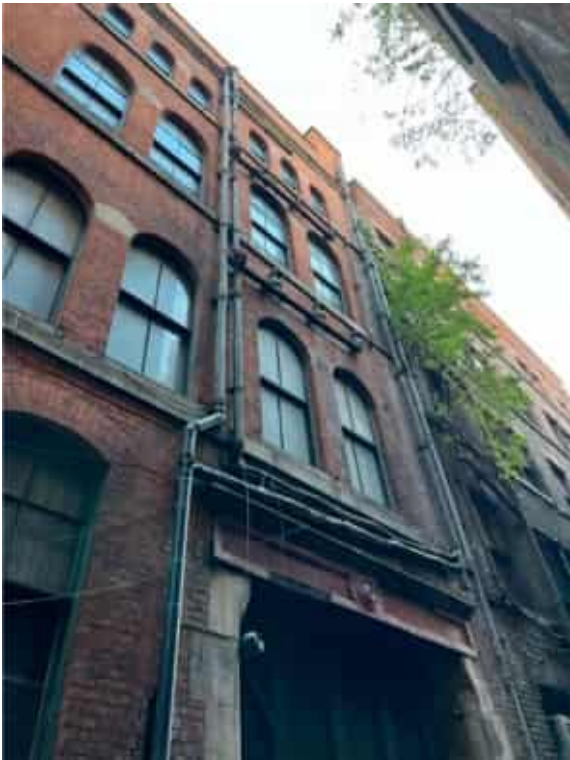
Photo 3, All foul water drainage from upper floor levels is located on the external walls.

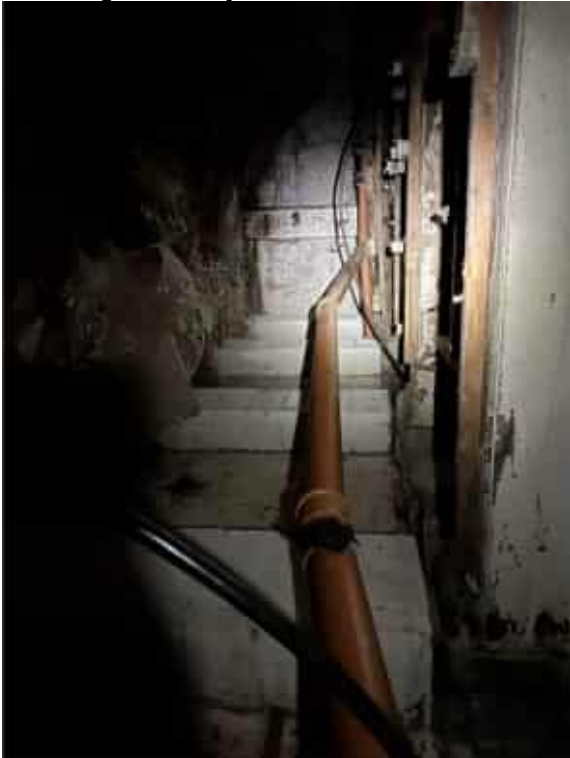
Photo 4, Drainage located in basement - RE1 and RE2 from the CCTV Drainage Survey

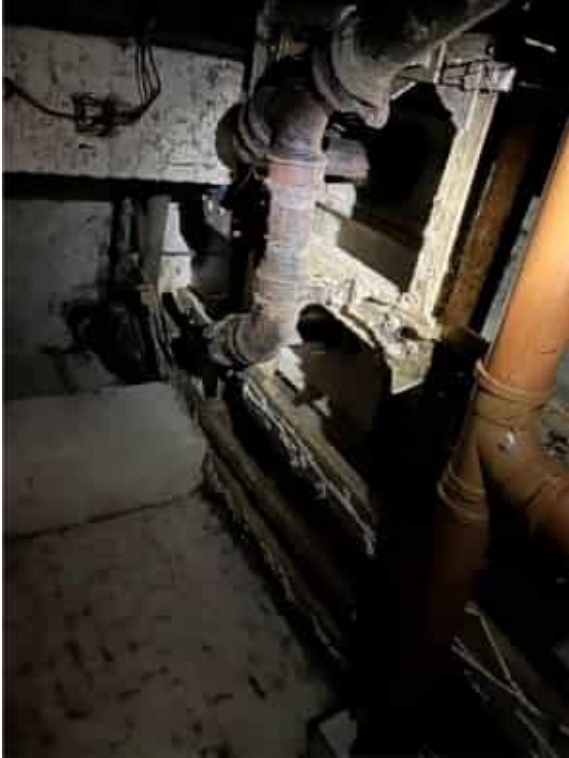
Photo 5, Drainage located in basement - RE2

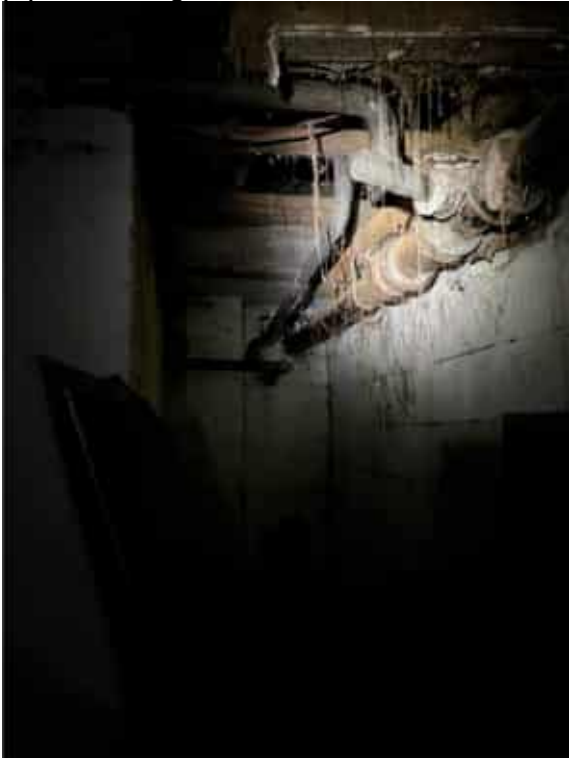
Photo 6, Drainage located in basement - this picture shows the main outfall pipe heading towards MH01

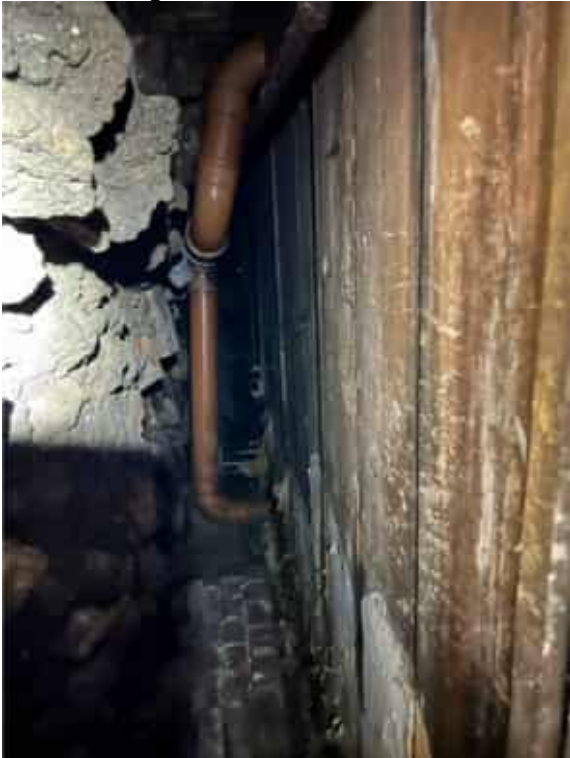
Photo 7, Drainage pipes under the Lower Ground Floor - previously served the existing toilets

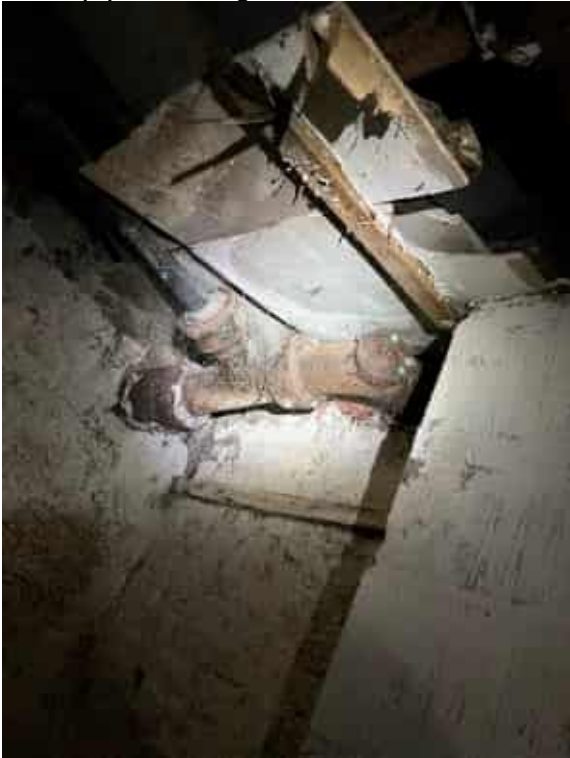
Photo 8, Picture shows the point where the basement sump connects to the main pipe leaving site

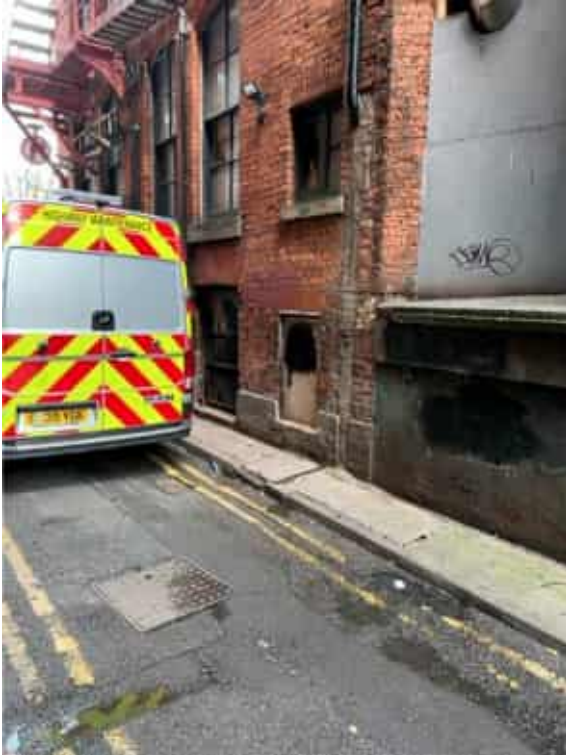
Photo 9, Public sewer manhole location

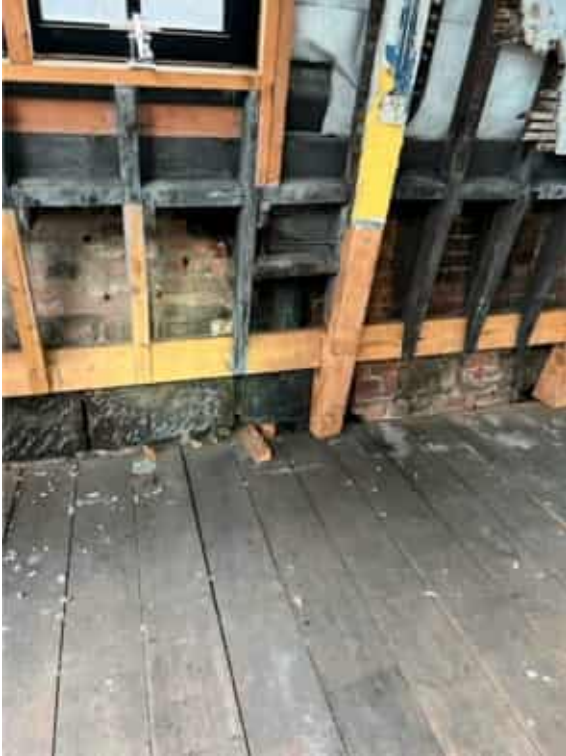
Photo 10, Rainwater pipe hoppers located on the top floor of the building, all discharge directly down to below ground drainage. No access points to rainwater pipes.

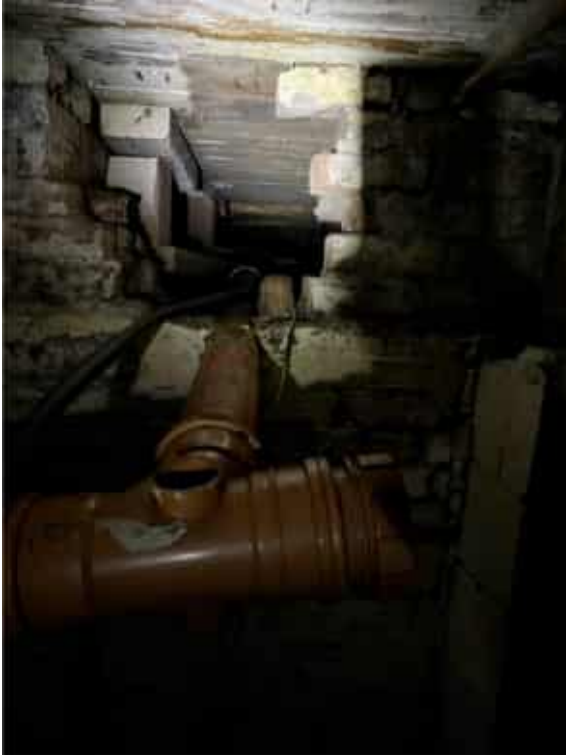
Photo 11, RE1 (rodding point 1) view heading up towards existing toilets

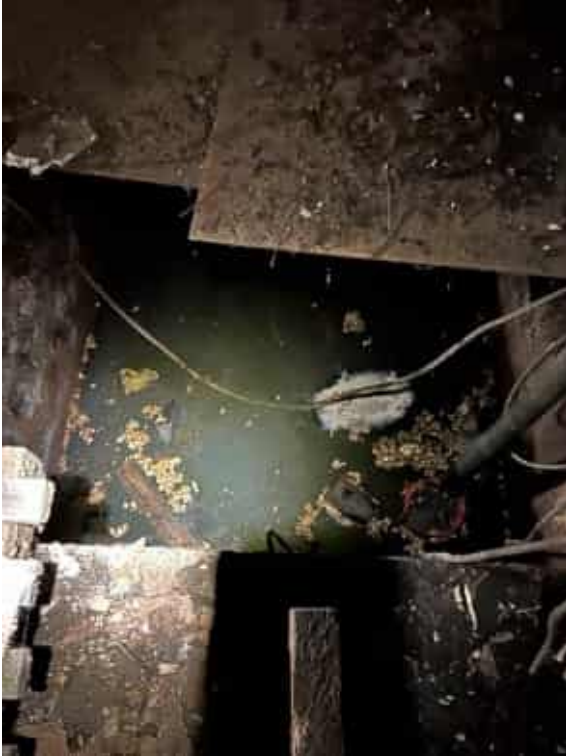
Photo 12, Sump pit located in basement - pumps out to MH2. Believed to be abandoned and disconnected.

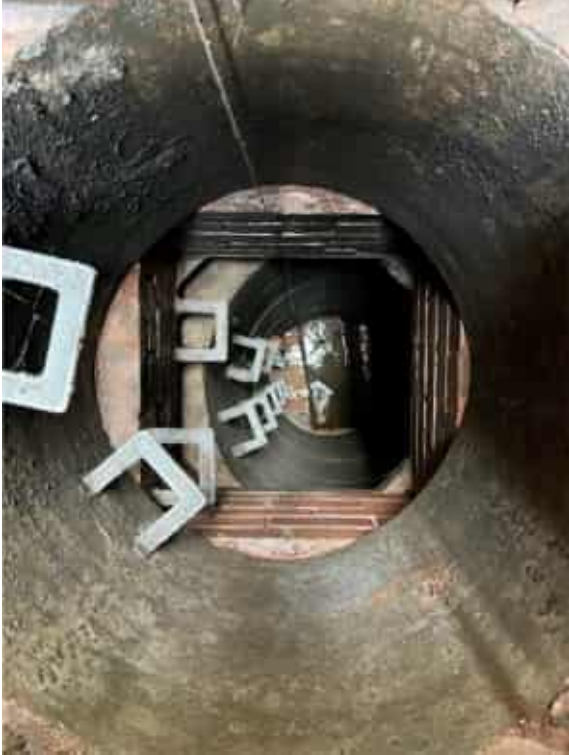
Photo 13, View down public sewer manhole - depth of manhole is 5.18m
