## WINDOW AND CEILING PLASTER CONDITION SURVEY

51-53 RICHMOND STREET, MANCHESTER

JOB NO. 213-41

29 NOVEMBER 2022

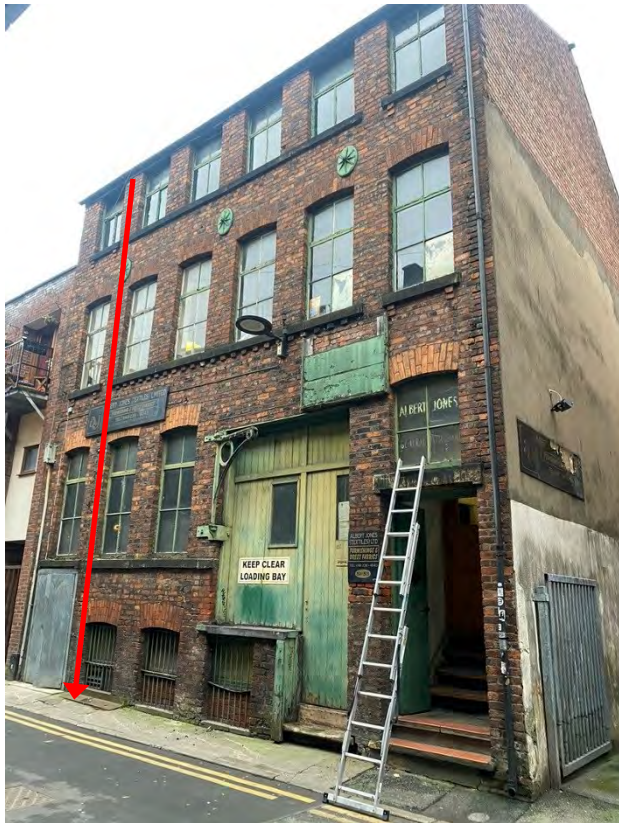
**Fig 1:**

North-west elevation; showing the windows and doors to the front elevation. Window references can be found on the Drawings

Note the original rainwater downpipe location (arrowed). Adjacent 2nd and 1st floor windows would have been at a heightened risk of decay

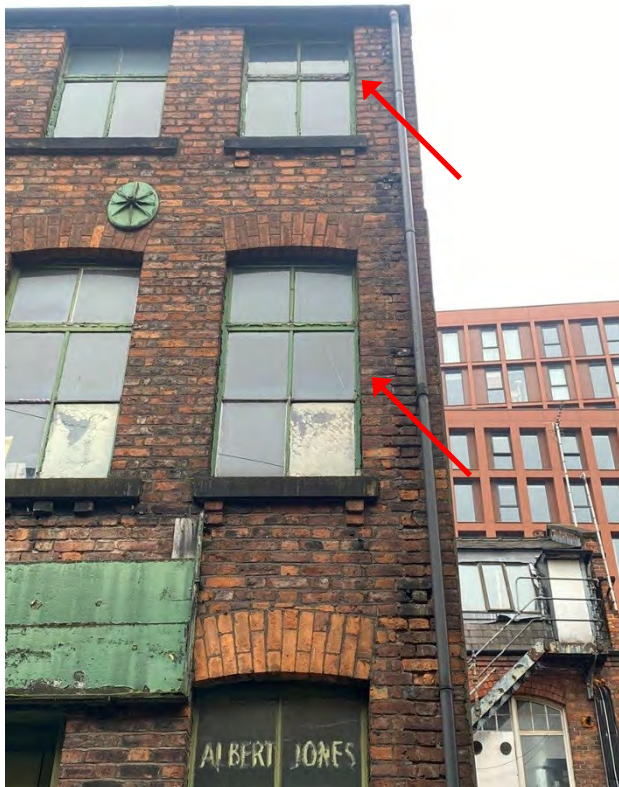
**Fig 2:**

North-west elevation; showing evidence of historical water penetration in the location of the uPVC downpipe. W2.06 and W1.06 are at a heightened risk of decay

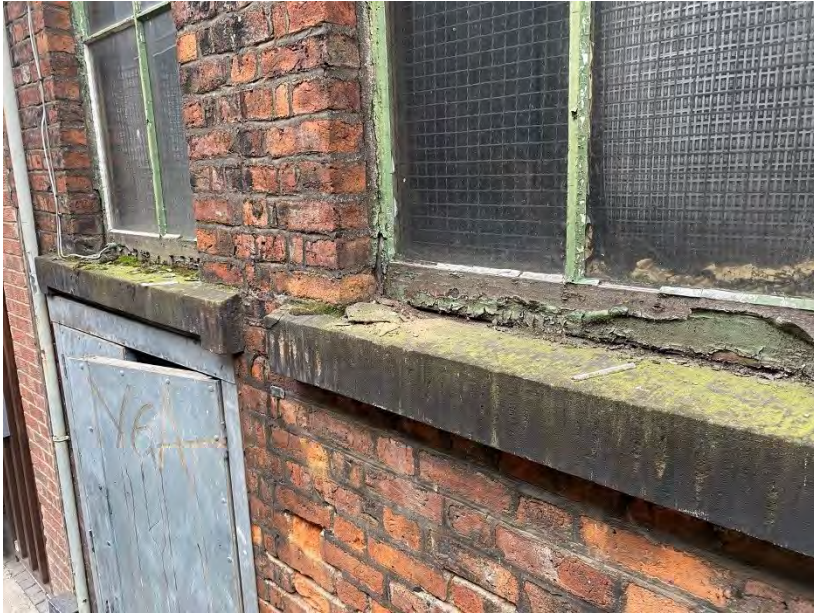
**Fig 3:**

North-west elevation; showing W0.01 and W0.02. The stone sills generally had a good fall but there were some areas of pooling water evident by moss growth. However, no significant timber decay was detected in the frames

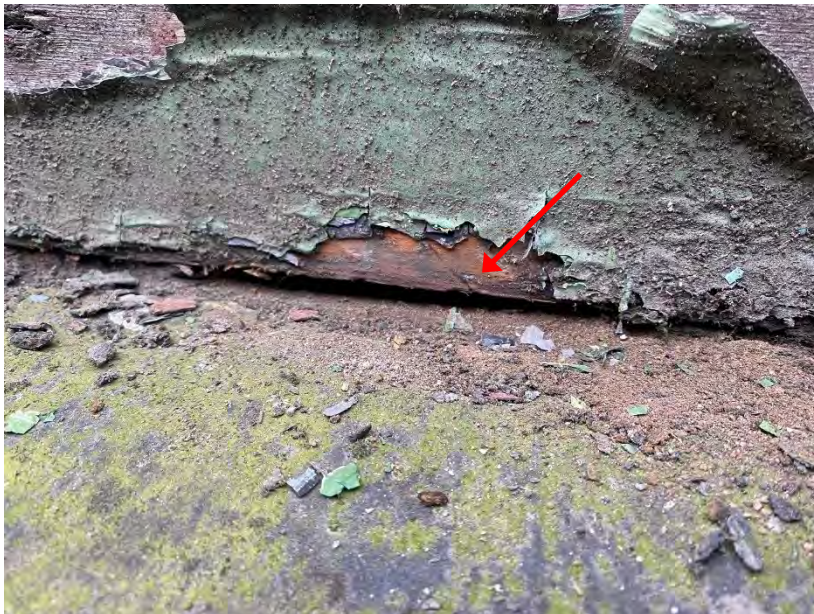
**Fig 4:**

North-west elevation, W0.02; showing exposure of the bottom beneath the numerous layers of paint. No significant timber decay was detected

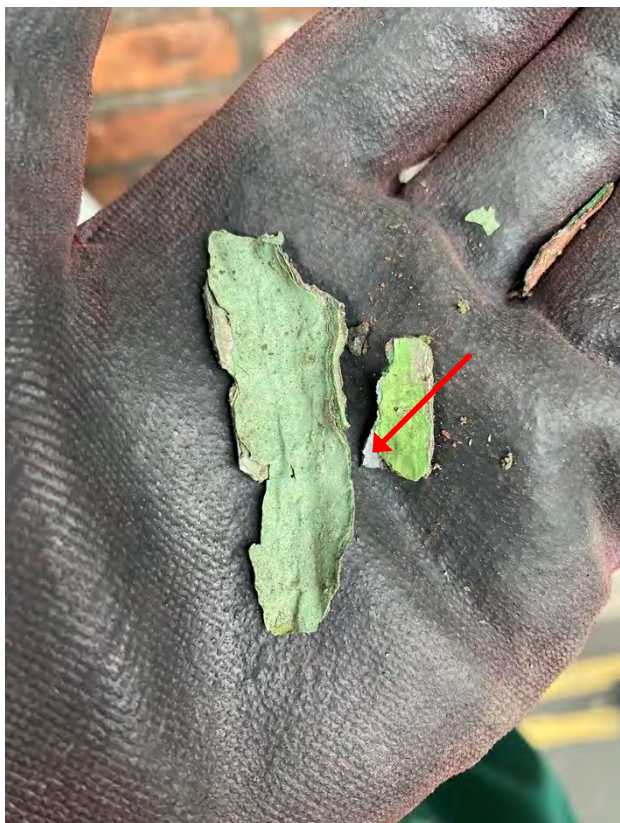
**Fig 6:**

North-west elevation, W0.02; showing build-up of green decorative finishes. Note that there was also a 'baby blue' finish

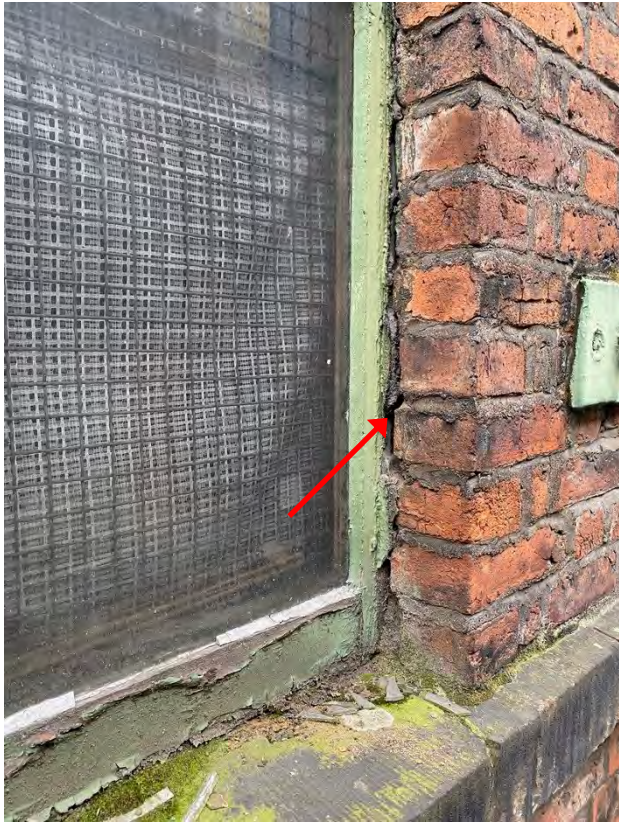
**Fig 7:**

North-west elevation, W0.02; showing missing mortar/mastic sealant at the reveal. No timber decay was detected in the frame where accessible behind the brickwork

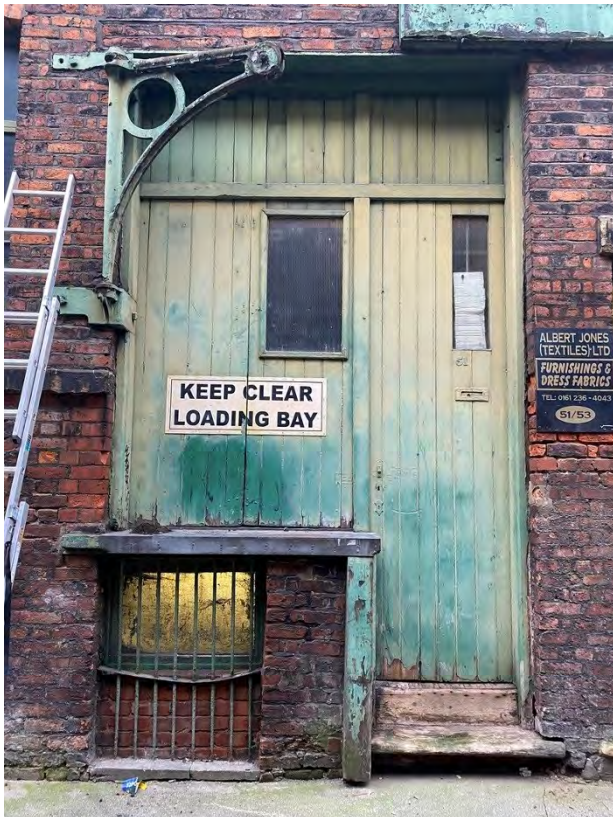
**Fig 8:**

North-west elevation, D.04; showing the tongue and groove softwood loading doors

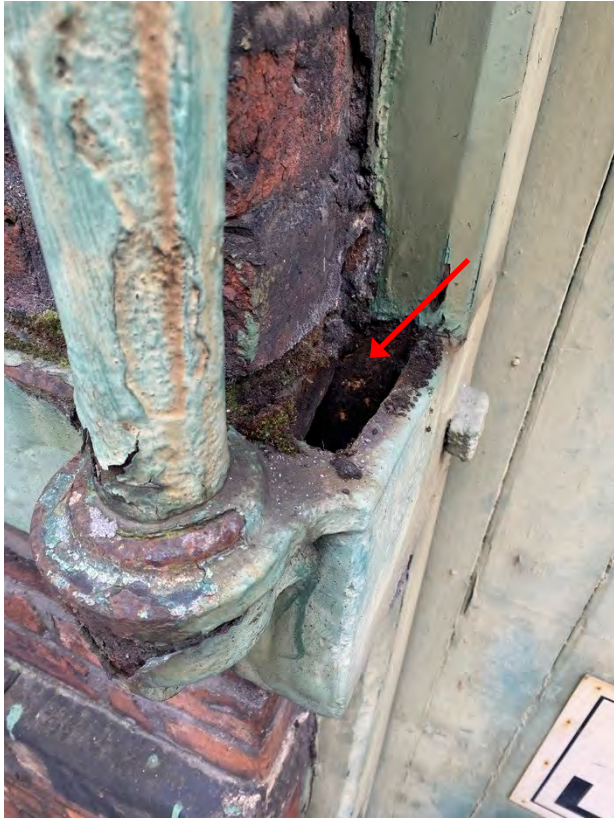
**Fig 9:**

North-west elevation, D.04; showing hinge for the cast-iron winch bracket. The small pocket was filled with debris. The door frame was damp and superficially decayed in this location. Decay was not significant

All debris was removed by H+R

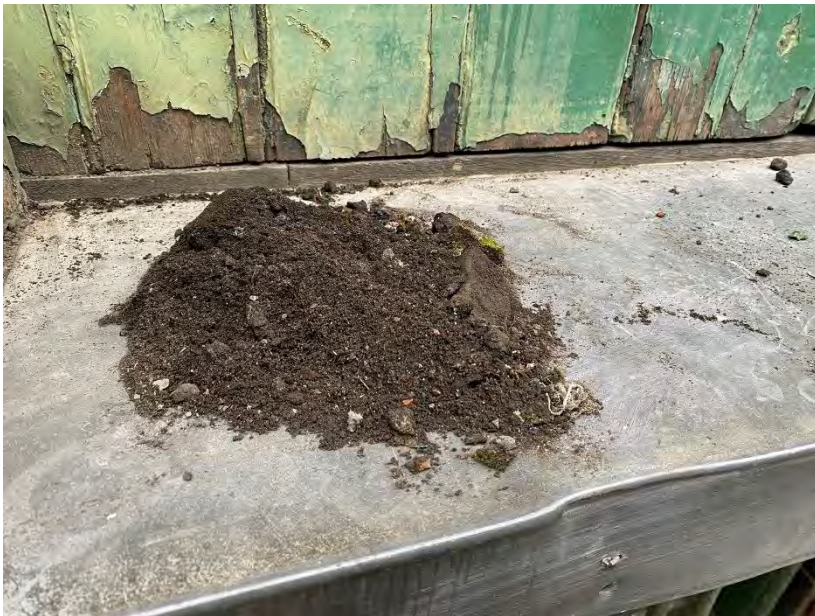
**Fig 10:**

North-west elevation, D.04; showing the accumulation of debris that was removed from the cast-iron hinge pocket

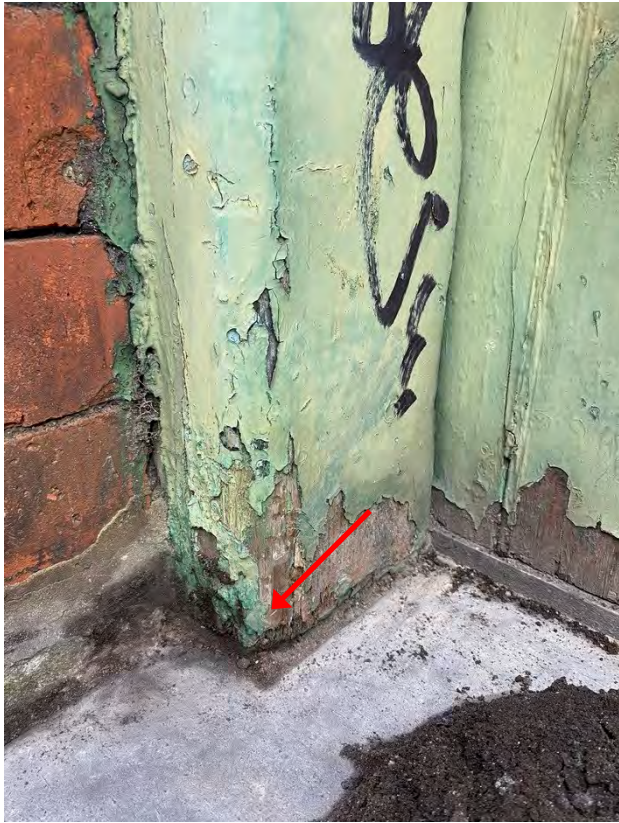
**Fig 11:**

North-west elevation, D.04; showing superficial decay in the base of the door frame. No major decay was detected

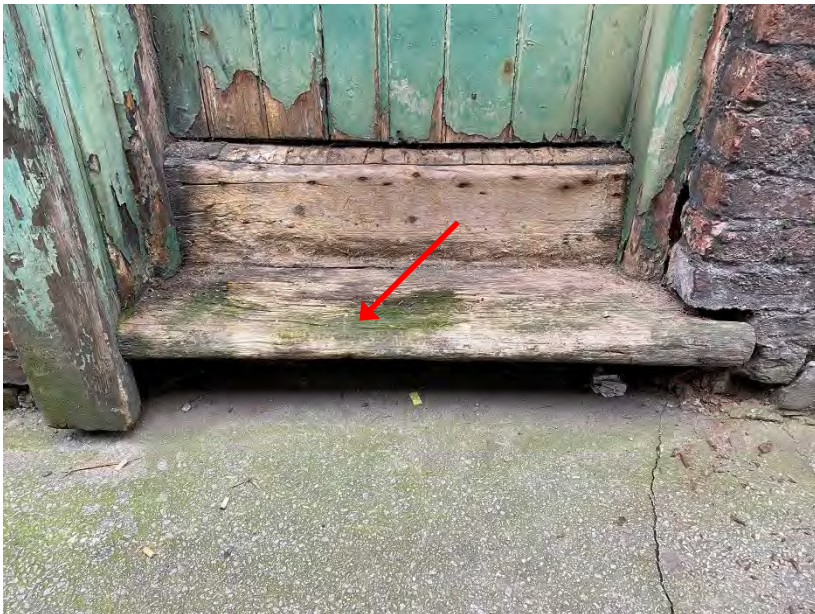
**Fig 12:**

North-west elevation, D.04; showing mechanical damage to the softwood threshold caused by foot traffic and wear. Moss growth was present where water was able to pool in the depression in the threshold

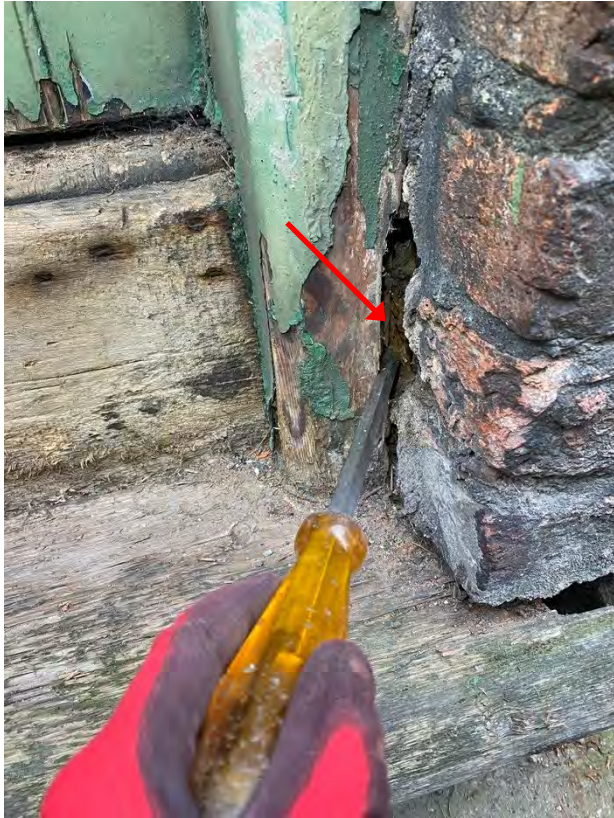
**Fig 13:**

North-west elevation, D.04; showing partial decay in the lower 300mm of the door frame. Decay was caused by wet rot and common furniture beetle

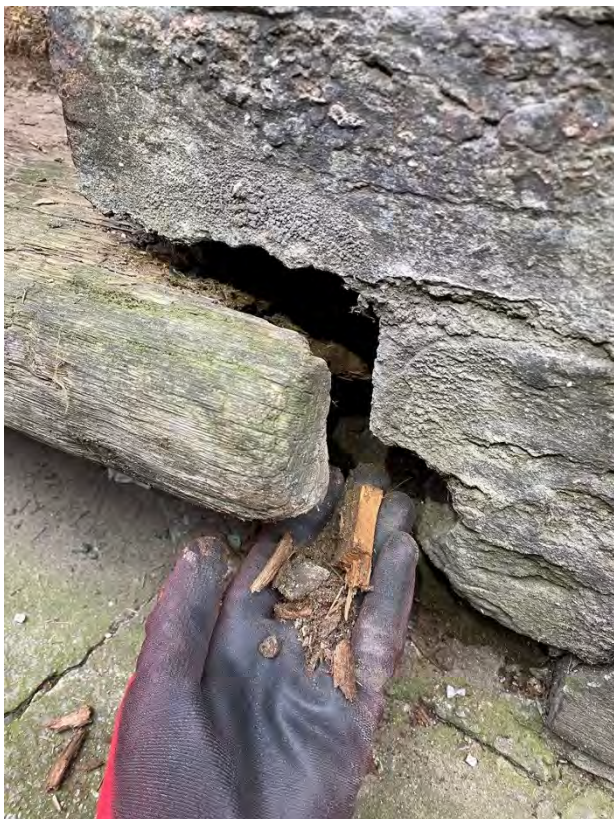
**Fig 14:**

North-west elevation, D.04; showing partial decay in the threshold where embedded in the brickwork.

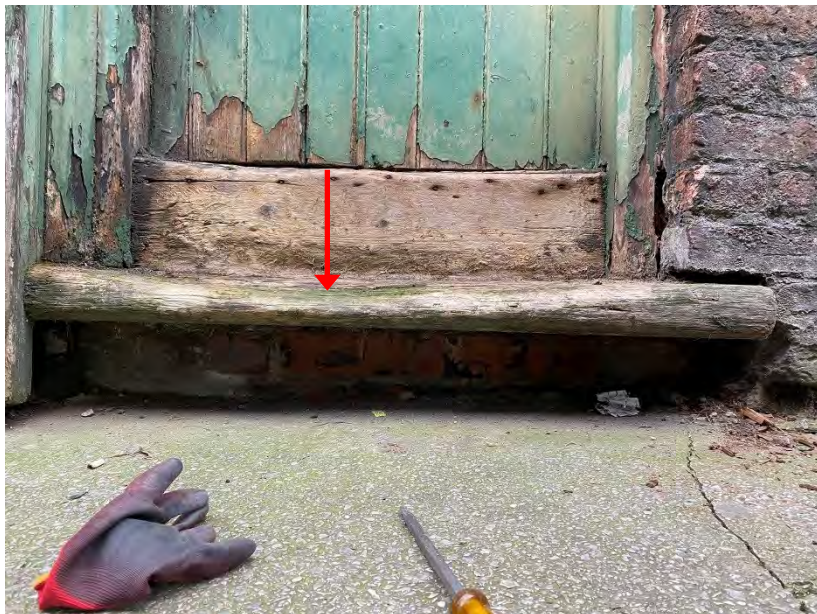
**Fig 15:**

North-west elevation, D.04; showing wear in the threshold. The depth of the timber had reduced by approximately 1/3rd

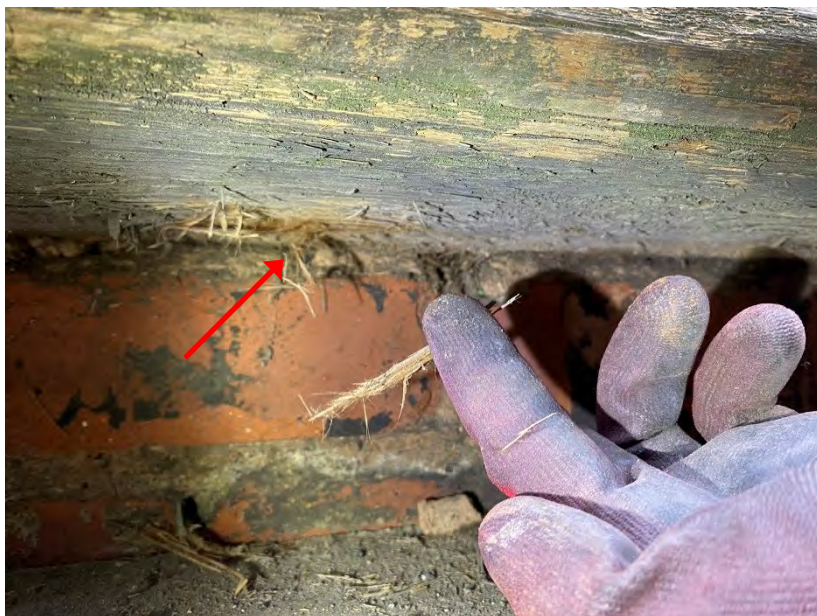
**Fig 16:**

North-west elevation, D.04; showing a view of the underside of the threshold. There was degradation to the timber caused by chemical attack. However, damage was only superficial

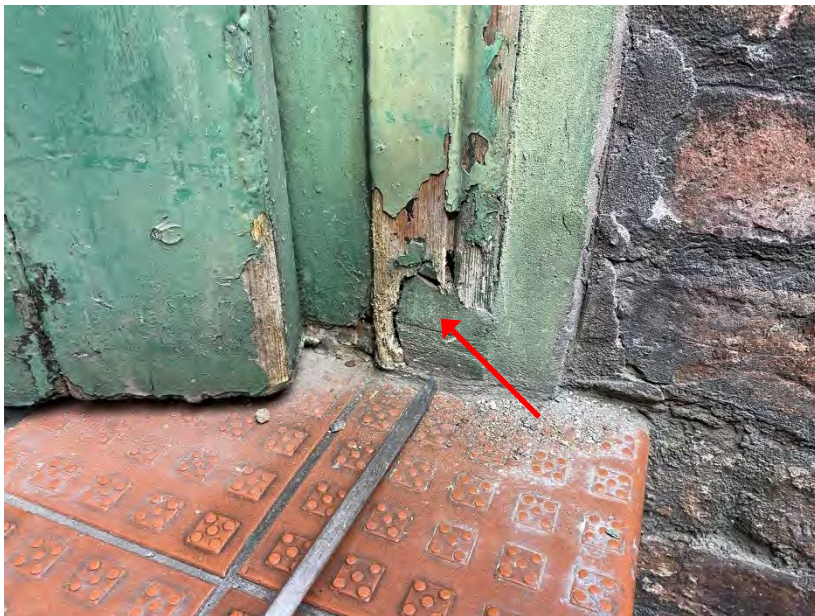
**Fig 18:**

North-west elevation, D.05; showing partial decay in the lower 150mm of the door frame. Note the decayed void had been infilled with mortar

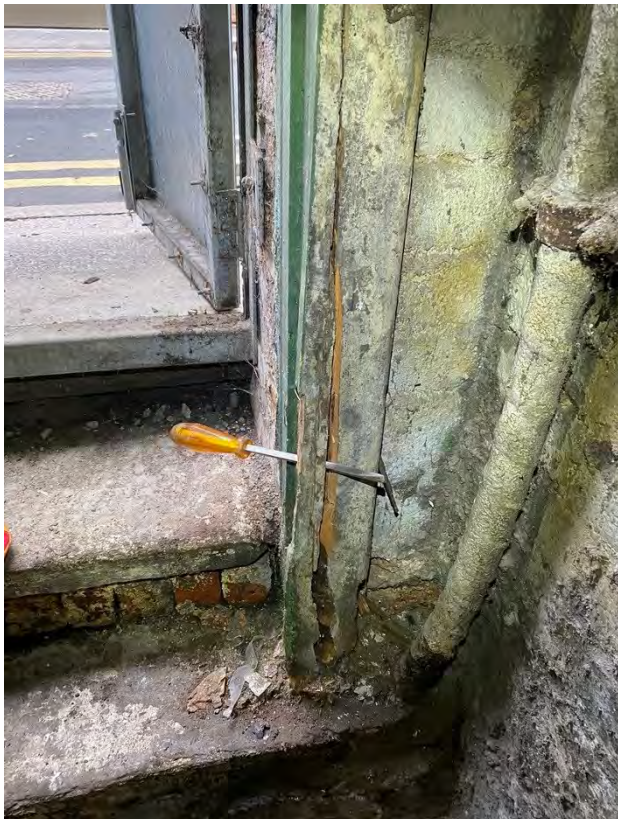
**Fig 20:**

North-west elevation, D.03; showing a split through the lower 1m of door frame. The base of the frame was also decayed by wet rot and wood-boring weevil

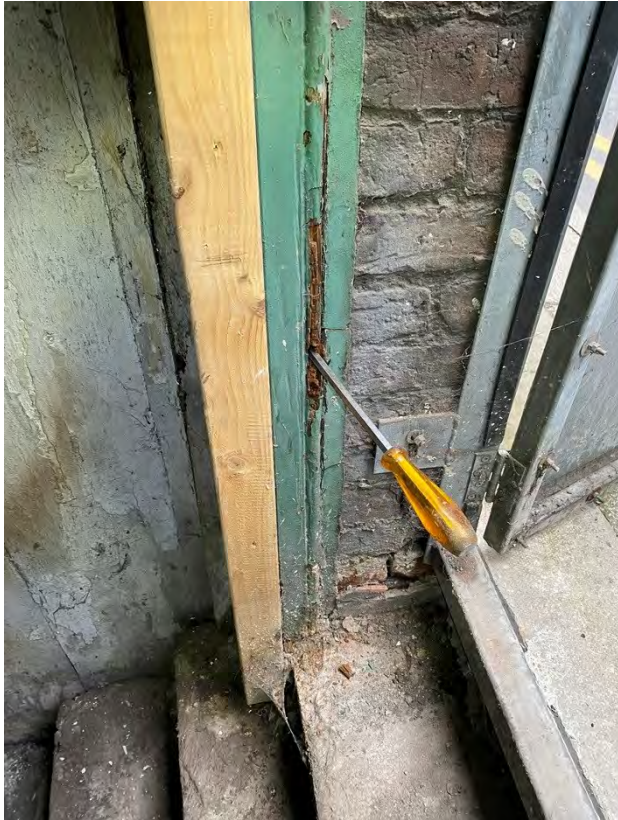
**Fig 21:**

North-west elevation, D.03; showing partial decay in the lower 600mm of door frame

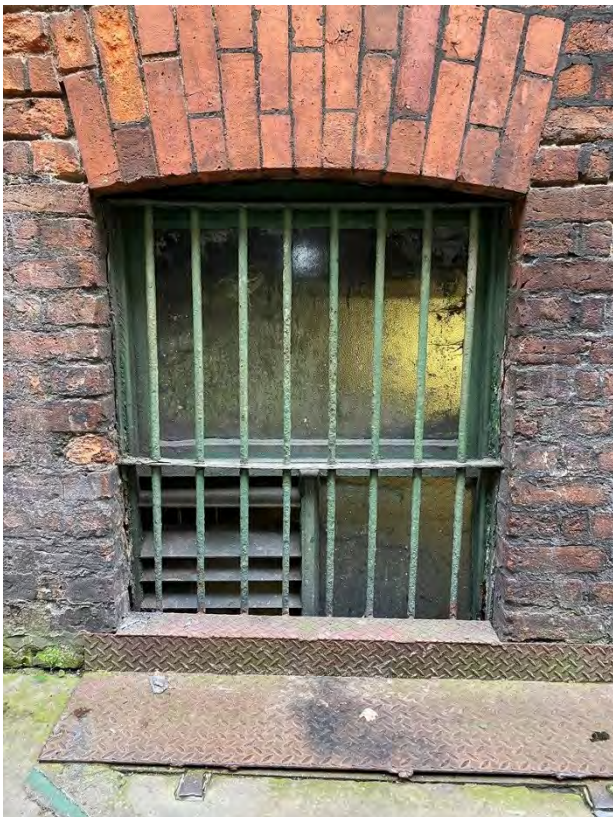
**Fig 22:**

North-west elevation, WB.01; showing window which extended below footpath level. The lower portions of the windows were decayed by wet rot and wood-boring weevil

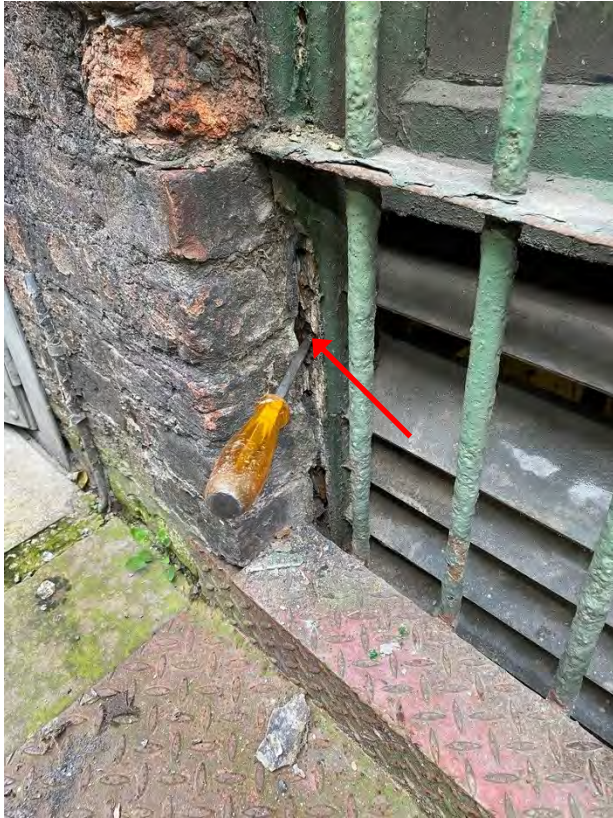
**Fig 23:**

North-west elevation, WB.01; showing decay in the frame extending 300mm above footpath level

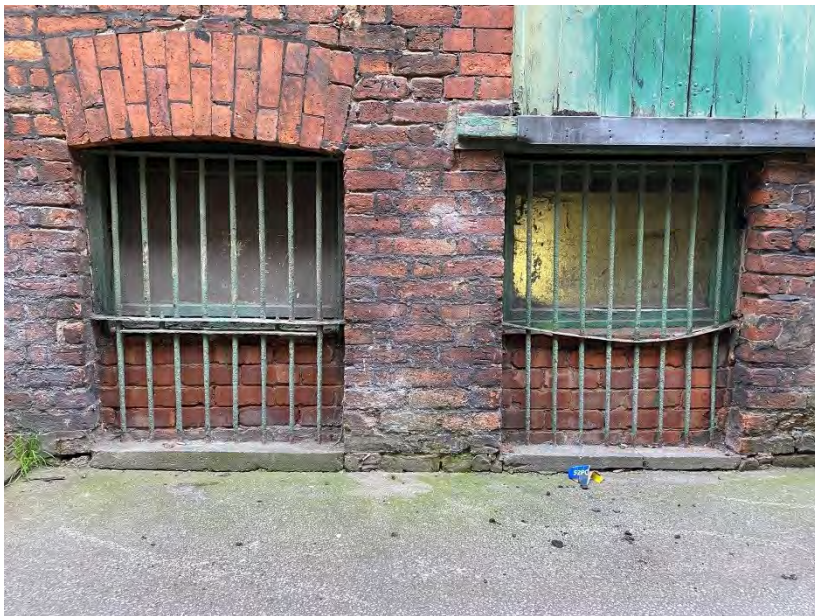
**Fig 24:**

North-west elevation, WB.02 and WB.03; showing only the upper hopper lights remaining. The lower 2/3rd of the window openings have been infilled with brickwork. No major timber decay was detected in the hopper frame

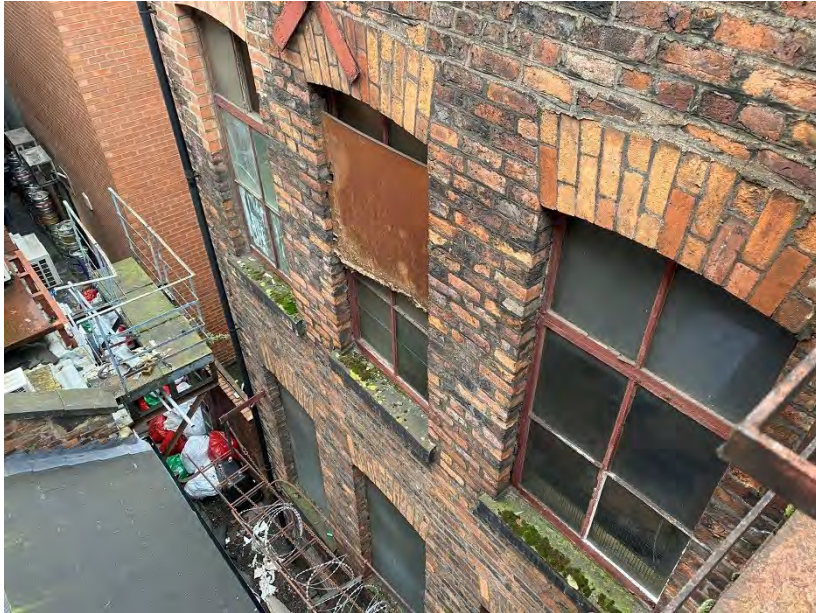
**Fig 25:**

South-east elevation; showing windows at 1st floor level which were inaccessible for external tactile assessment. There was no evidence of major decay. However, the bottom rails were particularly vulnerable to decay in areas of pooling water/moss growth

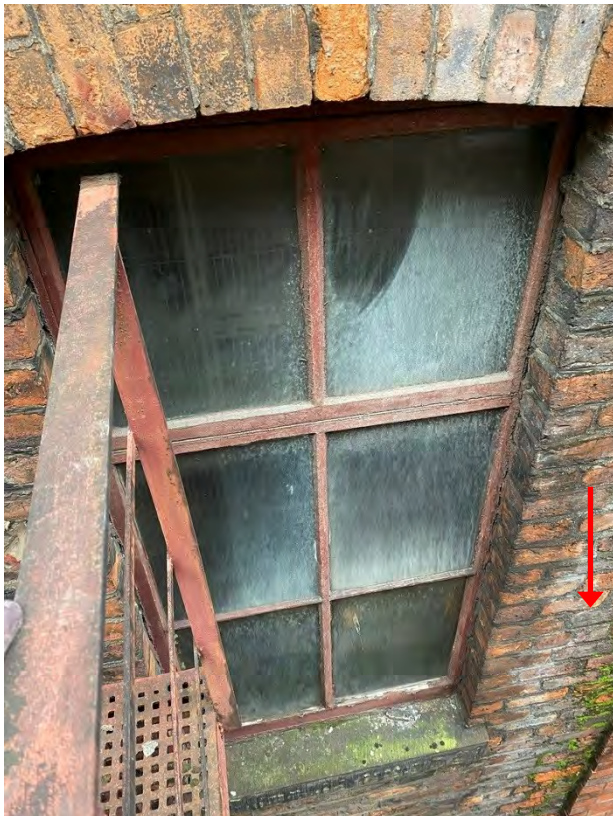
**Fig 26:**

South-east elevation, W1.07; showing biological growth to the masonry where the neighbouring eaves gutter was leaking onto the brickwork. This window and the windows directly beneath were vulnerable to damp and decay

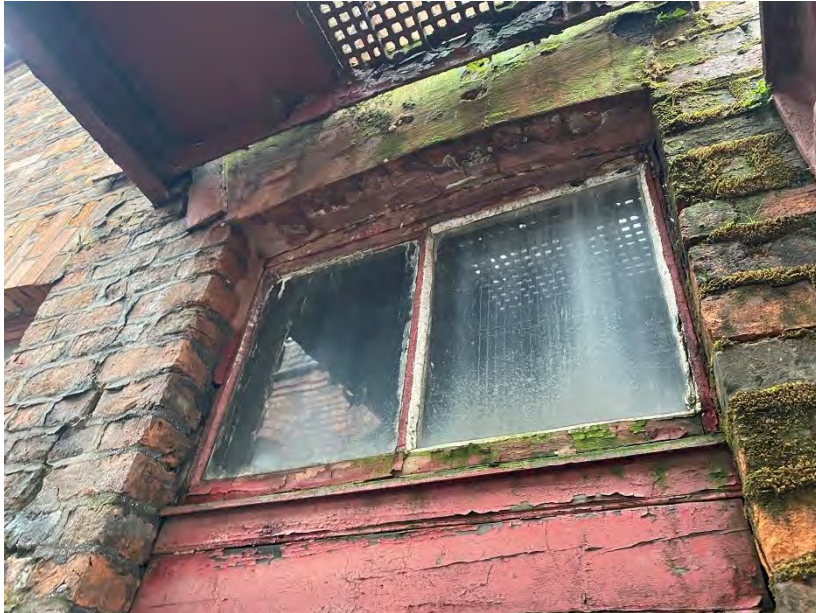
**Fig 27:**

South-east elevation, W1.09; showing saturation of the masonry beneath the leaking eaves gutter. The transom window was damp and vulnerable to decay. However, no major decay was detected where accessible

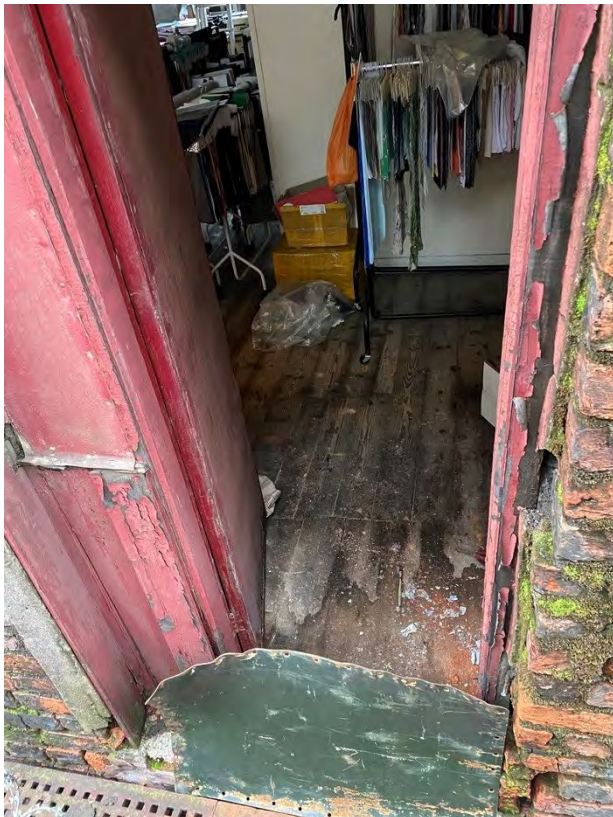
**Fig 28:**

South-east elevation, D.02; showing saturation of the masonry beneath the leaking eaves gutter. The door frame was damp and vulnerable to decay. However, no major decay was detected where accessible

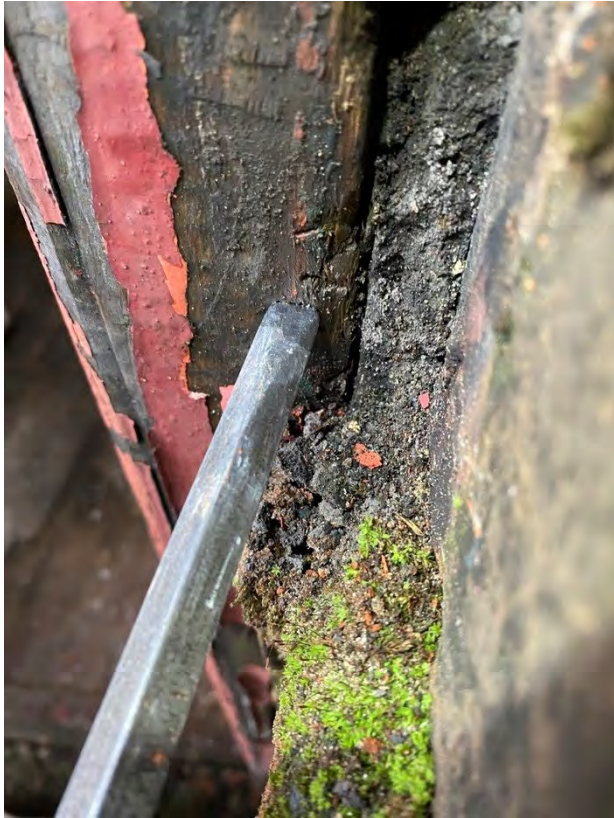
**Fig 29:**

South-east elevation, D.02; showing a close-up of the damp and superficially decayed doorframe

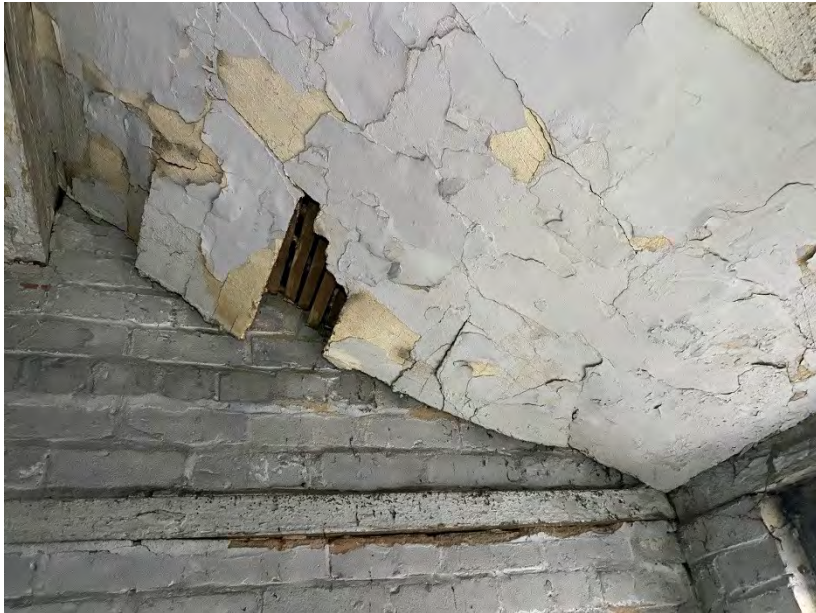
**Fig 31:**

Second floor; showing an example of cracked and loose plaster

- 1 Repairs: Allow for localised repairs to the lath and plaster ceiling in the areas identified on the drawings. Carefully release the defective plaster from the laths. Replace any partially decayed laths. A conservation plasterer should replaster with a lime, sand hair mix to match the existing. Ensure the floor voids are carefully cleared of any remaining loose debris and dust without damaging the plaster 'keys'. Ensure any new ceiling finishes applied over the lath and plaster are fixed to the underside of the floor joists

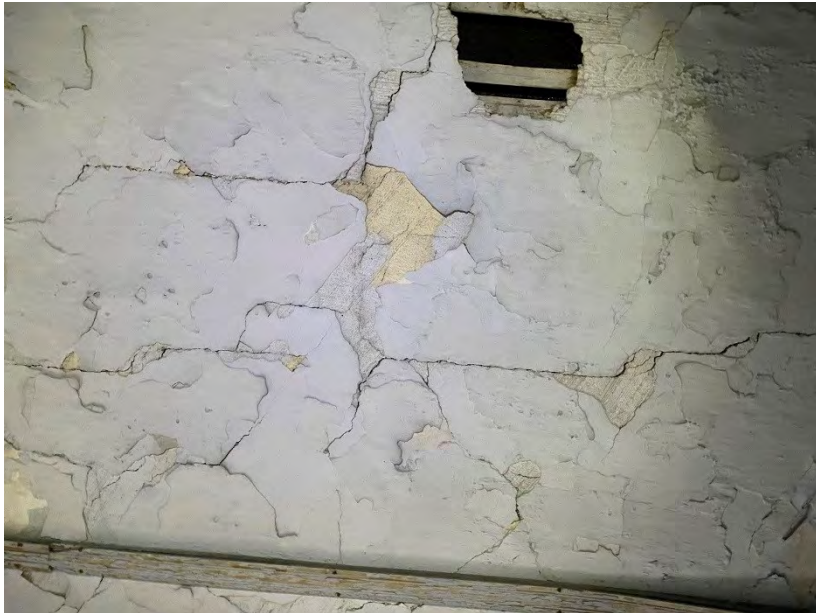
**Fig 35:**

Second floor; showing typical example of the widespread cracking in the plaster

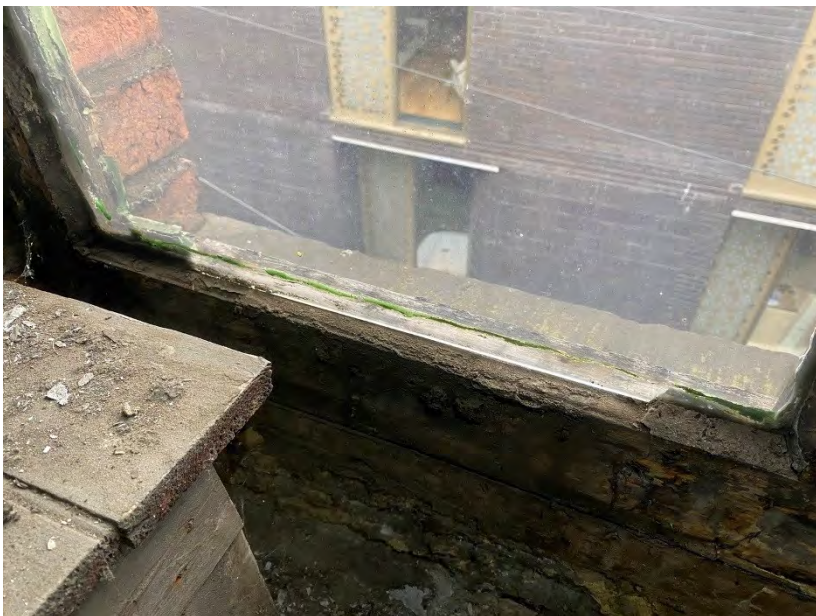
**Fig 36:**

Second floor, W2.01; showing biological growth to the bottom rail of the window. The exteriors of the window are vulnerable to decay. However, no major was detected in the frame internally

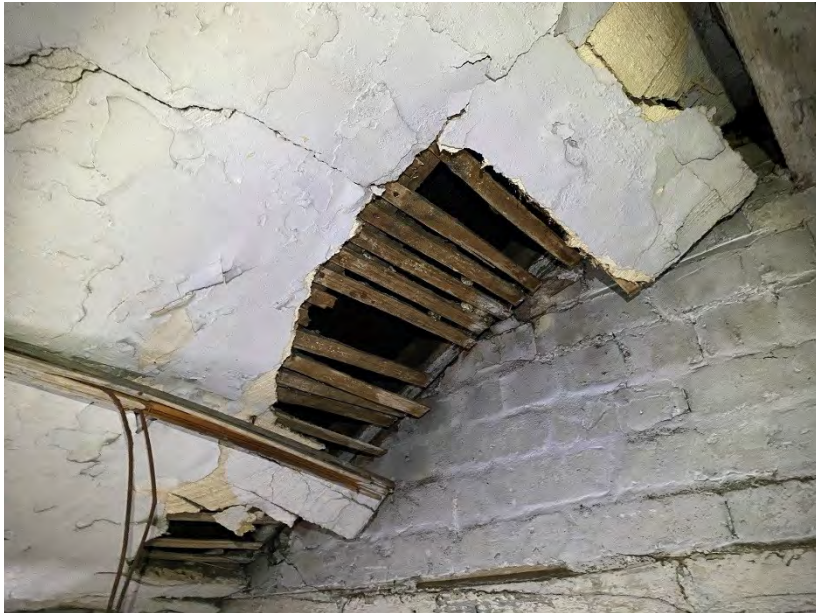
**Fig 37:**

Second floor; showing loose plaster and damaged laths

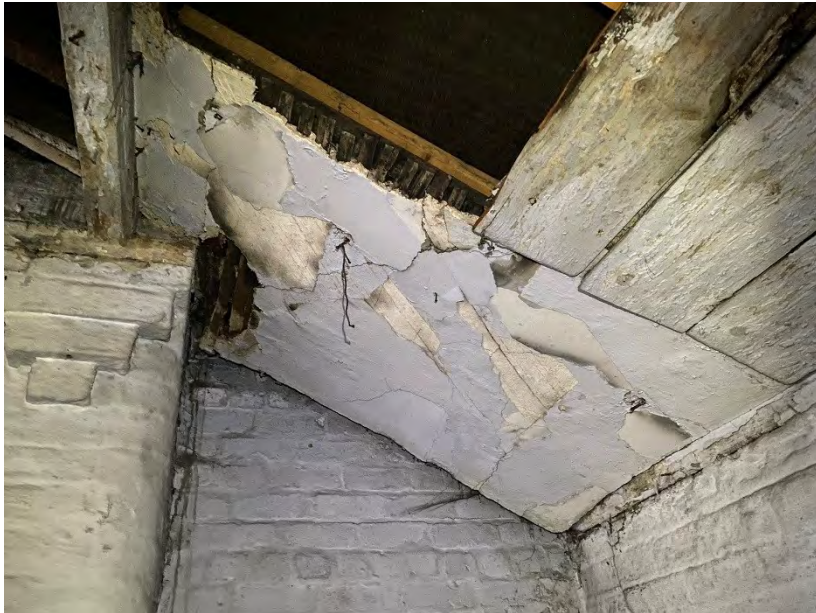
**Fig 39:**

Second floor; showing widespread cracking through the plaster

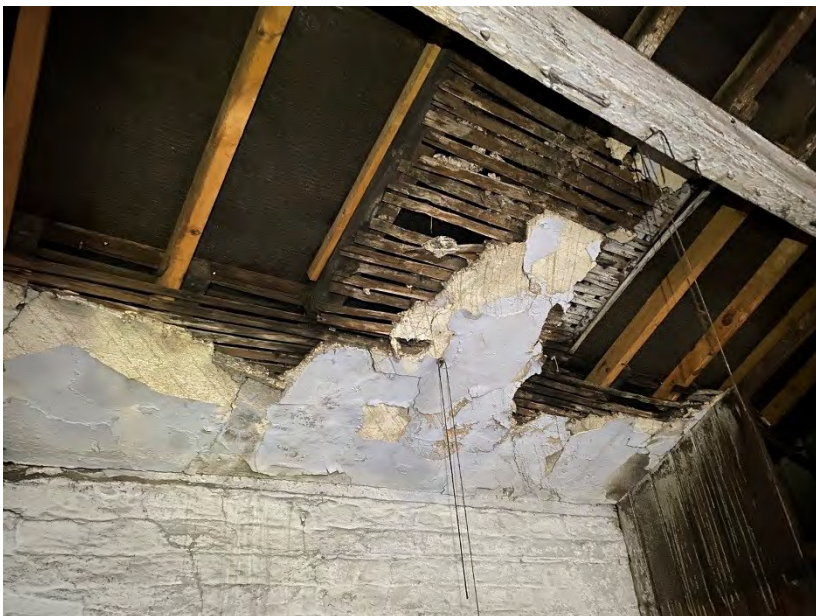
**Fig 40:**

Second floor; showing missing plaster and historical decay in the laths

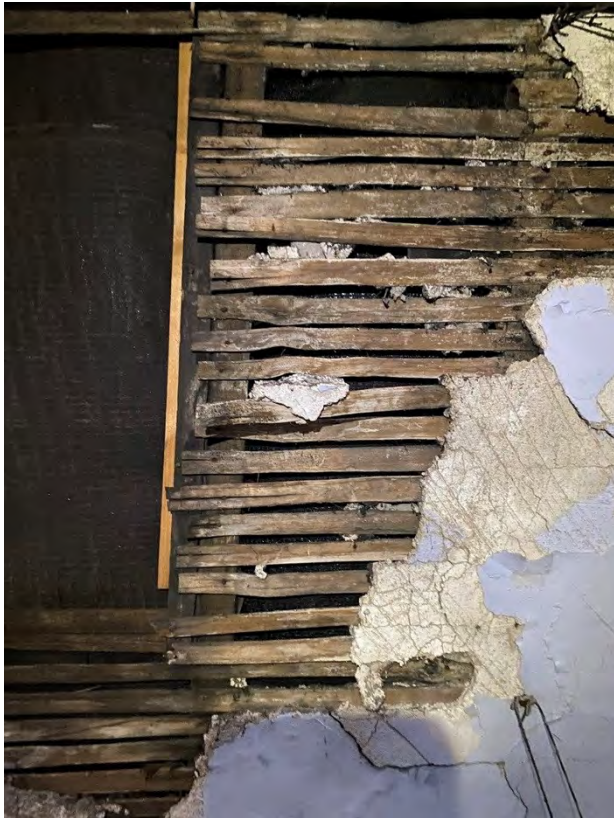
**Fig 41:**

Second floor; showing riven laths. A proportion of the laths were partially decayed by historical damp and timber decay

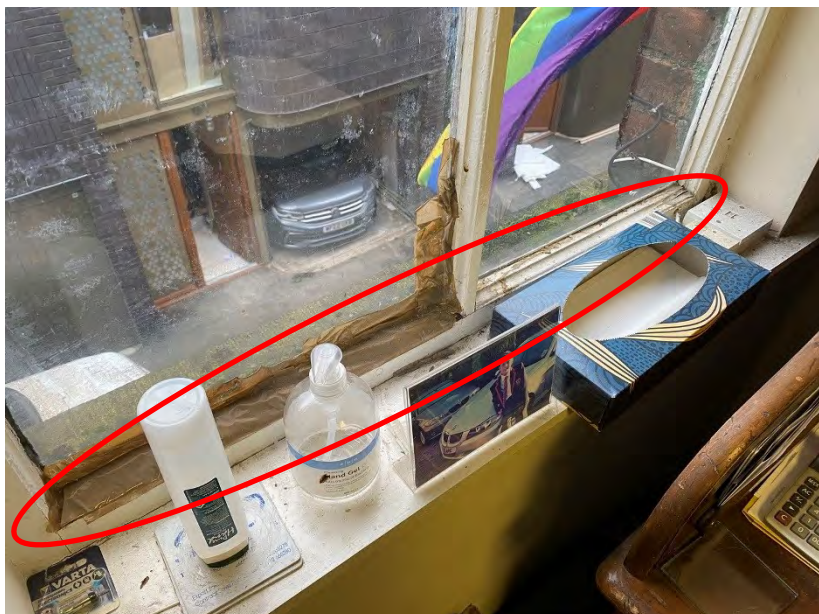
**Fig 47:**

First floor, W1.01; showing superficial decay in the bottom rail of the window caused by condensation. No major decay was detected where accessible internally

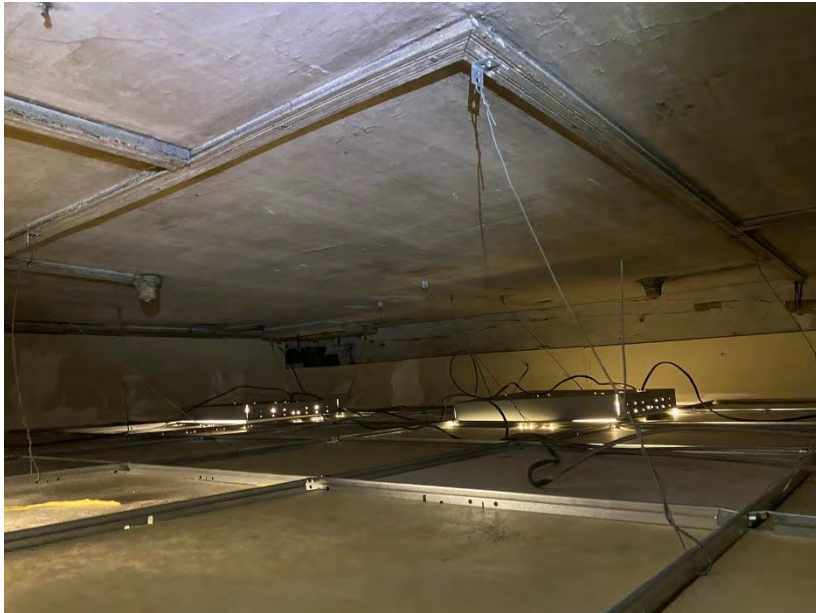
**Fig 49:**

First floor, Office; showing modern gridwork suspended ceiling hung from wires. Wires appeared to be fixed to the floor joists. There was no obvious major cracking in the lath and plaster

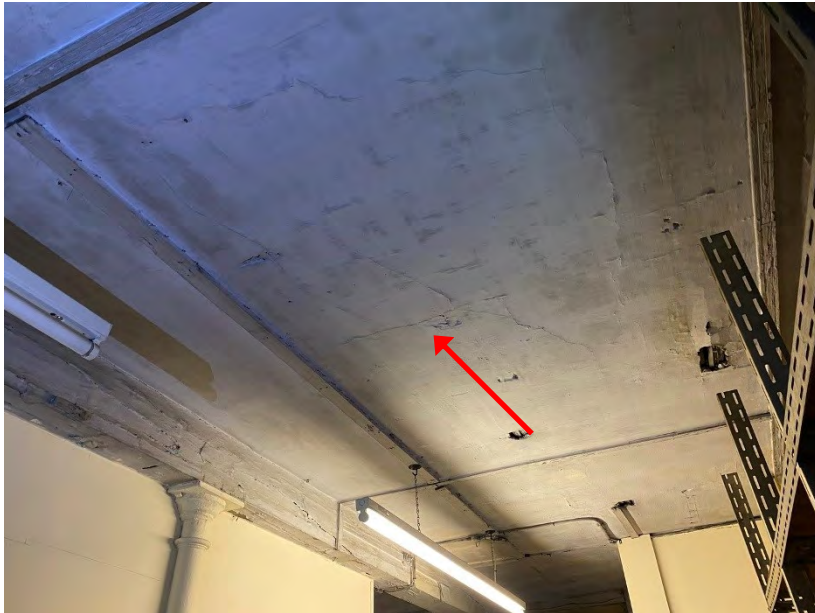
**Fig 51:**

First floor; showing minor cracking in the ceiling. There was no risk of imminent failure on this location

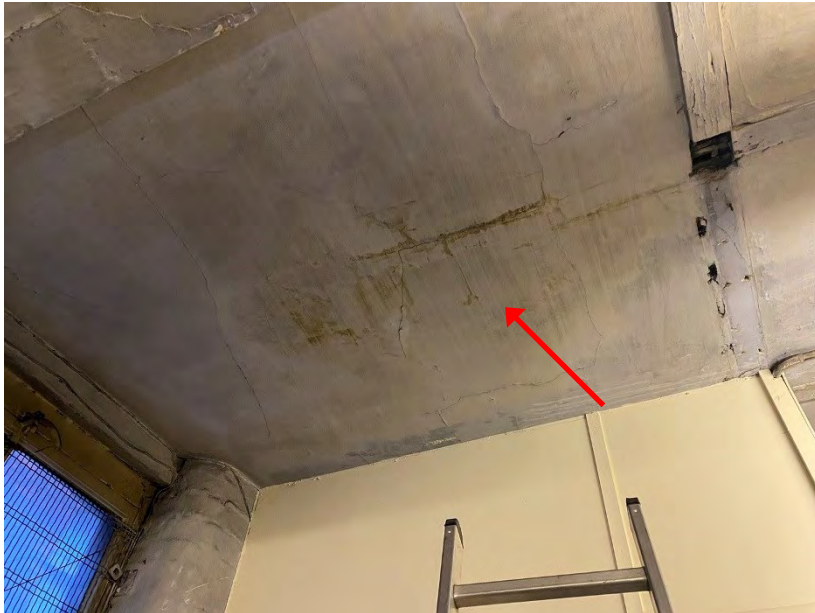
**Fig 55:**

First floor; showing minor cracking in the ceiling. There was no risk of imminent failure on this location. There appeared to have been a historical leak in this location

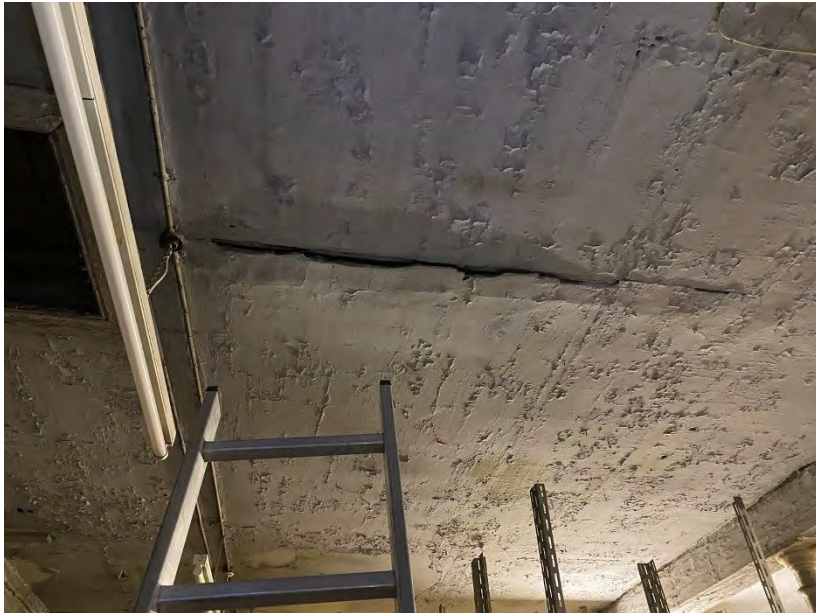
**Fig 61:**

Upper ground floor; showing large crack and area of loose plaster directly beneath the Office

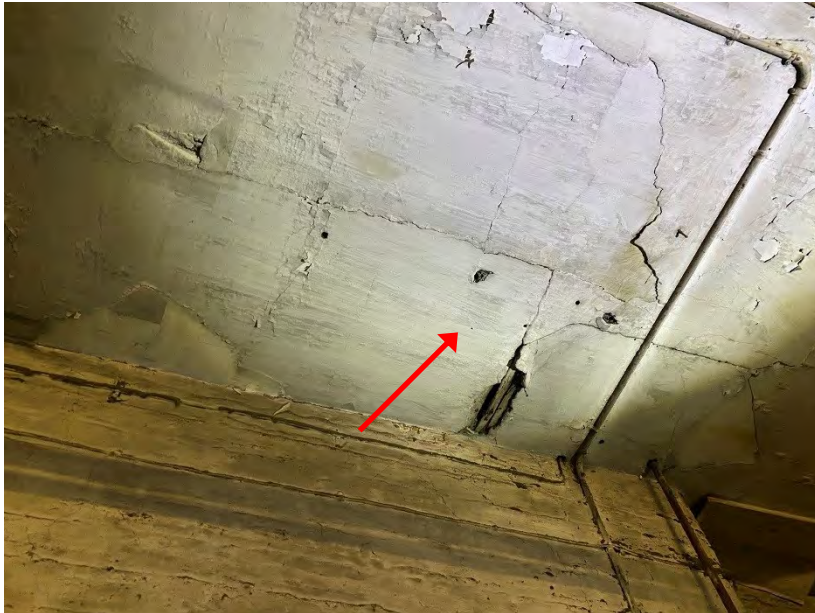
**Fig 63:**

Upper ground floor; showing cracking through lath and plaster ceiling above fireplace

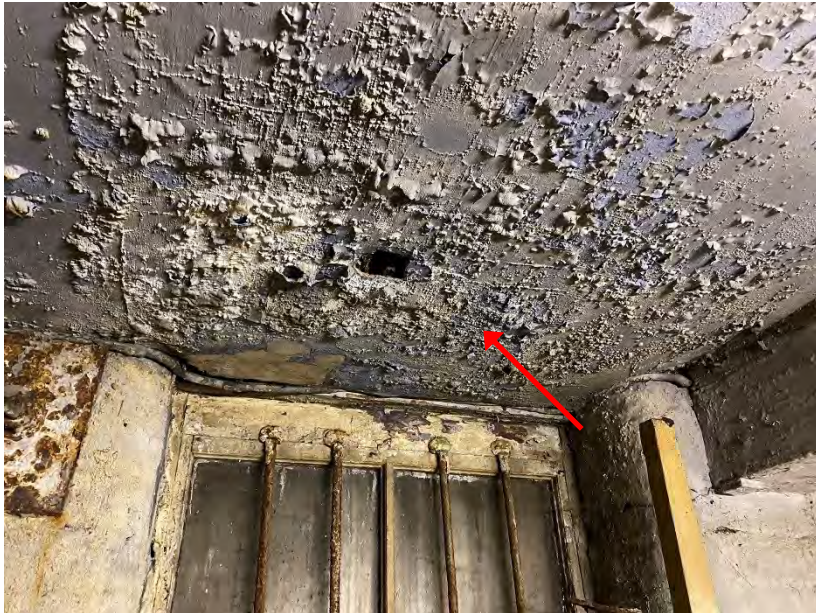
**Fig 65:**

Upper ground floor; showing damp and partially decayed ceiling laths. Decay in the laths was caused by wet rot fungi

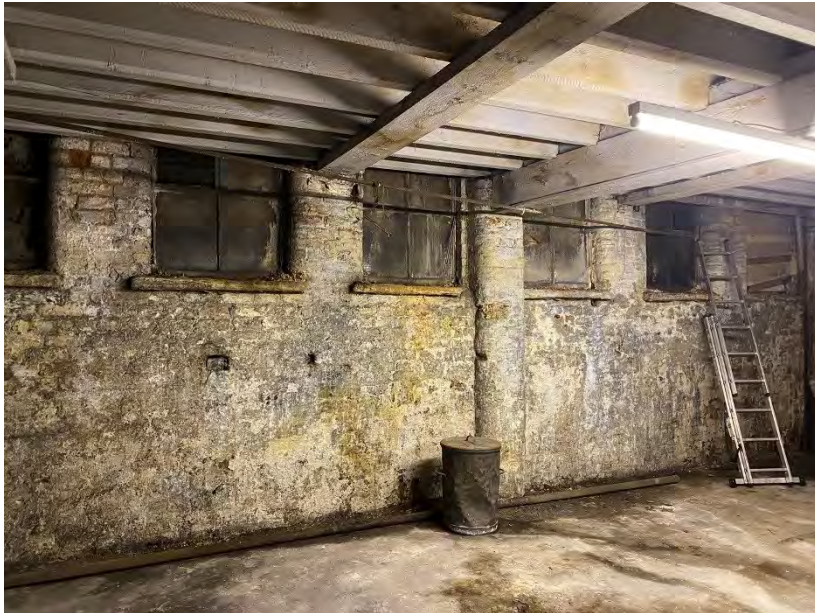
**Fig 69:**

Lower ground floor; showing windows to the rear elevation. The base of all window frames were damp and partially decayed by wet rot

- 2 Repairs: Repairs should be undertaken by a conservation joiner. Decayed joinery should be cut back to 'sound' material and new timber appropriately jointed so that the frames are renewed to their original form. No preservation or chemical remedial treatments are required. Renewed elements or splices to partially decayed softwood frames should be replaced with a suitably specified durable softwood timber species (H+R should be requested to advise further on specification) or Accoya (Acetylated Pine species). Splices should be arranged so that water drains outwards from the component and away from the interior of the building. A suitably specified elastic epoxy resin should be used between the splice repair and sound timber, following the manufacturer's recommendations. Epoxy fillers should only be used for very small areas of the surface imperfections so long as the moisture content of the associated timber is less than 20 per cent w/w. Broken glazing should be replaced as necessary with a suitably specified heritage glass. Natural linseed oil putty should be used for the glazing compound and a traditional burnt sand mastic for the perimeter sealant, applied in accordance with best practice. Existing historical ironmongery should be retained and like for like replacements sought where missing/damaged
