## WINDOW AND CEILING PLASTER CONDITION SURVEY

51-53 RICHMOND STREET, MANCHESTER

JOB NO. 213-41

29 NOVEMBER 2022

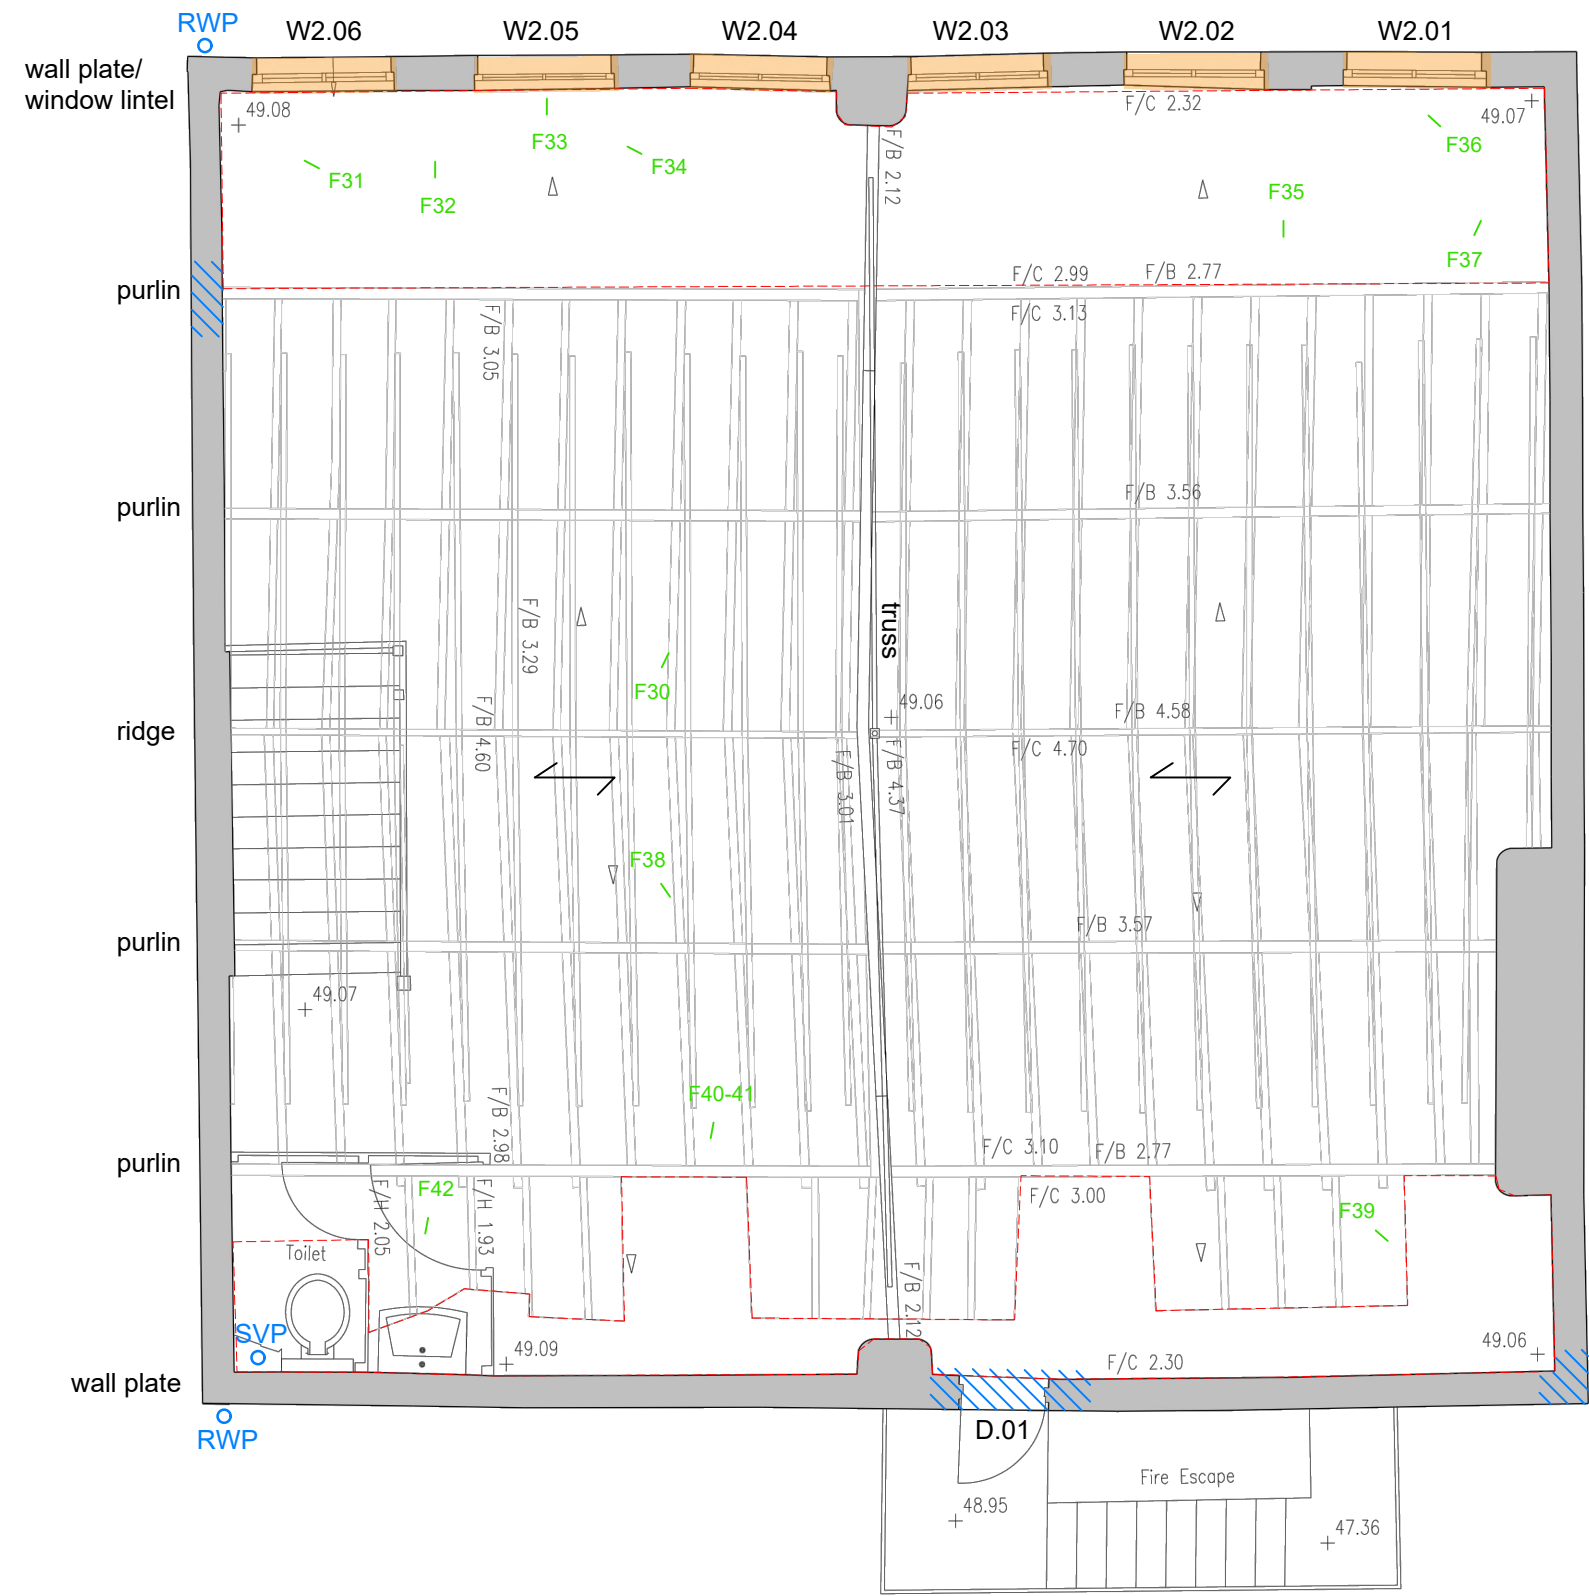
**51-53 Richmond Street, Manchester - Second Floor/ Attic**  
**WINDOW AND CEILING PLASTER CONDITION SURVEY**  
**29 November 2022**

| | <div></div> | Area of defective lath and plaster | | |

- 1 Repairs: Allow for localised repairs to the lath and plaster ceiling in the areas identified on the drawings. Carefully release the defective plaster from the laths. Replace any partially decayed laths. A conservation plasterer should replaster with a lime, sand hair mix to match the existing. Ensure the floor voids are carefully cleared of any remaining loose debris and dust without damaging the plaster 'keys'. Ensure any new ceiling finishes applied over the lath and plaster are fixed to the underside of the floor joists
