2<sup>ND</sup> RECONNAISSANCE DAMP AND TIMBER DECAY SURVEY

GREAT NORTHERN, MANCHESTER

JOB NO. 211.18

30 MAY-1 JUNE 2022

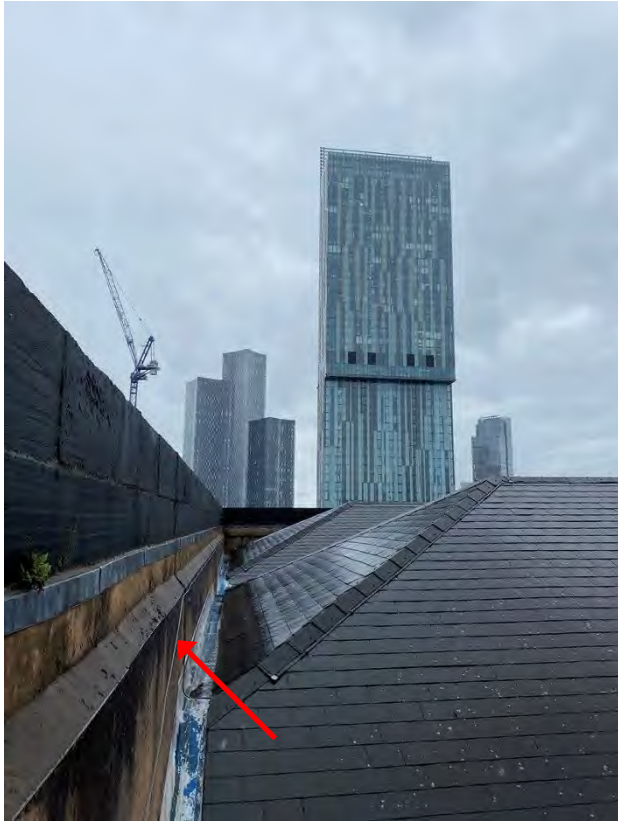
**Fig 1:**

Roof; showing a general view of the slate covered hipped roofs with single-ply EPDM gutters. Access over the roofs was via the parapet gutter and aided by a steel wire rope handrail secured to the parapet wall

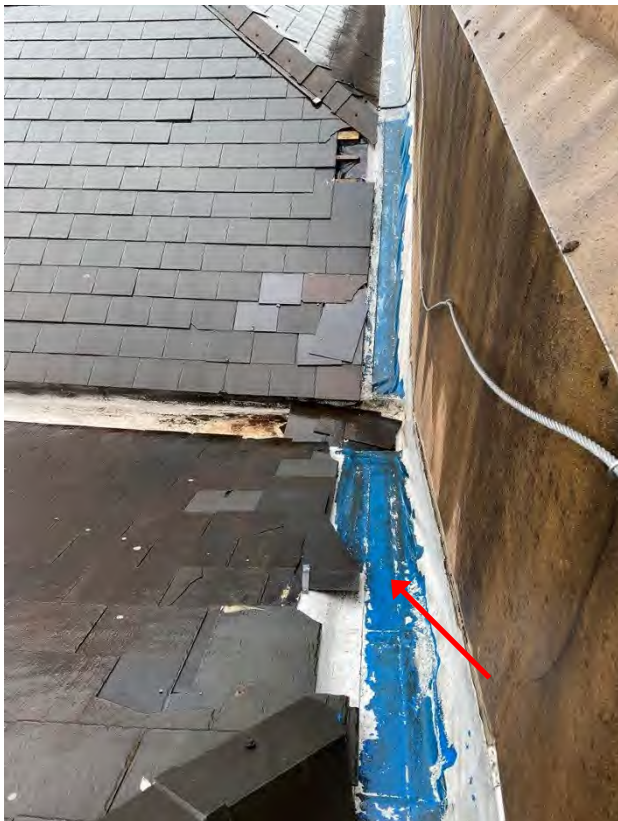
**Fig 2:**

- 1      Slates: Several localised areas of damaged slate reported in June 2017 had been replaced with artificial slate, as opposed to natural slate. However, there remained multiple areas of damaged slate especially in close proximity to the perimeter parapet gutter and central valley gutters. There were also breakages in the artificial slate. The damage had been caused by people walking the gutters to undertake maintenance works, as the provision for safe and convenient access was inadequate. There were also isolated areas of damaged slates to the east, which are believed to have been caused by glass bottles thrown from the balconies of the neighbouring Great Northern Tower apartments. However, in the short-term the presence of a roofing membrane beneath the slate battens should stop any water penetration due to broken slates

Roof; showing blue anti-slip paint applied over the pitched parapet gutters. Note the damaged slates and slate patch repairs

*Allowance should be made for replacement of all broken natural and artificial slates with a suitably specified natural slate*

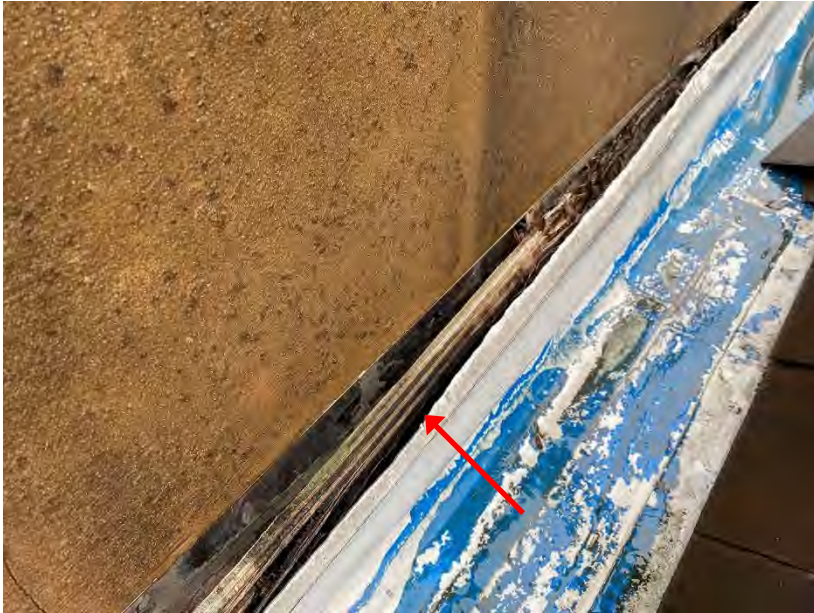
**Fig 3:**

- 2      Gutters: Although generally free from biological debris there were some areas of build-up and broken slates allowing rainwater to pool within the EPDM lined valley and parapet gutters. In some localised areas the plywood gutter boarding and upstand was 'spongy' underfoot, notably at the southern end of the east parapet for approximately 3m and centre of the north parapet for 2m. The gutter boards were partially decayed in these areas and potentially at risk of failure/collapse if too highly loaded by persons accessing the roof or by snow

Roof; showing separation of the parapet gutter flashing from the wall. The plywood upstand and gutter deck were spongy and decayed by wet rot (see Fig 37-38 below)

*Access onto the two areas of decayed gutter should be prohibited until temporary repairs are undertaken or propping has been undertaken from beneath*

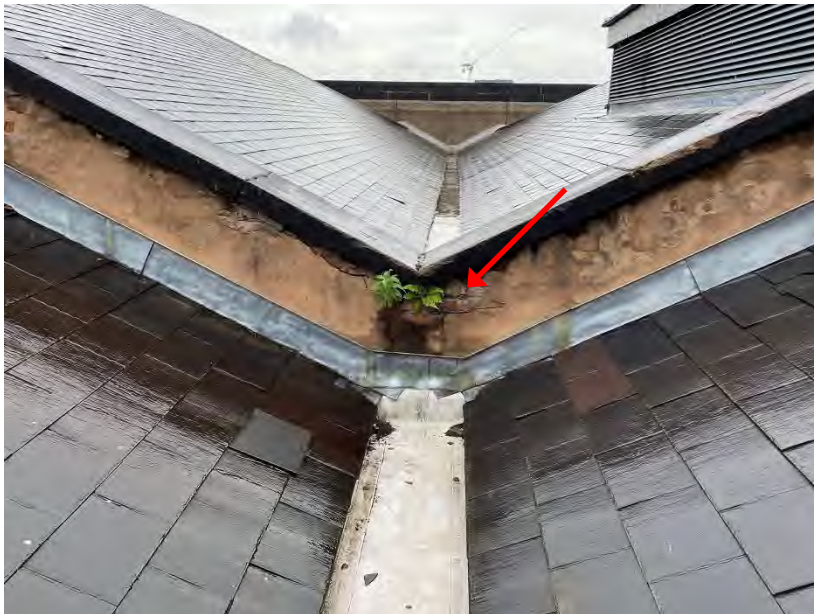
**Fig 4:**

- 3      Parapets: The coping stone butt joints were heavily washed-out throughout the perimeter parapet walls and central parapet wall. There was no DPC beneath the copings to the central parapet wall. There was craze cracking throughout the render to the inside face of the parapets which is shrinkage related. However, in some areas the render was defective and had separated from the brickwork revealing washed-out mortar joints behind. Some lead flashings had also separated from the base of the parapet. These defects were allowing water penetration and presenting a hazard to the softwood roof structure beneath. There were multiple buddleia and ferns growing from the central and perimeter parapets, evidence of high moisture levels within the masonry

Roof; showing failure of the render to the central parapet and plant growth within the brickwork. Note there was no damp-proof course beneath the coping stones to the central parapet wall

*H+R to carry out detailed investigation of parapet walls and provide recommendations on appropriate repairs*

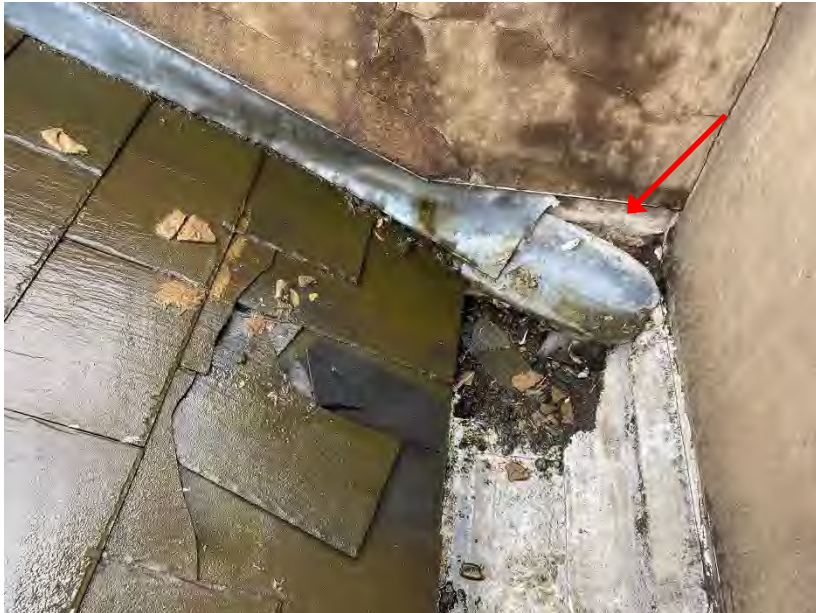
**Fig 5:**

Roof; showing separation of the lead flashing from the central parapet wall.

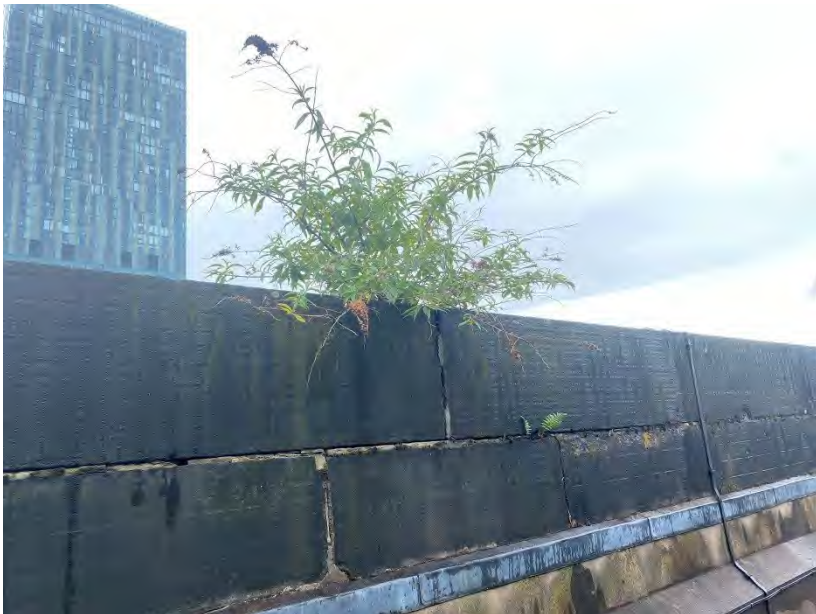
**Fig 6:**

Roof; showing Buddleia growth from the parapet masonry. Root growth had slightly displaced these parapet stones

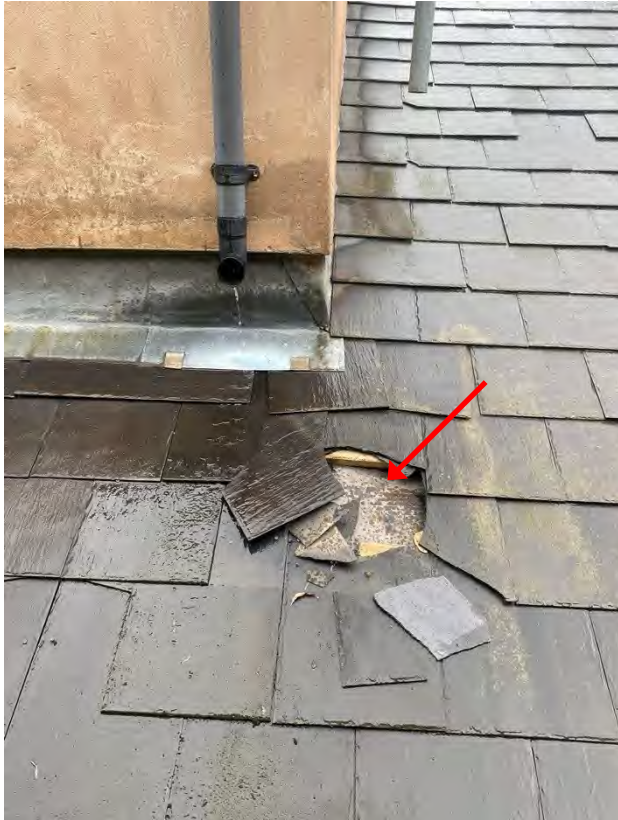
**Fig 7:**

Roof; showing an example of isolated broken slates towards the south-east corner of the roof. Damage appears to be caused by a glass bottle thrown from the neighbouring Great Northern Tower apartments. However, in the short term the presence of a roofing membrane beneath the slate battens should stop any water penetration due to broken slates

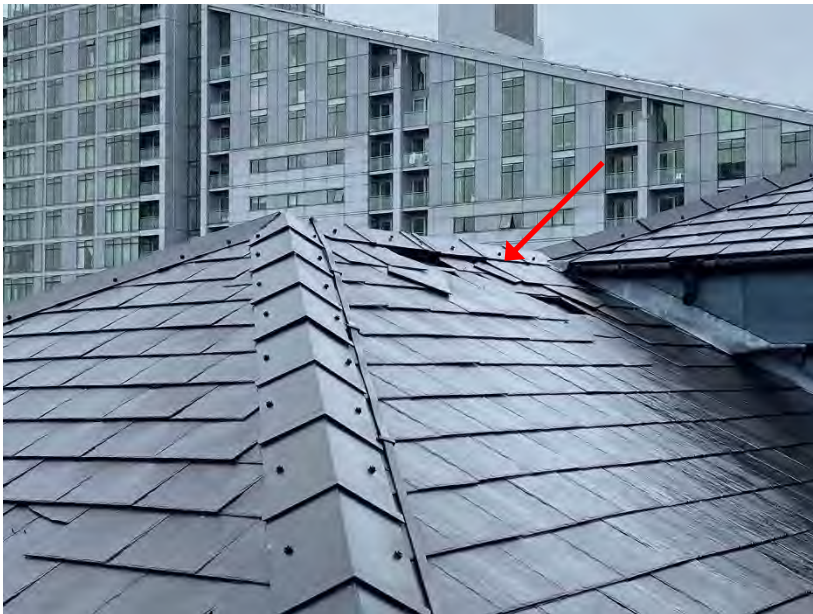
**Fig 8:**

Roof; showing an example of disturbed broken slates

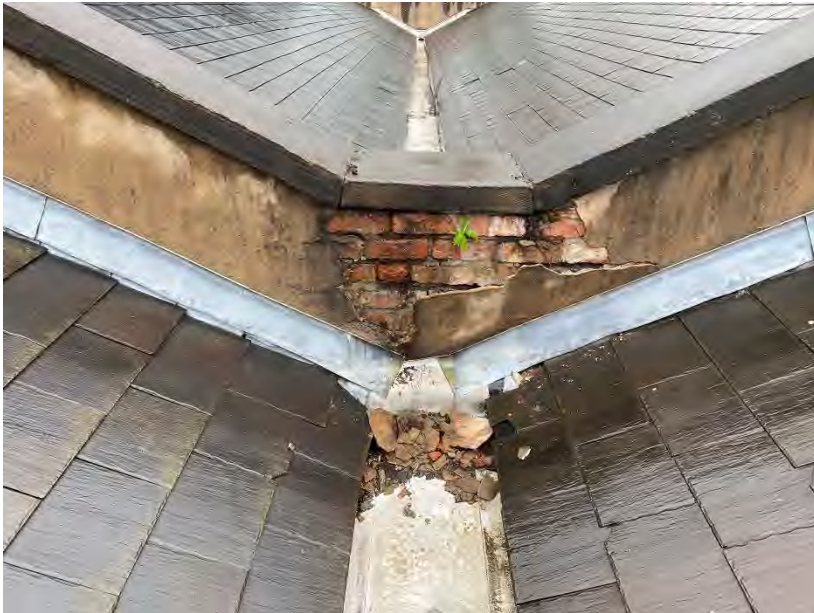
**Fig 9:**

Roof; showing failure of the render to the central parapet and plant growth within the brickwork

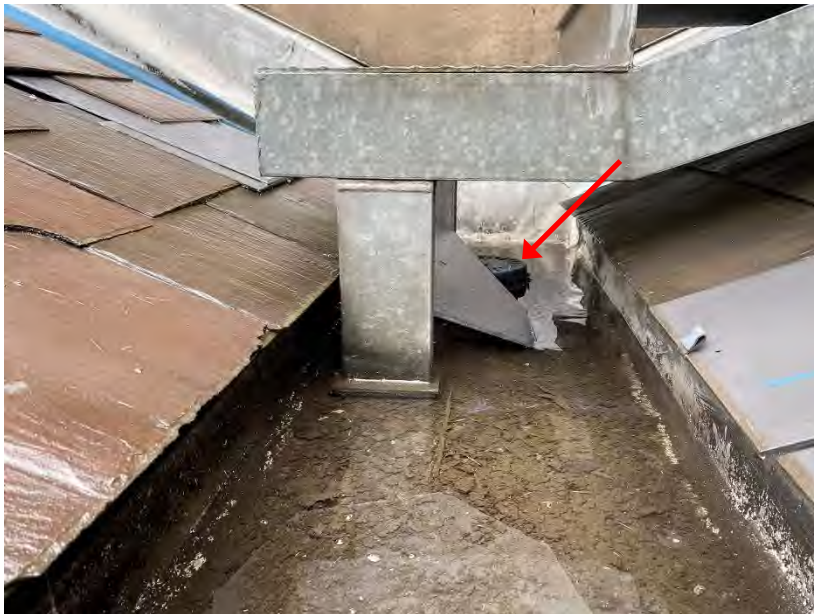
**Fig 10:**

- 4 Roof drainage: The roof was drained via raised outlet spigot drains at the end of each valley gutter that discharge into internal cast-iron downpipes which swan-neck into cast-iron hoppers and external downpipes on the east and west elevations. There was no noted evidence of chronic water penetration to the facades associated with the rainwater goods. At ground level, the downpipes drain below pavement level and are accessed via sealed access covers. Although the roof drainage appears to have been relatively well maintained, some outlets were partially blocked with debris and broken slates

Roof; showing broken slates and debris build-up causing water to pool within the valley gutter. Note the raised outlet spigot drain

*Allow for routine inspection and maintenance of rainwater drainage goods. H+R to carry out detailed investigation of rainwater drainage systems and provide recommendation on appropriate repairs, when necessary*

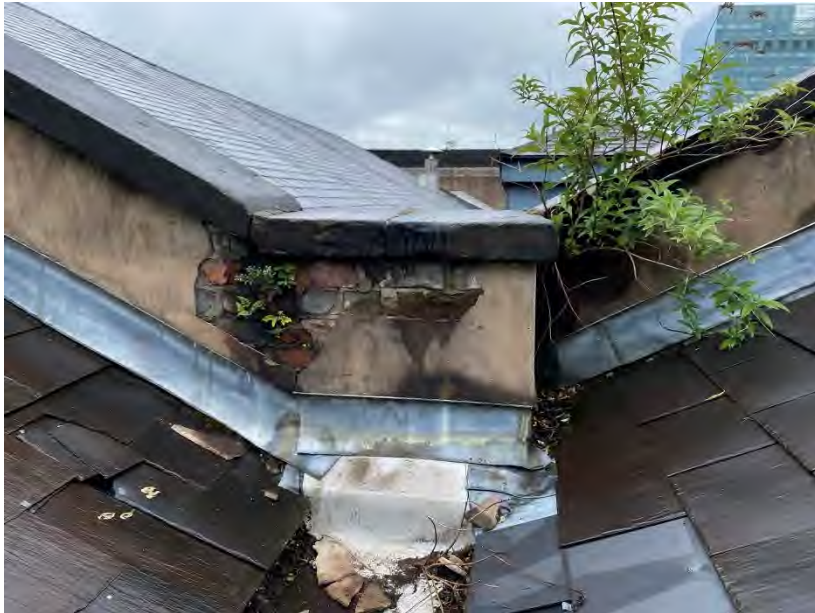
**Fig 11:**

Roof; showing failure of the render to the central parapet and Buddleia growth within the brickwork

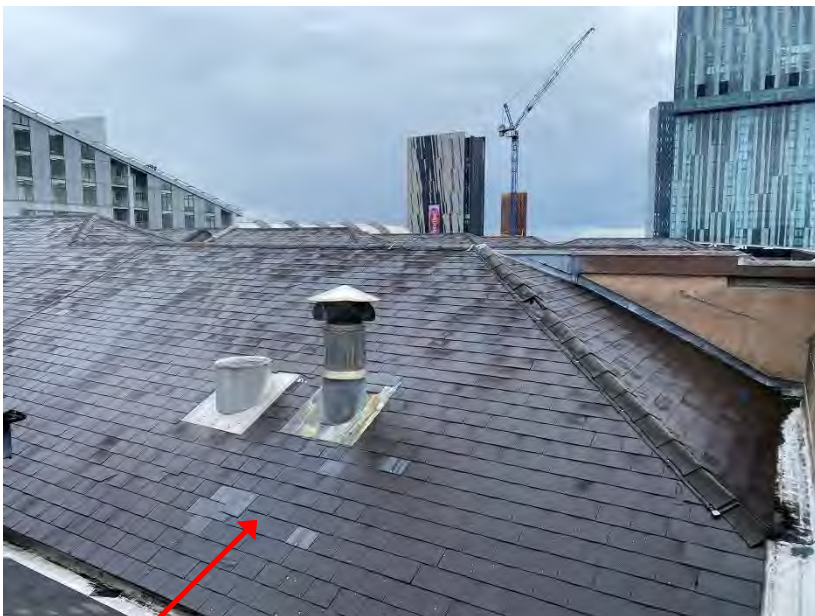
**Fig 12:**

Roof; showing example of patch repairs to the roof pitches using a synthetic slate restrained by aluminium tingles

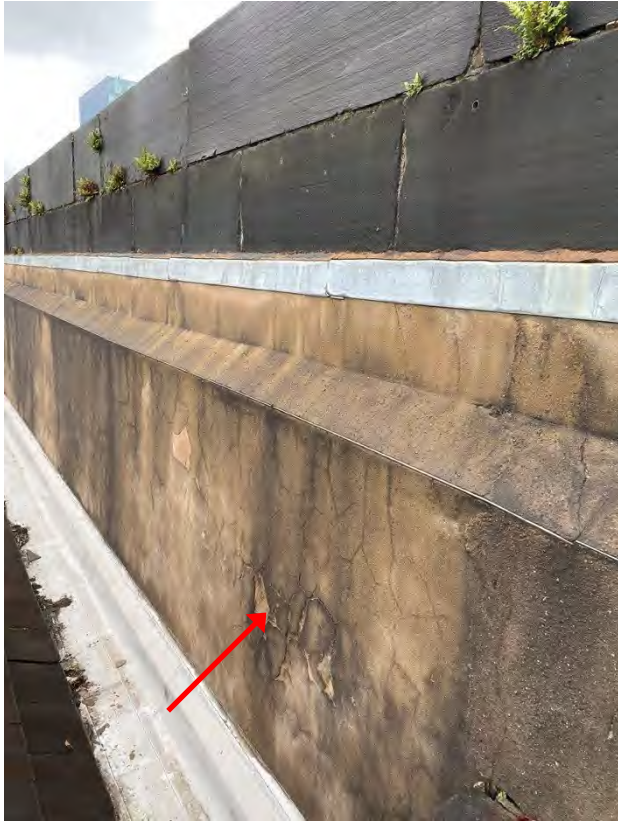
**Fig 13:**

Roof; showing shrinkage related craze cracking throughout the rendered parapet

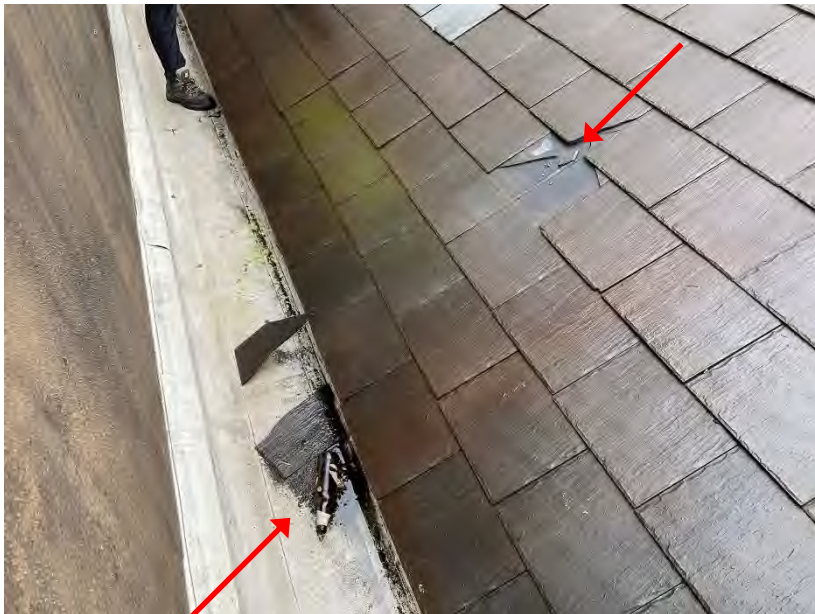
**Fig 14:**

Roof; showing a single broken slate to the north-east corner of the roof. Damage appears to be caused by a glass bottle presumably thrown from the neighbouring Great Northern Tower apartments

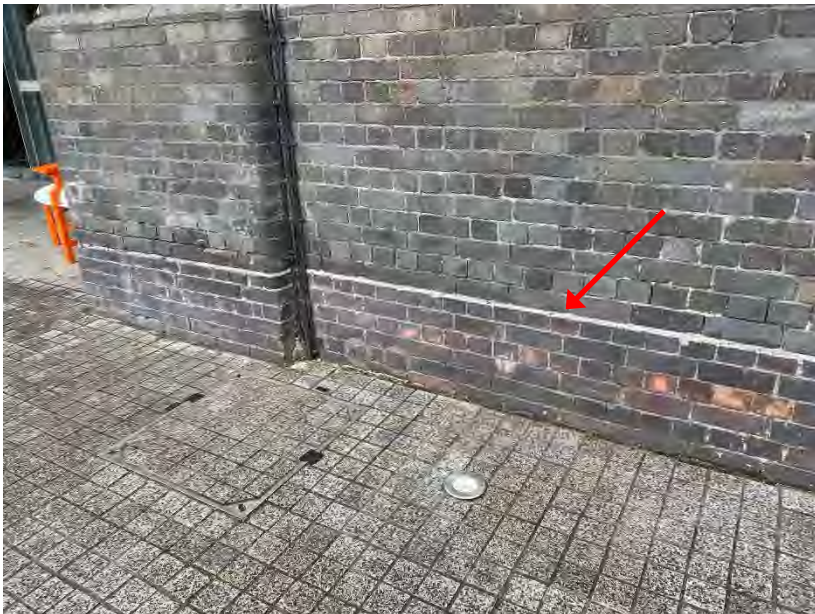
**Fig 16:**

North elevation; showing the rock asphalt damp-proof course

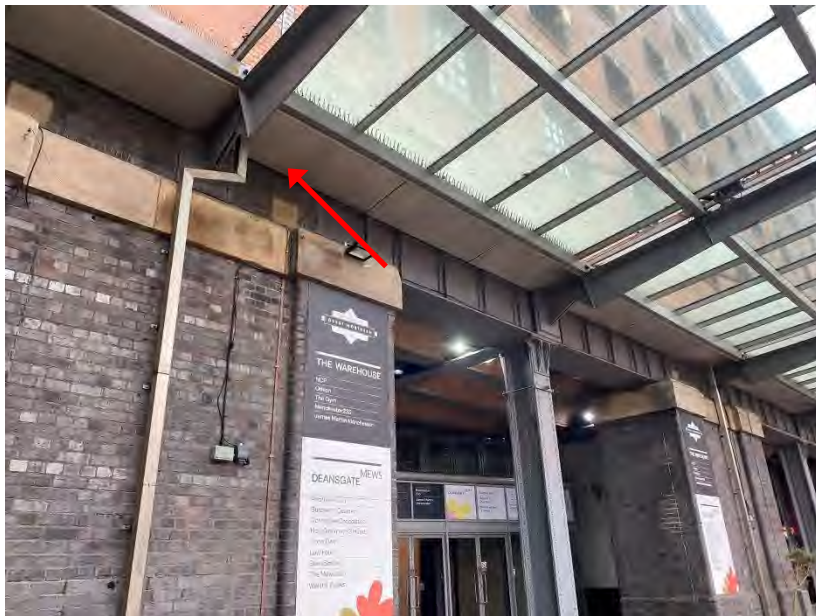
**Fig 17:**

North elevation; showing the valley gutter to the canopy roof. The valley gutter was vulnerable to blockage if not maintained from above the canopy

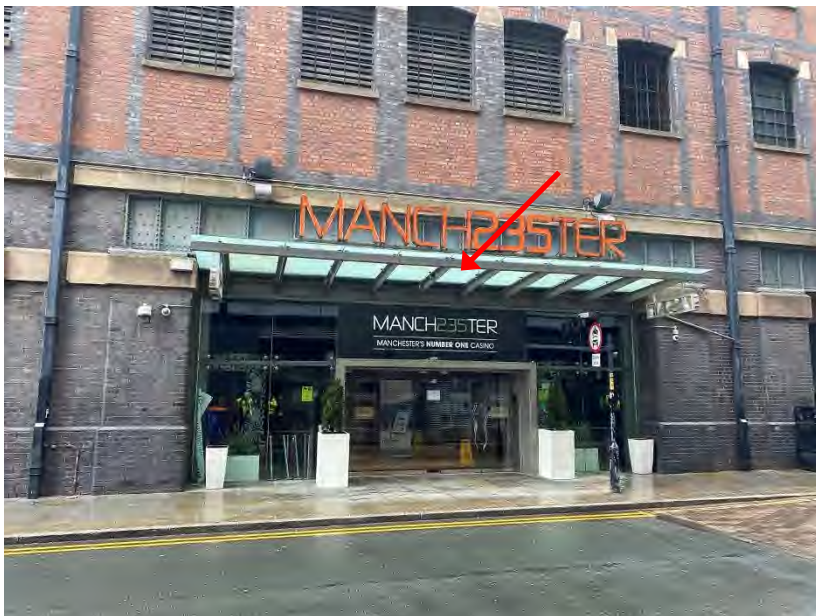
**Fig 18:**

East elevation; showing the canopy roof over the entrance to Manchester 235 Casino. The valley gutter was vulnerable to blockage if not maintained from above the canopy

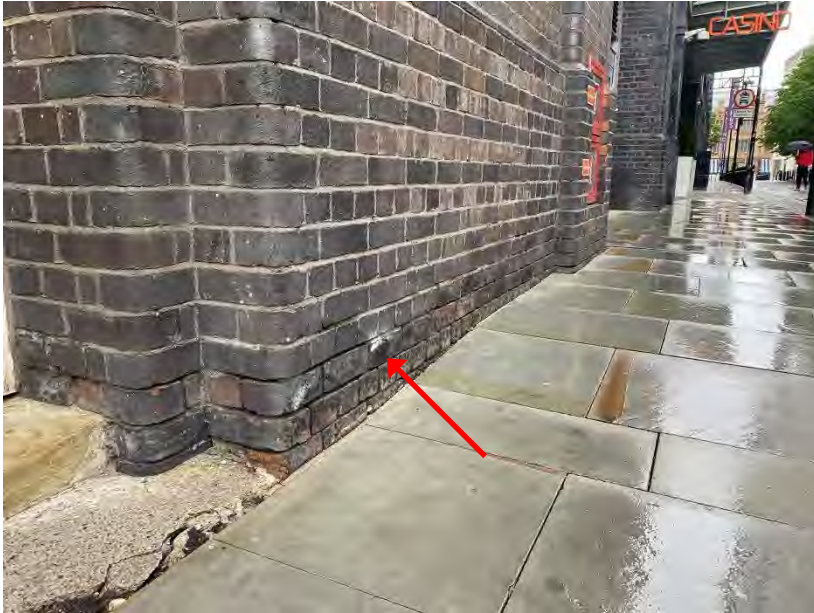
**Fig 19:**

- 3 Ground and surface drainage: The lower courses of brickwork were washed-out with biological growth the full length of the elevation indicating high moisture levels, providing conditions for damp and decay. It is unclear whether the canopy drainage over the entrance into Manchester 235 Casino is maintained and this could potentially be overtopping during periods of heavy rainfall

East elevation; showing 'bridging' of the damp-proof course due to raised footpath level. Also note the washed-out mortar in the lower courses of brick

*External ground levels should be reduced to at least 150mm below DPC height where practical. Alternatively, allow internal waterproofing/damp mitigation e.g., a cavity drainage system capable of providing dry internal surfaces but that will not damage to historic fabric*

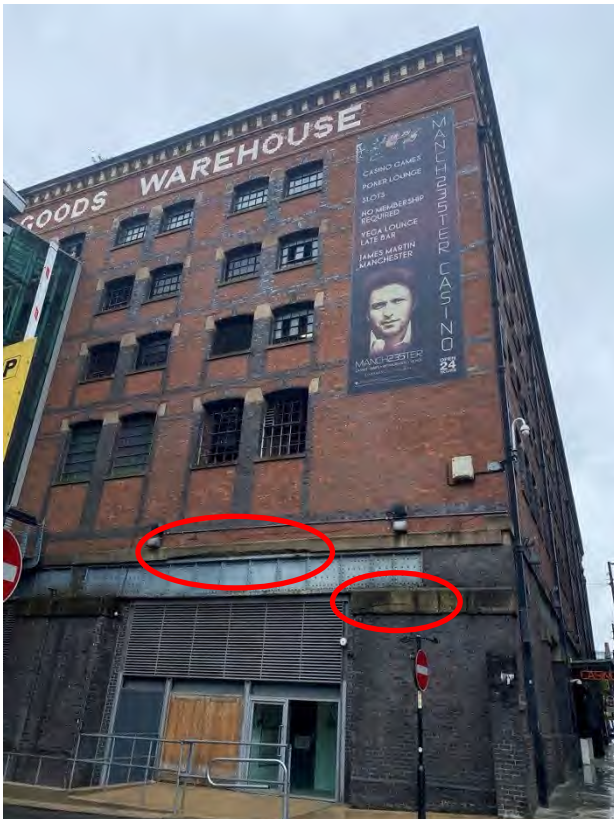
**Fig 20:**

- 1 Stonemasonry: There was mechanical damage and cracking through the stone string course above and either side of the opening to the south-east corner. Although this damage appears to be historical there is a potential risk that cracked stone may detach and fall onto the footpath beneath

South elevation; showing areas of mechanical damage and cracking through the stonemasonry

*Allow for tactile assessment of the damaged stonemasonry, removing any loose material vulnerable to detachment. H+R to carry out detailed investigation of facades and mortar analysis and provide recommendations on appropriate repairs*

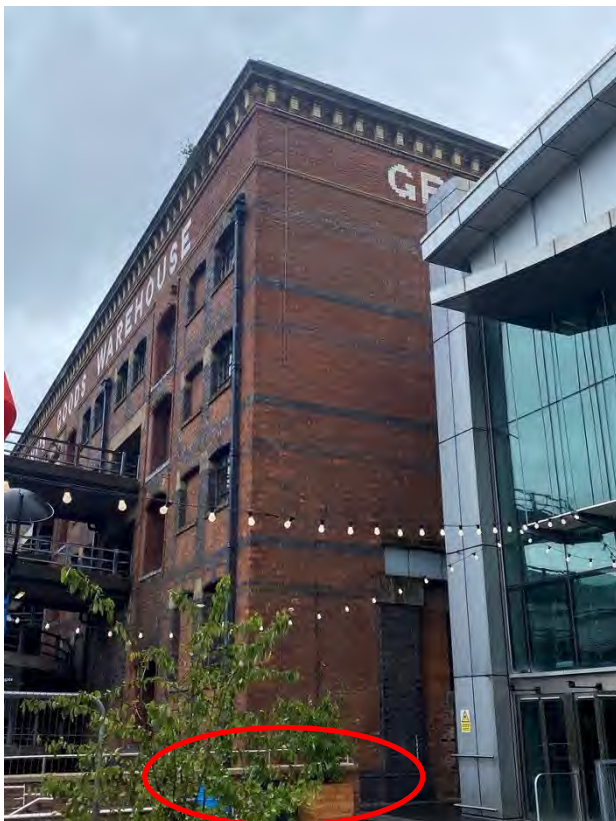
**Fig 22:**

South elevation; showing the location of defective surface water drainage from the podium deck (see Fig 23)

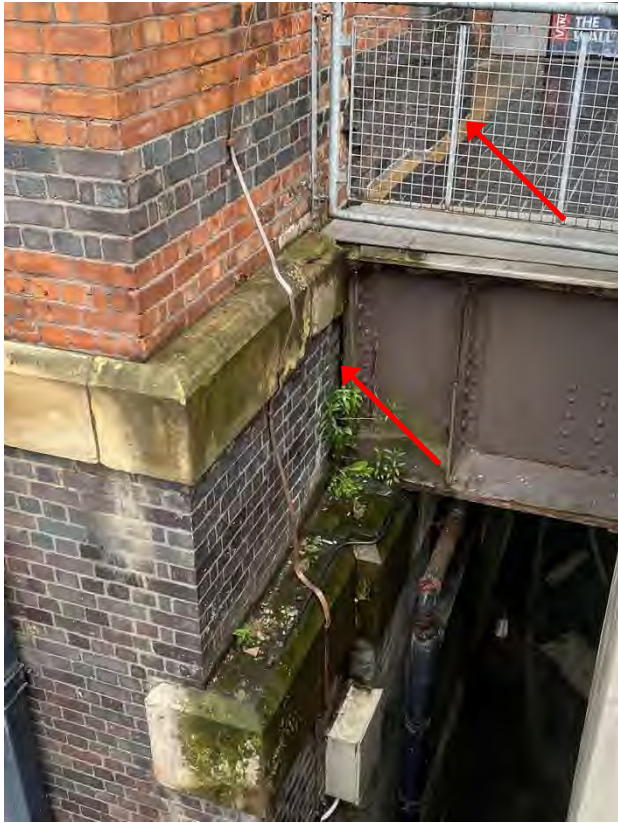
**Fig 23:**

- 3 Ground and surface drainage: In the south-east corner the brickwork beneath the plinth brick had generally been washed-out allowing water penetration on the structures beneath. In the south-west corner, defective surface drainage from the Mews level bridge has washed-out approximately 3m<sup>2</sup> of brickwork and caused erosion of stonemasonry. There is extensive plant and biological growth indicating high moisture levels, providing the conditions for damp and decay

South elevation; showing defective drainage to the south-west corner causing erosion of the stone string course and wash-out of the mortar to the brickwork

Note that the loose stable pavers reported in 2017 had been replaced with concrete with a lead flashing

*Allow for detailed inspection of the above façade defects and for a schedule of repairs to be provided*

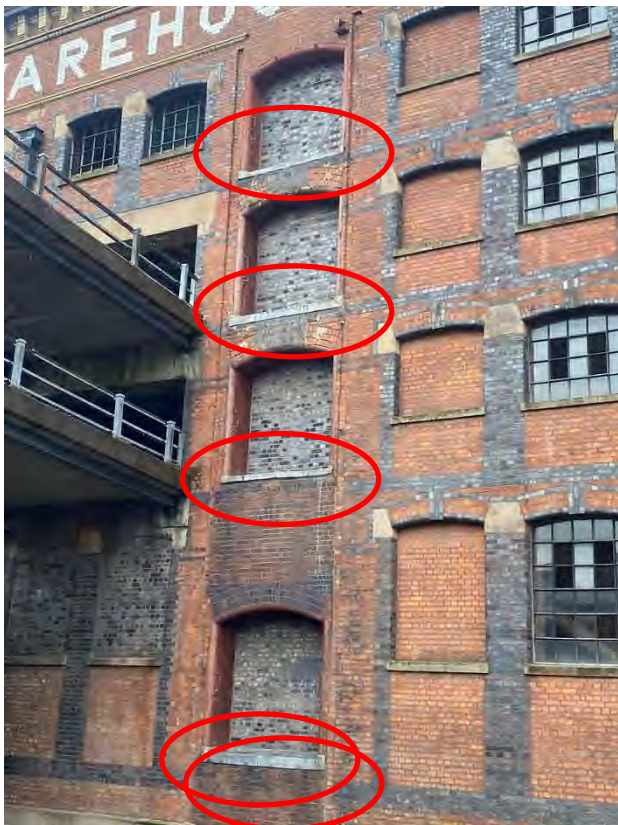
**Fig 24:**

- 3 Timber sills: The cast-iron loading doorways have lead-lined timber sills and in some areas the timber sills were partially exposed and vulnerable to wet rot. Disturbance of the leadwork presumably due to thermal movement was also noted and this increased the likelihood of lead splitting. This provided an additional route for water penetration and entrapment

West elevation; showing leadwork applied over timber sills to the bricked-up loading doorways. Timber sills are vulnerable to decay

*H+R to carry out investigation of all timber sills to establish areas of water penetration, extent of decay and provide recommendations*

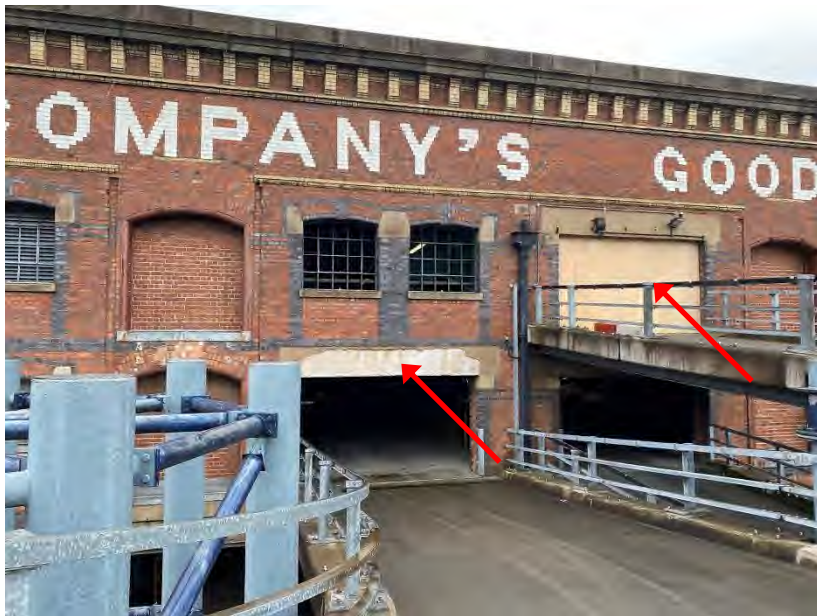
**Fig 25:**

- 2 Concrete lintels: Pairs of segmental headed windows and the brickwork between them have been removed and concrete lintels introduced to allow for vehicular access. A render has been applied over the concrete lintels to give the appearance of stone, but in some areas the render had failed and appears to have been deliberately removed from one lintel, presumably to limit damage to passing cars beneath. No mechanical key had been made to this smooth concrete lintel and this may be the case elsewhere

West elevation; showing defective render concrete lintel. Note that access onto the 4th floor was restricted

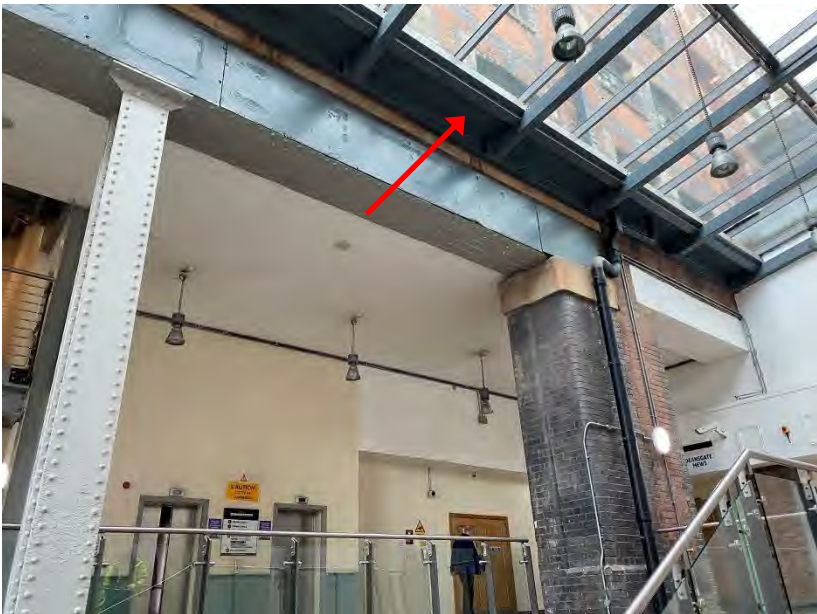
**Fig 26:**

- 1 Glazed roof: Water penetrating was occurring via the valley gutter to the glazed canopy towards the north-west corner of the building. There were no obvious timber structures beneath but there was a risk to the electrics, and pooling water on the corridor was a slip hazard

West elevation; showing water penetration via the valley gutter to the glazed roof extension

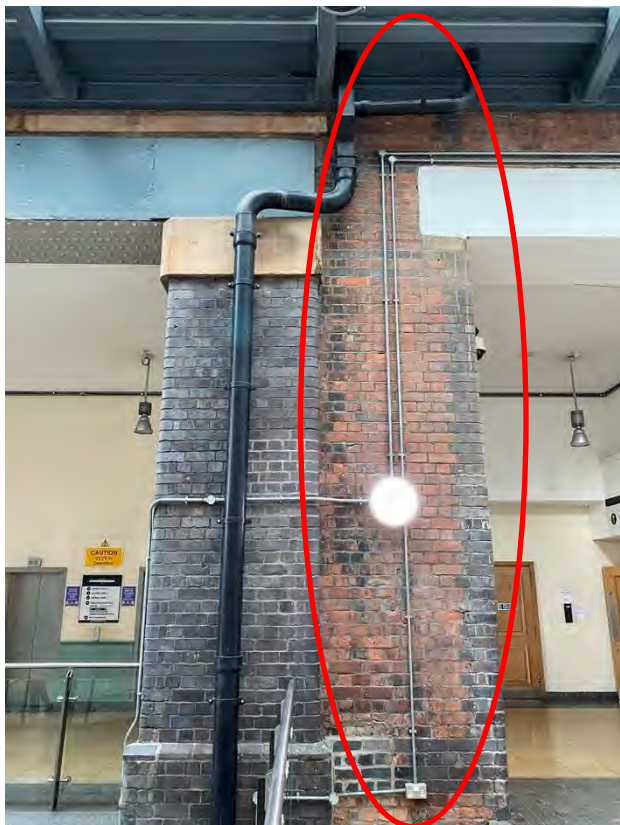
**Fig 27:**

West elevation; showing electrics directly beneath the area subject to water penetration. Pooling water was also noted on the corridor floor

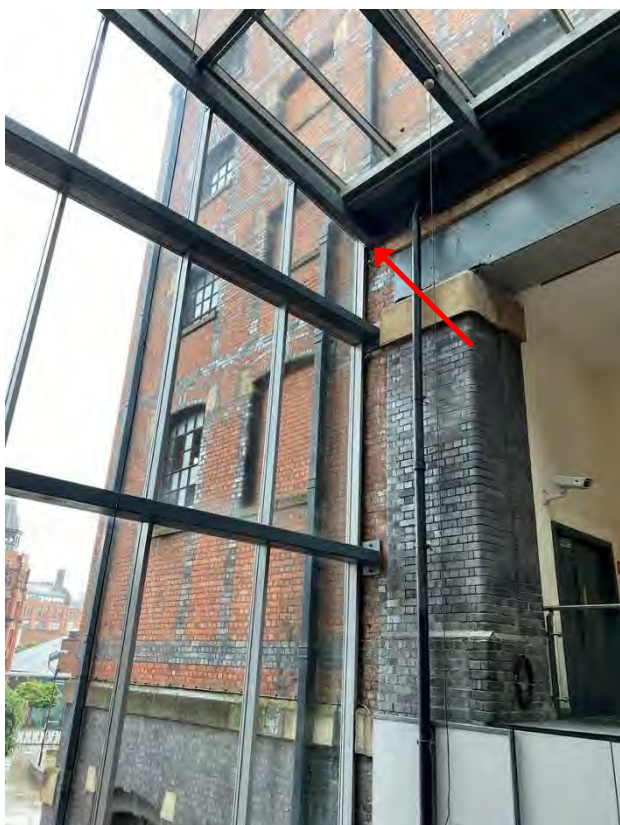
**Fig 28:**

West elevation; showing area of water penetration and plant growth beneath the northern end of the valley gutter

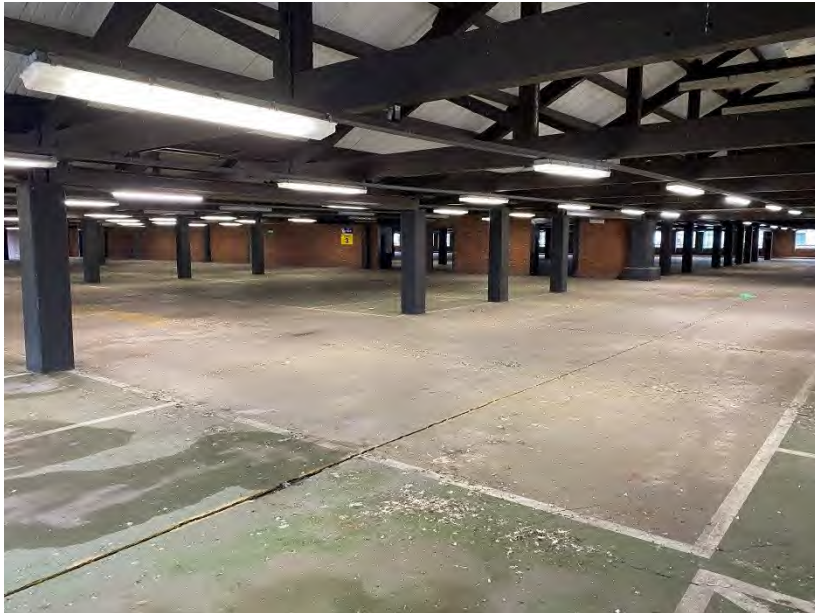
**Fig 29:**

Fourth Floor, NCP car park; showing a general view of the roof structure that was a softwood construction. All floors were of 'fireproof' brick-arch and riveted steel construction

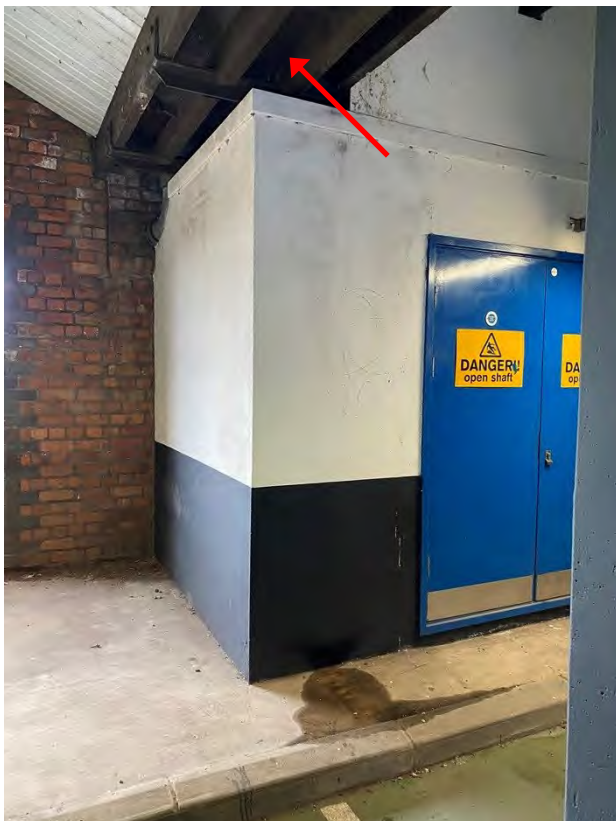
**Fig 30:**

Fourth Floor, NCP car park; showing water penetration via the valley gutter

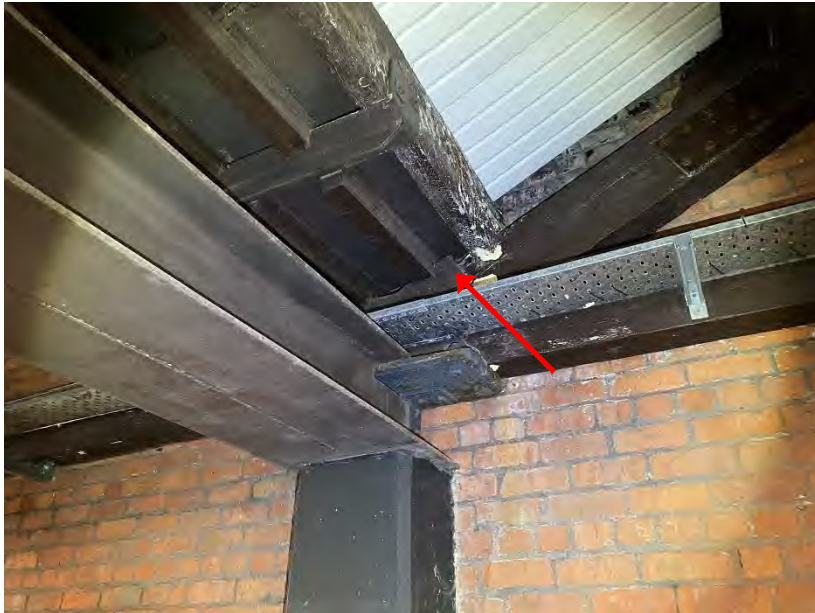
**Fig 31:**

Fourth Floor, NCP car park; showing water penetration via the central parapet (directly below Fig 9)

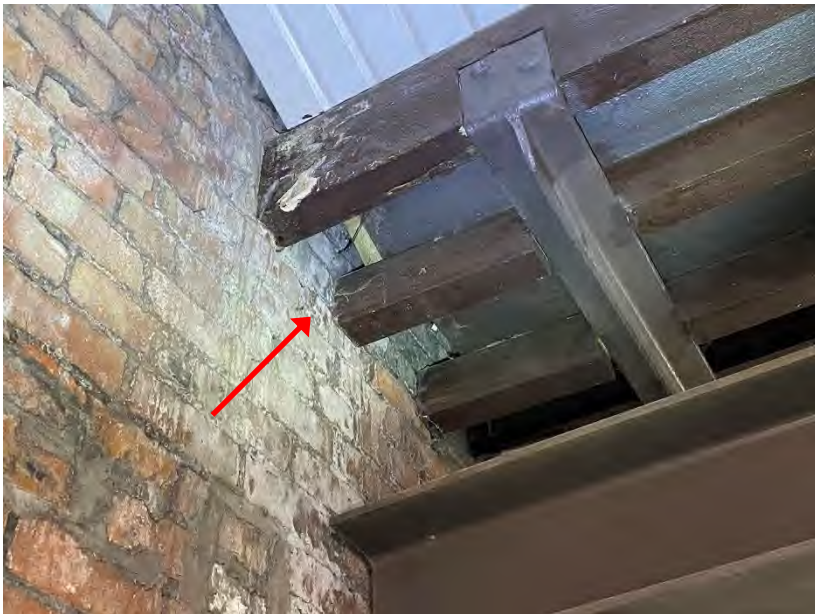
**Fig 32:**

Fourth Floor, NCP car park; showing water penetration via the central parapet (directly below Fig 11)

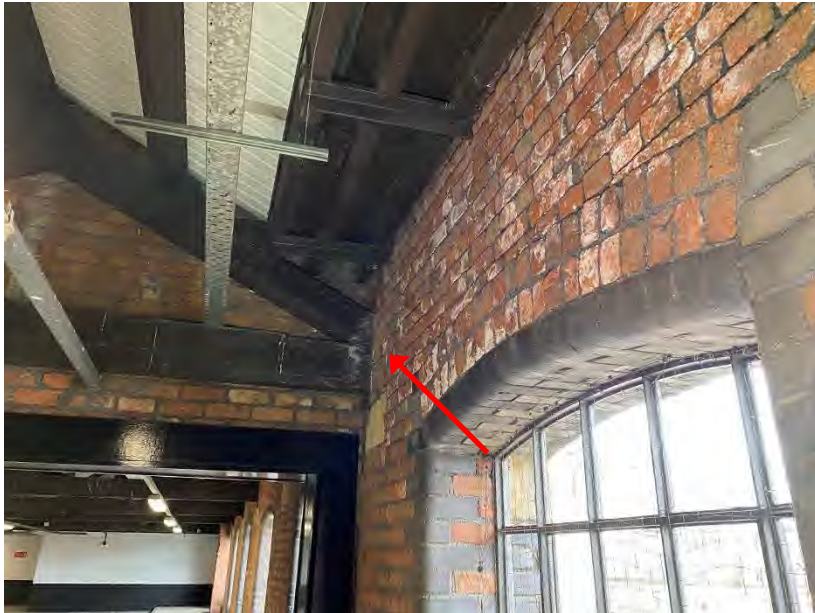
**Fig 33:**

Fourth Floor, NCP car park; showing an example of a steel flitch plate repair to the bearing end of the roof truss. This indicates a history of water penetration and decay

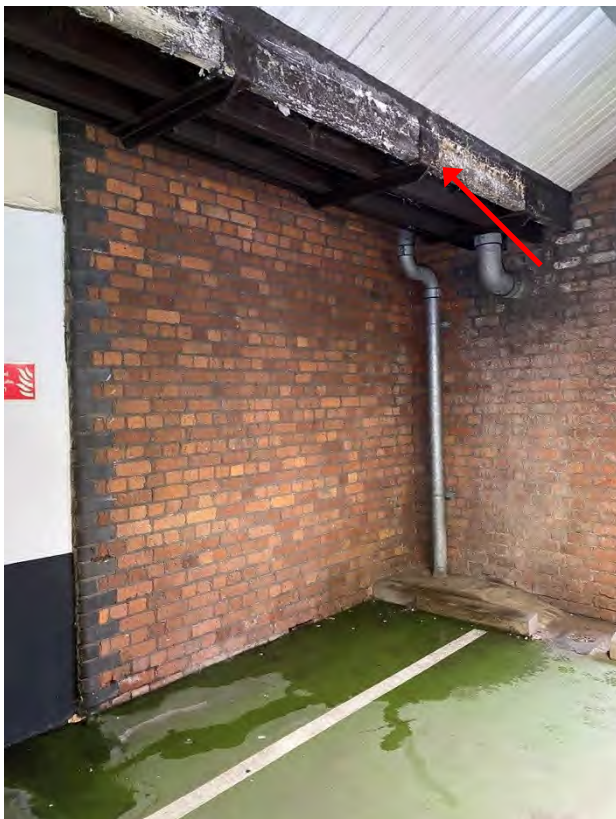
**Fig 34:**

Fourth Floor, NCP car park; showing water penetration via the valley gutter

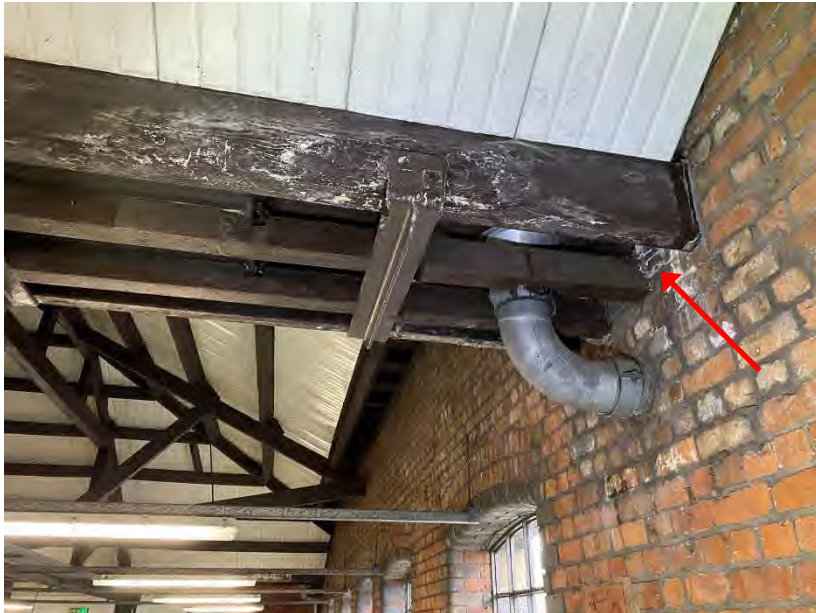
**Fig 35:**

Fourth Floor, NCP car park; showing water penetration via the valley gutter

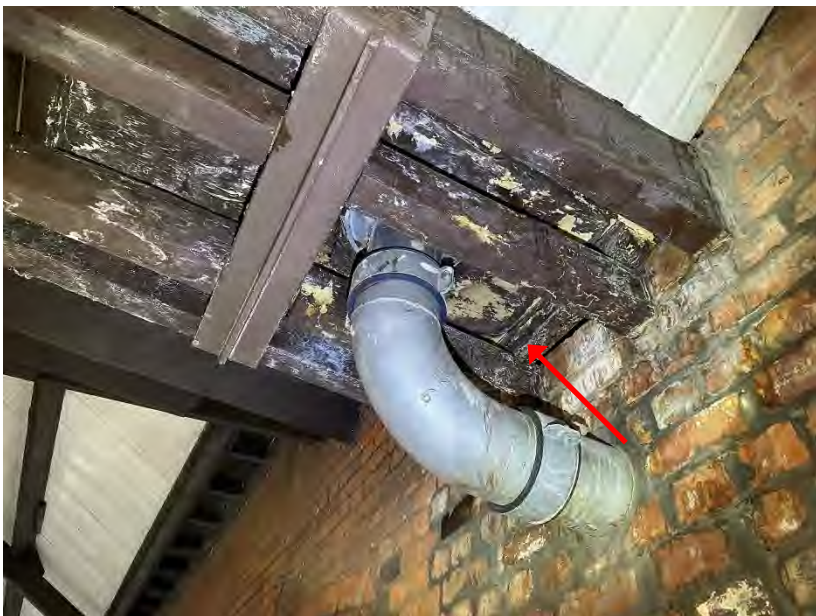
**Fig 36:**

Fourth Floor, NCP car park; showing water penetration via the valley gutter

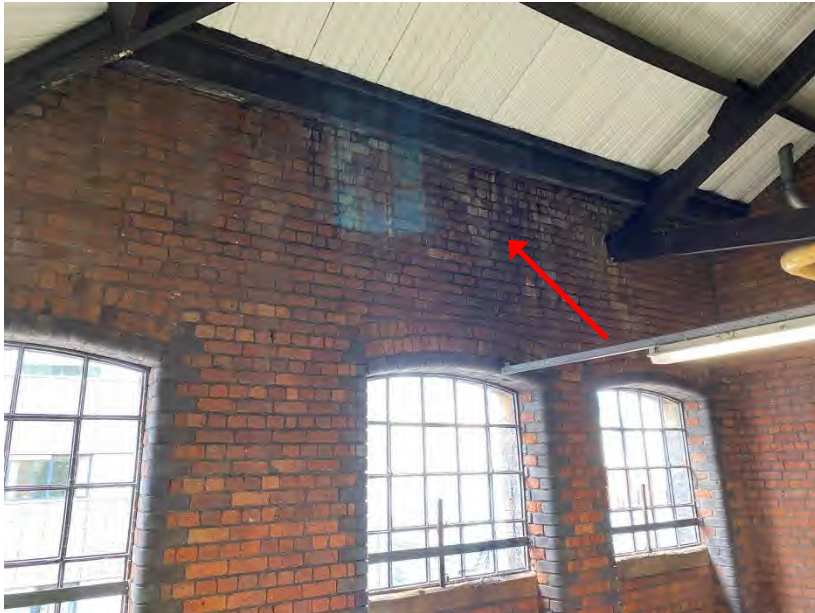
**Fig 37:**

Fourth Floor, NCP car park; showing water penetration via the parapet gutter (directly below Fig 3)

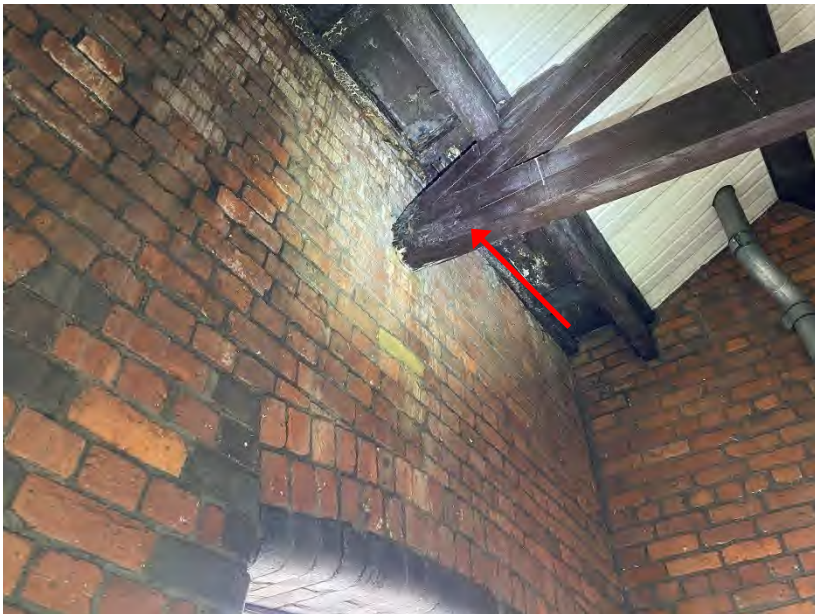
**Fig 38:**

- 1 Water penetration: There was ongoing water penetration occurring in numerous areas, primarily associated with defects in the central parapet wall and parapet and valley gutters. This was providing the condition for damp and timber decay affecting roof timbers especially where embedded or in direct contact with the masonry. Areas of water penetration are identified on the Plans at Appendix F. Since our survey of 2017 the upper floor of the NCP car park had been closed to vehicles, possibly due to water penetration
- 2 Timber decay: There was structurally significant decay identified in the bearing end of a truss tie beam to the south-east corner. The parapet gutter boards were also structurally decayed. The parapet gutter boards were also decayed to the centre of the north elevation

Fourth Floor, NCP car park; showing decayed parapet gutter boards and probable decay in the bearing end of the truss. The truss should be propped immediately

*Allow for the temporary propping of the structurally decayed truss tie beam*

*H+R to undertake a detailed timber condition survey from beneath the roof structure by decay detection drilling and deep moisture content probing, along with the gutter timbers*

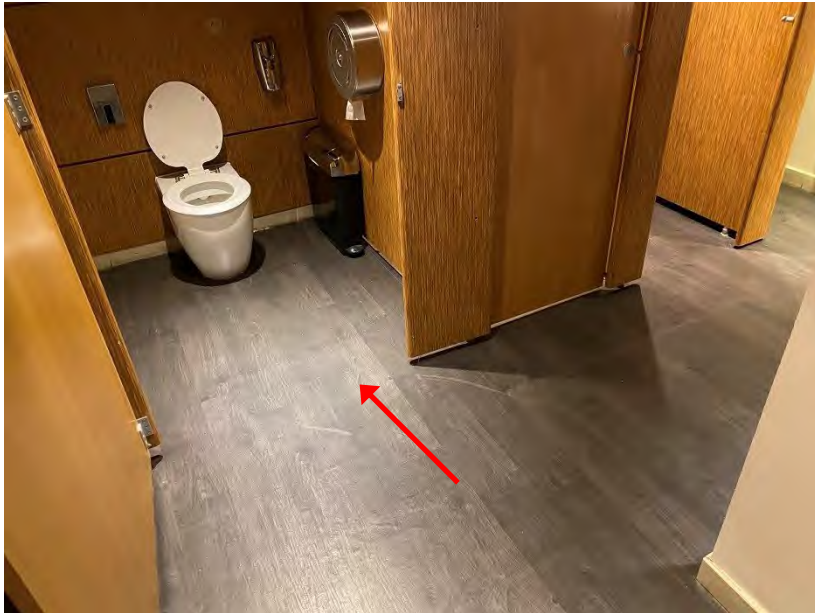
**Fig 39:**

First Floor, Manchester 235 Casino;  
showing undulations beneath the vinyl  
floor coverings where high moisture  
readings were taken

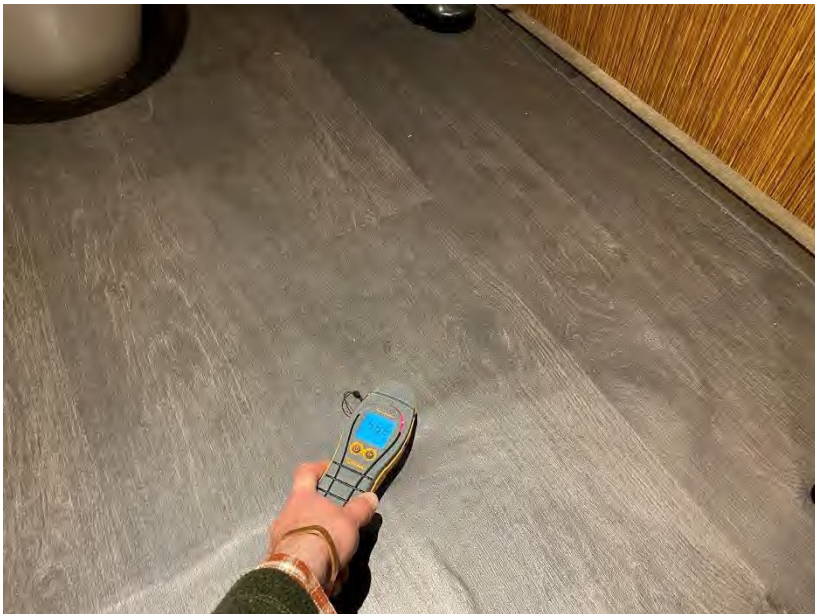
**Fig 40:**

First Floor, Manchester 235 Casino;  
showing high moisture reading beneath  
the vinyl. This may be caused by a  
plumbing leak or entrapped moisture  
from wet mopping
