2<sup>ND</sup> RECONNAISSANCE DAMP AND TIMBER DECAY SURVEY

GREAT NORTHERN, MANCHESTER

JOB NO. 211.18

30 MAY-1 JUNE 2022

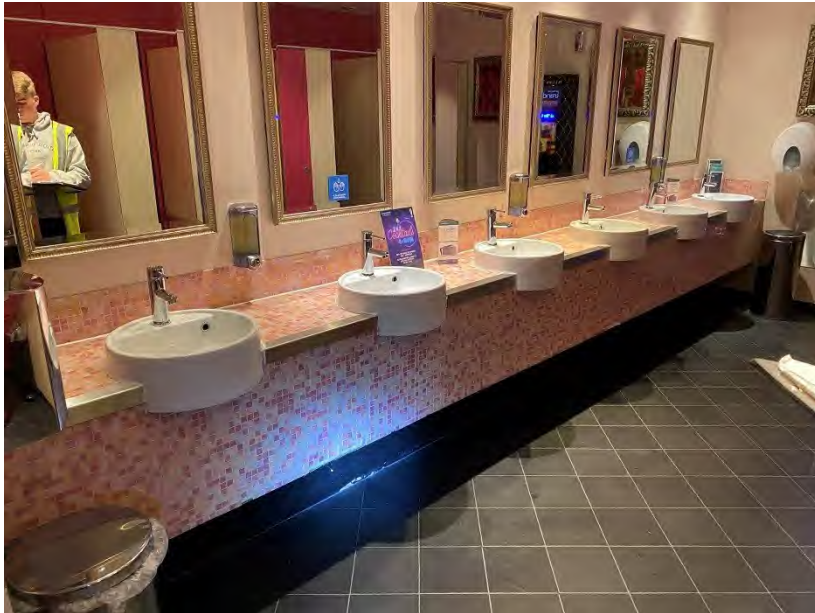
**Fig 41:**

First Floor, Manchester 235 Casino;  
showing water staining to the timber  
cabinetry beneath the Female W.C.  
sink.

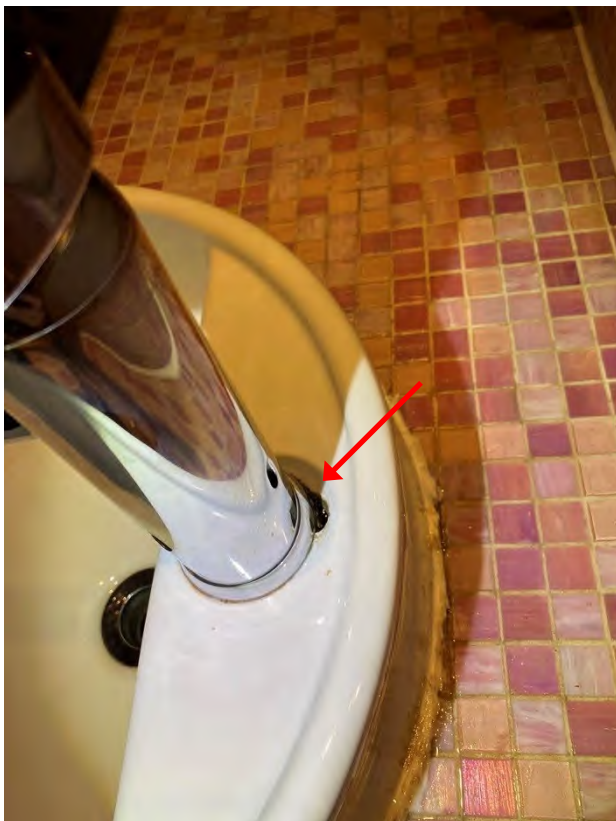
**Fig 42:**

First Floor, Manchester 235 Casino;  
showing defective seal to tap allowing  
water to leak below

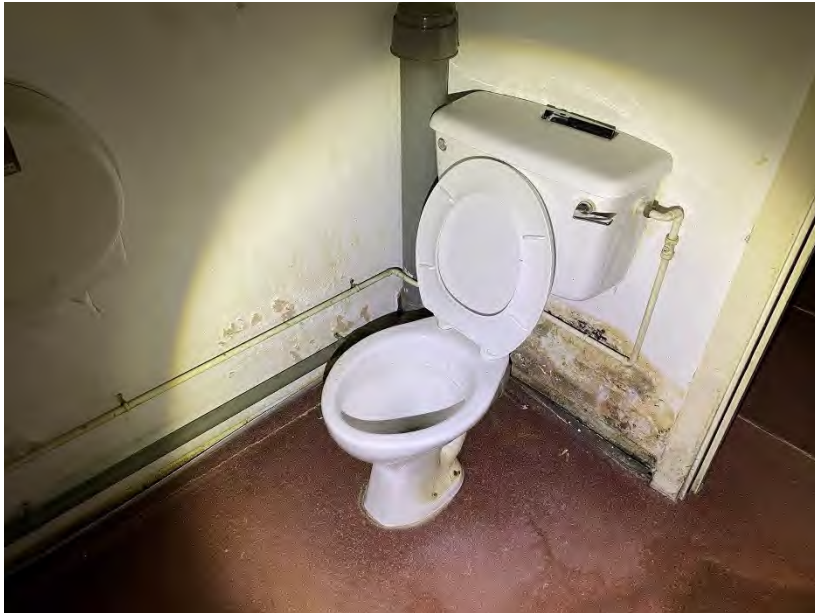
**Fig 43:**

Ground Floor, Manchester 235 Casino;  
showing an old plumbing leak from the  
W.C. cistern. Joinery was partially  
decayed

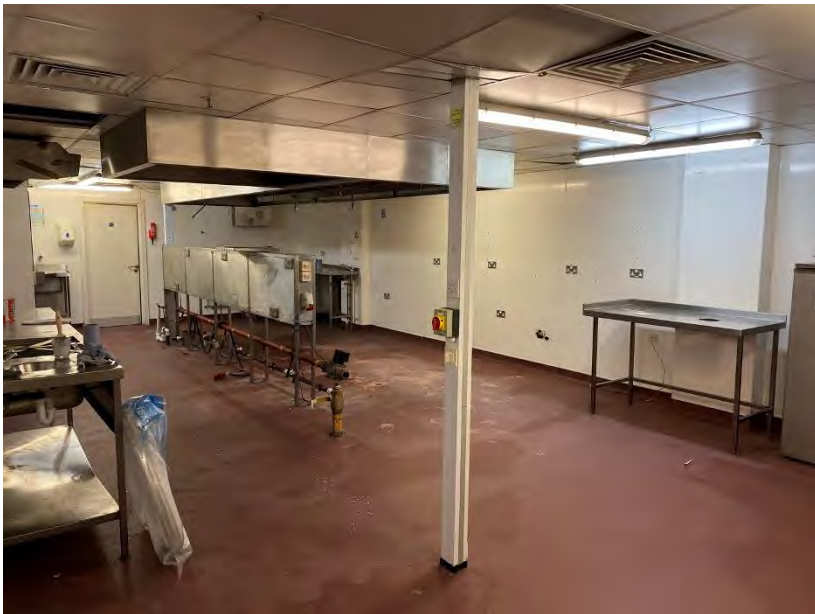
**Fig 44:**

Ground Floor, Manchester 235 Casino;  
showing evidence of numerous  
historical leaks from the disused  
Kitchen

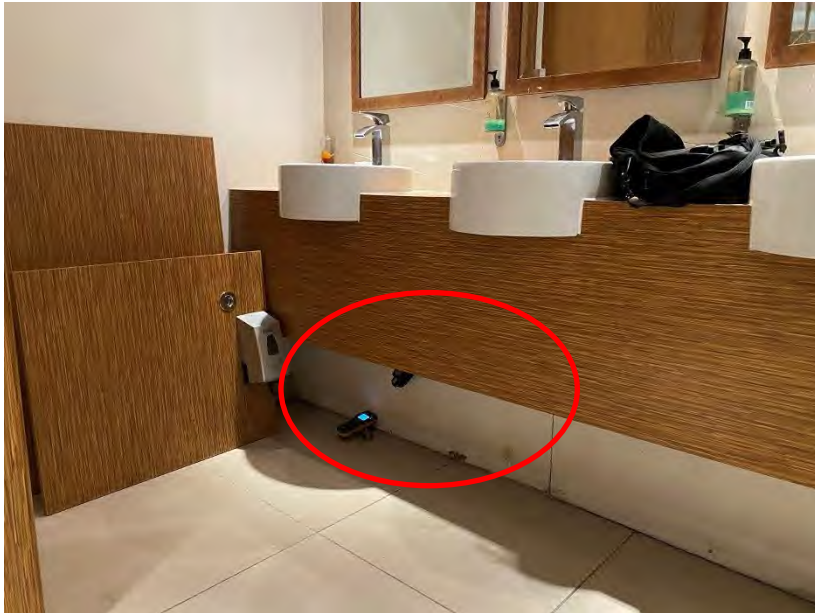
**Fig 45:**

Ground Floor, Manchester 235 Casino;  
showing a high moisture reading in the  
timber joinery beneath the W.C. sink.  
Timbers were partially decayed by  
active wet rot fungus due to the  
ongoing plumbing leak

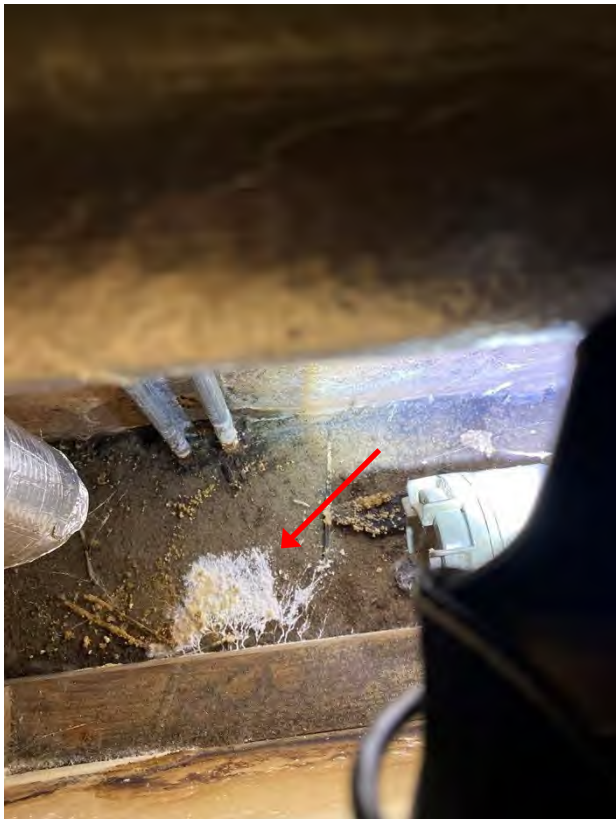
**Fig 46:**

Ground Floor, Manchester 235 Casino;  
showing wet rot fungus to the floor  
beneath the sink

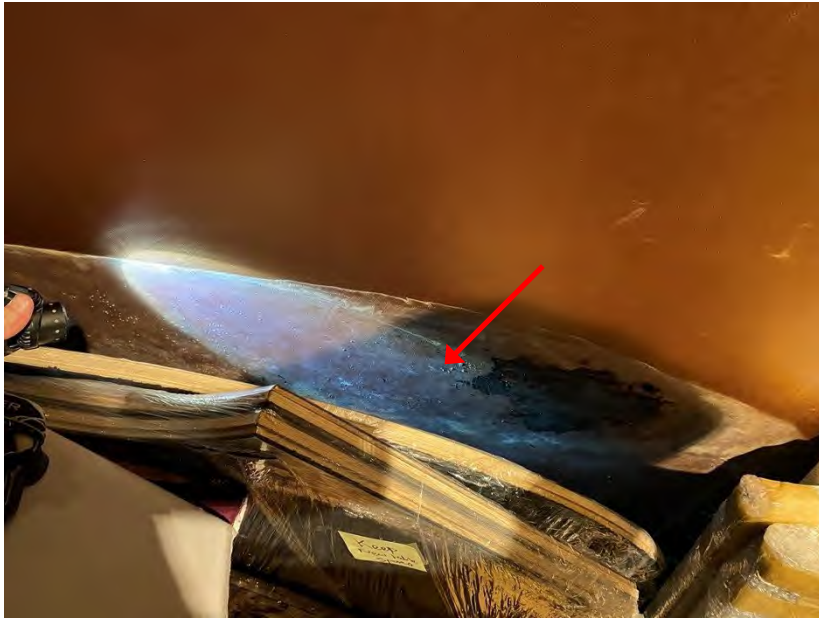
**Fig 47:**

Ground Floor, Manchester 235 Casino;  
showing damp and mould growth to  
the plaster finishes on the other side of  
the W.C. sink

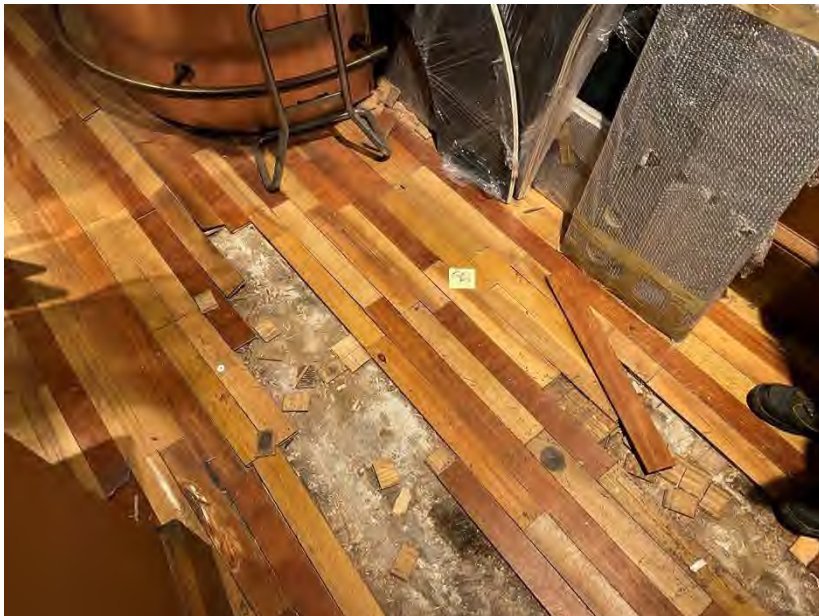
**Fig 48:**

Ground Floor, Manchester 235 Casino;  
showing decay and warping of the  
timber floor finishes

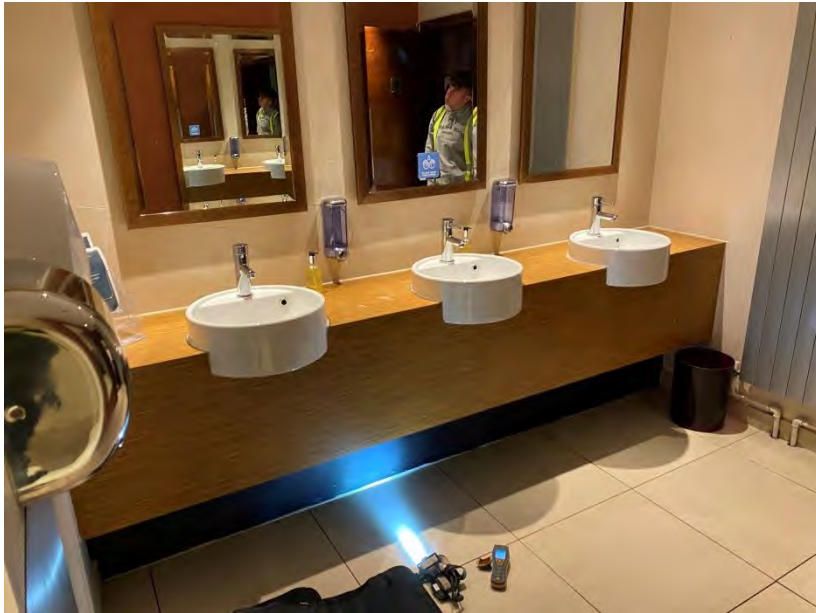
**Fig 49:**

Ground Floor, Manchester 235 Casino;  
showing the location of an old  
plumbing leak

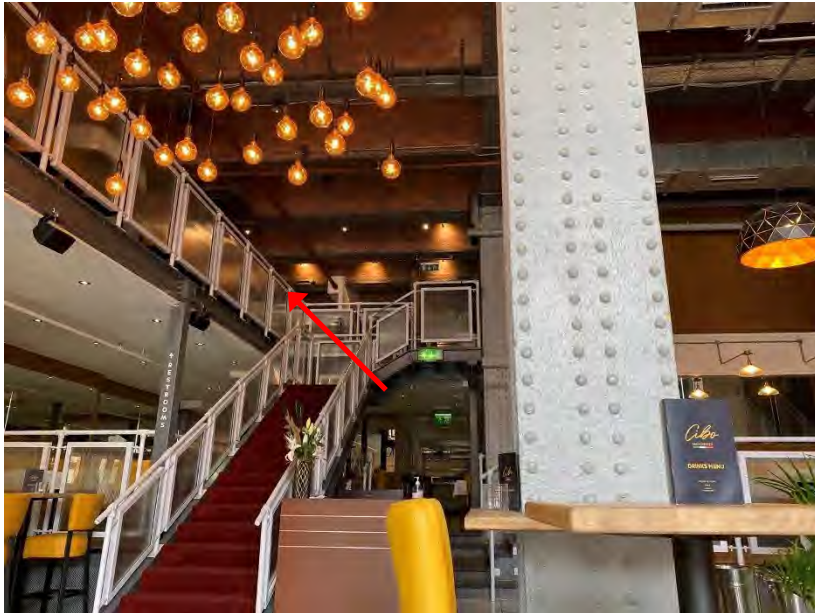
**Fig 51:**

Ground Floor, CIBO; showing the Mezzanine where there was an ongoing plumbing leak in the Male W.C.

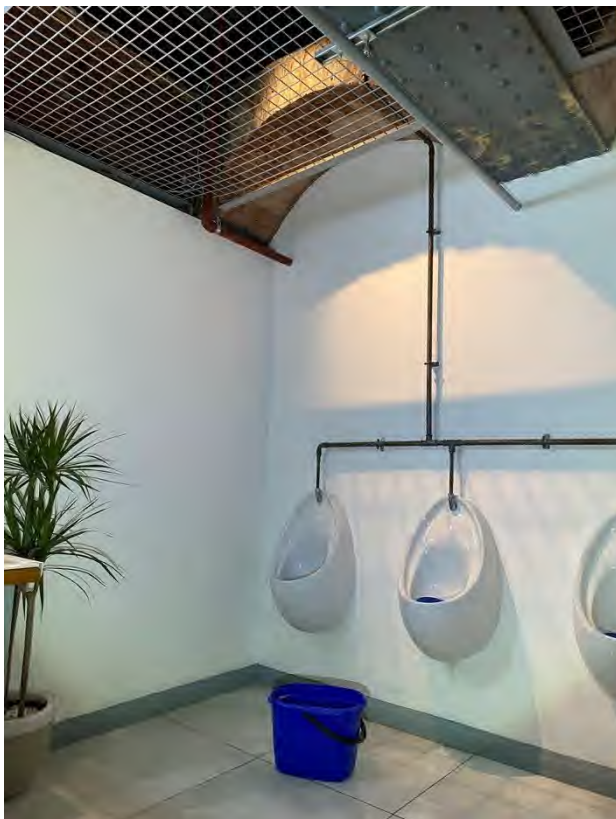
**Fig 52:**

Ground Floor Mezzanine, CIBO; showing the plumbing leak from the water tank above the urinals
