# 51-53 Richmond Street

Civil & Structural Engineering

Stage 2 Report

**Status:** S02  
**Revision:** P03  
**Date:** 16.12.2022

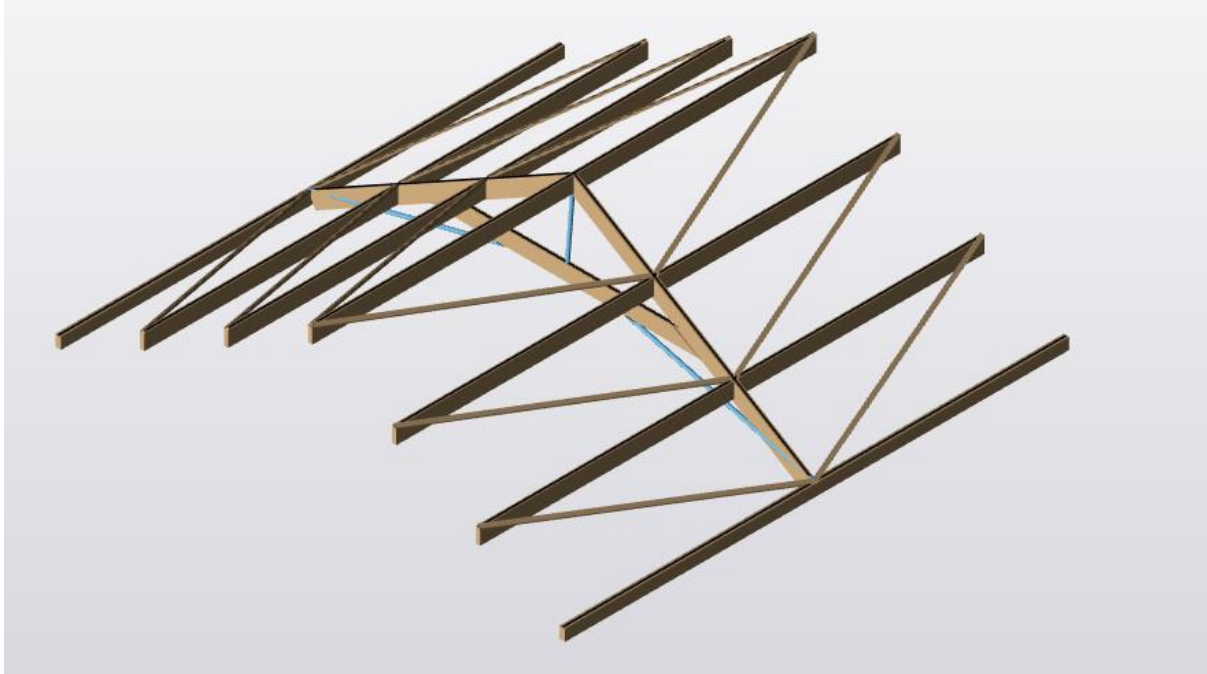
*Figure 3: Tekla Model of the Braced Roof Structure (Isometric View) NB. Rafters omitted for Clarity*

The assessment has instead focussed on the suitability of the roof structure in its currently deformed geometry for adequacy. As per the structural inspection report, the roof appears to have been reconstructed some time after WWII with latent defects in its construction, namely the lack of in plane bracing and restraint.

The intended intervention here would be to strap the purlin ends to the gable walls and provide new in plane timber bracing tying the purlin ends to the main timber truss. This should stabilise the roof structure by reducing the lateral reaction into the gable walls and limit any further sideways racking to an acceptable amount.

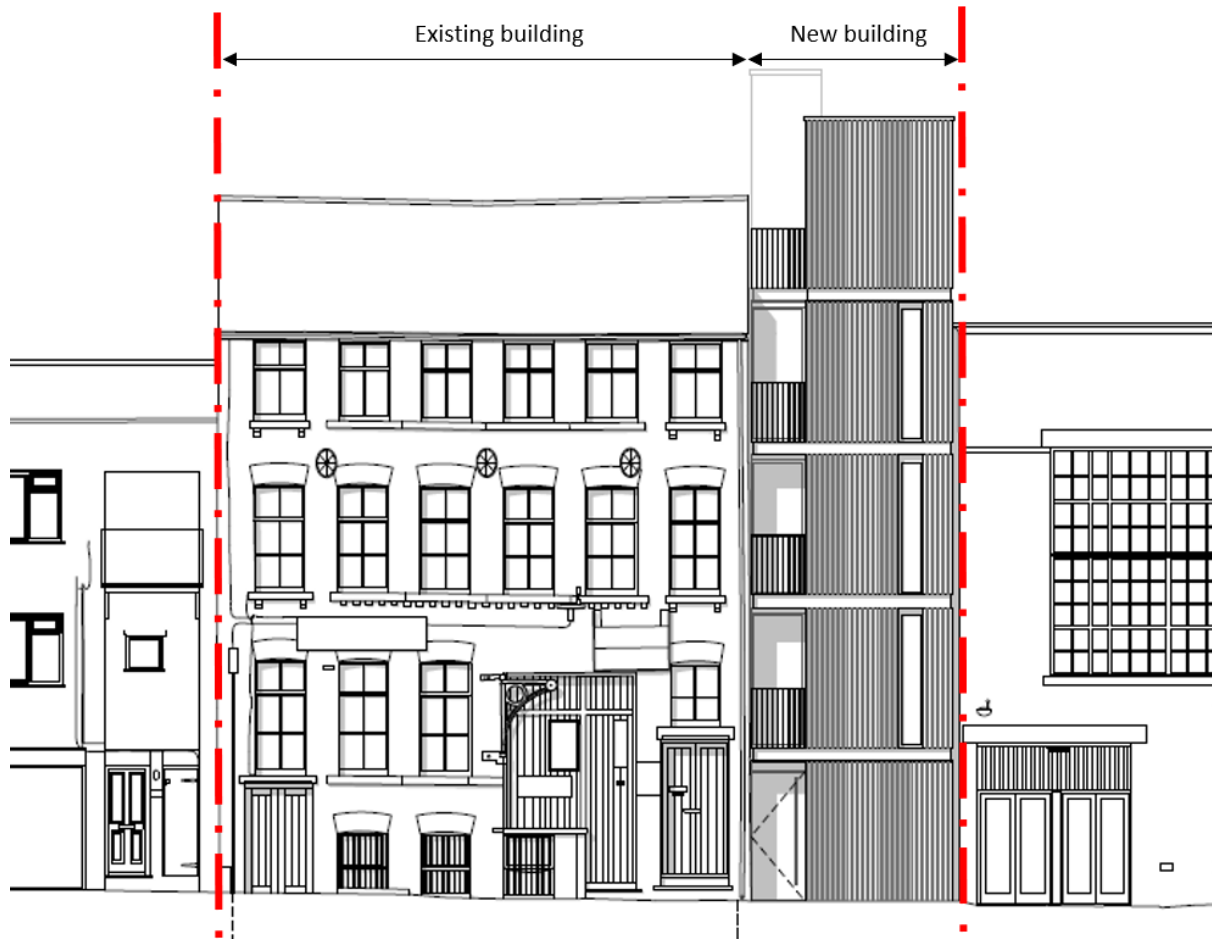
The plot is currently used as parking. There is a masonry wall to the rear and a galvanised steel full width gate to the front.

To the rear there is also a metal escape staircase encroaching slightly over the brick wall.
