**The Great Northern Warehouse**

**Survey 2022**

**Great Northern Warehouse & Deansgate Terraces, Manchester**

**Condition Survey**

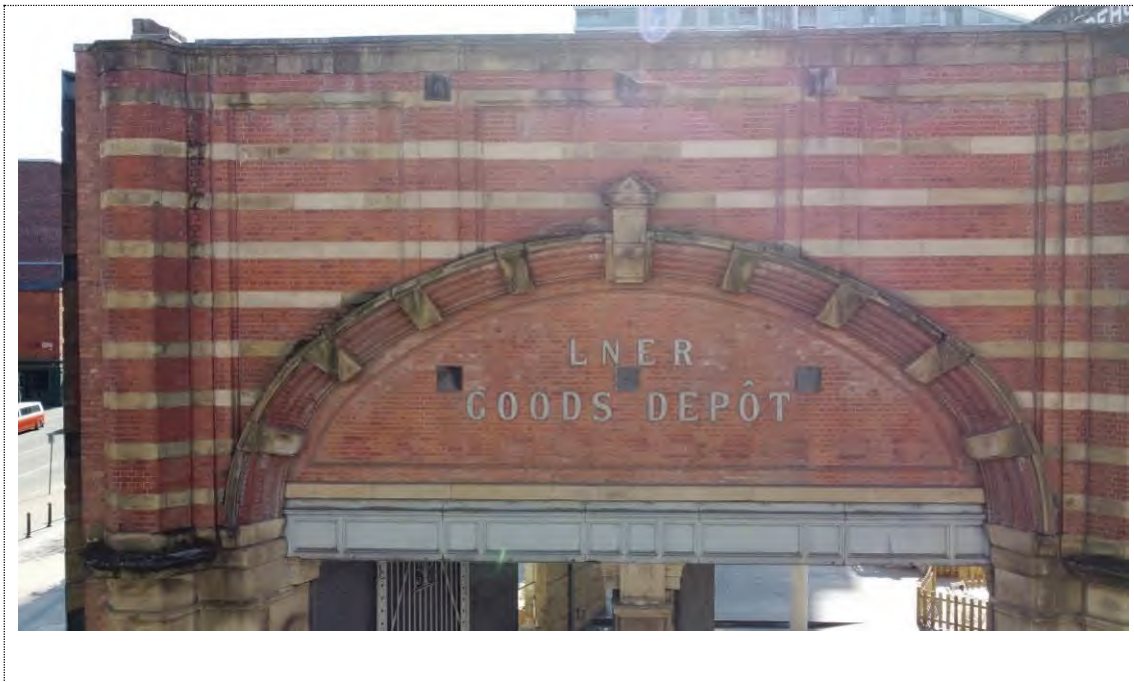
| Photograph: | 1 |

| Description: | Redress spalling stone to a sound surface. Cut out defective stone and replace new matching stone. Repoint defective joints. (West facing) |

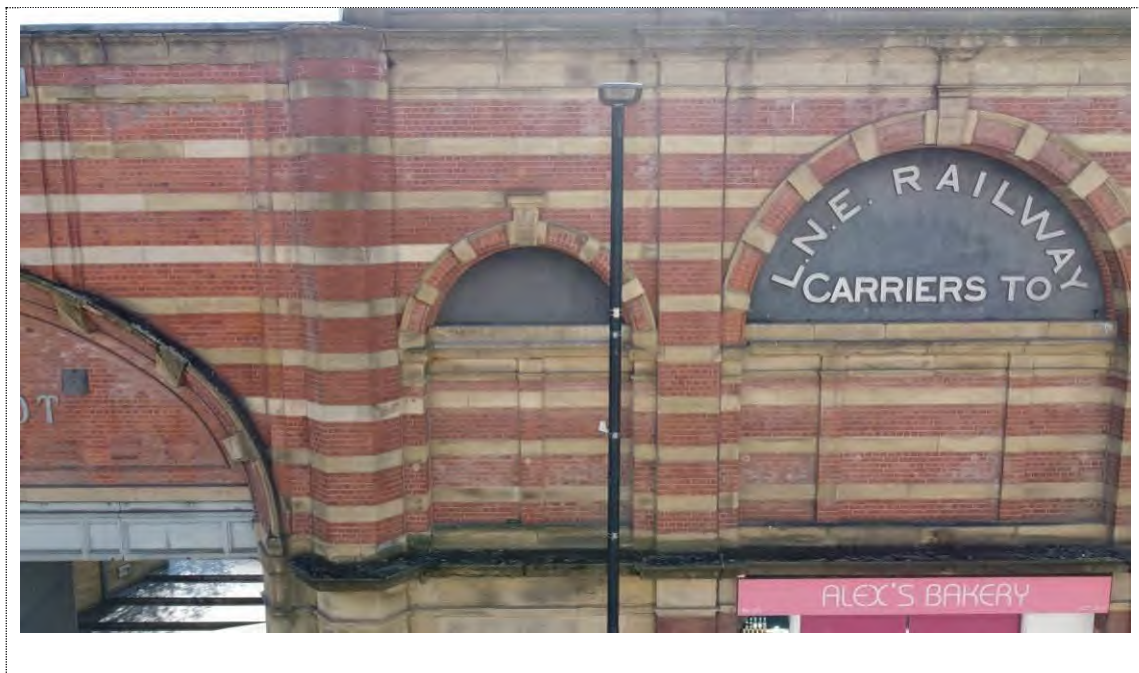
| Photograph: | 5 |

| Description: | Redress spalling stone to a sound surface. Cut out defective stone and replace new matching stone. (West facing) |

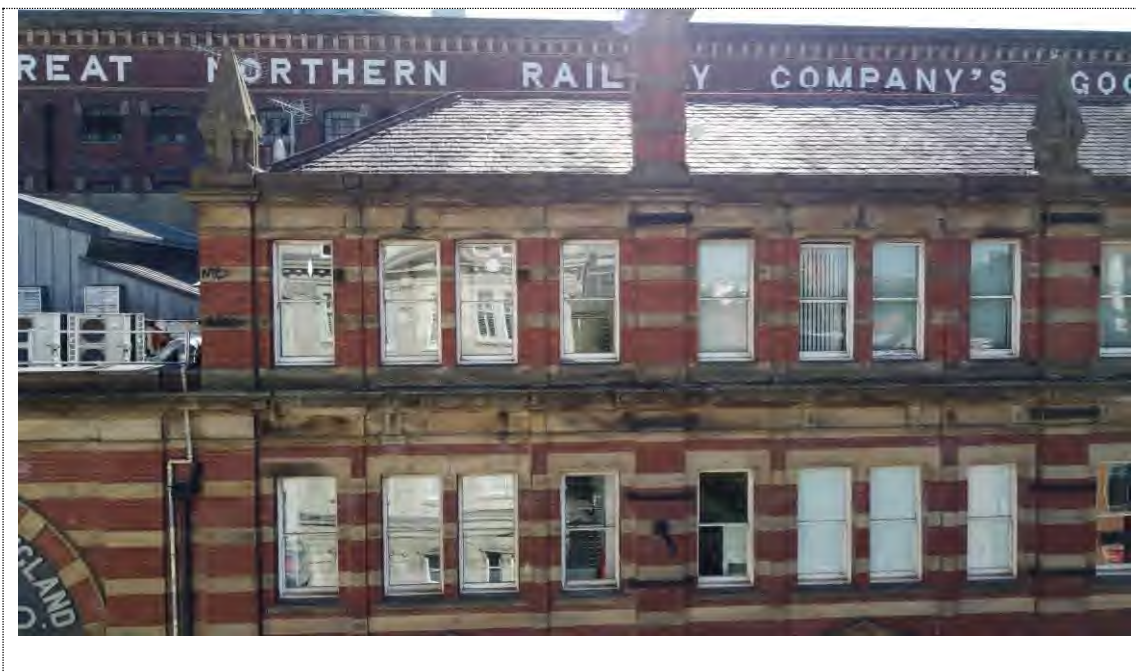
| Photograph: | 9 |

| Description: | Redress spalling stone to a sound surface. Treat CI straps. (West facing) |

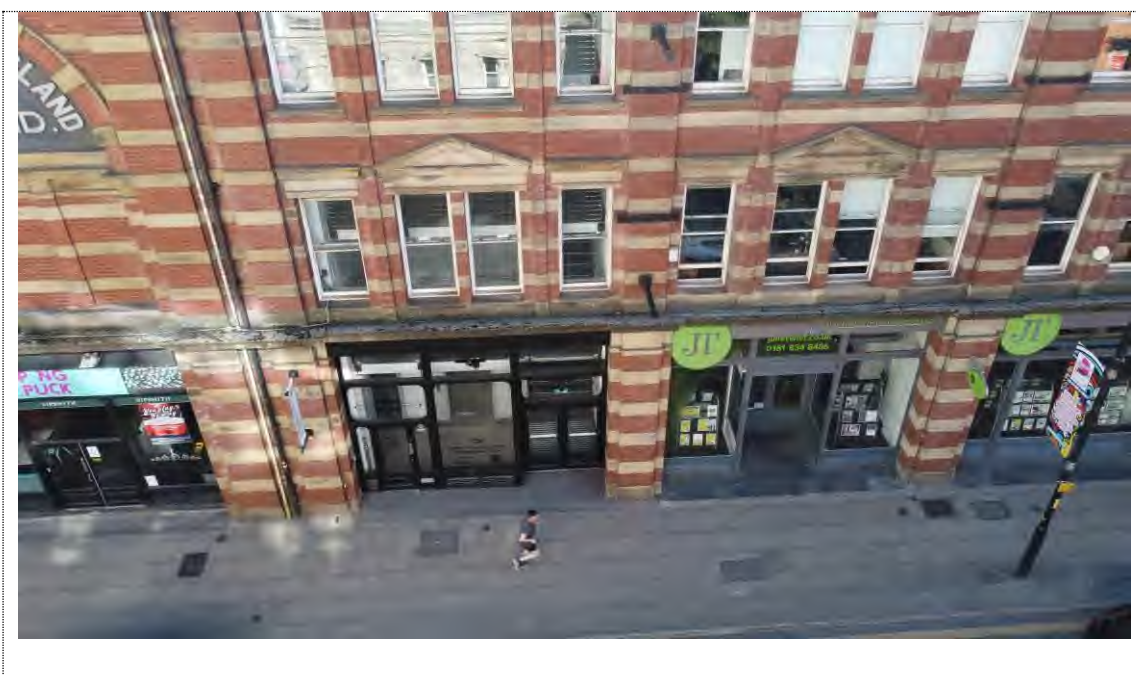
| Photograph: | 10 |

| Description: | Redress spalling stone to a sound surface. Treat Ci straps. (West facing) |

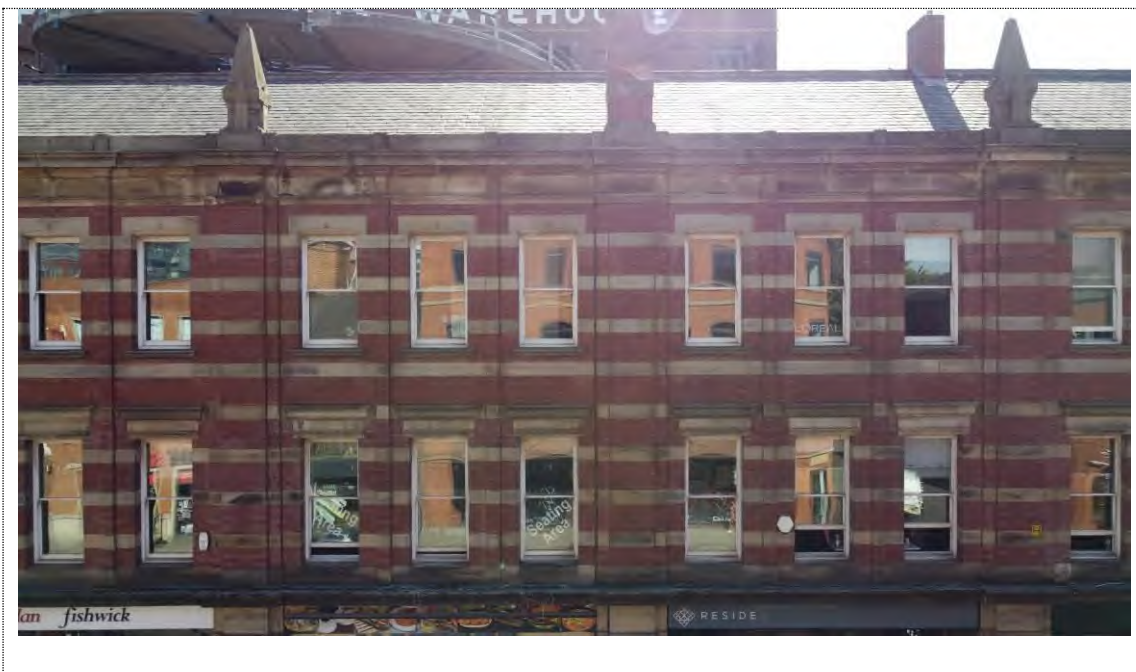
| Photograph: | 21 |

| Description: | Redress spalling stone to a sound surface. Cut out defective stone and replace new matching stone. (West facing) |

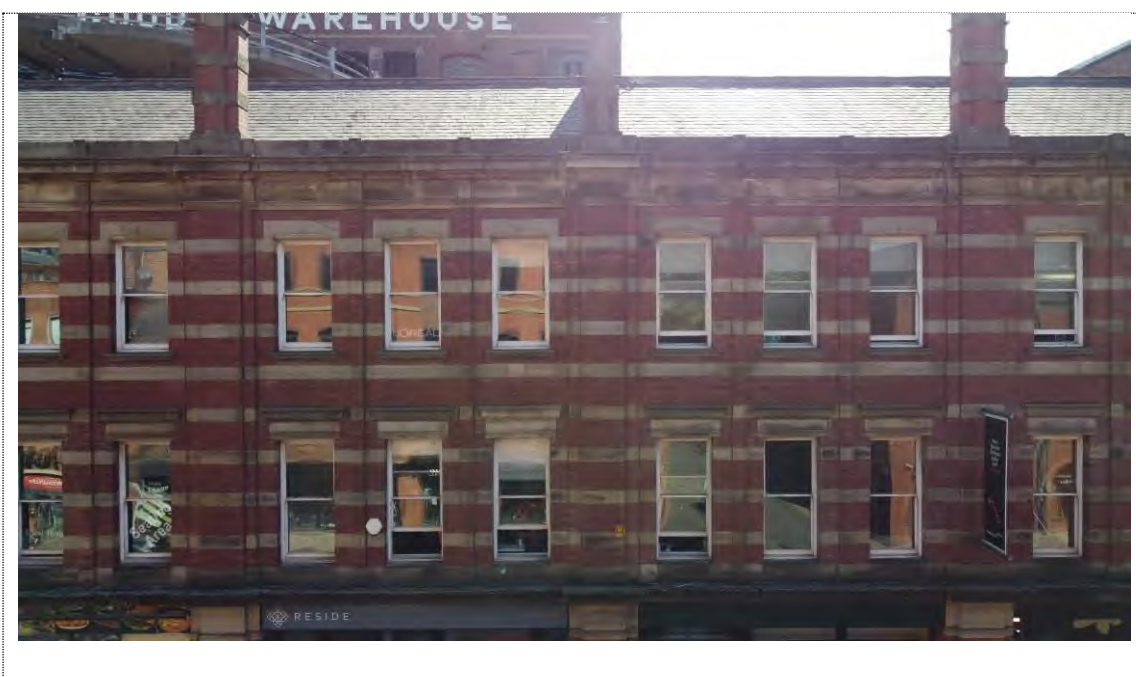
| Photograph: | 22 |

| Description: | Redress spalling stone to a sound surface. Cut out defective stone and replace new matching stone. (West facing) |

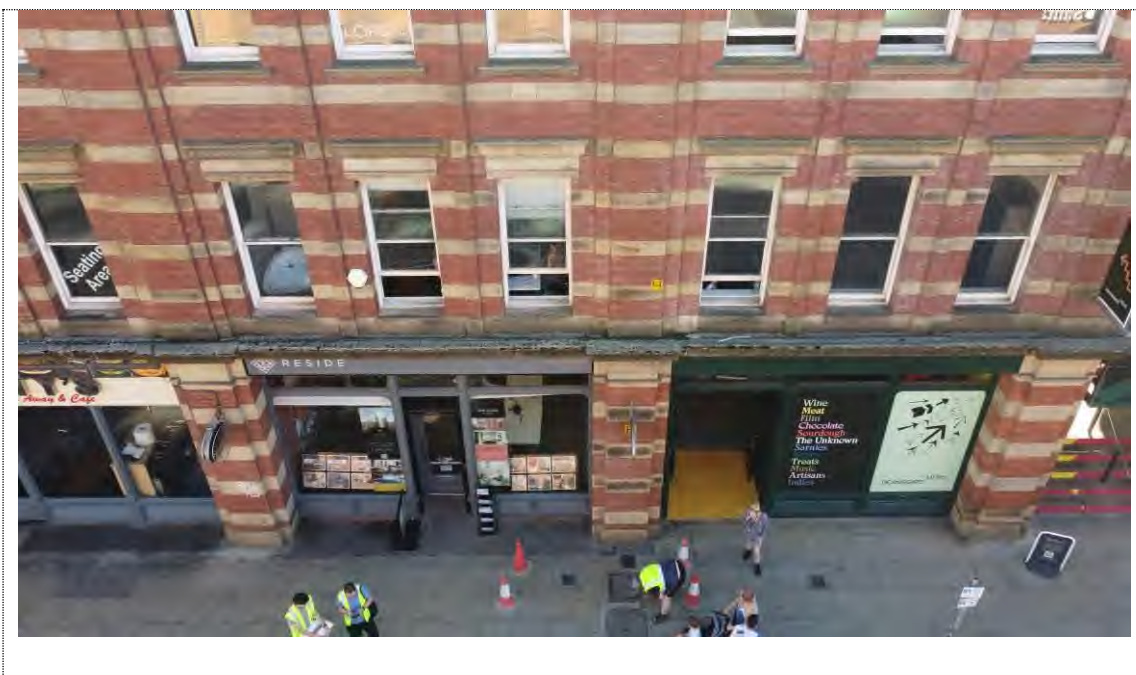
| Photograph: | 23 |

| Description: | Redress spalling stone to a sound surface. Cut out defective stone and replace new matching stone. (West facing) |

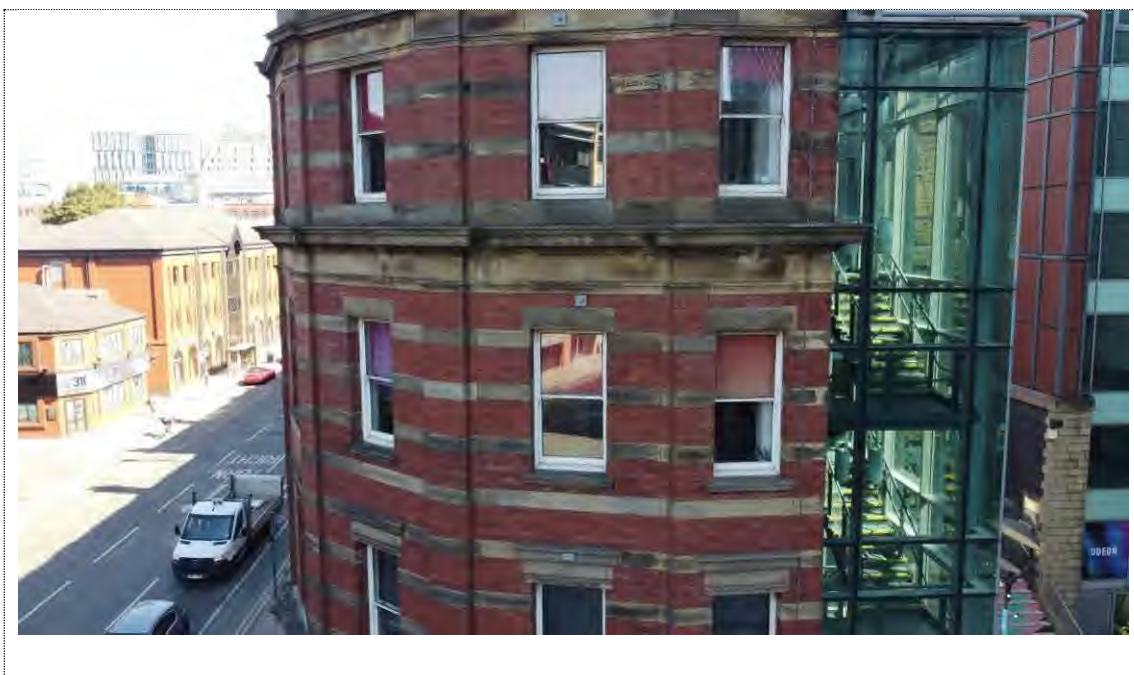
| Photograph: | 67 |

| Description: | Redress spalling stone to a sound surface. (South facing) |

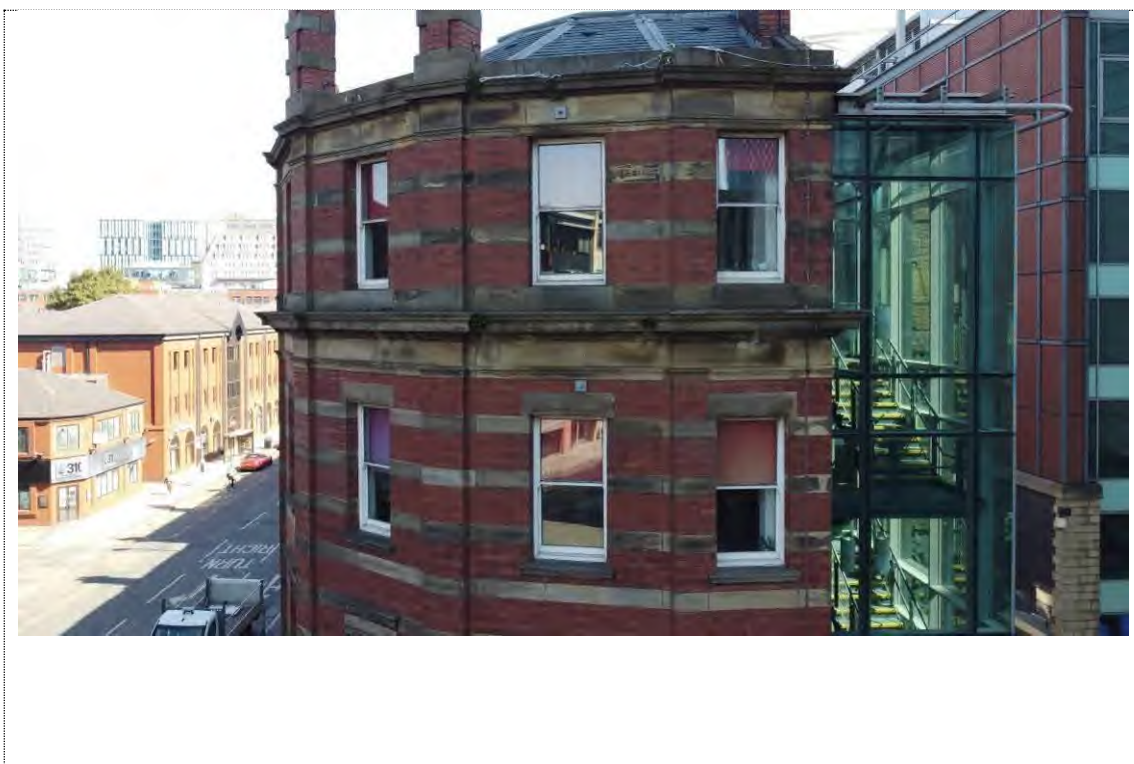
| Photograph: | 68 |

| Description: | Redress spalling stone to a sound surface. (South facing) |

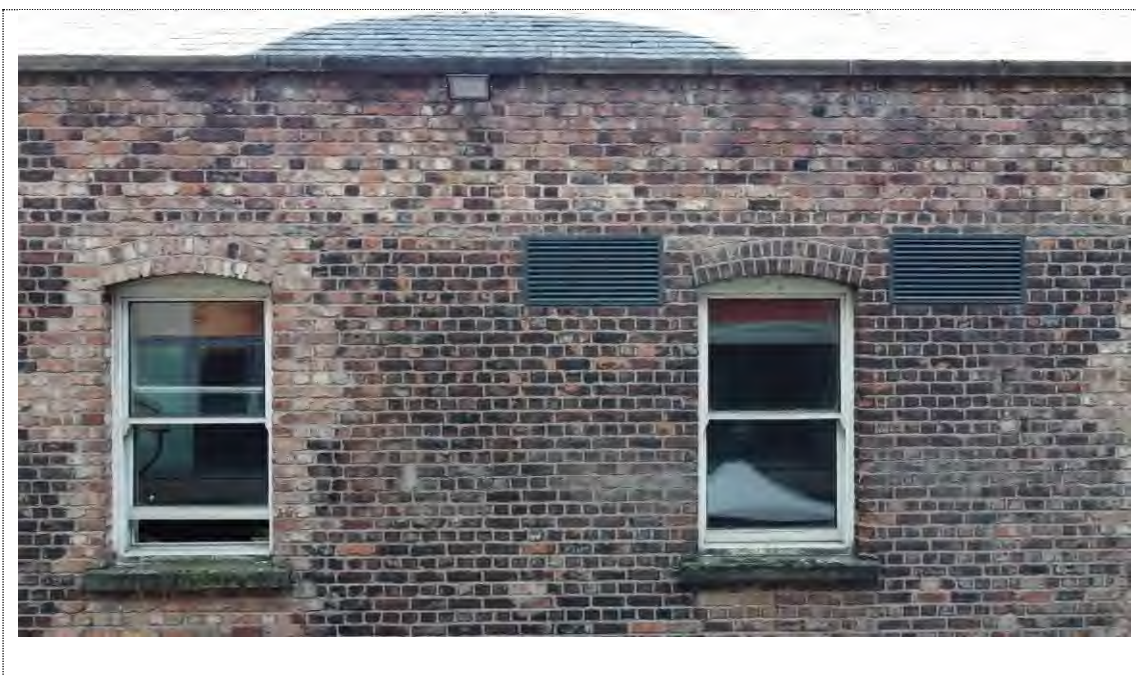
| Photograph: | 83 |

| Description: | Doff clean all areas of brickwork and stonework. Rake out defective and open joints of the brickwork and repoint. (East facing) |

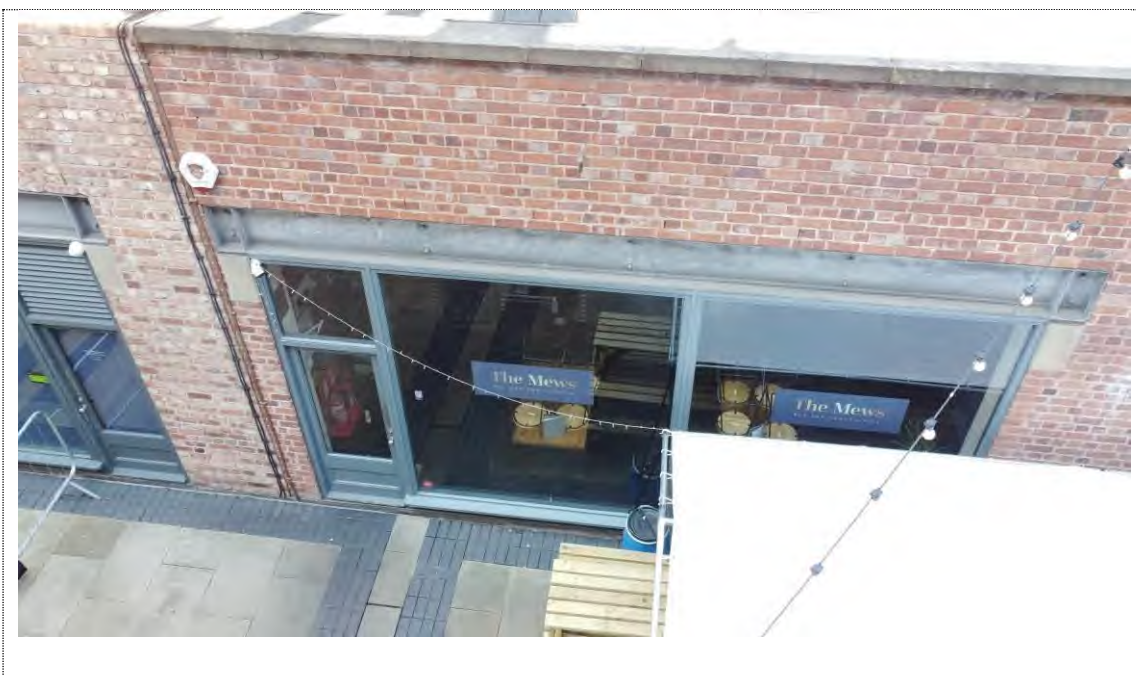
| Photograph: | 95 |

| Description: | Doff clean all areas of brickwork and stonework. Rake out defective and open joints of the brickwork and repoint. (East facing) |

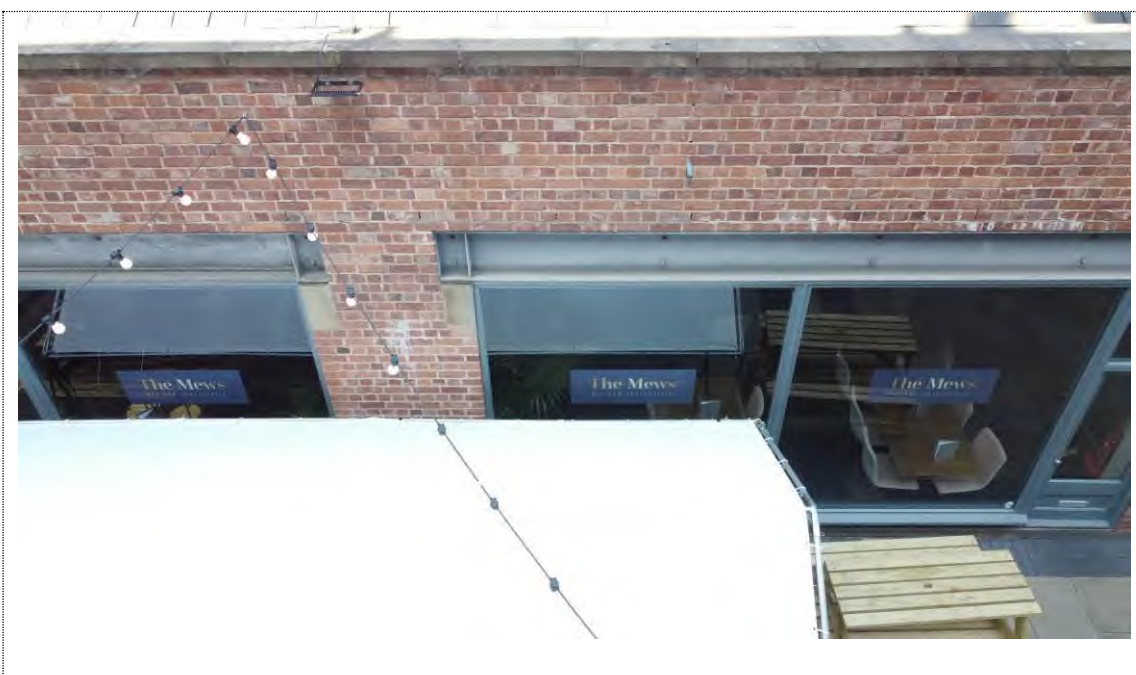
| Photograph: | 96 |

| Description: | Doff clean all areas of brickwork and stonework. Rake out defective and open joints of the brickwork and repoint. (East facing) |

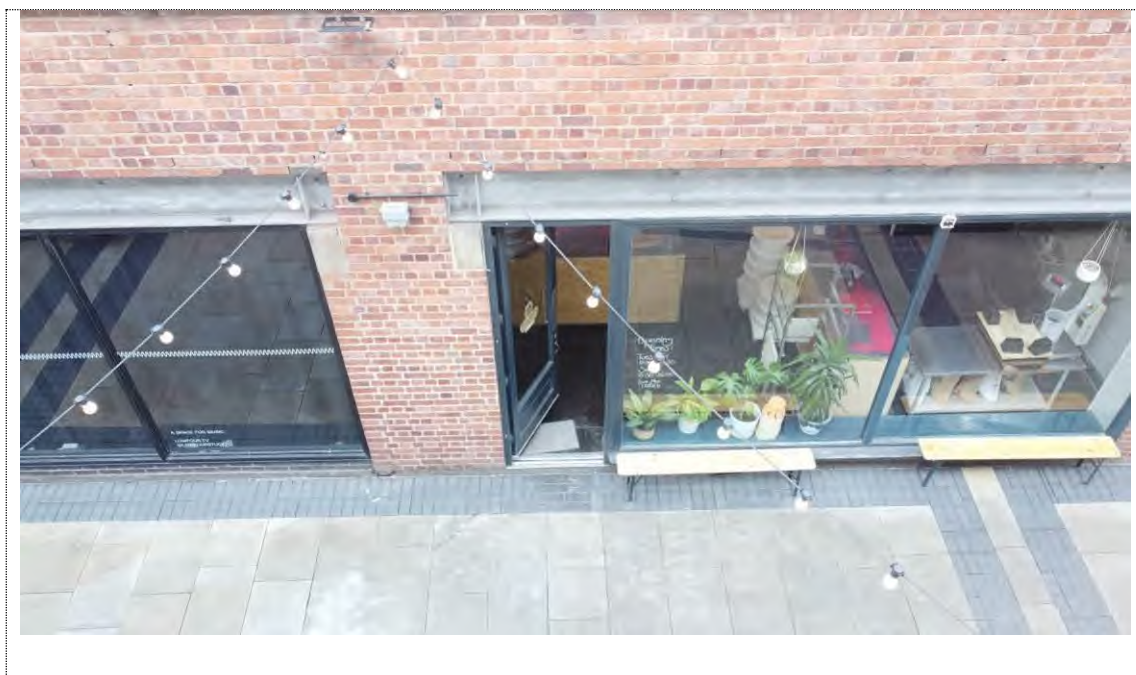
| Photograph: | 101 |

| Description: | Doff clean all areas of brickwork and stonework. Rake out defective and open joints of the brickwork and repoint. (East facing) |

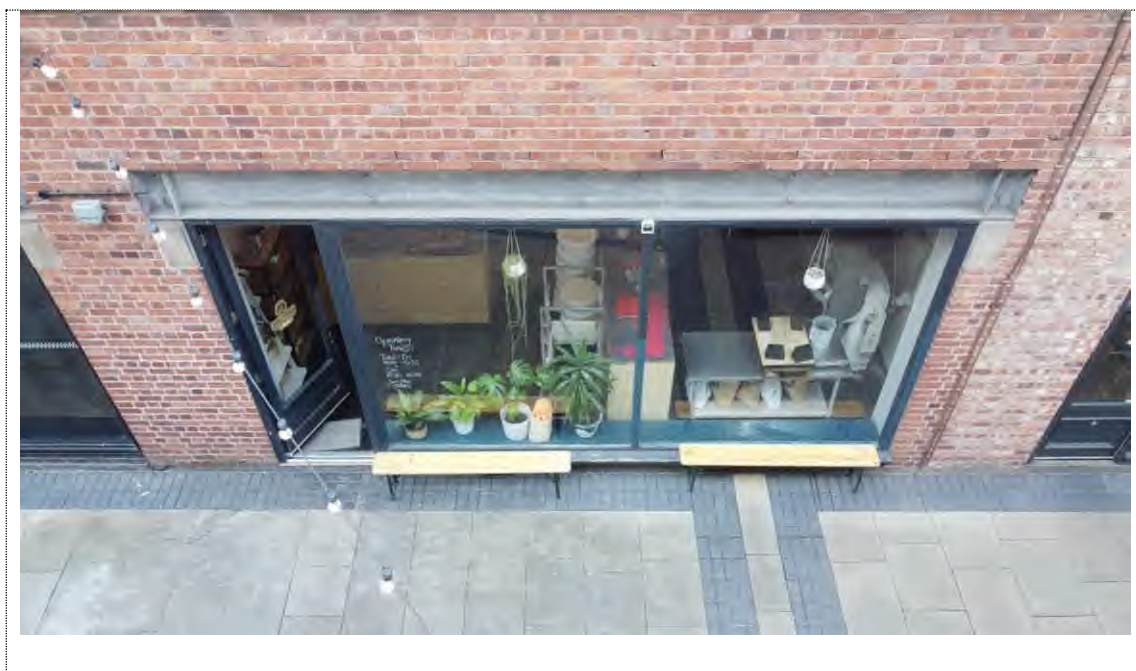
| Photograph: | 102 |

| Description: | Doff clean all areas of brickwork and stonework. Rake out defective and open joints of the brickwork and repoint. (East facing) |

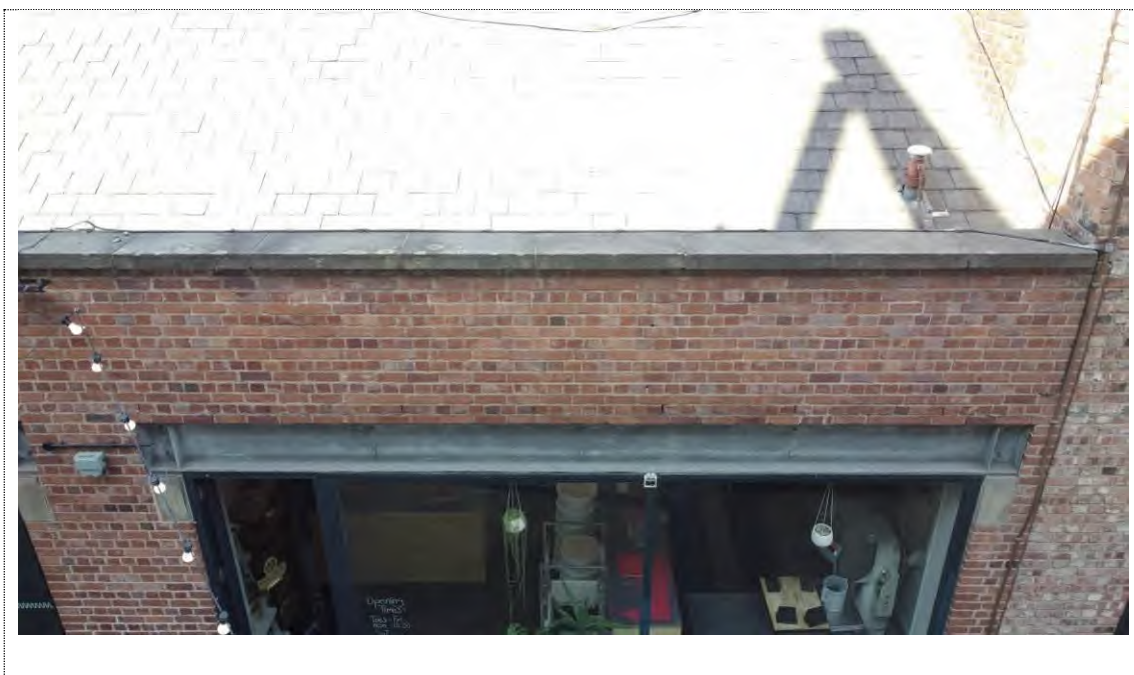
| Photograph: | 103 |

| Description: | Doff clean all areas of brickwork and stonework. Rake out defective and open joints of the brickwork and repoint. (East facing) |

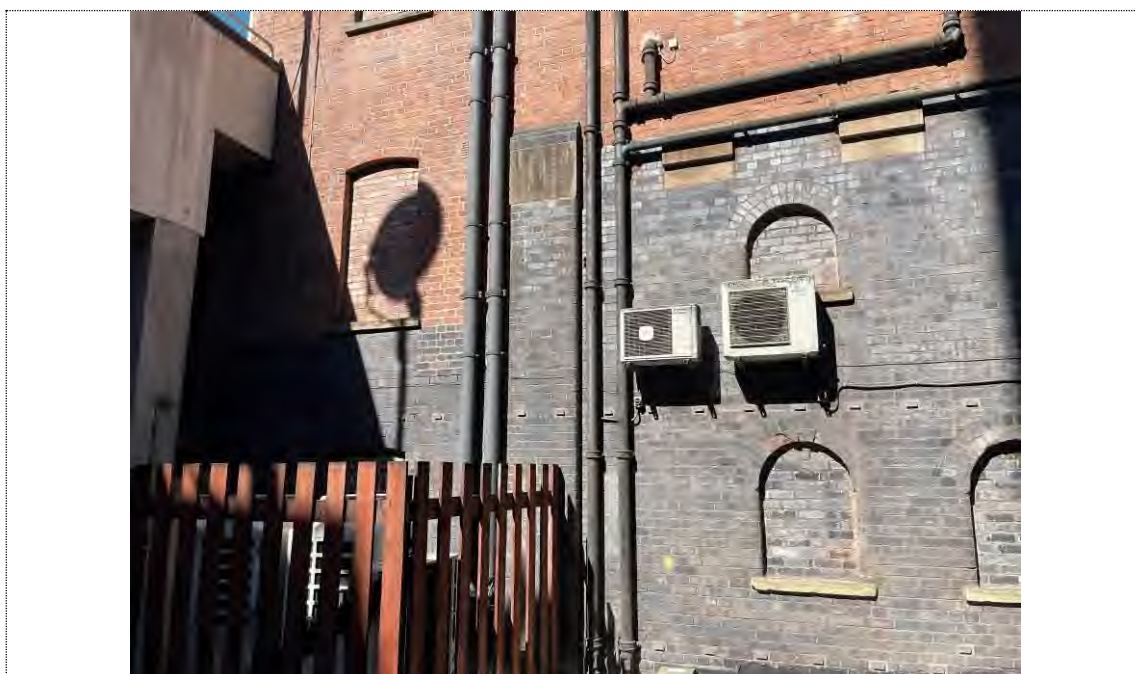
| Photograph: | 128 |

| Description: | Doff clean all areas of brickwork and stonework. Rake out defective and open joints of the brickwork and repoint. (East facing elevation) |

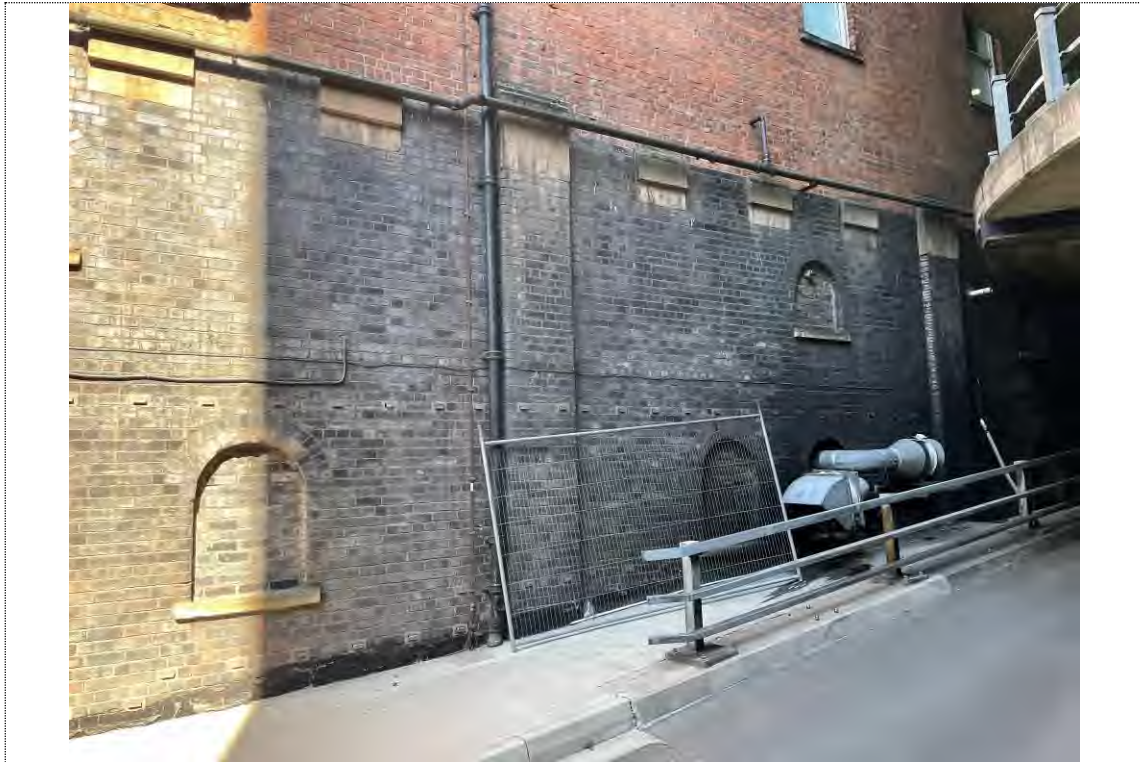
| Photograph: | 129 |

| Description: | Doff clean all areas of brickwork and stonework. Rake out defective and open joints of brickwork and repoint. (East facing elevation) |

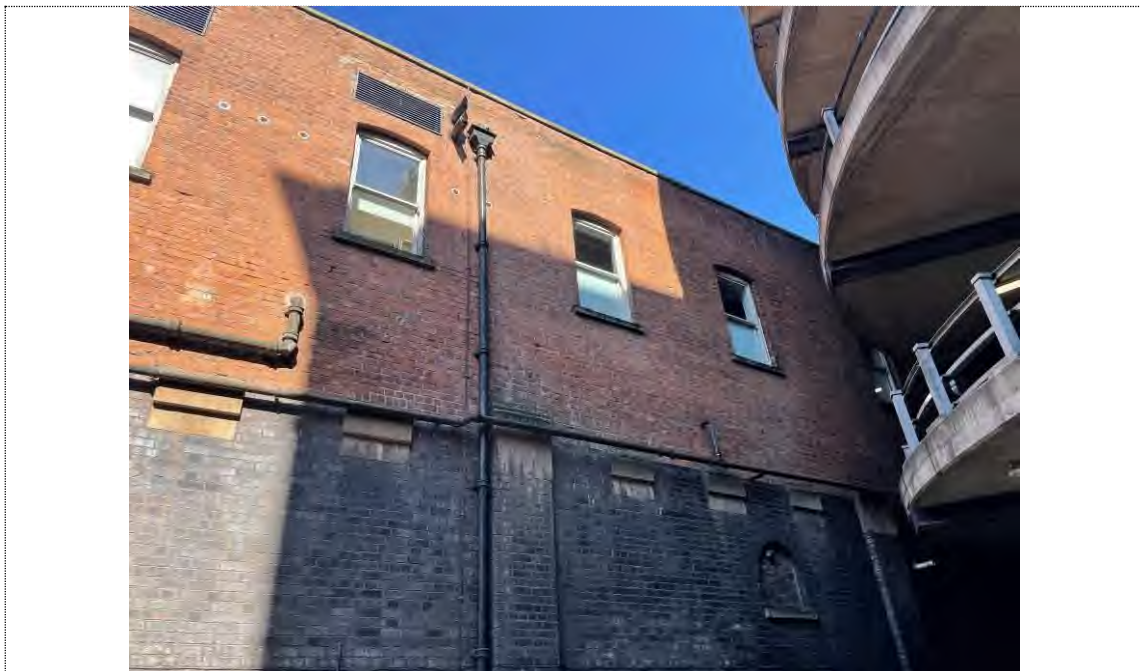
| Photograph: | 130 |

| Description: | Doff clean all areas of brickwork and stonework. Rake out defective and open joints of the brickwork and repoint. (East facing elevation) |

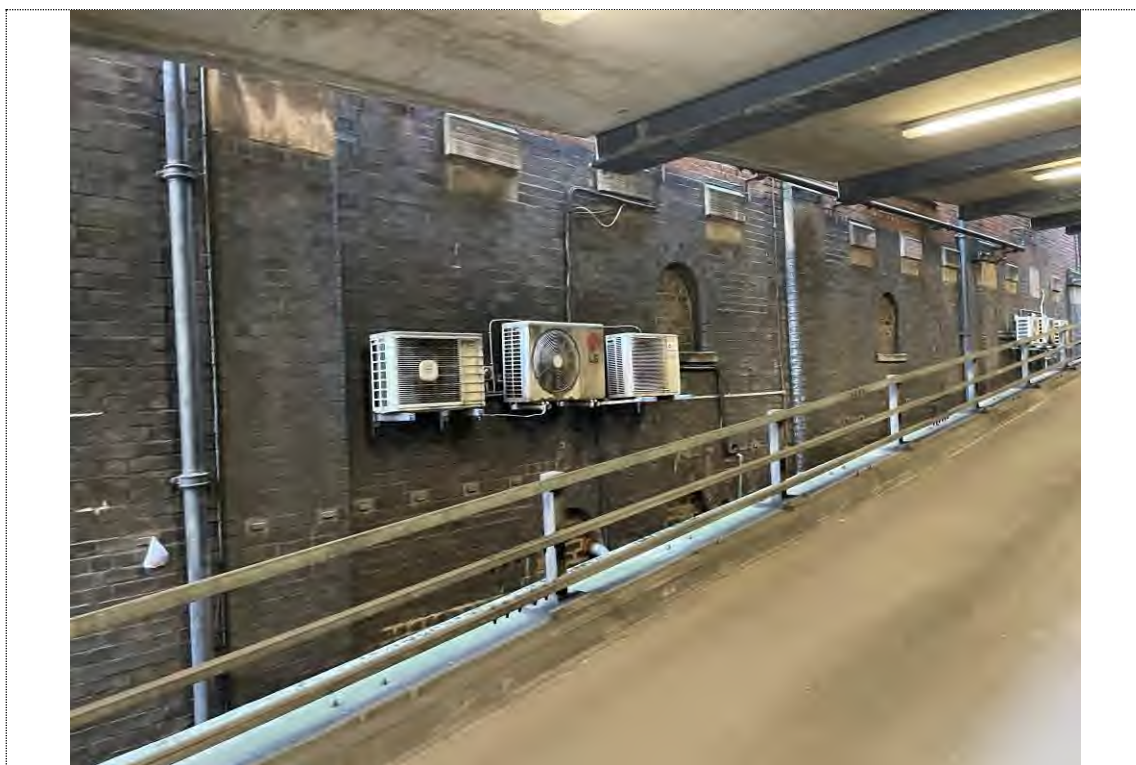
| Photograph: | 133 |

| Description: | Doff clean all areas of brickwork and stonework. Rake out defective and open joints of the brickwork and repoint. (East facing elevation) |

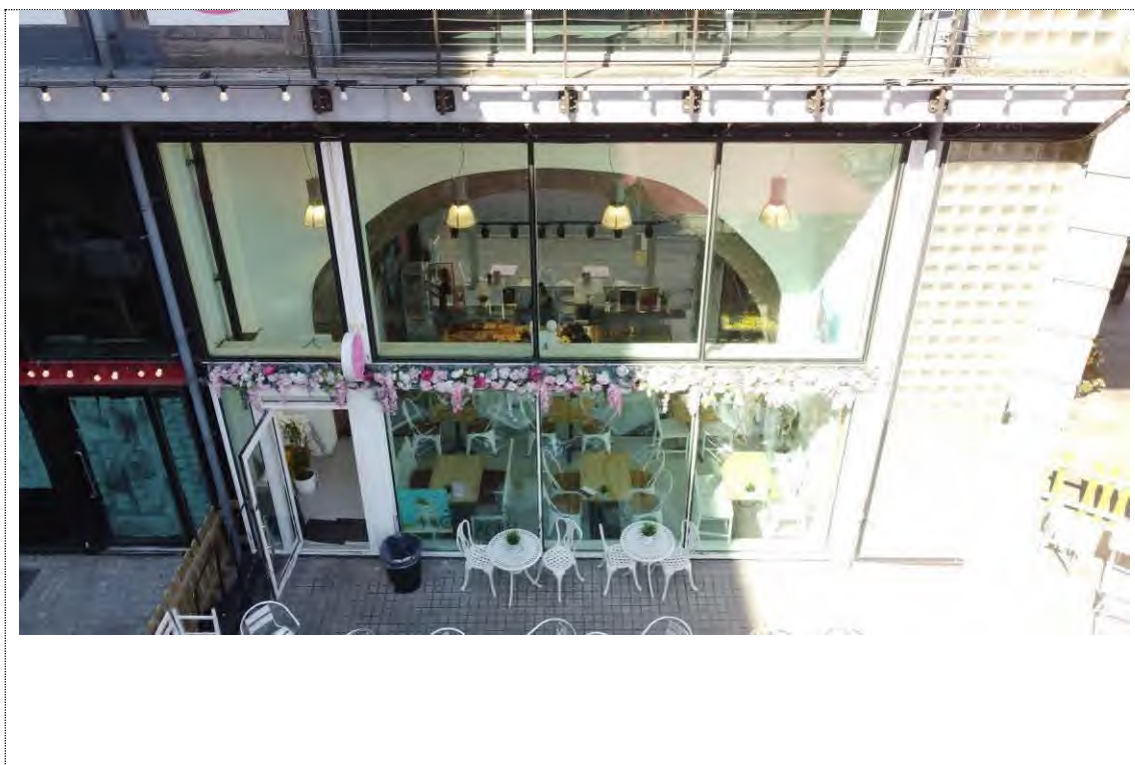
| Photograph: | 141 |

| Description: | Glazed shopfronts generally in good condition. (East facing elevation) |

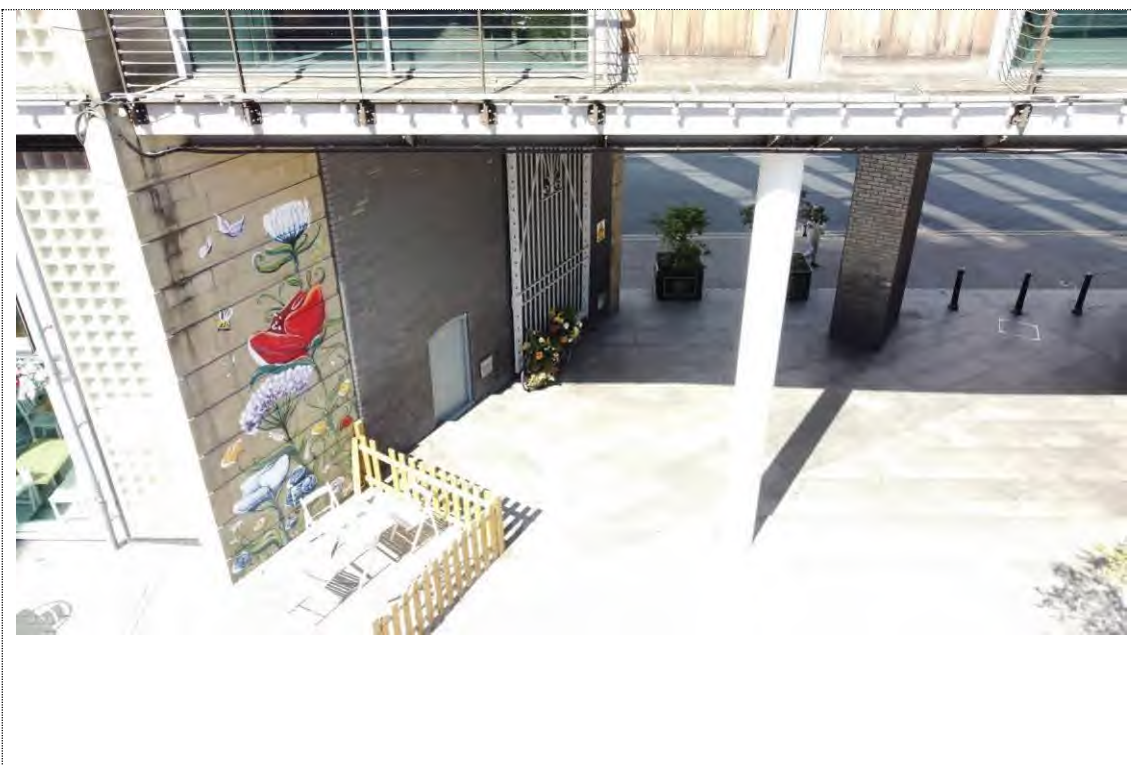
| Photograph: | 145 |

| Description: | Steel work generally in good condition. (East facing elevation) |

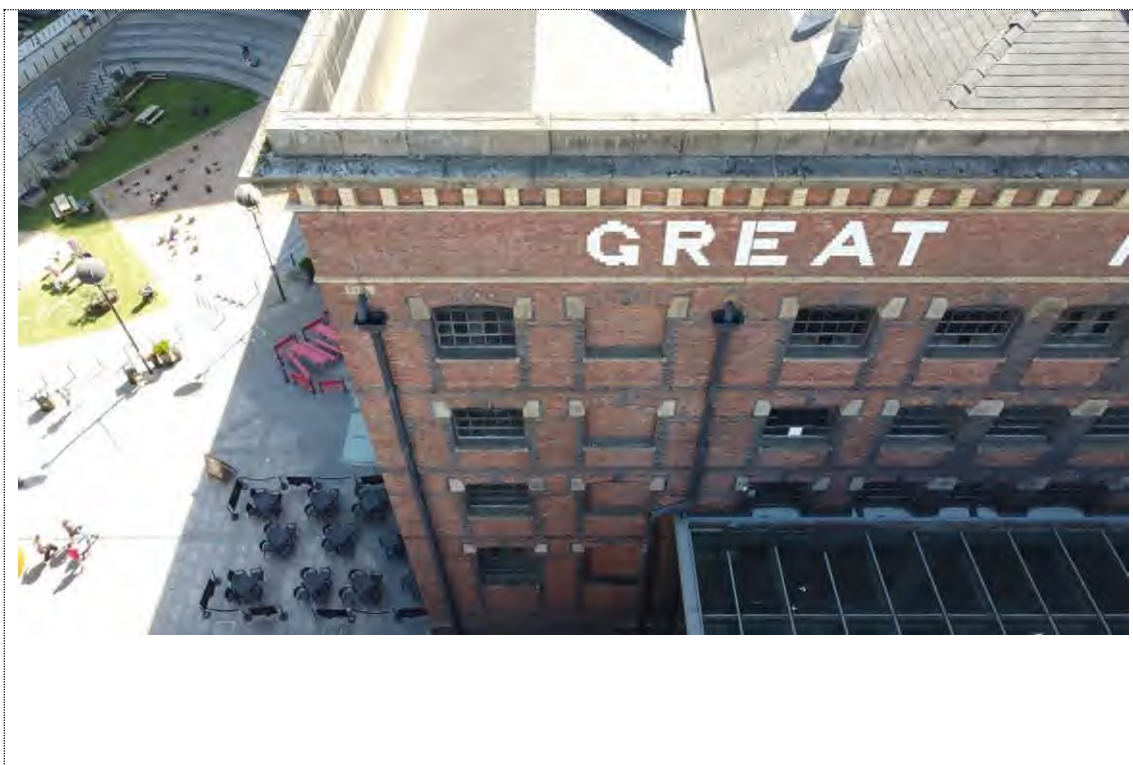
| Photograph: | 15 |

| Description: | Redress spalling stone to a sound surface. (West facing elevation) |

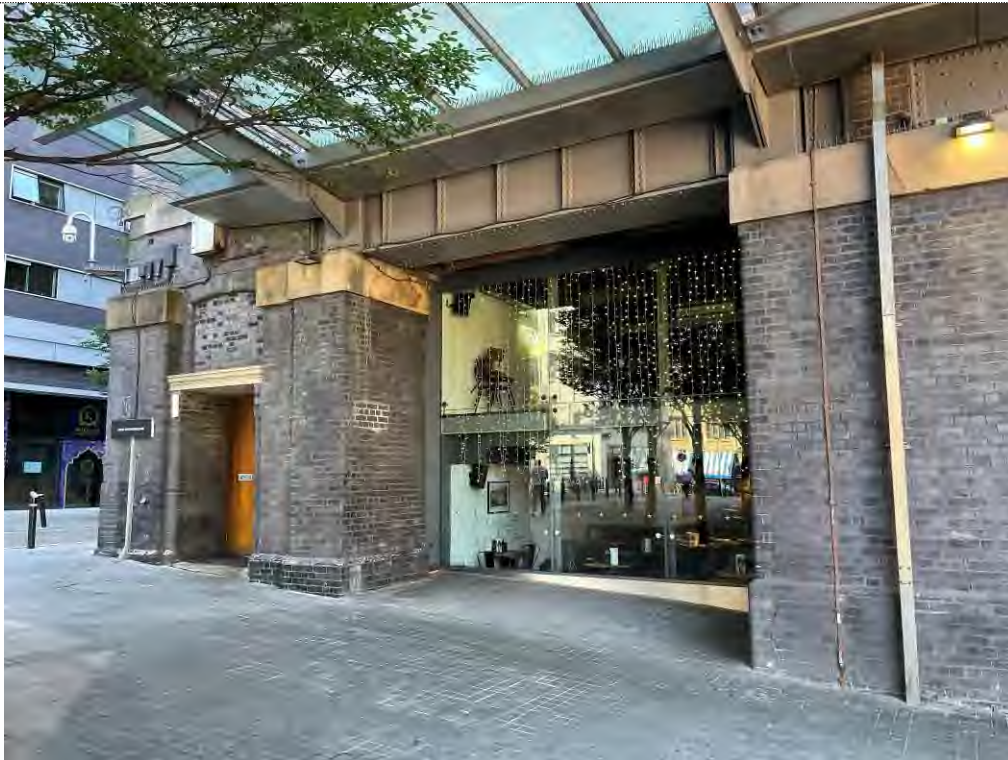
| Photograph: | 58 |

| Description: | General view of the north facing elevation. Doff clean all areas of brickwork and stonework. |

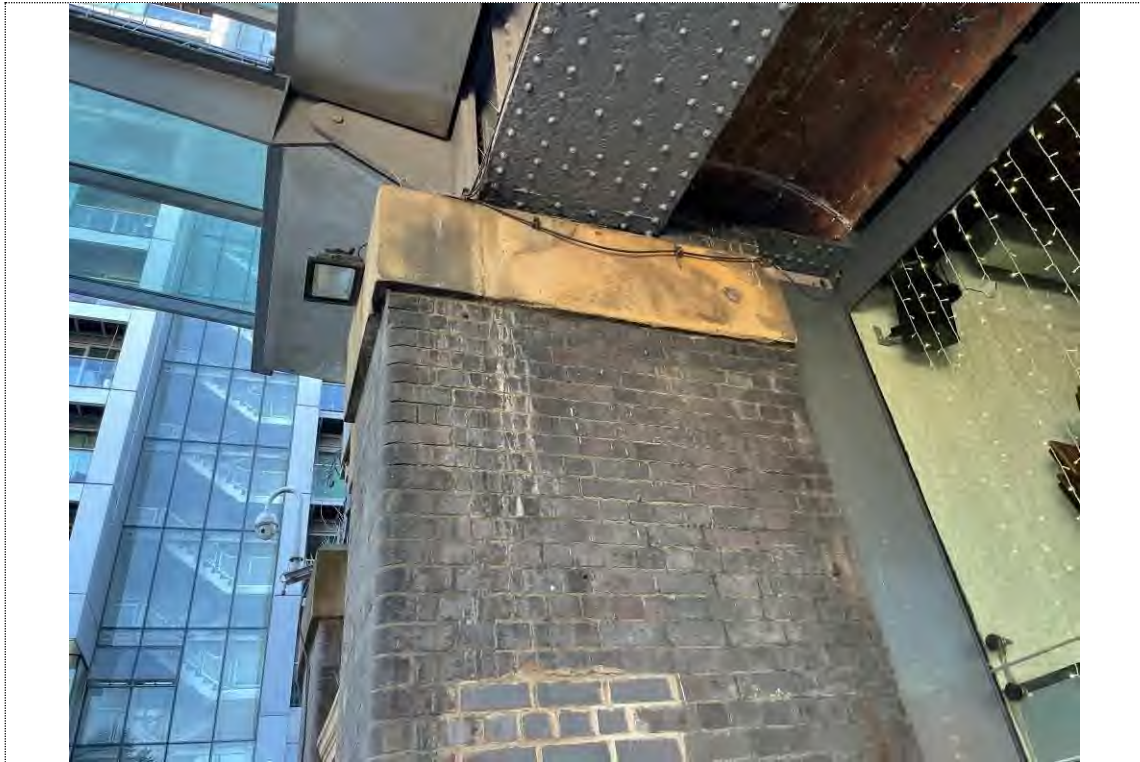
| Photograph: | 59 |

| Description: | General view of the stonework and steelwork. Evidence of brick replacement. |

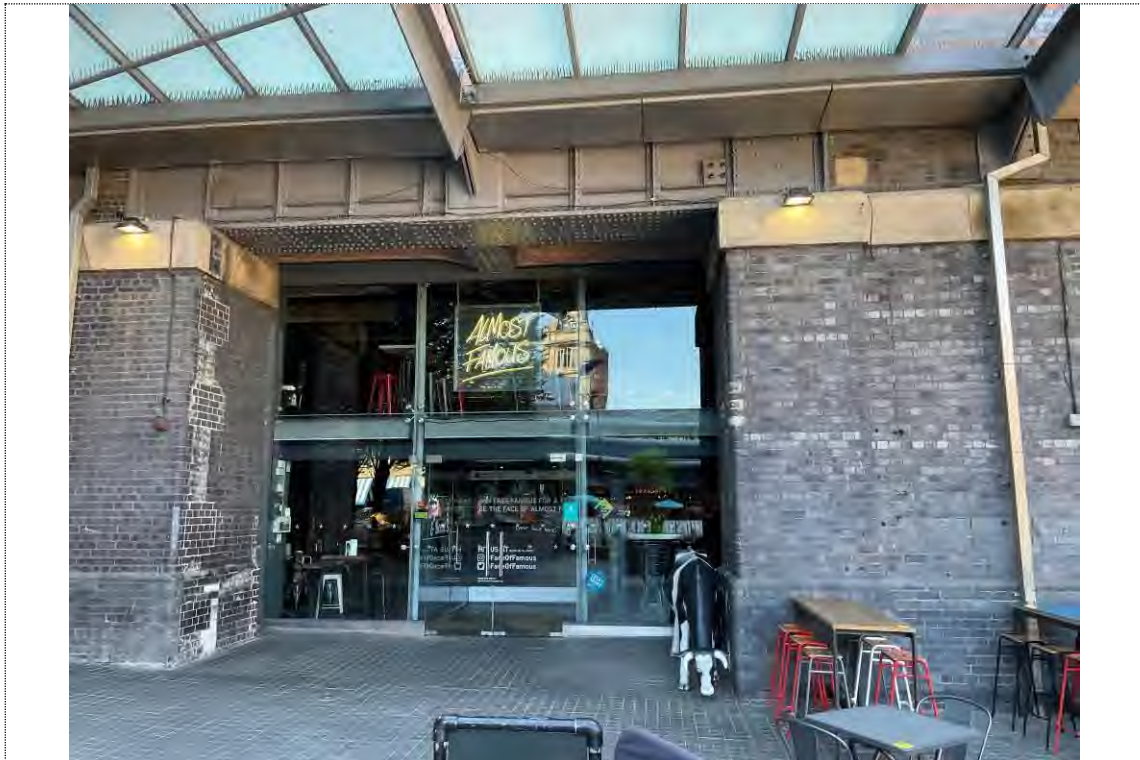
| Photograph: | 60 |

| Description: | Evidence of brick replacement and salt damage. Doff clean all areas of brickwork and stonework. |

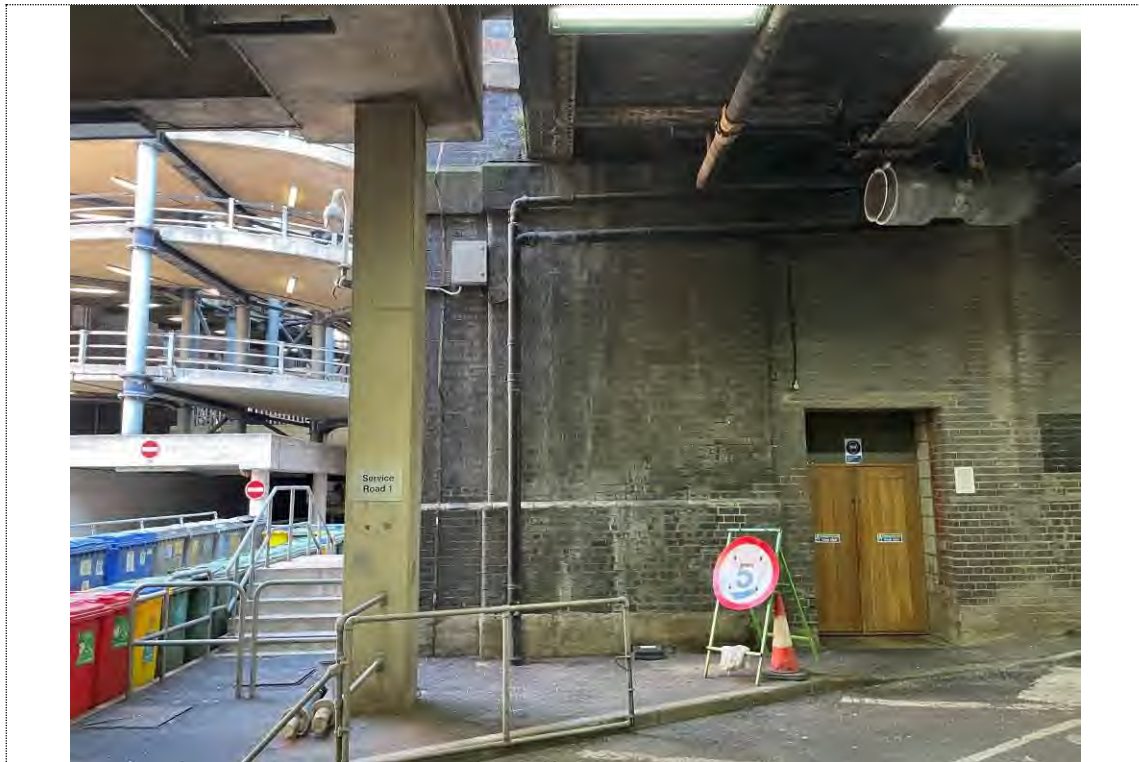
| Photograph: | 65 |

| Description: | General clean and replace of defective brickwork and stonework, underneath neighbouring structure. (South facing) |

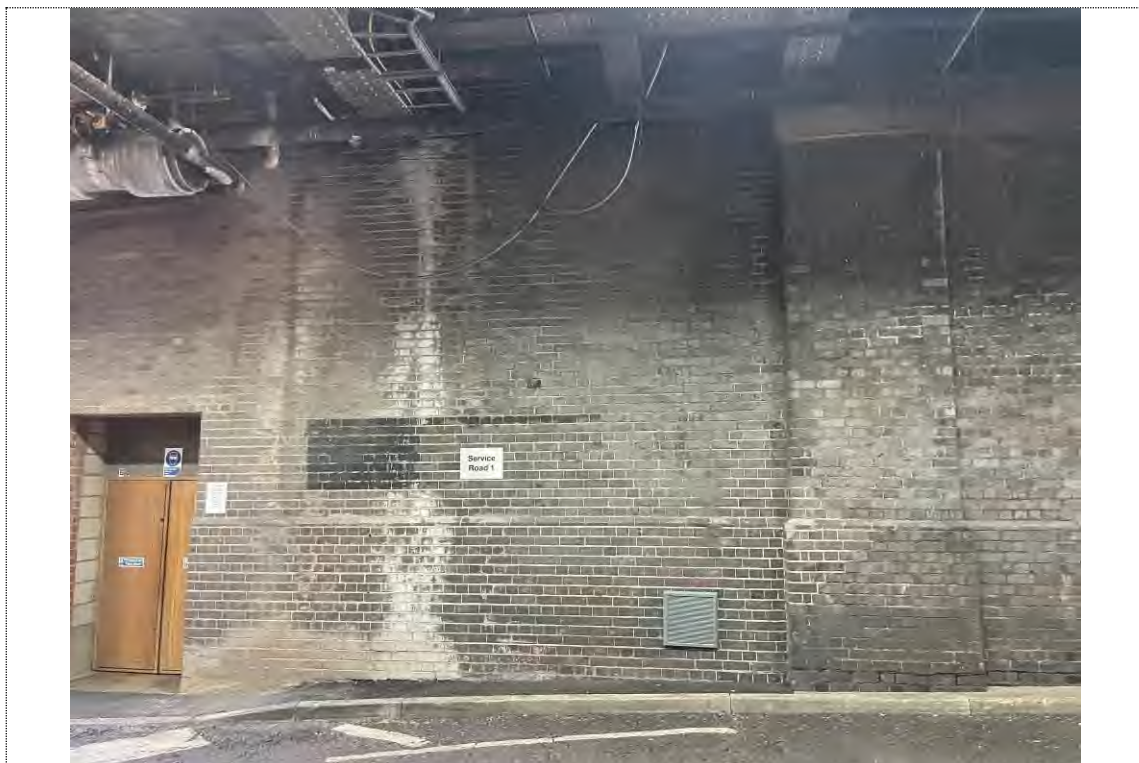
| Photograph: | 66 |

| Description: | General clean and replace of defective brickwork and stonework, underneath neighbouring structure. Evidence of salt damage to brickwork. (South facing) |
