**The Great Northern Warehouse**

**Survey 2022**

**Great Northern Warehouse & Deansgate Terraces, Manchester**

**Condition Survey**

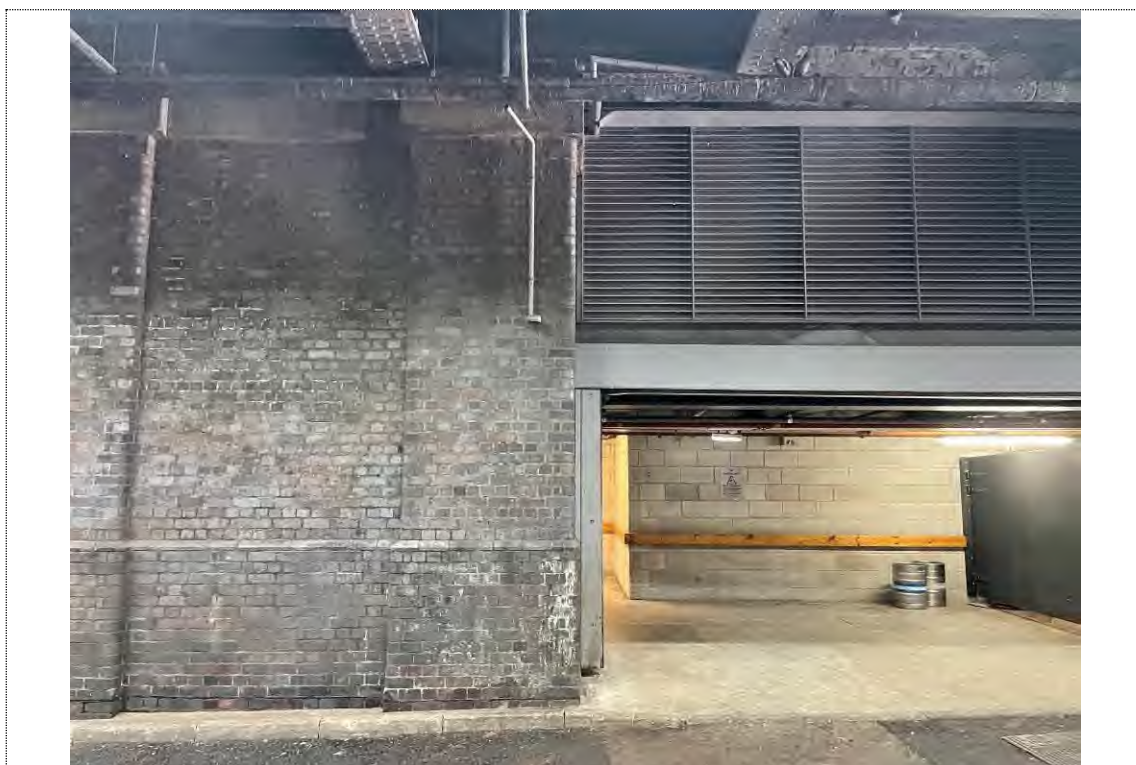
| Photograph: | 67 |

| Description: | General clean and replace of defective brickwork and stonework, underneath neighbouring structure. Evidence of salt damage to brickwork. (South facing) |

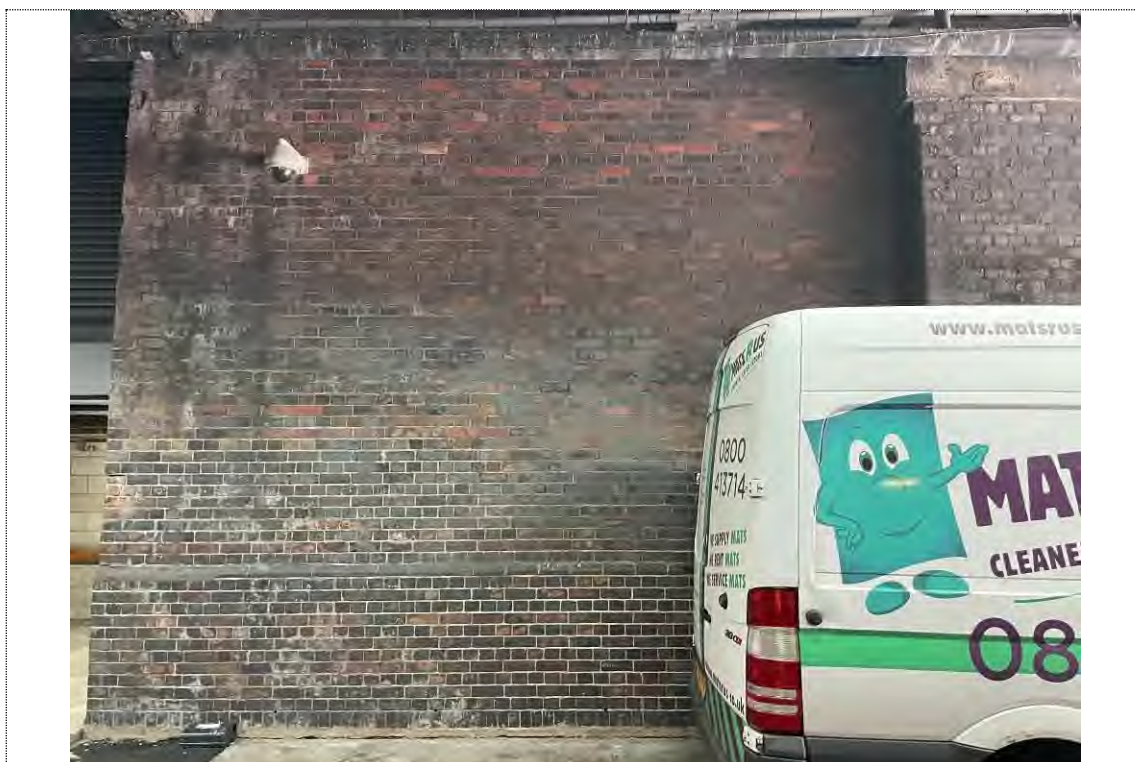
| Photograph: | 68 |

| Description: | General clean and replace of defective brickwork and stonework, underneath neighbouring structure. (South facing) |

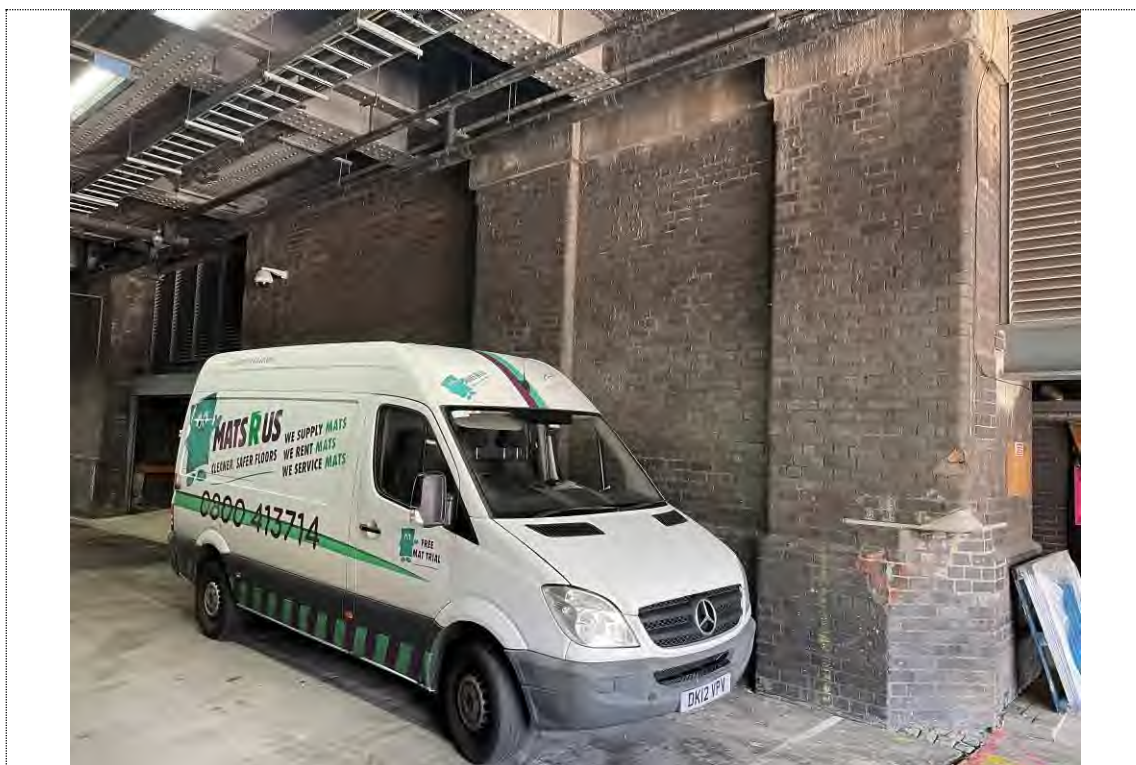
| Photograph: | 69 |

| Description: | General clean and replace of defective brickwork and stonework, underneath neighbouring structure. Impact damage to brickwork. (South facing) |

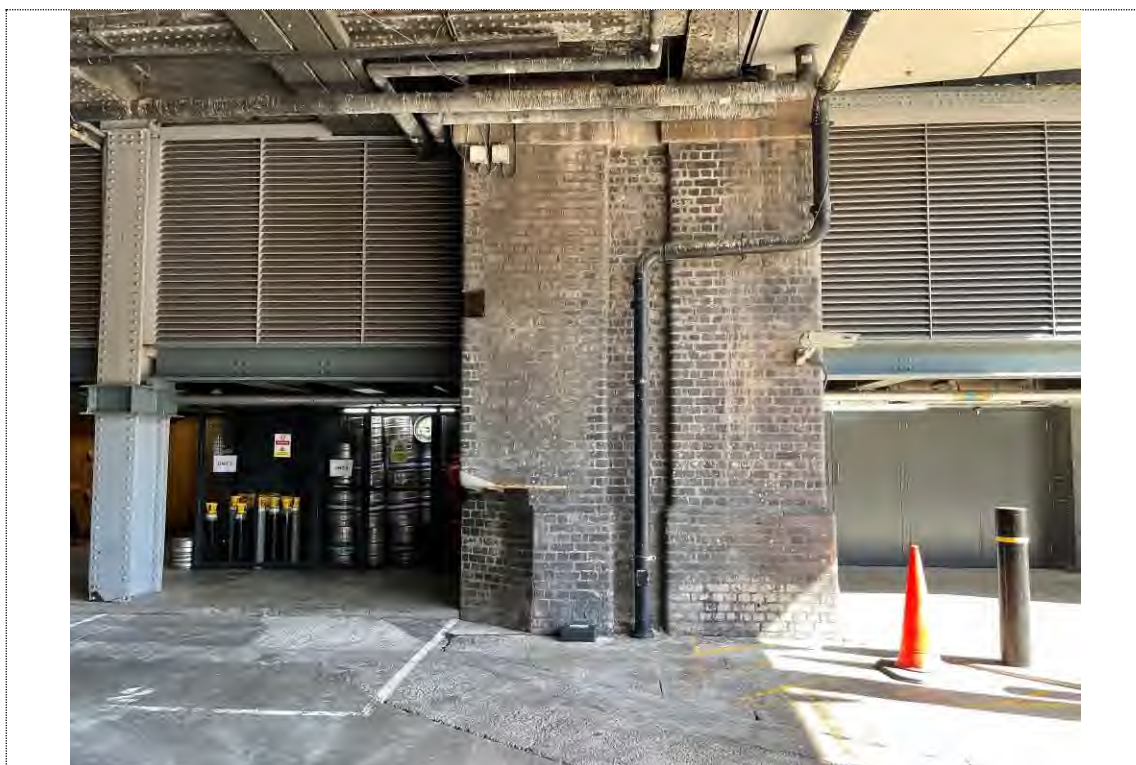
| Photograph: | 70 |

| Description: | General clean and replace of defective brickwork and stonework, underneath neighbouring structure. (South facing) |

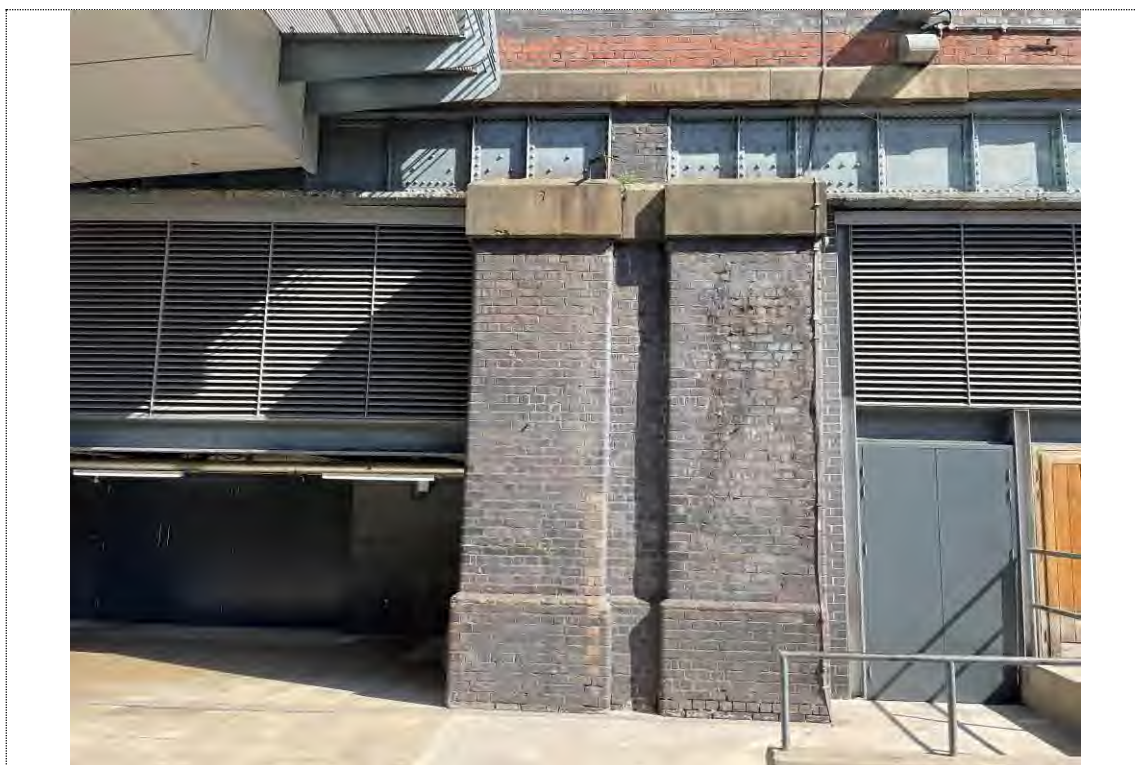
| Photograph: | 71 |

| Description: | General clean and replace of defective brickwork and stonework. Evidence of corrosion to steels. (South facing) |

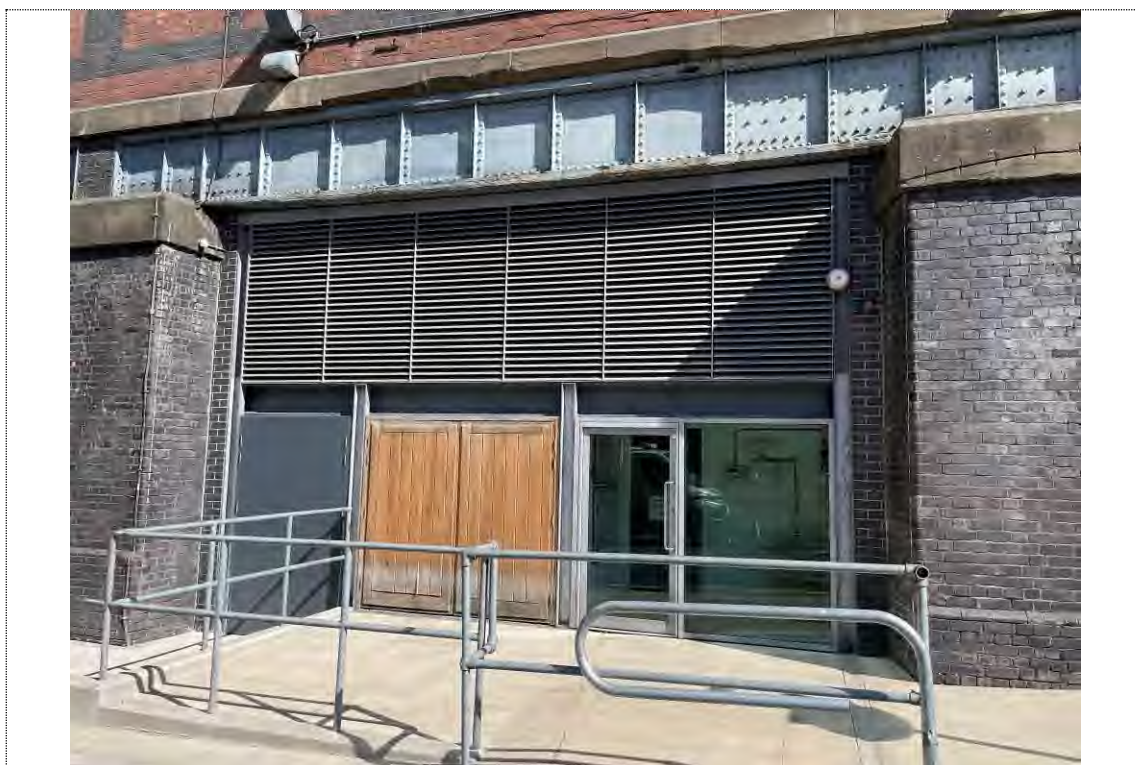
| Photograph: | 72 |

| Description: | General clean and replace of defective brickwork and stonework. Evidence of corrosion to steels. (South facing) |

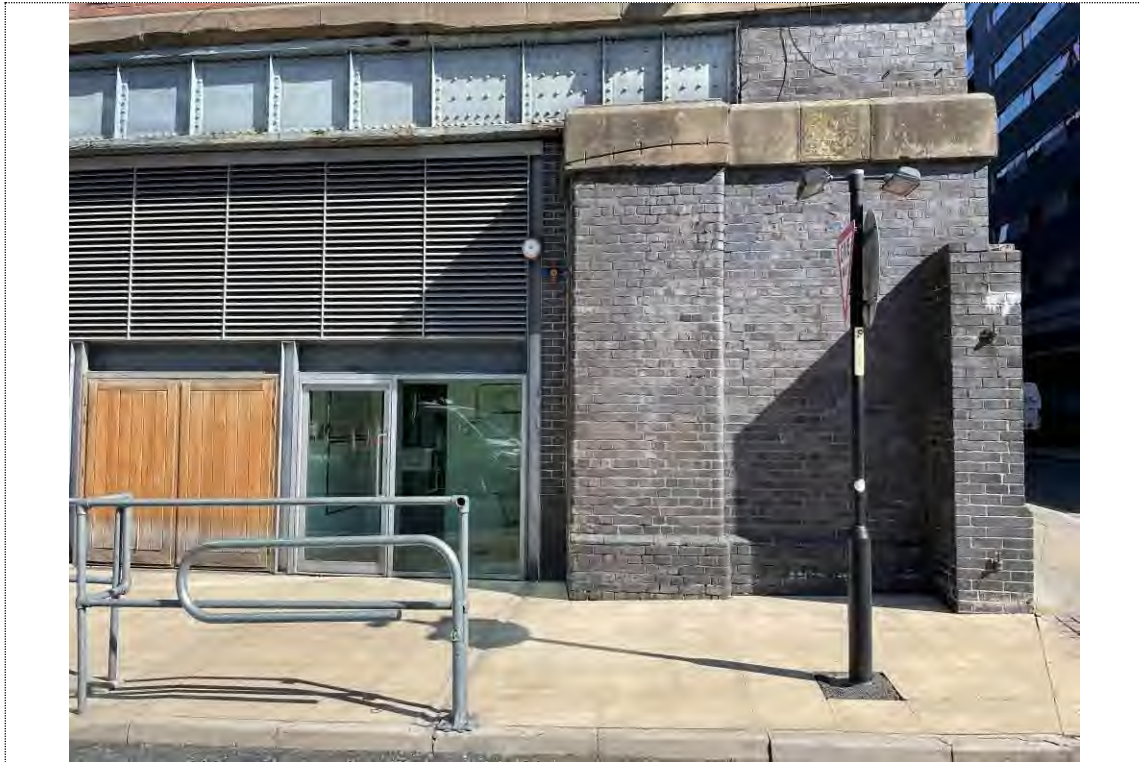
| Photograph: | 73 |

| Description: | General clean and replace of defective brickwork and stonework. Evidence of corrosion to steels. (South facing) |

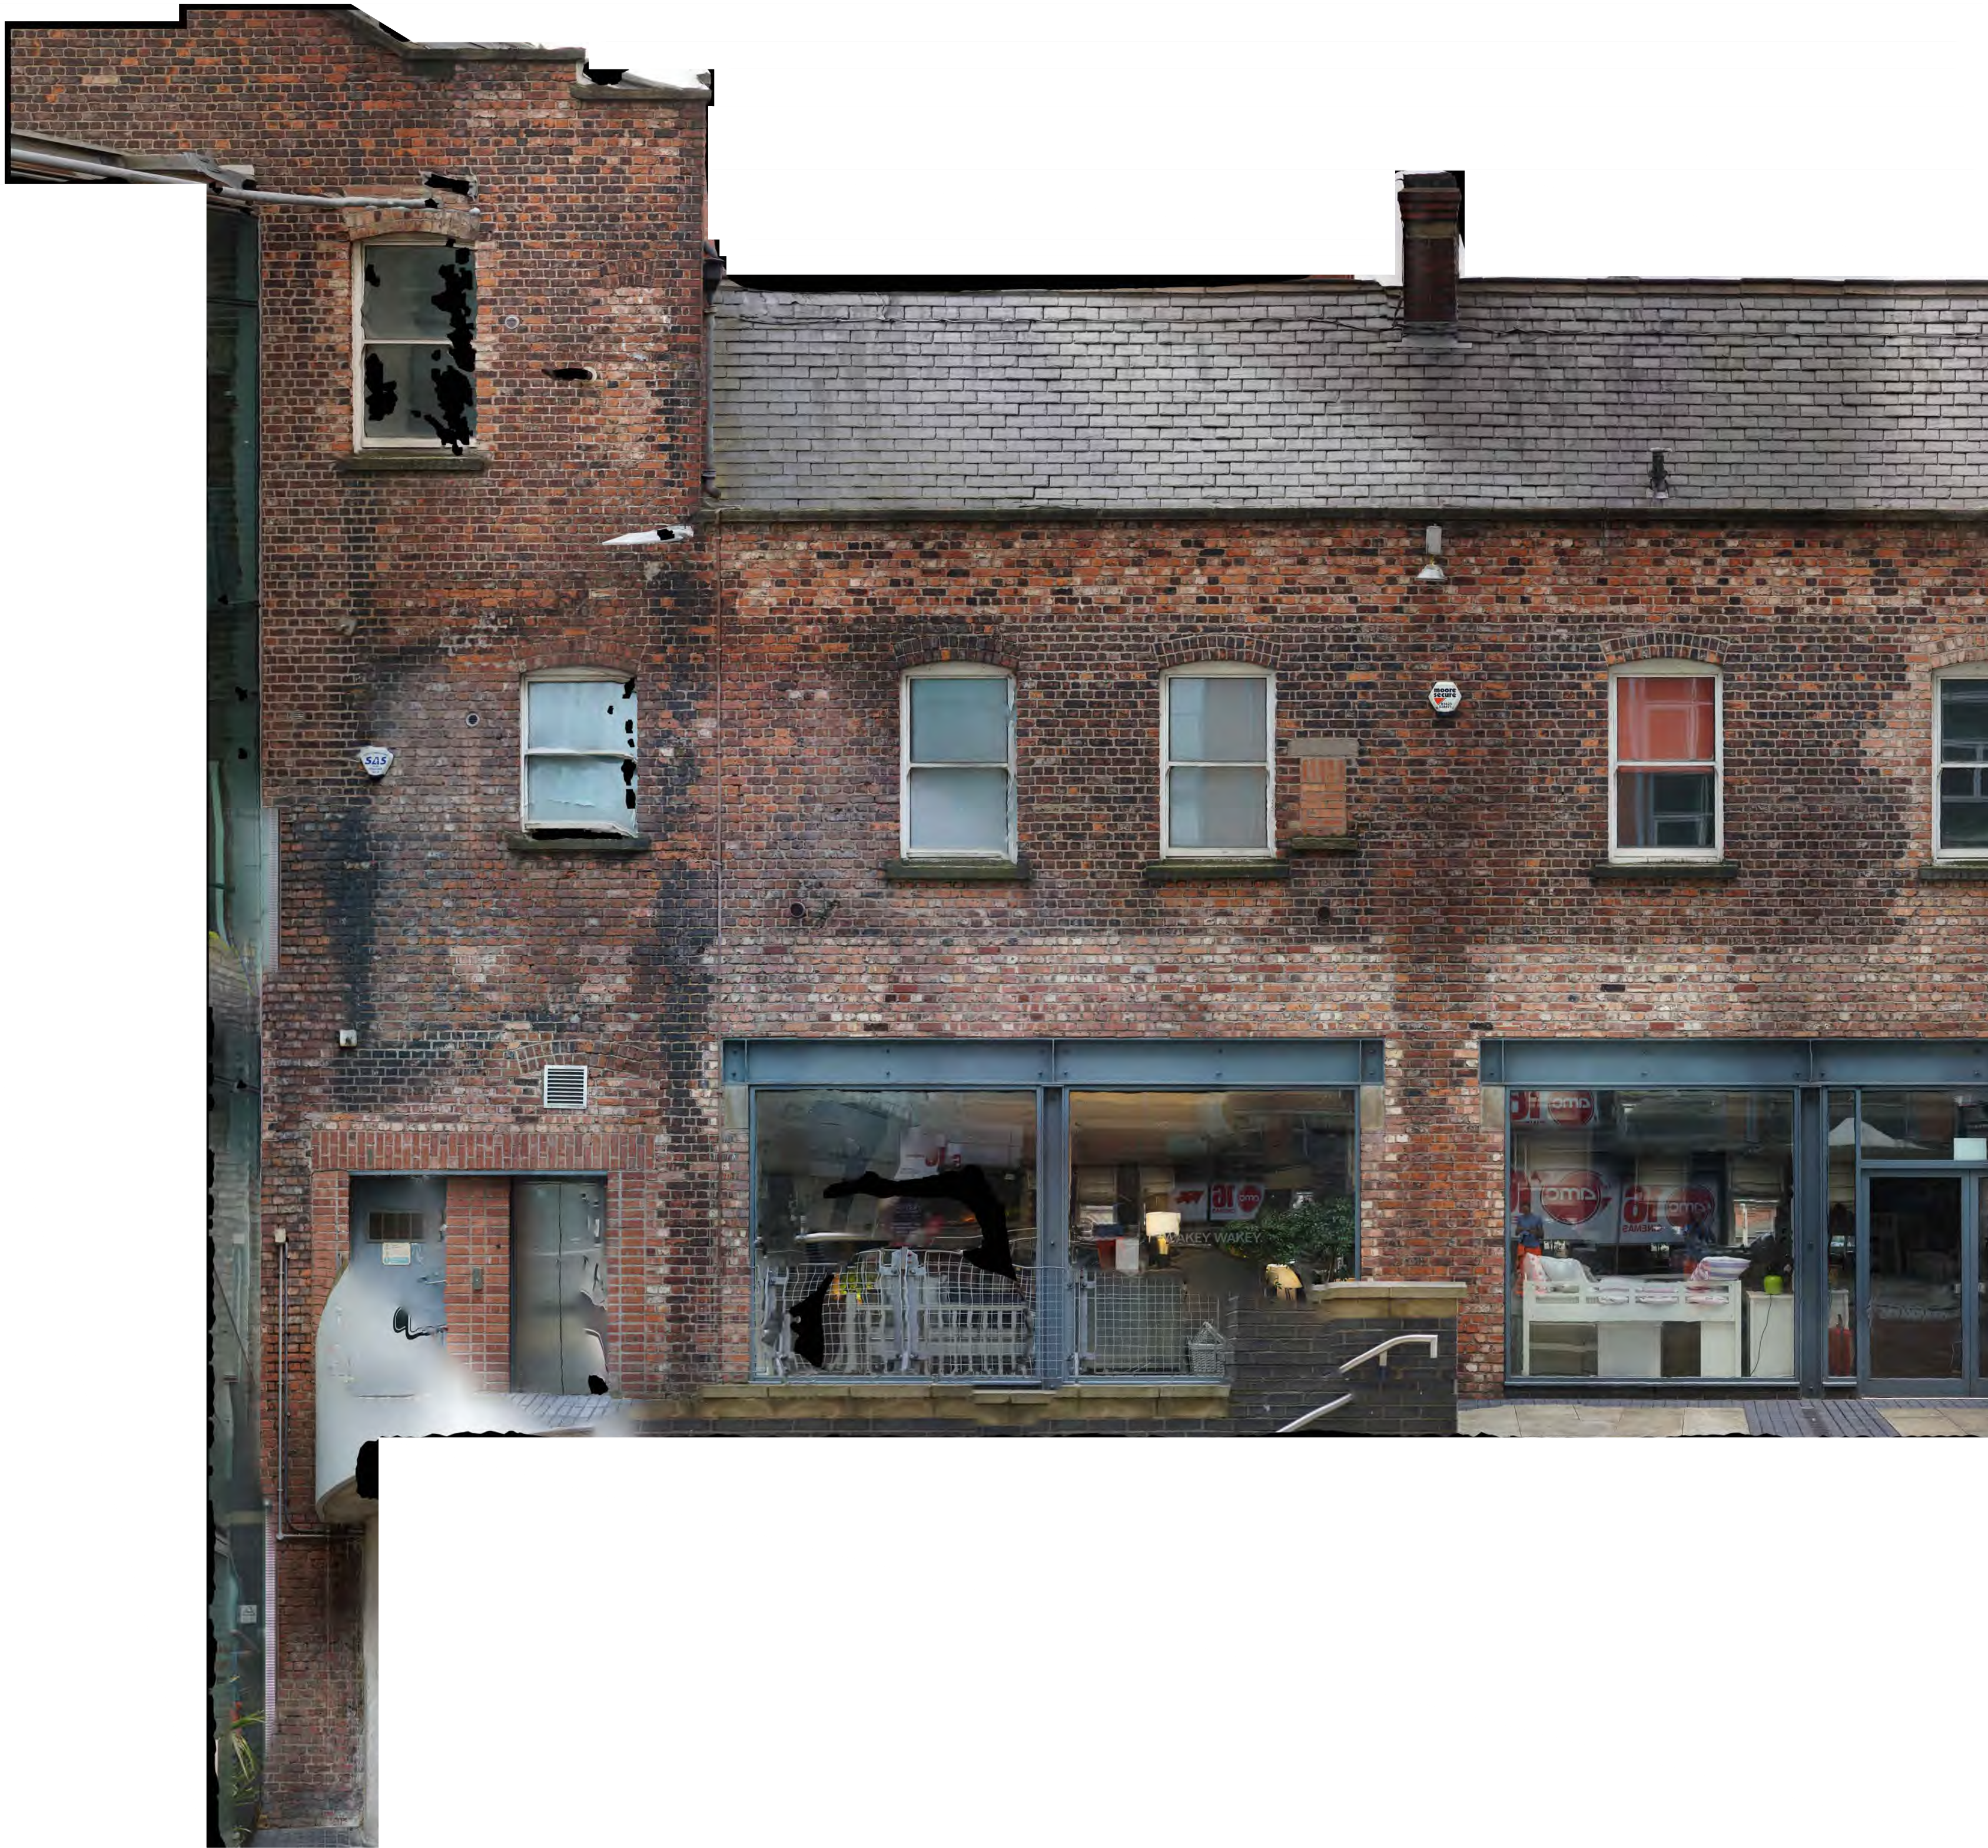
Cube Ref No. A71 - A81 & A179 - A182

Doff Clean all areas of brickwork and stonework.

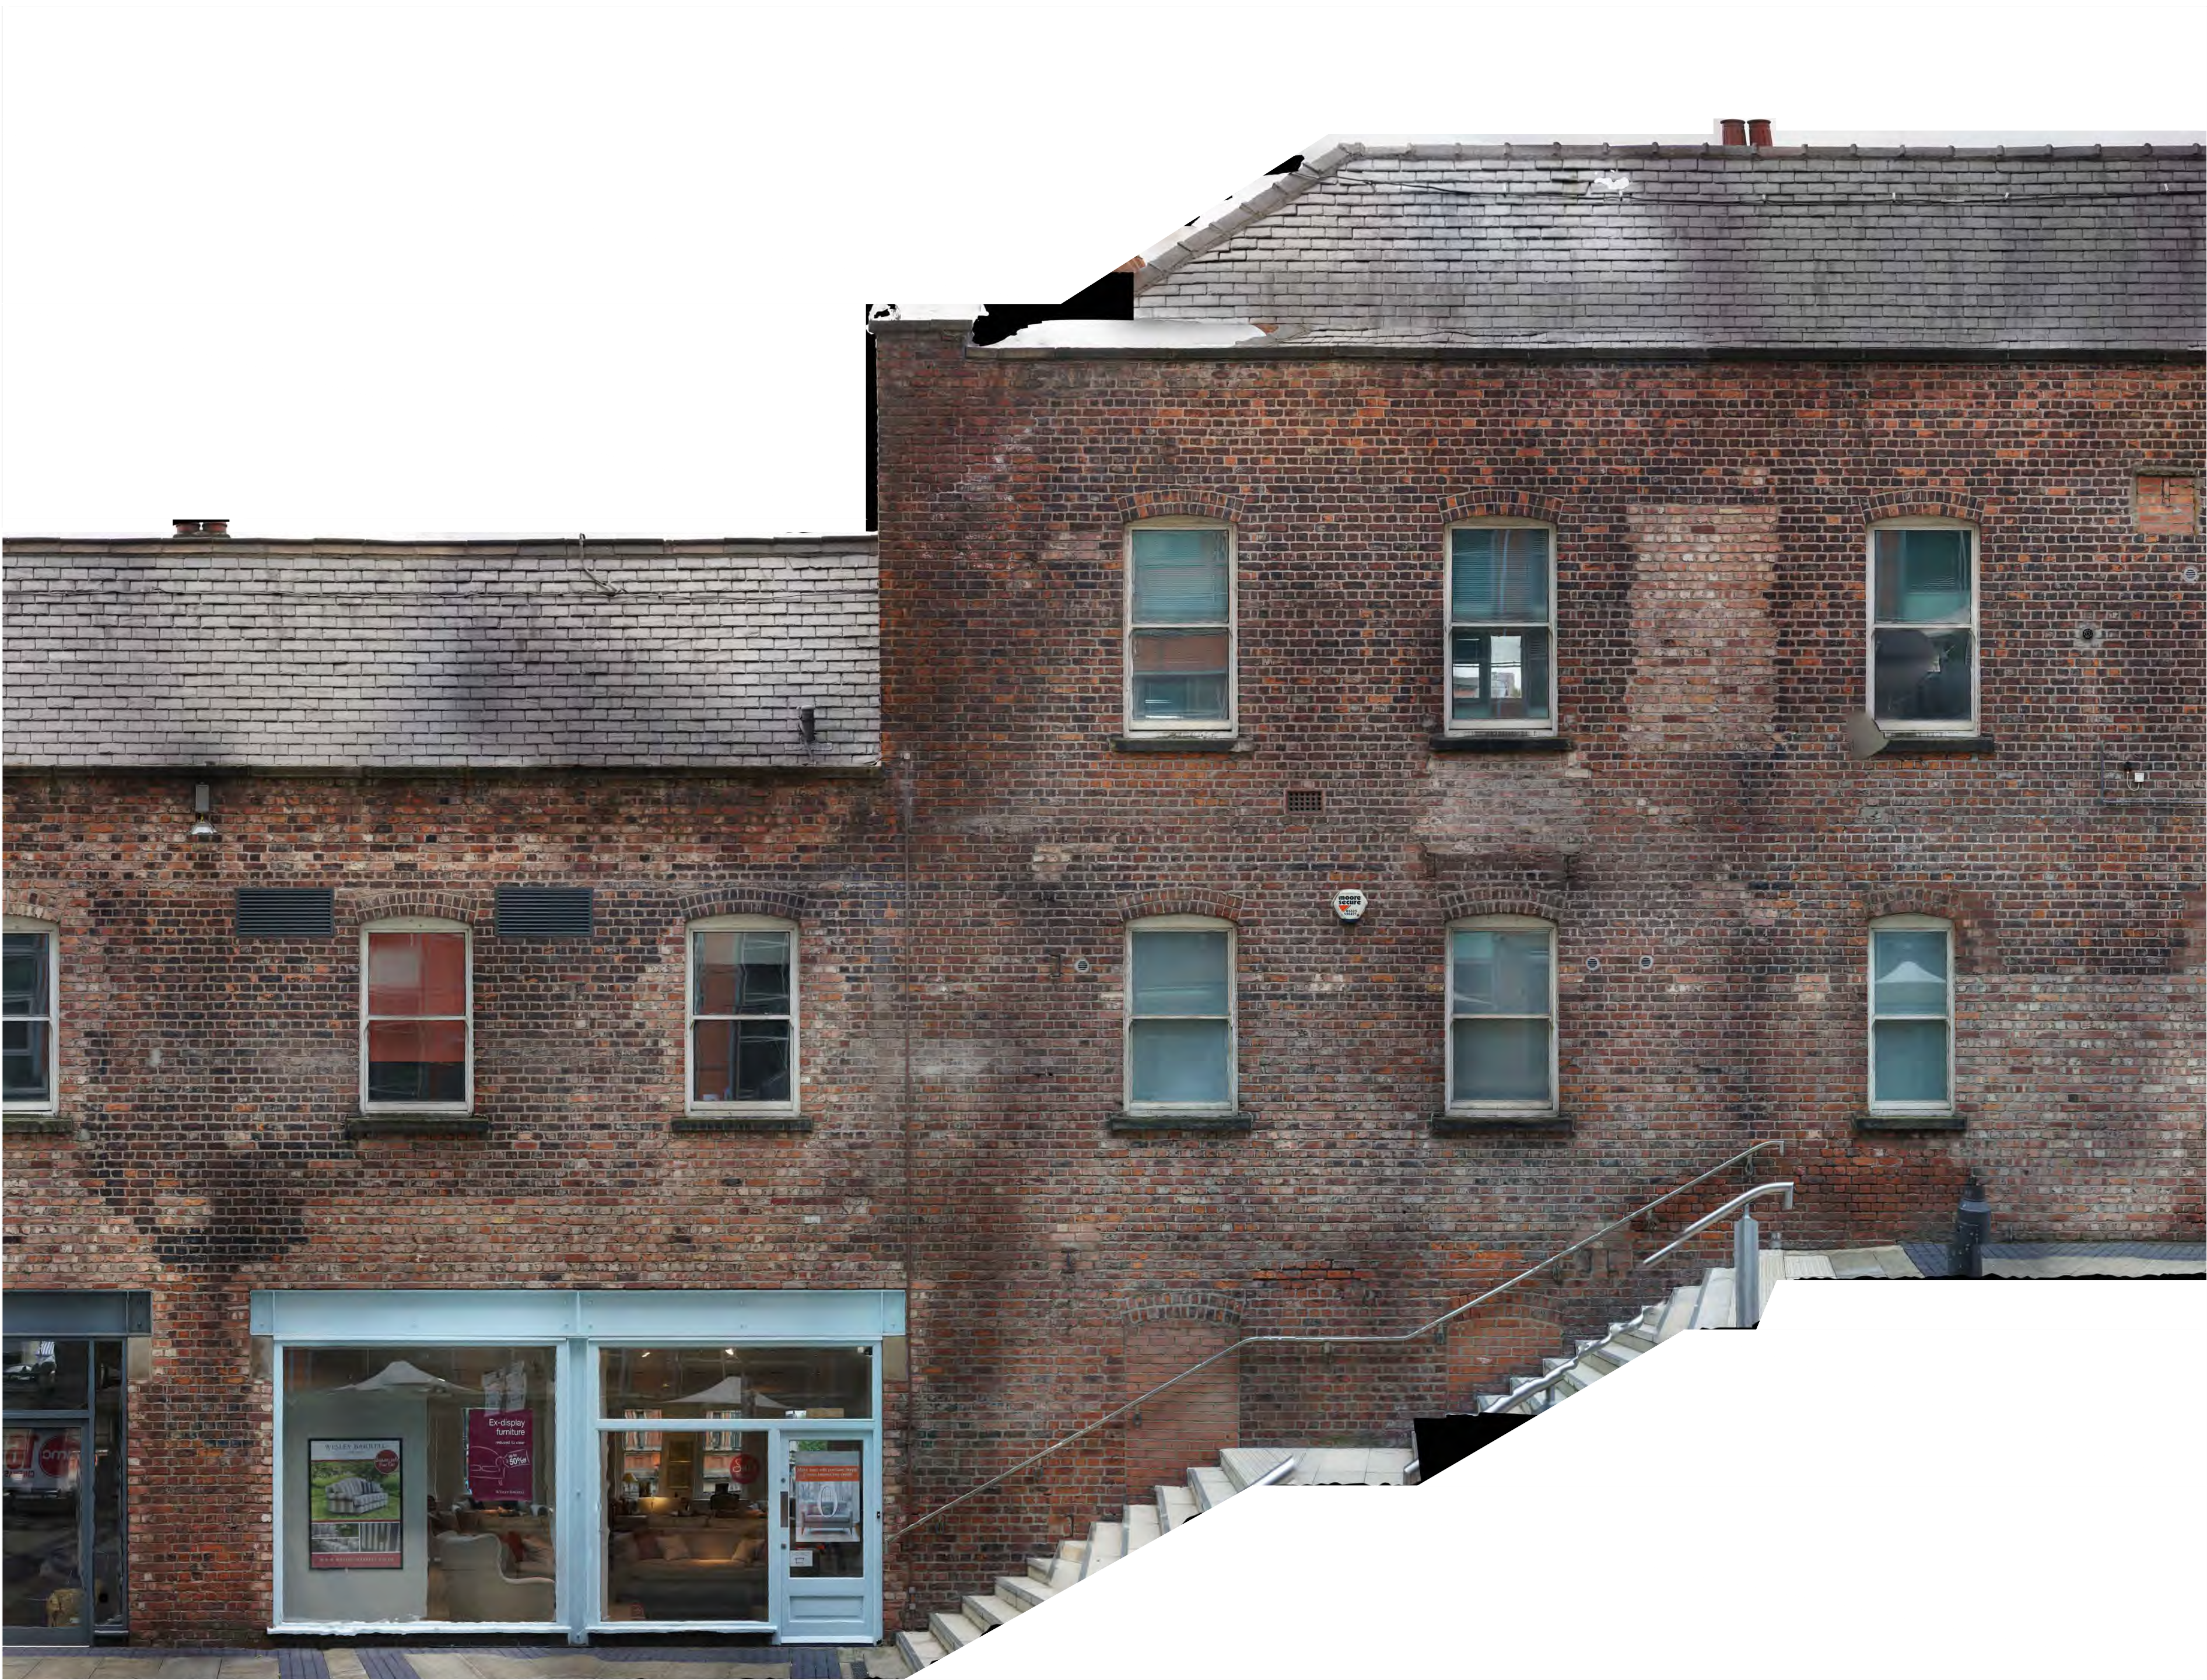
Cube Ref No. A81 - A88 & A179 - A184

Doff Clean all areas of brickwork and stonework.

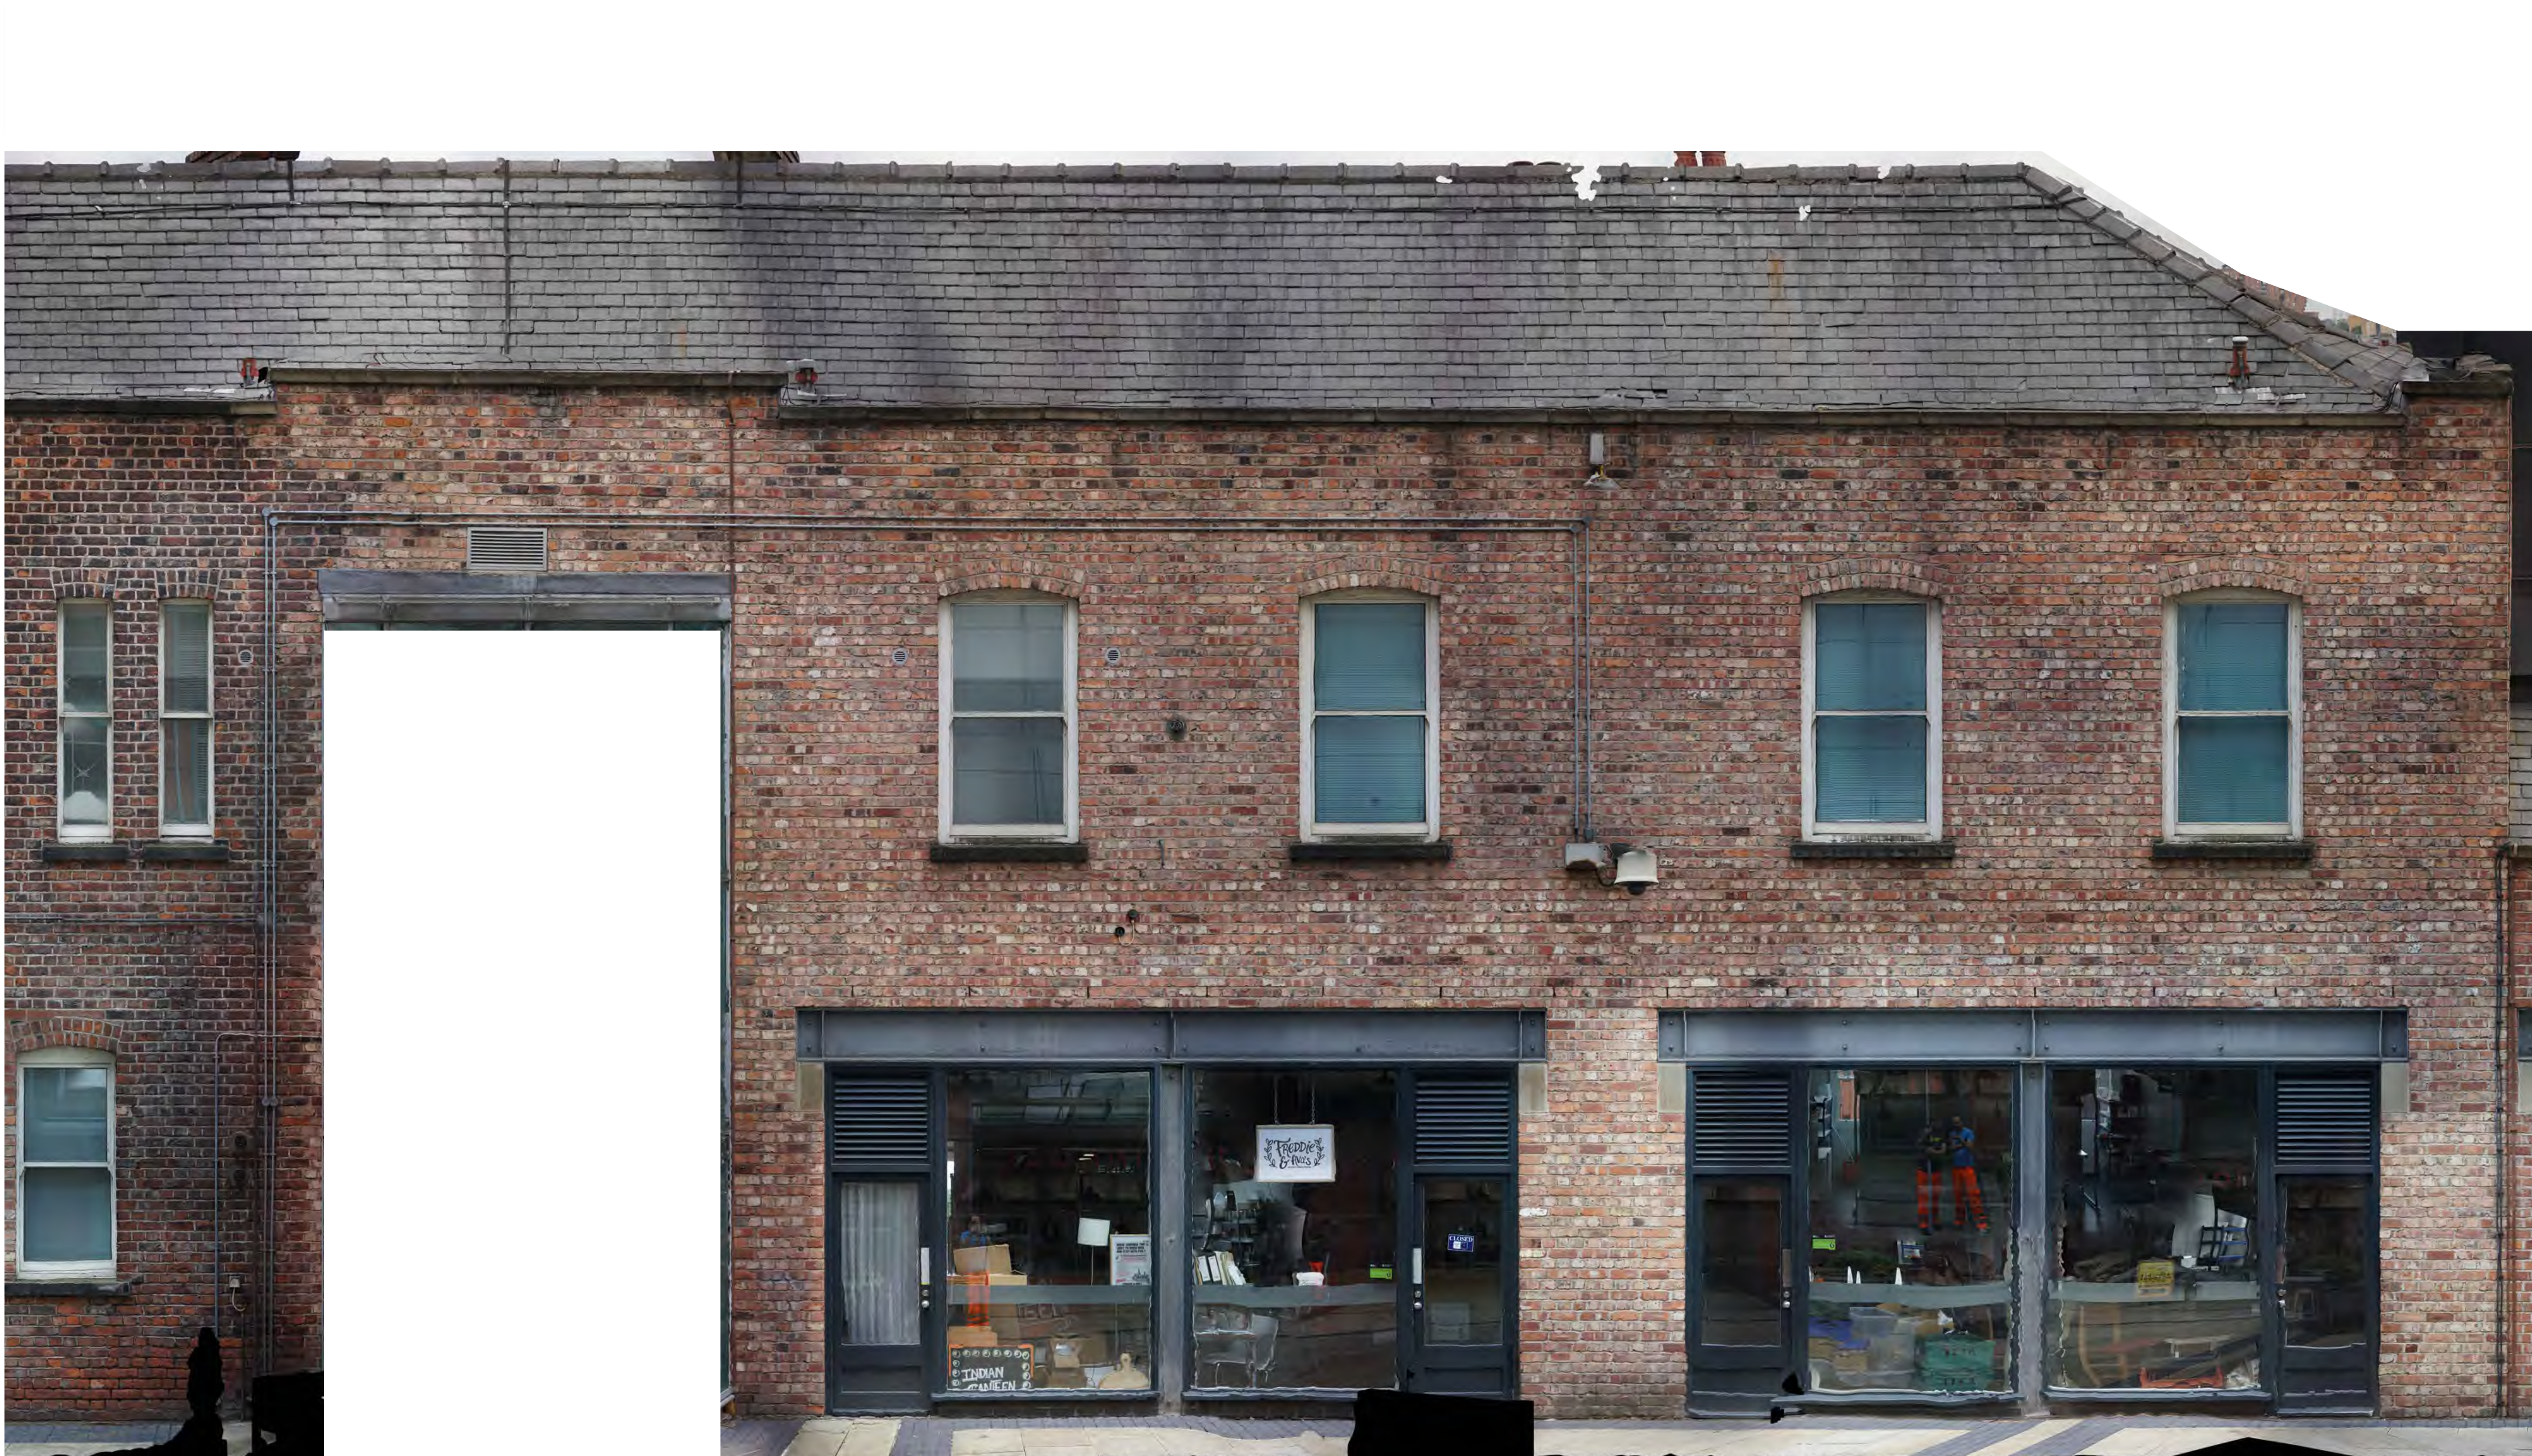
Cube Ref No. A88 - A94 & A182 - A184

Doff Clean all areas of brickwork and stonework.  
Rake out defective and open joints of the brickwork and repoint.  
Areas of previously repaired brickwork have been carried out with different bricks. These repaired areas are quite obtrusive

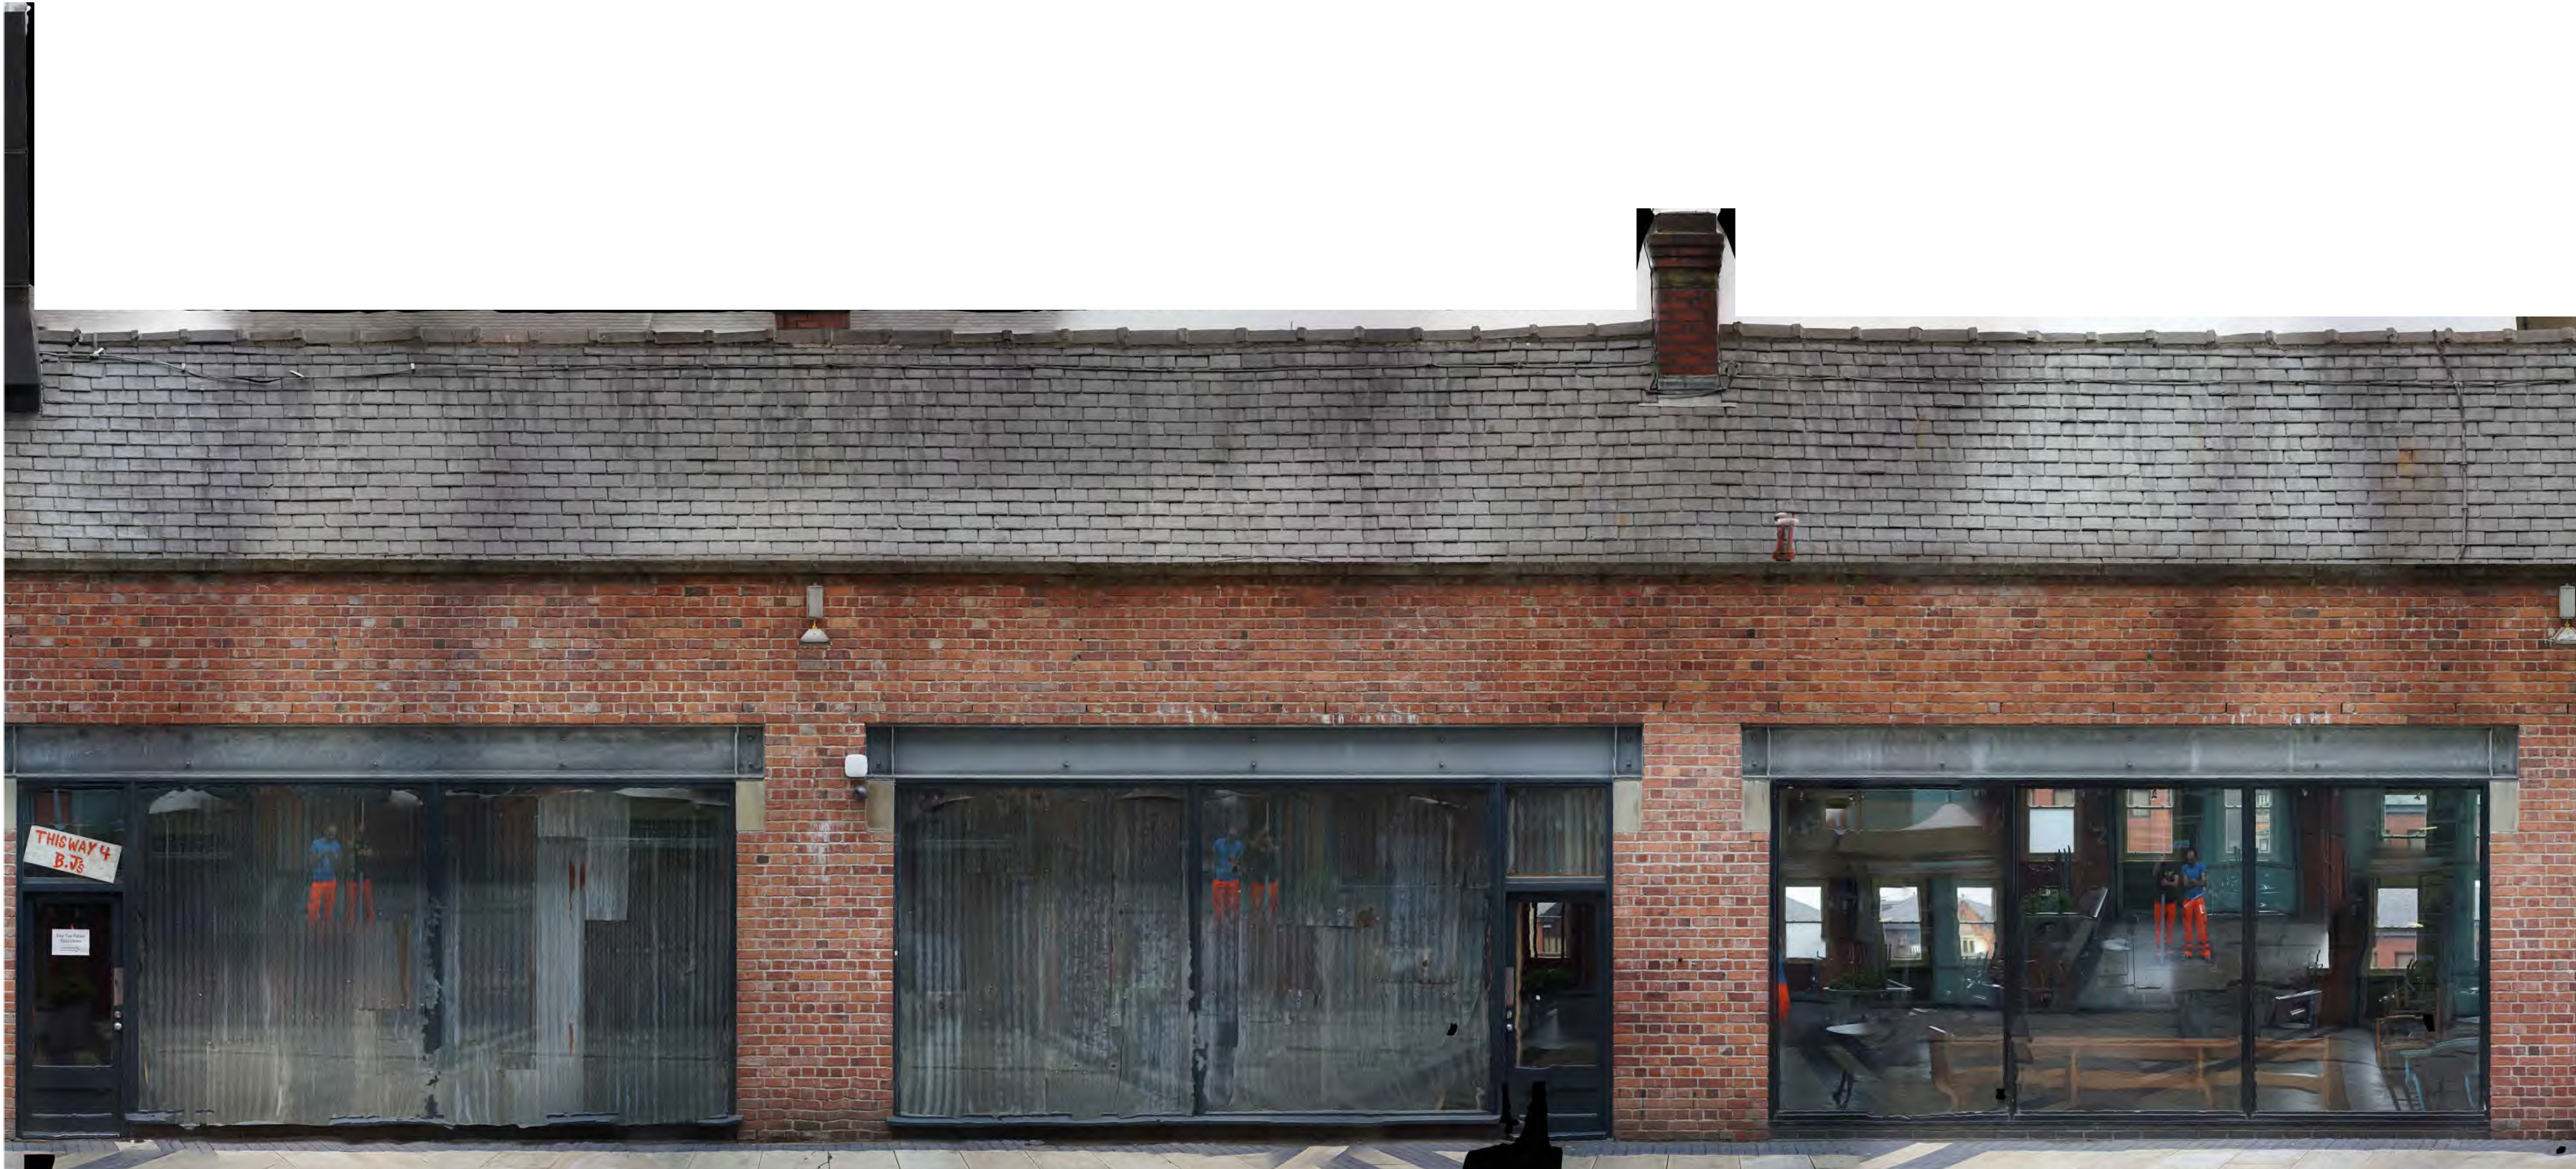
Cube Ref No. A94 - A98 & A185 - A191

Doff Clean all areas of brickwork and stonework.  
Rake out defective and open joints of the brickwork and repoint.  
Areas of previously repaired brickwork have been carried out with different bricks. These repaired areas are quite obtrusive
