**The Great Northern Warehouse**

**Survey 2022**

**Great Northern Warehouse & Deansgate Terraces, Manchester**

**Condition Survey**

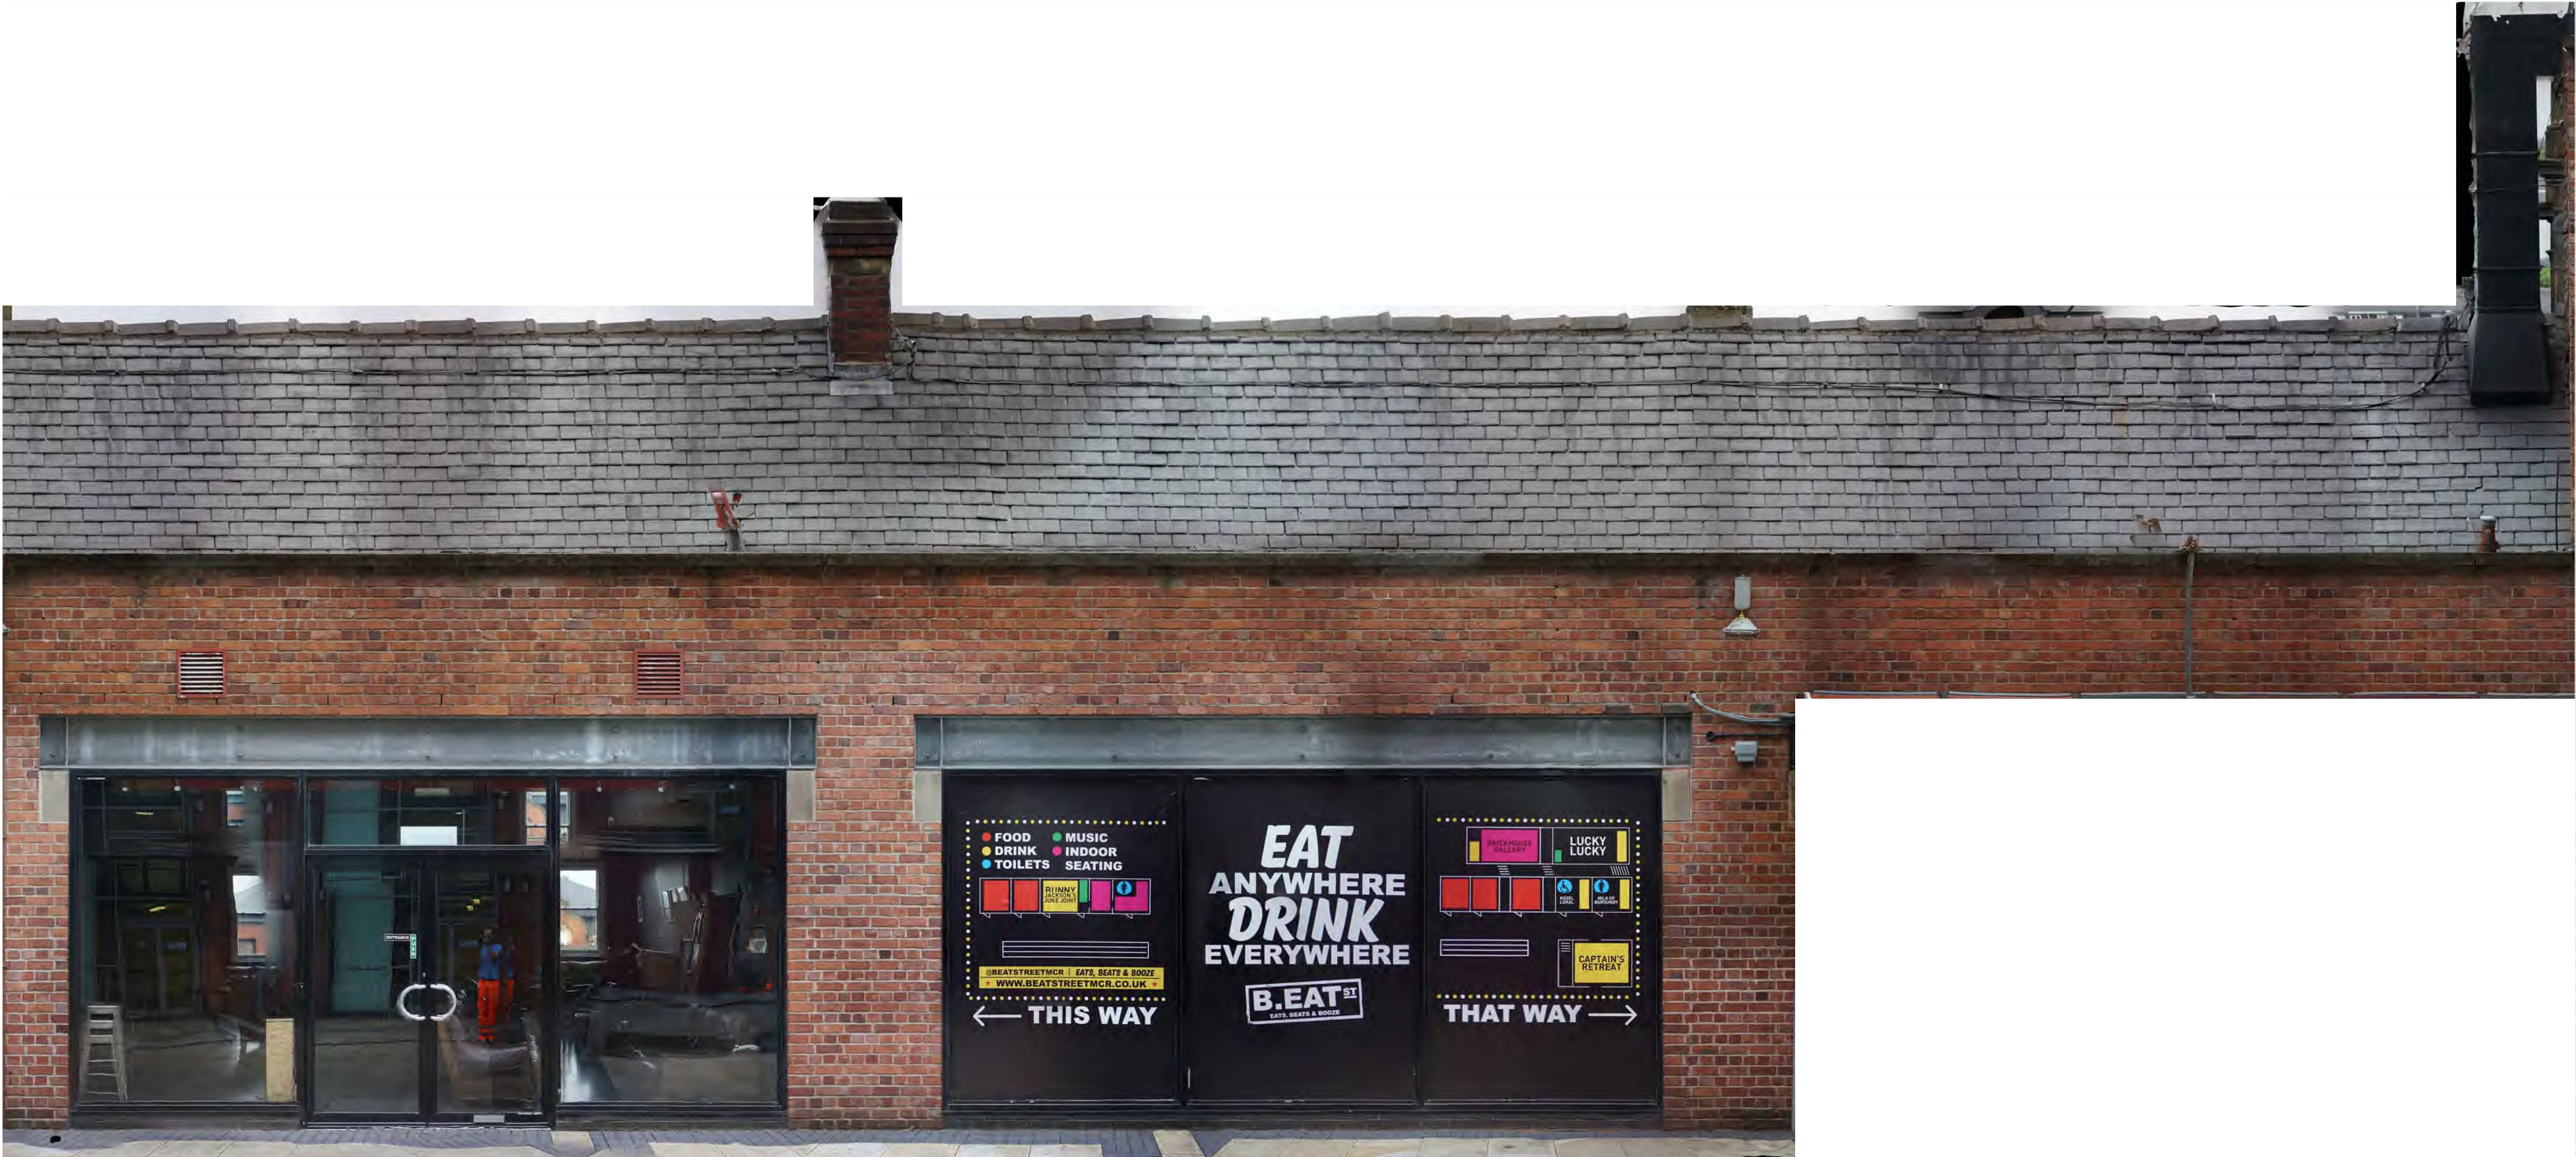
Cube Ref No. A99 - A103 & A192 - A196

Doff Clean all areas of brickwork and stonework.

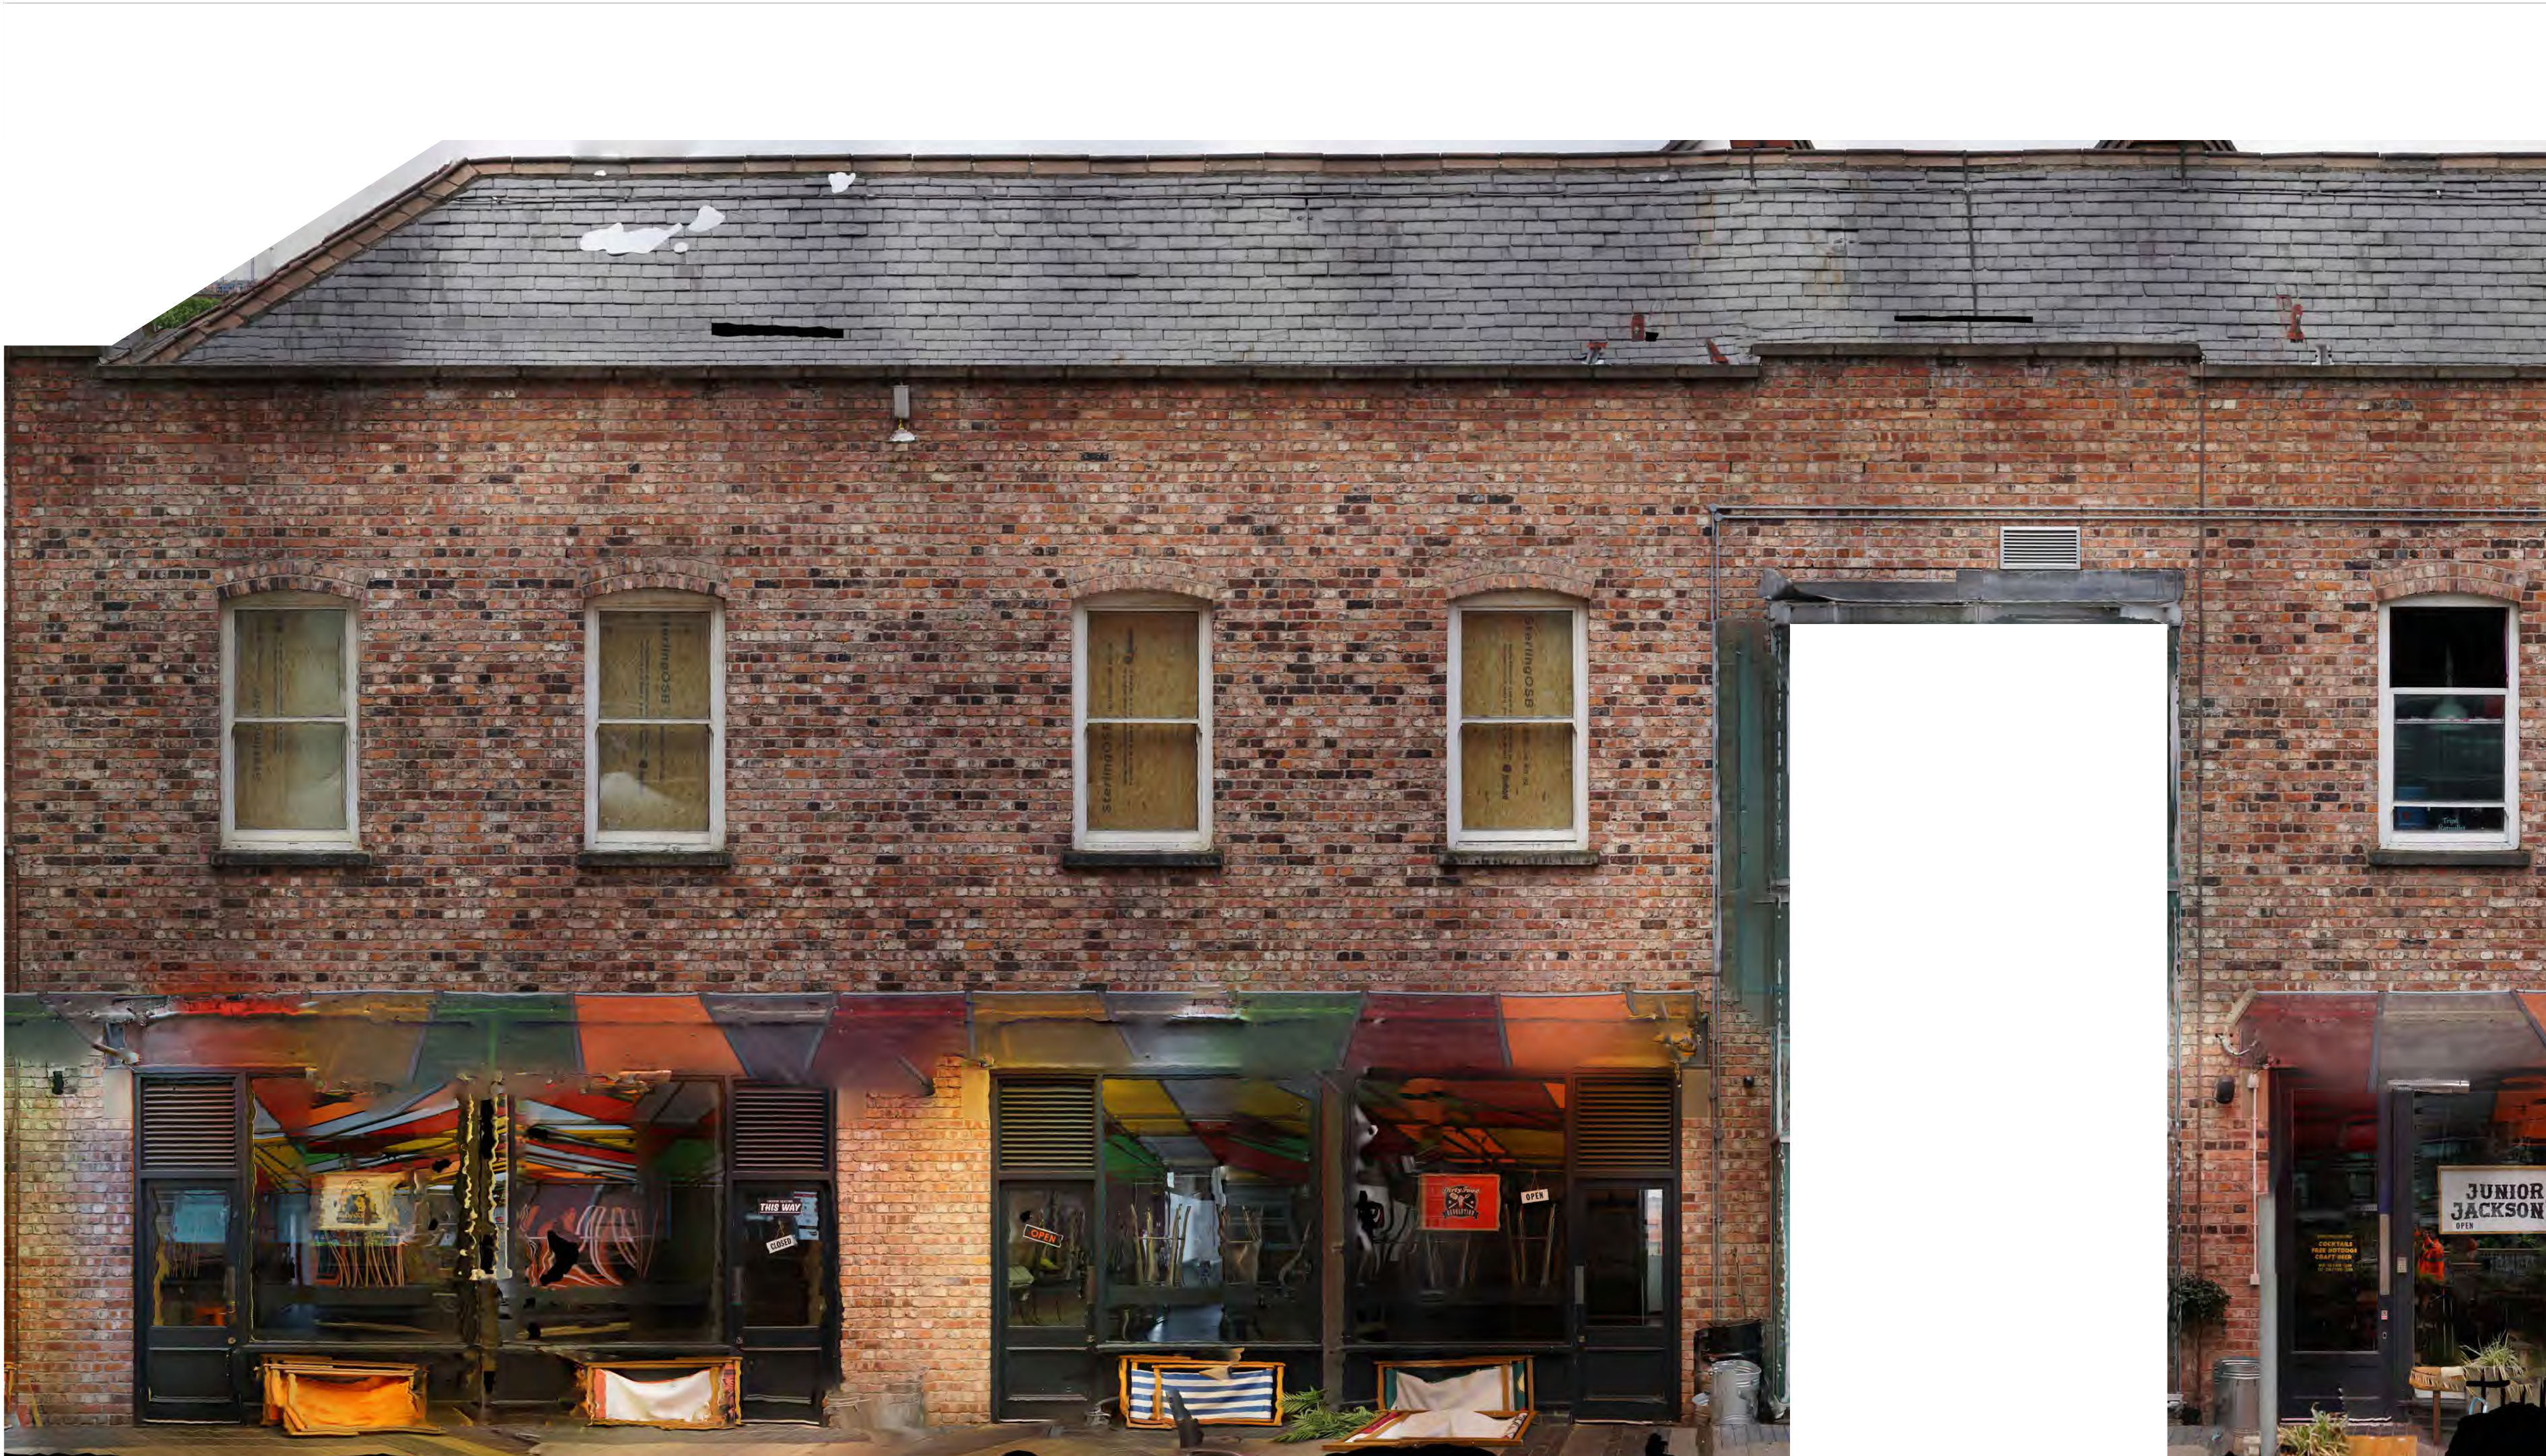
Cube Ref No. A103 - A112 & A192 - A196

Doff Clean all areas of brickwork and stonework.

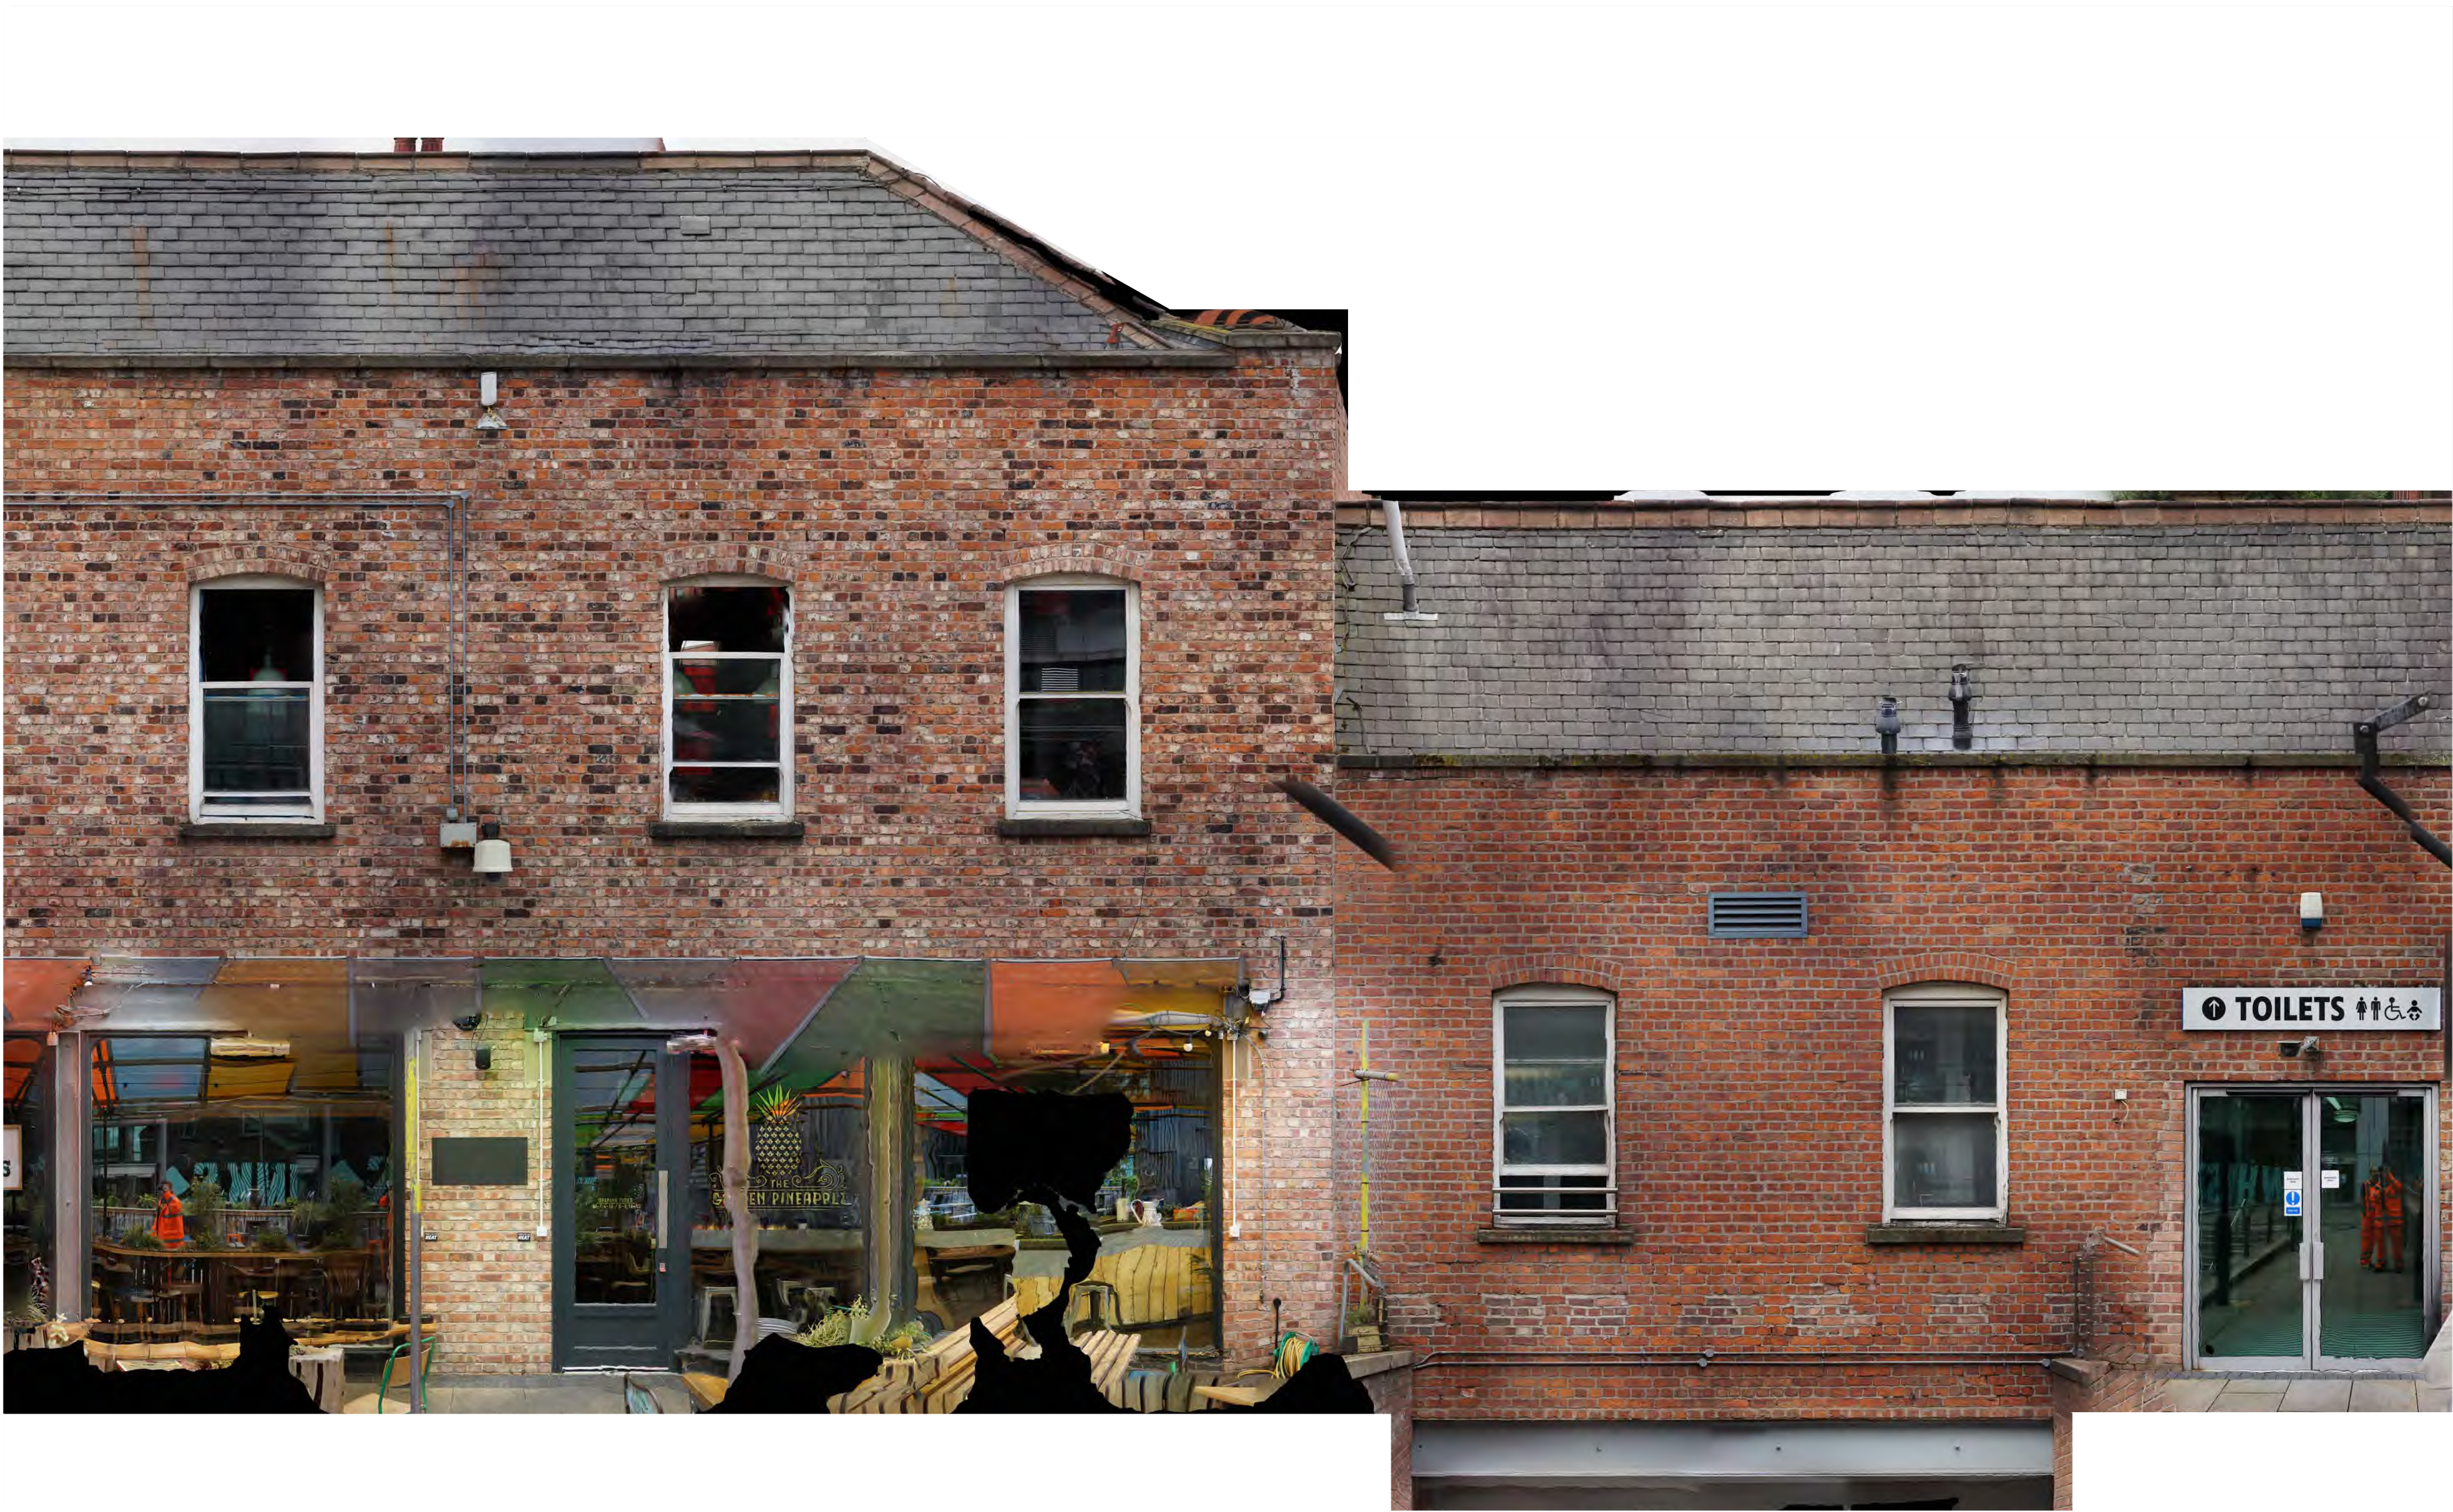
Cube Ref No. A112 - A116 & A192 - A197

Doff Clean all areas of brickwork and stonework.

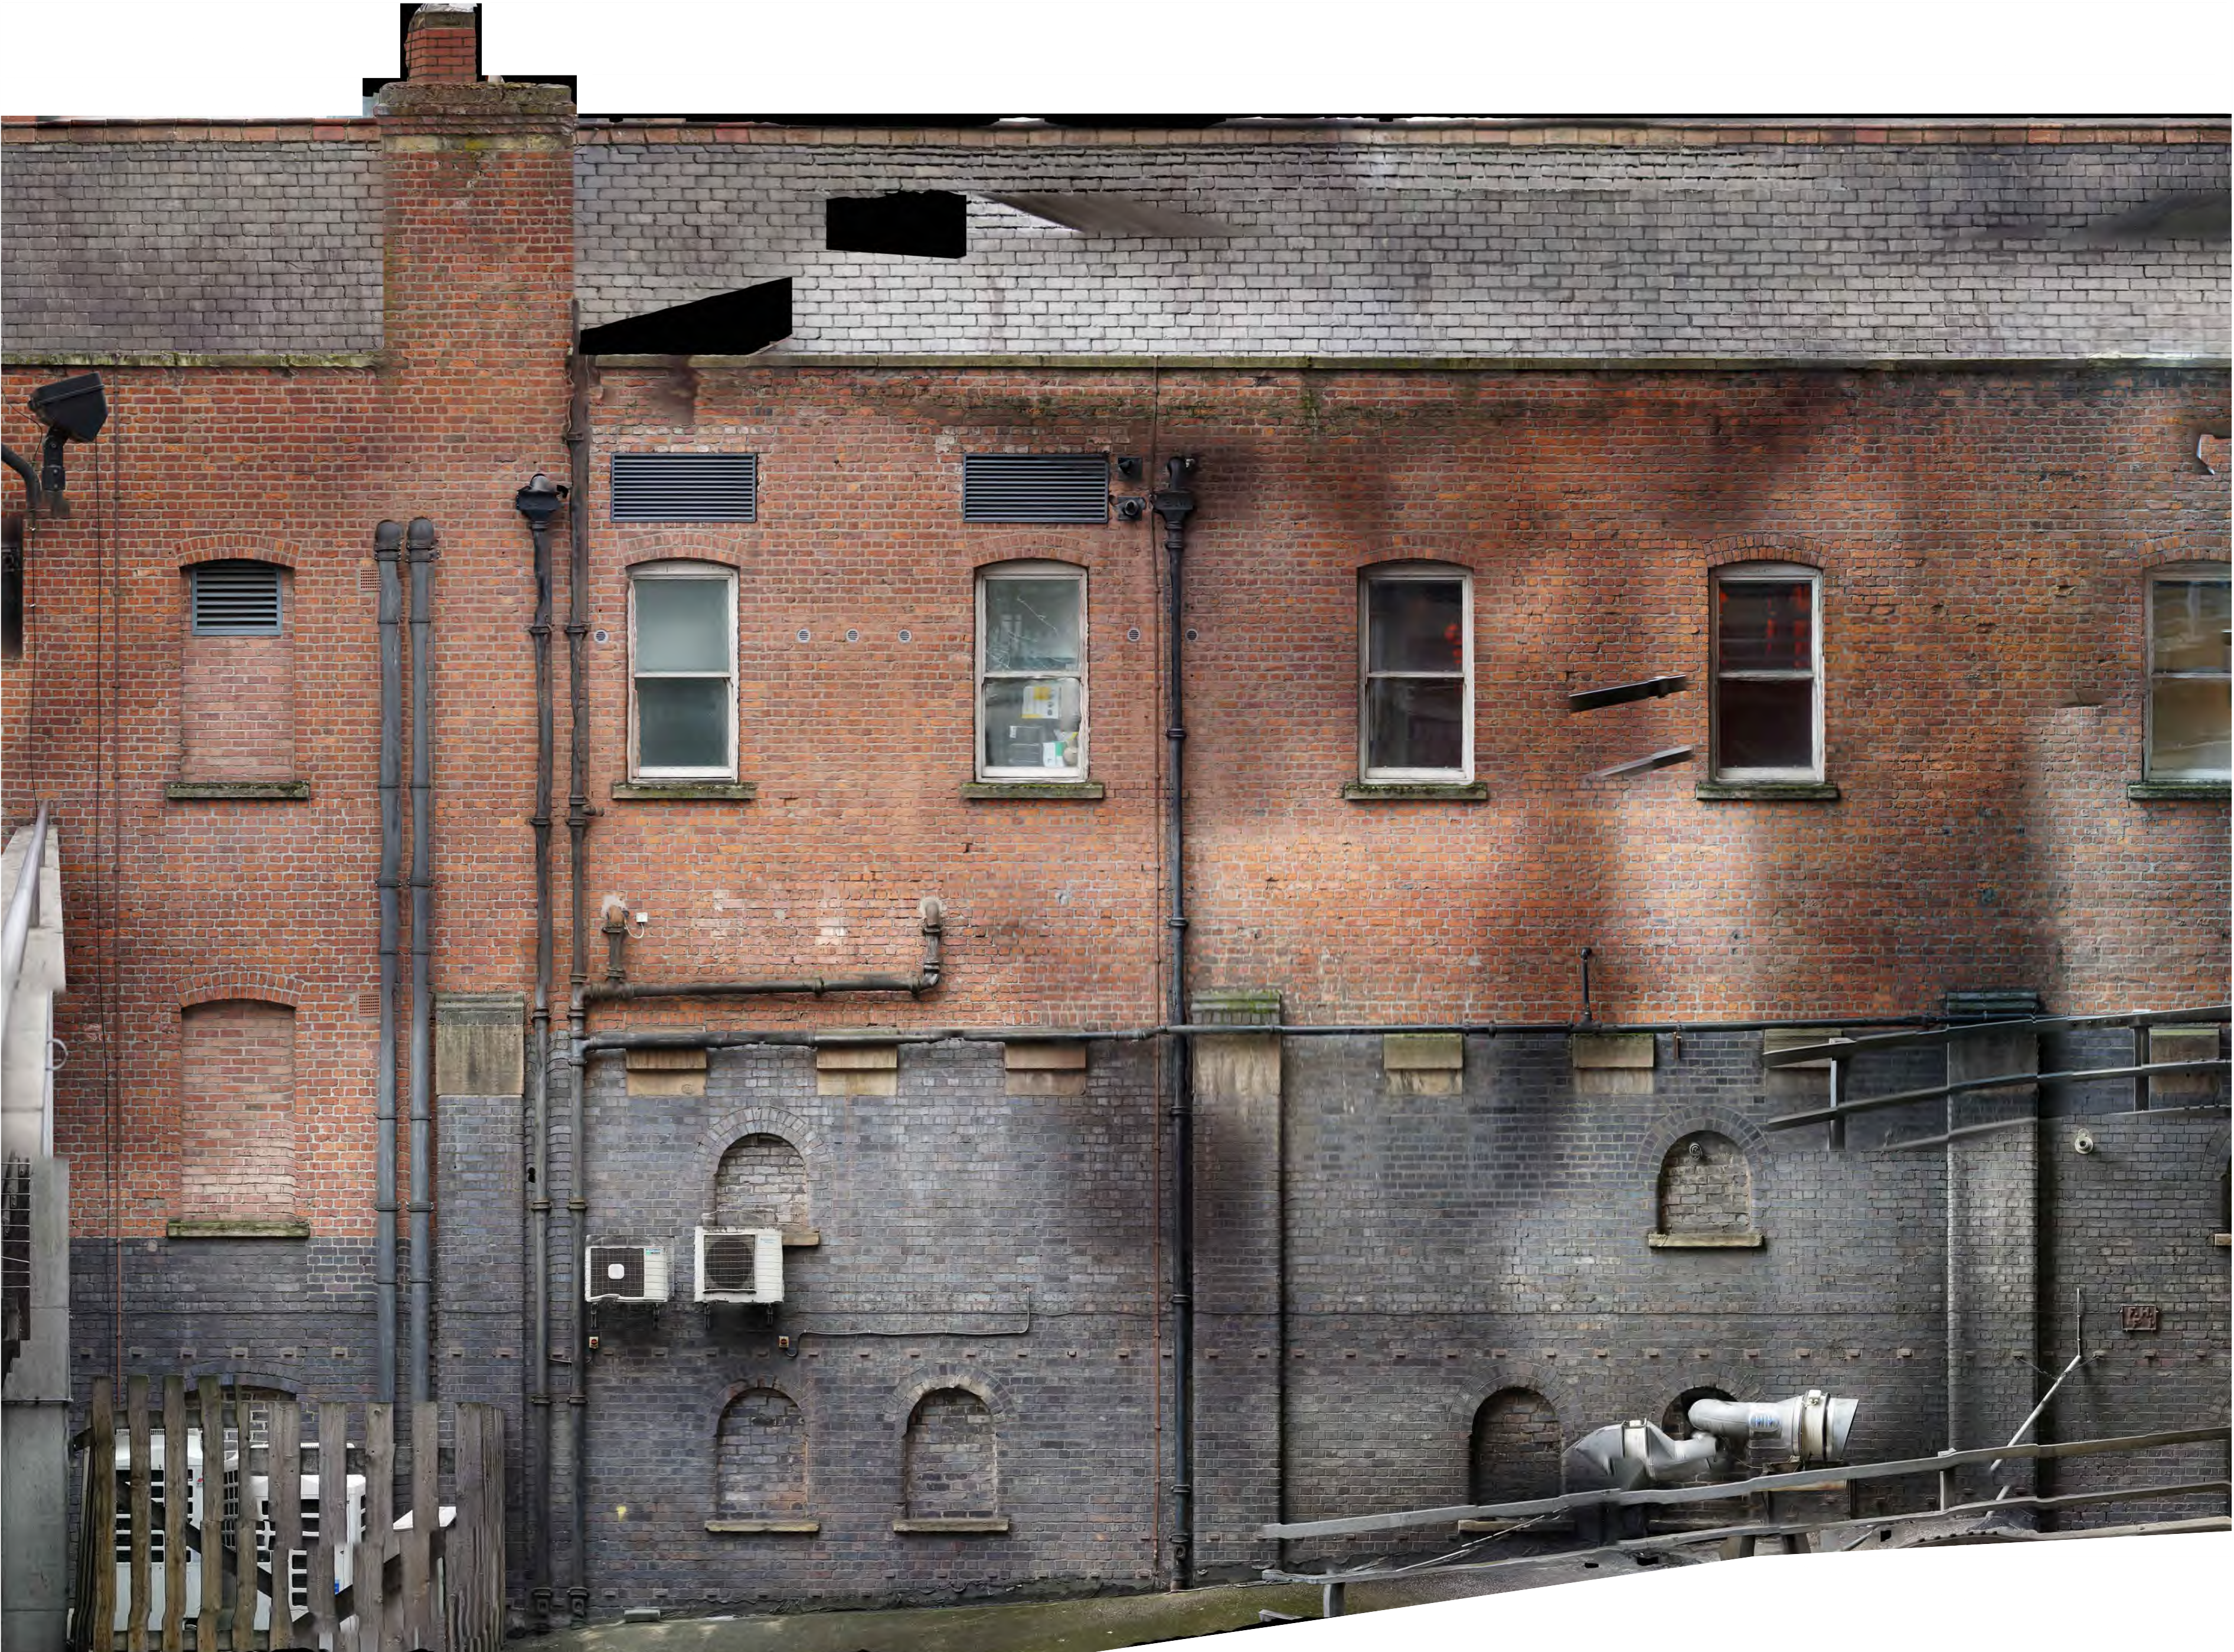
Cube Ref No. A88 - A94 & A182 - A184

Doff Clean all areas of brickwork and stonework.

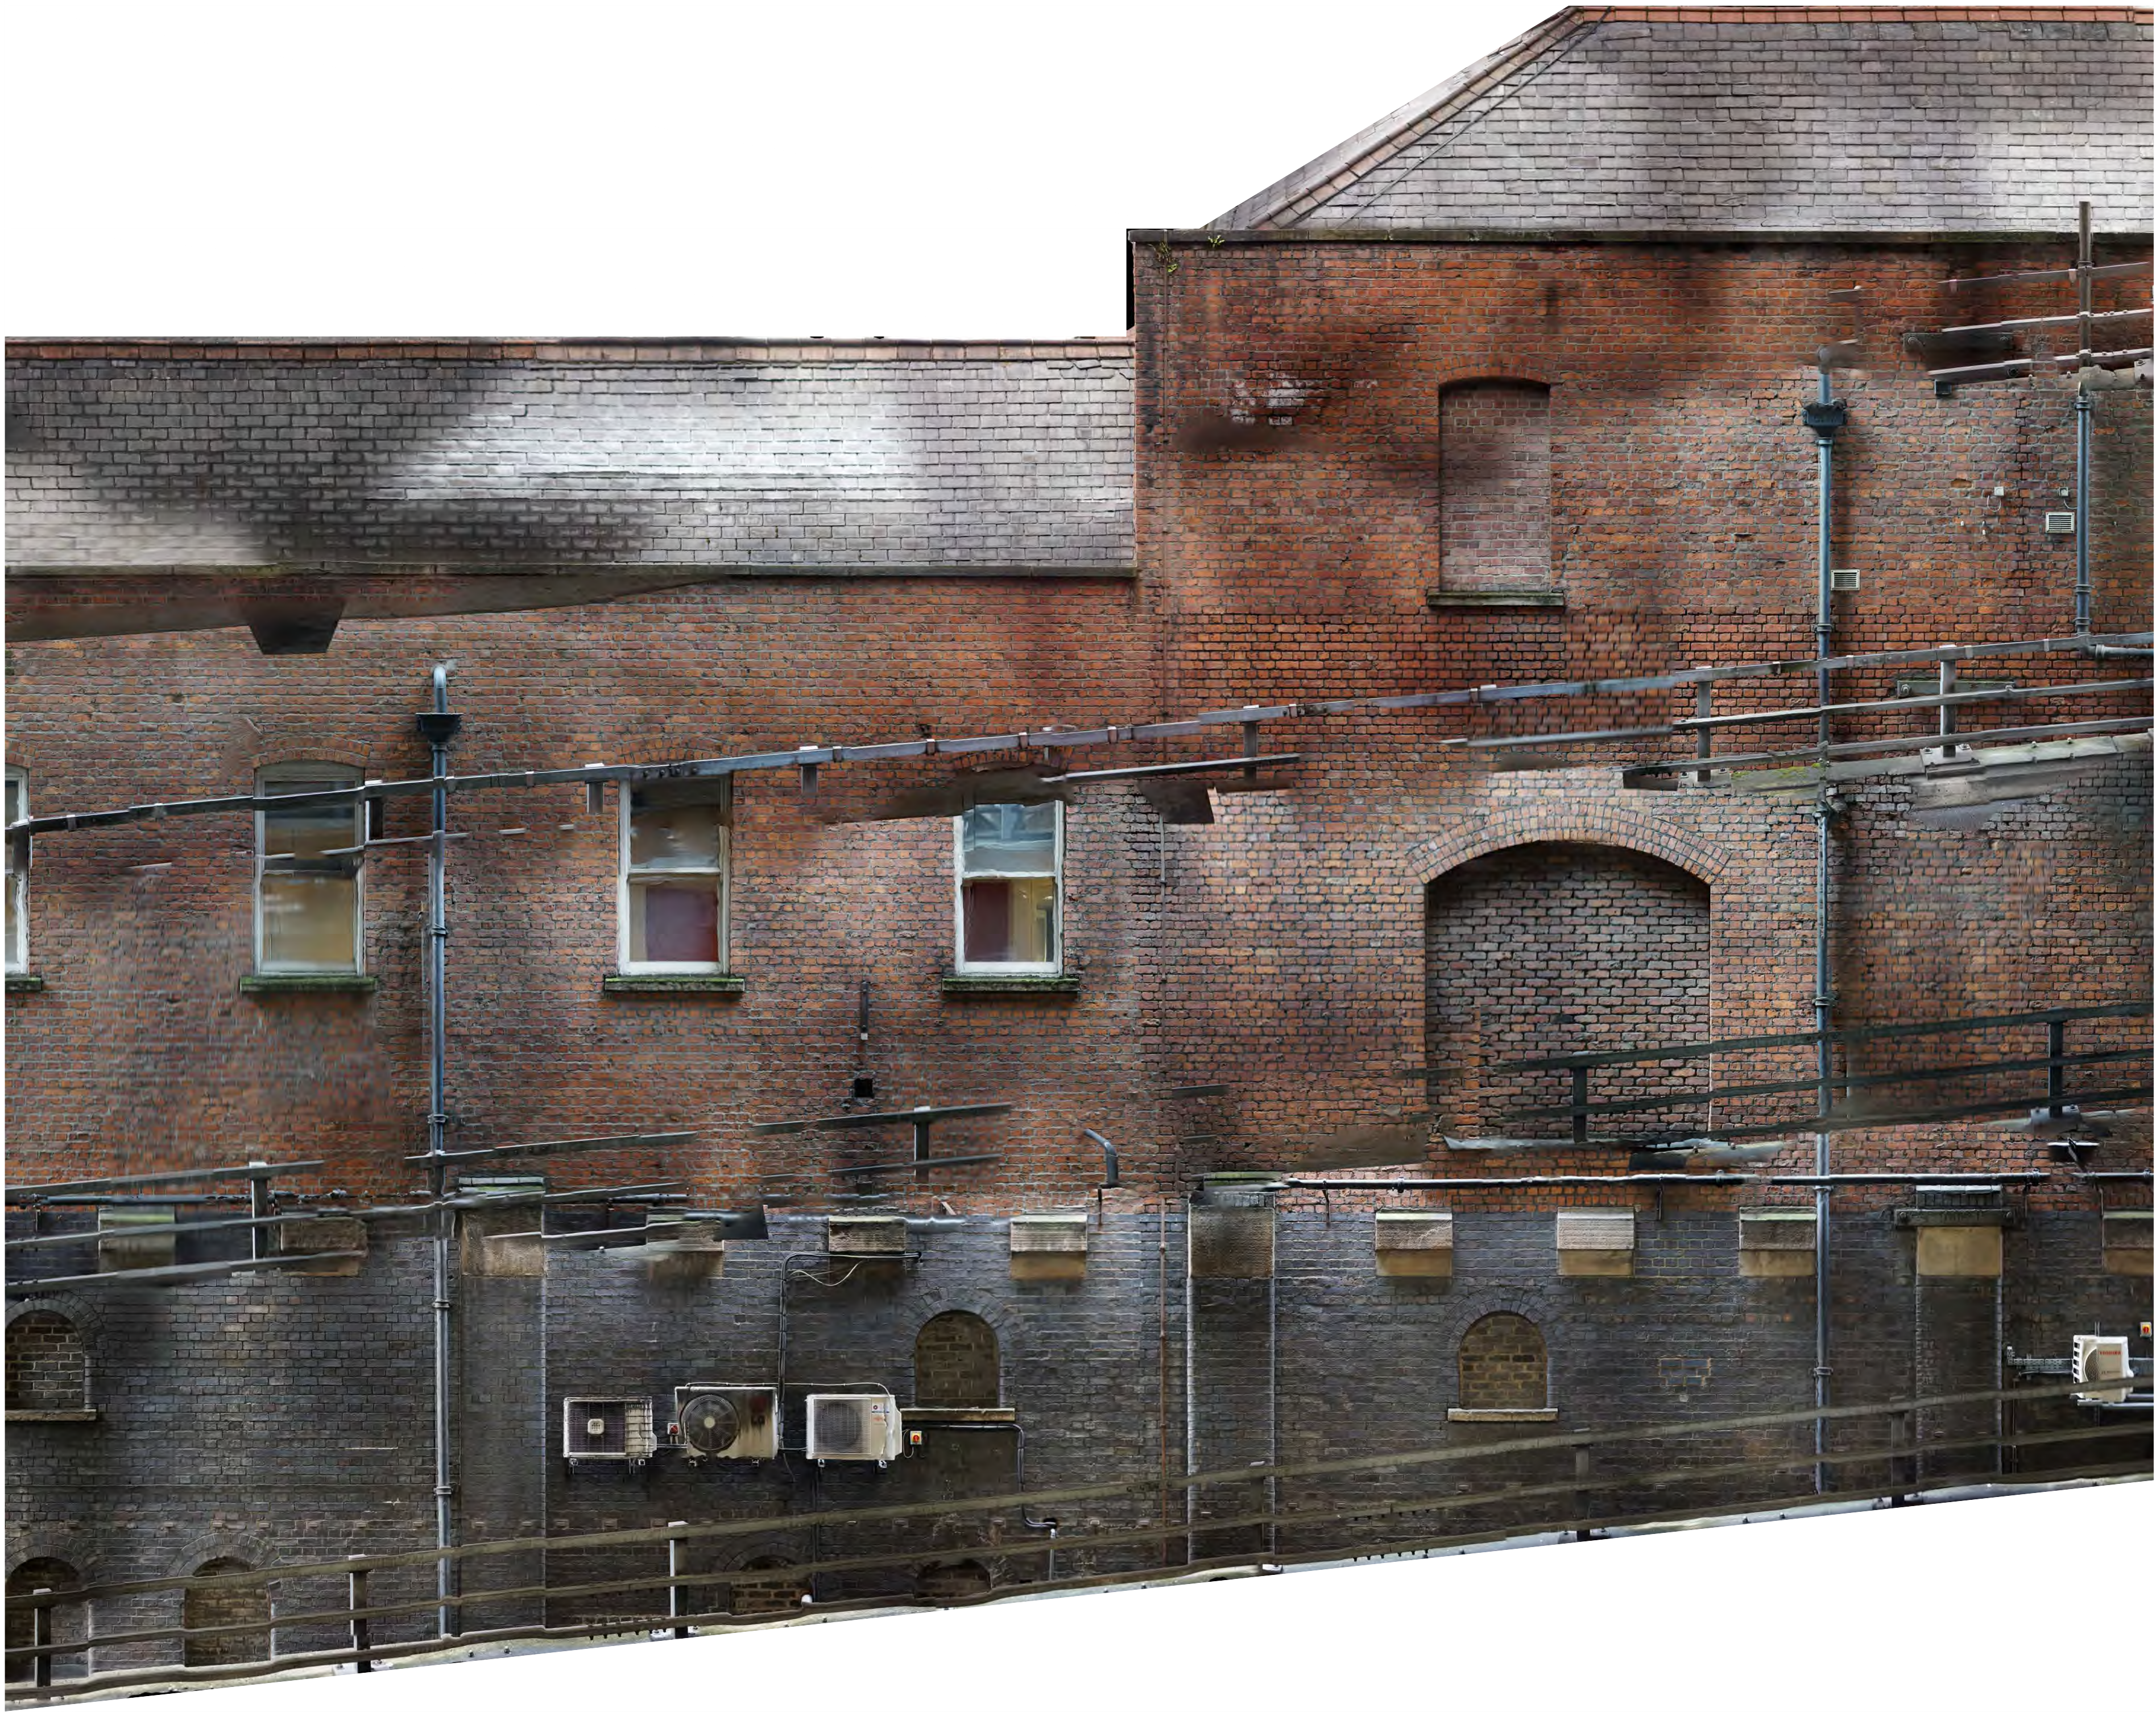
Cube Ref No. A132 - A134 & A197

Doff Clean all areas of brickwork and stonework.  
Rake out defective and open joints of the brickwork and repoint.  
Areas of previously repaired brickwork have been carried out with different bricks. These repaired areas are quite obtrusive

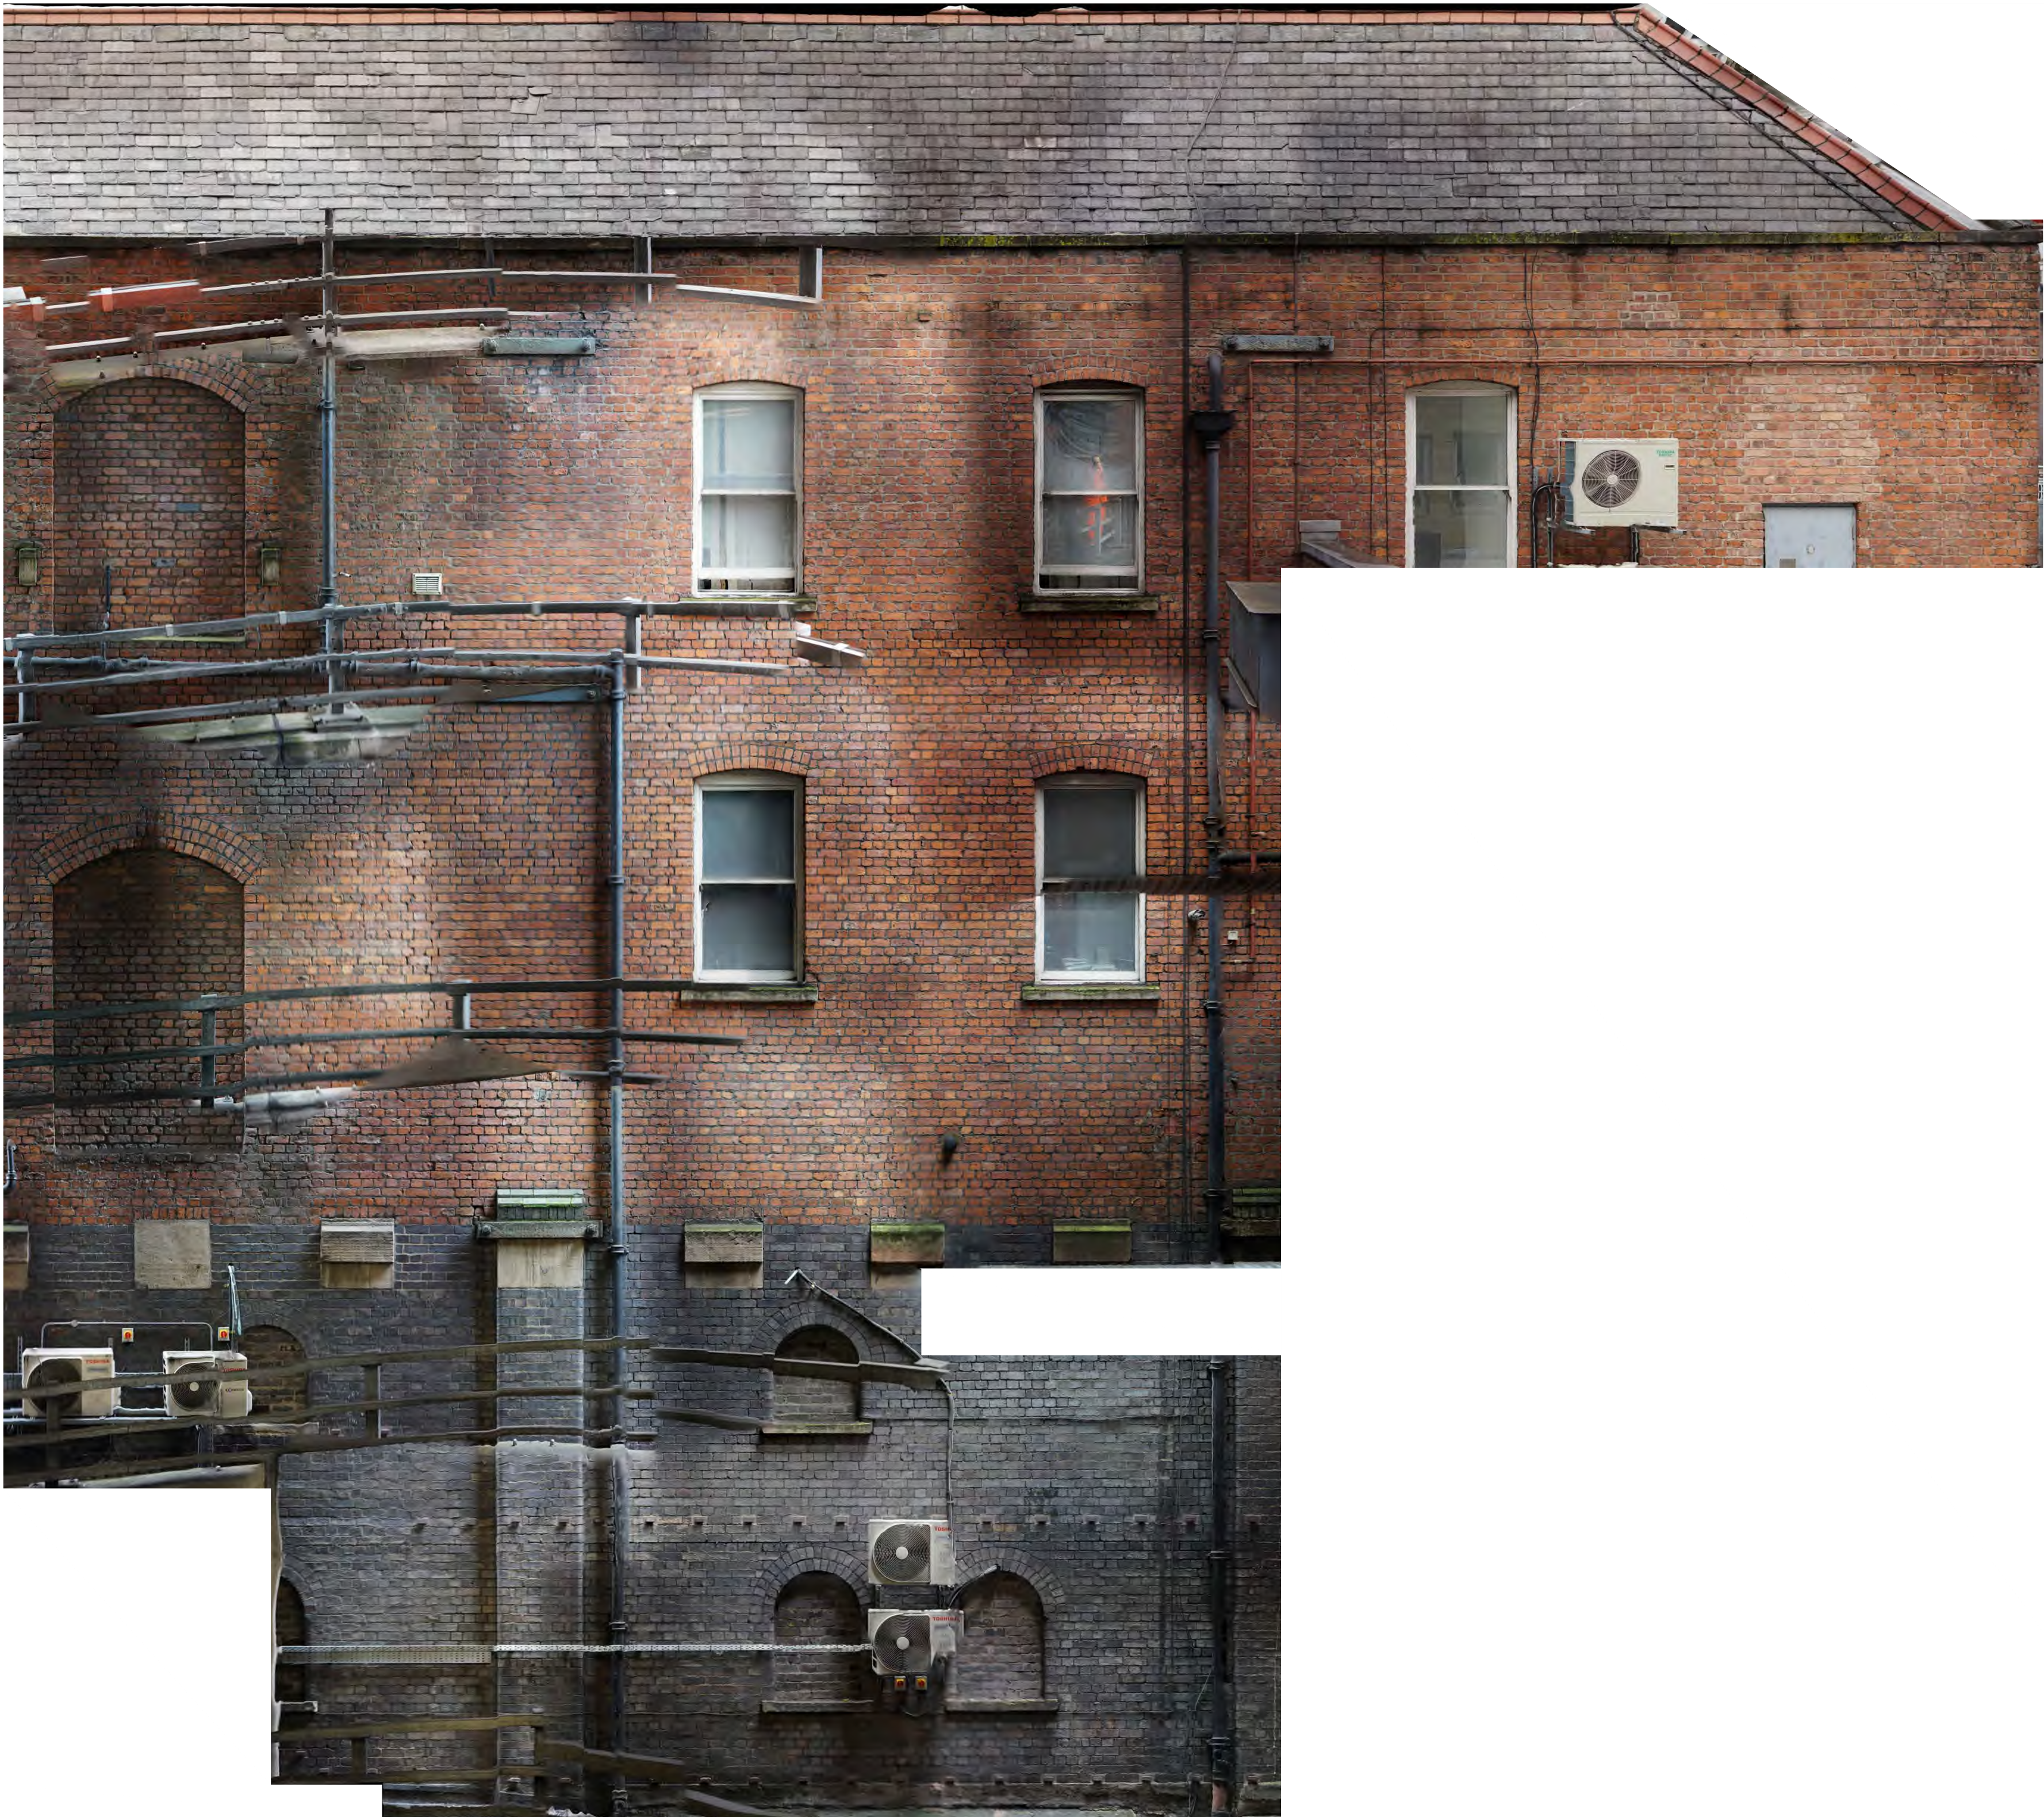
Cube Ref No. A134 - A136 & A197

Doff Clean all areas of brickwork and stonework.  
Rake out defective and open joints of the brickwork and repoint.  
Areas of previously repaired brickwork have been carried out with different bricks. These repaired areas are quite obtrusive
