**The Great Northern Warehouse**

**Survey 2022**

**Great Northern Warehouse & Deansgate Terraces, Manchester**

**Condition Survey**

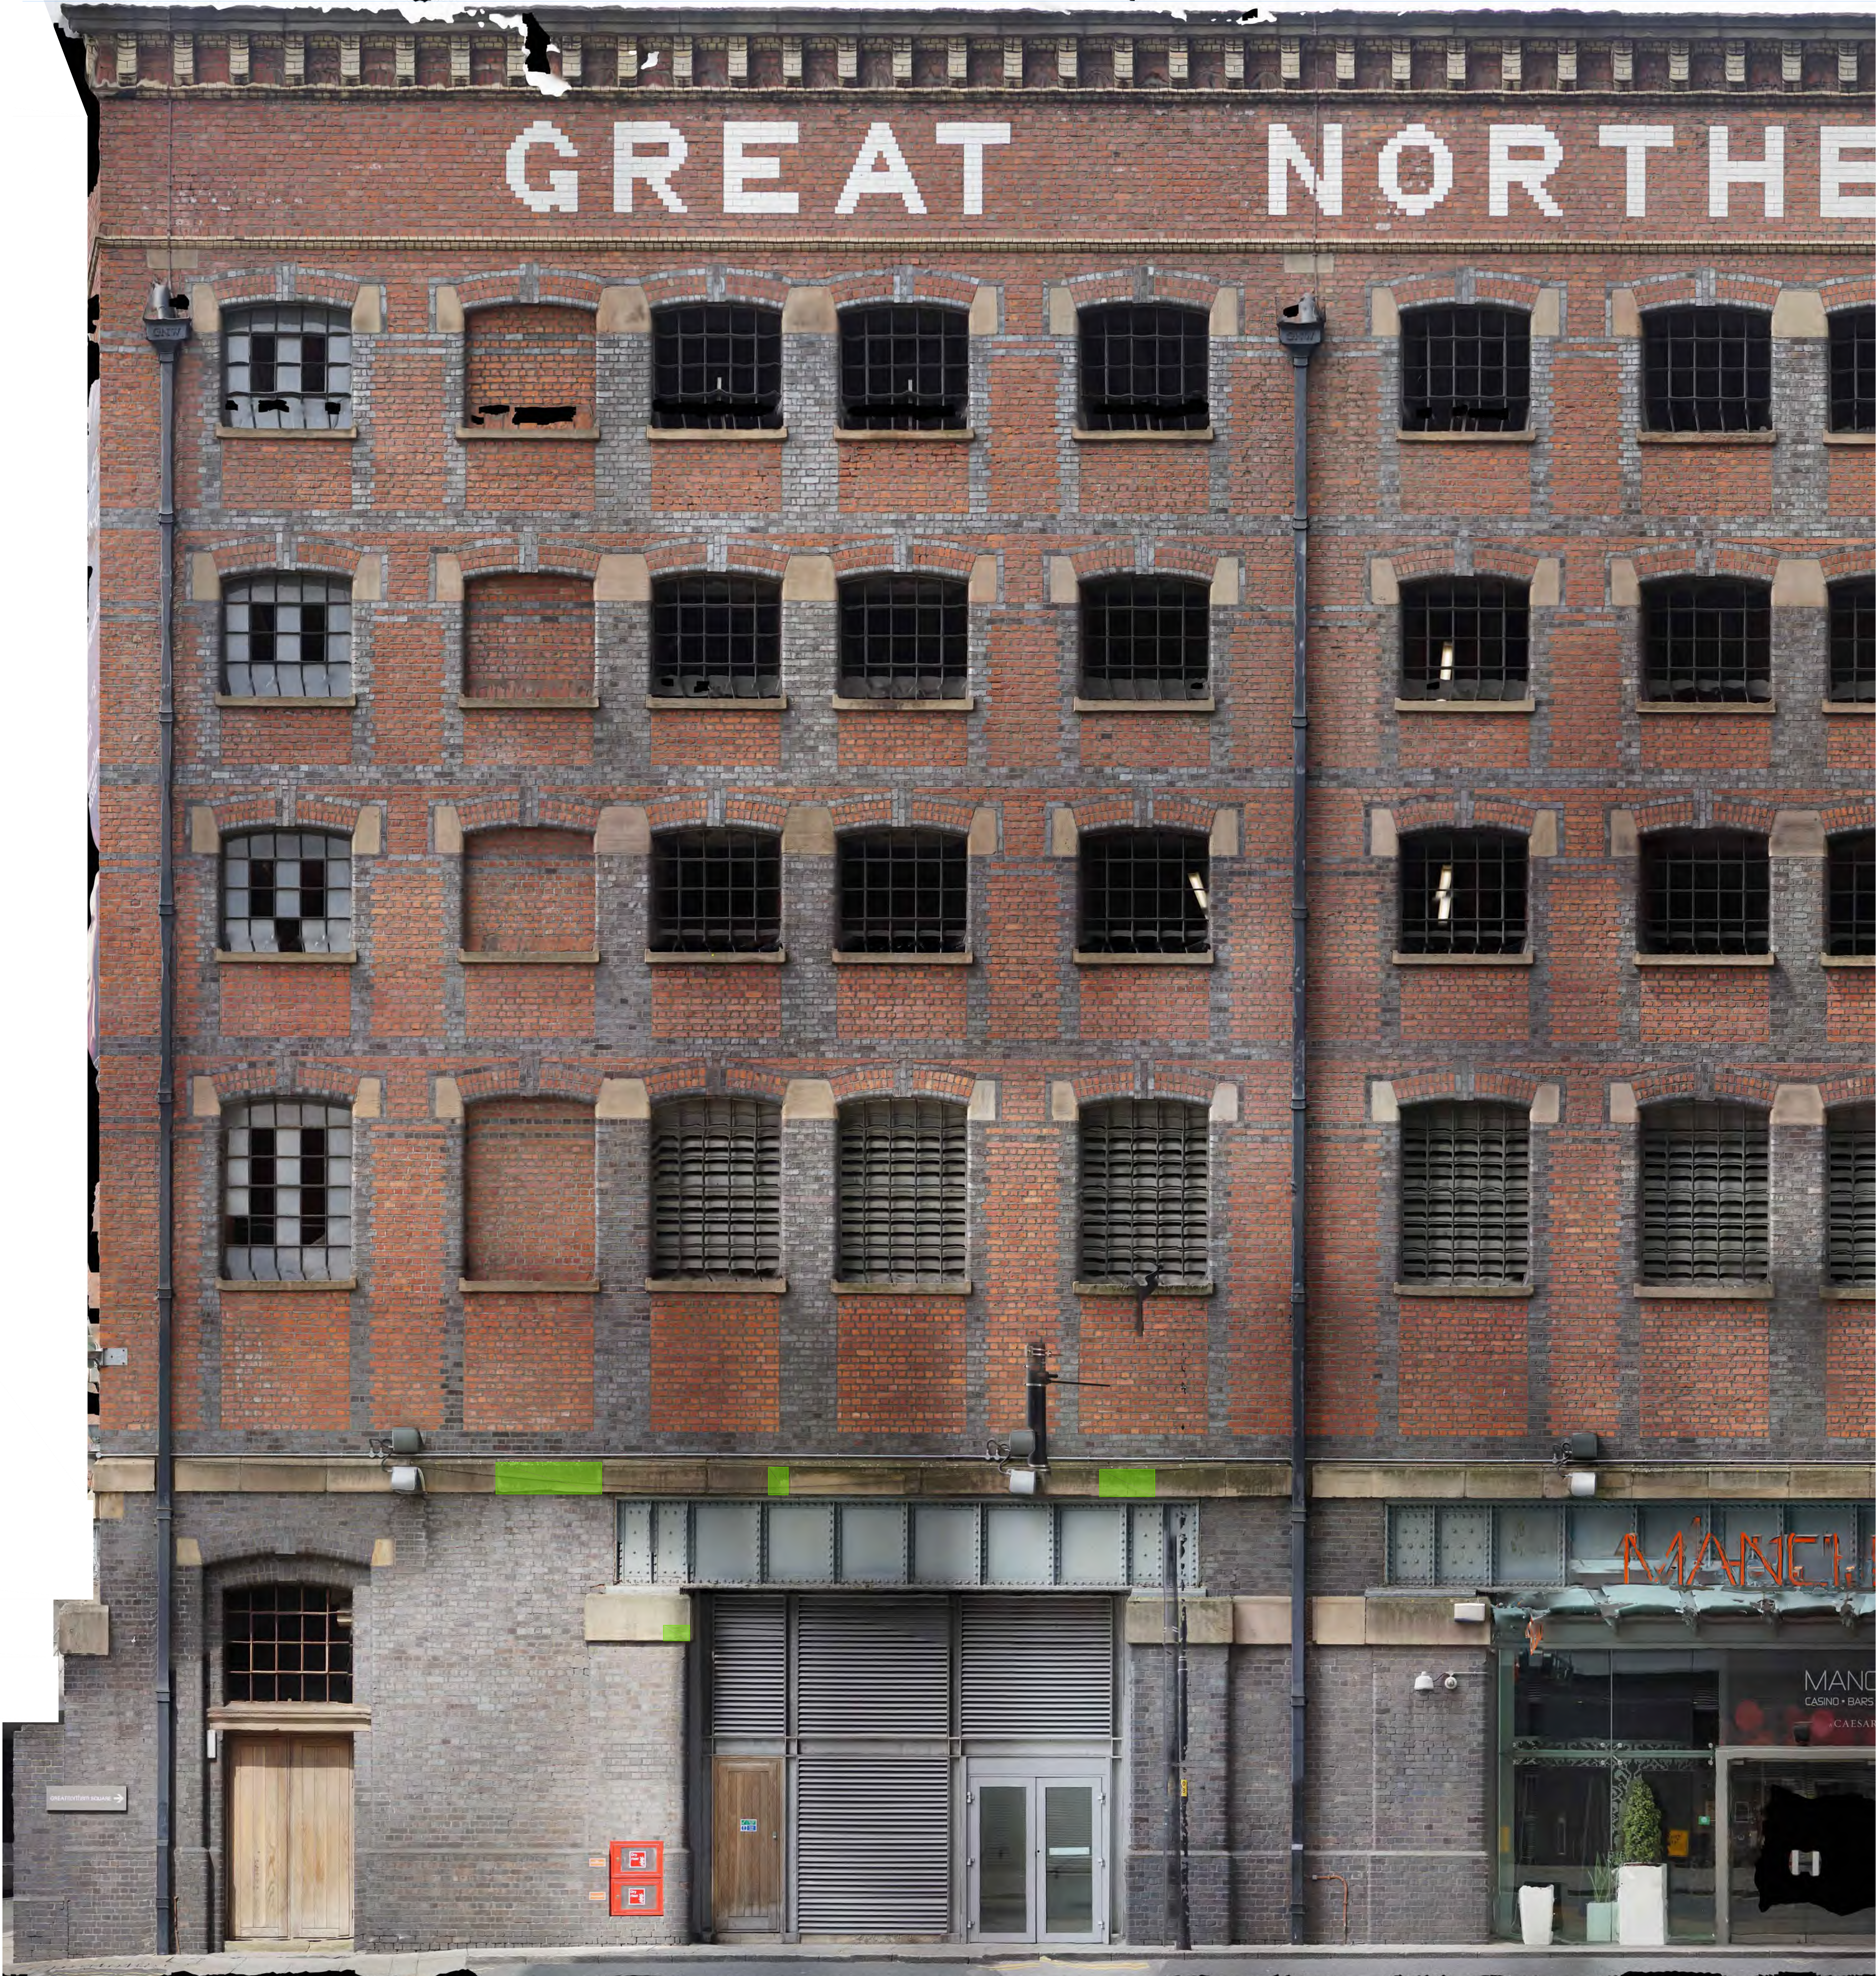
Remove vegetation.  
Rake out all joints of the parapet and cornice.  
Apply biocide.  
Repoint all joints of the cornice and parapet.  
Repoint isolated areas of defective brickwork.

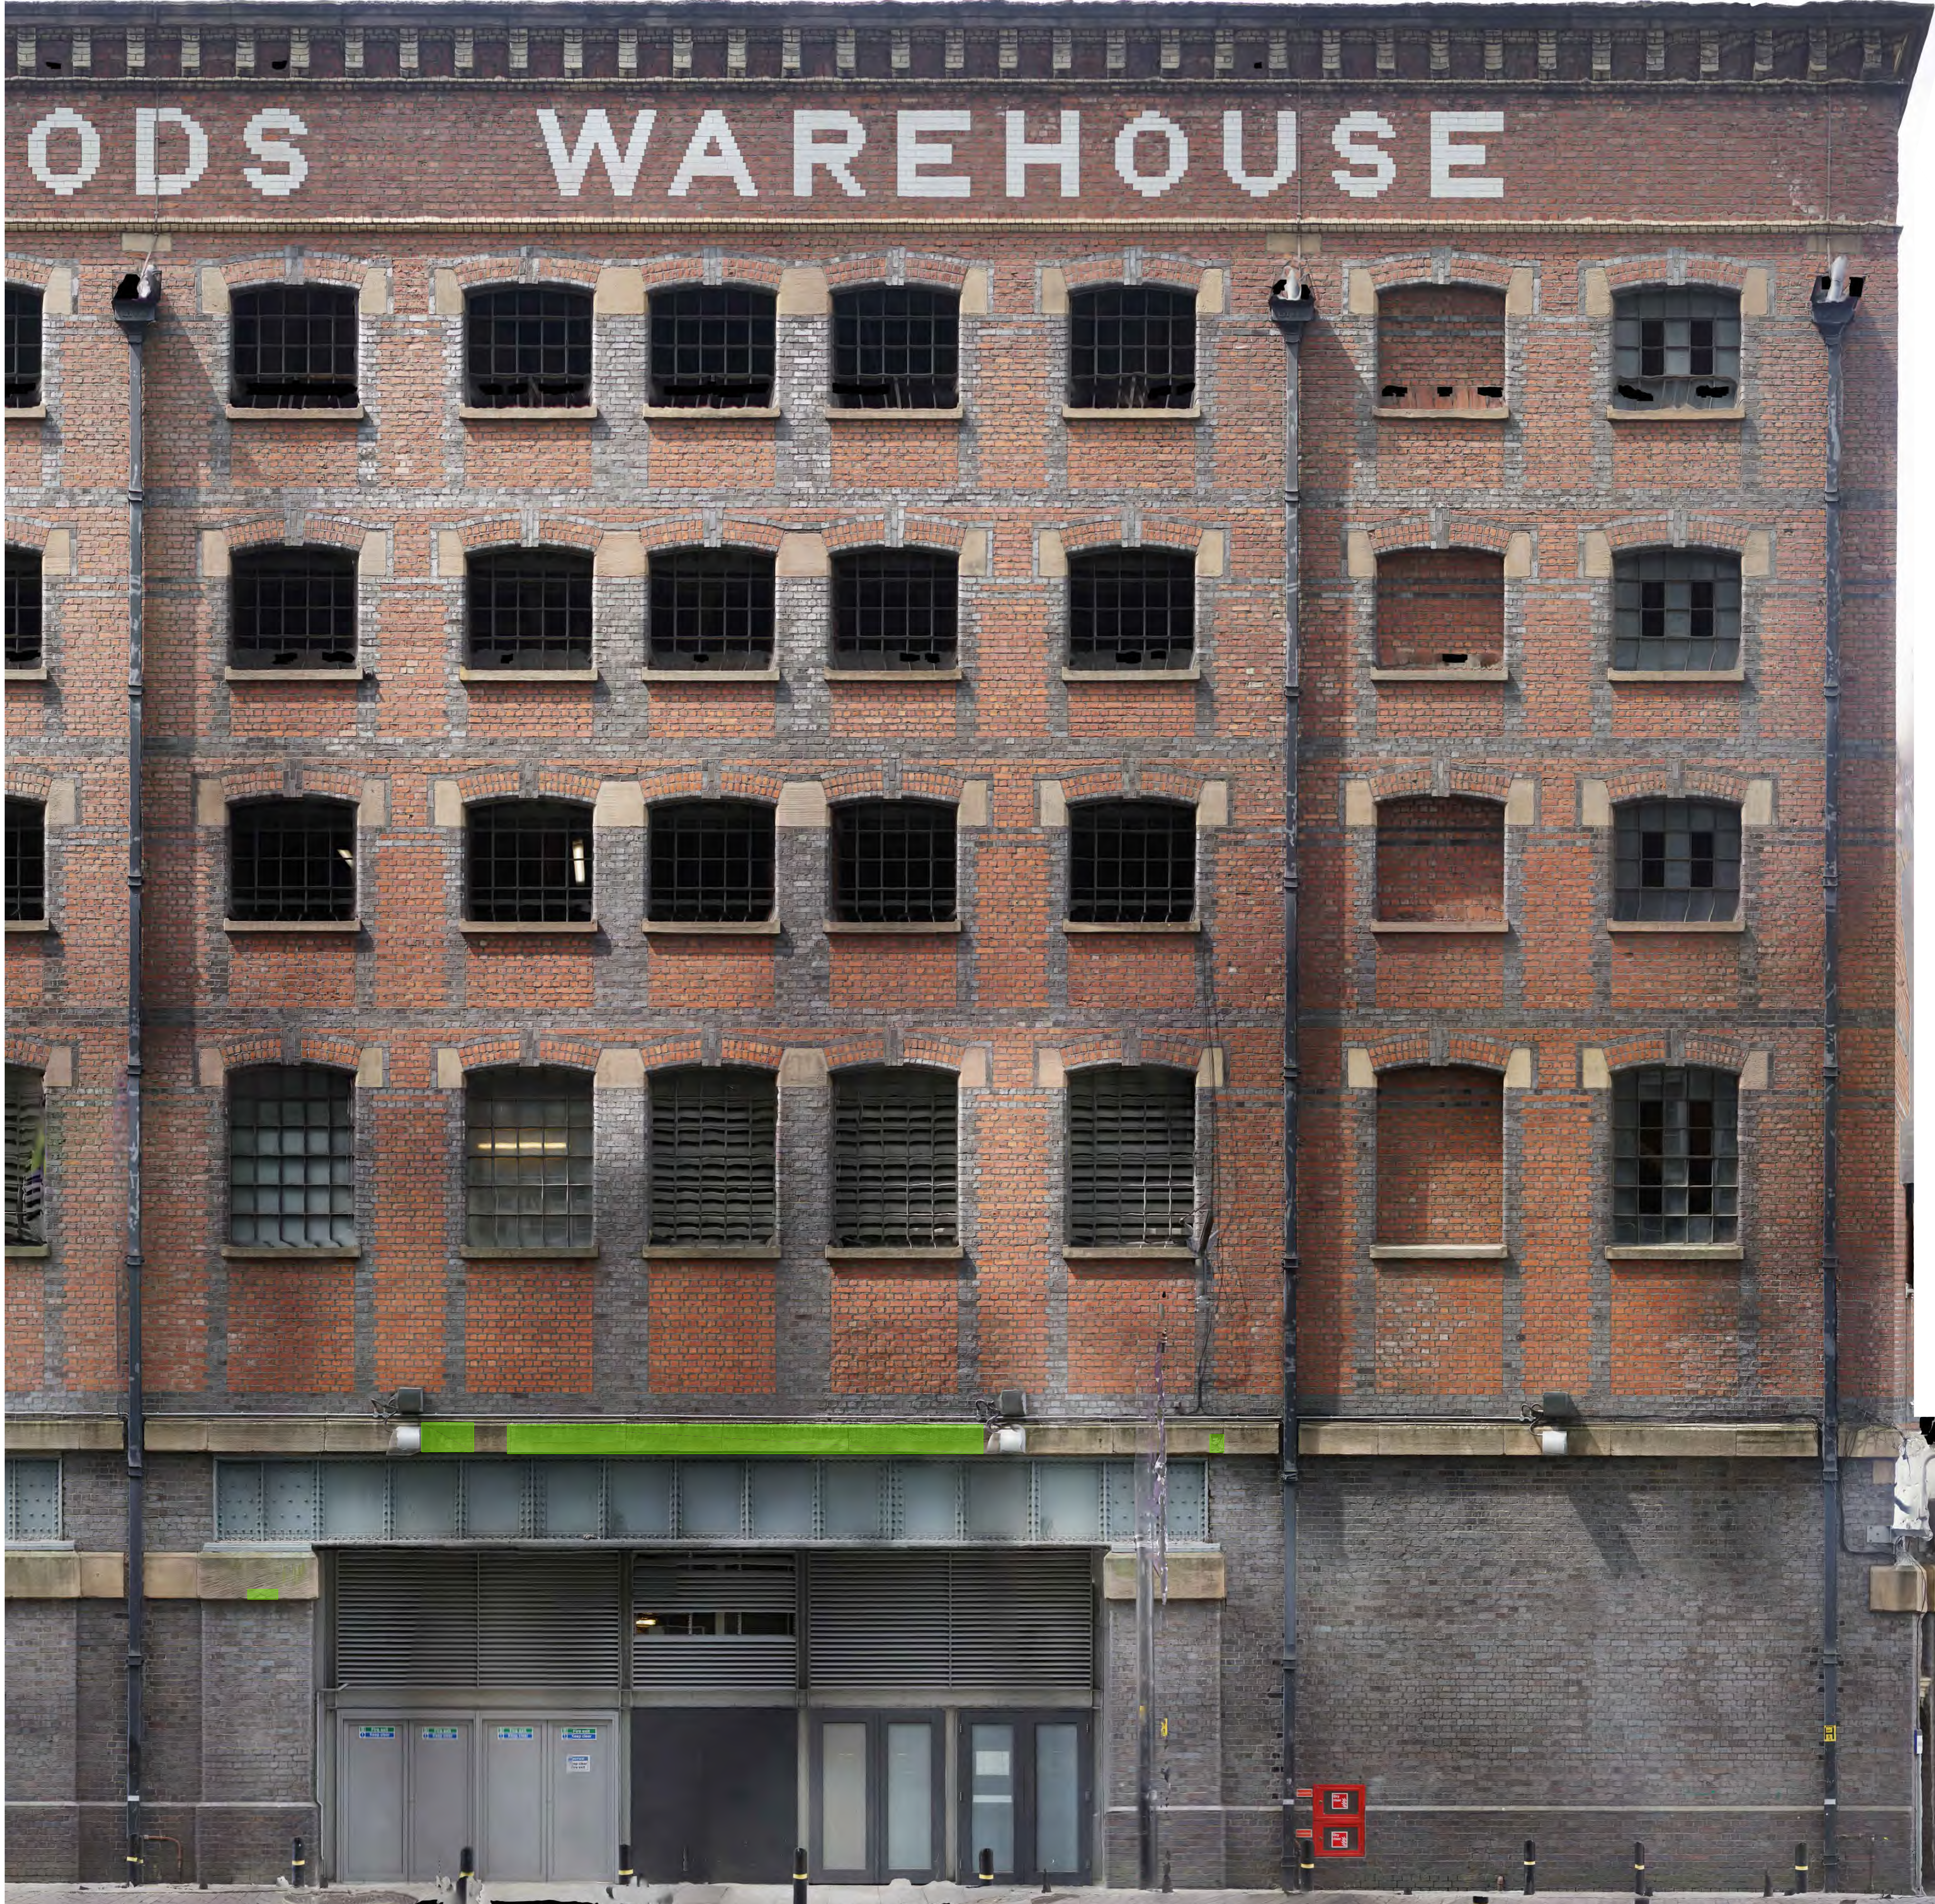
Remove vegetation.  
Rake out all joints of the parapet and cornice.  
Apply biocide.  
Repoint all joints of the cornice and parapet.  
Repoint isolated areas of defective brickwork.

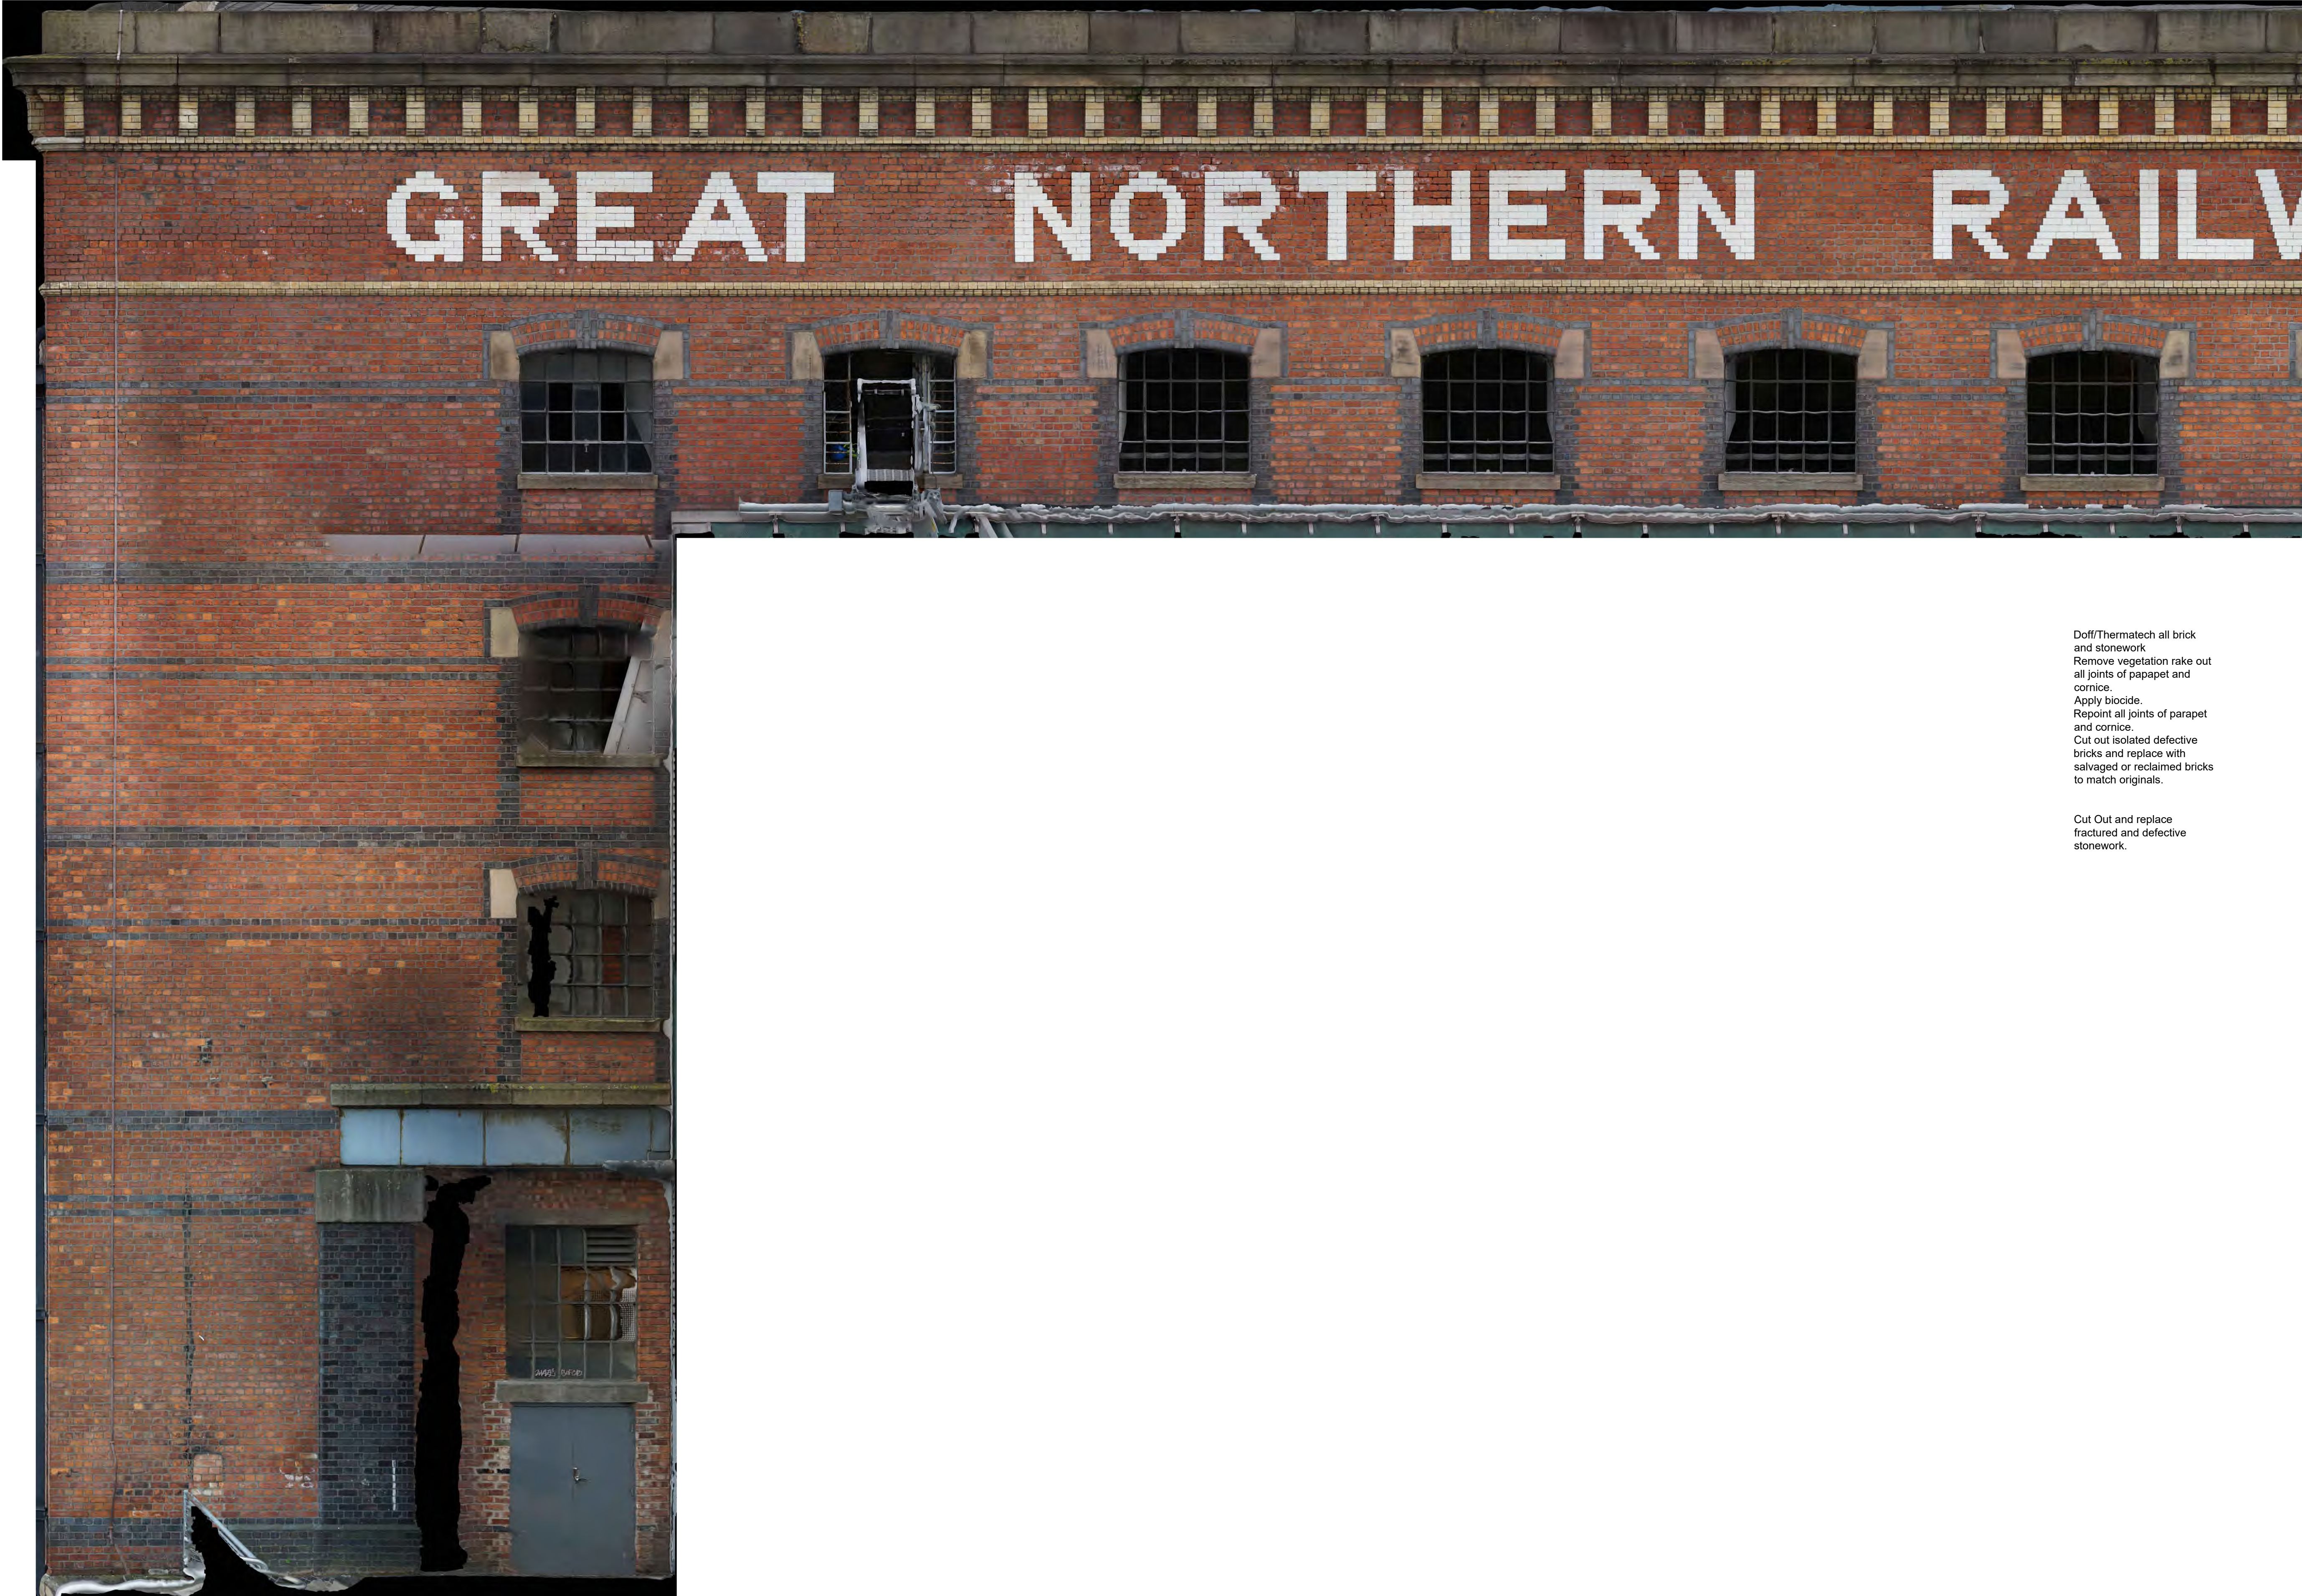
Doff/Thermatech all brick and stonework  
Remove vegetation rake out all joints of parapet and cornice.  
Apply biocide.  
Repoint all joints of parapet and cornice.  
Cut out isolated defective bricks and replace with salvaged or reclaimed bricks to match originals.

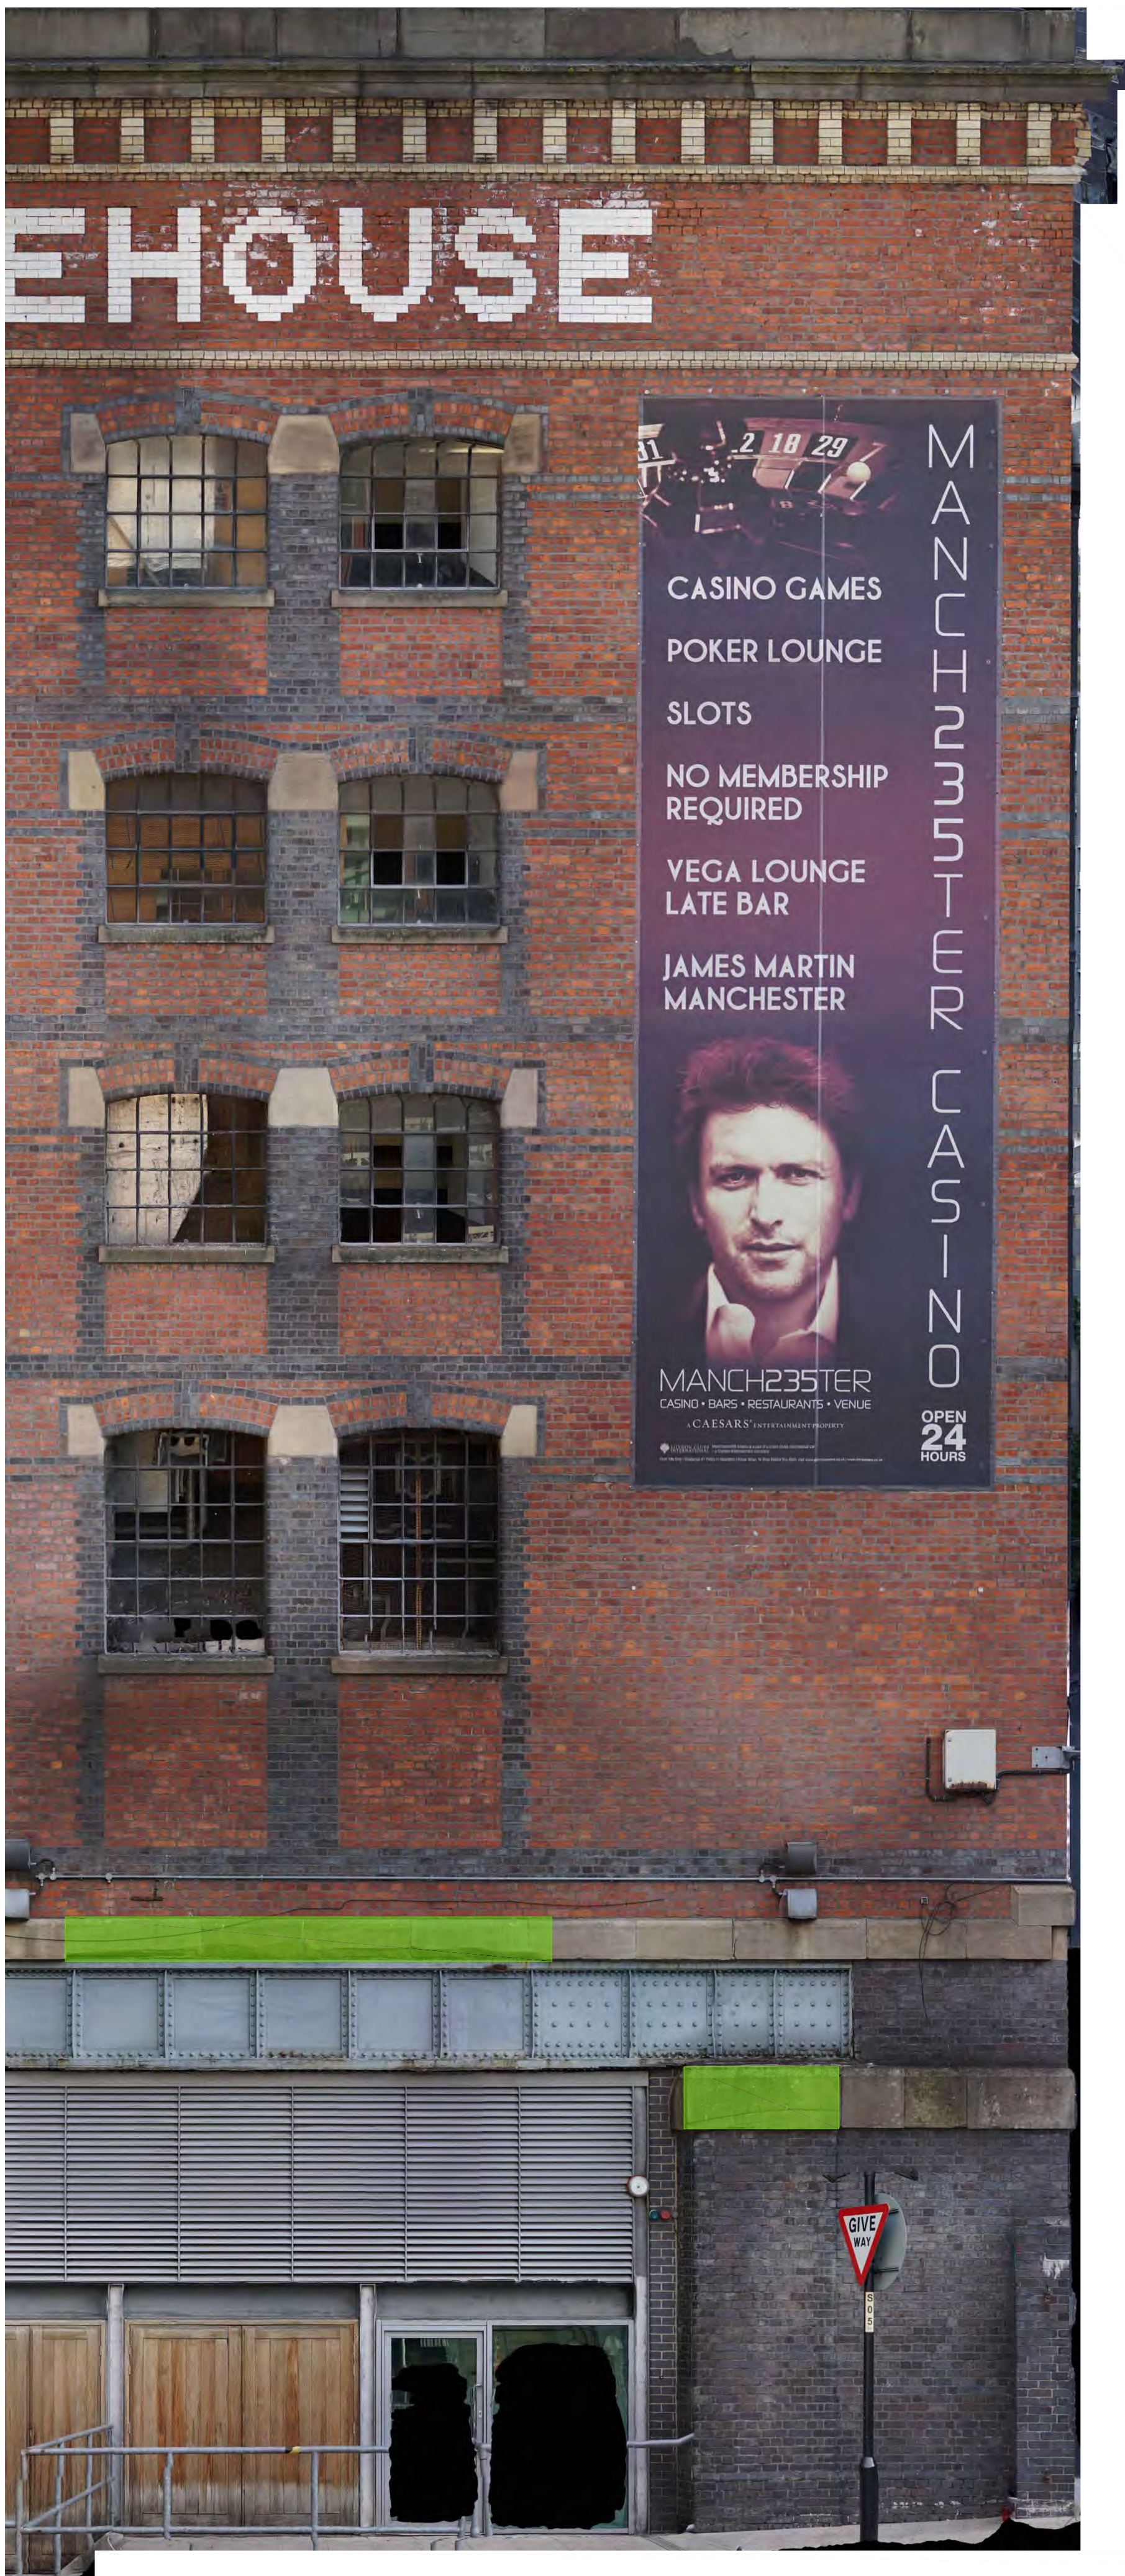
Doff/Thermatech all brick and stonework  
Remove vegetation rake out all joints of parapet and cornice.  
Apply biocide.  
Repoint all joints of parapet and cornice.  
Cut out isolated defective bricks and replace with salvaged or reclaimed bricks to match originals.
