**GENERAL CONDITION SURVEY  
OF  
EXTERNAL MASONRY FAÇADE & WINDOWS  
AT  
37 PETER STREET AND BOOTLE STREET ELEVATIONS  
THE FREE TRADE EXCHANGE (HARVESTER HOUSE)**

**Date – 23<sup>rd</sup> February 2022**

**FREE TRADE EXCHANGE MASONRY AND WINDOW CONDITION SURVEY**

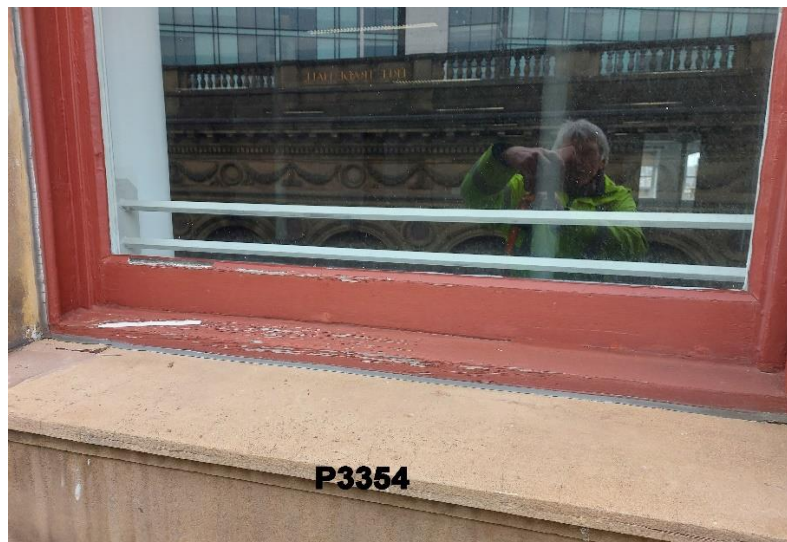
2.1.3

2.1.2 There has been a number of previous insitue mortar repairs in the past , ( sometimes referred to as Plastic Repairs)some of which are starting to fail. This failing is shown in either hairline fracturing, cracks and debonding from the underlying substrate. Cementitious repair mortars trap moisture within the stone and during winter months the moisture freezes causing expansion which causes voids to form between the host material and the surface repair. During warmer periods the frozen moisture thaws and the material begins to either crack or spall. They also generally prevent the natural evaporation of moisture from stone into the atmosphere resulting in accelerated decay of the original stone under the cementitious repair mortar.

2.1.4 A common insitue mortar repair to the façade is the 'sky 'surface (top) of window cills . Most of those noted show signs of failure by having hairline fractures and sounding hollow to a hammer test. See Image P3354.

2.1.5 Consideration needs to be given to removing and possibly not reinstating these repairs where water run off may not be affected. An example of this are the repairs to the vertical faces of some window cills to the rear Bootle Street elevation. All insitue repairs need regular inspection and replacement. Insitue repairs should last over 5 years often 25 years or more. However, many factors affect their life expectancy, ie exposure, quality of host stone and the repair mortar used. Removing unnecessary repairs reduces the requirement for inspection and maintenance. In some cases, the existing stone face can be redressed to as 'sound face', depending on the extent of 'keying applied originally to the repair.

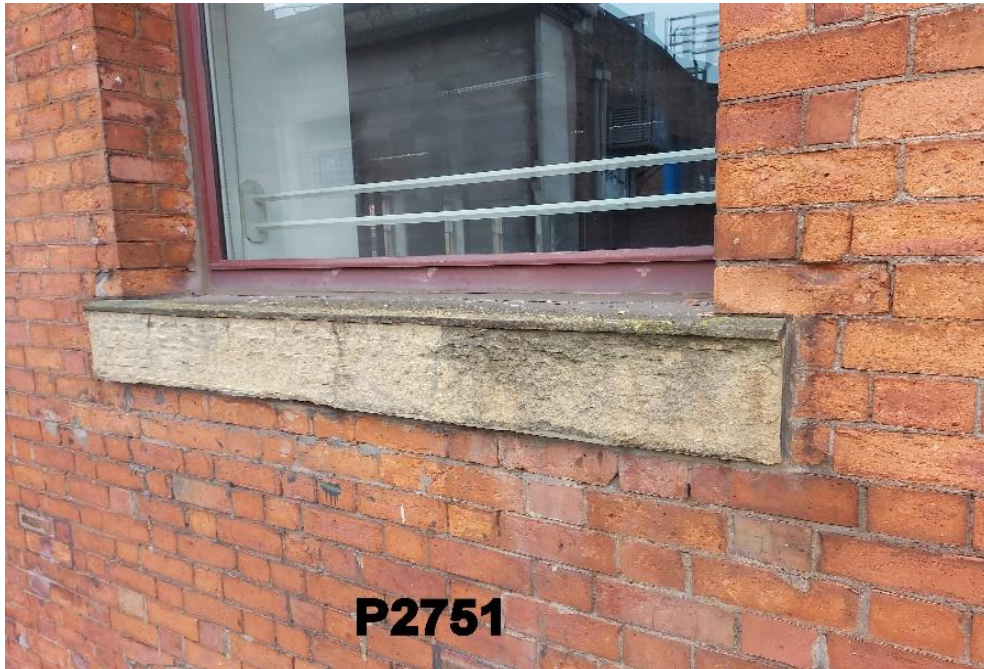
2.1.7

See image P2751 where the previous repair to a face of a cill has failed.

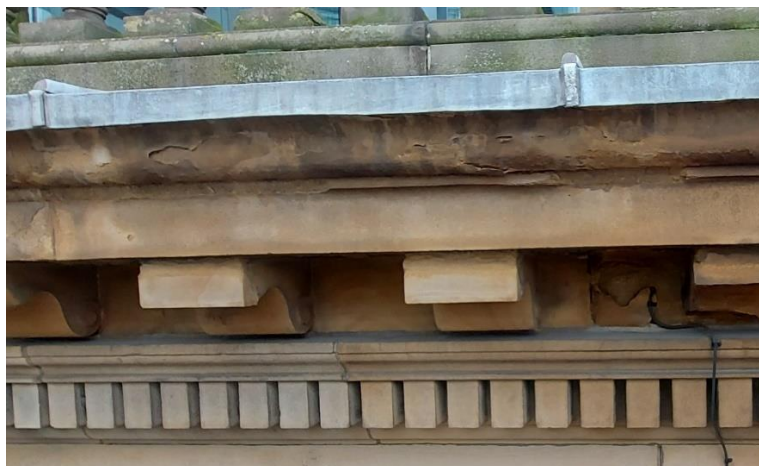
2.1.9

There are many areas where there is light 'delamination' or 'exfoliation' of the surface of the stone. In many cases this is very thin (0.5 to 1.5mm thick) and is viewed as the top surface of the stone peeling away from the substrate. This leaves the exposed surface generally with a rougher texture which has the potential to retain moisture and further accelerate decay. This is more common at upper levels. Where noted loose matter was removed during the survey.

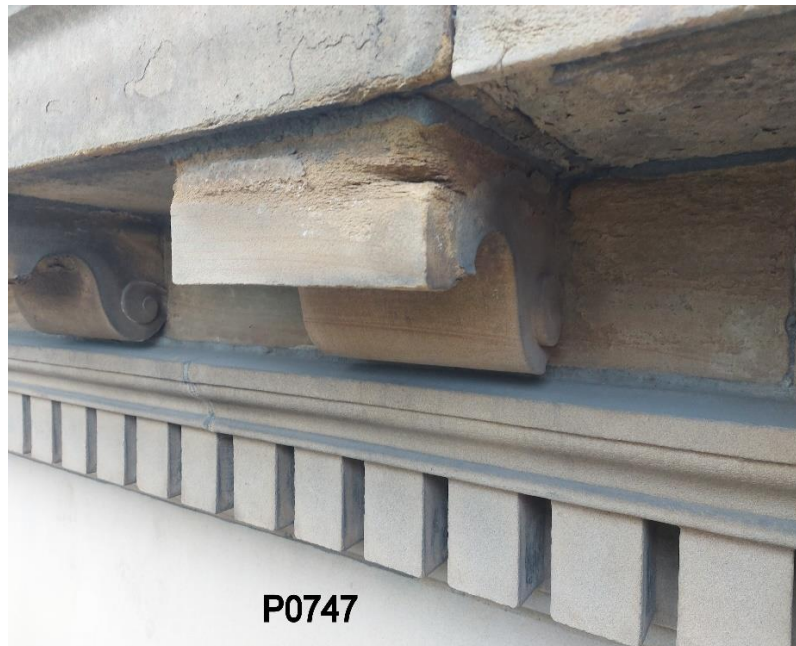
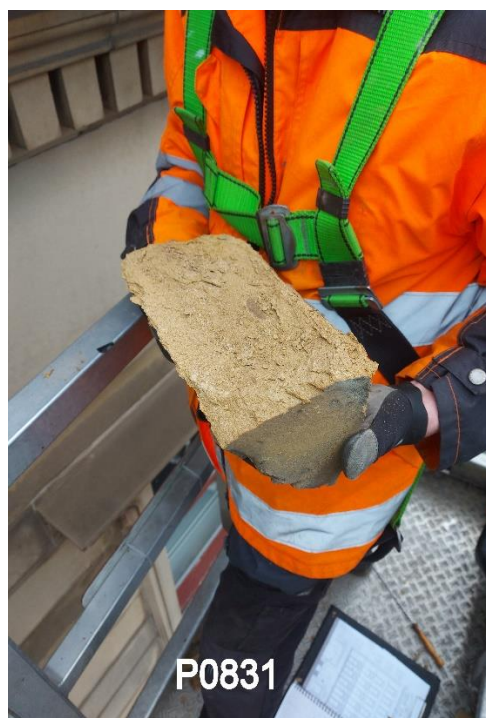
2.1.11

There were a number of areas where masonry sections had become loose. This defect mainly to overhanging details such as drips details, modillions and the underside of string and cornice courses. Natural strata (bed lines) within the stone can weather and become weak, leaving undercut sections to become loose.

- 2.1.12 Where sections were suspected of becoming loose or were sounding hollow to a hammer test these sections were removed for safety purposes. This is an ongoing issue with many sedimentary stones, regular inspections are required on all masonry facades to try and identify such defects before they develop to a point where failure is imminent. See image P0747 and P0831 showing an example of laminating strata and the removed section of a modillion.

- 2.1.13 Discussions need to be undertaken with the client and Conservation Authorities as to what level of repair is undertaken to such defects. There are several such defects where masonry was removed in this survey or previously. One option is to accept the defects as they are with redressing the exposed face assuming water runoff is not affected. Given that most of these items are at locations high on the façade and not highly visual this may be a consideration. Alternatively, dependant on budget, location and size of repair an insitu mortar repair could be considered or indenting a new section of stone may be an alternative option. For the purpose of this report, it has been assumed that the majority of such defects are re dressed to a sound face. Please see individual items in the Schedule of repairs in Appendix 1.

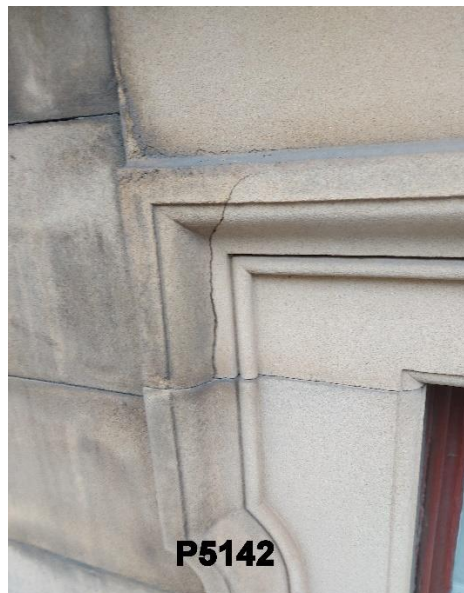
2.1.16

- 2.1.15 There are a number of cracks and natural fissures in the stonework. Many are relatively short and pose no risk of failure, however they should be repointed to prevent moisture ingress and subsequent damage.

- 2.1.17 A small number of fractures are noted that require stitching with stainless steel pin to ensure that sections do not become loose or to ensure structural stability. See image 5142.
- 2.1.18 Ther is a large fracture over the ground floor former entrance which will require stitching. The clients Structural Engineer should be consulted for their comment as to cause and suitability of the proposed stitch repair.

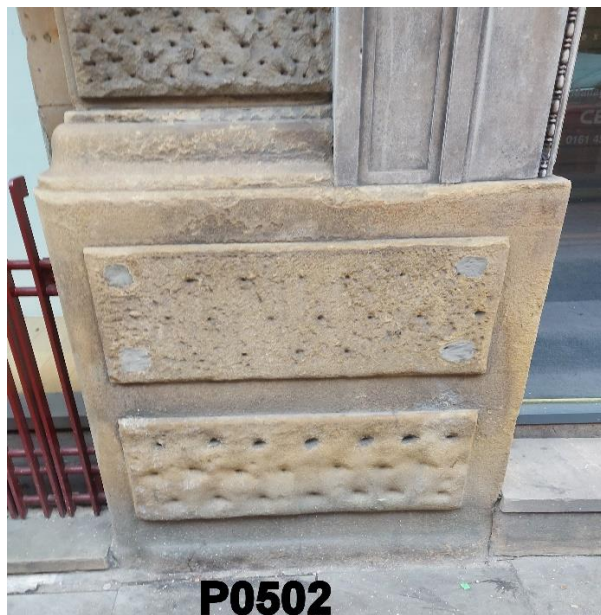
2.1.22

- 2.1.23 A common defect around ground level is surface erosion due to salt attack and excessive moisture. This shows as accelerated loss of detail and surface erosion as noted to the lower section of stone in photo P0502.

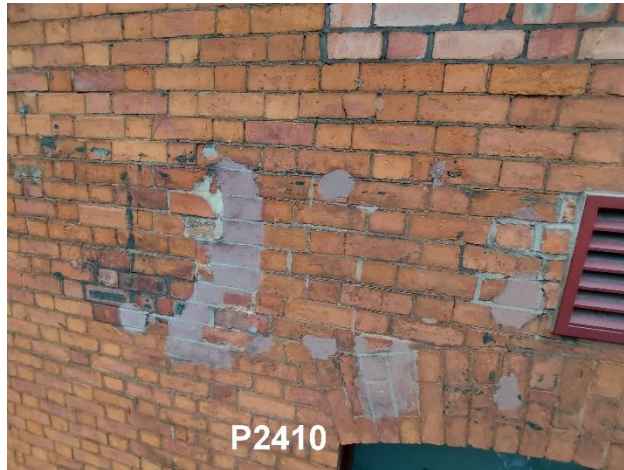
2.1.25

- 2.1.24 The brick areas, ie Bootle Street, the right hand side return elevation to Bootle Street and the left hand return to Peter Street have varying degrees of brick surface failure, ie the surface of the brick crumbling.

- 2.1.26 Many of these areas have previously been repaired in a Red insitue mortar mix to mimic the brick colour, the red dyes used in such repairs are not colour fast and often fade to 'pink' colour which can be visually distracting. See photo P2410. Consideration could be given to replacing such previous repairs on aesthetic grounds.

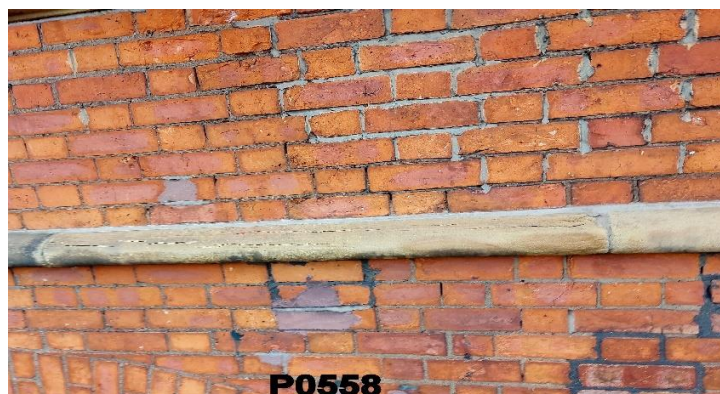
2.1.29

- 2.1.28 Some of these patch pointing areas are in what would appear to be a very hard cementitious mortar with a strong grey colour. This can often result in moisture retention and accelerated decay to the surrounding brick face.

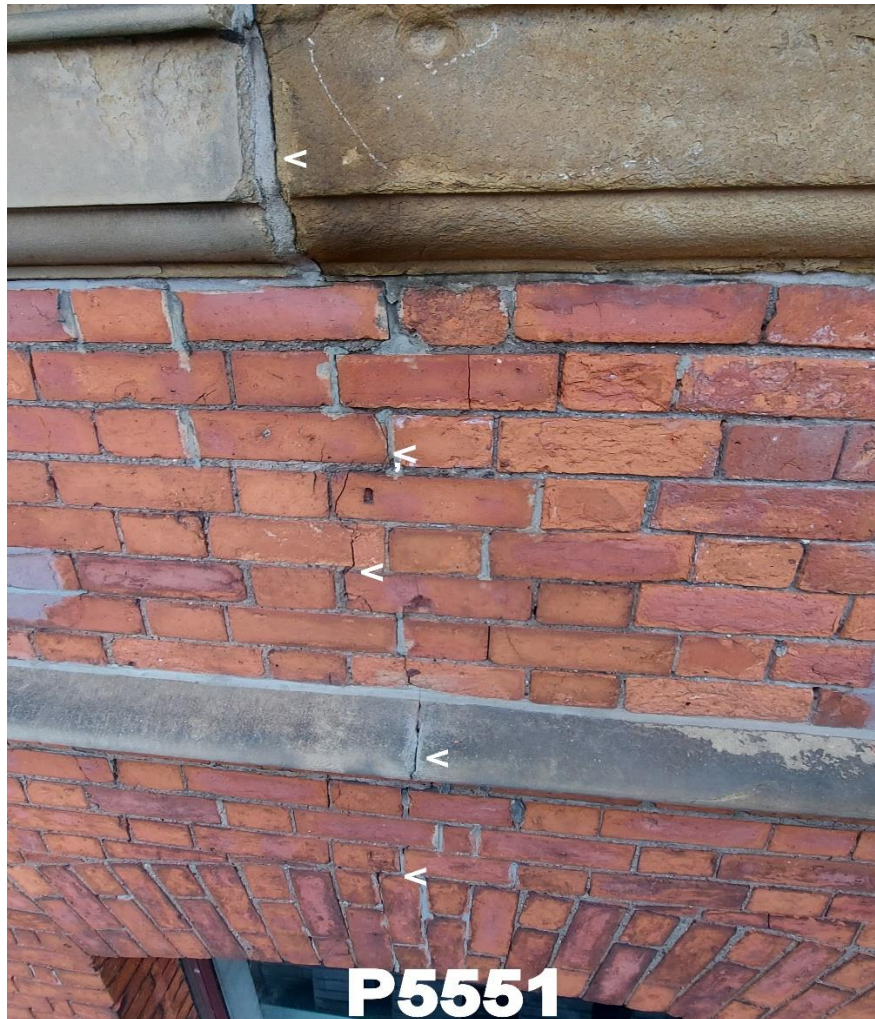
- 2.1.30 There are a number of cracks to brick areas generally running vertically with some extending over 1.5 ml. Whilst not considered of major structural significance the projects structural engineer should be consulted for their view on the cause and potential remedial action. For the purpose of this report these have been considered for cross stitch repair using Helibar and Helifix grout. See Photo P5551.

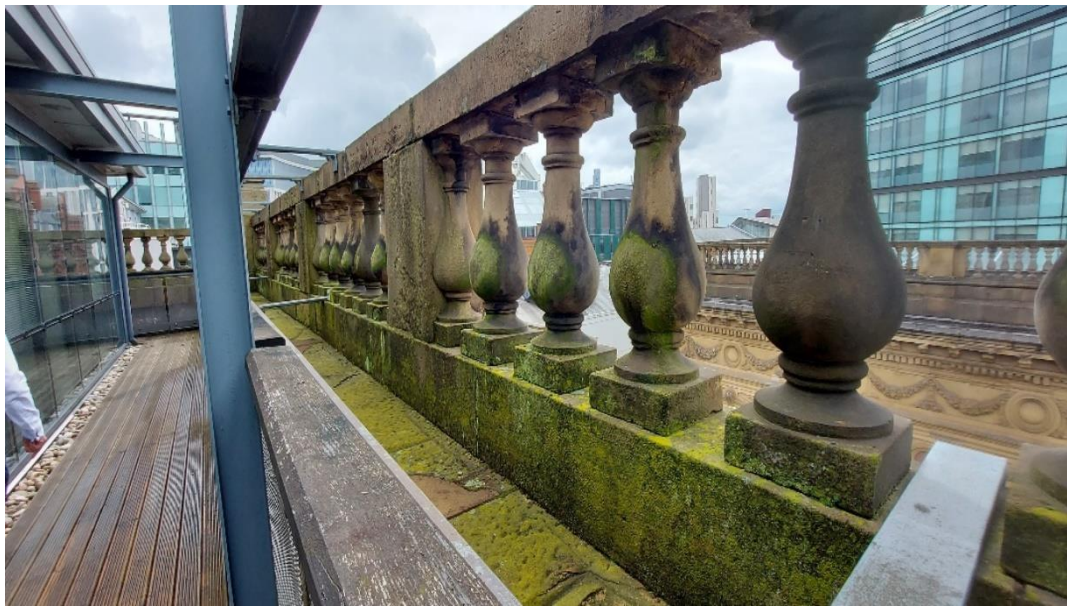
- 2.1.34 There is significant algae growth and moss to joints around parapet level. This will require cleaning off which will expose further open/ defective joints. Algae and moss also retain moisture to the surface and can accelerate some types of surface erosion. Cleaning should be carried out to all areas to remove loose dirt / carbon deposits and further identify any laminations forming which could develop to failure of overhanging details.

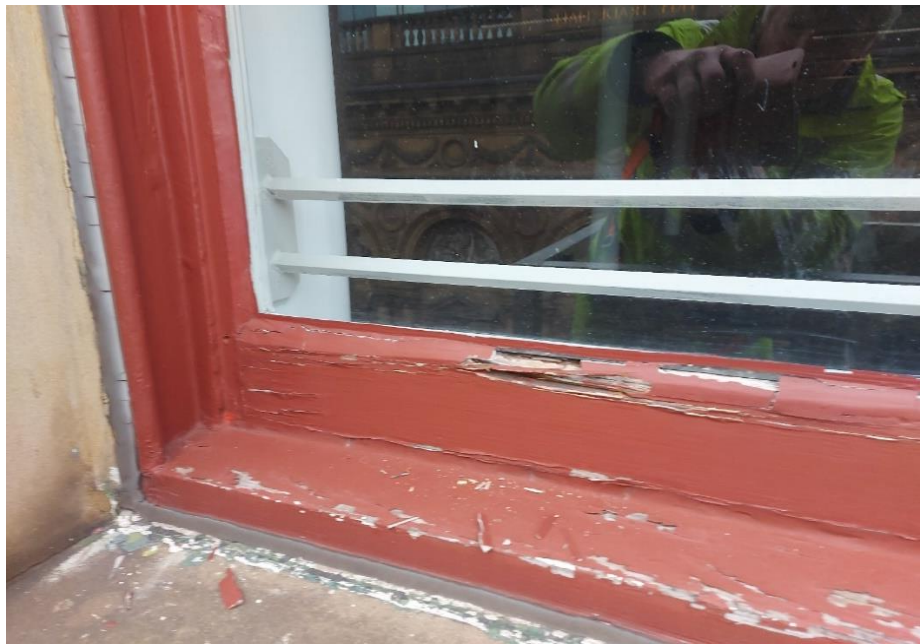
- 2.2.2 The condition of the newer slimmer frames to the Bootle Street elevation is good. The older frames to Peter Street are also in good order but do show a couple of areas of timber decay which will require minor resin repairs and a cill which could be considered for a full cill replacement. See photo P3757 below.
- 2.2.3 There are a few instances to Peter Street where the glazing putty has dried and fallen from the frame. It is however likely that during decoration preparation works further defective areas will become evident.

- 2.2.4
- 2.2.5 The mastic jointing between the timber frames and the masonry has dried out and is extensively shrunken and crazed. See photo P3757. All the frames to the building should be repointed. It is likely that the Conservation Authorities would prefer a Burnt Sand mastic mortar in lieu of a gun applied mastic.
- 2.2.6 The decoration to the windows of Peter Street is starting to show splitting and peeling to cills and horizontal members. The same is for the windows to Bootle Street but to a lesser extent. A full redecoration is now urgently required before timber conditions start to decay.
- 2.2.7 Internally the windows have been recently redecorated, all existing fittings have been removed, weights and ropes have been removed and the windows sealed. It is therefore assumed that repairs to frames are purely for maintaining the fabric and appearance of the frames.
