# Demolition Asbestos Survey Report

The Grove Public House, 1515 Ashton Old Rd, Openshaw, Manchester, M11 1GR.

| <b>Survey Type:</b> | Demolition Asbestos Survey. | |
| <b>Job Reference:</b> | JPR/AR/3438. | |

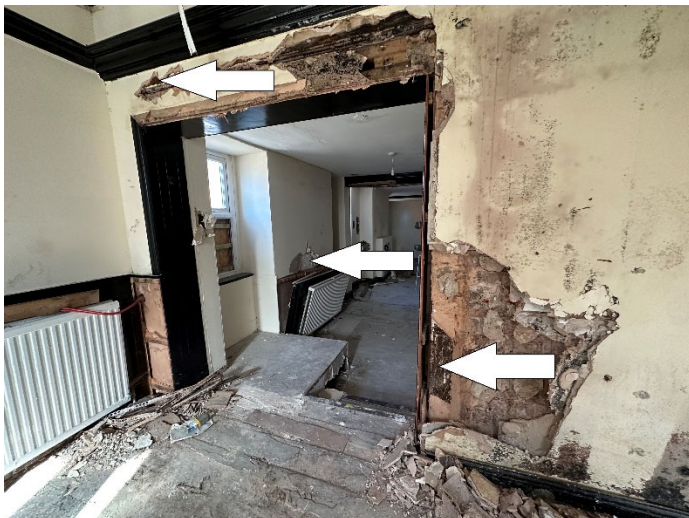
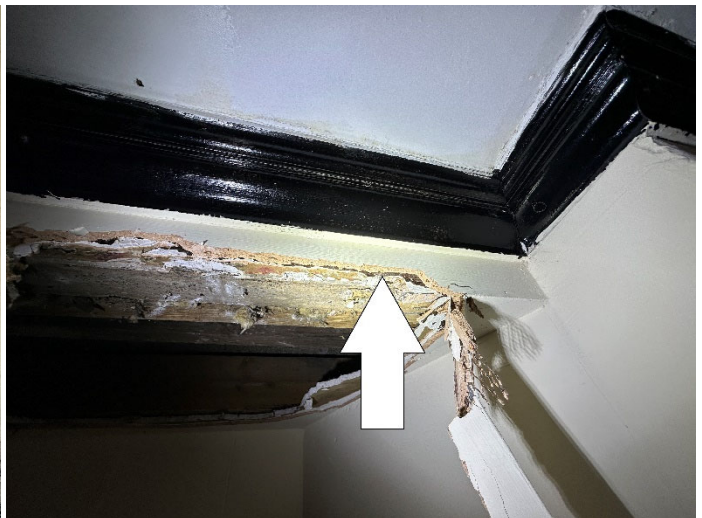
| <b>Sample Number:</b> | <b>Sample GP/01 and GR/02</b> | | |

**Sample GP/01 and GR/02:** Asbestos textured coating to specific sections of walls and opening headers/surrounds (behind plaster and or plasterboard), seen to x4 locations. The textured finish is an original coating which has been concealed by overlying plaster and plasterboards, making it difficult to identify the full extent. A sample of visually similar coating was also found negative for asbestos content. The coating was seen to x4 locations (refer to diagram), further occurrences may be exposed during soft strip works. It is known that the demolition and soft strip are being undertaken by a demolition contractor with an asbestos license. The contractor should undertake soft strip works with caution disposing of any original textured coating, as asbestos waste. Due to building dilapidation, some areas where the coatings are present are in poor condition.

Chrysotile (white) asbestos

Medium condition

Full extent unknown, will become apparent during soft strip works – Approx 5 Sqm seen

Remove prior to, or in conjunction with demolition. All works with asbestos must be undertaken in accordance with the Control of Asbestos Regulations 2012 and it's supporting approved code of practice and guidance.

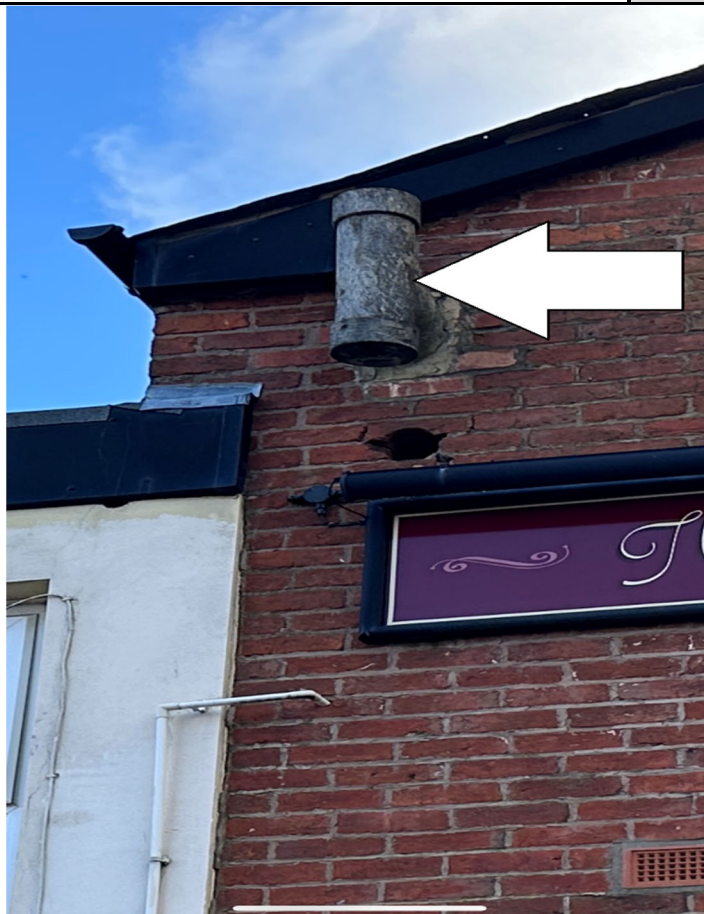
| <b>Sample Number:</b> | <b>Known Asbestos/01 (Surveyor Confirmed)</b> | | |

**Known Asbestos/01 (Surveyor Confirmed):** Asbestos cement flue pipe. The Flue pipe is visible from within the first-floor bedroom and externally

Chrysotile (white) asbestos

Good condition

X1 Cement flue pipe

Remove prior to, or in conjunction with demolition. All works with asbestos must be undertaken in accordance with the Control of Asbestos Regulations 2012 and it's supporting approved code of practice and guidance.

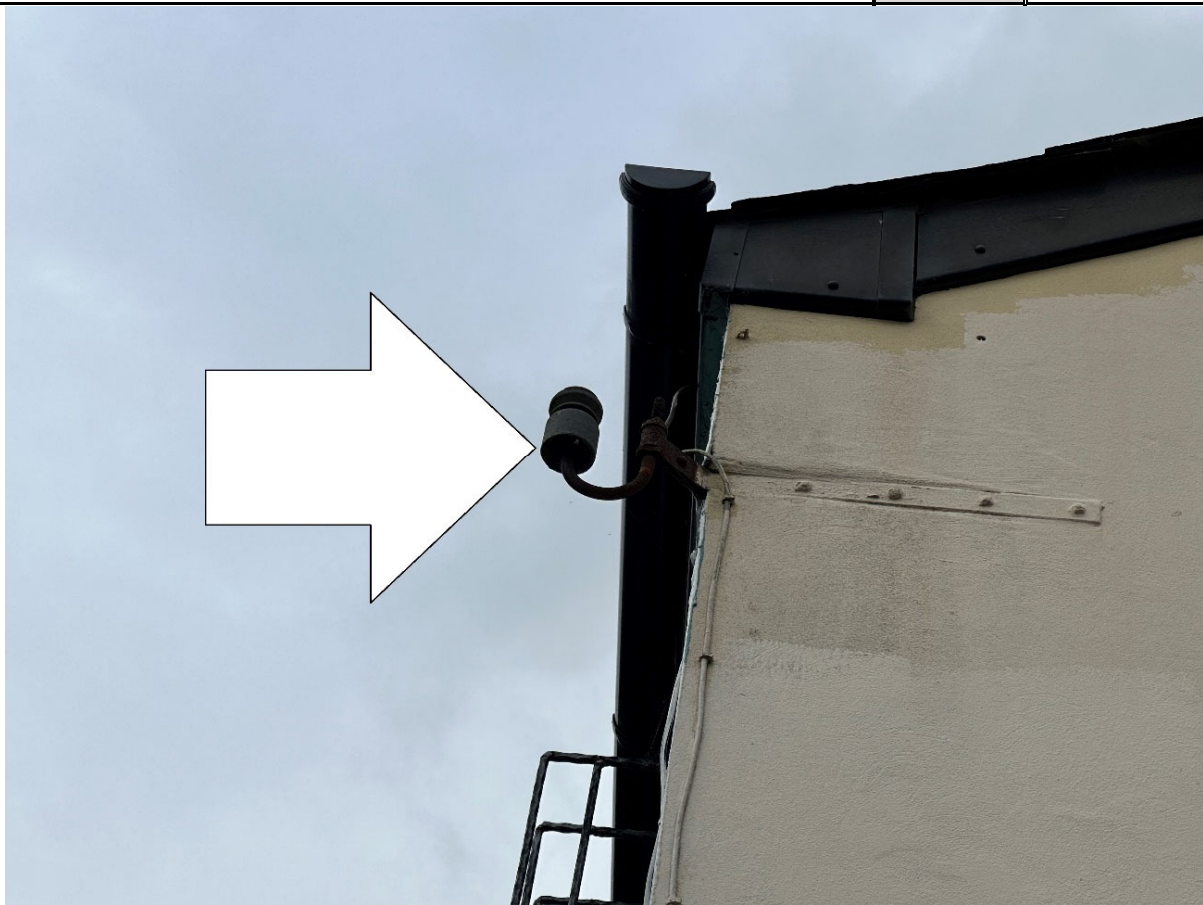
| <b>Sample Number:</b> | <b>Known Asbestos/02 (Surveyor Confirmed)</b> | | |

| <b>Product/Material Description:</b><br><b>Known Asbestos/02 (Surveyor Confirmed): Asbestos containing telephone connector.</b> | <b>Asbestos Type</b> | Amosite (brown) asbestos |
| | <b>Condition</b> | Good condition |
| | <b>Approximate Quantity</b> | X1 Telephone connector |

| <b>Recommendations/Comments:</b> | Remove prior to, or in conjunction with demolition. All works with asbestos must be undertaken in accordance with the Control of Asbestos Regulations 2012 and it's supporting approved code of practice and guidance. |
