**TECHNICAL REPORT ON A SUBSIDENCE CLAIM**

**Crawford Reference: SU2001722**

**Kingform Limited  
28 College Road  
Whalley Range  
Manchester  
M16 8FH**

**SUBSIDENCE CLAIM**

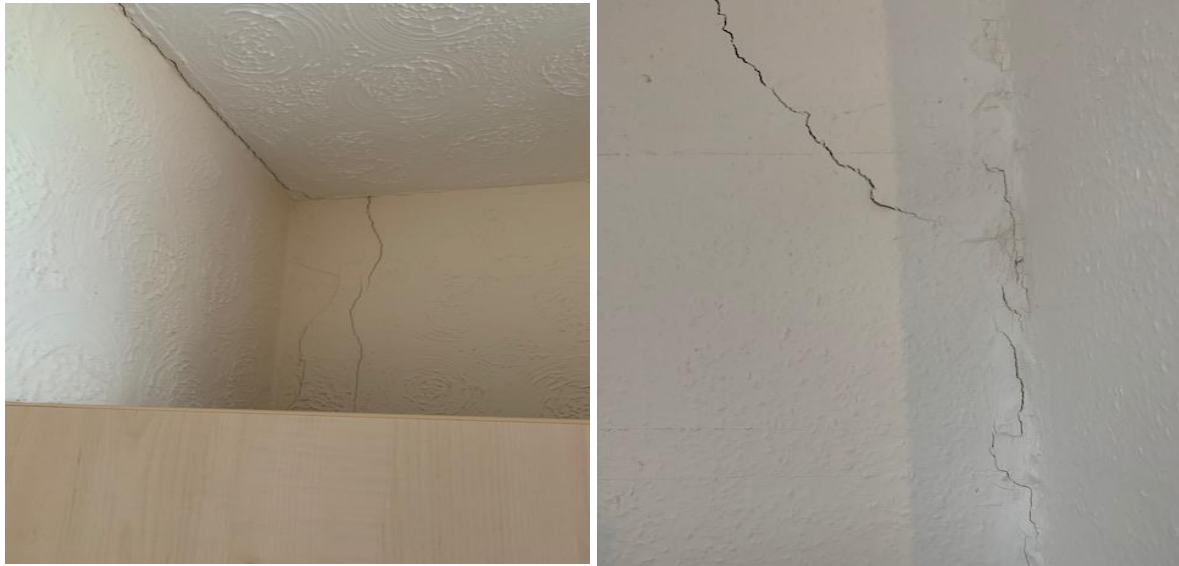
**INTERNAL**

**Flat 1- Lounge**

- 2mm wide diagonal crack damage to the chimney breast.
- Hairline cracking to the ceiling angles.
- The floor slopes into the front by 16mm out of level.

**Flat 1 - Kitchen**

- 0.5mm wide diagonal crack damage to the right hand wall.
- 2mm wide diagonal crack damage to the left hand wall.
- Horizontal separation to the front ceiling angle.
- The floor slopes 9mm to the rear.
- The rear hall door head slopes into the rear by 21mm out of level.
- Diagonal crack damage above the door head, which extends along the ceiling junction.

**Basement**

- The front wall had evidence of bulging up to 40mm out of vertical alignment.
- There was evidence of water pooling adjacent the rear door.

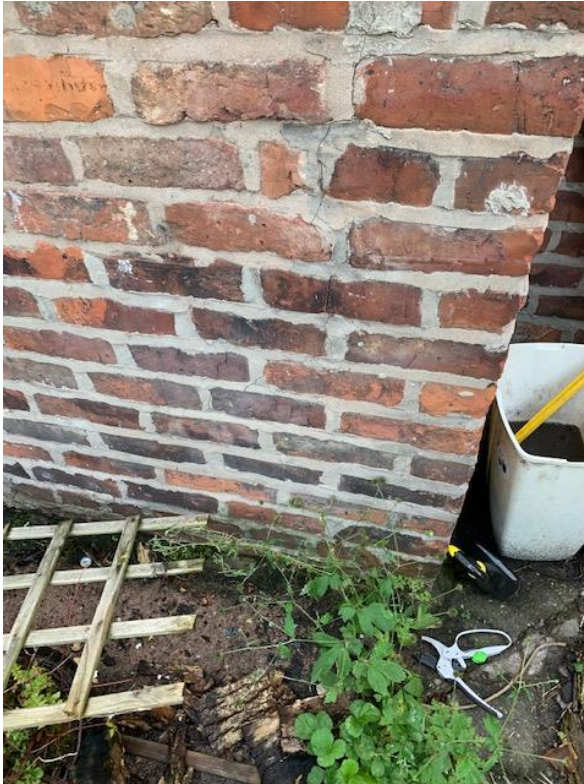
**EXTERNAL**

**Cellar Steps**

- 15mm separation between the steps and the rear wall

**Boundary Wall**

- 20mm wide separation between the boundary wall and rear elevation of the main property.

**Front Elevation**

- Longstanding distortions to the bay, which orientate towards the left side.
- Longstanding distortions to the brickwork above the bay together with approximately 3mm wide diagonal stepped cracking.
- Evidence of a failure to the arch over the first floor bedroom window.
- Minor cracking to the render below the roof line.
- Evidence of sagging to the centre of the roof.
- Deteriorated pointing to the brickwork of the bay at ground level.
- Longstanding shear cracking to the concrete hardstanding path.
- 0.5mm wide diagonal crack damage above the front door.
