**Whitworth Park Mansions, Moss Lane East, Manchester**  
**Appendices: Heritage Condition Survey and Schedule of Works**

**Jerry Spencer Associates**  
Regeneration and Urban Design

**Appendix B**  
**Summary of overall condition**

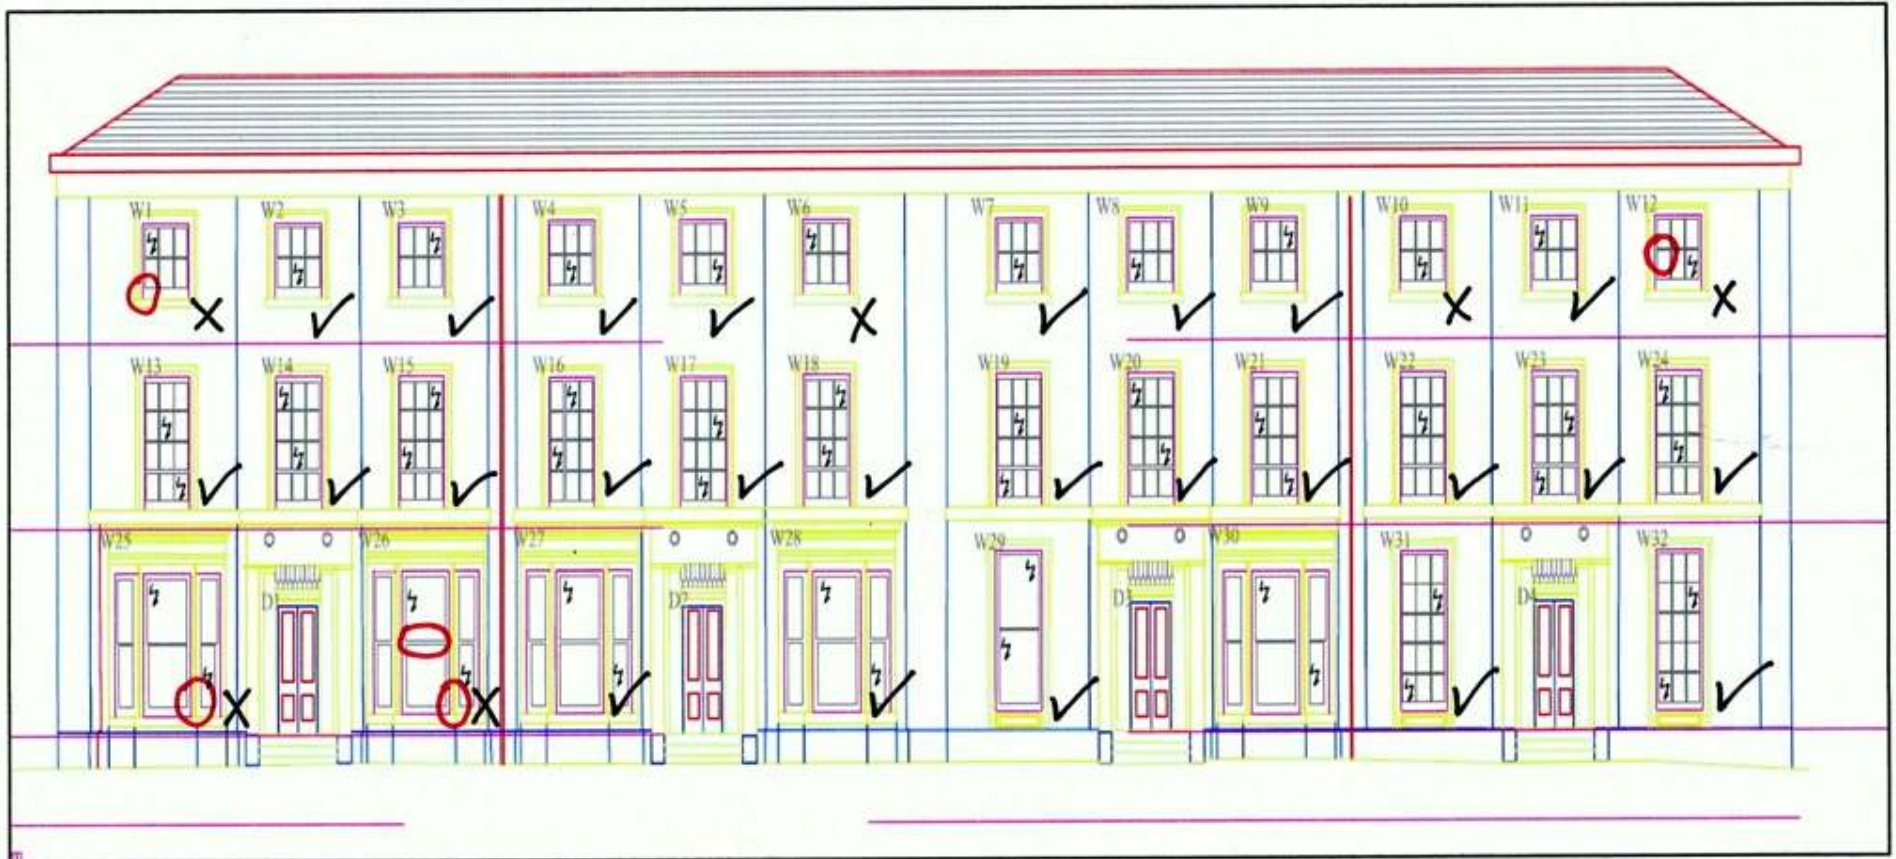
Elevation Plan (front) of Positive and negative windows & doors.

Areas highlighted in red are areas for repair and these include rot to window mullions and cills.

The positive windows contribute to the overall character and a comprehensive programme of repair (in part) should be commissioned. This should involve the rubbing down of all woodwork, re-priming and paint of choice to finish. In addition to repair as specified above a programme of internal (secondary) double-glazing should be implemented to improve thermal performance of the windows.

Where windows and doors are considered to be negative or inappropriate a programme of replacement should take place comprising of replacement timber sash windows and timber casements. Doors should be timber-paneled doors.

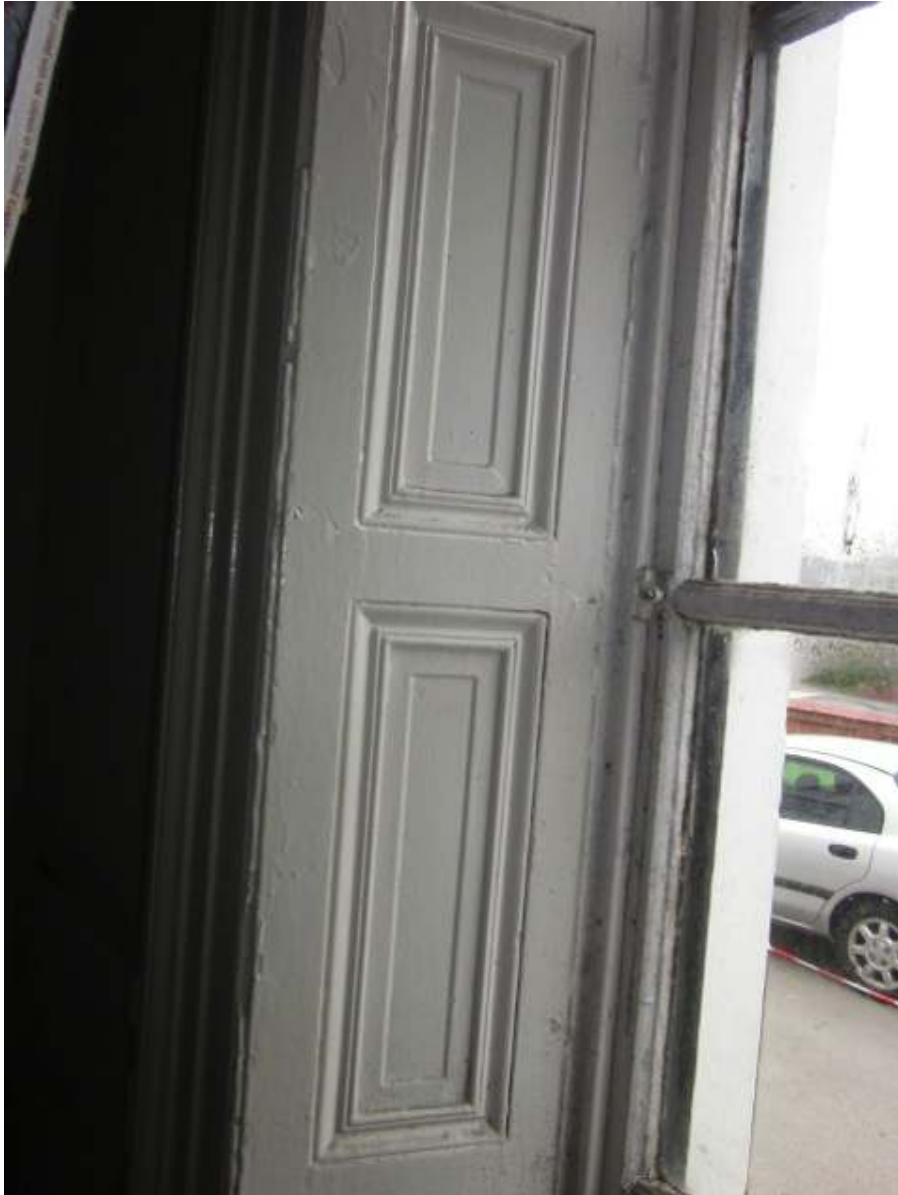
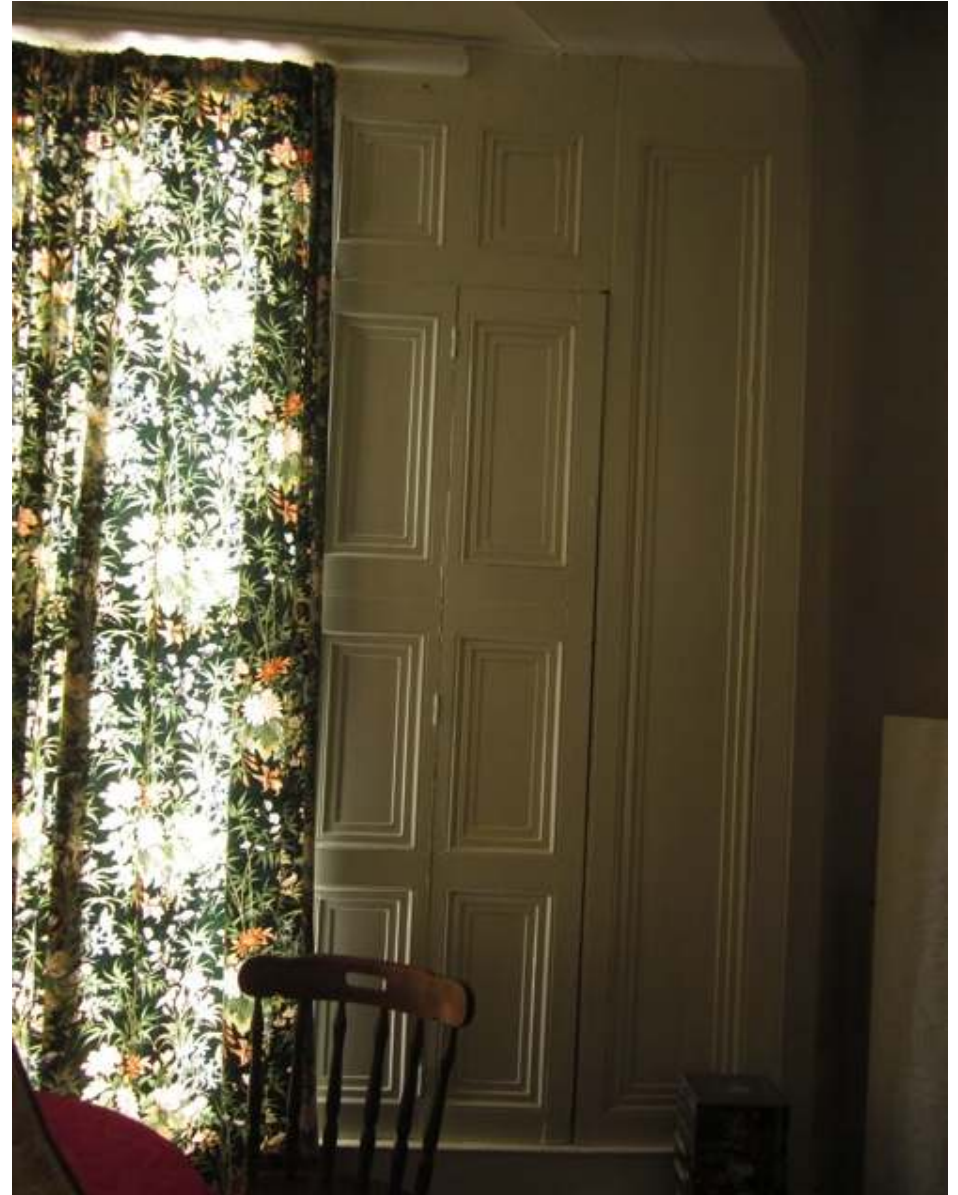
| Flat No | Condition | Timberwork of merit, to include window shutters, picture rails, dado rails, skirtings | Plasterwork of merit | Significant features and/or fittings | Windows of merit |
|---|---|---|---|---|---|
| Flat 1 | Fair | Interesting timberwork and the only apartment with insitu and original window shutters to front ground floor sash windows. | Extensive plasterwork to coving | Original Fireplace | Original timber bay windows with timber sash windows |

Timber Panneling – Window Shutters

| <b>Internal Timberwork</b> , to include skirting boards, dado rails, picture rails, window shutters and doors. | Many of the flats have a number of identified heritage features much of which is decorative timberwork comprising of either or a mix of ornate high skirting boards, Dado rails at waist height and Picture Rails. There are a limited number of good examples and original internal timber shutters to windows. Generally the condition from visual inspection appears to be fair to good. Some areas of timberwork are not present or been removed and ideally a programme of reinstatement should be implemented. | Much of the identified internal timberwork appears to be in good order and little repair or conservation is required. However, where areas are missing as identified on the plans, it may be advisable to introduce new timberwork, which can be reproduced to the same moulding of the original. All timberwork requires remedial treatment and redecoration. | |

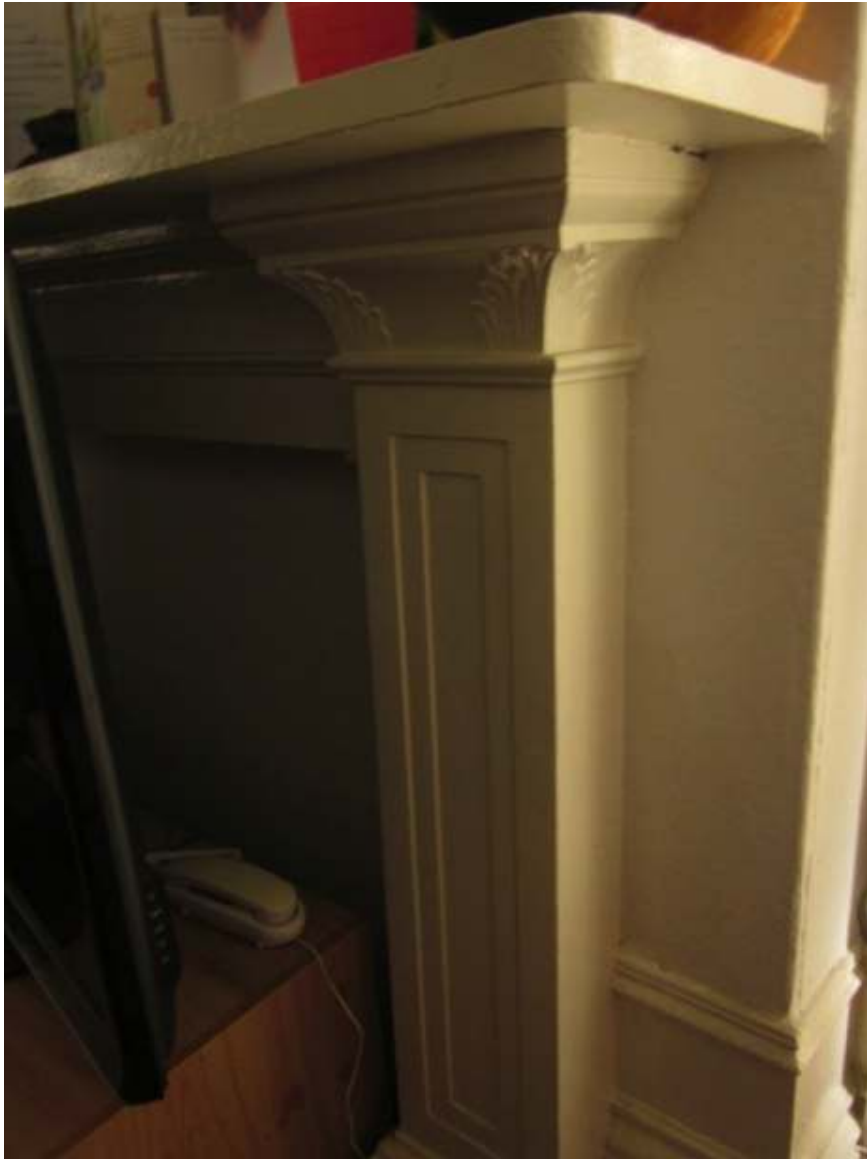
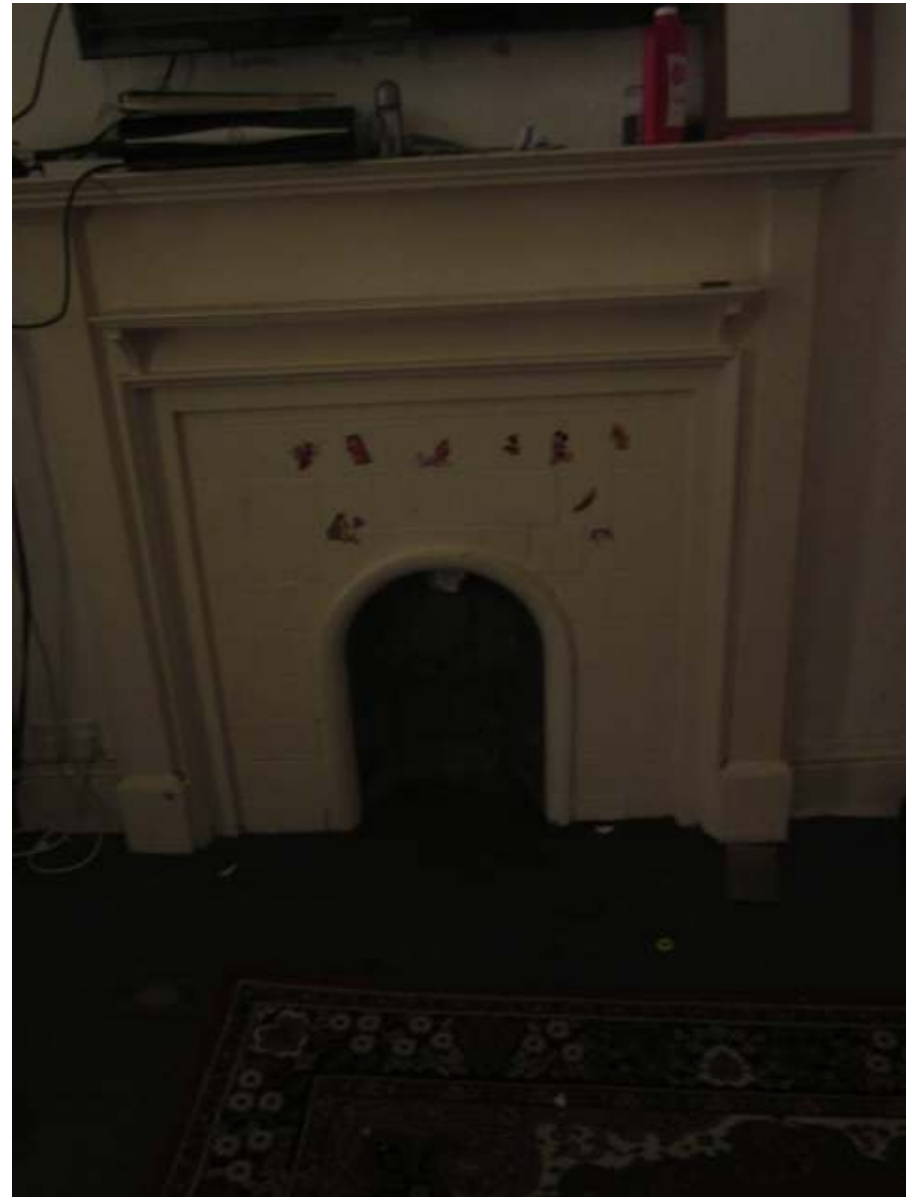
| <b>Fireplaces</b> | Only two original fireplaces were noted to exist in flats No 1 and 3. The fireplaces are large openings with marble insets and painted over mantles. No grates or guards were identified and chimneys were blocked up | Fireplaces form a ventilation duct to a room and if not in use should ideally be fitted with an air vent to which should remain unblocked and ideally be accessible for future cleaning. | |

Identified Fireplaces

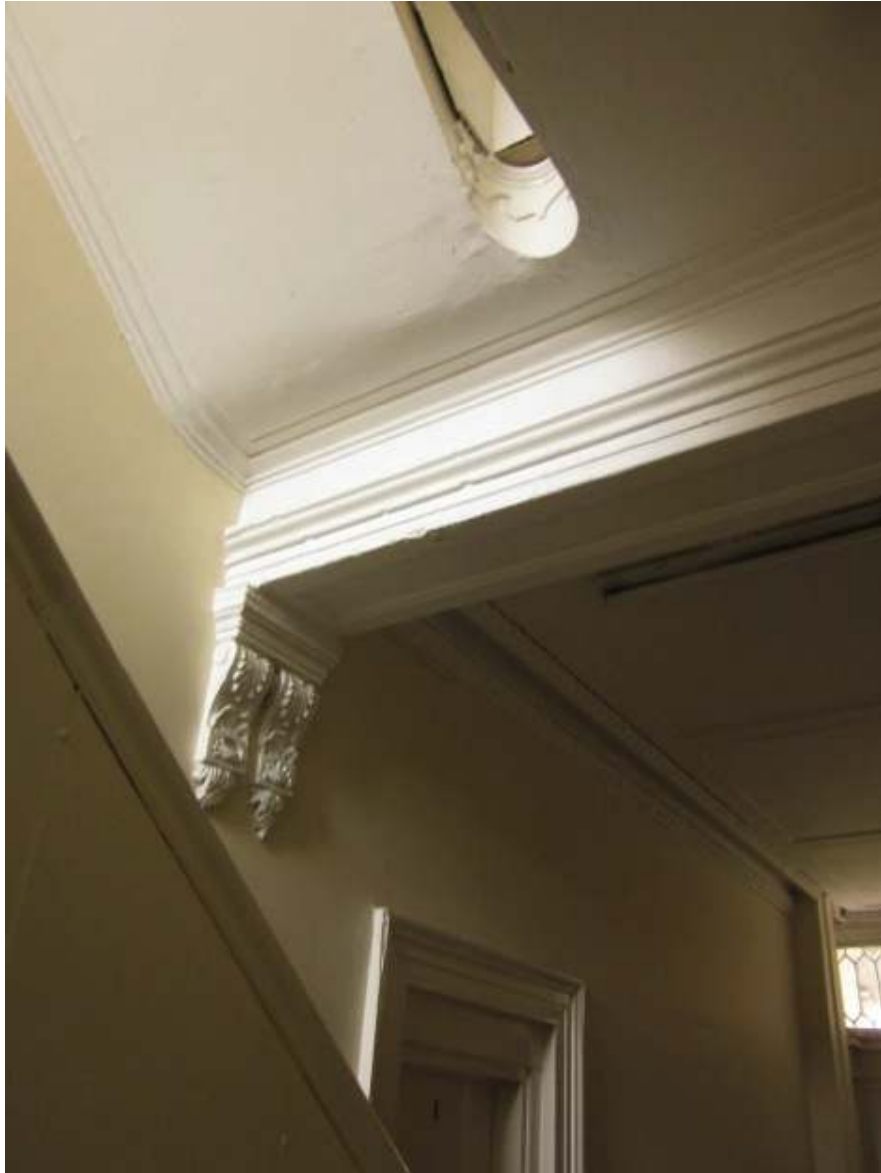
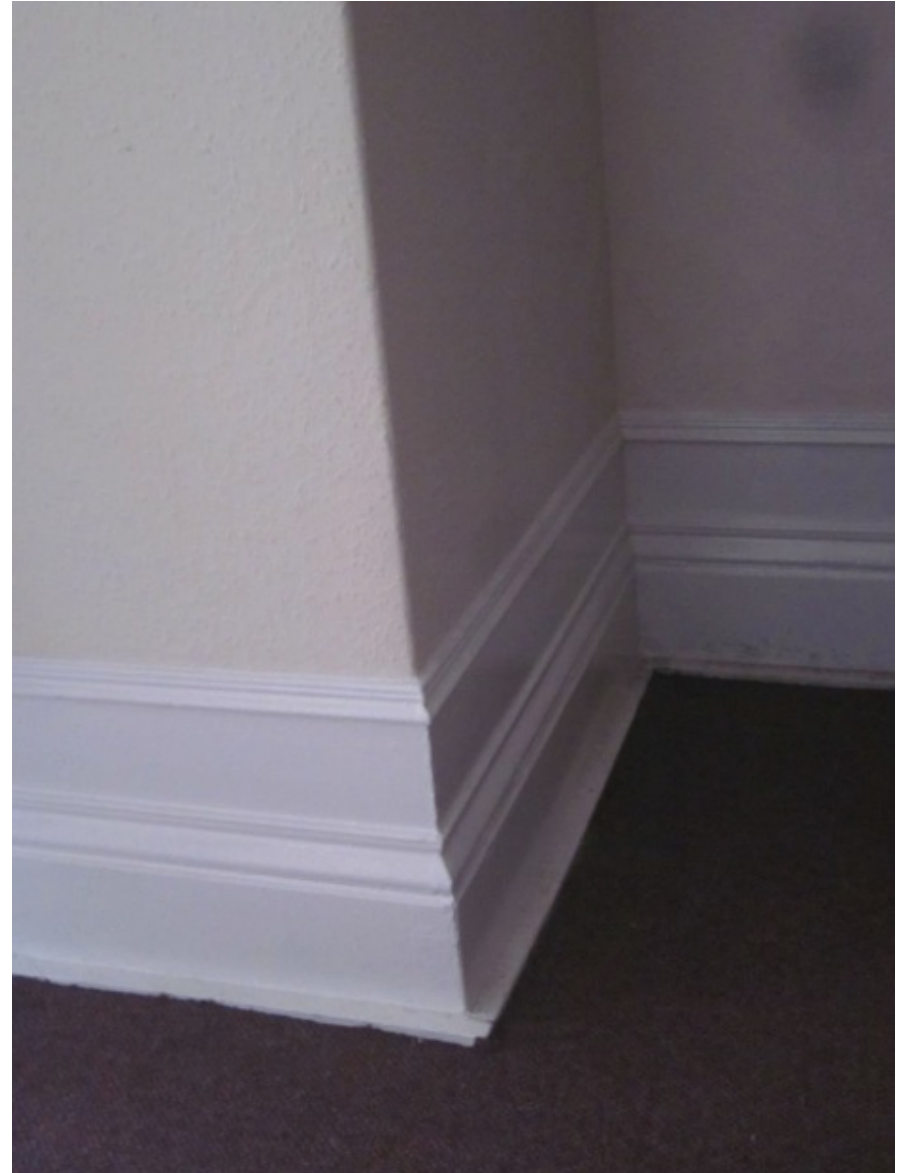
Plaster Cornices & Timber skirting board

| <b>Decorative Plaster work</b> | <p>Cornice Moldings are decorative plaster features used to fill the corners between walls and ceilings. The plaster is often in (pre 1930's) attached to a timber lath beneath the plaster.</p> <p>They are often damaged as a result of a house/building settling over a period of time.</p> <p>Cracks can be repaired with finish plaster or joint compound but missing pieces and/or sections of molding need to be recreated and formed in place and longer pieces made on a bench and fixed in place</p> | <ol style="list-style-type: none"> <li>1. All decorative plasterwork identified should be assessed against movement and deflection.</li> <li>2. Areas identified as loose or cracked should be gently cleaned and prepared for adhesive (joint setting compound) agent added to stiffen the plasterwork.</li> <li>3. Areas identified to be imminent of falling away can be shored up and re-attached to the timber lath. Support the plasterwork drills holes to a depth of the timber lath and fix with screws; fill holes using a jointing compound via a caulk gun.</li> <li>4. Leave for 24 hours to set</li> <li>5. Clean plasterwork and apply paint finish.</li> </ol> <p><b>Reinstatement works to missing plaster</b></p> <ol style="list-style-type: none"> <li>1. This involves the use of a timber mold that is run along existing plaster to</li> </ol> | |

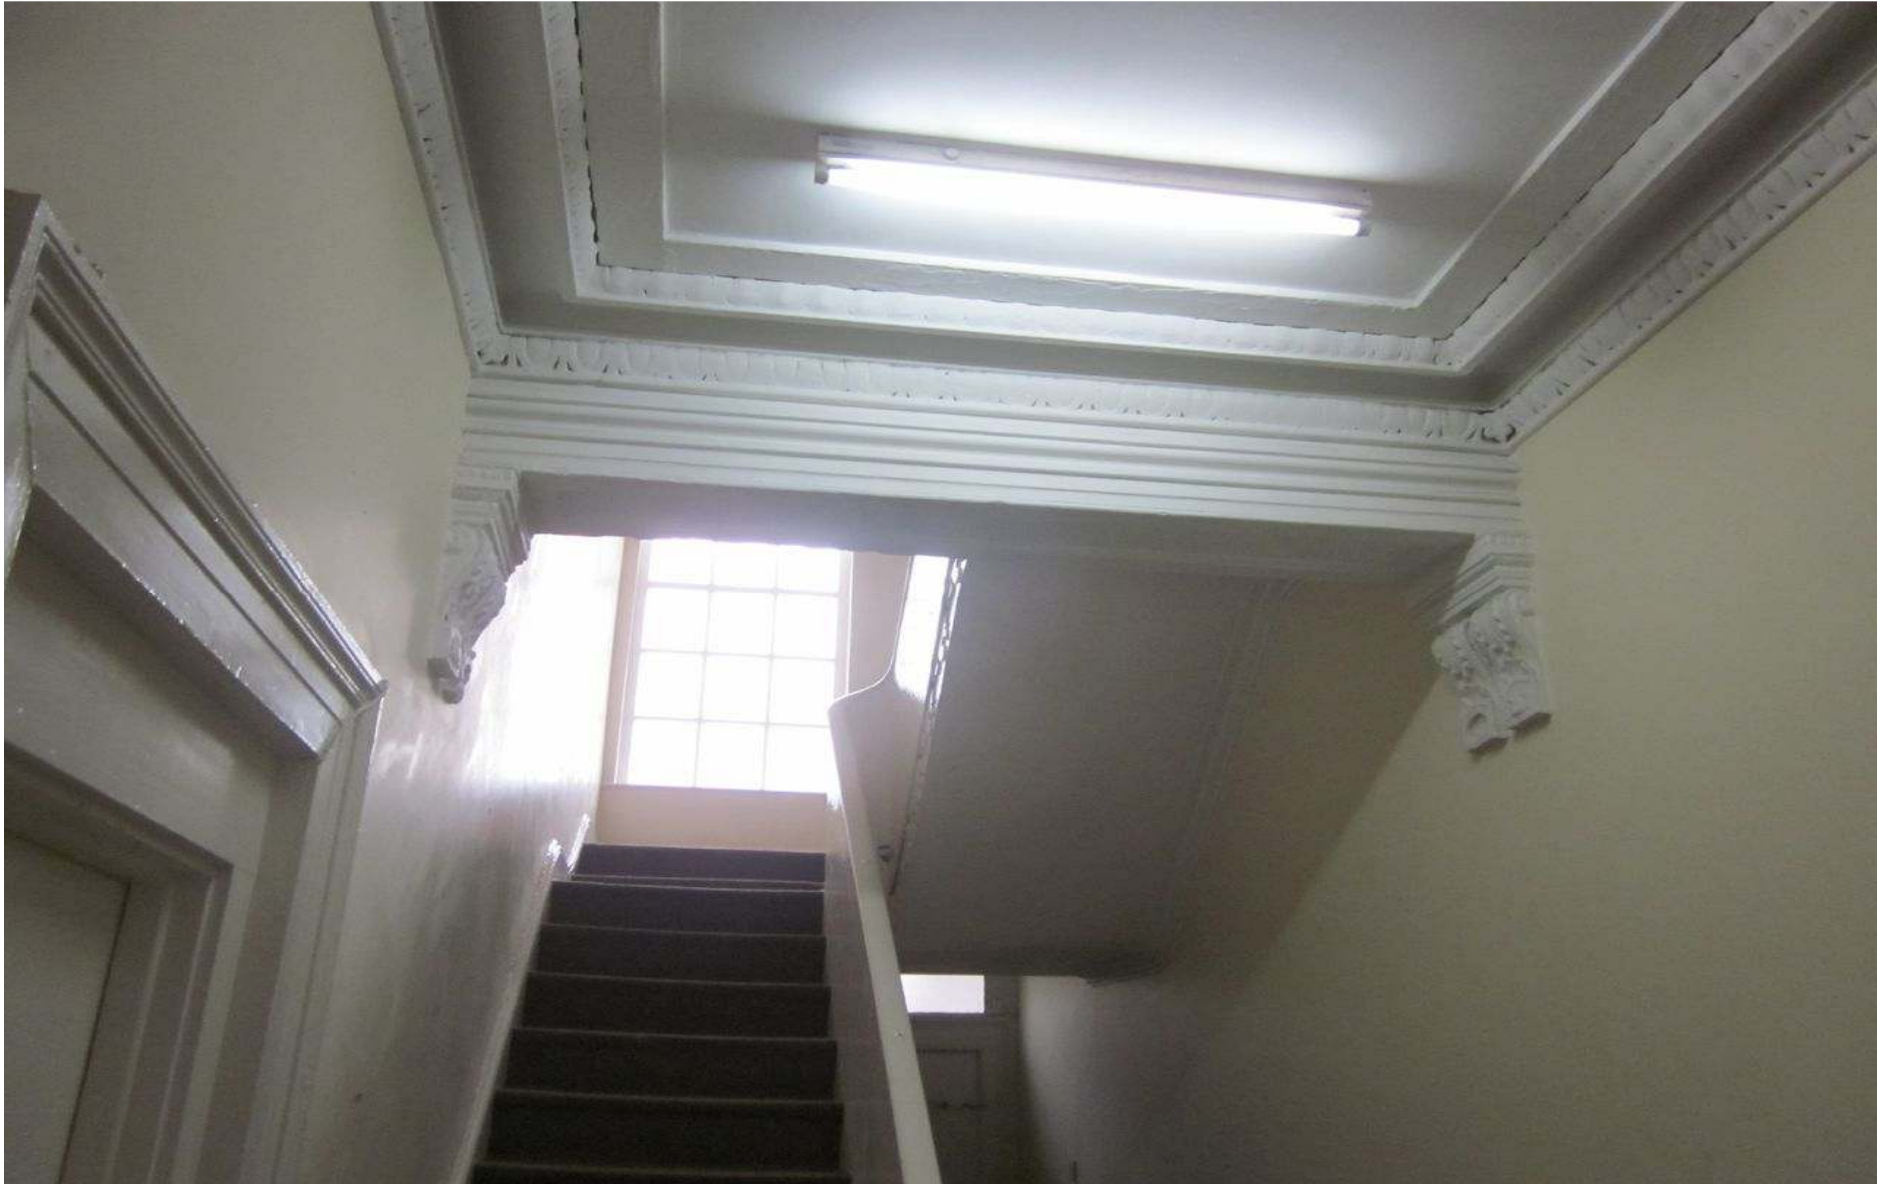
| <b>Common areas</b> | Within the stairwells and the common/shared areas heritage features of merit identified a number of significant plaster wall cornices, decorative plaster coving (egg & dart style), fanlight glazing, original doors and original staircases | <ul style="list-style-type: none"> <li>• All of the identified plasterwork should be checked, assessed and repairs made where necessary according to the specification</li> <li>• Original timber front doors are overall in fair condition, but would benefit from common ironmongery to all.</li> </ul> | |

Intact heritage features common to all vestibules

| | | <ul style="list-style-type: none"> <li>• Fanlight glazing above the main entrances are original and in good condition and require only a clean and repaint (re-putty to glazing bars where necessary).</li> <li>• Identified timberwork to include picture rails, skirting boards etc. should ideally be rubbed down sanded and repainted as required.</li> <li>• The original staircases exist (spindles boxed in); these should be exposed and refurbished. 3rd floor staircases are more commonplace in appearance with turned newel posts and again should be cleaned and refurbished where required.</li> <li>• Expose staircases, rub down all paintwork where practical and reapply colour/paint of choice.</li> </ul> | |

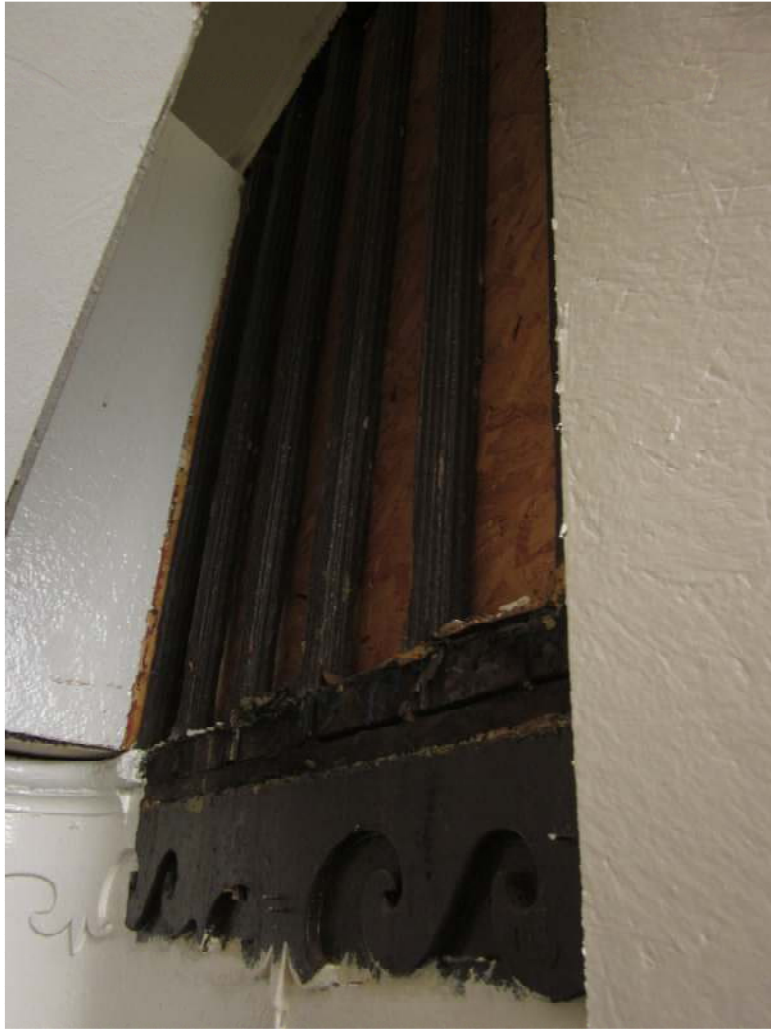
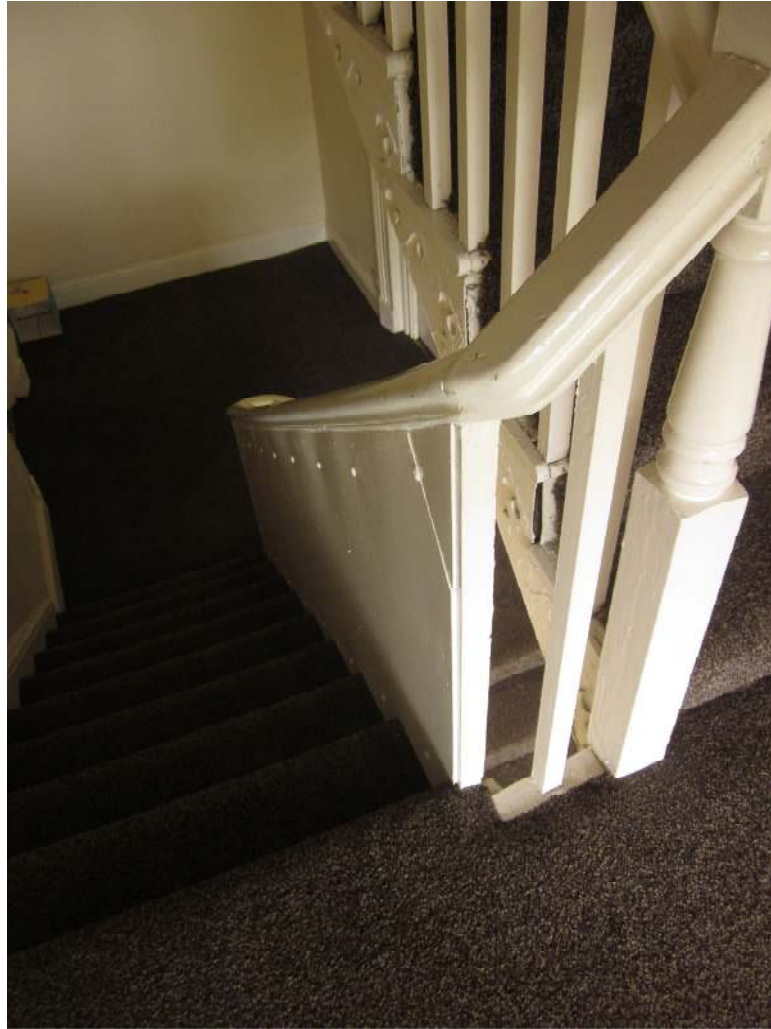
The original banisters revealed beneath chip board covering Upper floors are less ornate

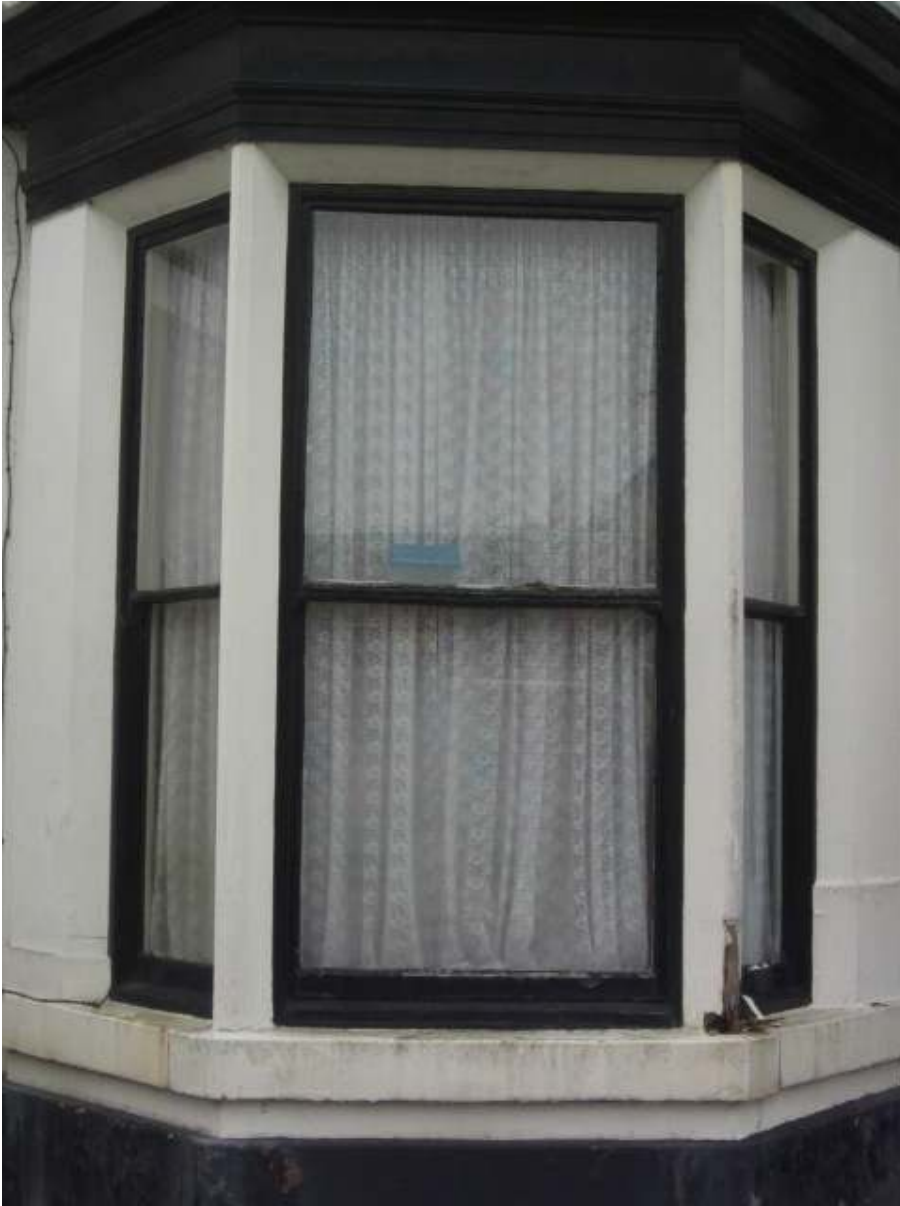
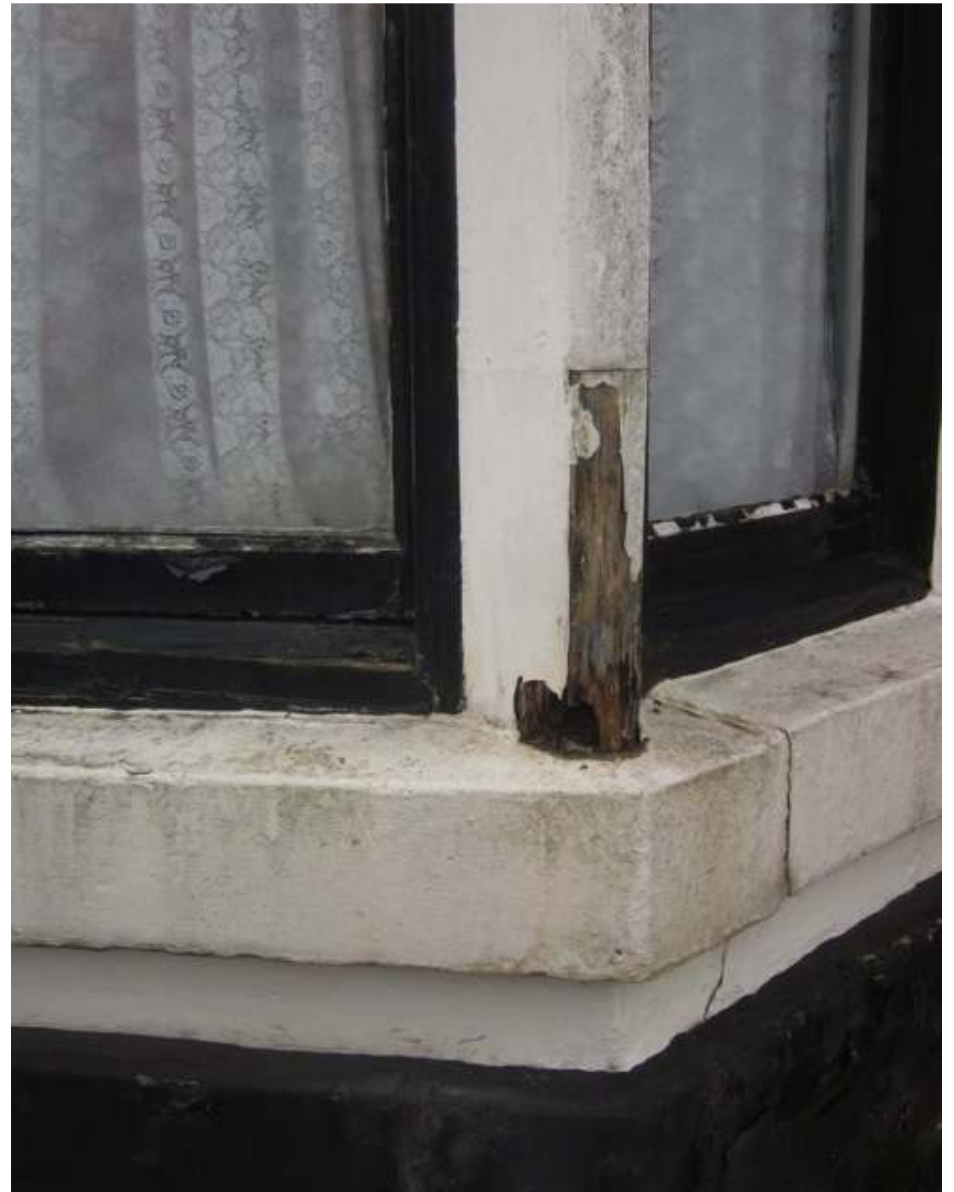
| Schedule of works specification | Details | Repair specification & intervention required | |
|---|---|---|---|
| <b>External Bay windows (Timber surrounds)</b> | All 5 ground floor bay windows are constructed in timber and all are showing areas of decay | | |

| | particularly to the cills, where evidence of rot is present. A programme of refurbishment is advised. | | |

Timber Bay window with Sash window showing signs of rot.

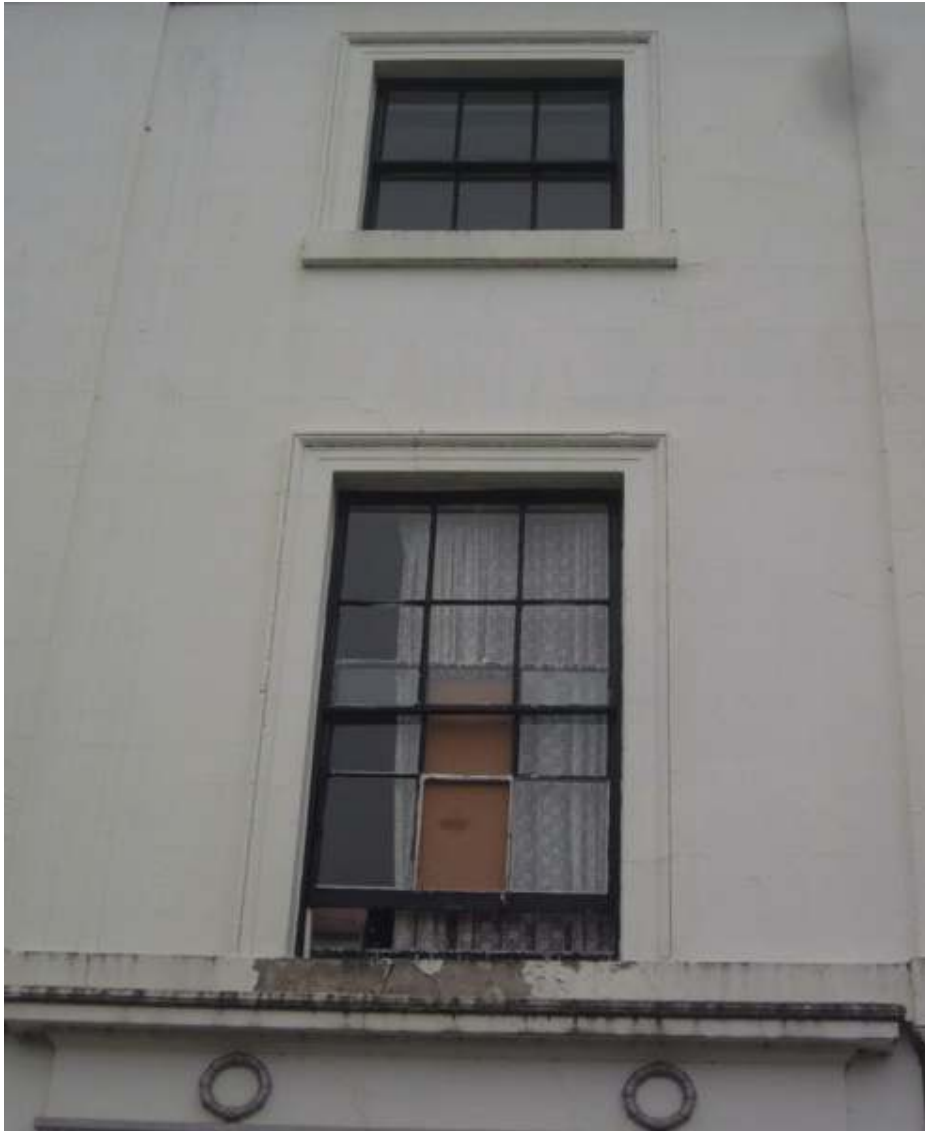
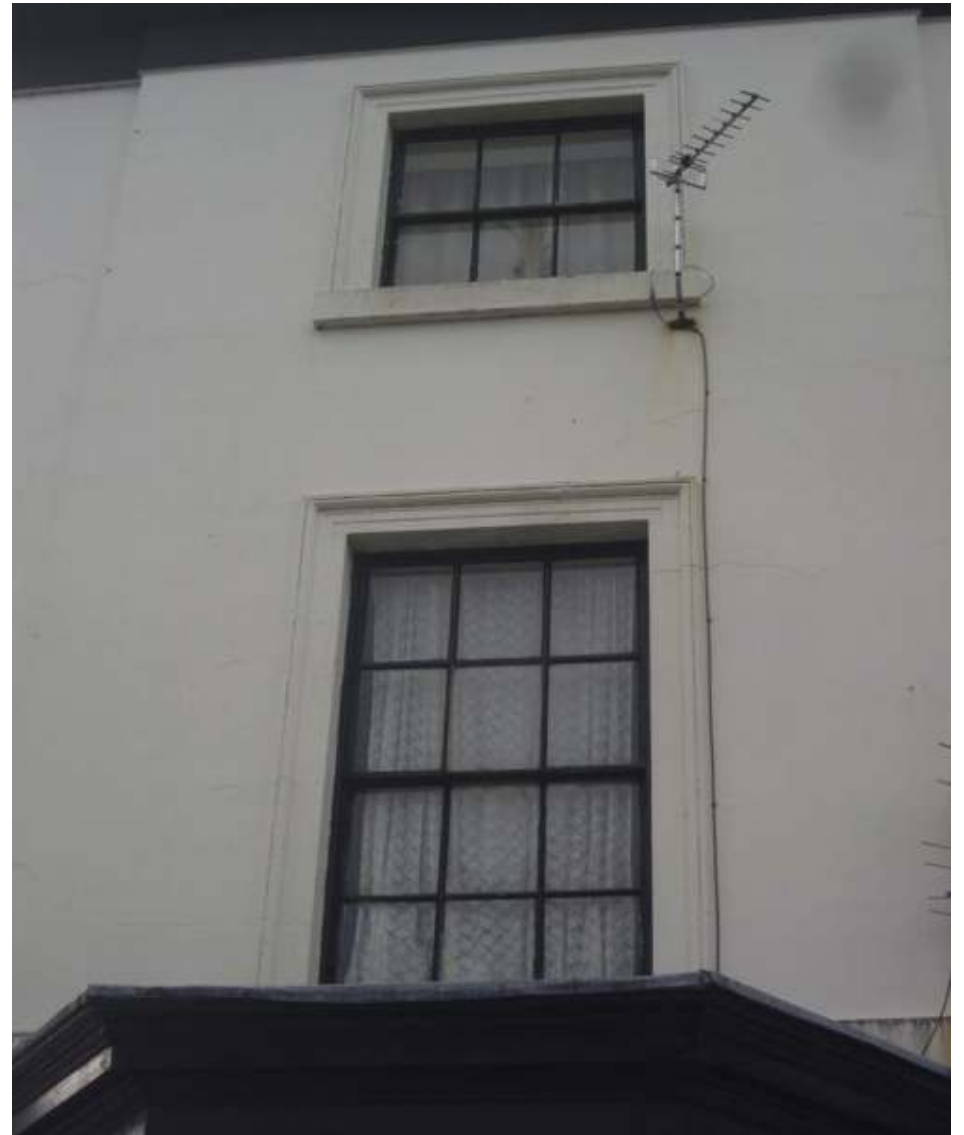
Original Timber Sash Windows to front elevation

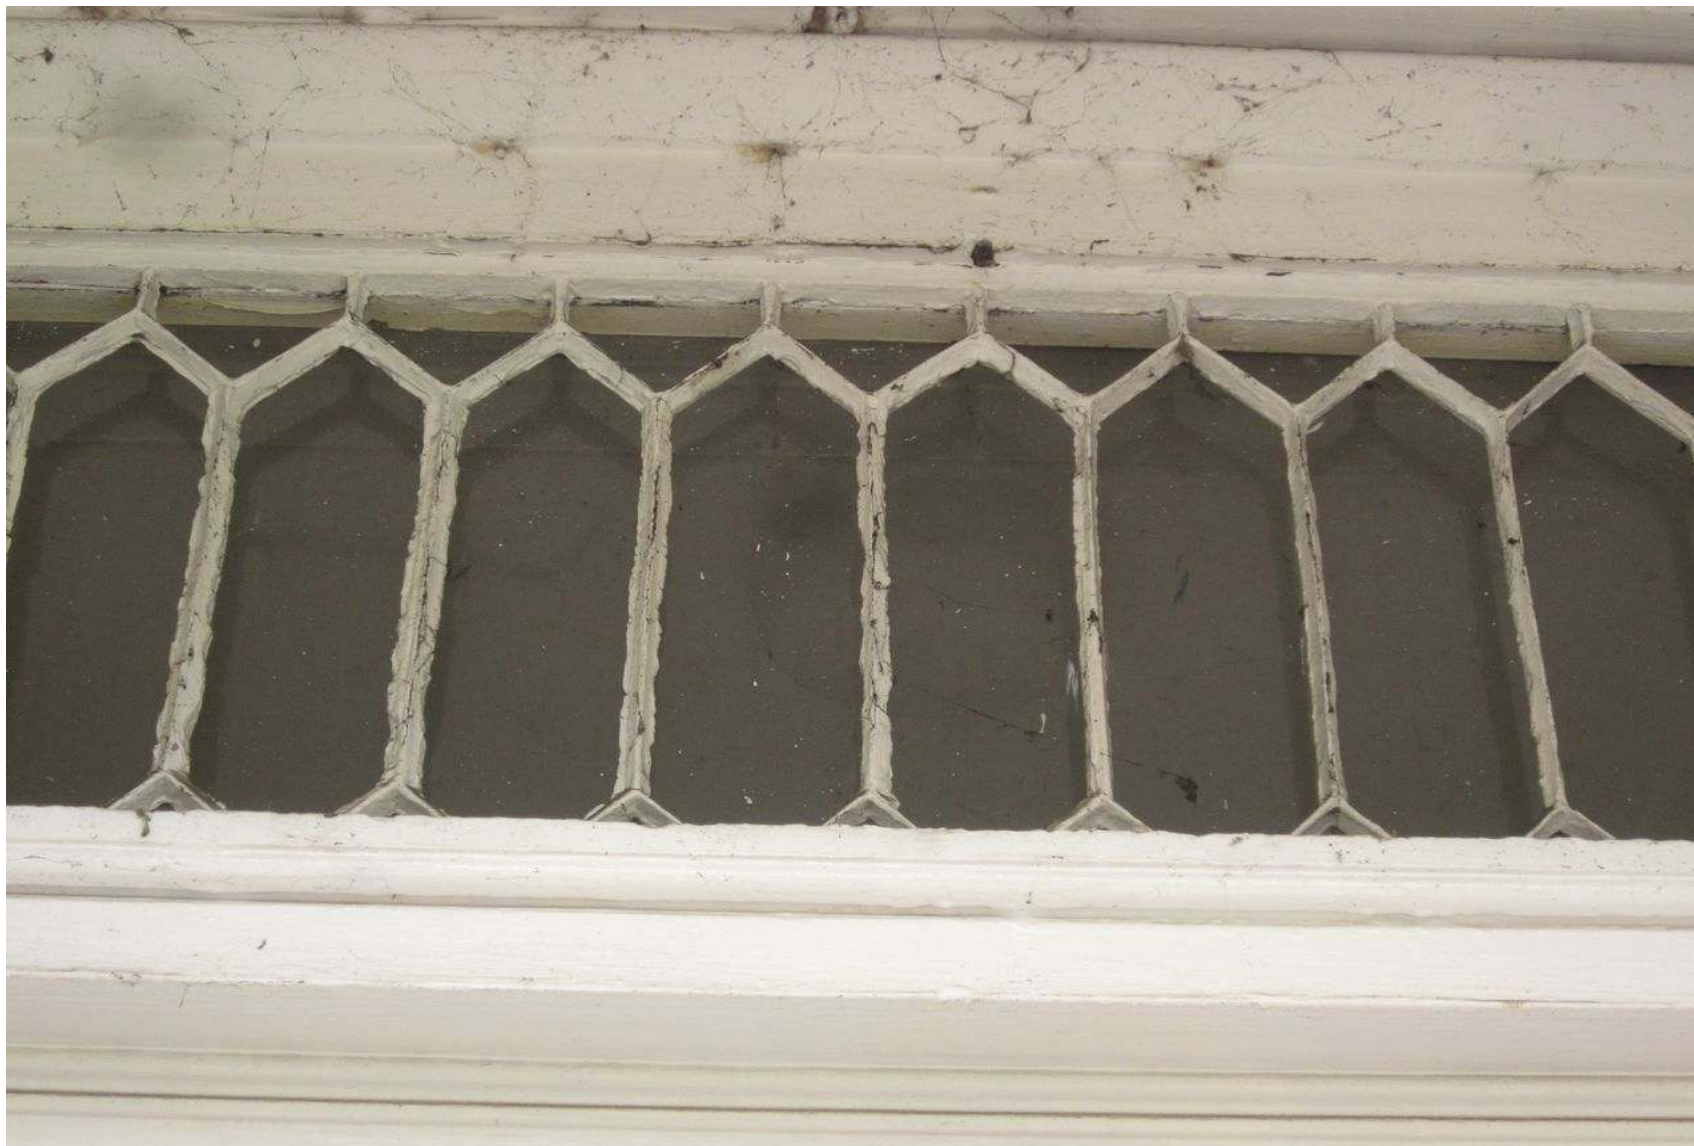
Original Vestibule Fanlight Glazing

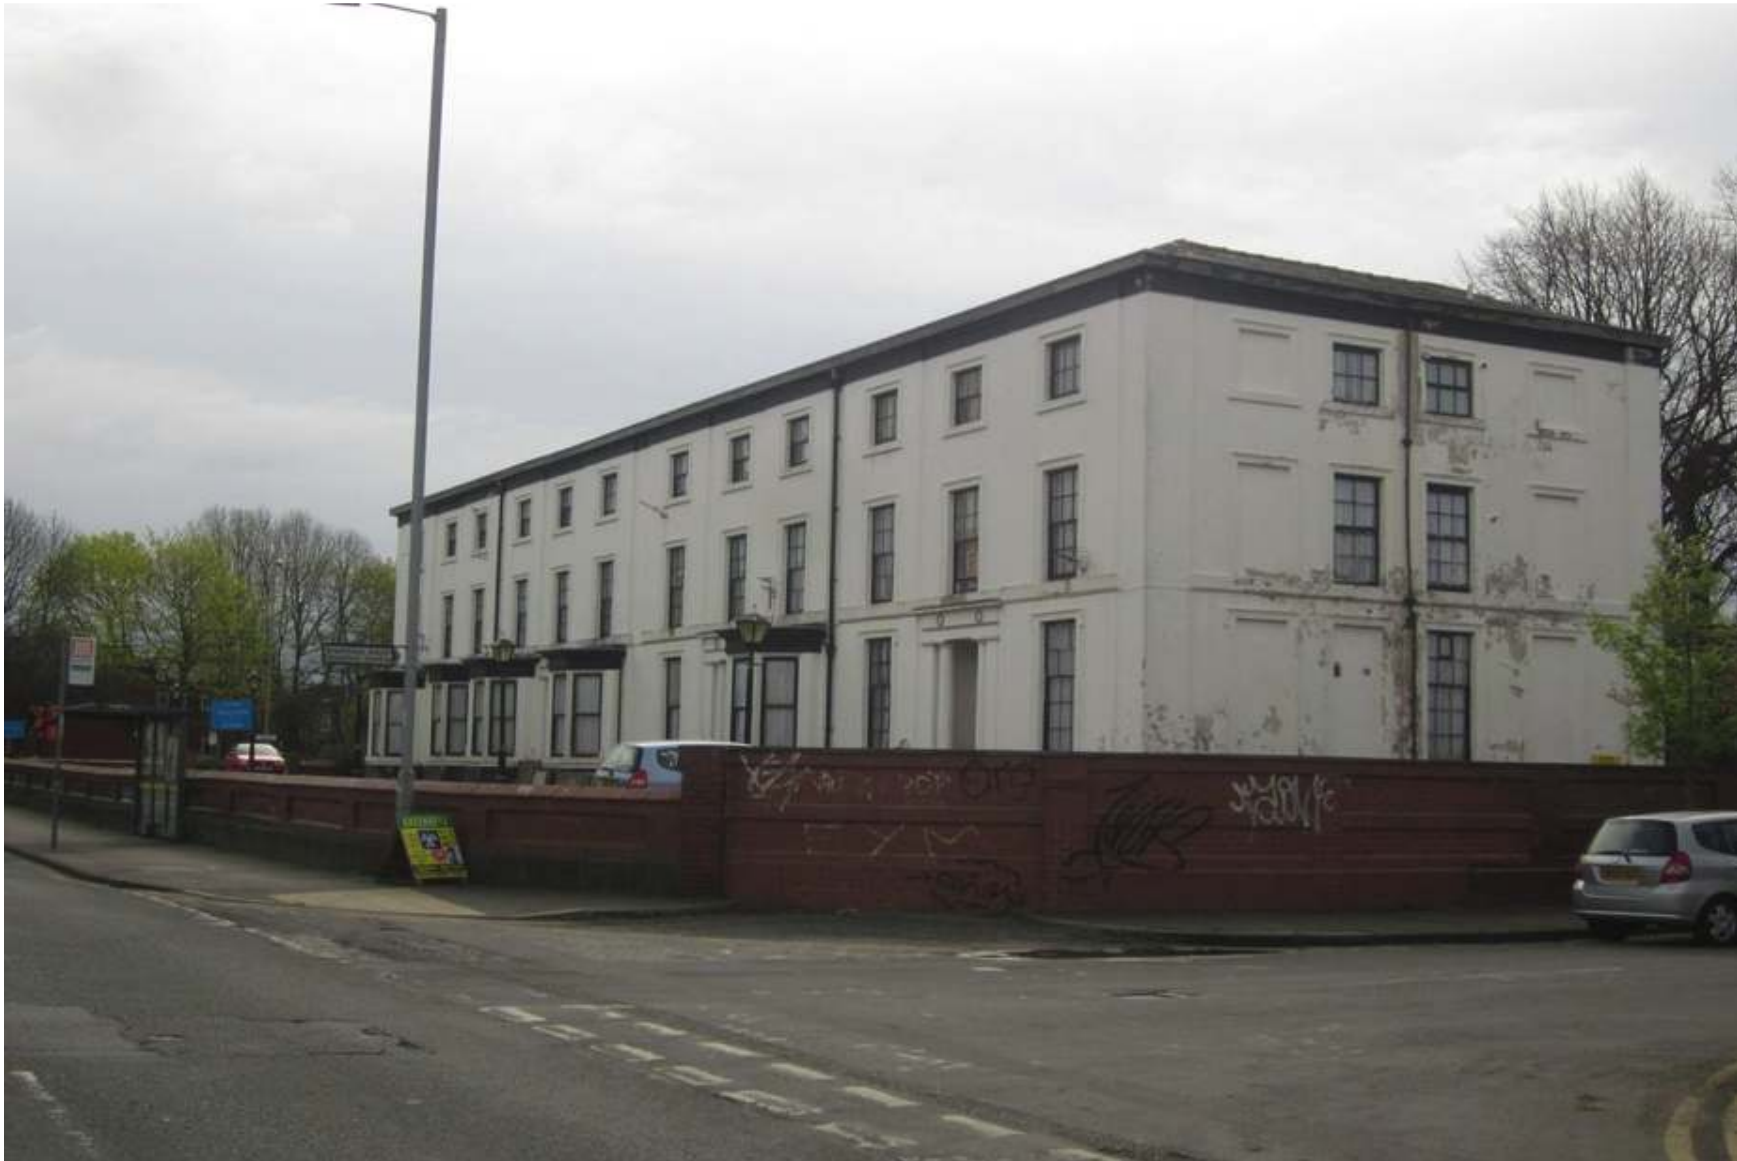
| <b>Boundary walls</b> | Brick built boundary walls to front<br>and side boundaries. Walls<br>appear to be in fair condition with<br>small amounts of brick spalling. | Monitor walls condition and repair<br>where necessary. Consider<br>reinstatement of historically<br>appropriate railings to front and<br>sides for added security. | |

External View of Boundary walls

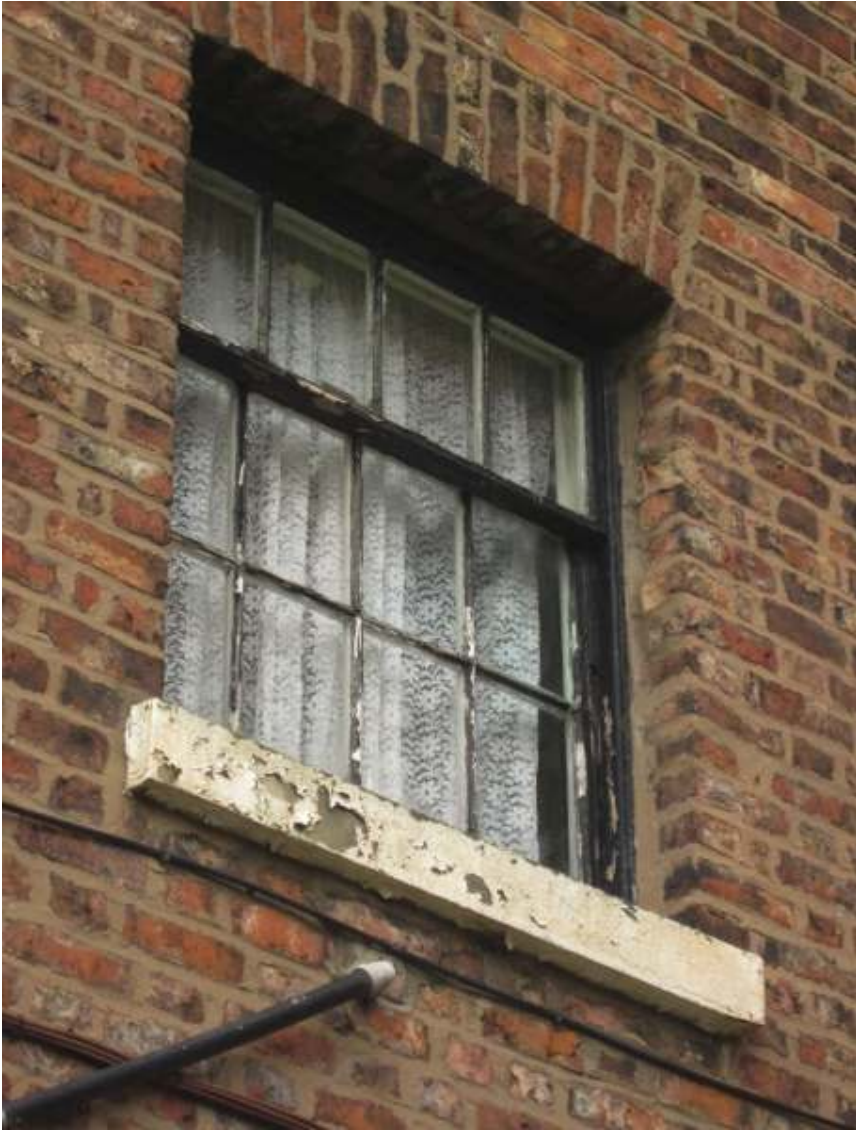
Original existing 12-pane top sash window
