**Whitworth Park Mansions, Moss Lane East, Manchester**  
**Appendices: Heritage Condition Survey and Schedule of Works**

**Jerry Spencer Associates**  
Regeneration and Urban Design

**Appendix B**  
**Summary of overall condition**

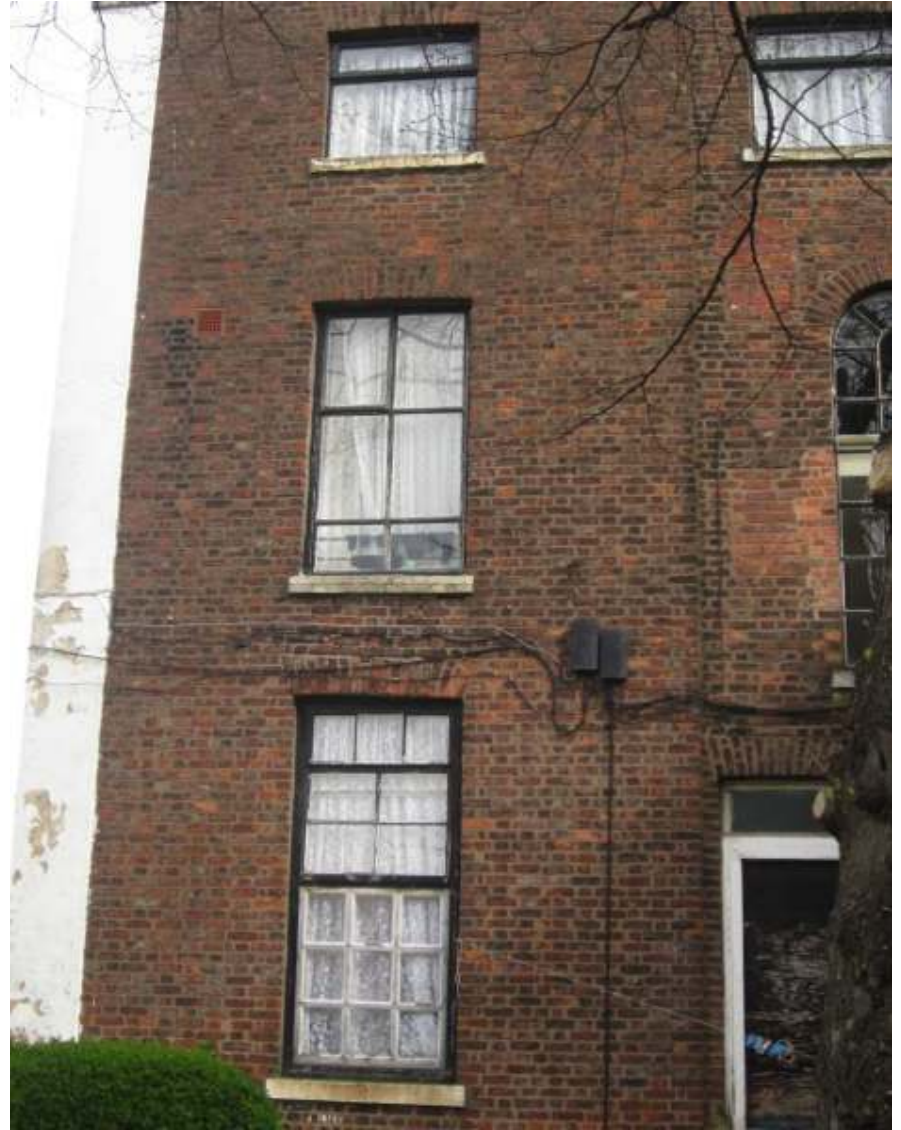
inappropriate windows to rear elevation

Where windows and doors are considered to be negative or inappropriate a programme of replacement should take place comprising of replacement timber sash windows and timber casements. Doors should be timber-paneled doors.

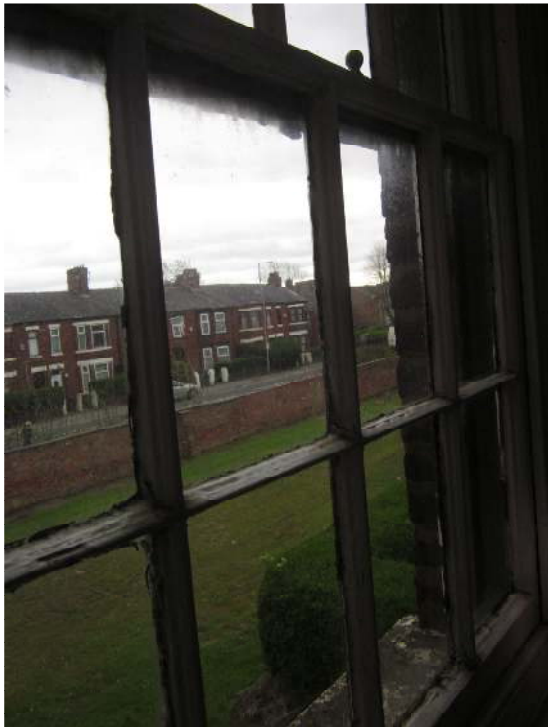
Slender Lambs tongue glazing bar profile

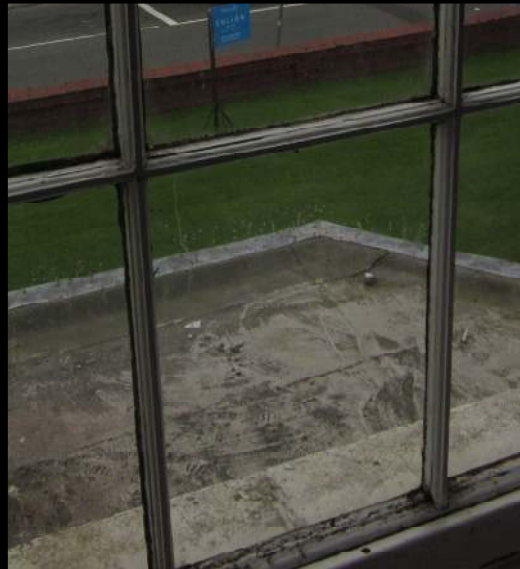
Late Victorian Thicker Ogee profile

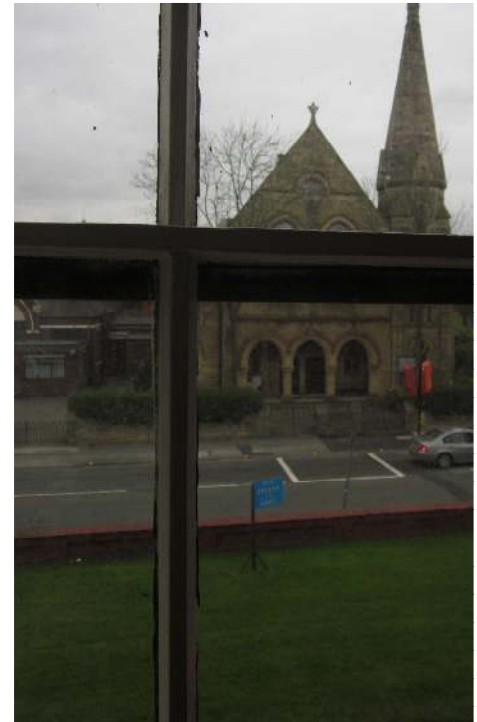
Chunky modern glazing bars
