GROUND FLOOR | WINDOWS

| snookarchitects | | project: | rev. | date | description |
|---|---|---|---|---|---|
| 89 Wood Street | Liverpool | bridgewater house | | | |
| t: 0151 707 0100 | | dwg title: | | window survey [1 of 16] | |

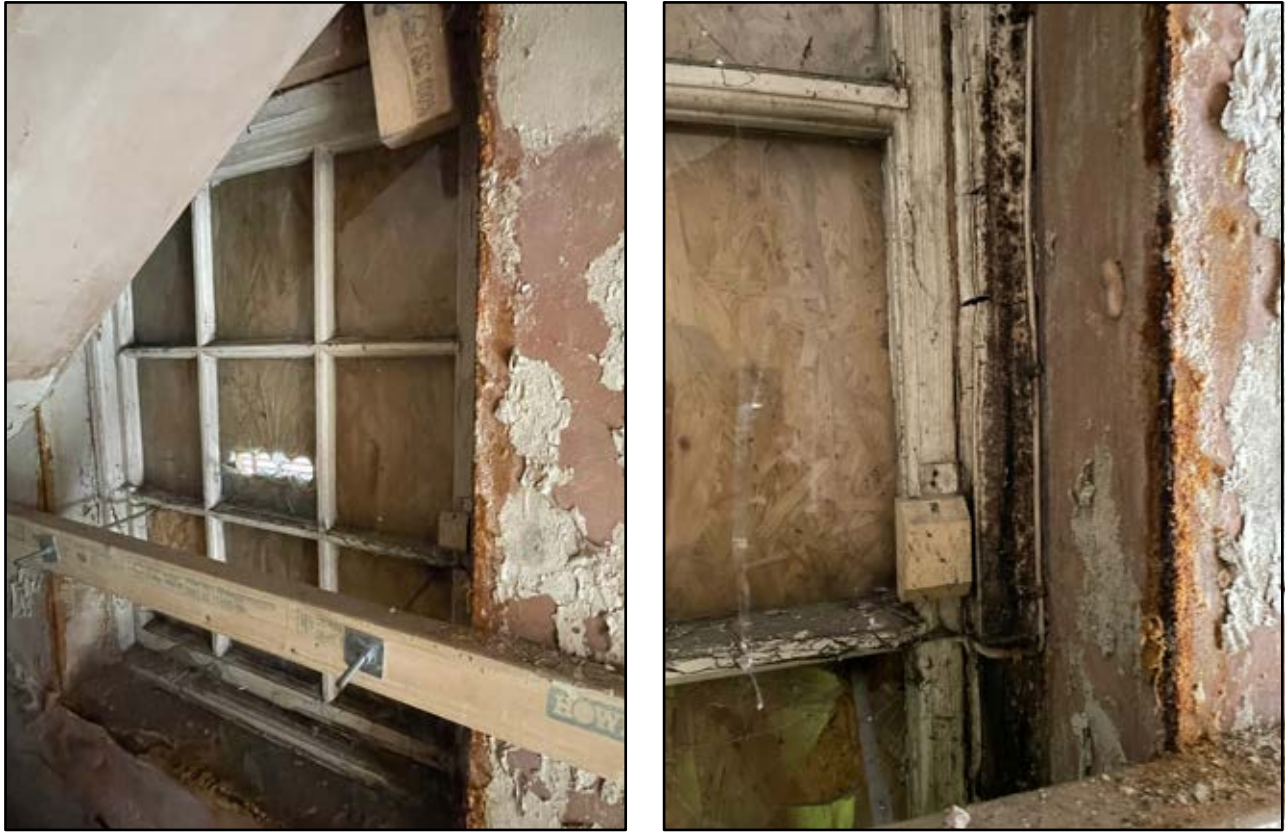
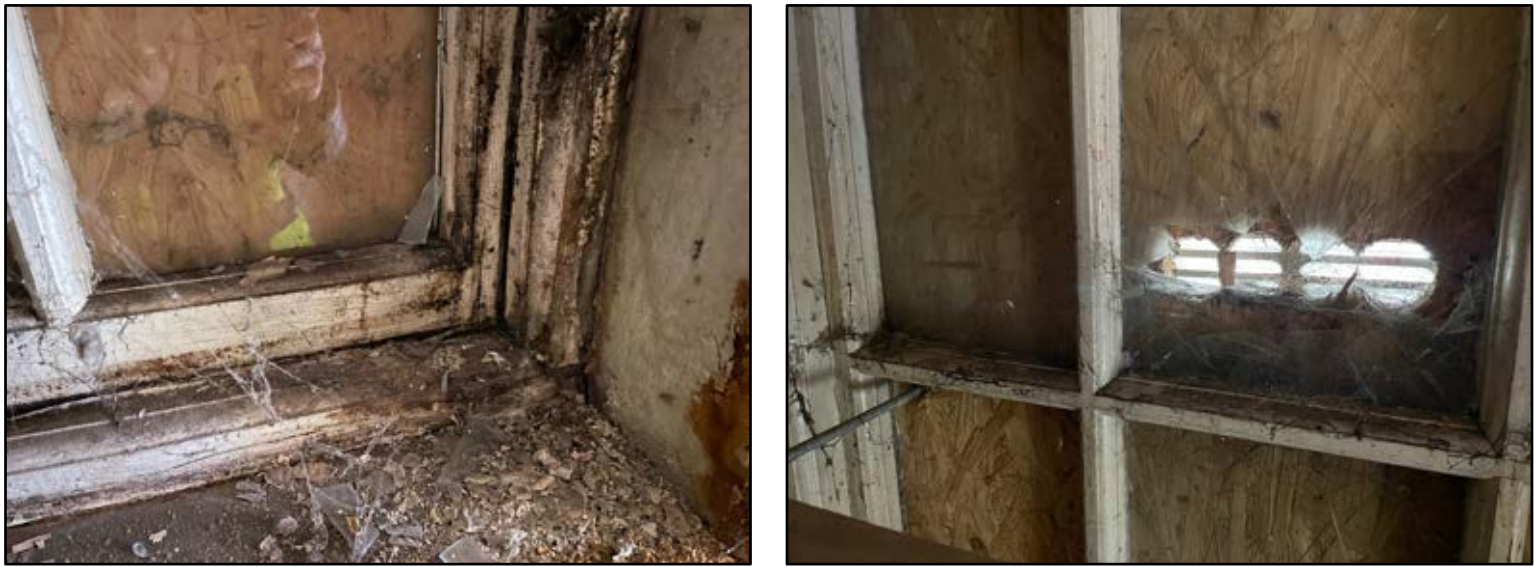
WINDOW WG.01

- Unable to open
- Single glazing
- Modern glass
- Broken glass
- Non original frame (damaged)

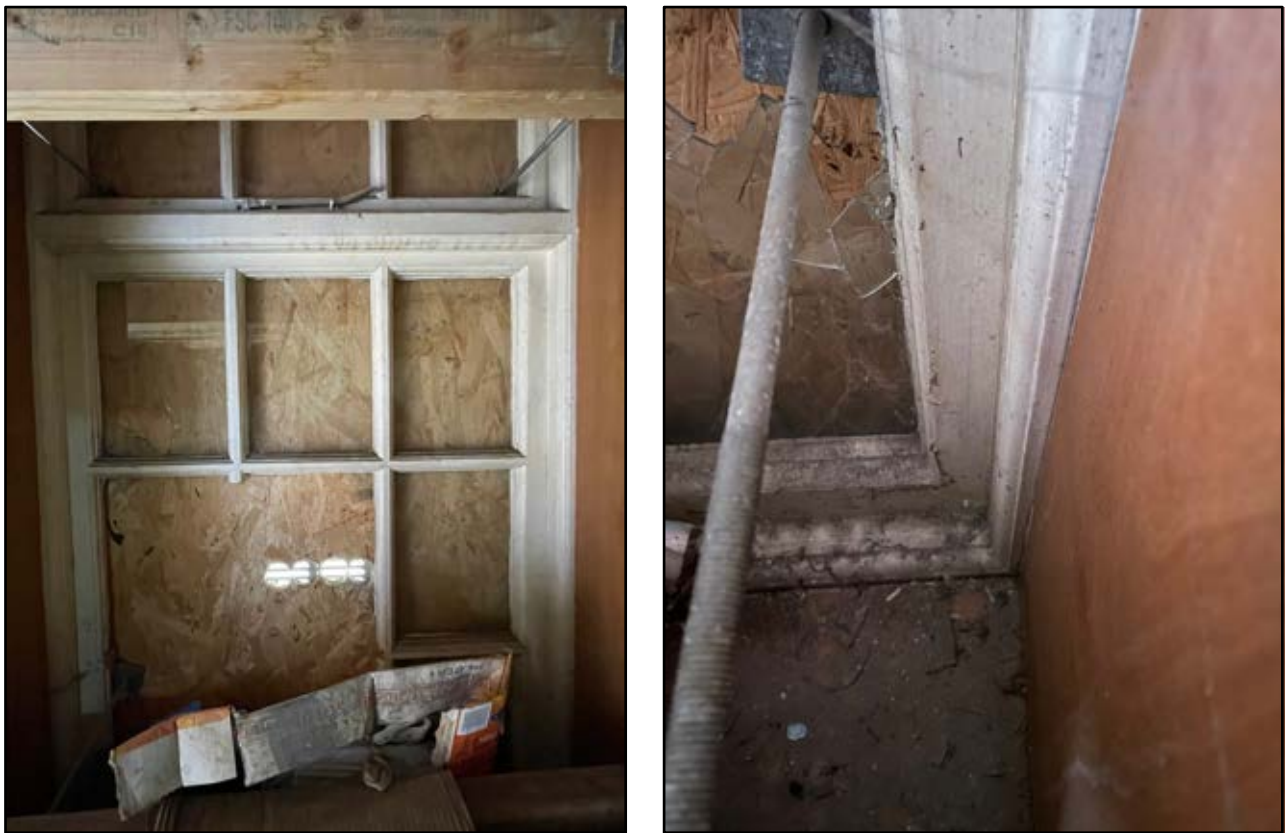
WINDOW WG.02

- Unable to open
- Single glazing
- Modern glass
- Non original frame (probably)
- Damaged frame

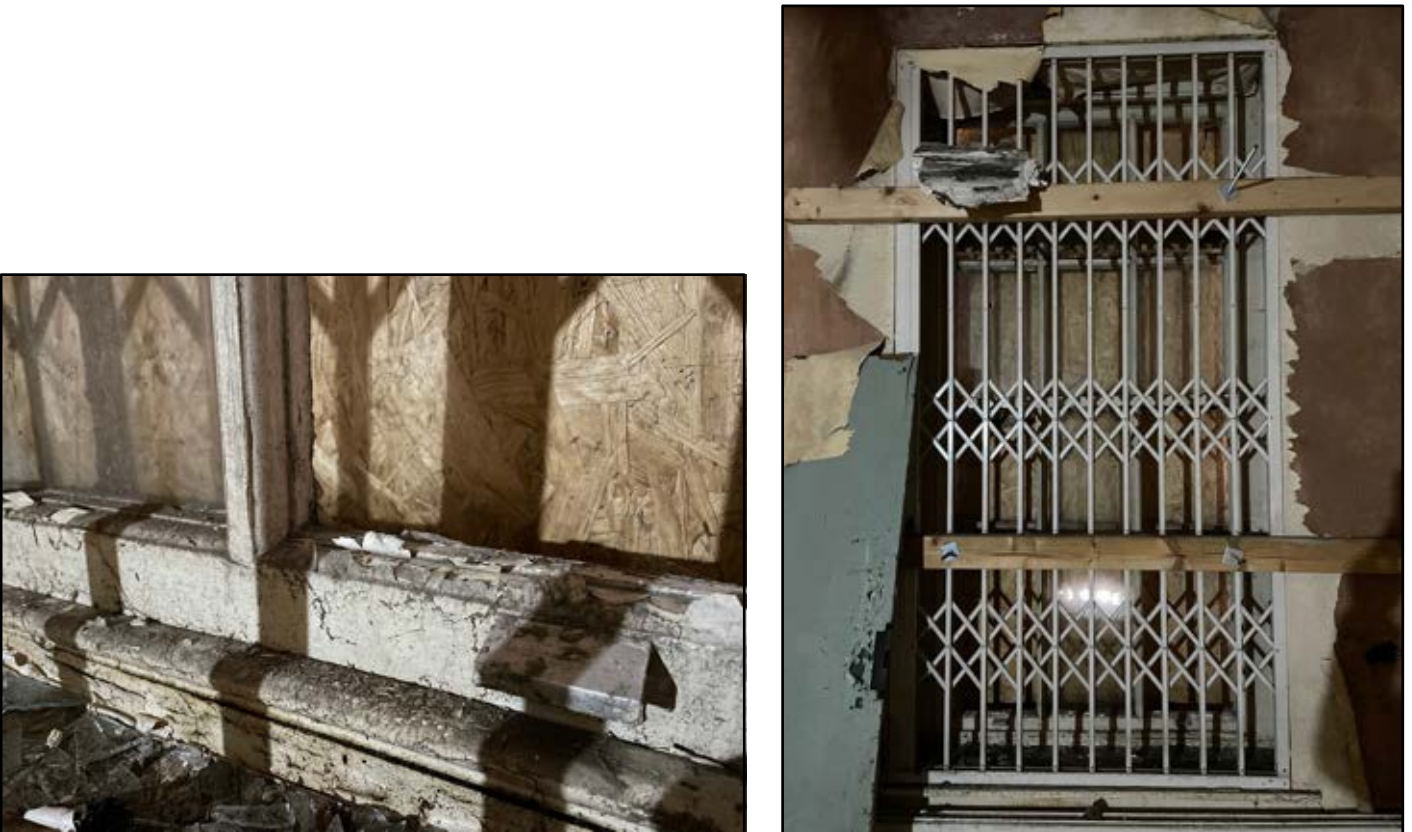
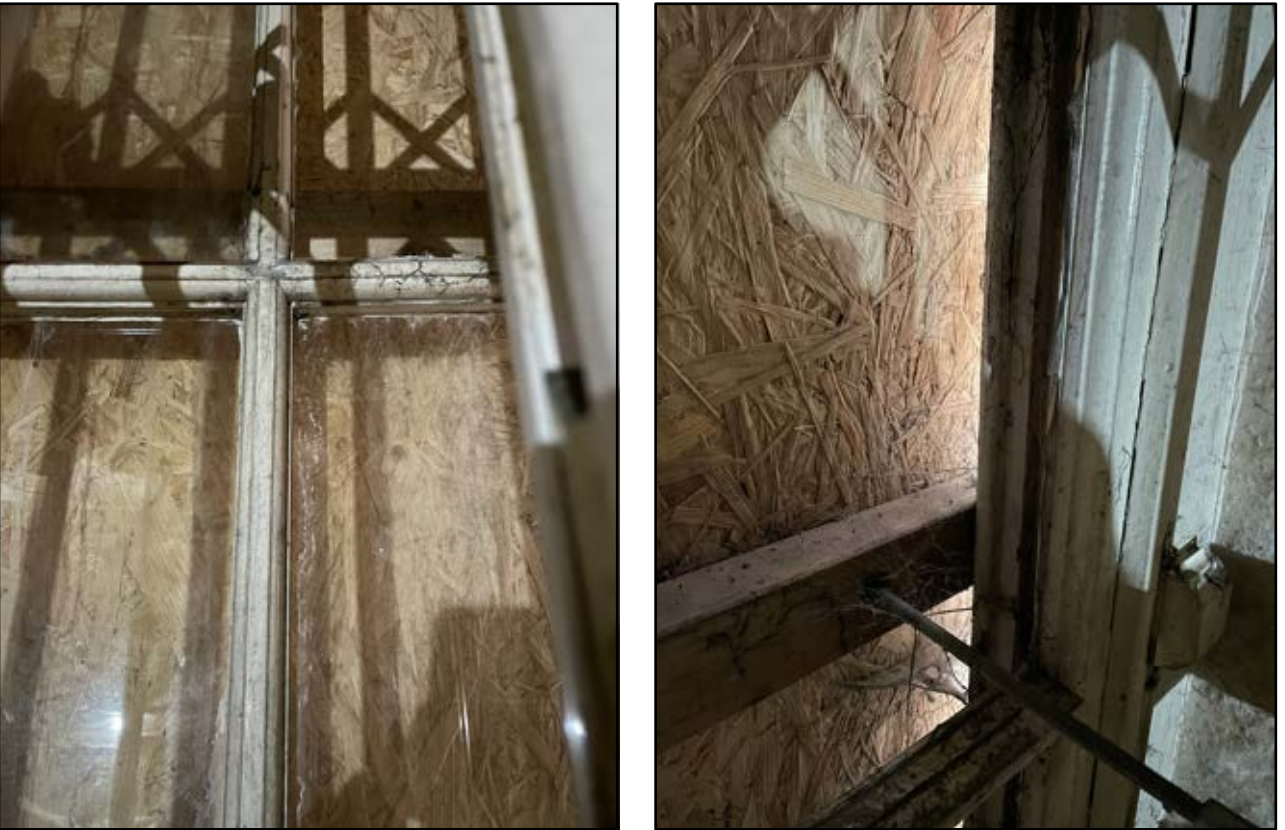
WINDOW WG.03

- Unable to open
- No glass
- Non original frame

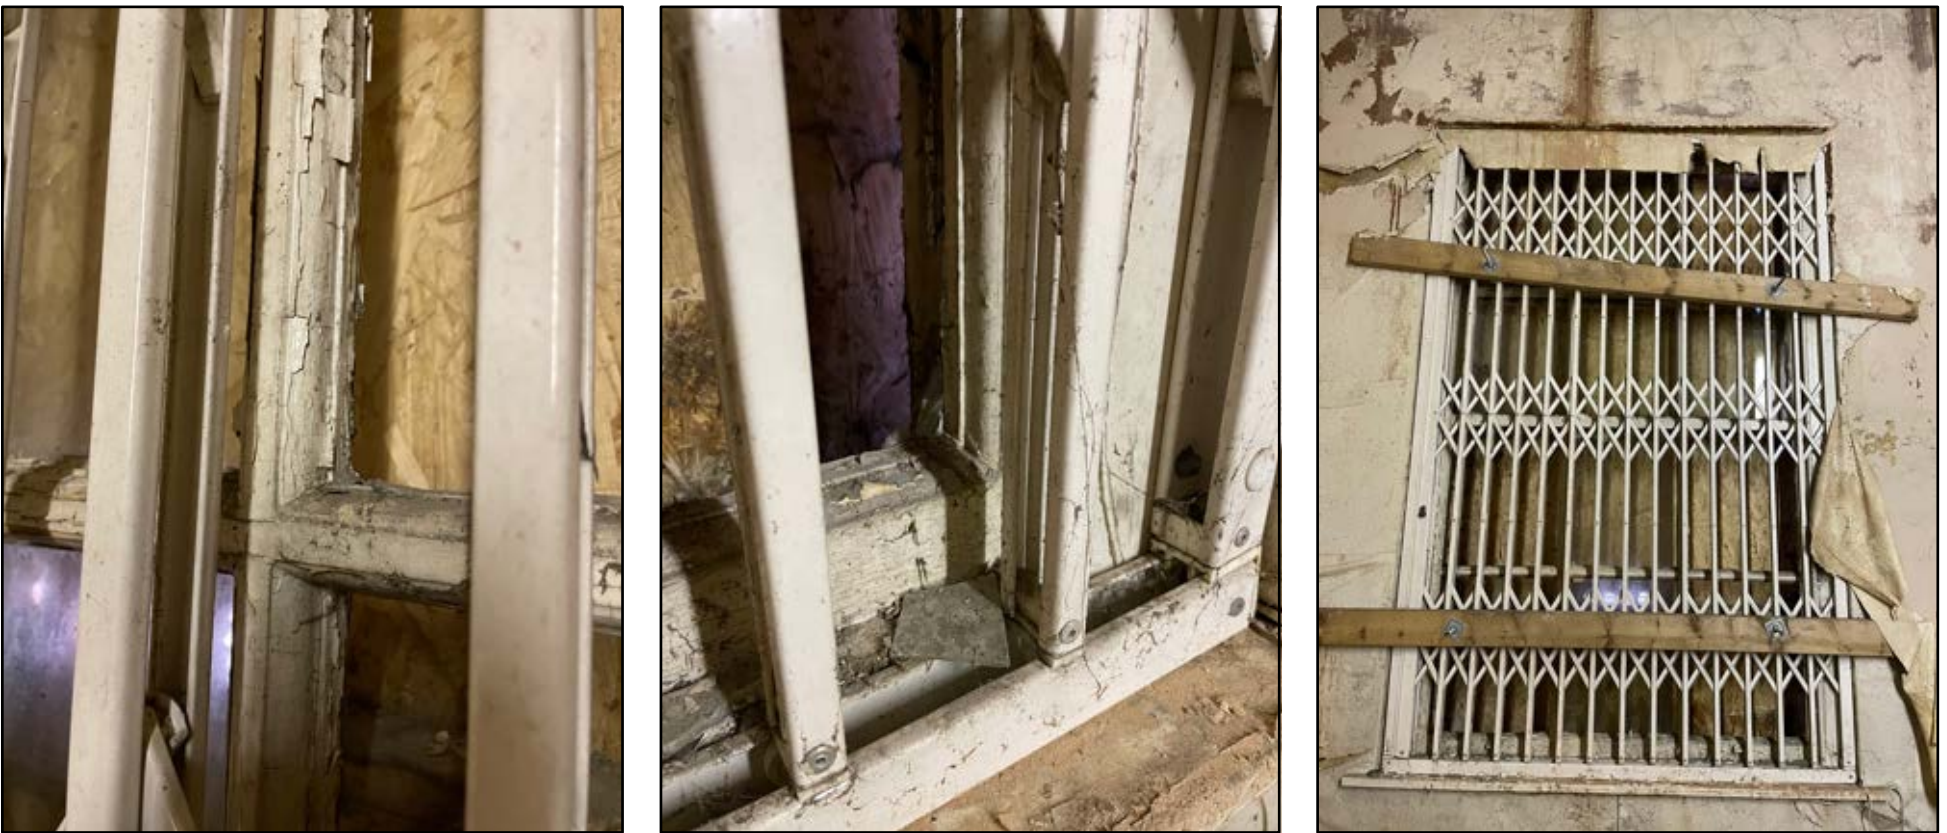
WINDOW WG.04

- Unable to open
- No glass
- Non original frame (probably)
- Damaged frame

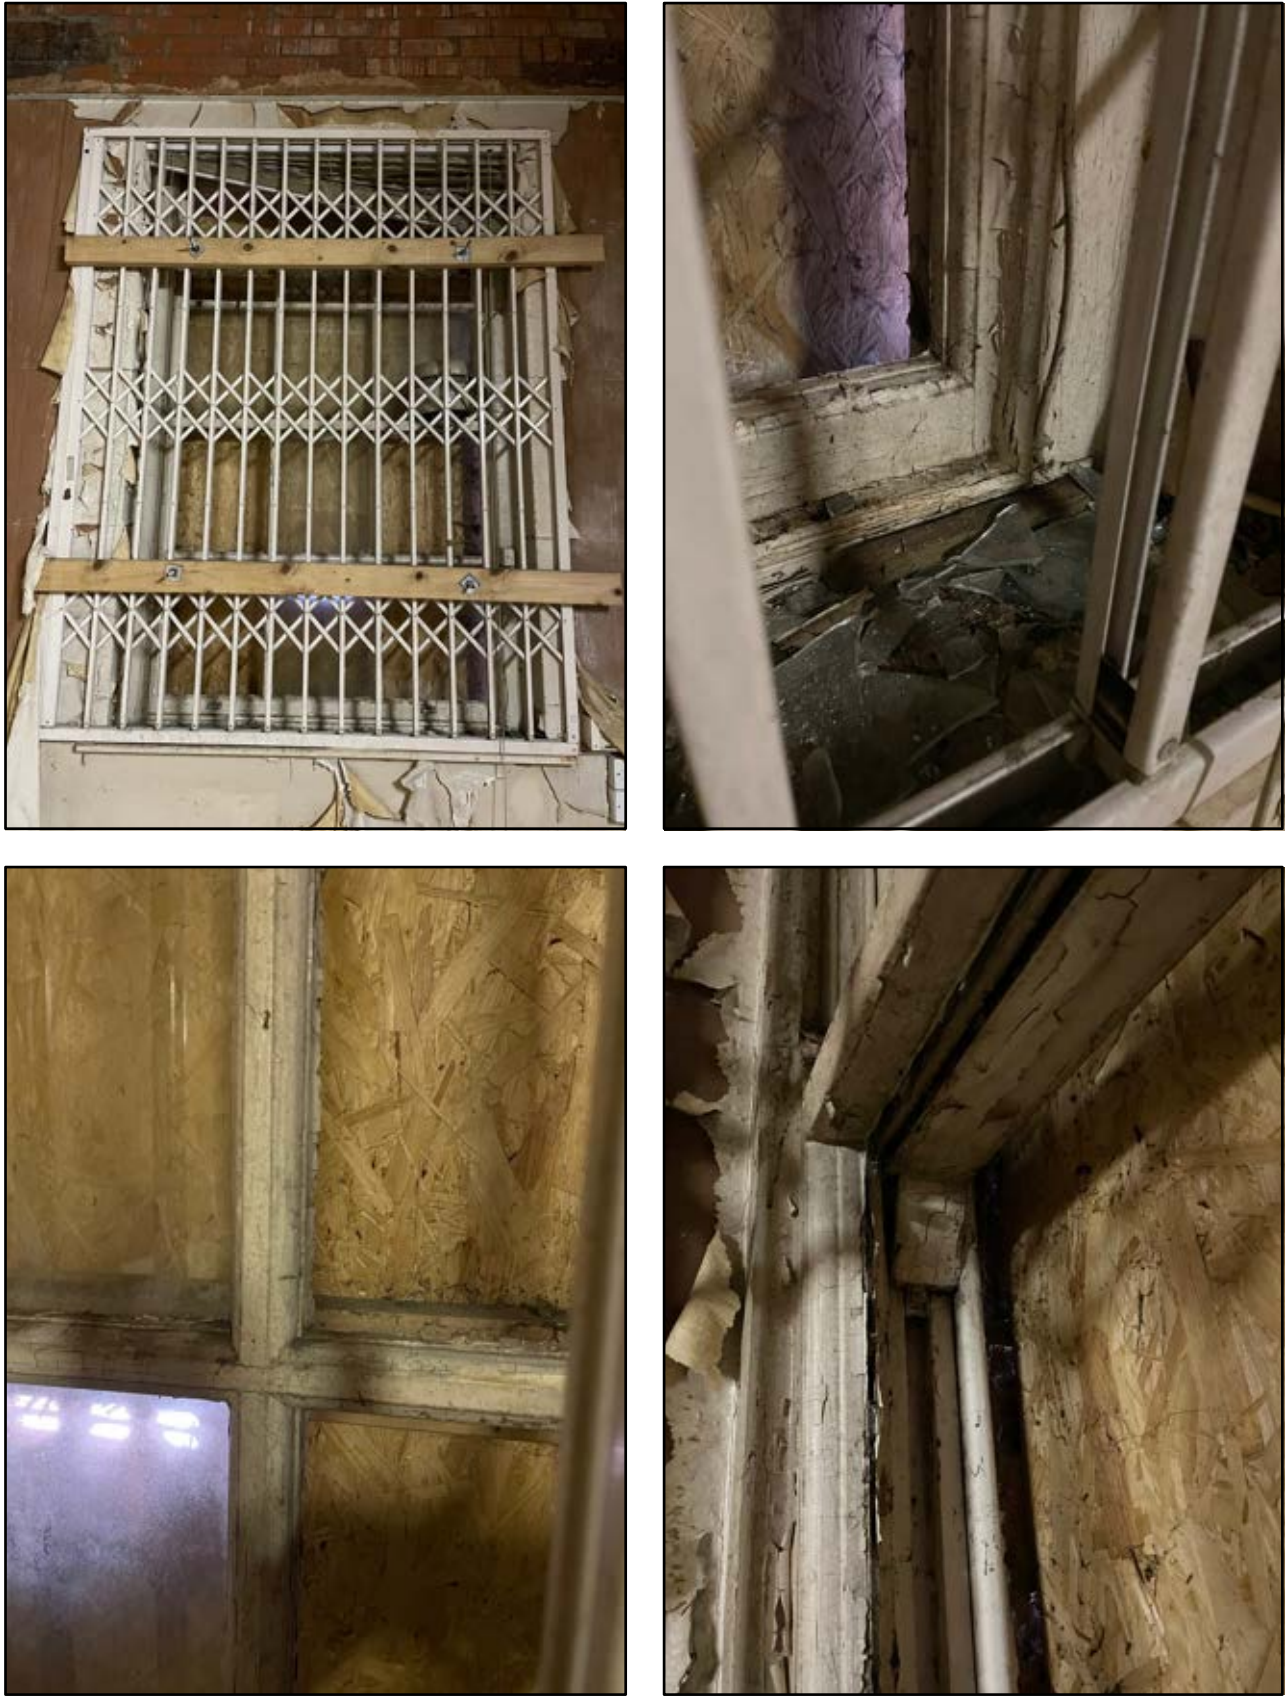
WINDOW **WG.05**

- Unable to open
- No glass
- Damaged frame
- Non original frame (probably)

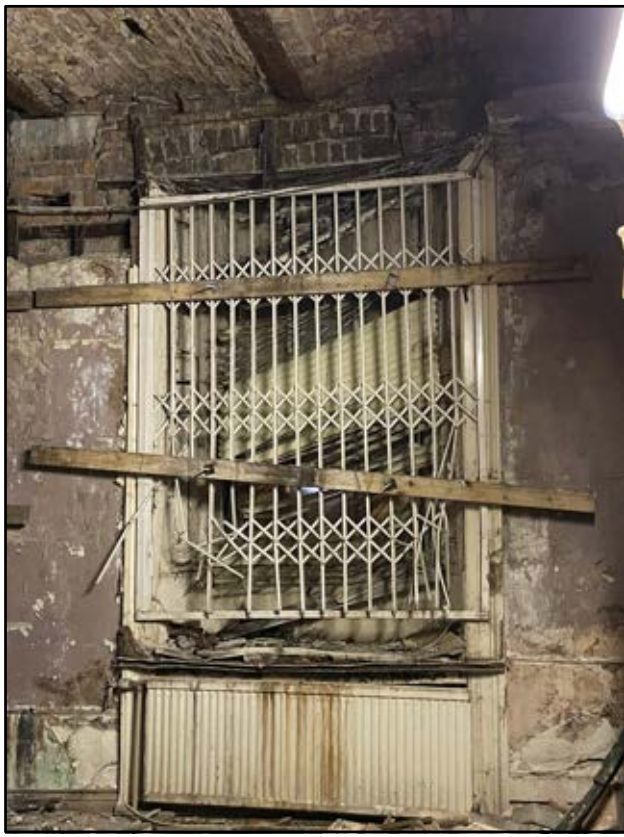
WINDOW **WG.09**

- Restricted access - Window is inaccessible due to collapsed ceiling and/or unsafe floor structure
- Photo taken from a distance
- Frame looks damaged
- Glass looks broken

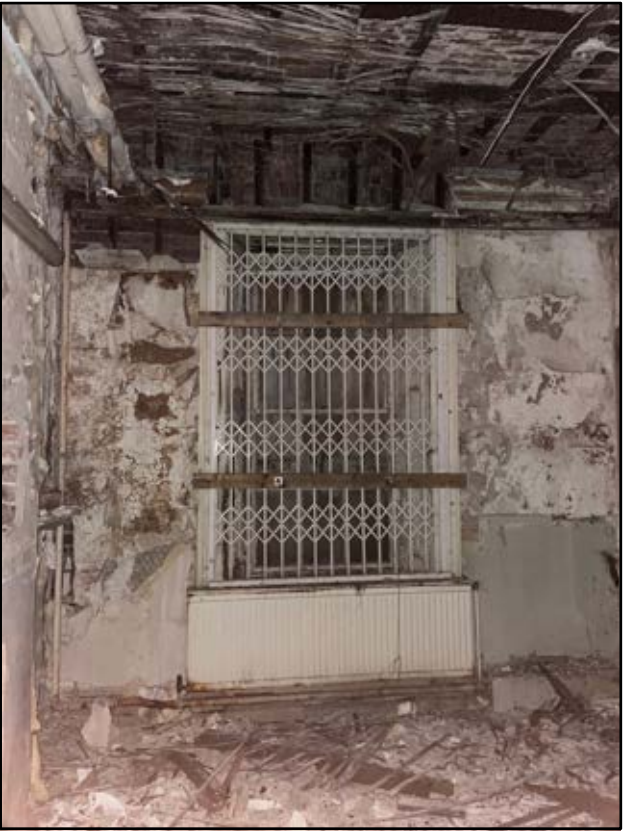
WINDOW **WG.15**

- Restricted access - Window is inaccessible due to collapsed ceiling and/or unsafe floor structure
- Photo taken from a distance
- Frame looks damaged
- Glass looks broken

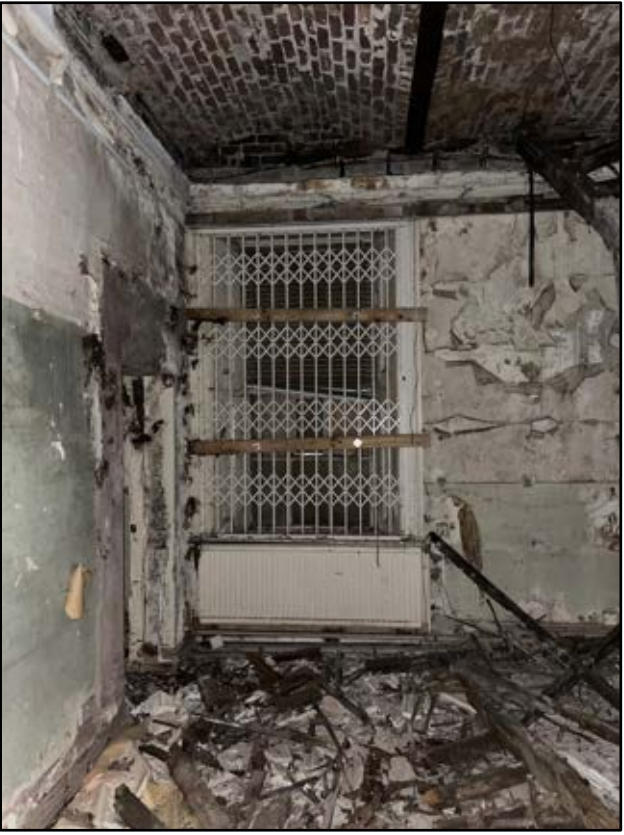
WINDOW **WG.16**

- Restricted access - Window is inaccessible due to collapsed ceiling and/or unsafe floor structure
- Photo taken from a distance
- Frame looks damaged
- Glass looks broken

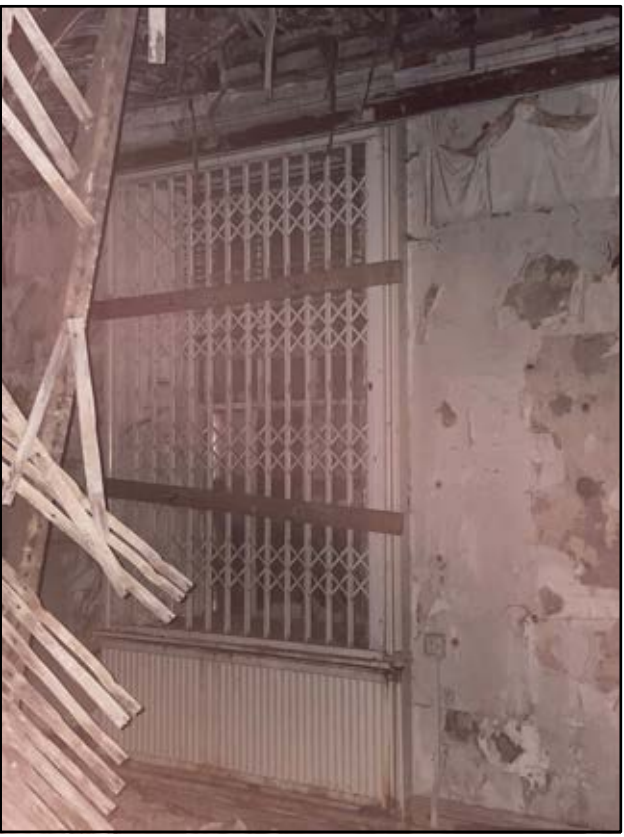
WINDOW **WG.17**

- Restricted access - Window is inaccessible due to collapsed ceiling and/or unsafe floor structure
- Photo taken from a distance
- Frame looks damaged
- Glass looks broken

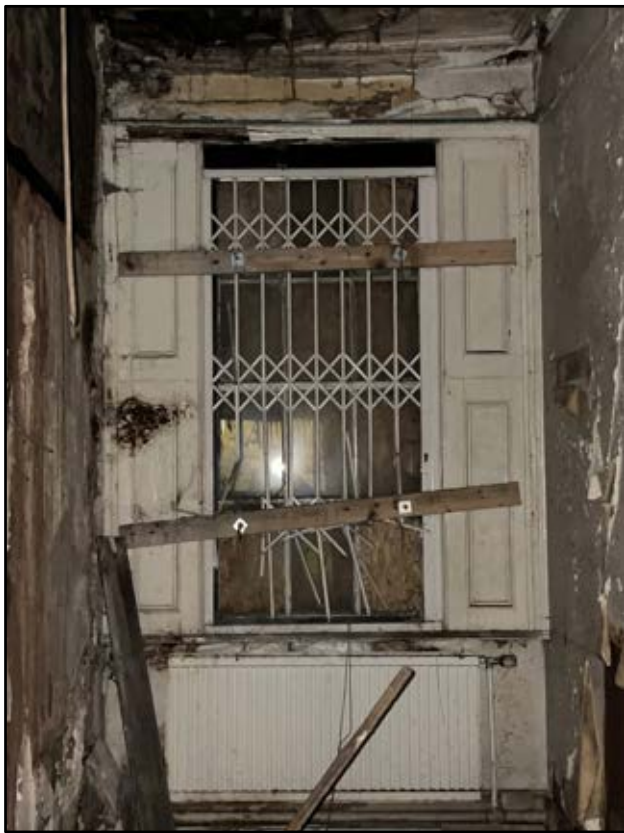
WINDOW **WG.20**

- Restricted access - Window is inaccessible due to collapsed ceiling and/or unsafe floor structure
- Photo taken from a distance
- Frame looks damaged
- Glass looks broken

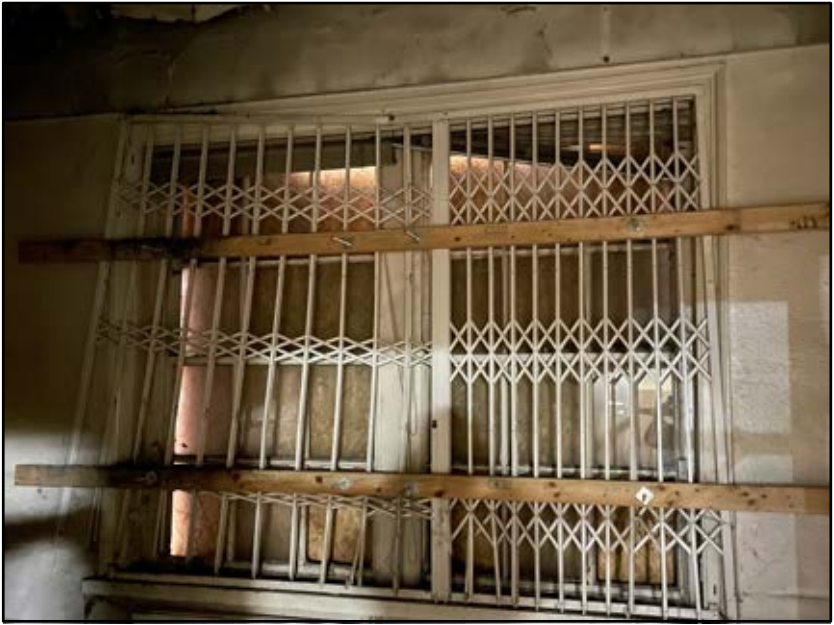
WINDOW **WG.21**

- Restricted access - Window is inaccessible due to collapsed ceiling and/or unsafe floor structure
- Photo taken from a distance
- Frame looks damaged
- Glass looks broken

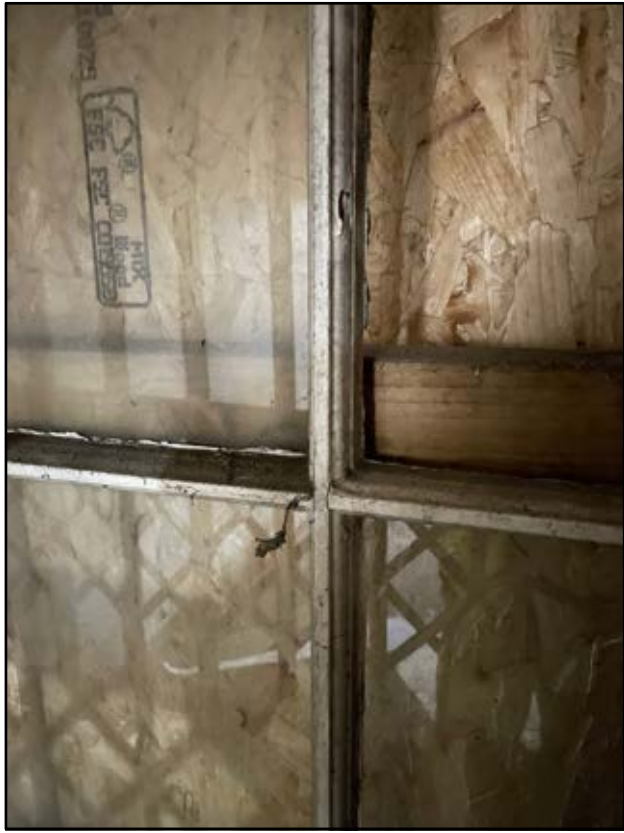
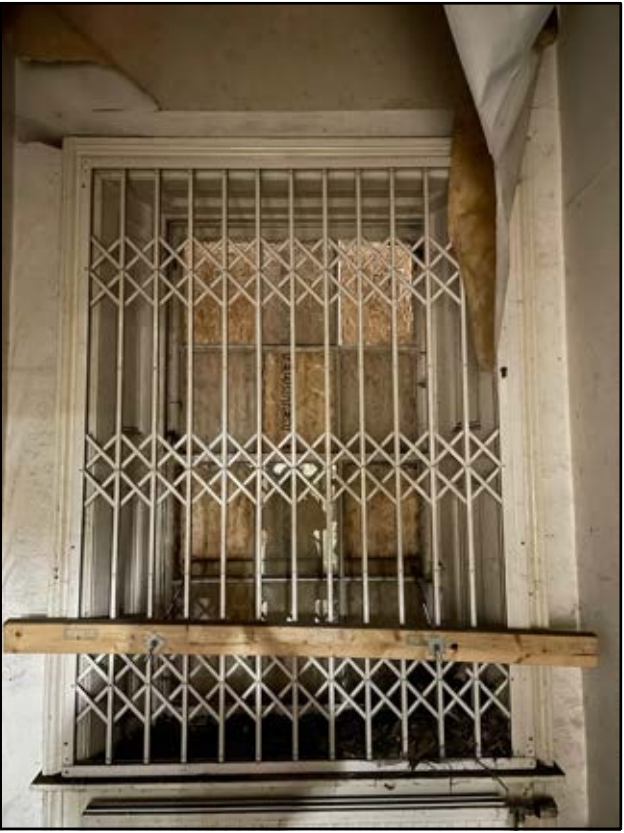
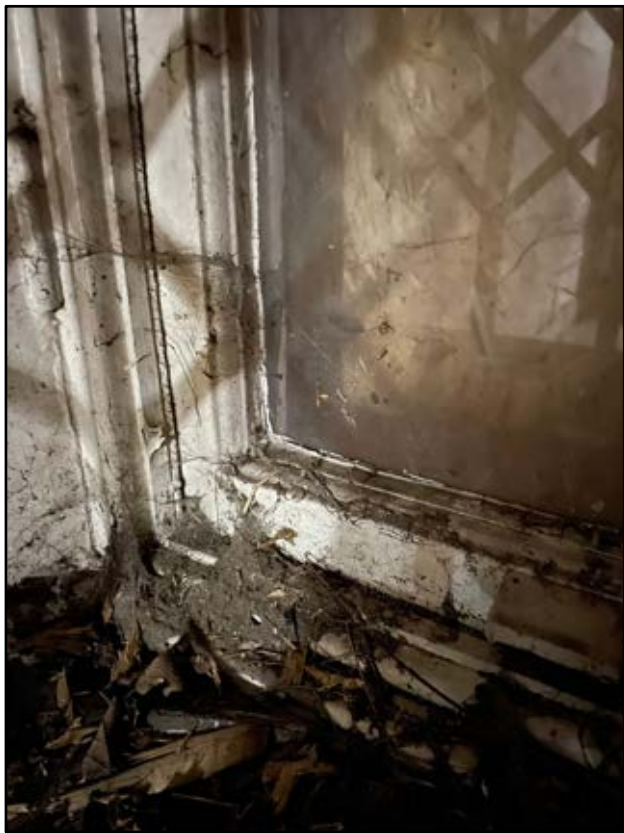
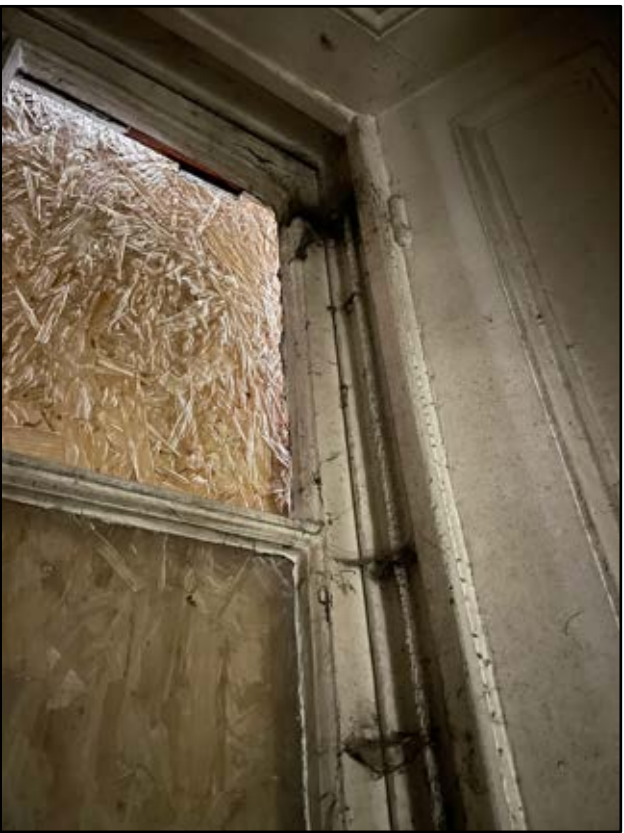
WINDOW **WG.22**

- Unable to open
- Original frame
- Damaged frame
- Glass mostly broken

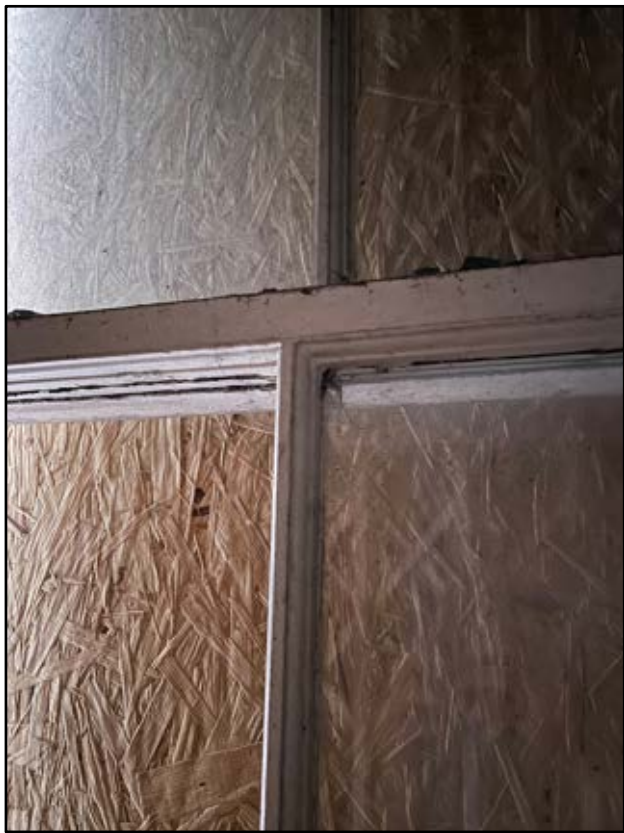
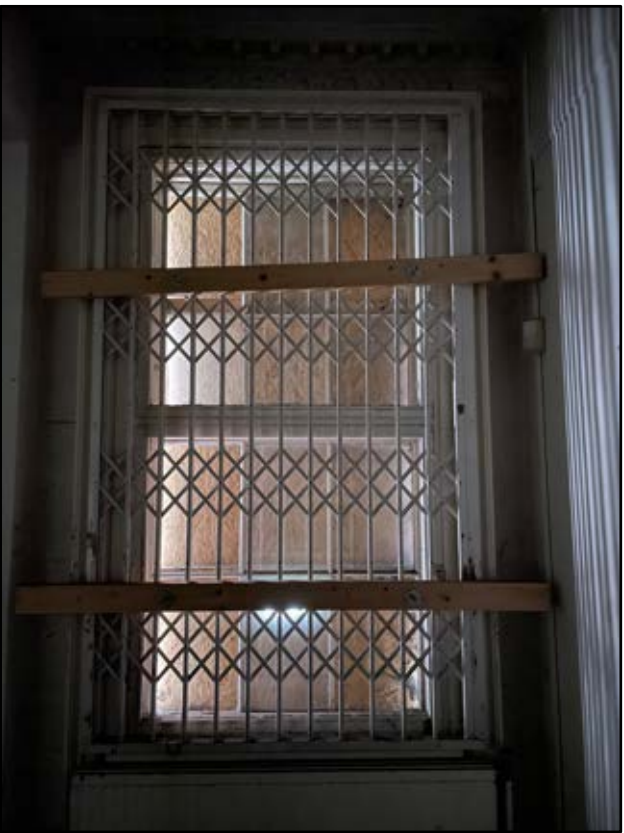
WINDOW WG.26

- Unable to open
- Original frame
- Damaged frame
- No glass (mostly broken)
- Non original glass

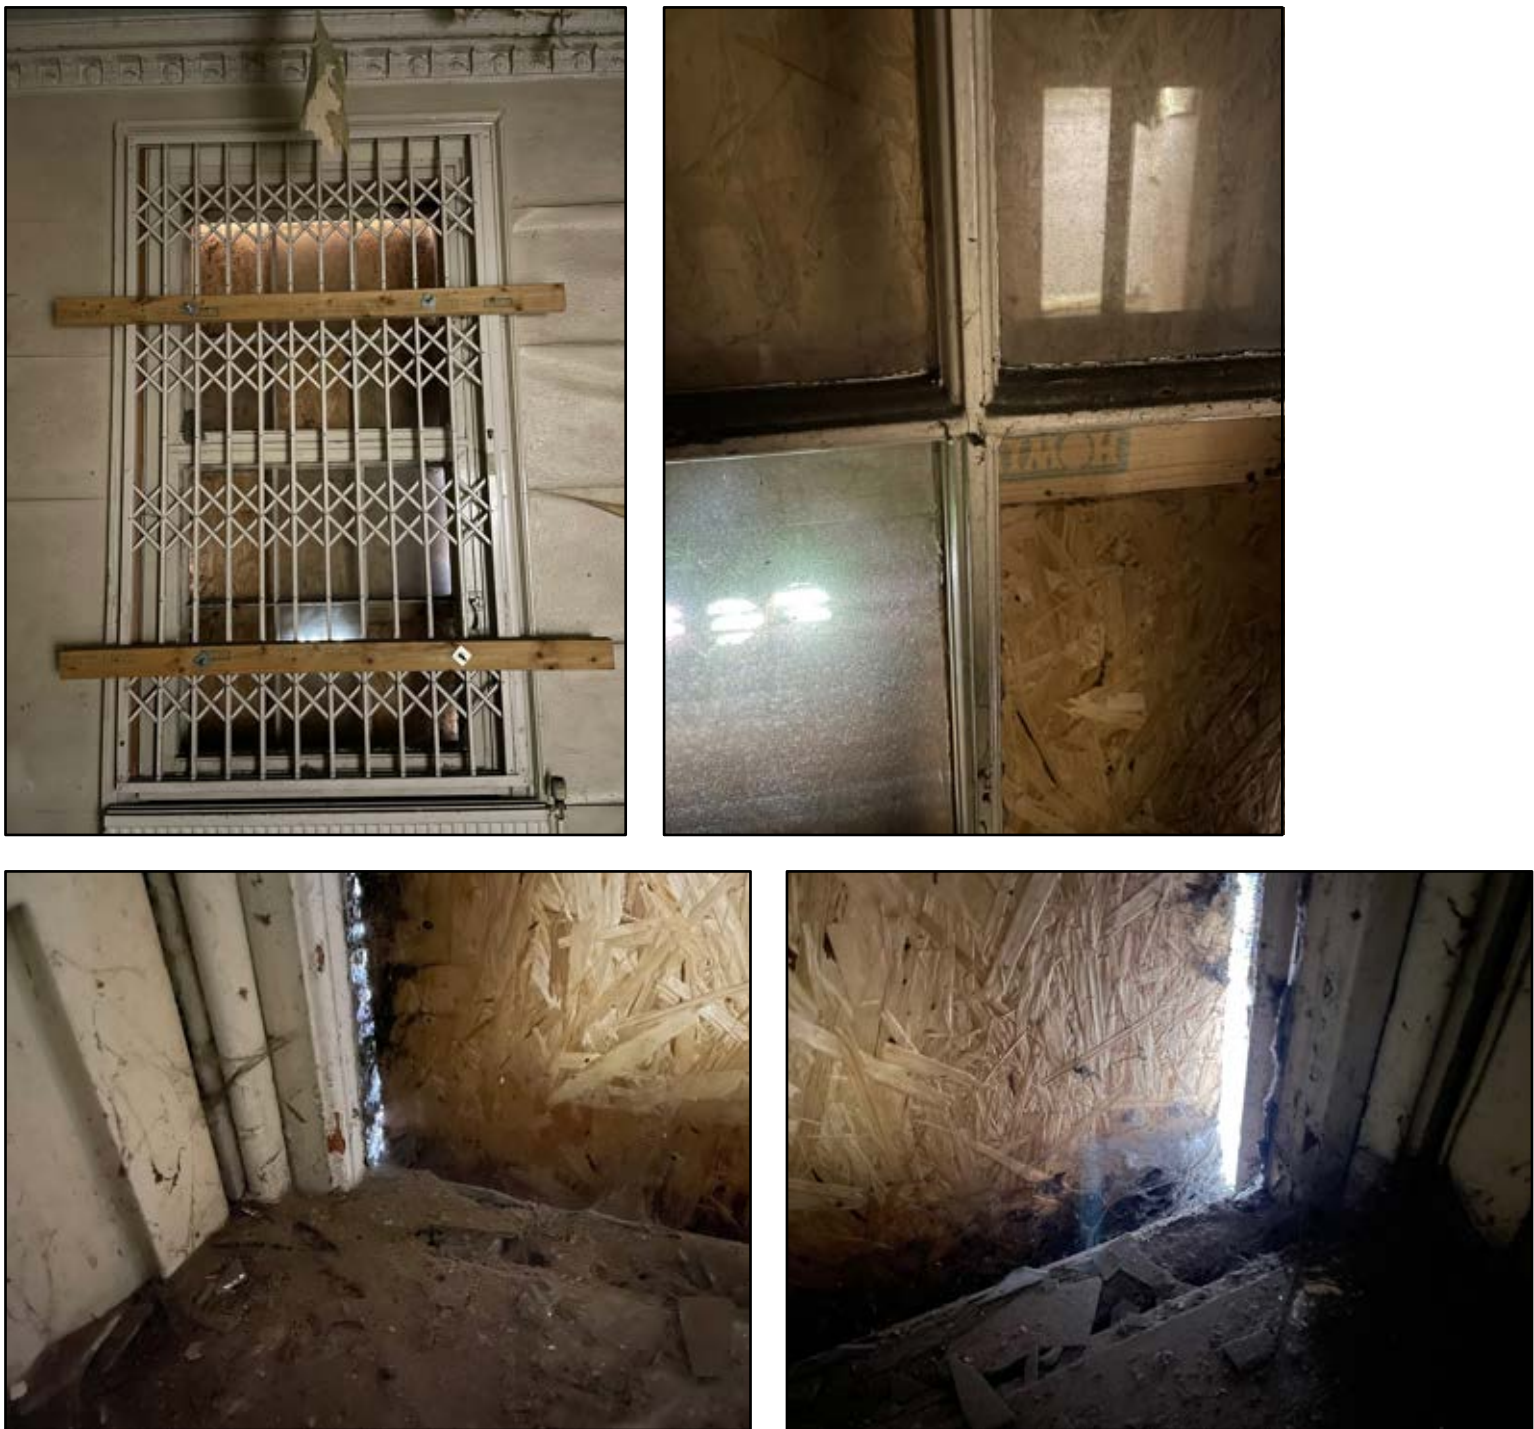
WINDOW WG.27

- Unable to open
- Original frame
- Damaged frame
- No glass (mostly broken)
- Non original glass

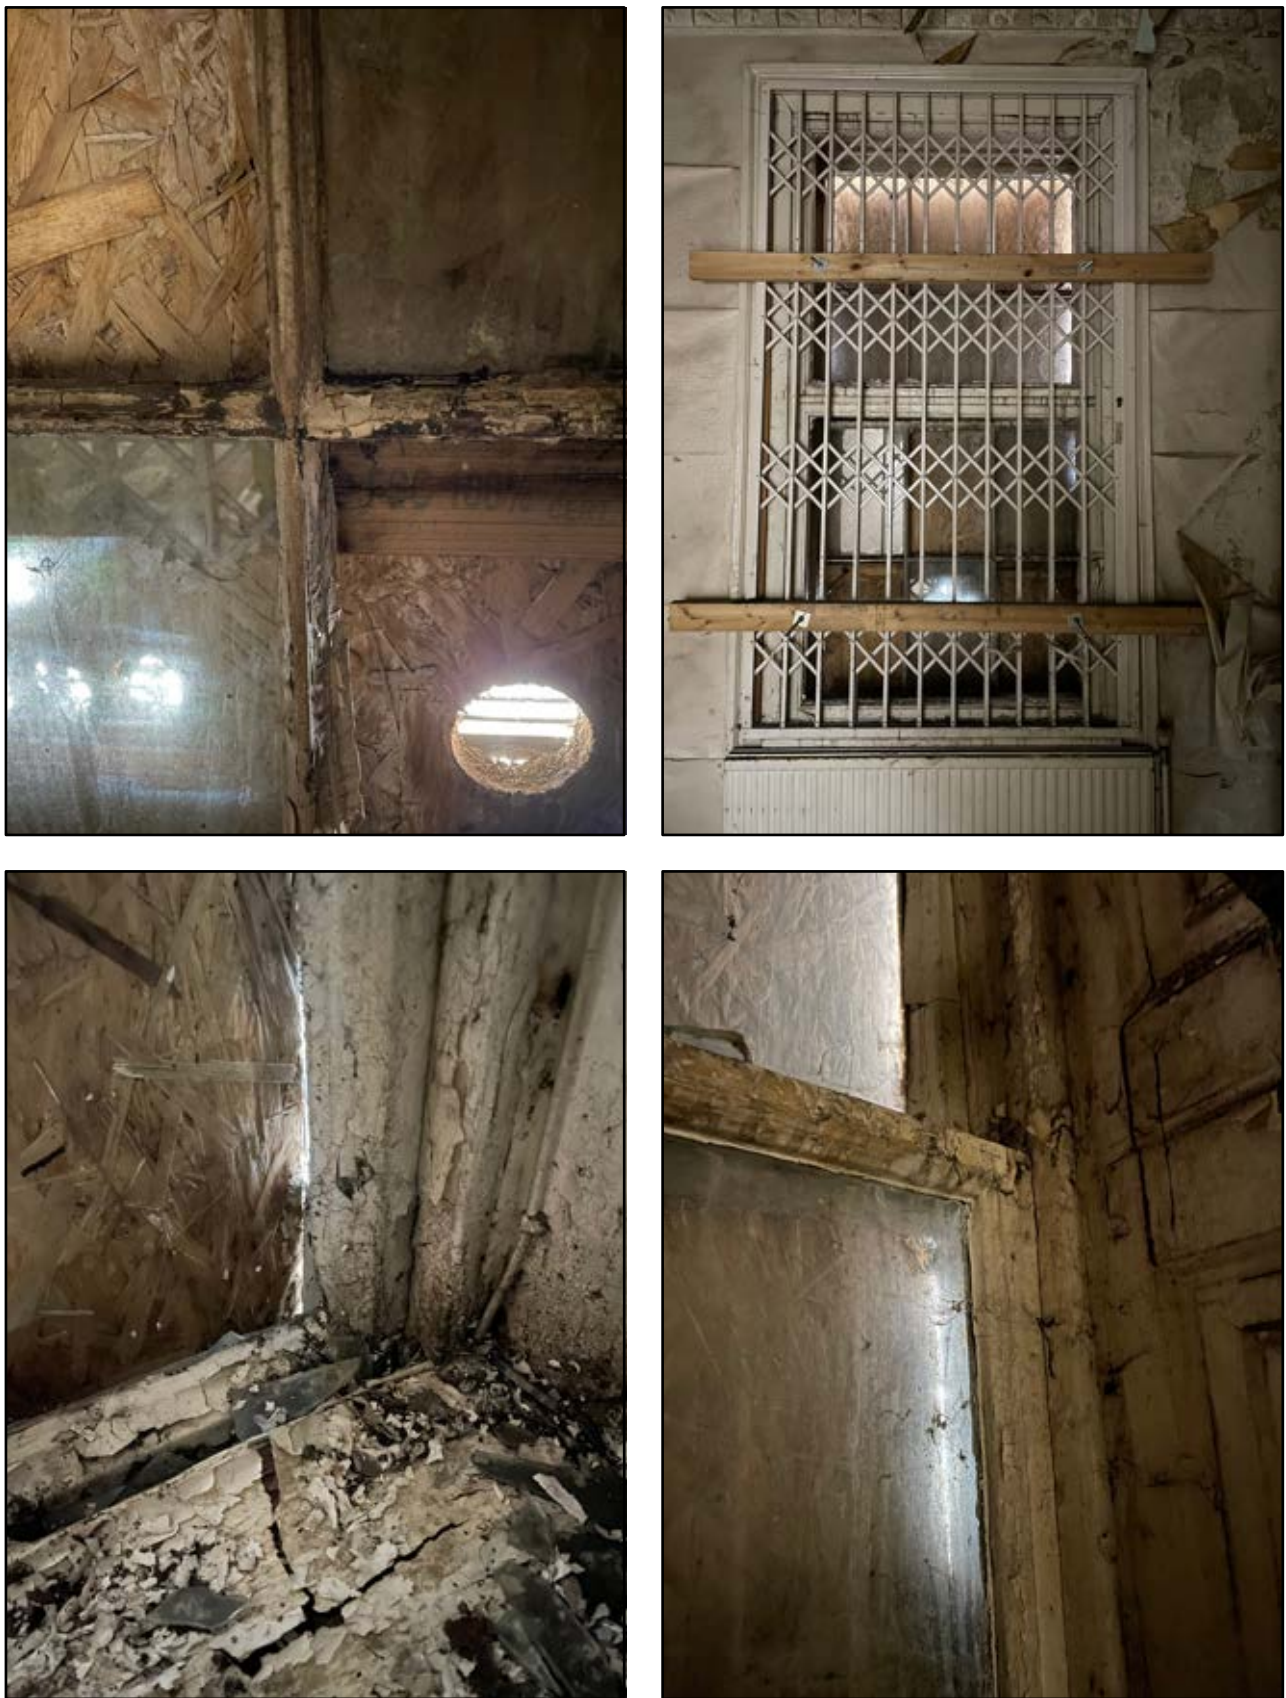
WINDOW WG.28

- Unable to open
- Original frame
- Damaged frame
- No glass (mostly broken)
- Non original glass

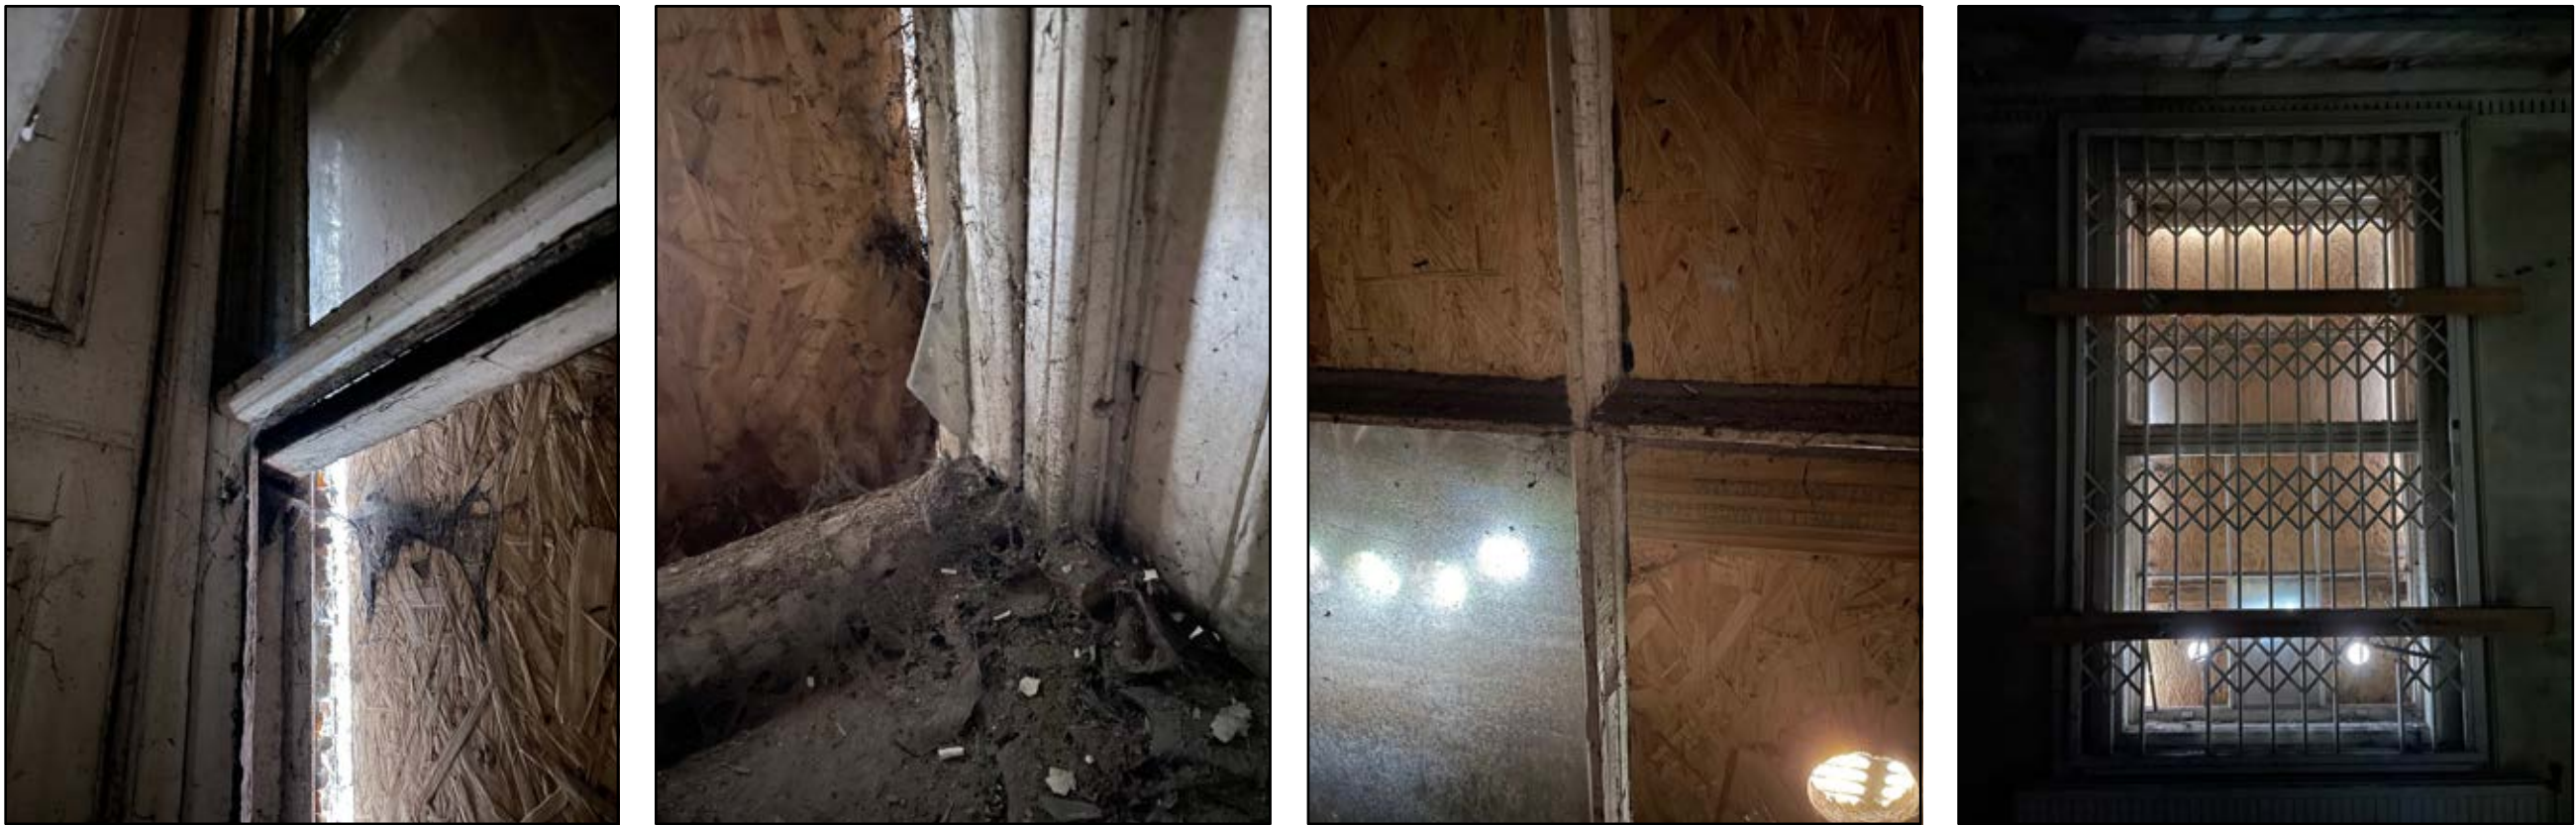
WINDOW WG.29

- Unable to open
- Original frame
- Damaged frame
- No glass (mostly broken)
- Non original glass
