GROUND FLOOR | WINDOWS

| snookarchitects | | project: | rev. | date | description |
|---|---|---|---|---|---|
| 89 Wood Street | Liverpool | bridgewater house | | | |
| t: 0151 707 0100 | | dwg title: | | window survey [1 of 16] | |

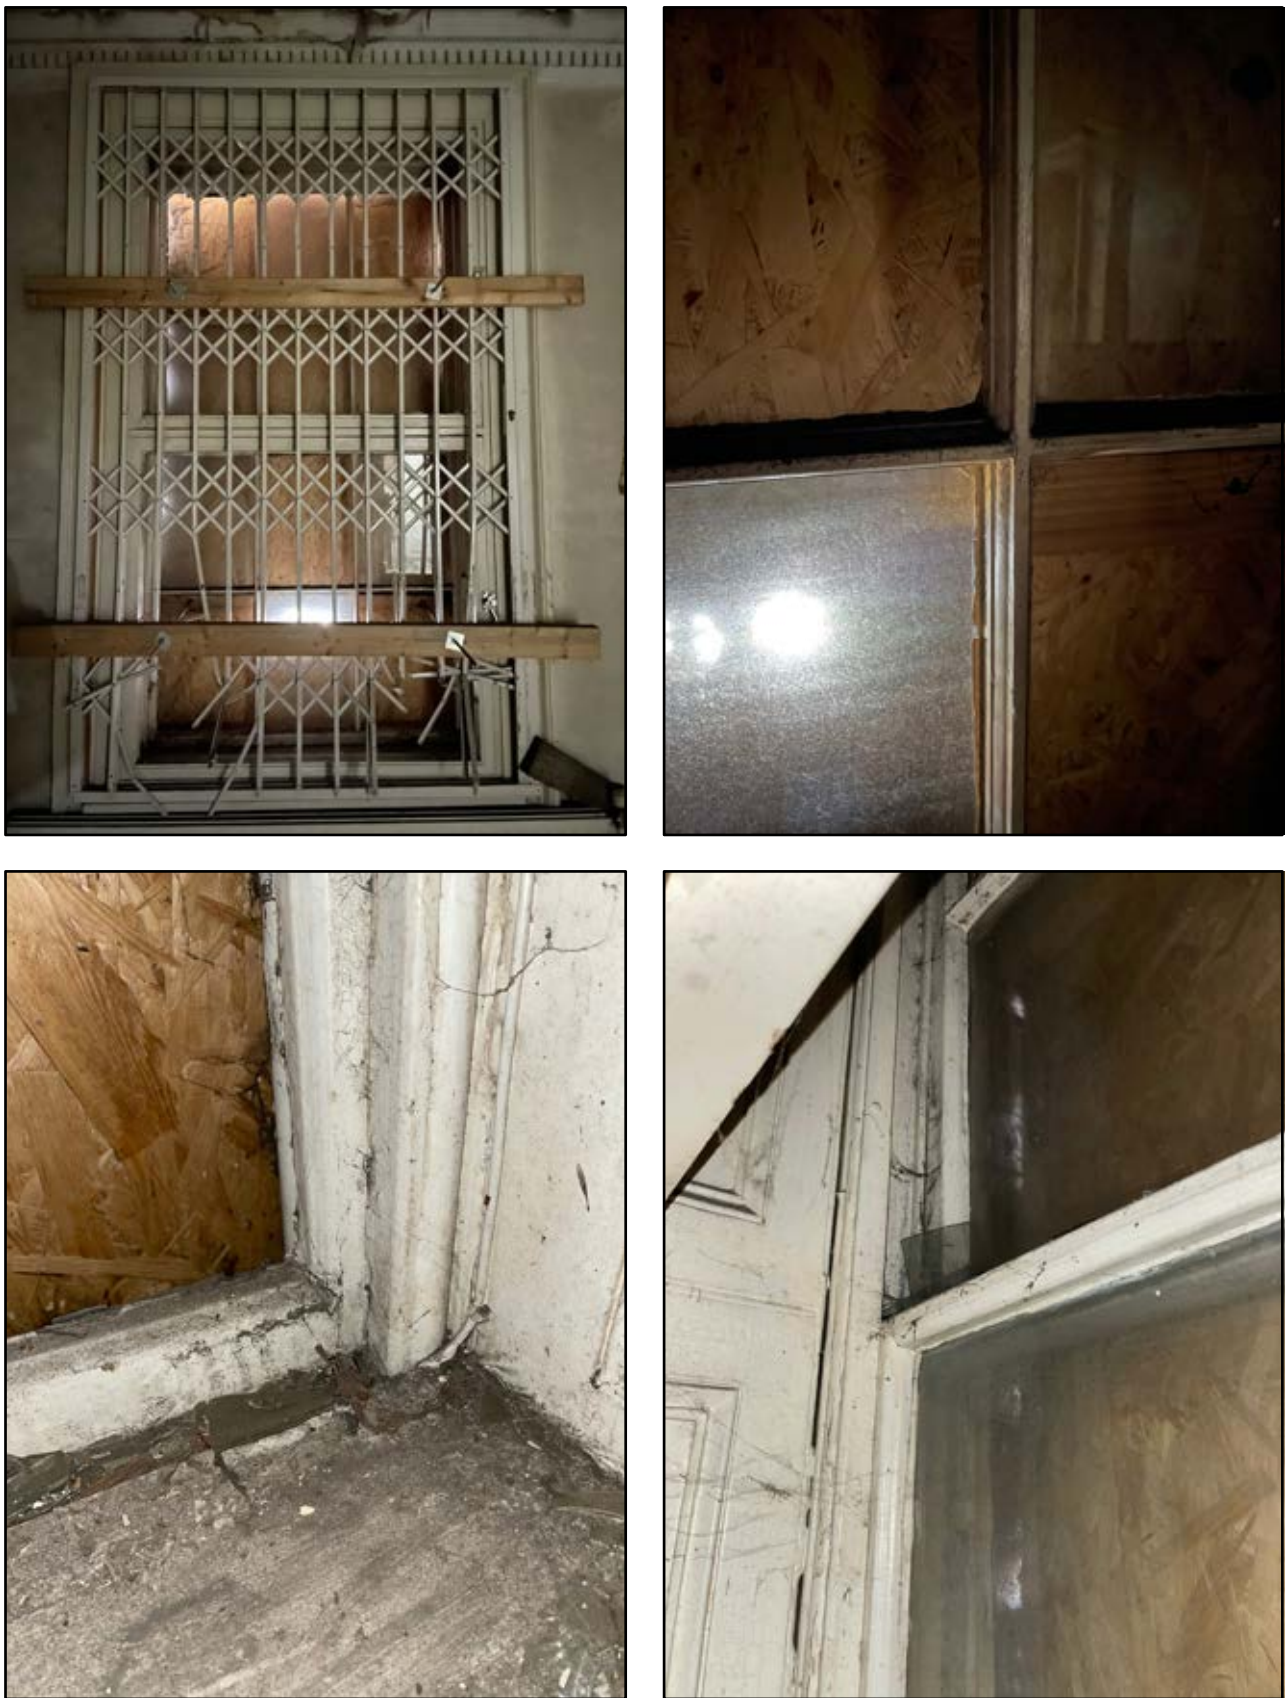
WINDOW WG.30

- Unable to open
- Original frame
- Damaged frame
- No glass (mostly broken)
- Non original glass

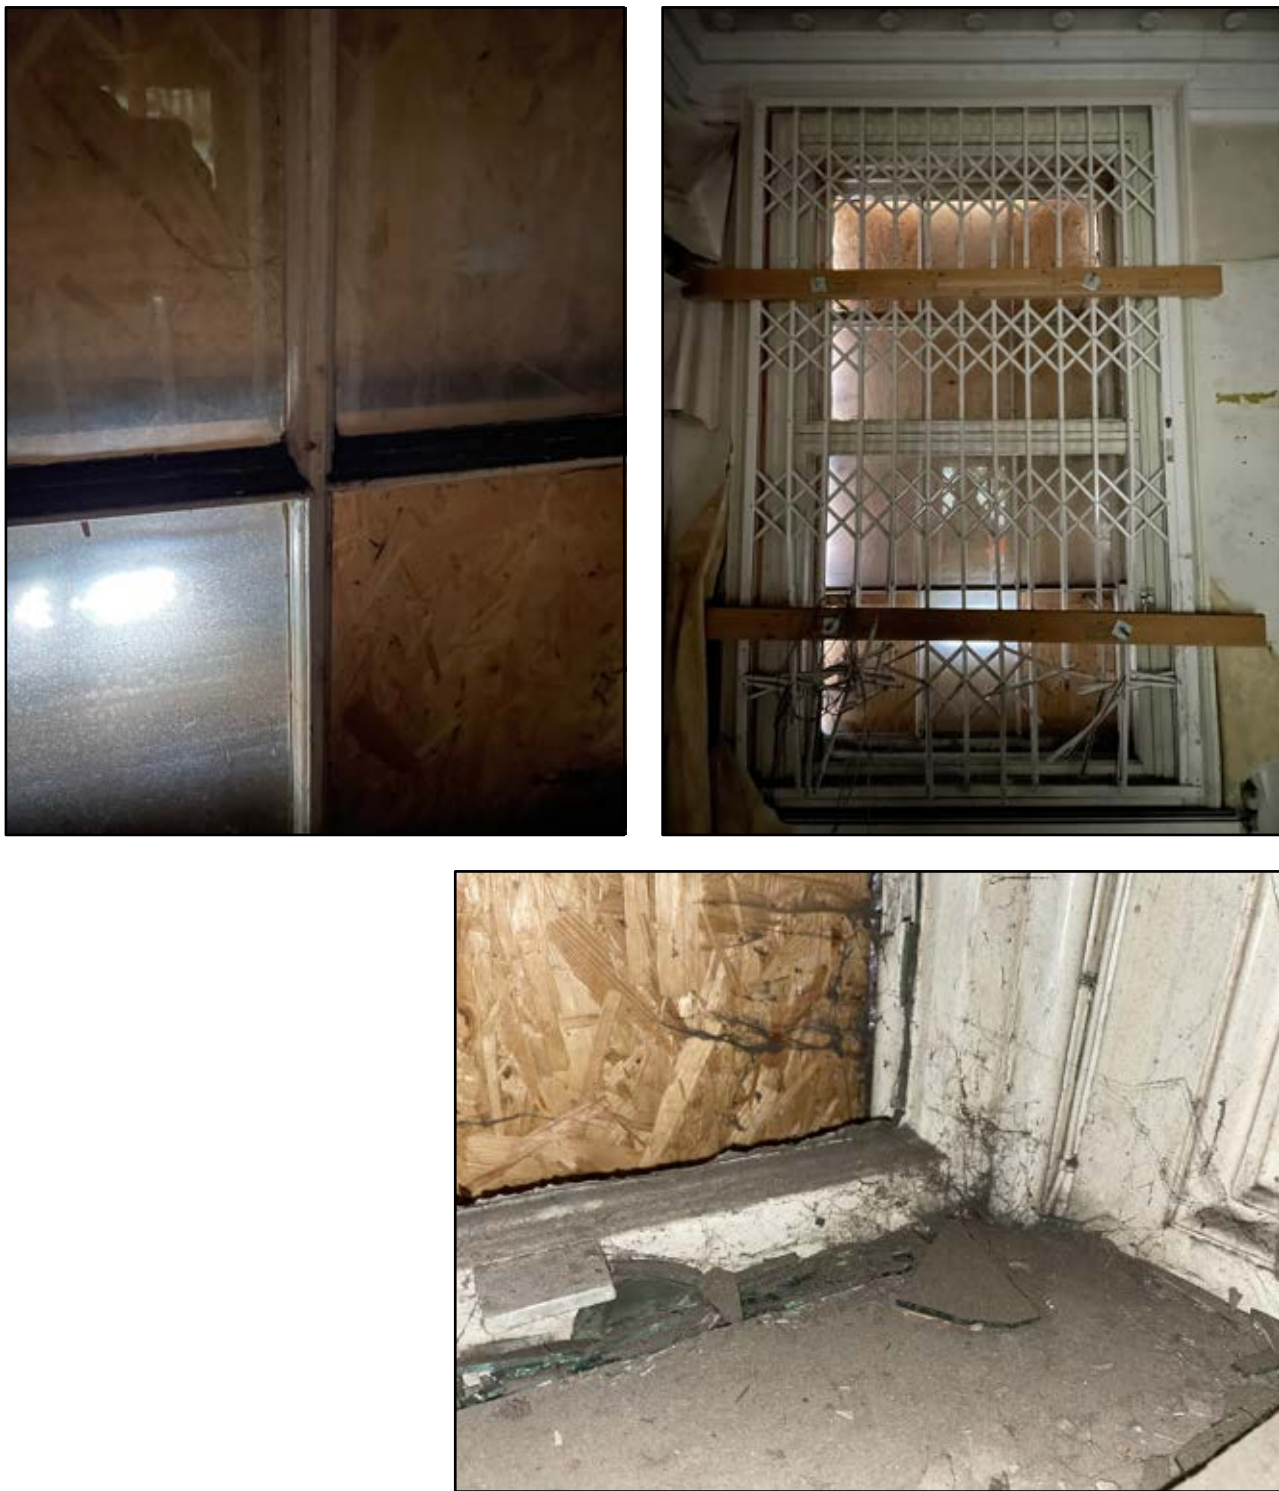
WINDOW WG.31

- Unable to open
- Original frame
- Damaged frame
- No glass (mostly broken)
- Non original glass

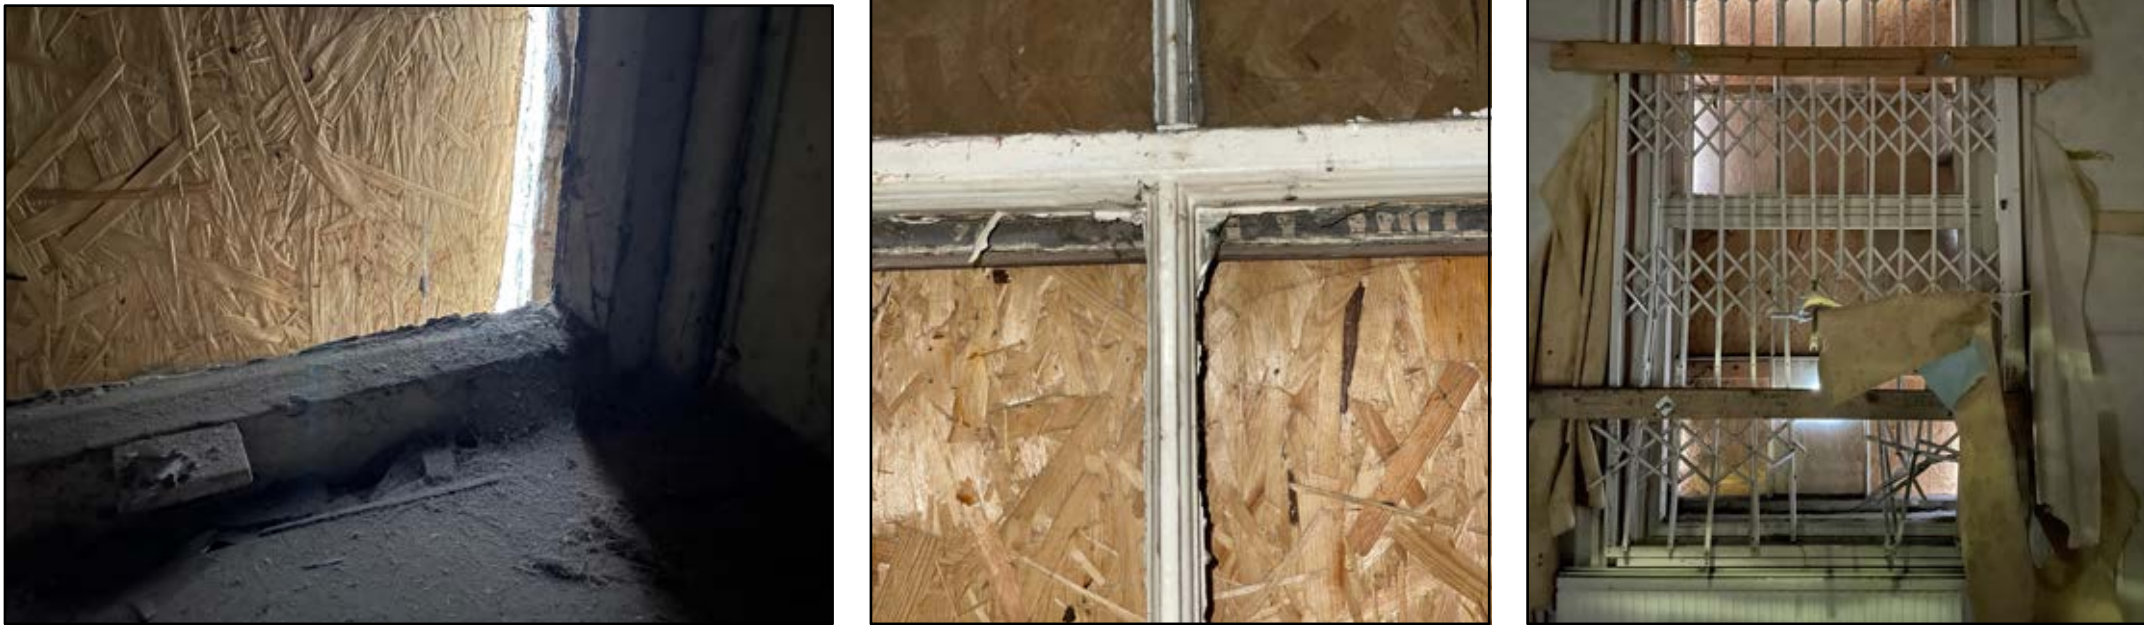
WINDOW WG.32

- Unable to open
- Original frame
- Damaged frame
- No glass (mostly broken)
- Non original glass

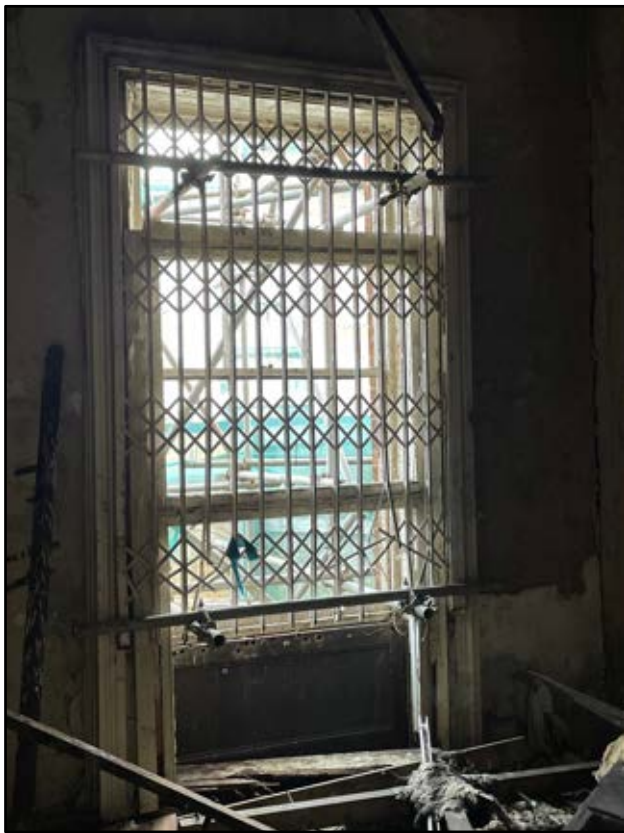
WINDOW **WG.34**

- Restricted access - Window is inaccessible due to collapsed ceiling and/or unsafe floor structure
- Photo taken from a distance
- Frame looks badly damaged

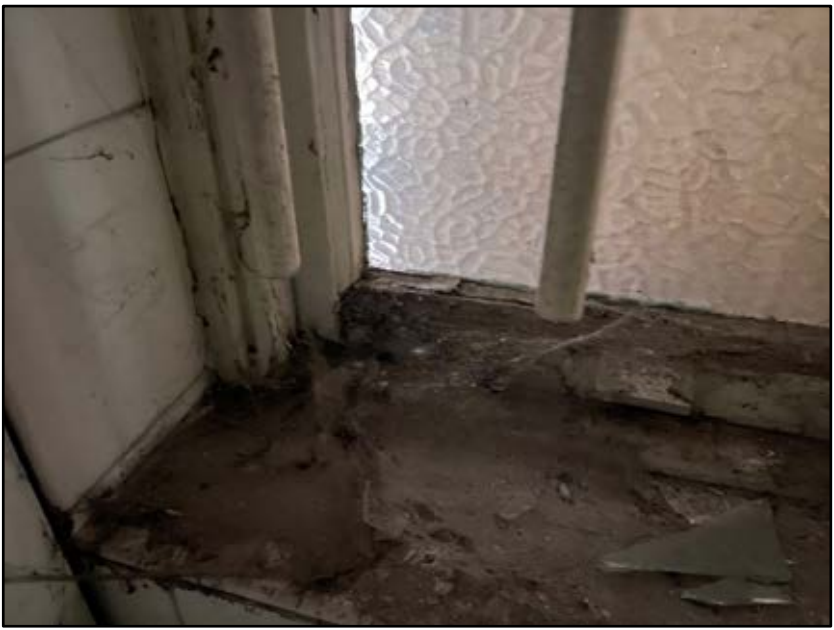
WINDOW **WG.39**

- Unable to open
- Original frame
- Damaged frame
- Non original glass

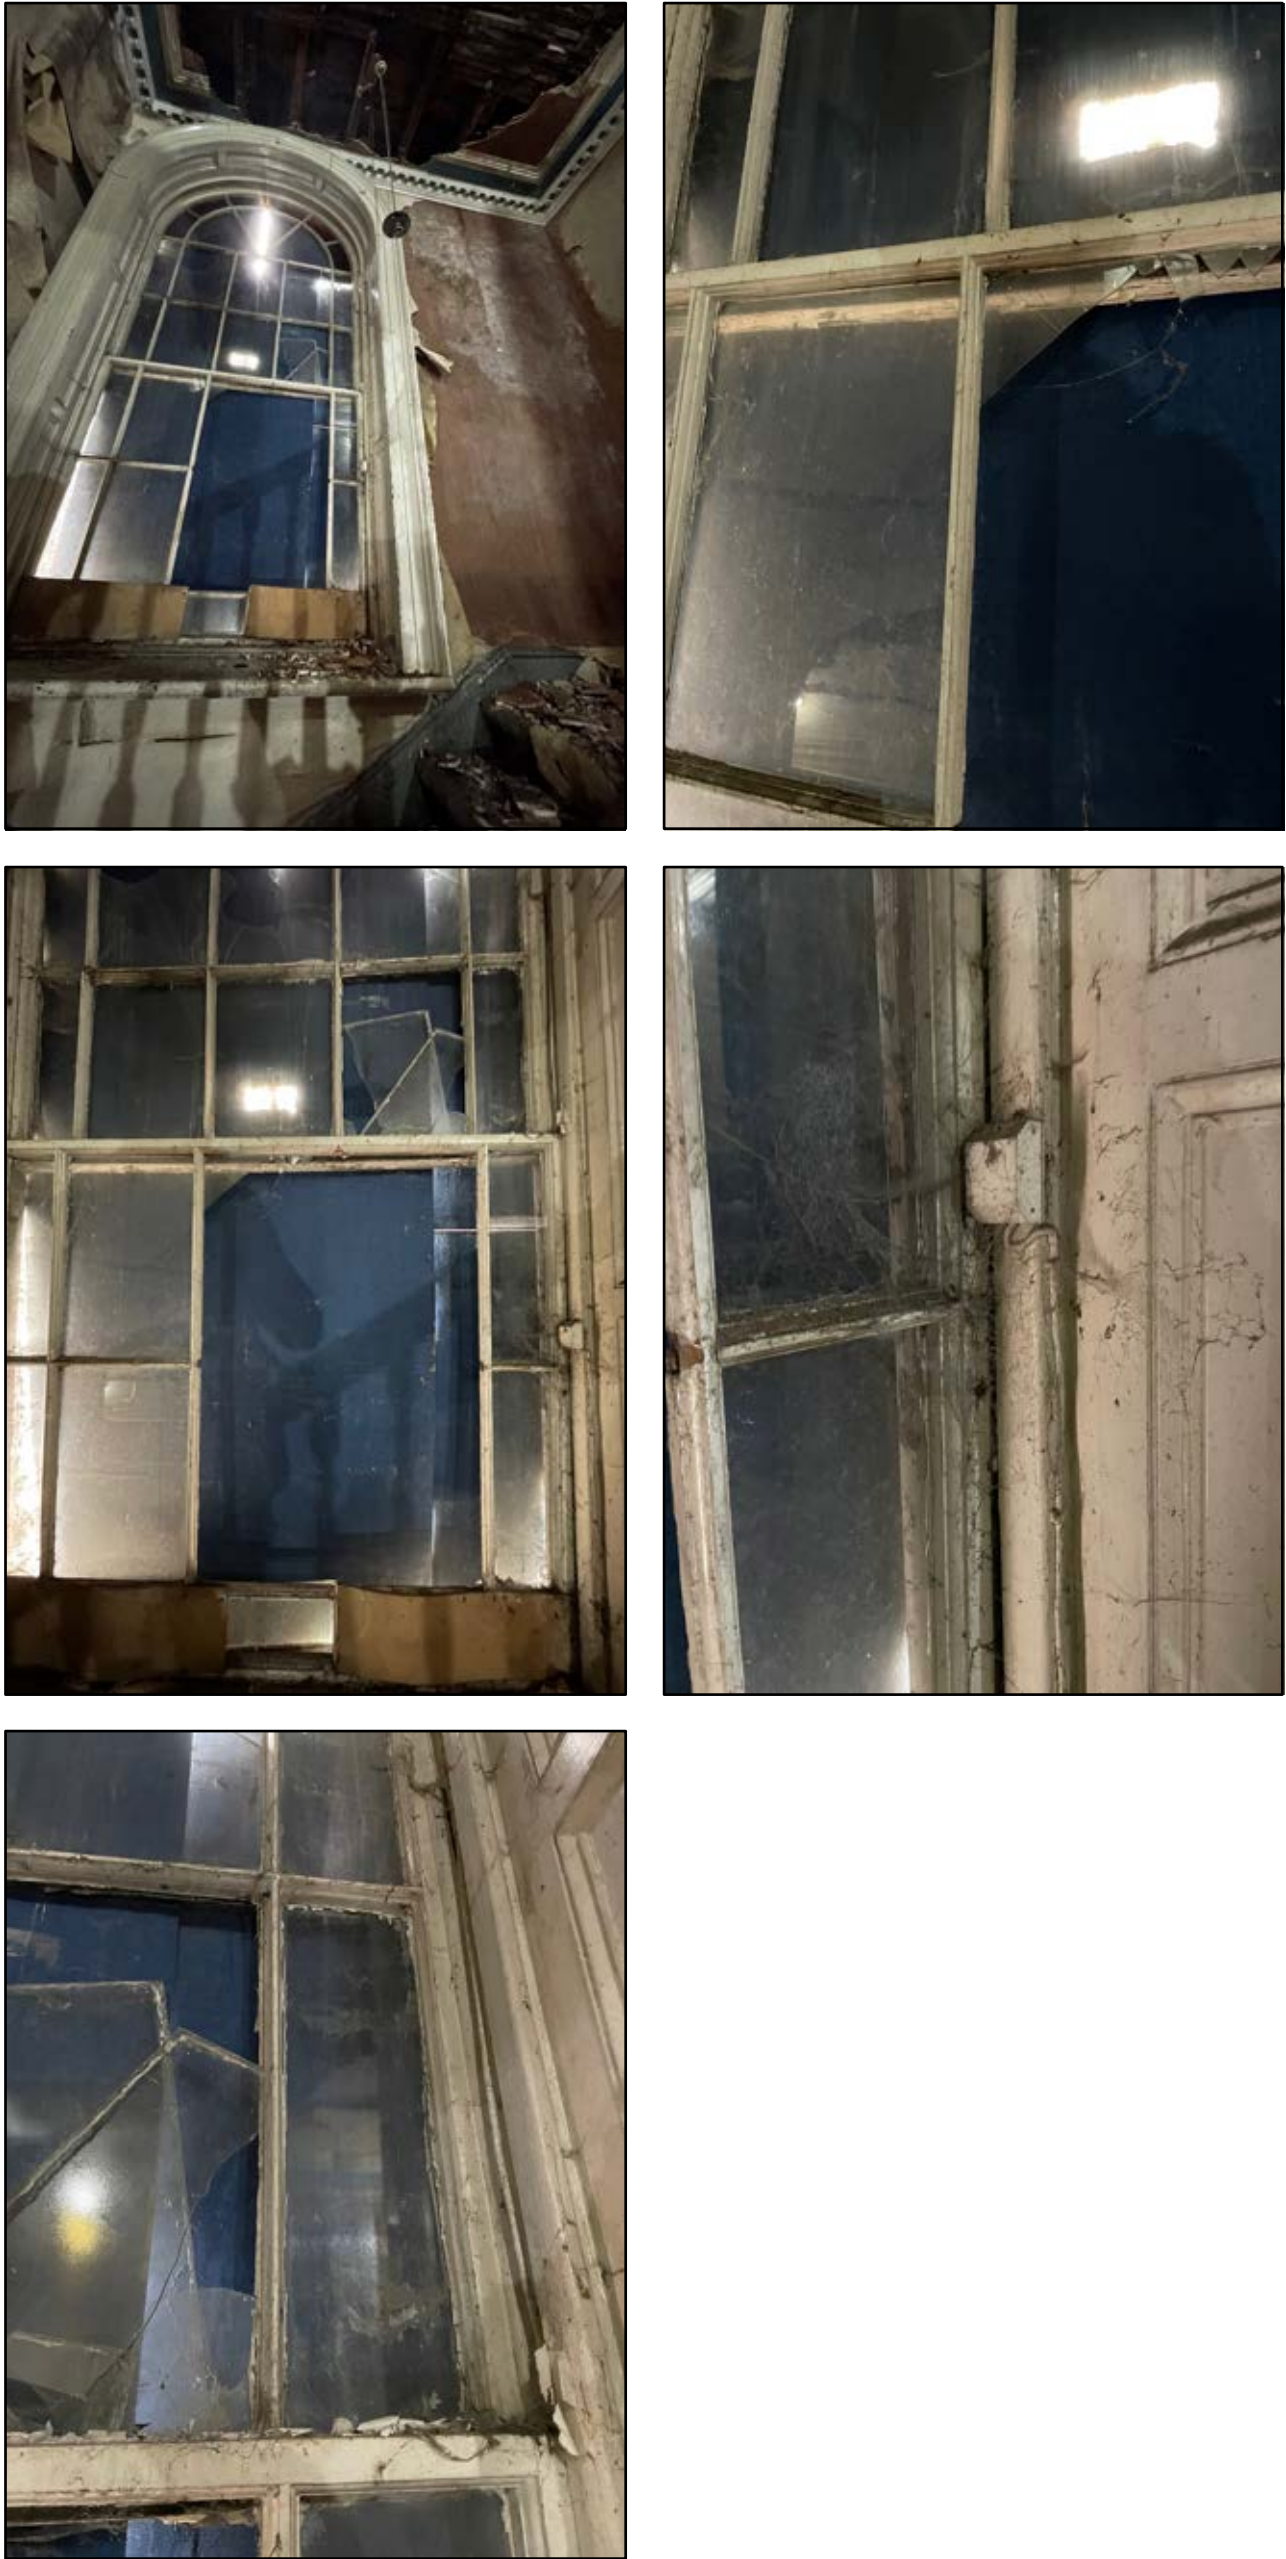
WINDOW W1.01

- Unable to open
- Damaged frame
- Non original glass
- Broken glass

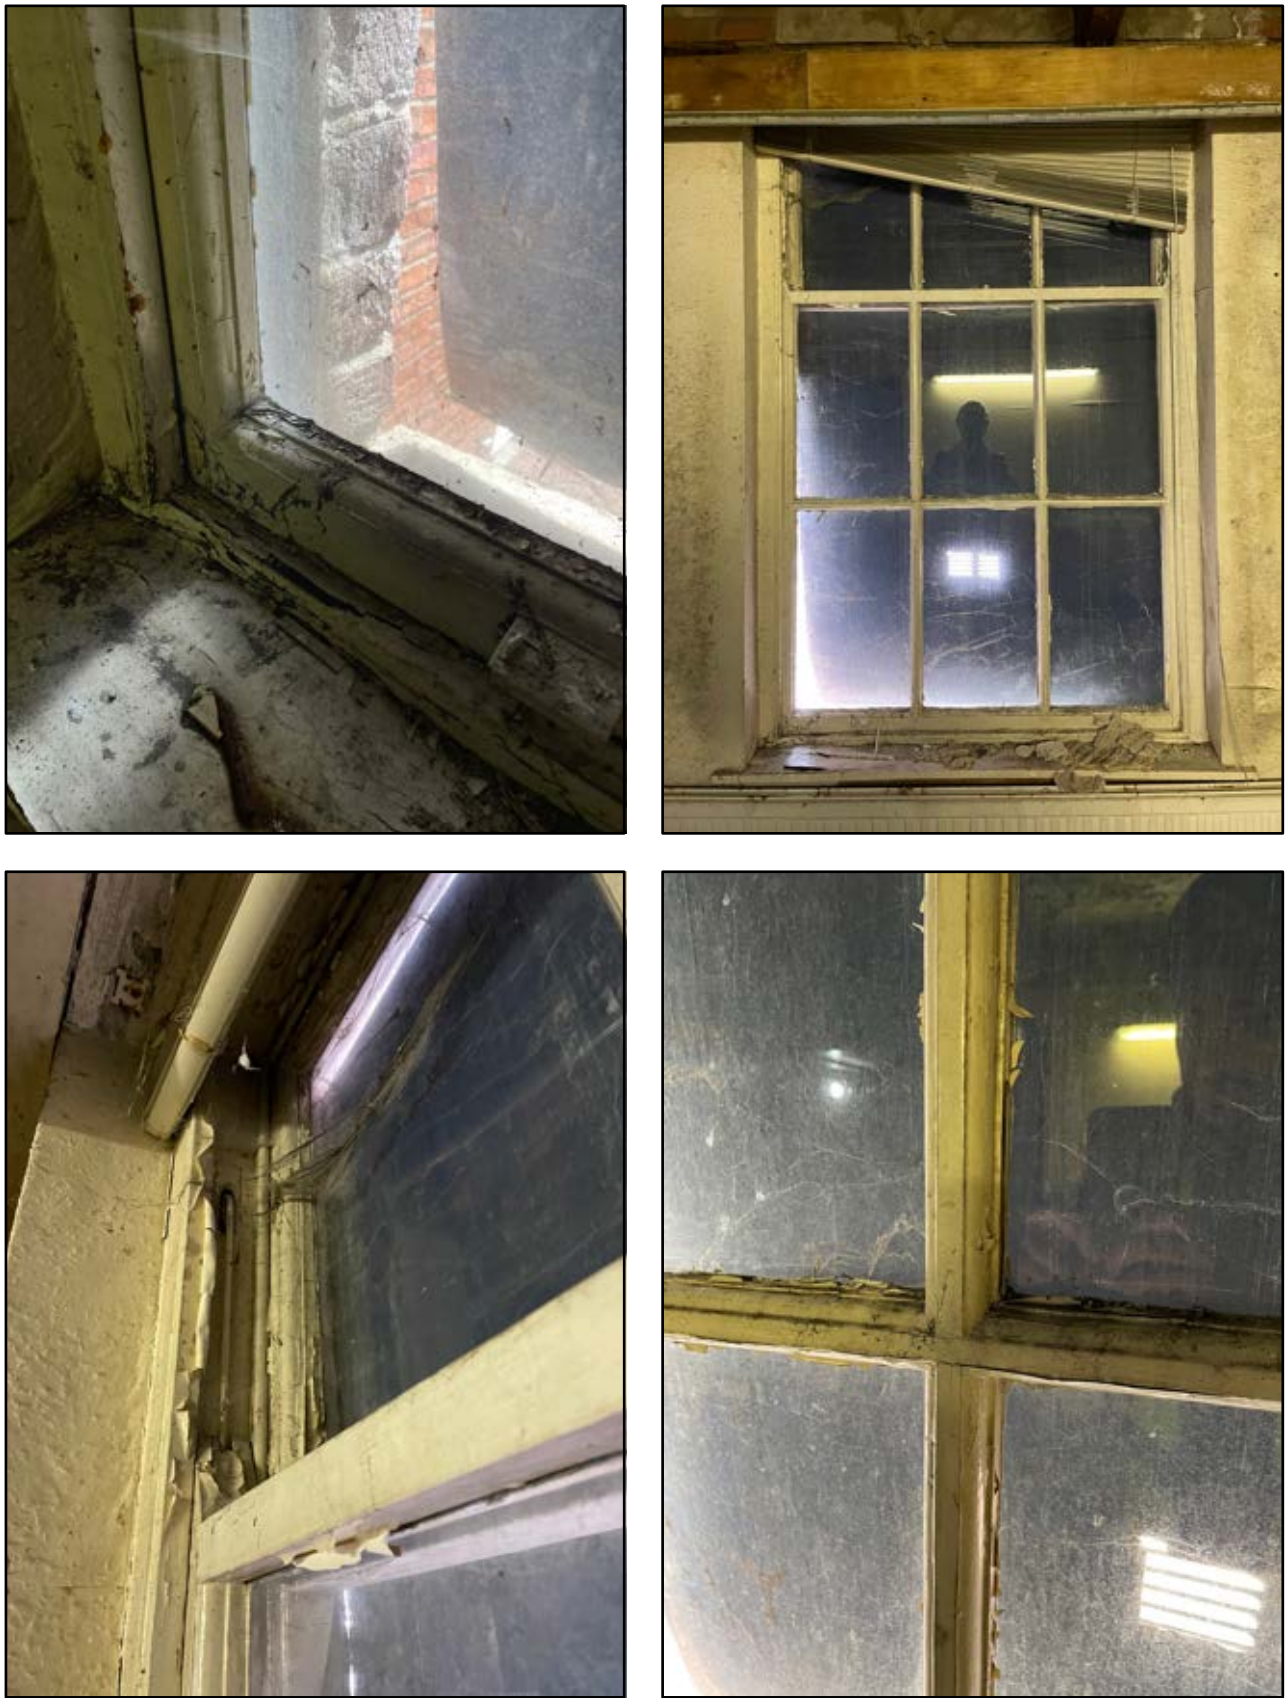
WINDOW W1.02

- Unable to open
- Non original frame
- Non original glass

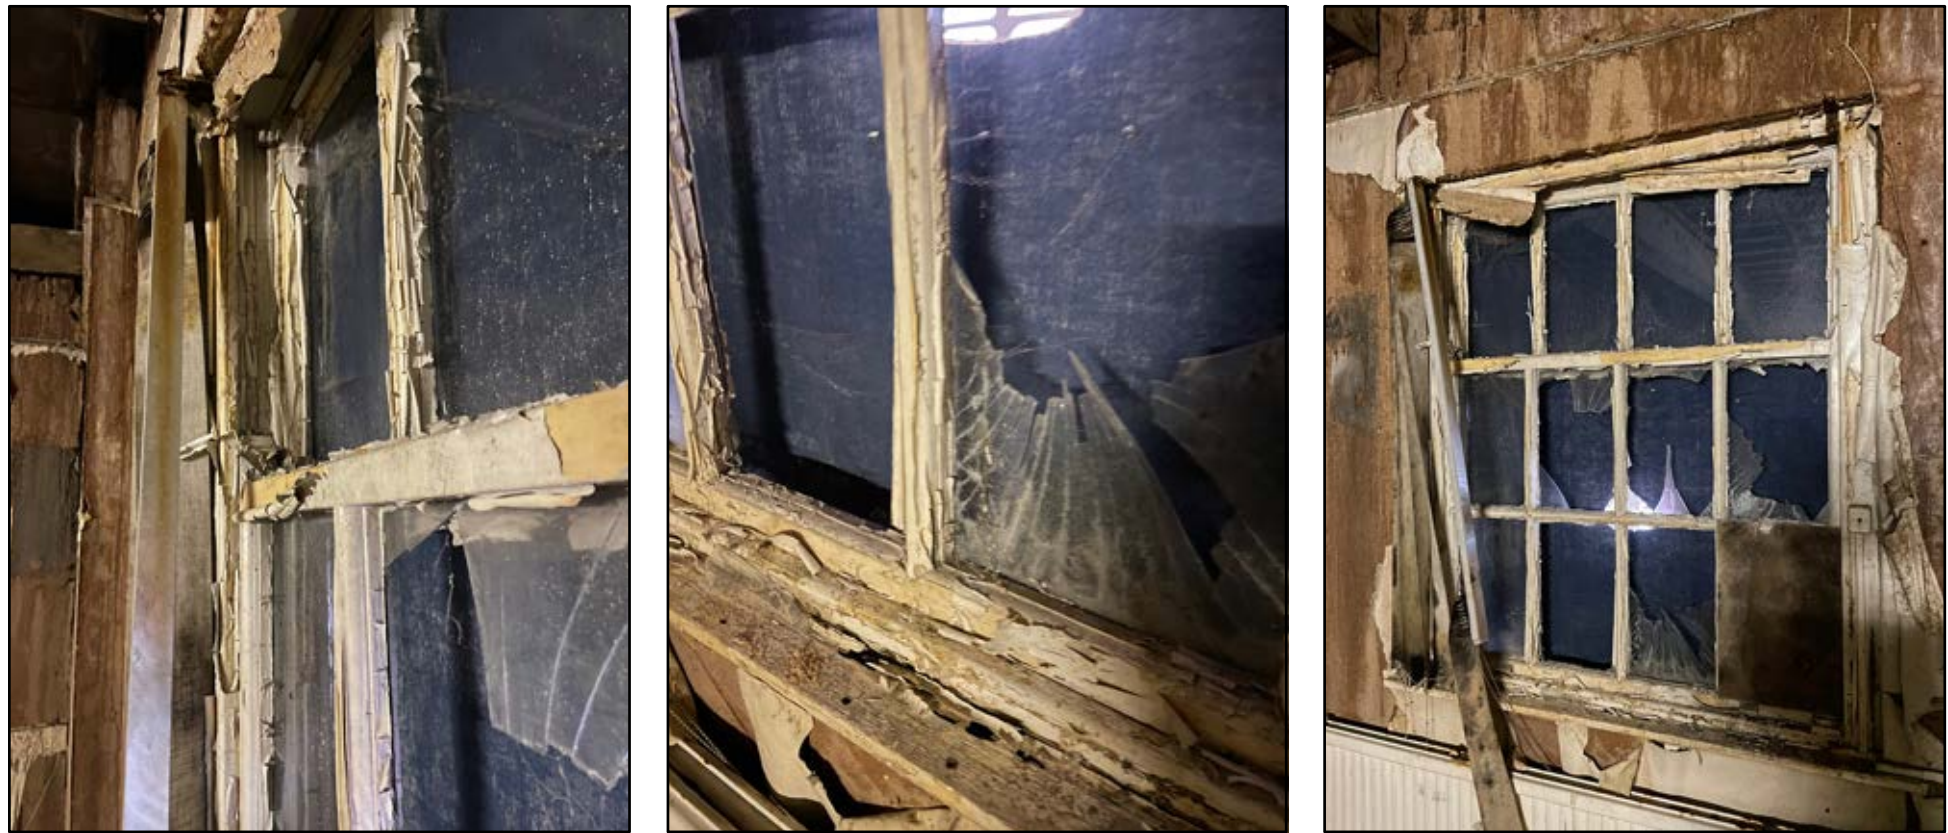
WINDOW W1.03

- Unable to open
- Non original frame
- Frame badly damaged
- Non original glass
- Glass broken

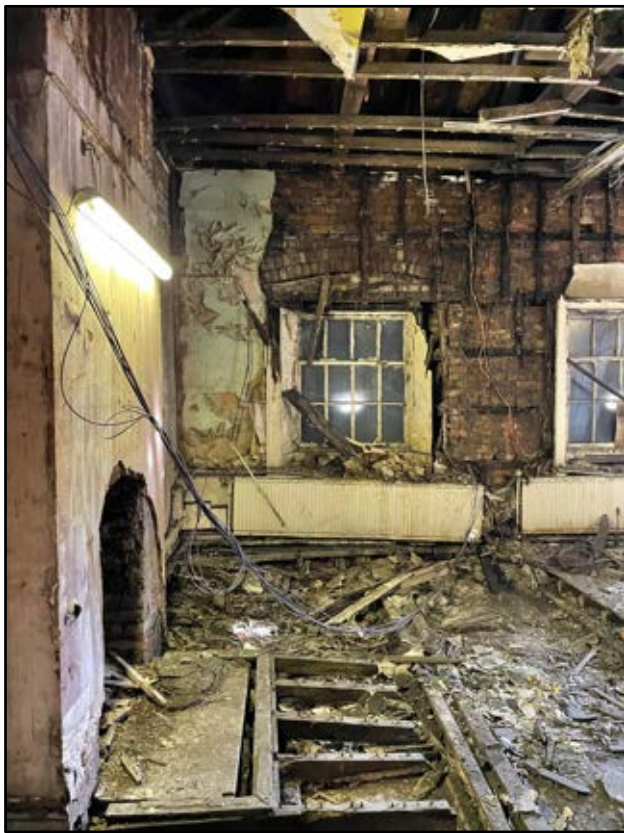
WINDOW **W1.05**

- Restricted access - Window is inaccessible due to collapsed ceiling and/or unsafe floor structure
- Photo taken from a distance
- Frame looks badly damaged

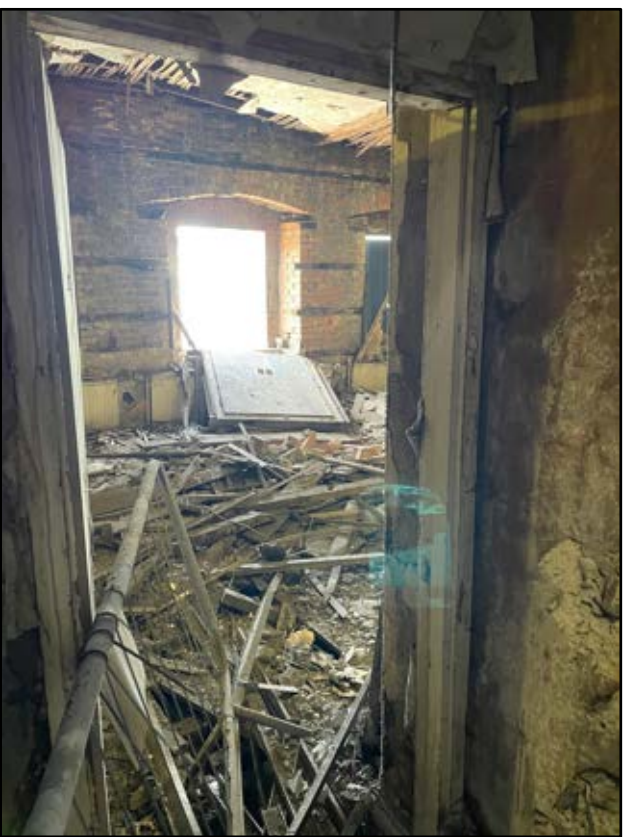
WINDOW **W1.07**

- Restricted access - Window is inaccessible due to collapsed ceiling and/or unsafe floor structure
- Photo taken from a distance
- Window is completely destroyed

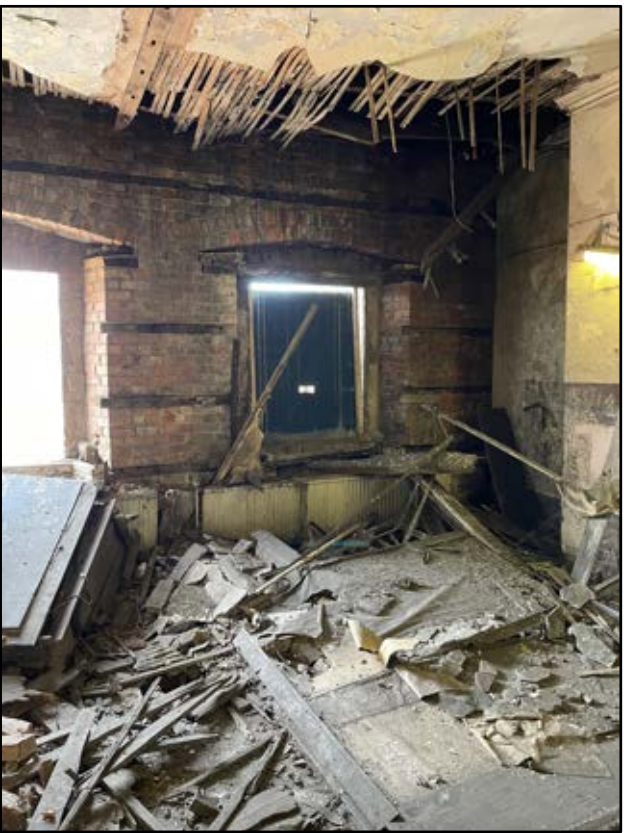
WINDOW **W1.08**

- Restricted access - Window is inaccessible due to collapsed ceiling and/or unsafe floor structure
- Photo taken from a distance
- Frame is completely destroyed
- There seems to be no glass remaining
- Window is boarded from the outside

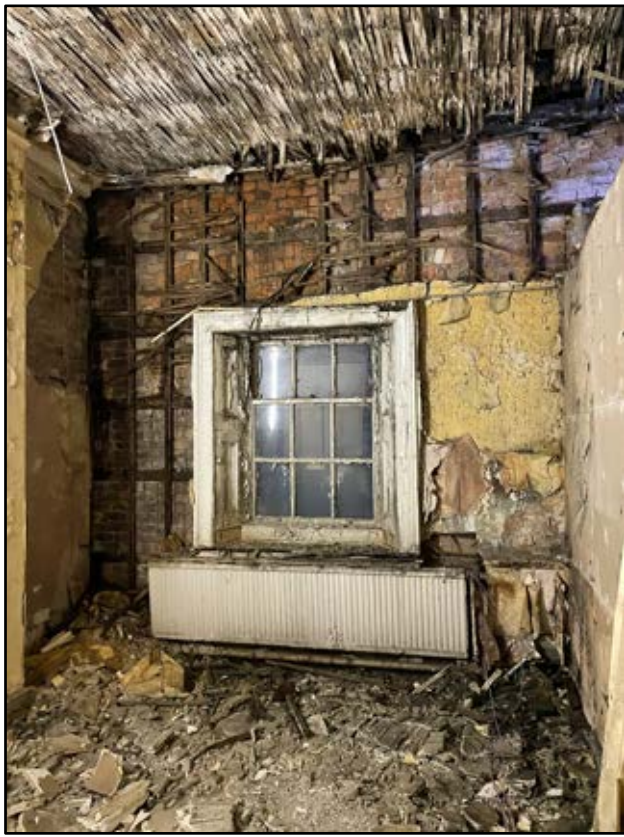
WINDOW **W1.13**

- Restricted access - Window is inaccessible due to collapsed ceiling and/or unsafe floor structure
- Photo taken from a distance
- Frame looks badly damaged

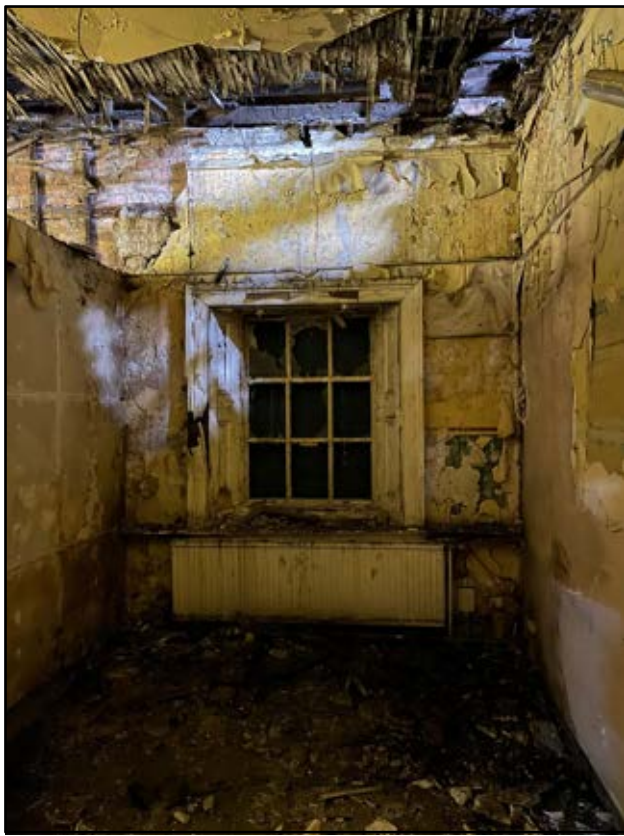
WINDOW **W1.14**

- Restricted access - Window is inaccessible due to collapsed ceiling and/or unsafe floor structure
- Photo taken from a distance
- Frame looks badly damaged
- Glass appears to be broken

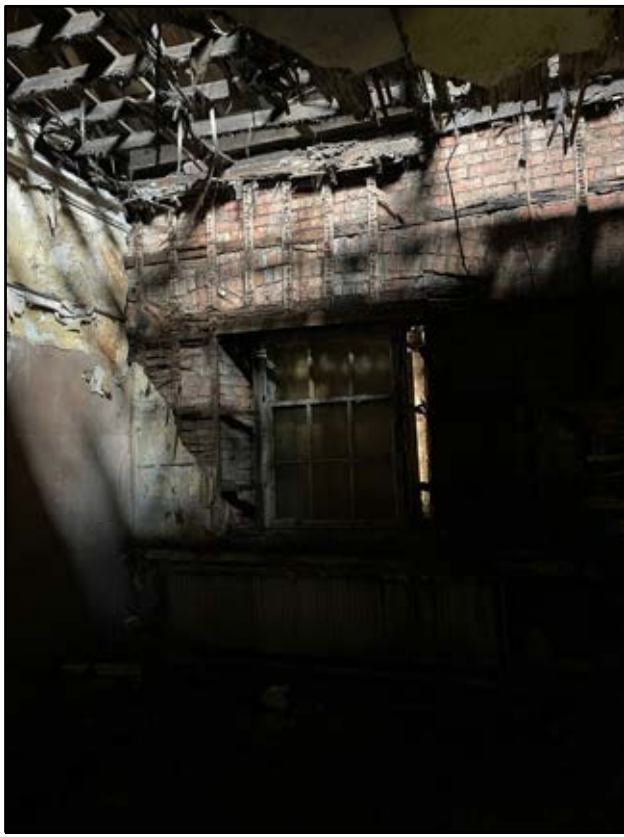
WINDOW **W1.15**

- Restricted access - Window is inaccessible due to collapsed ceiling and/or unsafe floor structure
- Photo taken from a distance
- Frame looks badly damaged
- Glass appears to be broken

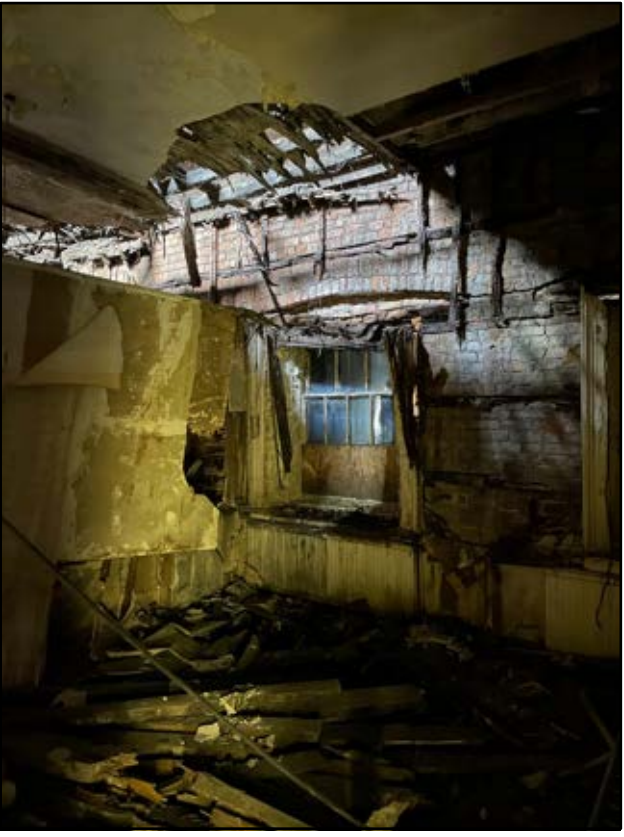
WINDOW **W1.16**

- Restricted access - Window is inaccessible due to collapsed ceiling and/or unsafe floor structure
- Photo taken from a distance
- Frame looks badly damaged
- Window is partially boarded up

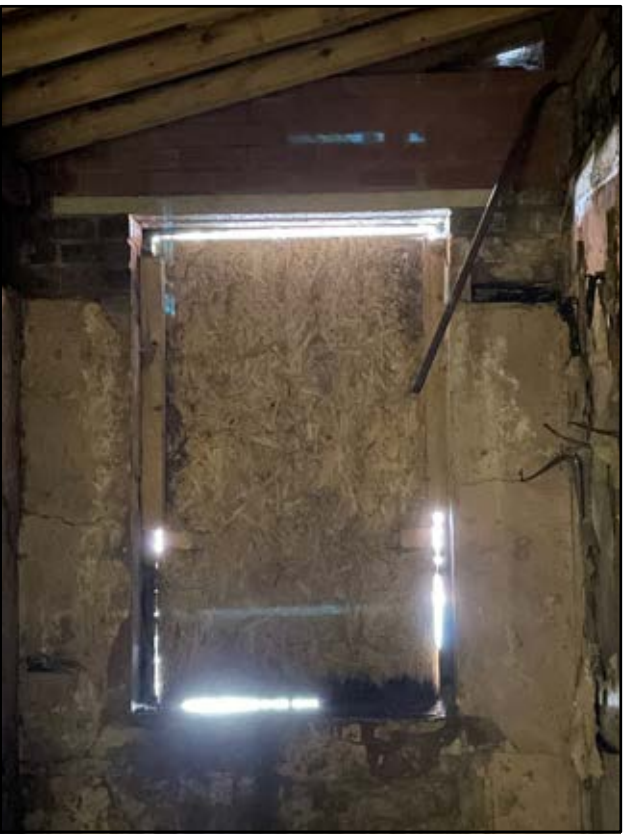
WINDOW **W1.18**

- Restricted access - Window is inaccessible due to collapsed ceiling and/or unsafe floor structure
- Photo taken from a distance
- Frame appears to be gone completely
- No glass remaining
- Window is boarded from the outside

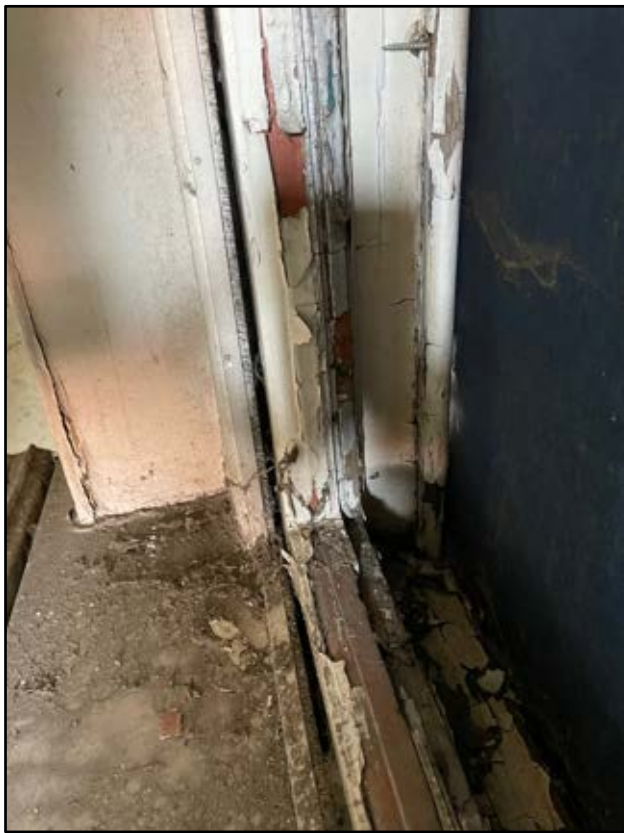
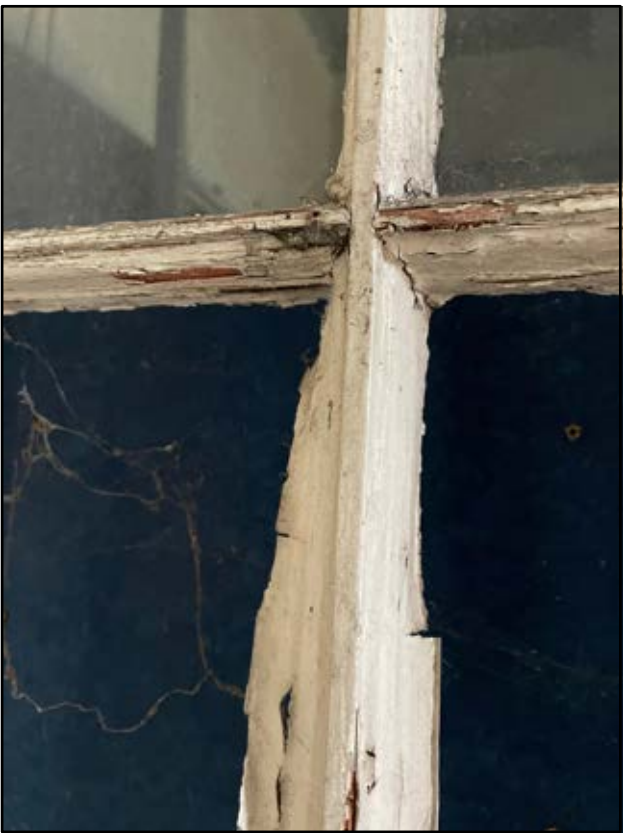
WINDOW **W1.20**

- Frame looks original
- Frame is rotten
- Glass is missing and/or broken

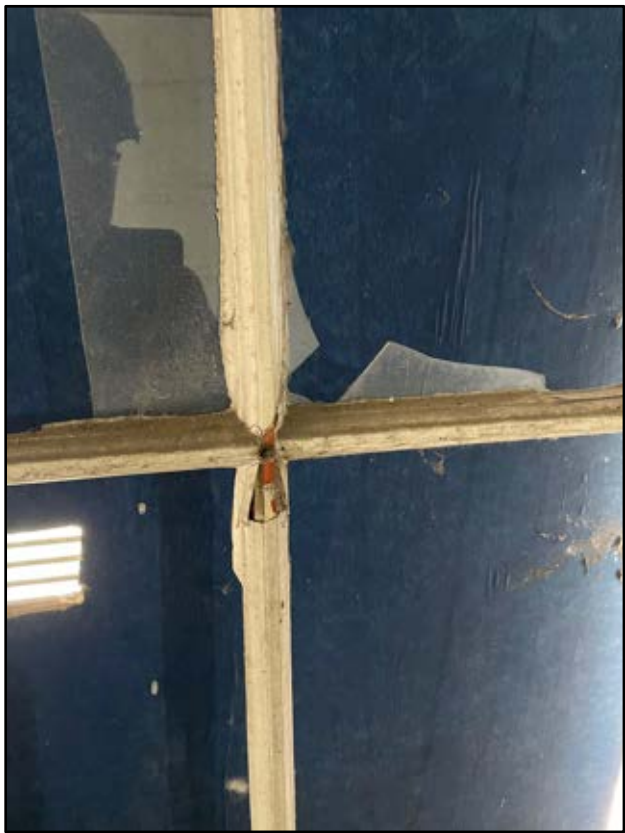
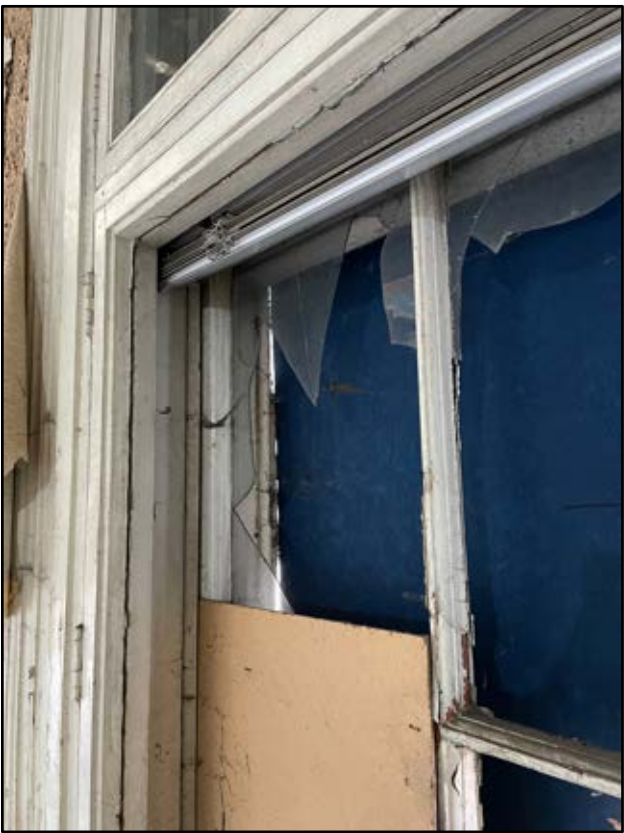
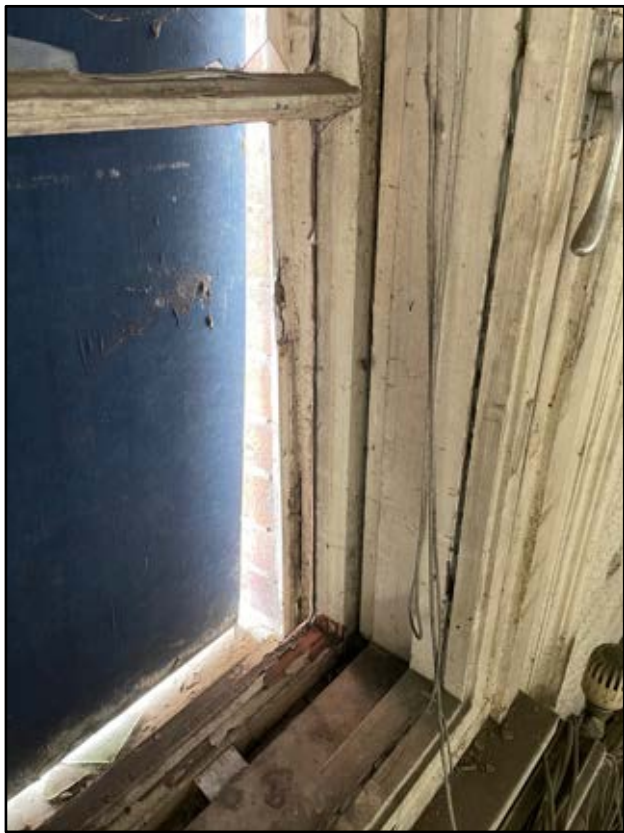
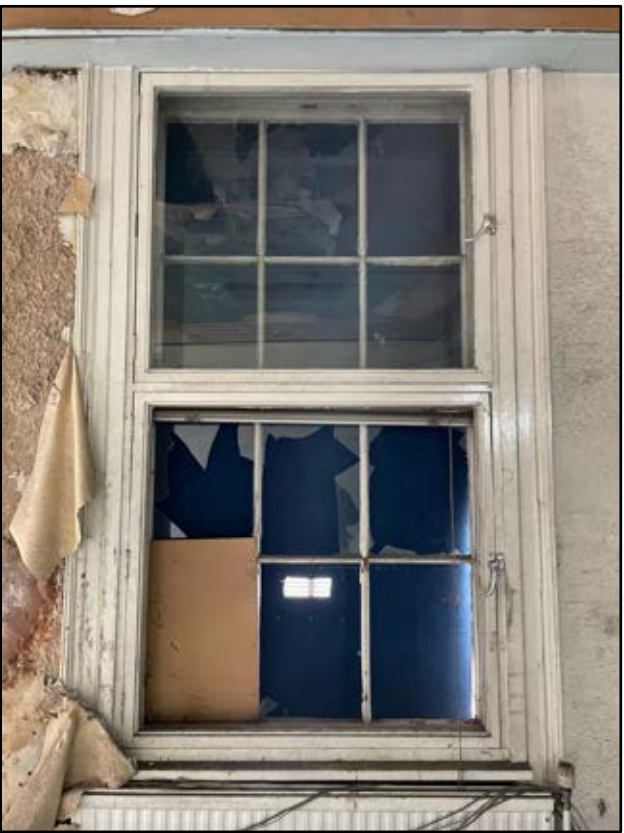
WINDOW **W1.23**

- Unable to open
- Original frame
- Frame is rotten
- Glass is missing and/or broken
- No chords
