GROUND FLOOR | WINDOWS

| snookarchitects | | project: | rev. | date | description |
|---|---|---|---|---|---|
| 89 Wood Street | Liverpool | bridgewater house | | | |
| t: 0151 707 0100 | | dwg title: | | window survey [1 of 16] | |

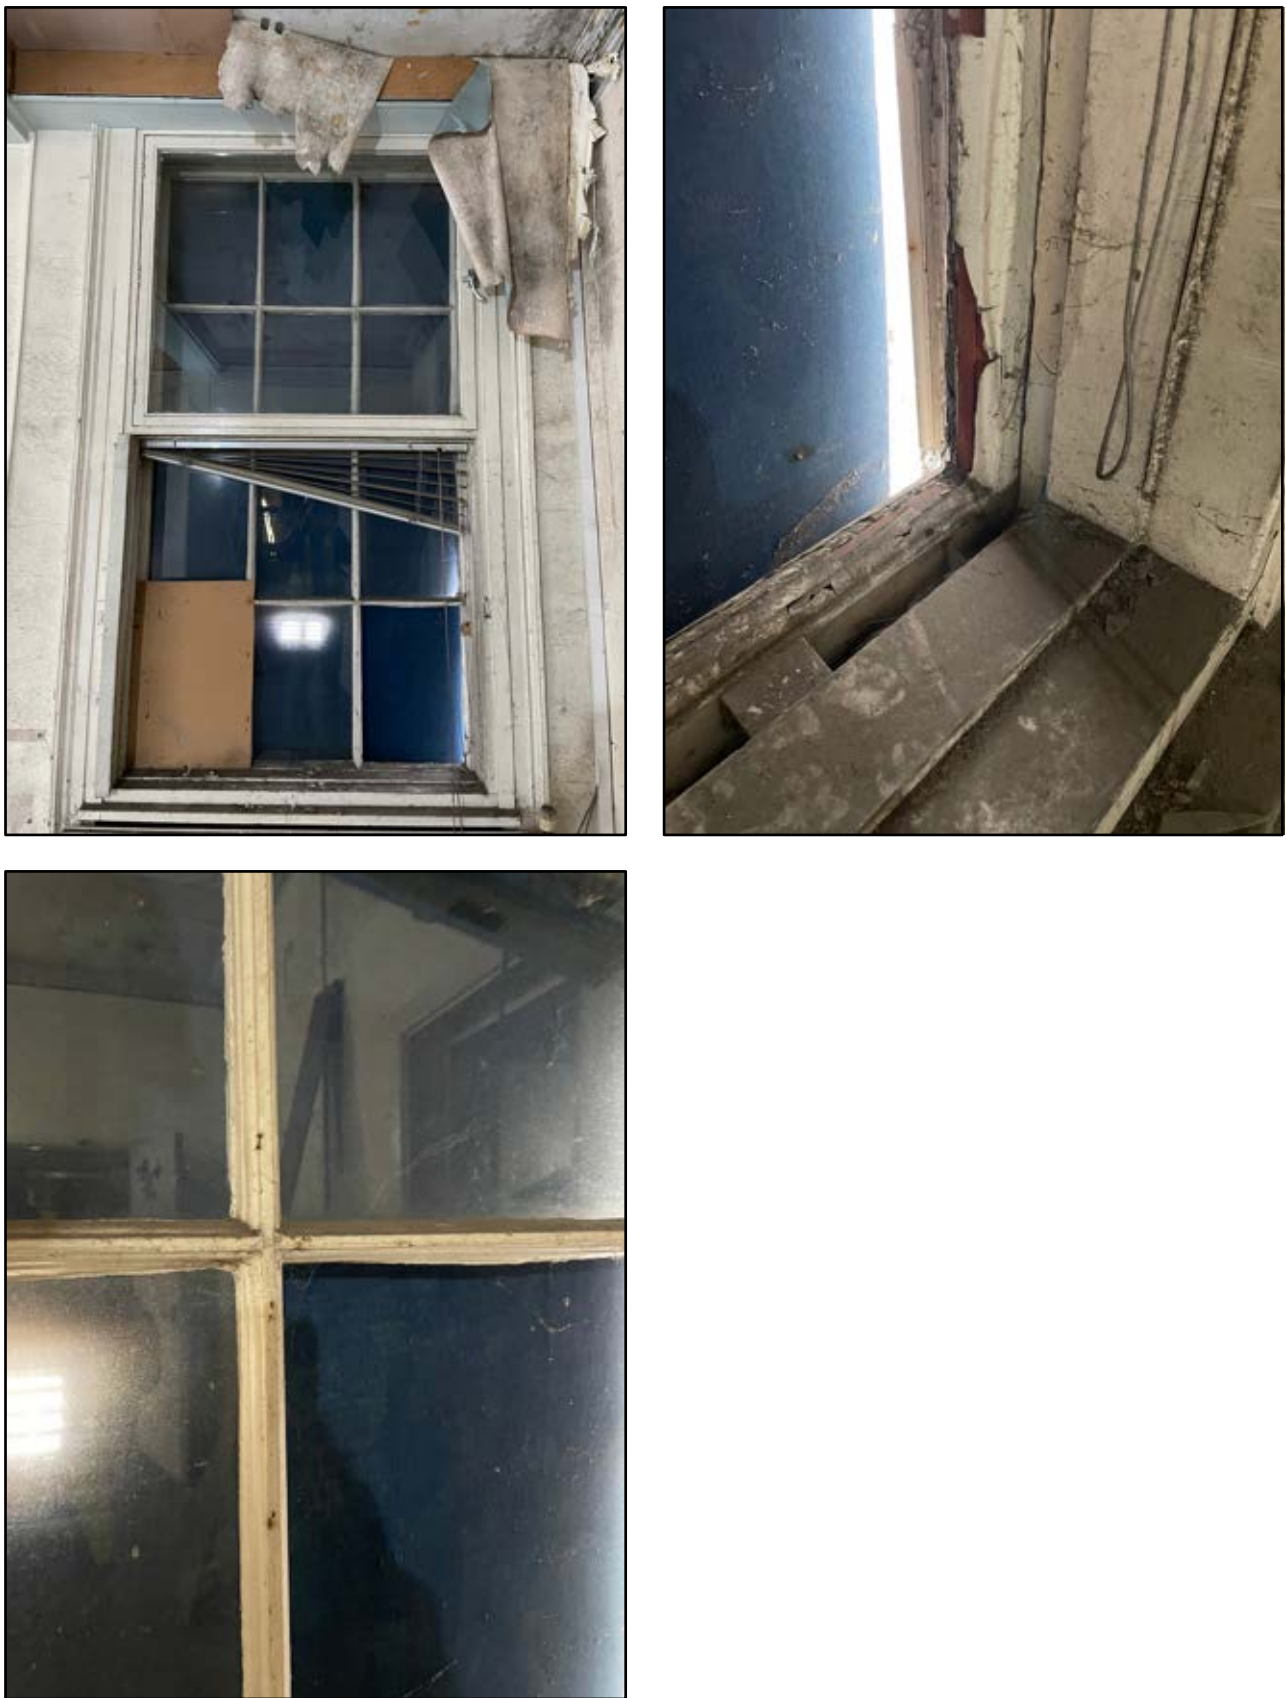
WINDOW W1.24

- Unable to open
- Original frame
- Frame is rotten
- Glass is missing and/or broken
- No chords

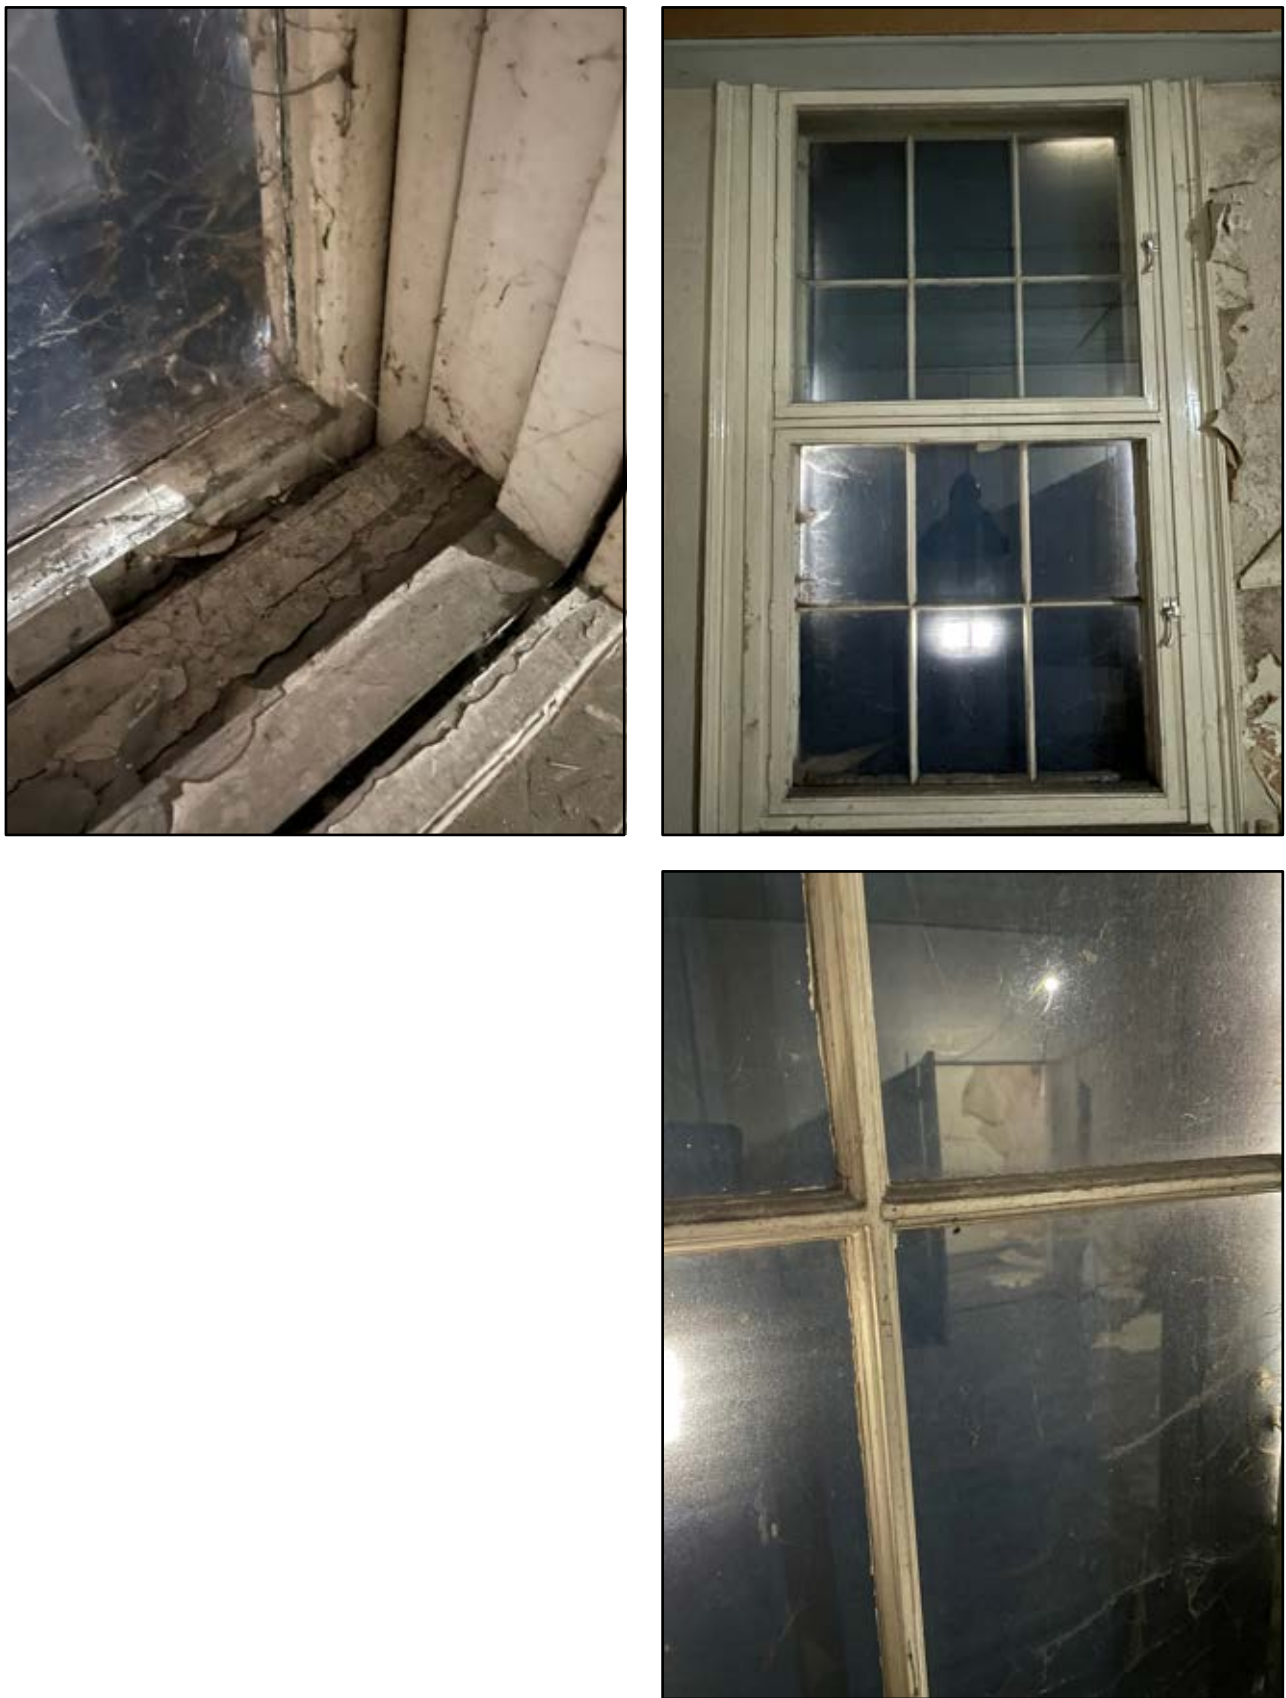
WINDOW W1.25

- Unable to open
- Original frame
- Frame is rotten and damaged
- Non original glass
- No chords

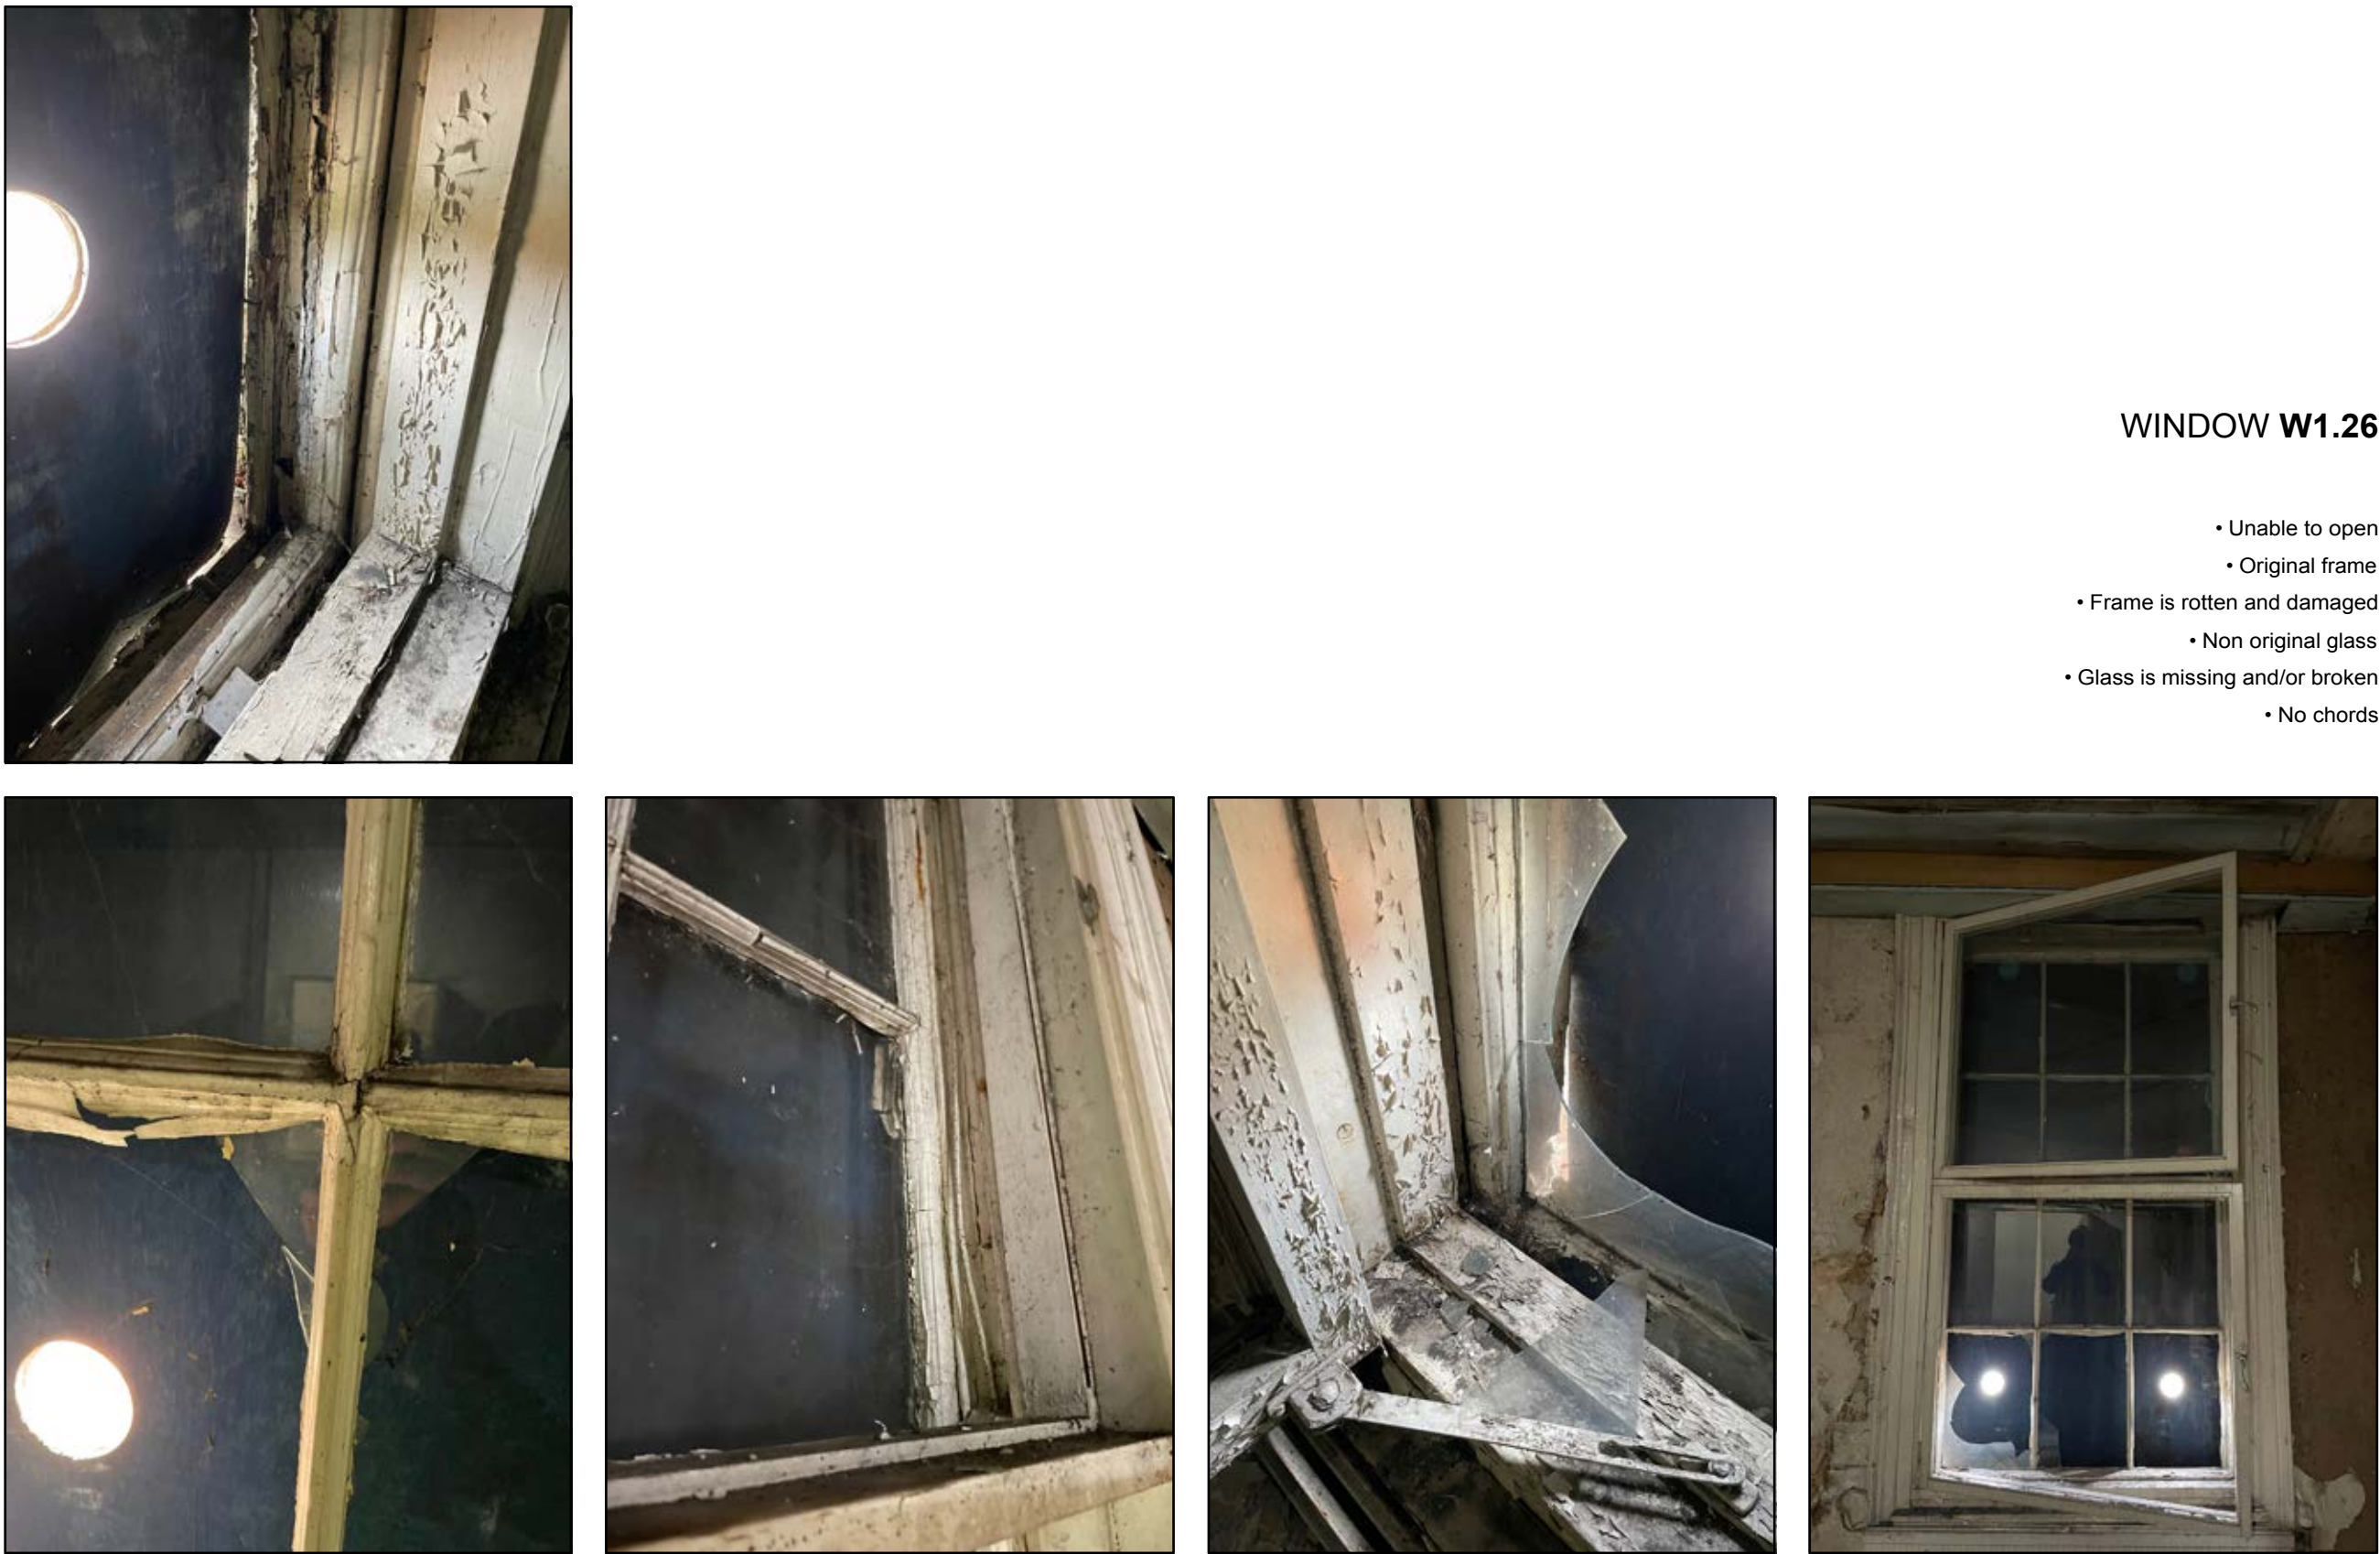
WINDOW W1.26

- Unable to open
- Original frame
- Frame is rotten and damaged
- Non original glass
- Glass is missing and/or broken
- No chords

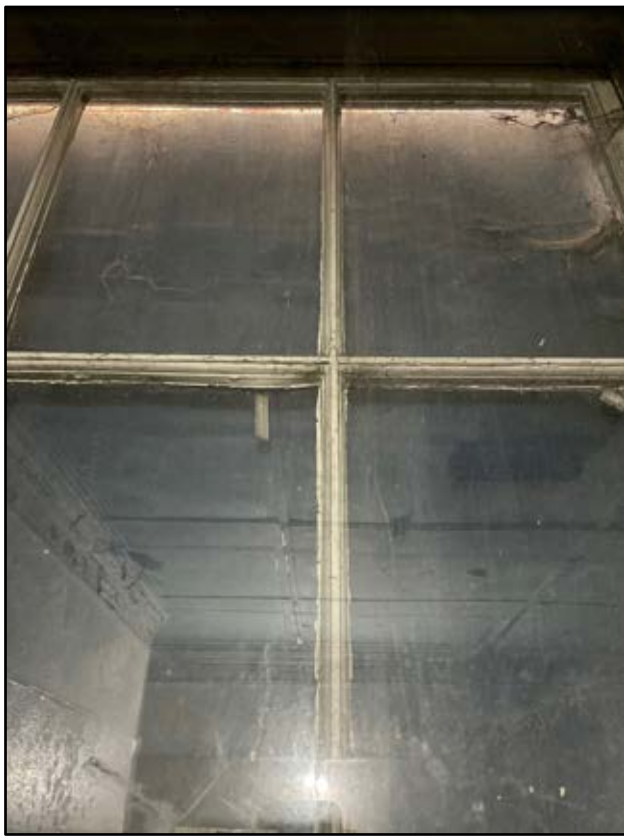
WINDOW W1.27

- Unable to open
- Unable to assess it properly - window is boarded up
- Frame looks original
- Frame is damaged
- Non original glass
- Glass missing and/or broken
- No chords

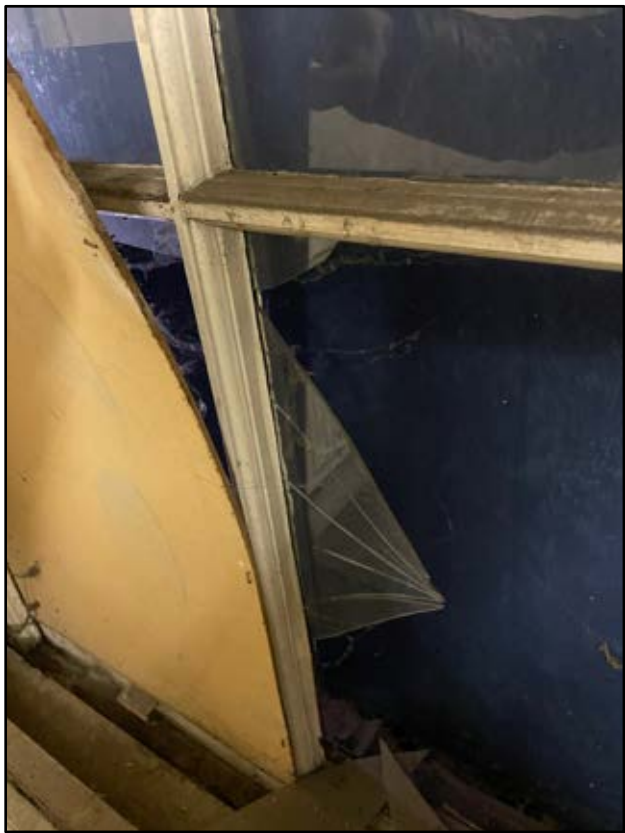
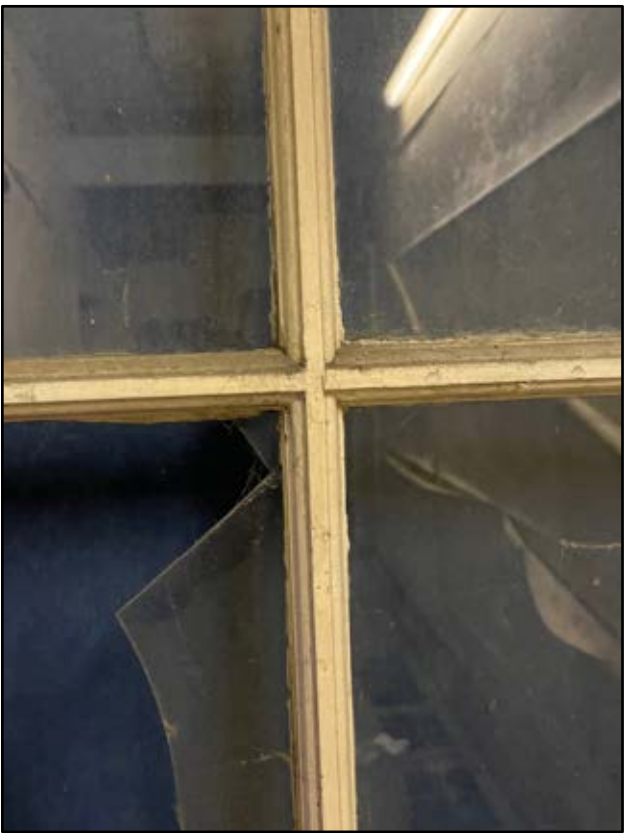
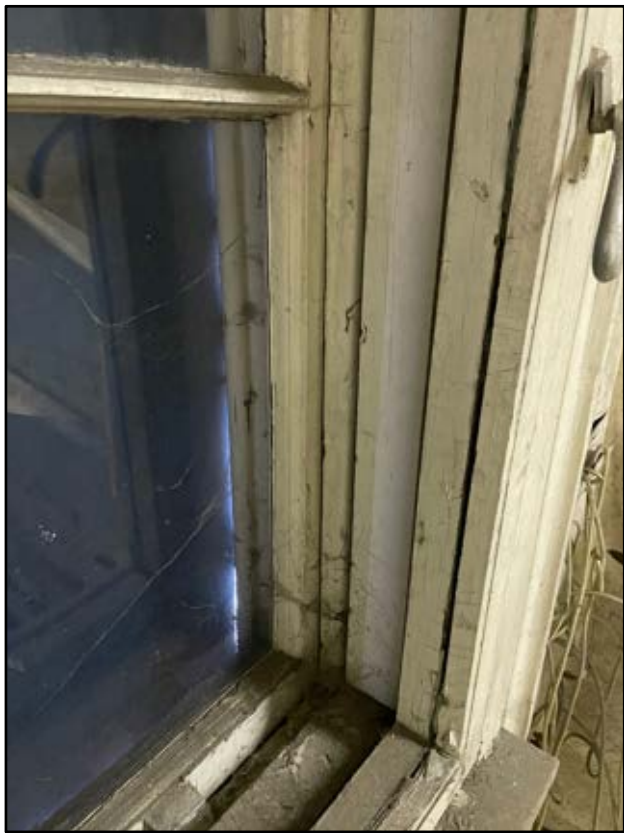
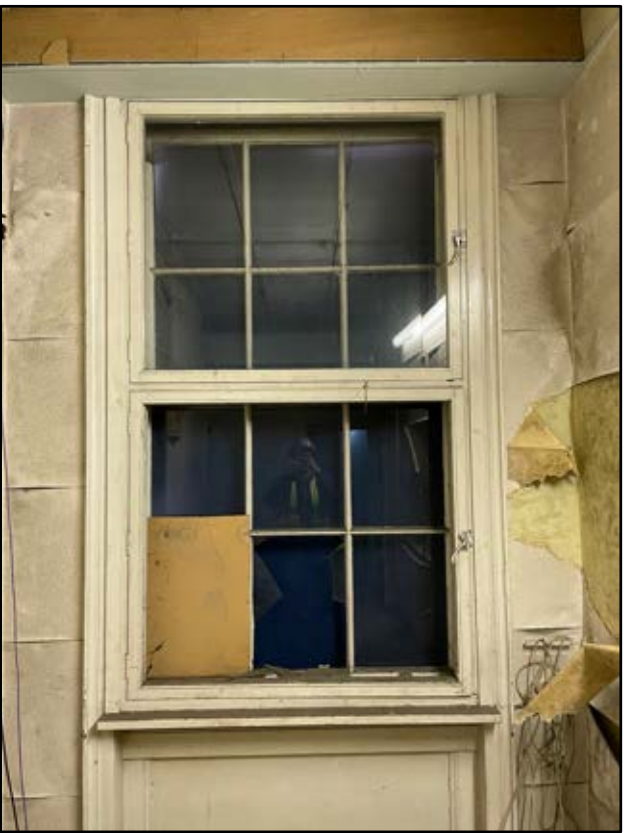
WINDOW W1.29

- Unable to open
- Original frame
- Non original glass
- Glass is missing and/or broken

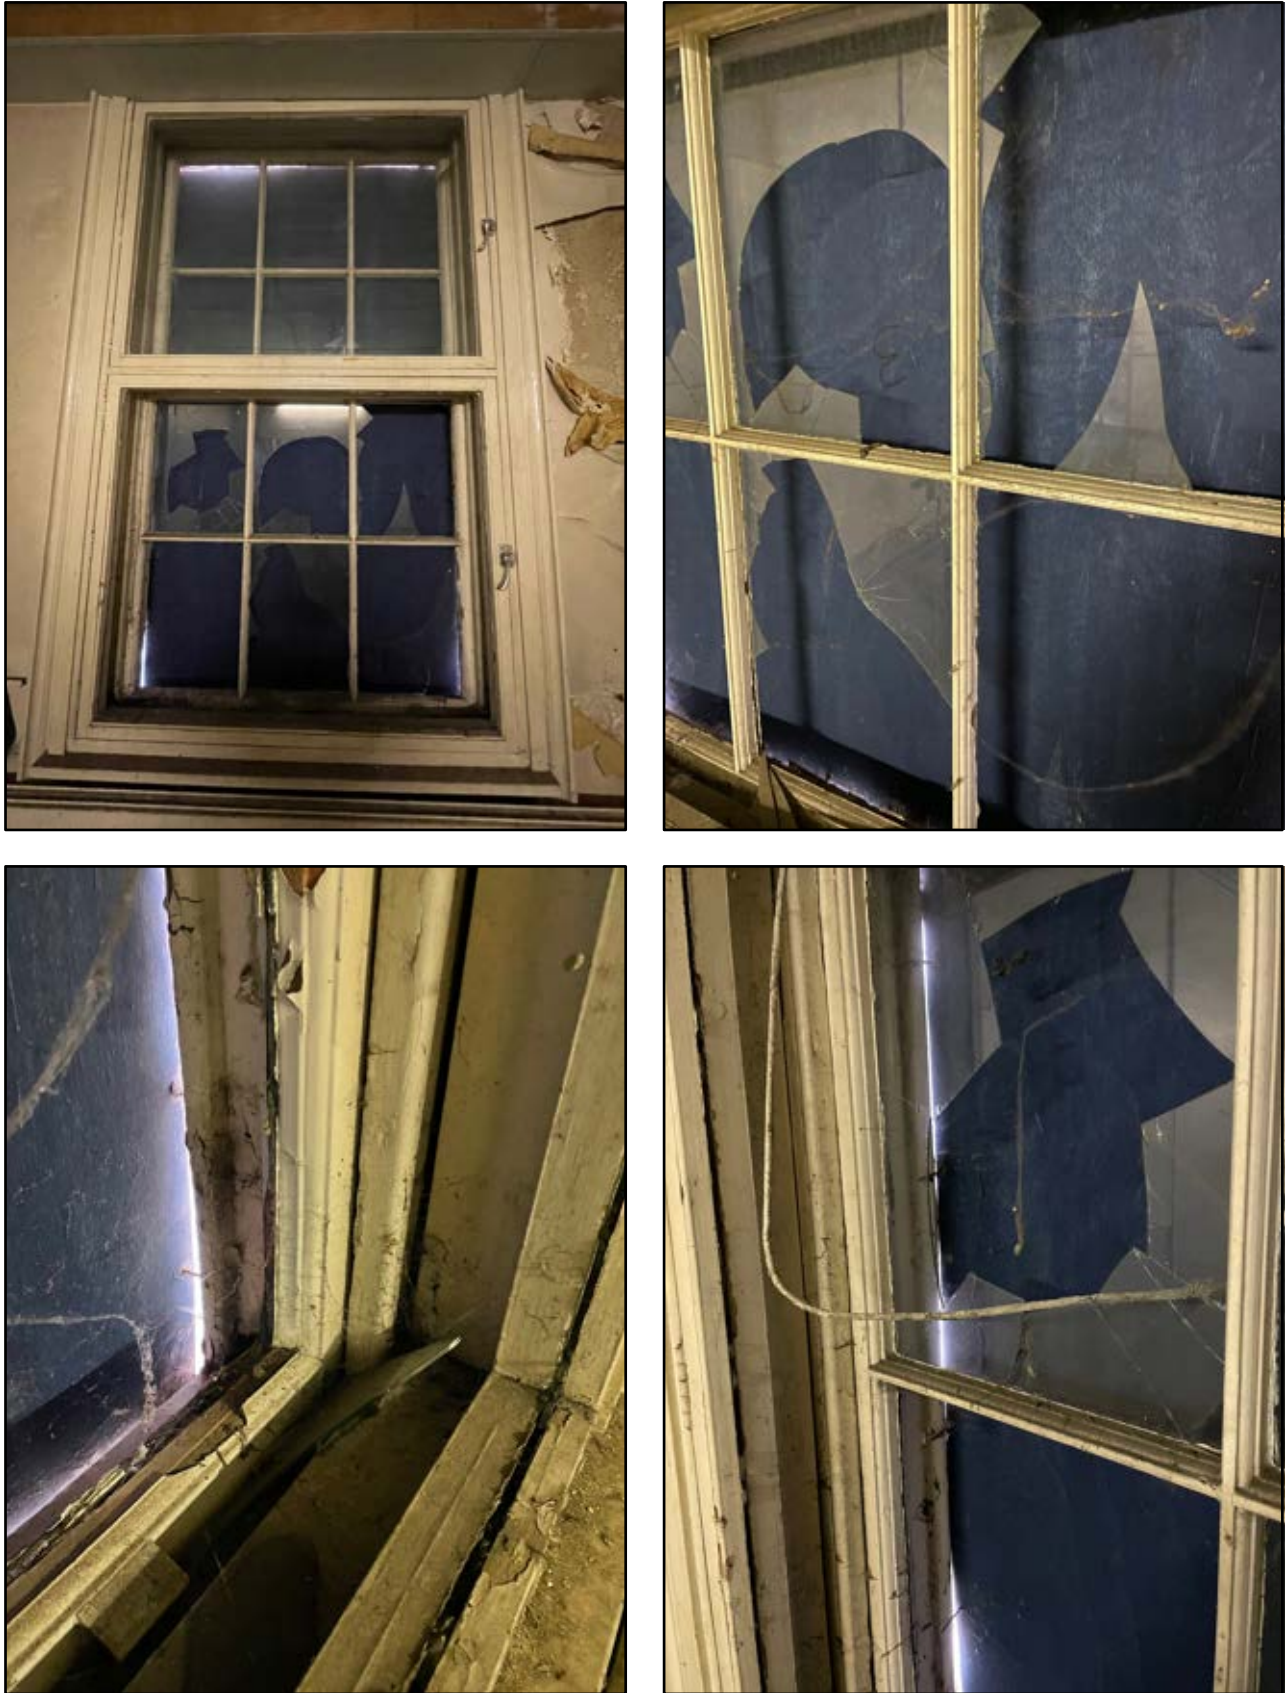
WINDOW W1.30

- Unable to open
- Original frame
- Non original glass
- Glass is smashed
- Chords are missing

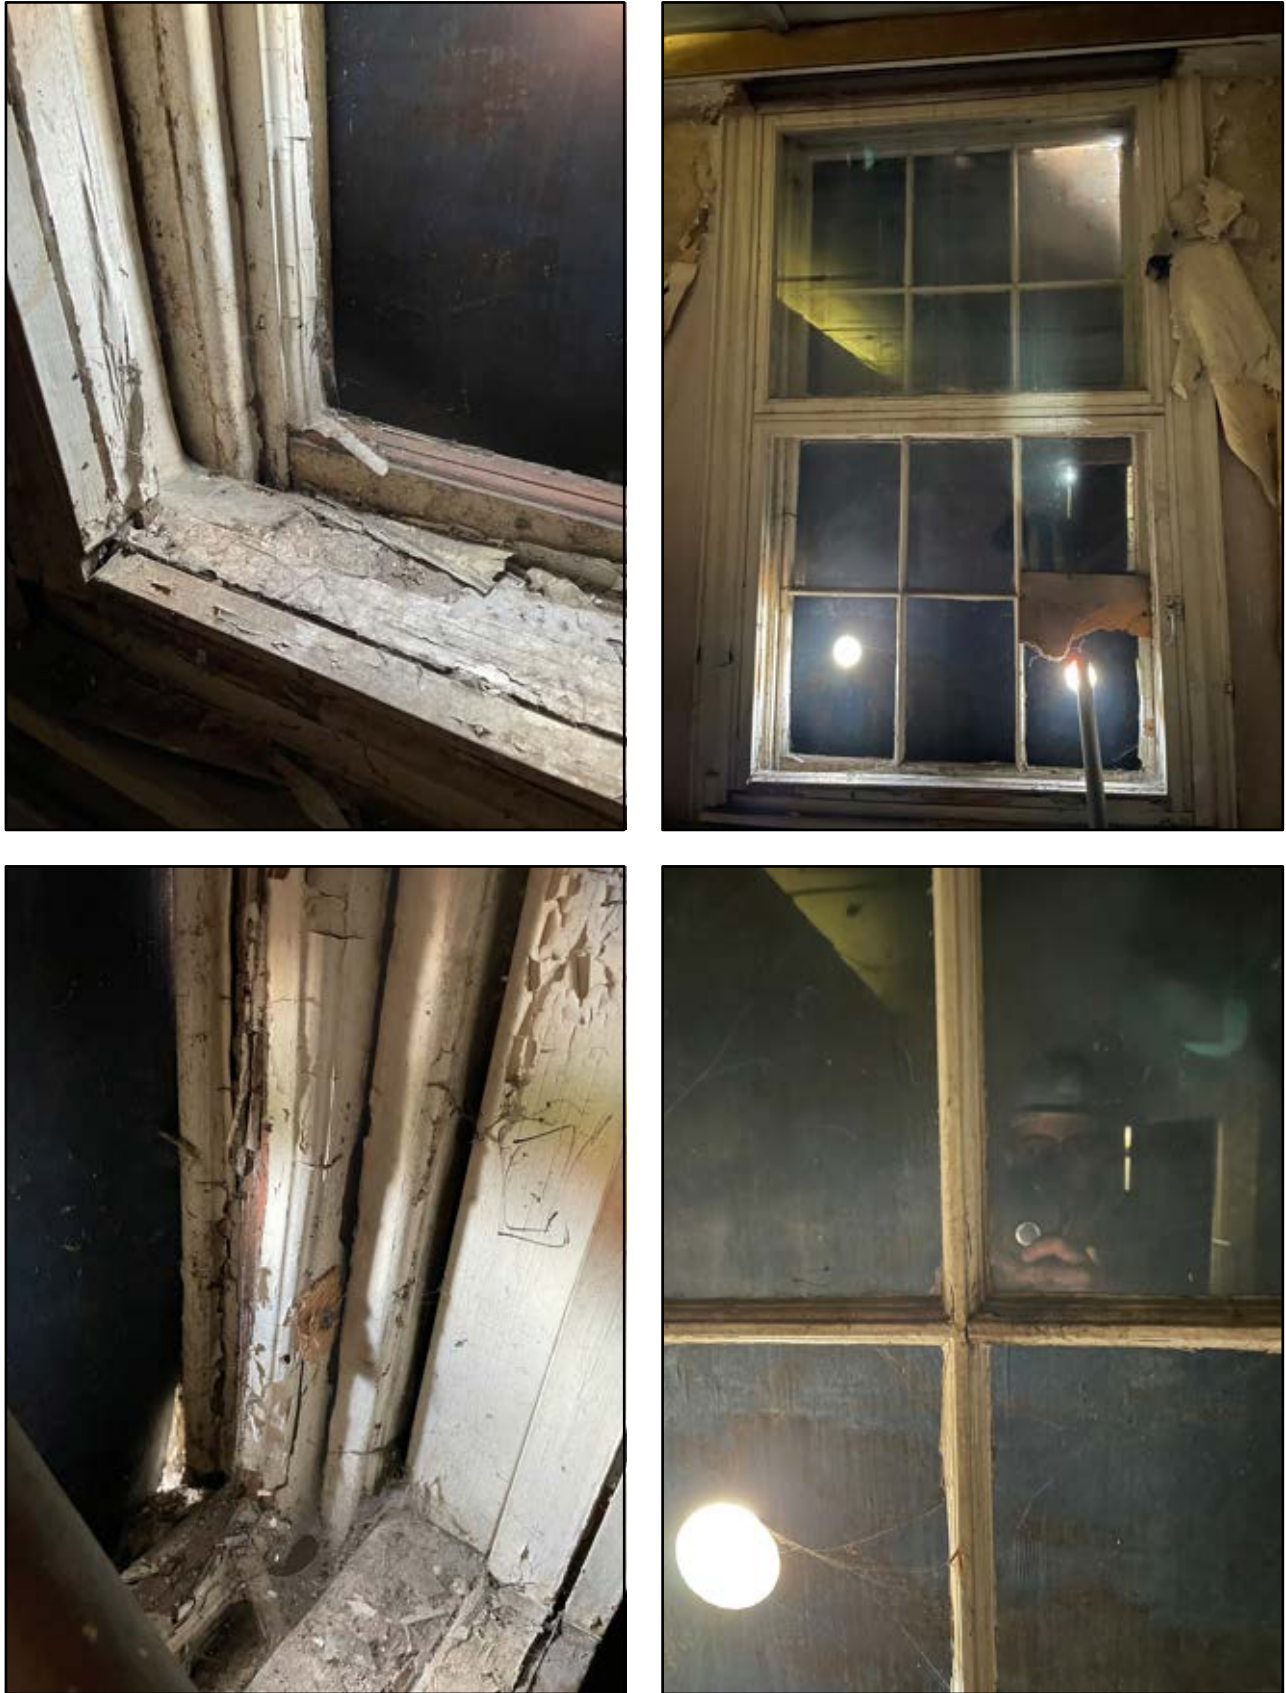
WINDOW W1.31

- Unable to open
- Original frame
- Non original glass
- Glass is smashed
- Chords are missing
