# EXTENDED PHASE 1 HABITAT SURVEY & DAYTIME BAT SURVEY

## AMBROSE STREET AND POTTERY LANE, GREATER MANCHESTER

AUGUST 2022

**RACHEL  
HACKING  
ECOLOGY**

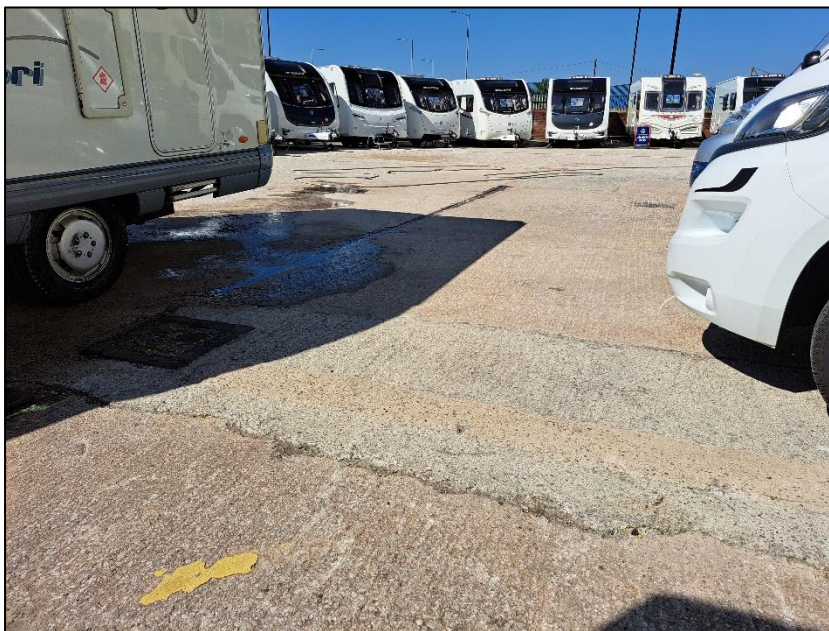
- 3.2 The majority of the site is covered with hardstanding, surrounding the buildings and used as car parking. Ephemeral short Perennial vegetation is growing on the edges of the hardstanding composed of Broad-leaved Dock *Rumex obtusifolius*, Common Nettle *Urtica dioica*, Perennial Rye-grass *Lolium perenne*, Cleavers *Galium aparine*, Groundsel *Senecio vulgaris* and Bramble *Rubus fruticosus* agg. (see Photograph 2).

Photograph 1 showing the hardstanding

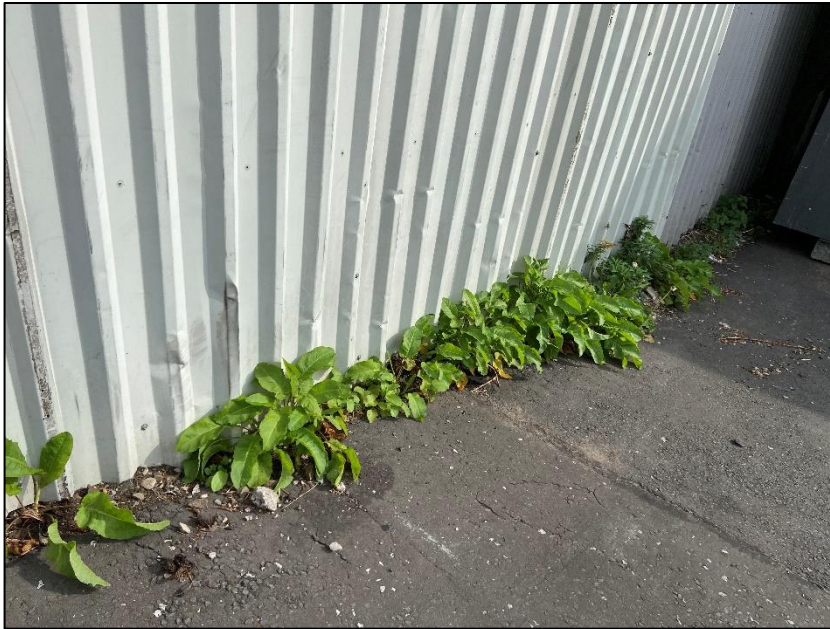
*Photograph 2 showing the ephemeral short perennial*

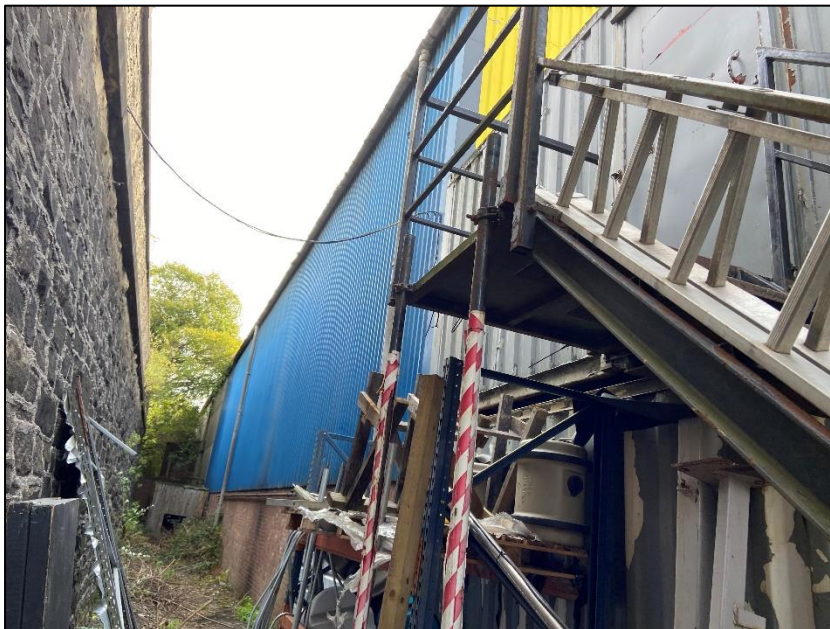
- 3.8 Units 1, 2, 7 and 8 form a large double height warehouse, the upper section of the walls and the gable ends are corrugated metal panels (see Photograph 3). The foundations and lower sections of the walls are constructed from brick, the brickwork is all in good condition with only minor areas of superficial damage (see Photograph 4), the mortar is otherwise complete and all the bricks in position.

Photograph 3 showing the back of Unit 1 and Unit 8

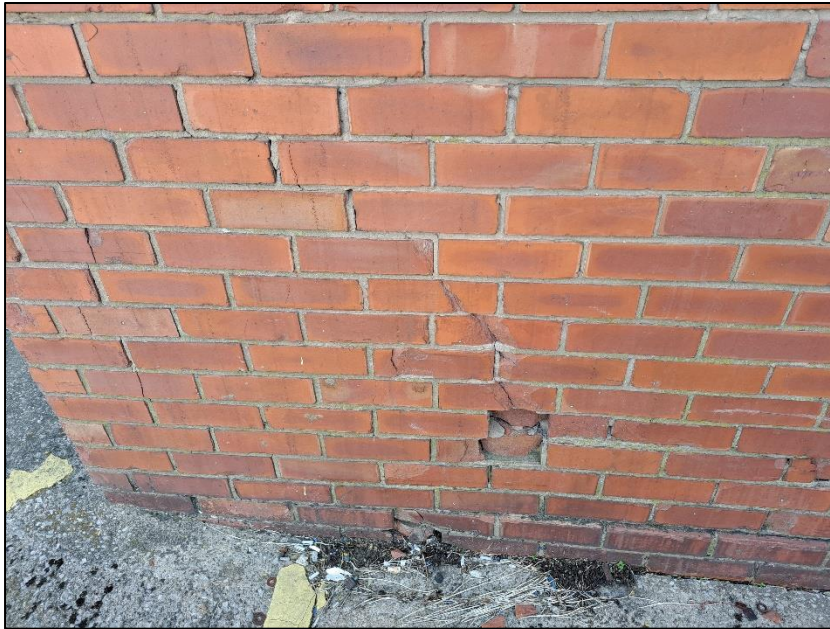
*Photograph 4 showing an area of superficial damage on the brick section of the walls*

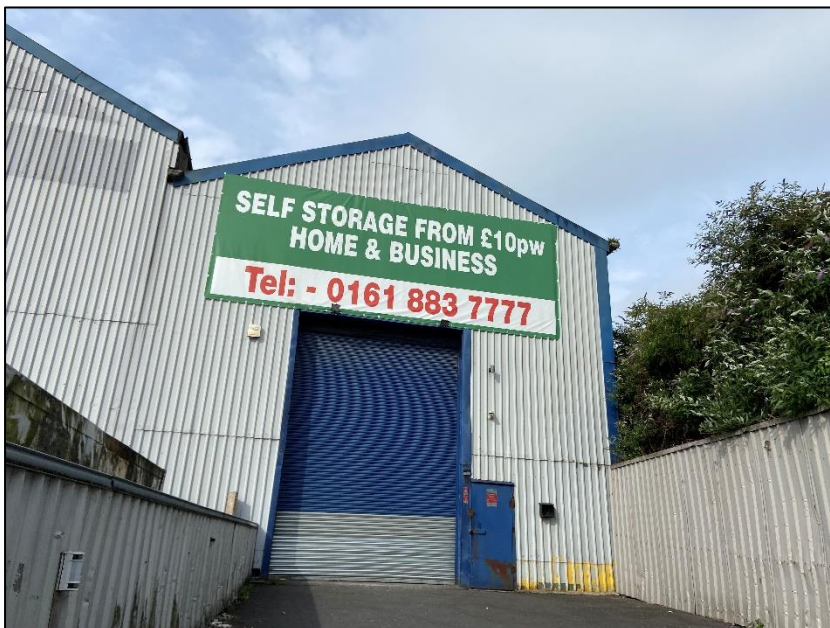
- 3.9 The corrugated metal cladding on the upper walls is in a reasonable condition, all of the panels are in position and generally lie flush to each other (see Photograph 5). Small gaps occur where the panels meet the brickwork, however due to the poor thermal capacity of the metal panels it is unlikely these would be utilised by bats for roosting (see Photograph 6). Large access roller door and regular doors are present throughout the building these are generally well sealed and do not provide possible access points for bats.

*Photograph 5 showing metal cladding and one of the access doors*

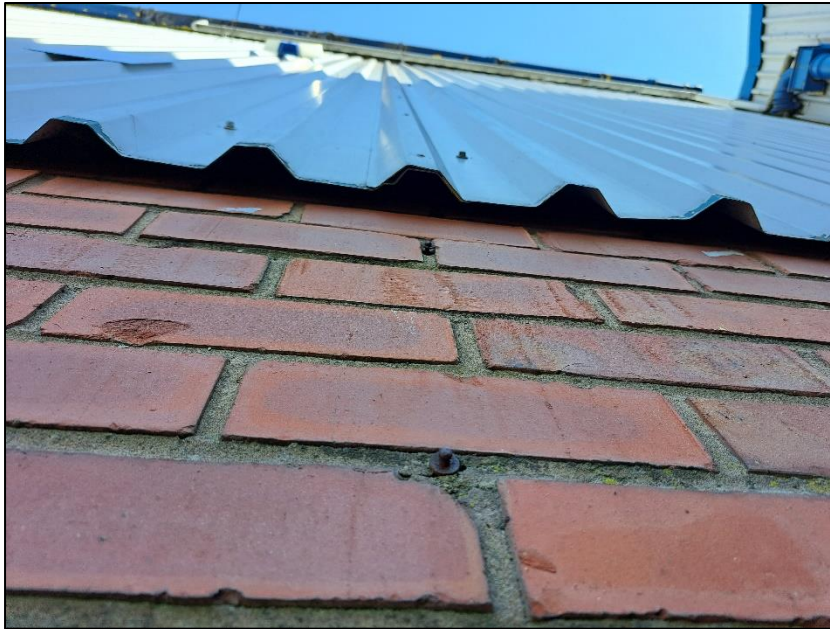
*Photograph 6 showing the gap between the brickwork and the metal cladding*

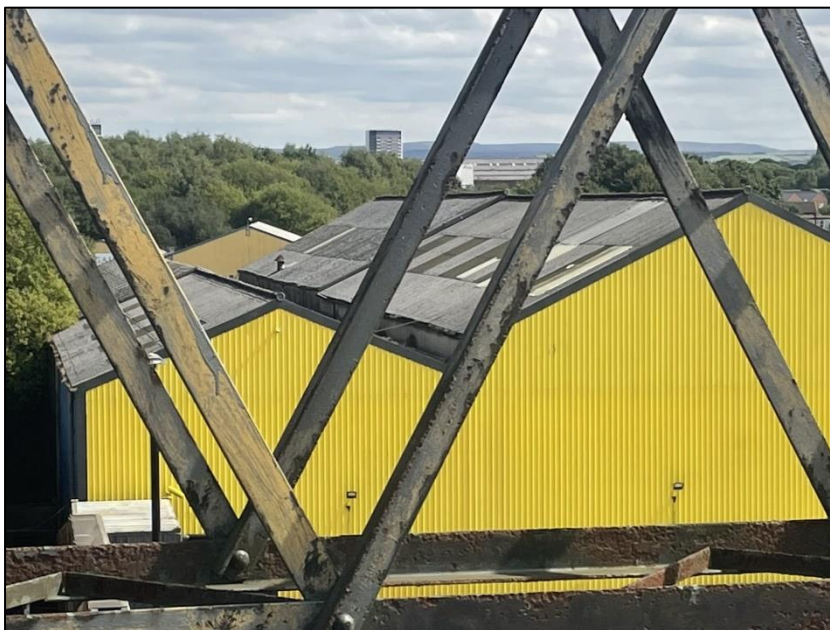
- 3.10 The roof is doubly pitched constructed from asbestos cement with skylights present throughout (see Photographs 7 and 9). The edges of the roof are sealed on the gable ends with metal capping which is all complete and intact. The corrugated shape of the roof and wall panels results in small gaps at the edges of the roof but due to the poor thermal capacity of the roofing material and the walls these gaps are unlikely to be used by bats.

*Photograph 7 showing the roof of units 1 and 2*

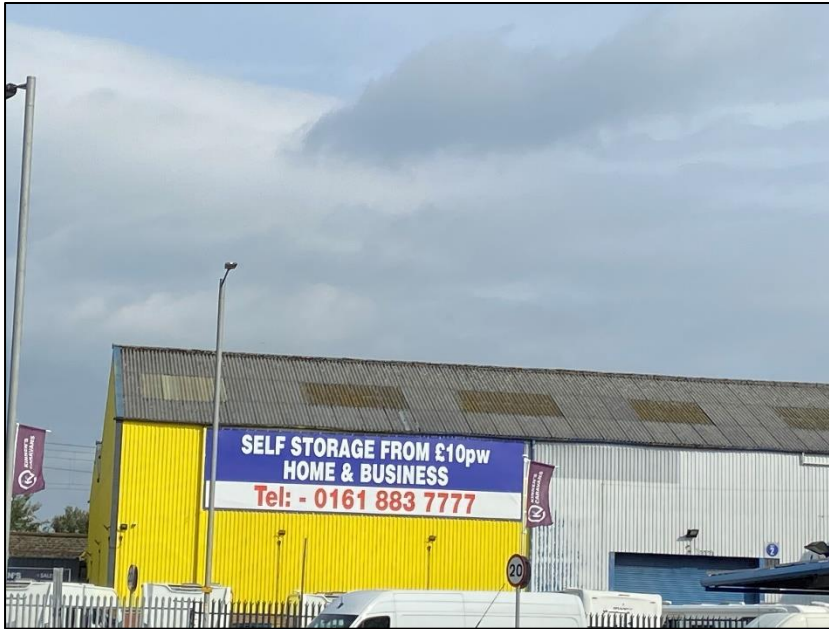
*Photograph 8 showing the roof of unit 2*

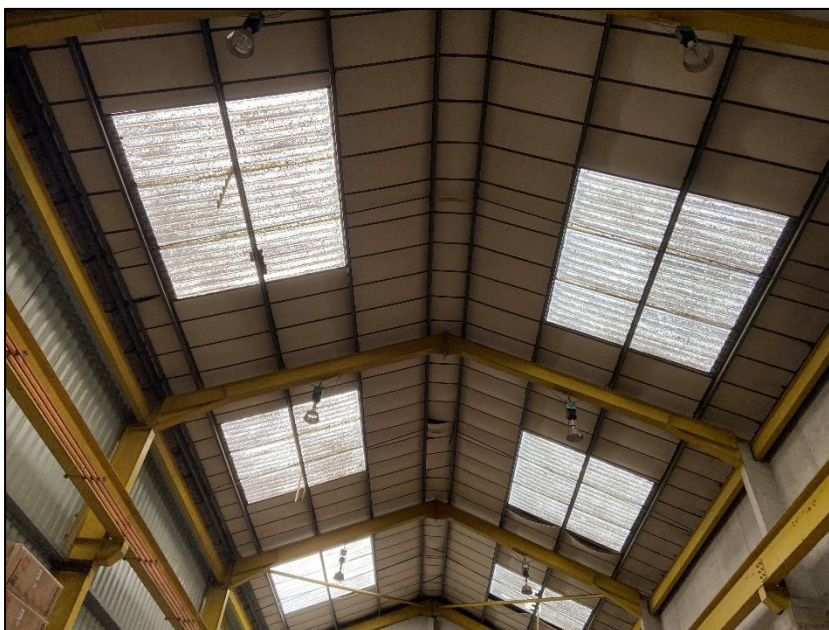
- 3.11 Unit 1 is a large open space that does not support a roof void (see Photograph 9). The internal walls are constructed from breezeblock which is all in good condition with no damaged/missing bricks or mortar. On the exterior wall the corrugated metal panels are visible, these are all complete. The roof is supported by a metal frame which does not offer suitable roosting opportunities for bats. The underside of the roof is lined with panels these are all in position, but some are sagging in places. The skylights allow natural light to enter the space. No evidence of bat activity was located within Unit 1 during the survey.

*Photograph 9 showing the interior space of Unit 1*

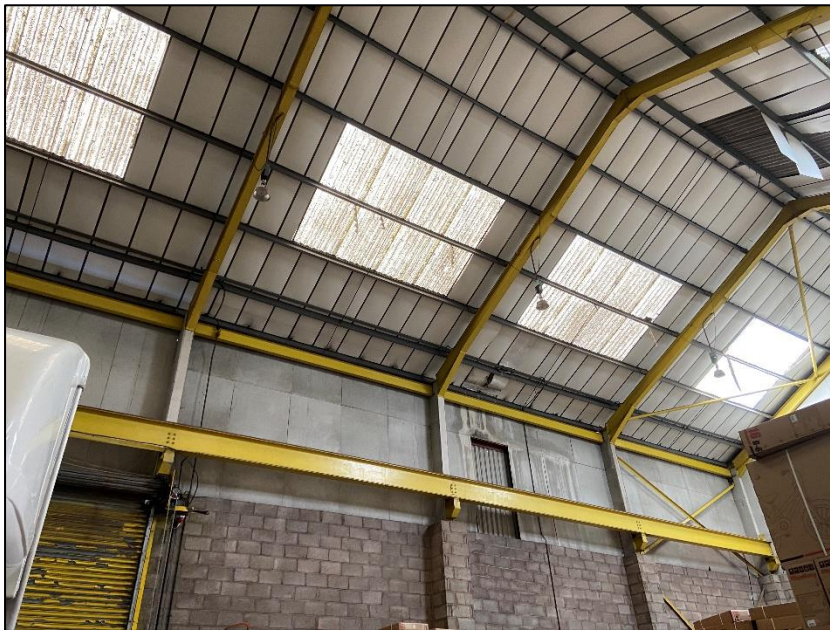
- 3.12 Unit 2 is similar to Unit 1 in construction and the two units are interconnected by an internal archway. The space is also well-lit by the skylights. The breeze block walls are all complete and in good condition, not presenting any potential roosting opportunities. The roof is supported by a metal frame which does not offer any roosting opportunities. The underside of the roof is lined with the same panelling as in Unit 1. However, some of the panels are missing exposing the asbestos cement panels behind, no cavity exists between the roofing panels and the lining that could be used by bats for roosting. The Unit is in use as a workspace during the day and therefore will be disturbed. No evidence of bat activity was found in Unit 2 during the survey (see Photograph 10).

*Photograph 10 showing the internal space*

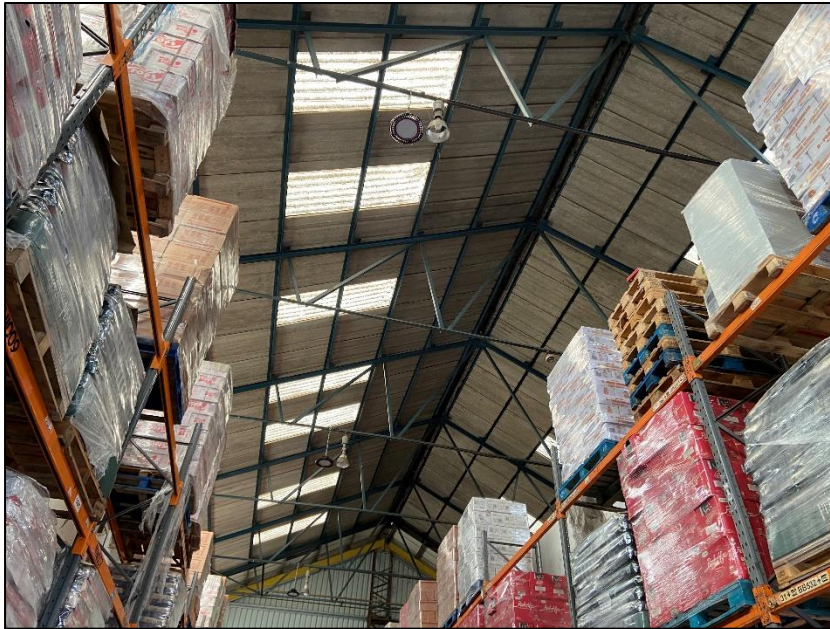
- 3.13 Unit 7 is an occupied warehouse space (see Photograph 11). There is no roof void, and the space is well lit by the number of skylights. The roof is supported by a metal frame which is in good condition with no roosting opportunities for bats. There is a well-sealed refrigerated unit that does not offer any bat roosting habitat. The roof lining here is mostly missing with only a small number of the panels remaining. The roof is in good condition, but water ingress is evident within parts of the internal space. No signs of bat activity were located during the survey.

*Photograph 11 showing the internal space of Unit 7*

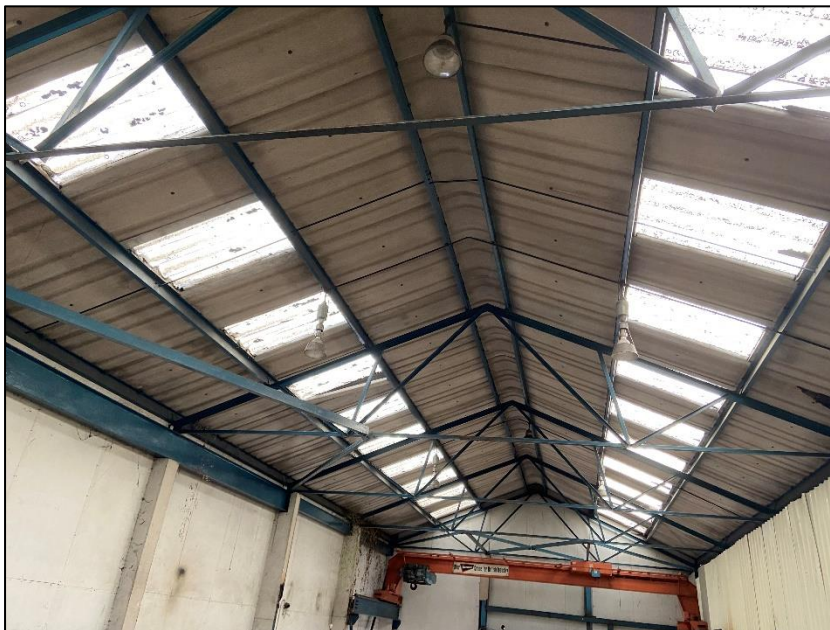
- 3.14 Unit 8 is an unoccupied space, that is open to the roof (see Photograph 12). The skylights allow natural light to enter the space. The roof lining is missing in this unit and the roof is complete, but water ingress is present internally. The walls are clad with panels these are all flush to each other offering no roosting opportunities.

*Photograph 12 showing the roof void above the main house*

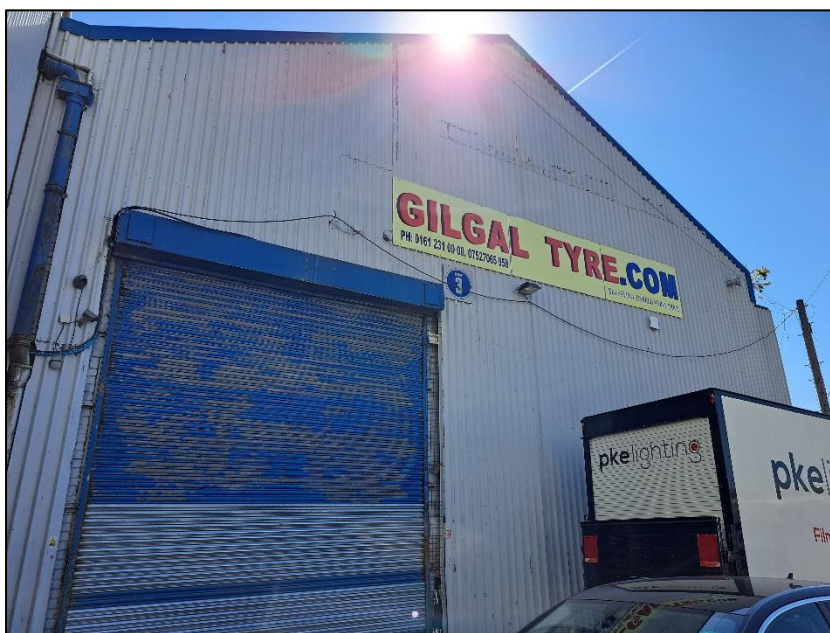
- 3.15 Unit 3 is attached to the southern elevation of units 2 and 7. It is constructed from corrugated metal panels which are all complete and lying flush to each other (see

Photographs 13 and 14). There are some areas of superficial damage, but this does not provide access to the internal space or offer a roosting opportunity. Large roller access doors are present on the western and eastern elevations these are well-sealed within the structure of the walls.

*Photograph 13 showing the western gable end of Unit 3*

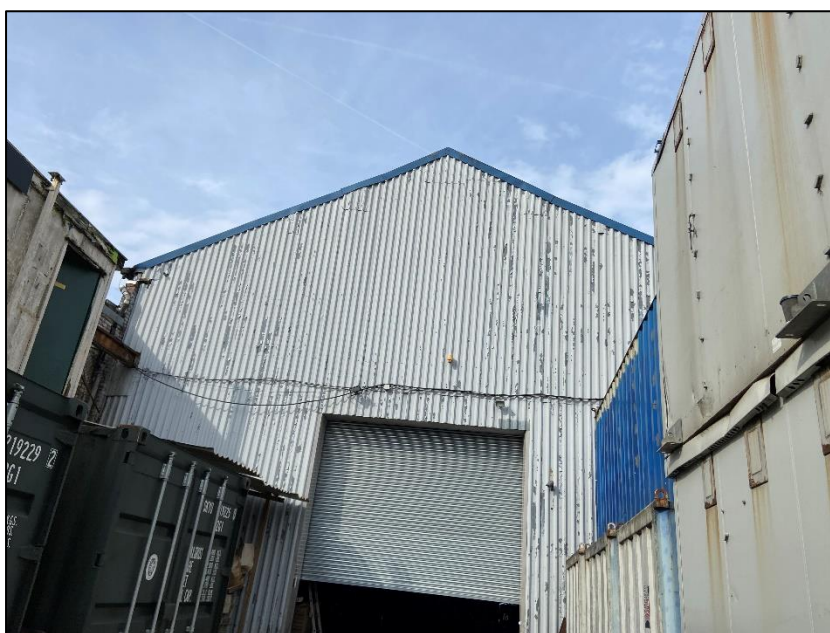
*Photograph 14 showing eastern gable end of Unit 3*

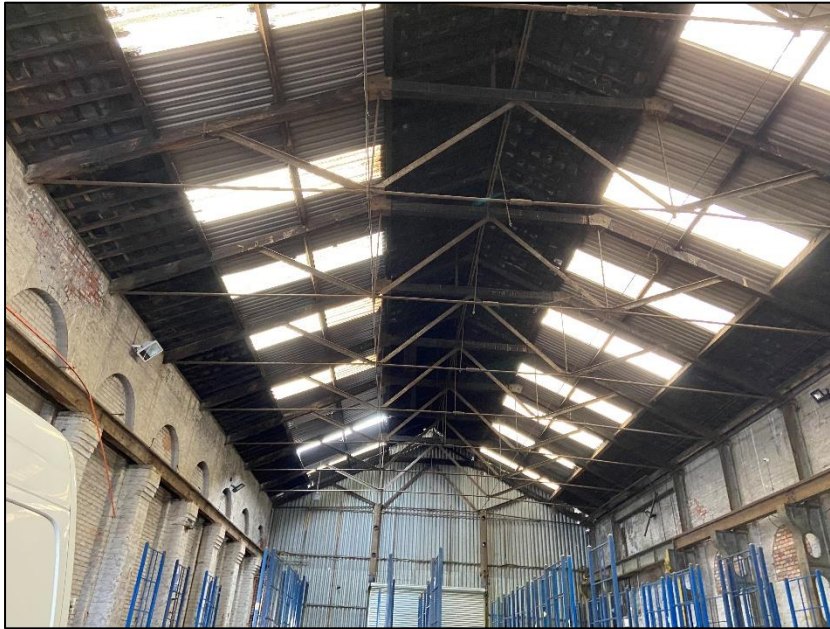
- 3.17 The internal space of Unit 3 is a large open space with no roof void, it is used as a workshop, causing daytime disturbance. The roof is supported by a wooden and metal frame, no cracks or crevices exist within the wooden beams that could be used by bats for roosting (see Photograph 14). The underside of the roof is unlined, and the space is uninsulated. The skylights allow natural light into the space. The internal walls are constructed from brick, which is all in good condition. A single cavity was found within the brickwork (see Photograph 15), this was searched with torches and found to be shallow.

*Photograph 14 showing the interior space of Unit 3*

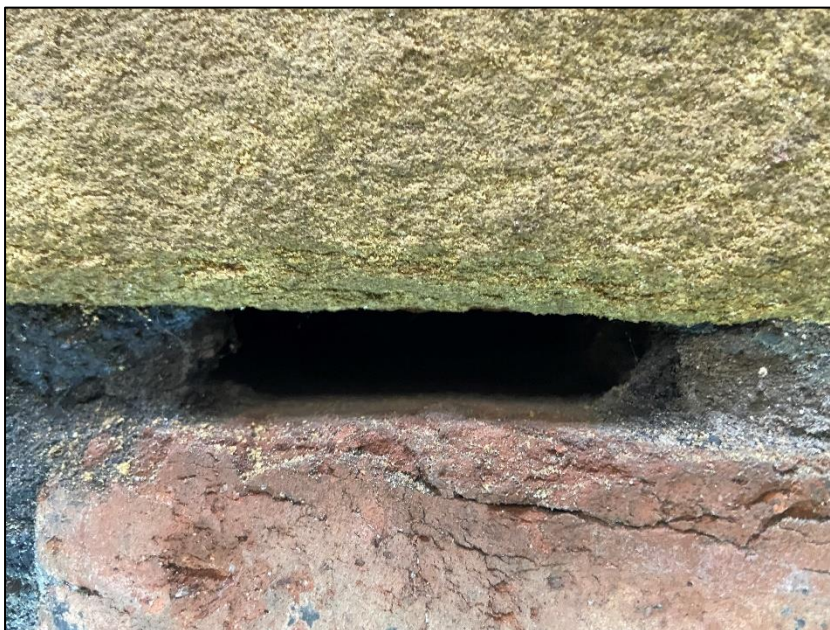
*Photograph 15 showing the shallow cavity within the brickwork*

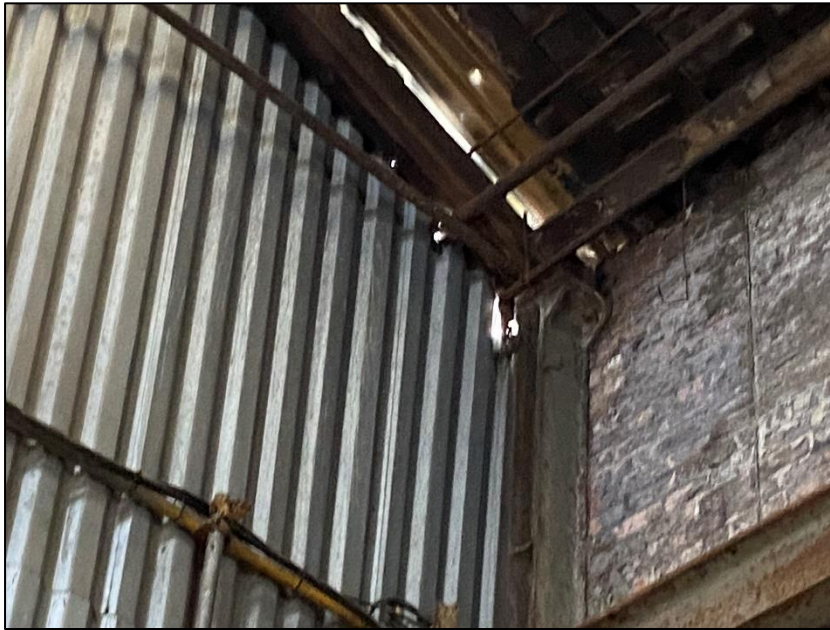
- 3.18 Daylight can be seen at the roof edges of the gable end (see Photograph 16), these are at the tops of the corrugated metal panels. It is possible that these gaps could offer a potential access point for bat to the building however, no signs of bat activity were located within Unit 3 during the survey.

*Photograph 16 showing the daylight at the roof edge*

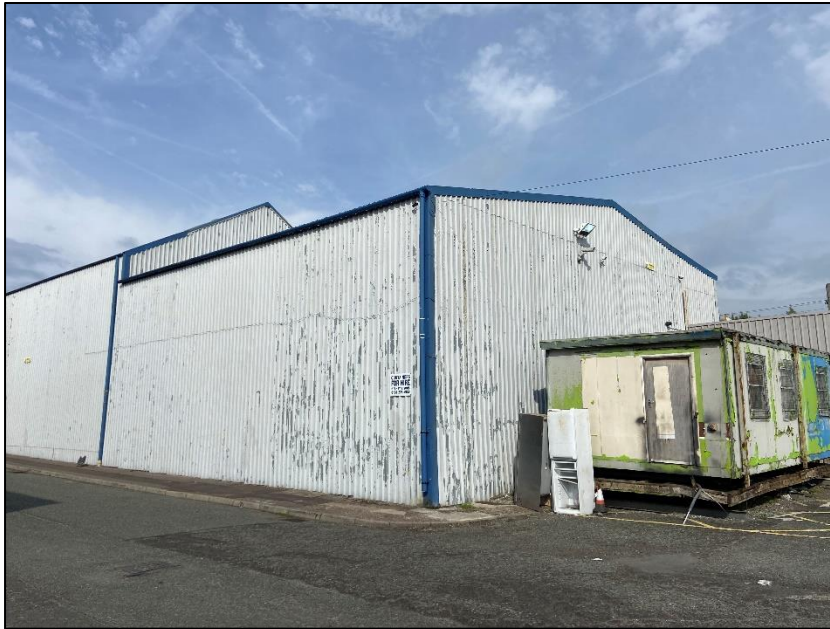
- 3.19 Unit 4 is attached to the southern elevation of Unit 3. It is constructed from corrugated metal panels and brick (see Photograph 17). All the panels are in position and lie flush to each other. The exposed brickwork is in good condition with no missing bricks or mortar. There are roller access doors on the eastern and western elevations which are well incorporated within the structure of the building with no potential access points for bats.

*Photograph 17 showing Unit 4*

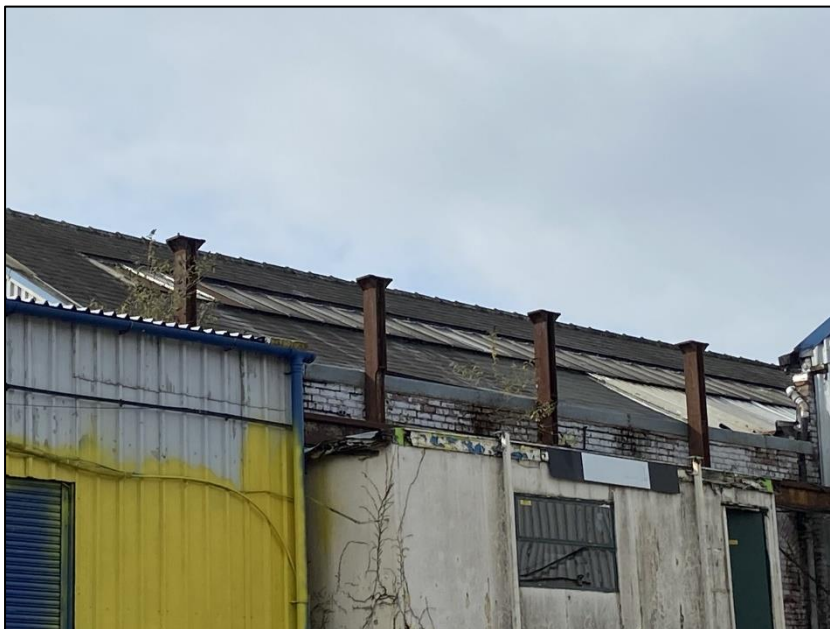
- 3.20 The roof on Unit 4 is also pitched and covered with slate tiles, with skylights throughout (Photograph 18). All of the tiles, panels and skylights are in position and the ridge is sealed with slate ridge tiles. No obvious potential access points for bats were found in association with the roof. The edges of the roof are sealed with metal capping on the gable ends.

*Photograph 18 showing the roof of Unit 4*

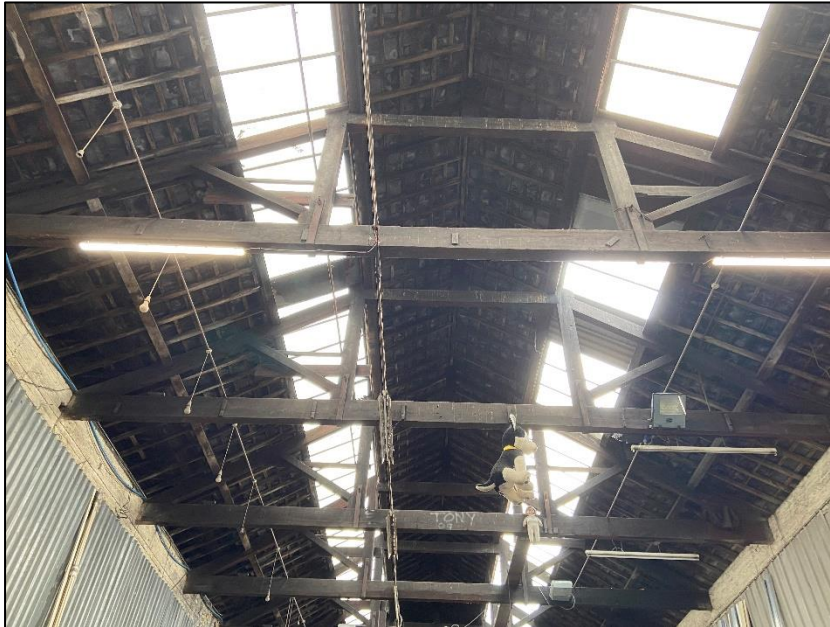
- 3.21 Unit 4 is also open to the roof, the underside of the tiles is unlined and uninsulated (see Photograph 19). The roof is supported by a wooden frame which is in good condition

with no gaps that could be used by bats for roosting. The skylights allow natural light into the space. The internal walls are constructed from brick which are clad with corrugated metal panels the exposed brickwork is all complete and intact with no missing brick or areas of recessed mortar that could offer roosting opportunities for bats and the metal panels are all complete and intact. The building is in use as a workshop and is therefore disturbed during the day.

*Photograph 19 showing the internal space of Unit 4*

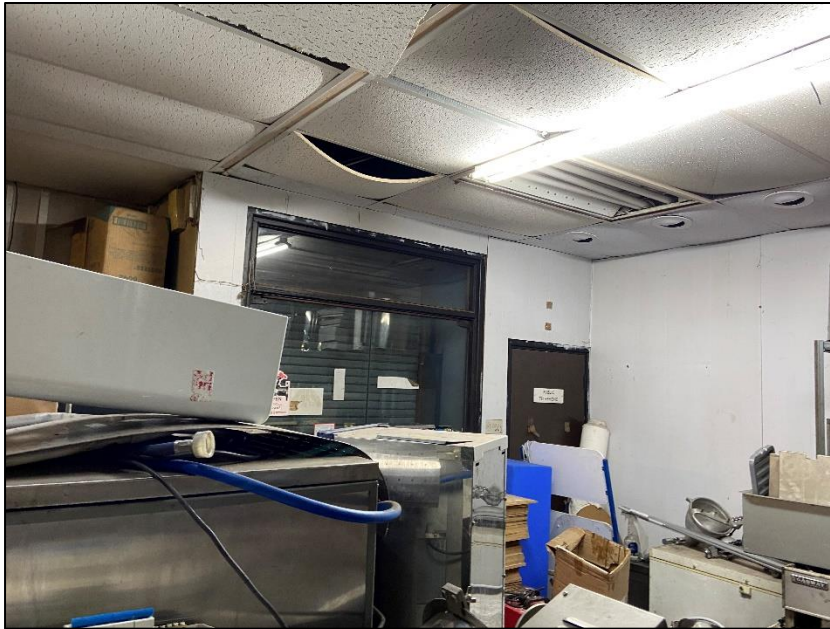
- 3.22 At the rear of the workshop an office space has been created, the office has a false ceiling many of the ceiling tiles are missing or falling down exposing a small cavity which is not considered to offer suitable bat roosting habitat (see Photograph 20). No signs of bat activity were found in Unit 4 during the day.

Photograph 20 showing the office space at the rear of the building
