## GLENDENE, WYTHENSHAW

### Remediation Method Statement

Report Ref: BEK-22097-1 (Rev A)

November 2022

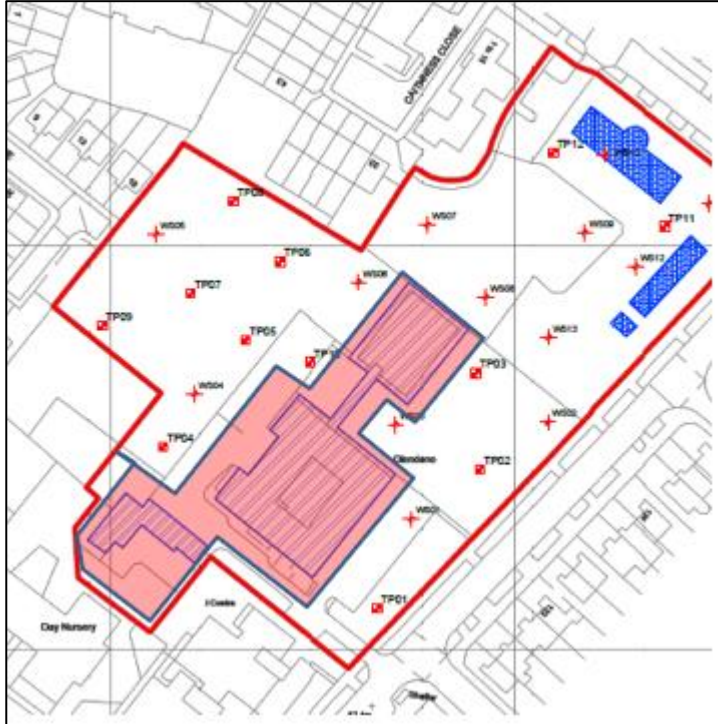
3.6.1 WML recommends that as a minimum the design sulphate class for the majority of site should be designed for DS-1 conditions and ACEC class AC-1 (white shaded in Figure 2).

- 3.6.2 However, the plots located within the areas encompassing the former children's home should be constructed utilising typical sulphate design class and 'Aggressive Chemical Environment for Concrete' (ACEC) class DS-2, AC-2 (red shaded in Figure 4) .

**Figure 2:** Areas to use concrete class DS-1, AC-1 (white shaded) and DS-2 AC-2 (red shaded)

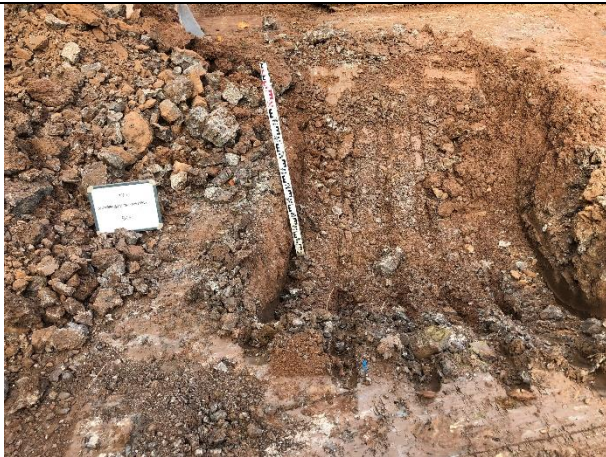
| Depth (m) | Soil Description |
|---|---|
| 0 – 0.4 | Firm orange/brown friable sandy clay with occasional coal fragments |
| 0.4 – 0.6 | Stiff orange brown occasionally grey mottled laminated sandy silty clay |

| P1: TP1 | P2: TP2 | | |

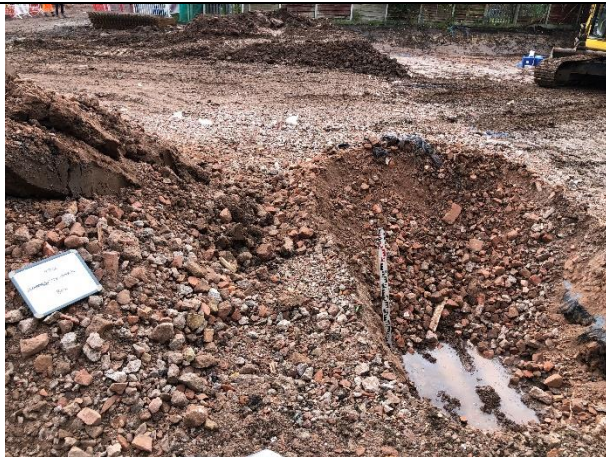
| Depth (m) | Soil Description |
|---|---|
| 0.0 – 0.5 | Red/grey fine to coarse sandy gravel of brick and concrete |
| 0.5 – 1.0 | Stiff orange brown occasionally grey mottled laminated sandy silty clay |

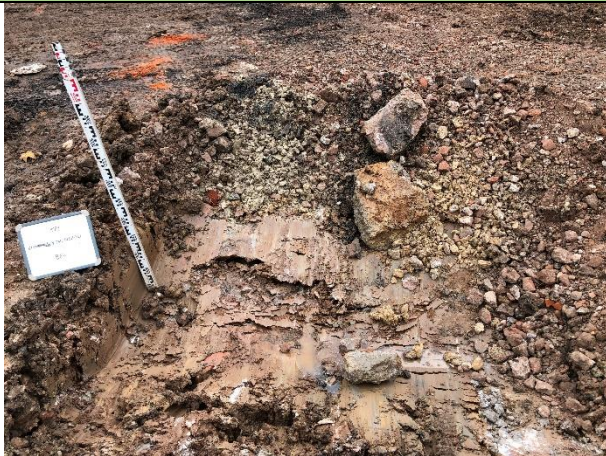
| Depth (m) | Soil Description |
|---|---|
| 0 – 0.35 | Red/grey fine to coarse sandy gravel of brick and concrete |
| 0.35 – 0.5 | Stiff orange brown occasionally grey mottled laminated sandy silty clay |

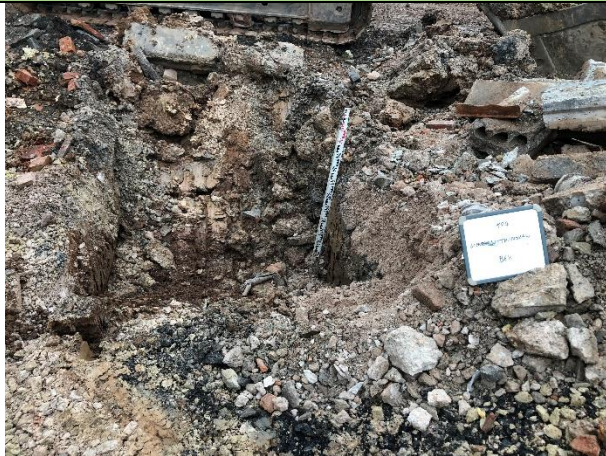
| Depth (m) | Soil Description |
|---|---|
| 0 – 0.5 | Grey/pink/black fine to coarse gravel with rare brick and rare rags |
| 0.5 – 1.0 | Stiff orange brown occasionally grey mottled laminated sandy silty clay |

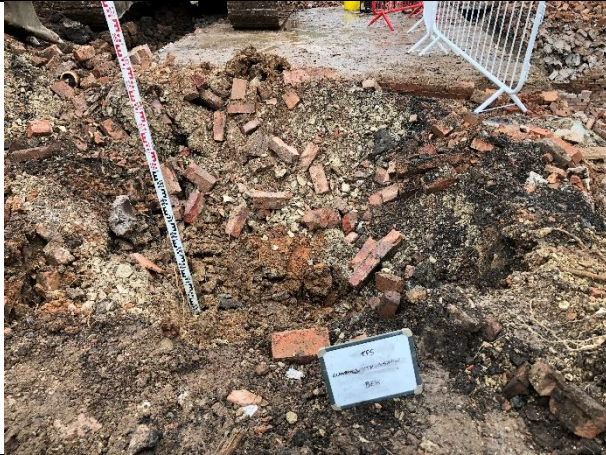
| Depth (m) | Soil Description |
|---|---|
| 0.0 – 0.5 | Black/brown fine to coarse ashy sand with occasional fine to coarse gravel of clinker, brick and occasional clay pockets |
| 0.5 – 0.8 | Stiff orange brown occasionally grey mottled laminated sandy silty clay |

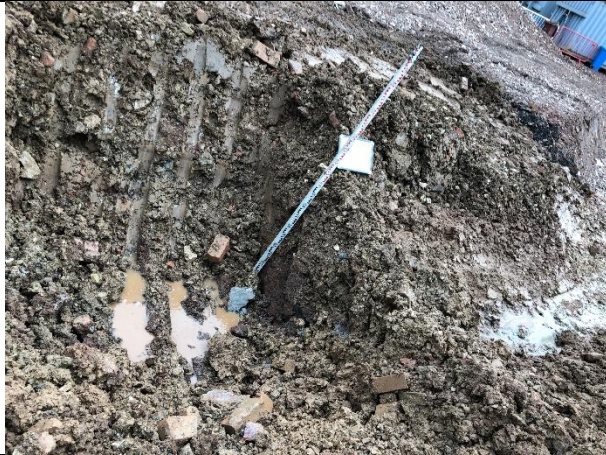
| Depth (m) | Soil Description |
|---|---|
| 0 – 0.7 | Grey/brown fine to coarse gravelly cobbly clay |
| 0.7 – 1.2 | Stiff orange brown occasionally grey mottled laminated sandy silty clay |

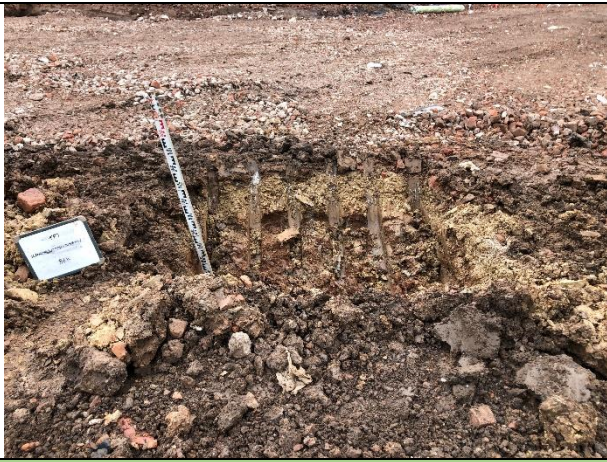
**P7: TP7**

| Depth | Soil Description |
|---|---|
| 0 – 0.1 | Soft brown fine to coarse sandy clay with occasional fine to coarse gravel of brick and wire |
| 0.1 – 0.4 | Yellow fine to coarse gravel |
| 0.4 – 0.6 | Stiff orange brown occasionally grey mottled laminated sandy silty clay |

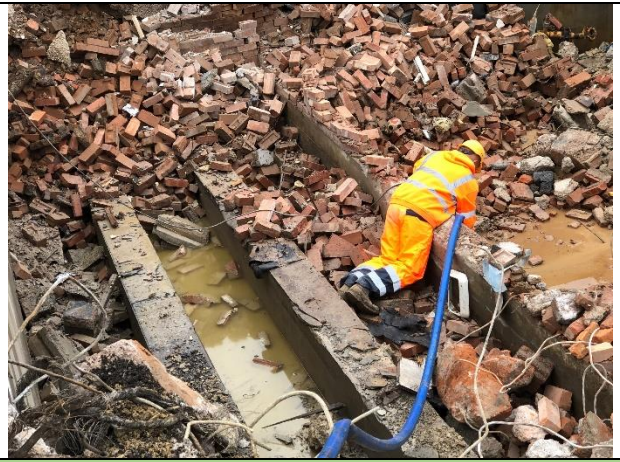
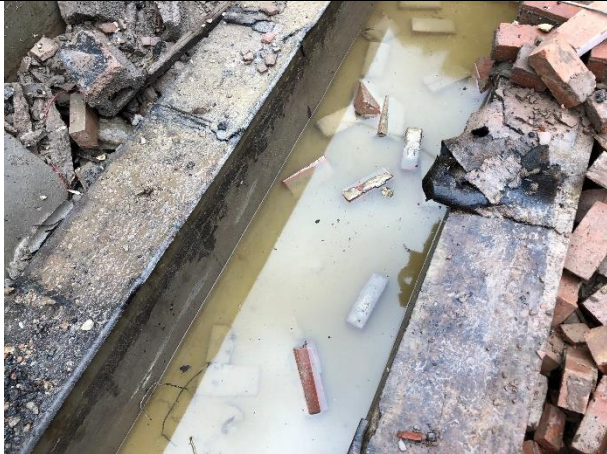
- 2.3.8 BEK also inspected the area where the tank formerly stood and collated photographic evidence of the tanks former location (on concrete plinths). Again, no visual/olfactory evidence of contamination was present within area where the tank formerly stood.

**P8: Area where tank formerly sat**

**P9: Area where tank formerly sat**

- 2.3.9 Following breaking out of the basement BEK recommend that the area where the tank formerly stood be inspected to determine if visual/olfactory evidence of hydrocarbon contamination is present.

- 2.3.10 If no evidence of contamination is encountered, BEK recommended further photographic evidence is collated by Caseys and sent to BEK to confirm this.

- 2.3.11 If evidence of contamination was encountered BEK recommended works in the areas cease and BEK be contacted to carry out further assessment and supervise remediation of any hydrocarbon impacted areas.

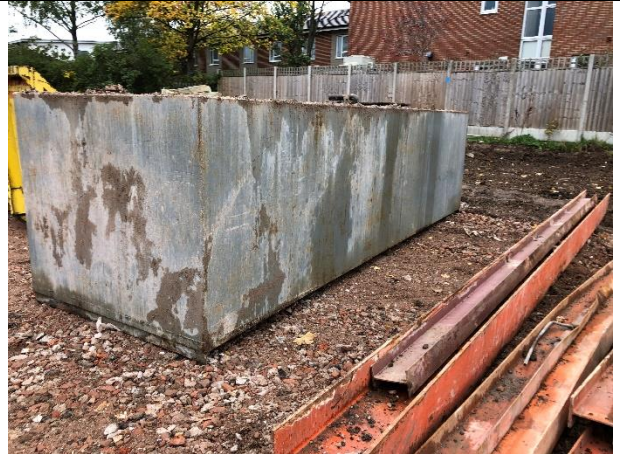
- 2.3.7 Inspection of the tank by BEK in its segregated location indicated no spillages from the tank with the tank being in good condition. Photographic evidence of this has been collated by BEK. BEK instructed the client and the remediation contractor that the tank should also be removed from site under appropriate duty of care regulations.

**P10: Tank appearing in good condition**

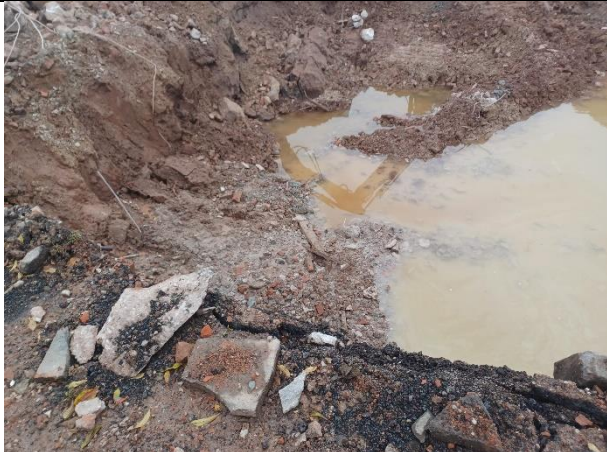
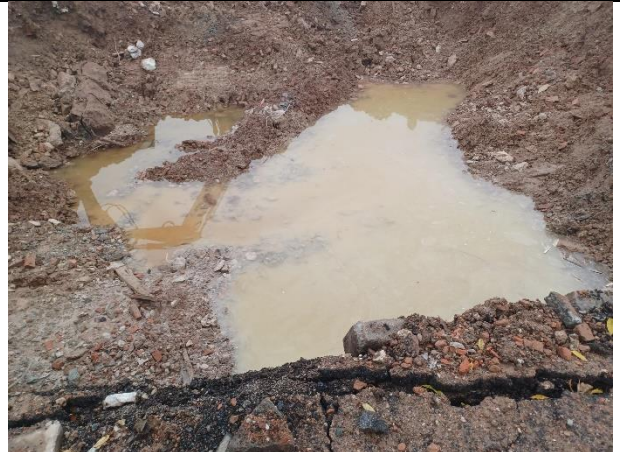
- 2.3.12 In an email dated 2<sup>nd</sup> November 2022, BEK received confirmation from Caseys that following the full removal of the oil tank and foundation/slab. There were no visual signs of any contamination in the area. Photographic evidence was provided to demonstrate this.

**P11: Area following the full removal of the oil tank and foundation/slab.**

**P12: Area following the full removal of the oil tank and foundation/slab.**
