## **Mayfield Regeneration**

### **Geoenvironmental and Geotechnical Desk Study Report**

10 August 2017

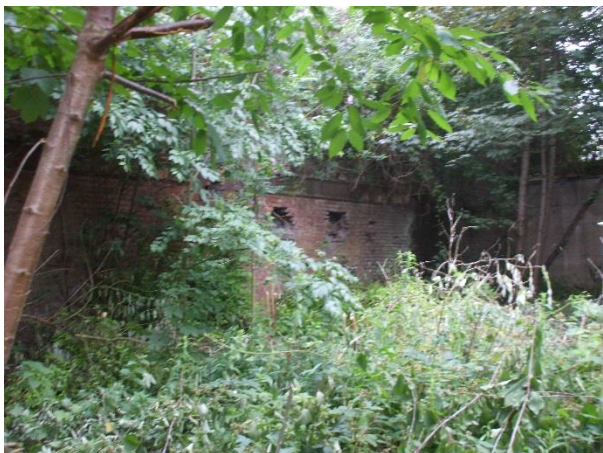
- N and E of building: Overgrown. Fly tipping and evidence of burning (ashes, charred material). Brick/concrete walls border the plot in the eastern area; poor state of disrepair. (Photographs 21 and 22)

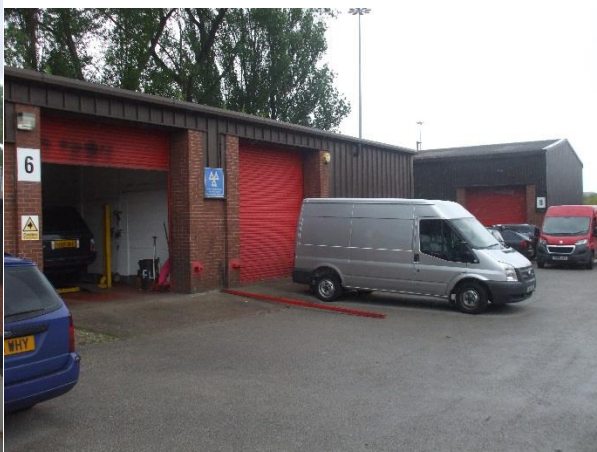
Photograph 27

- JS advised high risk of sharps, needles etc. in the area, and presence of drug users and prostitutes
- Hoyle Street Industrial Estate (Photograph 27)

Sharps and Needles were identified on Site during the Site walkover. It is recommended that a sharps and needle disposal specialist is consulted with regards to identifying the extent of and appropriate measures for Site management and/or removal of these items prior to the start of any construction works. It is also recommended that the site is secured prior to any such removal to prevent further sharps being dumped on site.
