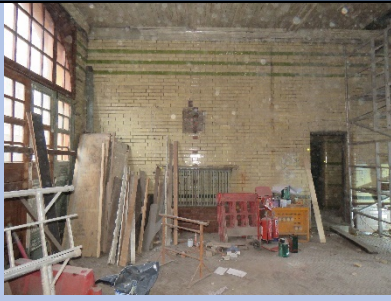
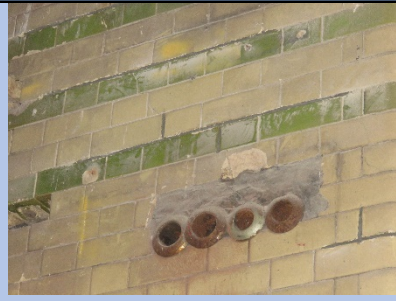
| Room Ref. | Element | Description / Item | Condition | Action | Photographs | | |
|---|---|---|---|---|---|---|---|
| 0.01 | Walls | Glazed brick. Holes to wall from now removed papes and pipe collars. | Good / fair | Enabling works <ul style="list-style-type: none"> <li>Remove pipe collars and infill with salvaged glazed brick.</li> <li>Existing glazed brick cleaned and protected</li> <li>Existing sliding timber door to be refurbished, repainted, and re-hung to location determined by Architect.</li> </ul> | | | |

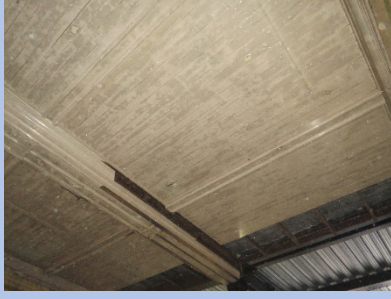
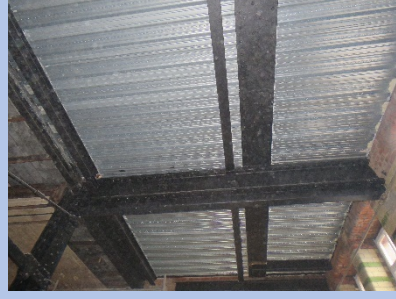
| Room Ref. | Element | Description / Item | Condition | Action | Photographs | | |
|---|---|---|---|---|---|---|---|
| | Ceiling | Painted timber board or exposed concrete and steel beams. Timber cornice. | Fair | Enabling works <ul style="list-style-type: none"> <li>Assess condition of all timber boards.</li> <li>Remove all flaking paint.</li> <li>Existing Timber boarding repaired and decorated in intumescent paint NBS:M60/127.</li> <li>Existing steel repaired and painted with intumescent paint NBS:M61/120.</li> </ul> | | | |

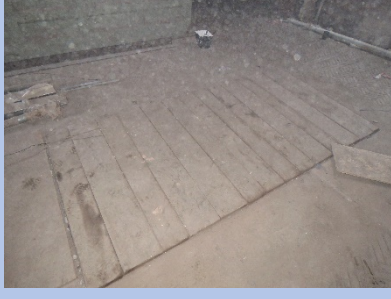
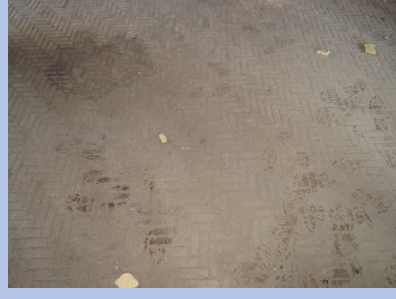
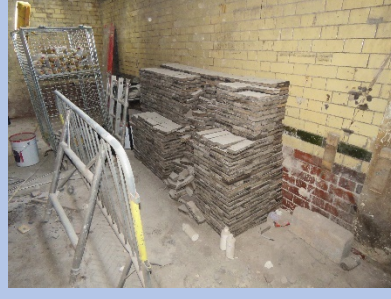
| Room Ref. | Element | Description / Item | Condition | Action | Photographs | | |
|---|---|---|---|---|---|---|---|
| | Floor | Brick. Timber sleepers. Cast steel drainage grille. Pile of wood block, unsure where from. Raised concrete slab. | Fair | Enabling works <ul style="list-style-type: none"> <li>Remove all debris.</li> <li>Clean bricks.</li> <li>Install protection.</li> <li>Quantify wood block and store on pallet.</li> <li>Remove raised concrete slab.</li> </ul> Proposed works <ul style="list-style-type: none"> <li>Provide new polished concrete screed to (NBS:E41/112) to areas where no brickwork is present. Allow to infill any pits in existing floor. Allow for screed to finish at same level as existing brickwork.</li> </ul> | | | |

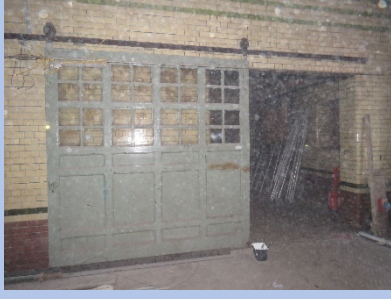
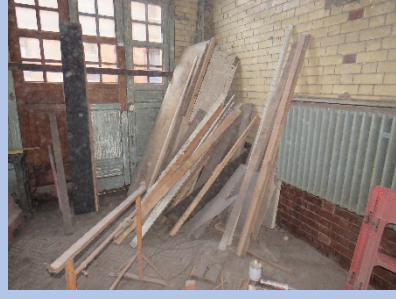
| Room Ref. | Element | Description / Item | Condition | Action | Photographs | | |
|---|---|---|---|---|---|---|---|
| | Joinery | Large timber doors. Misc. joinery. | | Proposed works <ul style="list-style-type: none"> <li>Timber doors and sliding mechanism to be repaired and redecorated and re-hung to location determined by Architect.</li> <li>Misc. joinery to be used for repairs, otherwise scrapped.</li> <li>Repair poor patches to ceiling timber and reinstate timber boarding to missing half of space.</li> <li>Replace architraves to large vehicle doors.</li> </ul> | | | |

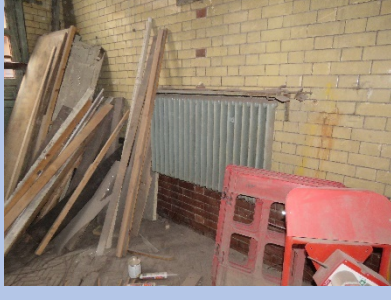
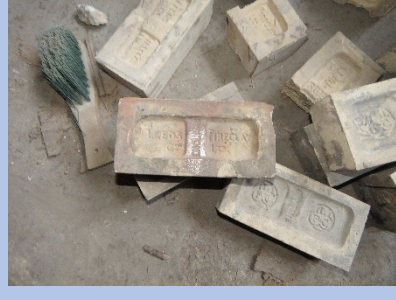
| Room Ref. | Element | Description / Item | Condition | Action | Photographs | | |
|---|---|---|---|---|---|---|---|
| | Misc. | Radiator. Salvaged glazed brick. | | <ul style="list-style-type: none"> <li>Record and remove radiator and bracket. Store in the heritage store.</li> <li>Quantify salvaged bricks and store on pallet.</li> </ul> | | | |

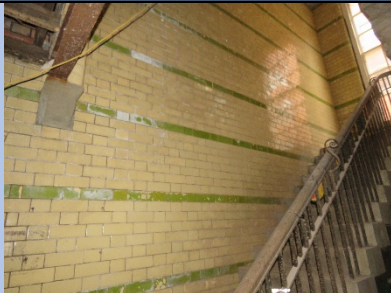
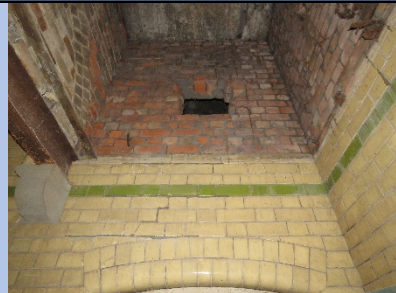
| Room Ref. | Element | Description / Item | Condition | Action | Photographs | | |
|---|---|---|---|---|---|---|---|
| S01 | Walls | Glazed brick.<br>Red brick.<br>Glazed timber partition.<br>Crack above door.<br>Hole to red brick. | Good / fair | <p>Enabling works</p> <ul style="list-style-type: none"> <li>• Clean and install protection.</li> <li>• Remove cracked glass to partition and remove flaking paint.</li> <li>• Refix timber laylight.</li> <li>• Remove corroded hinges and fixings from partition.</li> <li>• CURTINS COMMENT: Crack appears to have already been crack stitched.</li> <li>• ALLIED LONDON COMMENT: Quadriga &amp; Curtins to inspect and advise if not already crack stitched.</li> <li>• Fill hole in brickwork with salvaged red brick.</li> </ul> <p>Proposed works</p> <ul style="list-style-type: none"> <li>• Existing glazed brick to be cleaned and protected</li> <li>• Repaint partition in matching colour and replace any missing glazed panes.</li> </ul> | | | |

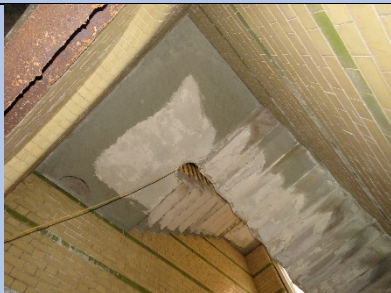
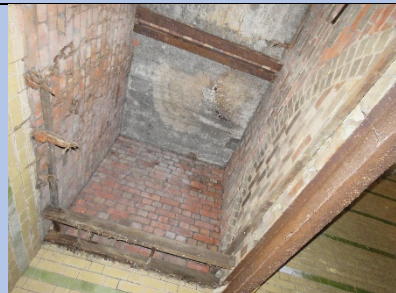
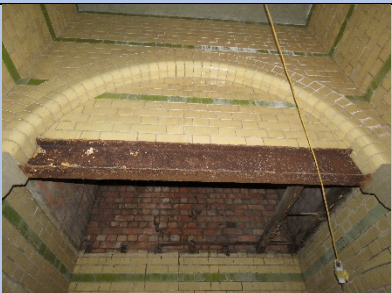
| Room Ref. | Element | Description / Item | Condition | Action | Photographs | | |
|---|---|---|---|---|---|---|---|
| | Ceiling | Exposed stone steps.<br>Redundant timber joists to riser.<br>Corroded steel beam.<br>Section of plaster on lath with paint finish and cornice surviving. | Various | <p>Enabling works</p> <ul style="list-style-type: none"> <li>• Brush down stone steps.</li> <li>• Remove redundant timber joists from riser.</li> <li>• De-rust steel beam.</li> <li>• Hammer test remaining plaster and remove any bossed plaster.</li> <li>• Remove flaking paint.</li> </ul> <p>Proposed works</p> <ul style="list-style-type: none"> <li>• Undertake repairs to lath and plaster ceiling (NBS:M20/340). and timber frame substrate where present</li> <li>• Elsewhere, existing exposed concrete soffit to be retained, repaired to SE details and painted in intumescent paint to NBS:Z12/211.</li> <li>• Steel beams to be treated with specification advised by Architect.</li> </ul> | | | |

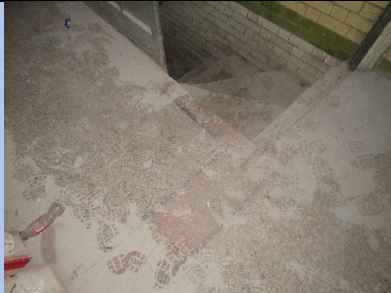
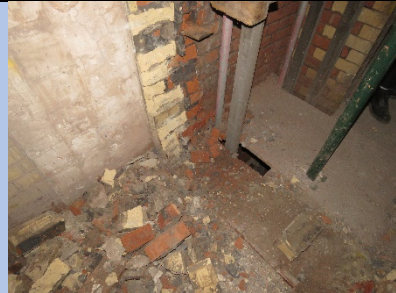
| Room Ref. | Element | Description / Item | Condition | Action | Photographs | | |
|---|---|---|---|---|---|---|---|
| | Floor | Terrazzo.<br>Rubber entrance matt.<br>Stone stairs. | Fair | <p>Enabling works</p> <ul style="list-style-type: none"> <li>• Remove all debris.</li> <li>• Remove rubber entrance mat and infill temporarily with plyboard.</li> <li>• Repair holes in existing terrazzo floor and protect.</li> </ul> | | | |

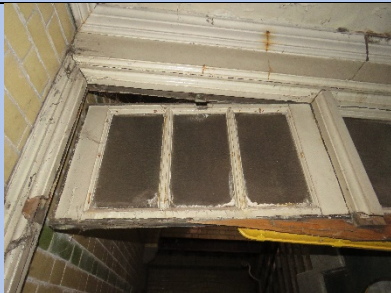
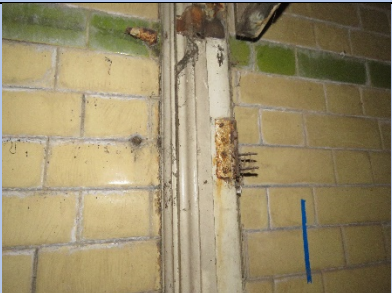
| Room Ref. | Element | Description / Item | Condition | Action | Photographs | | |
|---|---|---|---|---|---|---|---|
| | Joinery | Timber partition / doorframe.<br>Timber handrail. | | <p>Proposed works</p> <ul style="list-style-type: none"> <li>• Timber handrail to be cleaned and protected.</li> <li>• Remove timber partition and door frame &amp; including fanlight section.</li> <li>• Treat and clean connection left to wall areas.</li> </ul> | | | |

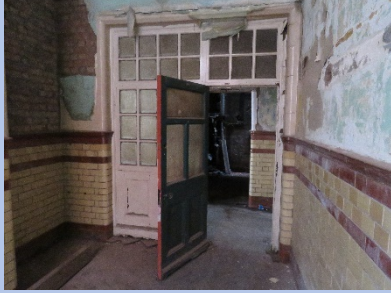
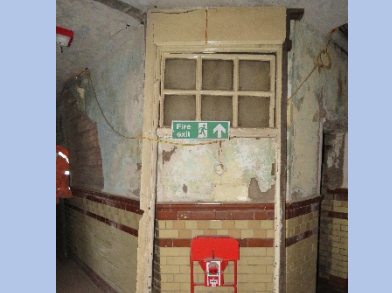
| Room Ref. | Element | Description / Item | Condition | Action | Photographs | | |
|---|---|---|---|---|---|---|---|
| | Joinery | Glazed timber partition.<br>Misc. joinery piled in room.<br>Timber door frame and laylight stored in room. | | Proposed works <ul style="list-style-type: none"> <li>Glazed timber partition restored, rotten sections cut out, treated and replaced and prepared for redecoration.</li> <li>Misc. joinery reused for repairs where possible, otherwise scrapped.</li> <li>Laylight to be returned to original location.</li> </ul> | | | |

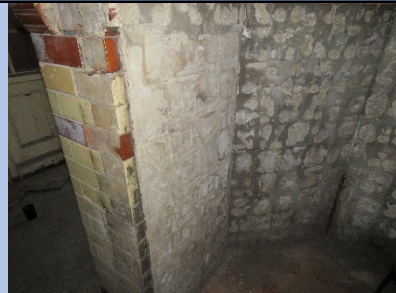
| Room Ref. | Element | Description / Item | Condition | Action | Photographs | | |
|---|---|---|---|---|---|---|--|
| 0.01c | Walls | Plaster on brick or tile adhesive over glazed brick. | Poor | Enabling works <ul style="list-style-type: none"> <li>Remove flaking paint with hand tools and any remaining paint using peelaway. Install protection.</li> </ul> Proposed works <ul style="list-style-type: none"> <li>Existing glazed bricks cleaned and retained</li> <li>Plaster to be stripped from existing masonry walls back to brickwork</li> </ul> | | | |

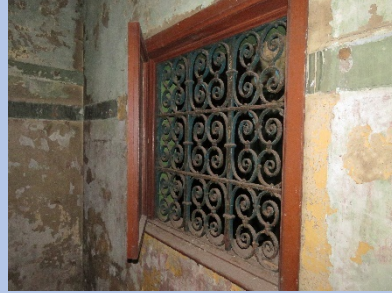
| Room Ref. | Element | Description / Item | Condition | Action | Photographs | | |
|---|---|---|---|---|---|--|--|
| | Misc. | Iron panel to hatch.<br>Misc. embedded pipe / conduit to wall. | | <ul style="list-style-type: none"> <li>Remove flaking paint and protect metalwork.</li> <li>Remove embedded pipe / conduit and fill holes.</li> </ul> | | | |

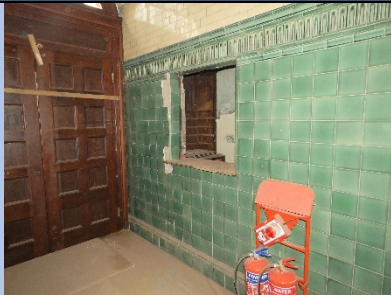
| Room Ref. | Element | Description / Item | Condition | Action | Photographs | | |
|---|---|---|---|---|---|--|--|
| Police Station Entrance | Walls | Glazed tile. | Fair | Enabling works <ul style="list-style-type: none"> <li>Clean and install protection</li> </ul> Proposed works <ul style="list-style-type: none"> <li>Existing glazed bricks cleaned and retained</li> <li>Plaster to be stripped from existing masonry wall</li> <li>Repair holes in glazed brickwork.</li> </ul> | | | |

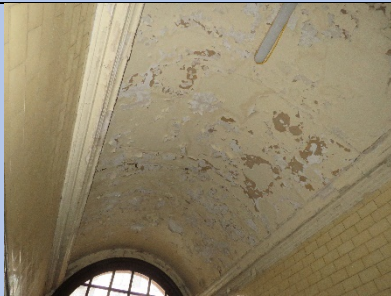
| Room Ref. | Element | Description / Item | Condition | Action | Photographs | | |
|---|---|---|---|---|---|--|--|
| | Ceiling | Barrel vaulted lath and plaster ceiling with paint finish. Surviving cornice. | Fair | Enabling works <ul style="list-style-type: none"> <li>Hammer test plaster and remove any bossed plaster.</li> <li>Remove flaking paint.</li> </ul> Proposed works <ul style="list-style-type: none"> <li>Existing lath and plaster ceiling, repaired (NBS:M20/587) and to receive intumescent paint coatings (NBS:Z12/212).</li> <li>Cornice to be repaired and reinstated where missing</li> </ul> | | | |

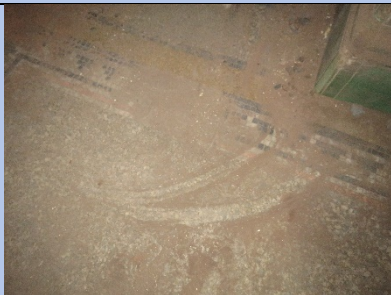
| Room Ref. | Element | Description / Item | Condition | Action | Photographs | | |
|---|---|---|---|---|---|--|--|
| | Floor | Terrazzo with mosaic tile border. | Fair | Enabling works <ul style="list-style-type: none"> <li>Remove all debris.</li> </ul> Proposed works <ul style="list-style-type: none"> <li>Existing terrazzo to be refurbished and cleaned to circulation and entrance lobby. Protect floor once complete.</li> <li>Loose floor coverings removed to all other rooms.</li> </ul> | | | |

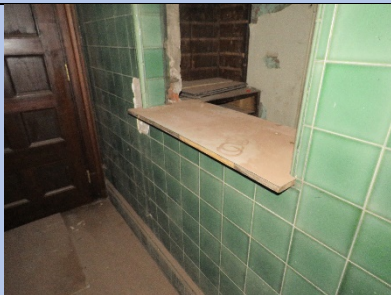
| Room Ref. | Element | Description / Item | Condition | Action | Photographs | | |
|---|---|---|---|---|---|--|--|
| | Misc. | Modern shelf to hatch to 0.07 store cupboard. | | <ul style="list-style-type: none"> <li>Remove shelf</li> </ul> | | | |

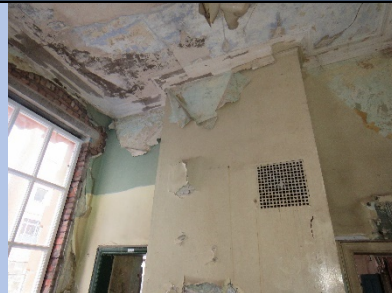
| Room Ref. | Element | Description / Item | Condition | Action | Photographs | | |
|---|---|---|---|---|---|---|---|
| 0.07 | Walls | Plaster on brick with paint finish. | Fair | Proposed works <ul style="list-style-type: none"> <li>Plaster to be stripped from existing masonry walls back to brickwork.</li> </ul> | | | |

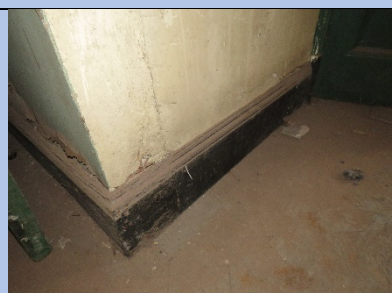
| Room Ref. | Element | Description / Item | Condition | Action | Photographs | | |
|---|---|---|---|---|---|---|---|
| | Floor | Wood block, partially lifted. | Fair | Enabling works <ul style="list-style-type: none"> <li>Remove all debris.</li> <li>Quantify and lift all wood block, store on pallet in room.</li> </ul> Proposed works <ul style="list-style-type: none"> <li>Existing timber block (parquet) to be for use elsewhere in the building</li> <li>Loose floor coverings removed to all other rooms.</li> <li>Remaining floor covering to be cleaned.</li> </ul> | | | |

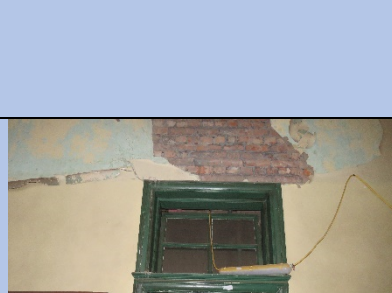
| Room Ref. | Element | Description / Item | Condition | Action | Photographs | | |
|---|---|---|---|---|---|---|---|
| | Joinery | Skirting<br>Door architrave<br>Hatch to entrance<br>5no. doors | | Proposed works <ul style="list-style-type: none"> <li>Remove skirting with plaster to walls and do not reinstate.</li> <li>Doors and architraves to be removed, except for door into small office which is to remain.</li> <li>Replace existing ply shelf with new timber.</li> </ul> | | | |

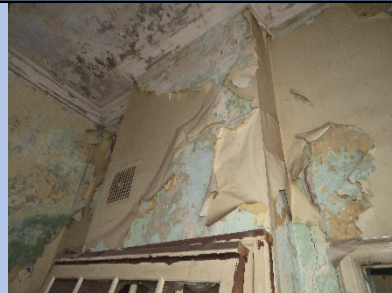
| Room Ref. | Element | Description / Item | Condition | Action | Photographs | | |
|---|---|---|---|---|---|---|---|
| 0.08 | Walls | Plaster on brick with paint finish. | Fair | <ul style="list-style-type: none"> <li>Plaster to be stripped from existing masonry walls back to brickwork</li> </ul> | | | |

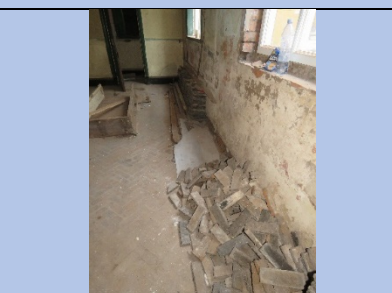
| Room Ref. | Element | Description / Item | Condition | Action | Photographs | | |
|---|---|---|---|---|---|---|---|
| | Floor | Wood block, partially lifted and stored in 0.07.<br>Glazed tile to hearth. | Fair | <p>Enabling works</p> <ul style="list-style-type: none"> <li>Remove all debris.</li> <li>Quantify and lift all wood block, store on pallet.</li> <li>Carefully remove glazed tiles and store</li> </ul> <p>Proposed works</p> <ul style="list-style-type: none"> <li>Existing timber block (parquet) to be removed for use elsewhere in the building</li> <li>Loose floor coverings removed to all other rooms.</li> <li>Remaining floor to be cleaned.</li> </ul> | | | |

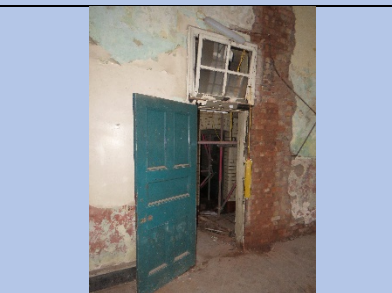
| Room Ref. | Element | Description / Item | Condition | Action | Photographs | | |
|---|---|---|---|---|---|---|---|
| | Joinery | Skirting<br>Door architrave<br>Hatch to entrance<br>2no. doors<br>2no. timber glazed partitions<br>Misc. pile of timber. | | <p>Proposed works</p> <ul style="list-style-type: none"> <li>Skirting remain in small section only. Remove with plaster to walls and do not reinstate.</li> <li>Doors and architraves to be removed, including glazed over light to door.</li> <li>Glazed partition to be set aside for reuse</li> <li>Misc pile of timber may be reused for repairs elsewhere.</li> </ul> | | | |

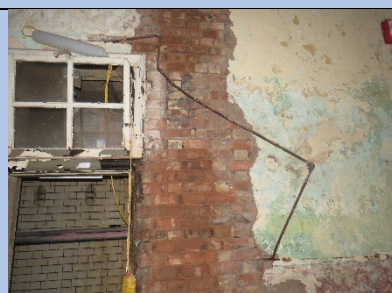
| Room Ref. | Element | Description / Item | Condition | Action | Photographs | | |
|---|---|---|---|---|---|---|---|
| | Misc. | 2no. ventilation grilles.<br>Pile of demolition waste.<br>Redundant M&E pipes and conduit. | | <ul style="list-style-type: none"> <li>Remove all demolition waste.</li> <li>Remove all redundant M&amp;E and fill holes.</li> </ul> | | | |

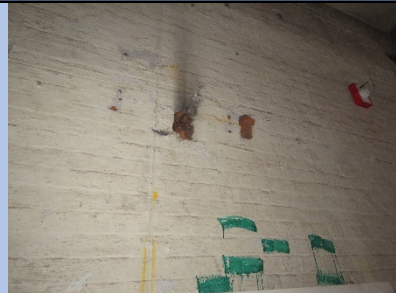
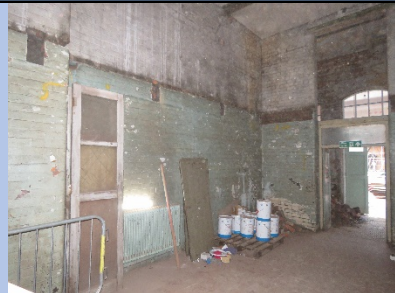
| Room Ref. | Element | Description / Item | Condition | Action | Photographs | | |
|---|---|---|---|---|---|---|---|
| G.017 Inc. 0.2a, 0.18, 0.19b and R2 | Walls | Painted brick, minor holes. | Fair | Enabling works <ul style="list-style-type: none"> <li>Remove flaking paint.</li> <li>Fill holes with salvaged red brick and mortar.</li> </ul> Proposed works <ul style="list-style-type: none"> <li>Existing walls stripped back to masonry</li> </ul> | | | |

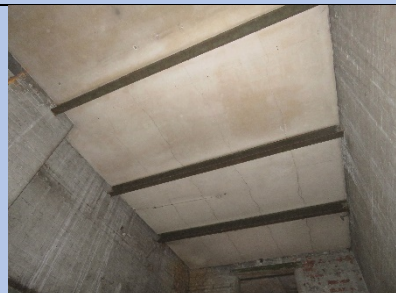
| Room Ref. | Element | Description / Item | Condition | Action | Photographs | | |
|---|---|---|---|---|---|---|---|
| | Ceiling | Plaster on concrete with paint finish. Painted steel beams. | Fair | Enabling works <ul style="list-style-type: none"> <li>Hammer test remaining plaster and remove any bossed plaster.</li> <li>Remove flaking paint.</li> </ul> Proposed works <ul style="list-style-type: none"> <li>Existing exposed concrete soffit to be retained, repaired to SE details and painted in intumescent paint to NBS:Z12/211.</li> </ul> | | | |

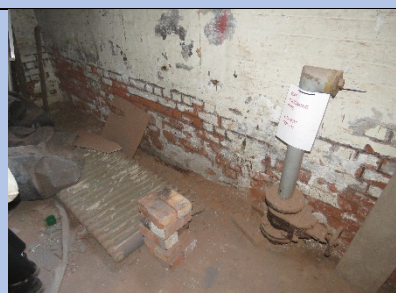
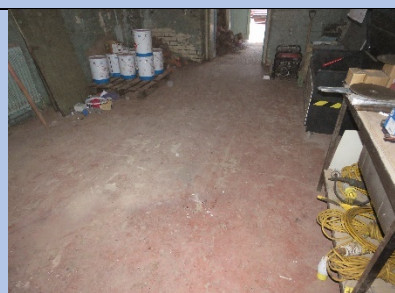
| Room Ref. | Element | Description / Item | Condition | Action | Photographs | | |
|---|---|---|---|---|---|---|---|
| | Floor | Exposed concrete floor. | Fair | Enabling works <ul style="list-style-type: none"> <li>Remove all debris</li> </ul> Proposed works <ul style="list-style-type: none"> <li>Install reclaimed timber parquet flooring. ALLIED LONDON COMMENT: This specification should be reviewed with Purcell prior to works commencing.</li> </ul> | | | |

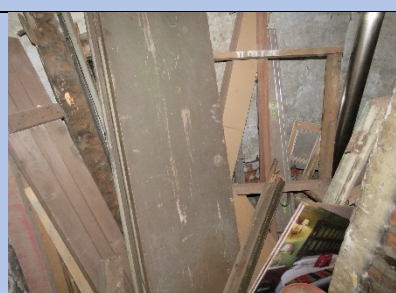
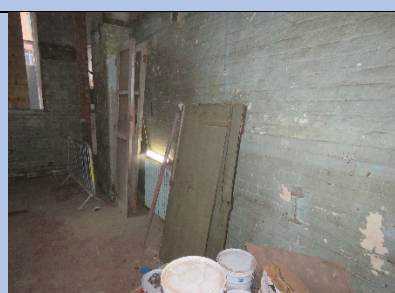
| Room Ref. | Element | Description / Item | Condition | Action | Photographs | | |
|---|---|---|---|---|---|---|---|
| | Joinery | 3no. doors<br>Misc. pile of timber. | | Proposed works <ul style="list-style-type: none"> <li>Misc. joinery and doors to be scrapped.</li> </ul> | | | |

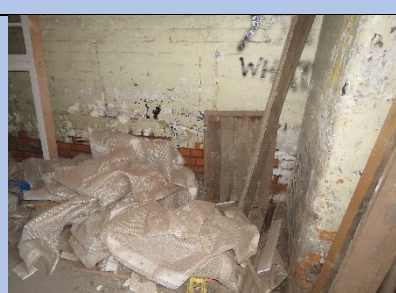
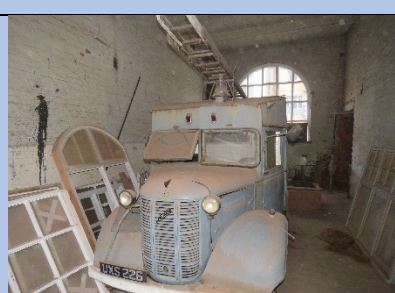
| Room Ref. | Element | Description / Item | Condition | Action | Photographs | | |
|---|---|---|---|---|---|---|---|
| | Misc. | Historic hook fixing to beam.<br>Radiators.<br>General construction materials and salvaged materials.<br>Incoming gas | | <ul style="list-style-type: none"> <li>Retain hook to beam (check fixing to beam and replace with new fixings if required).</li> <li>Remove all construction waste.</li> <li>Catalogue all salvaged / stored materials and store in heritage store.</li> <li>Protect gas pipe.</li> <li>Sweep down van and install protection.</li> </ul> | | | |

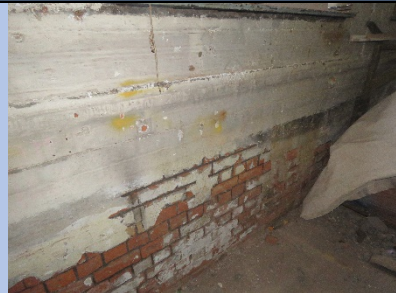
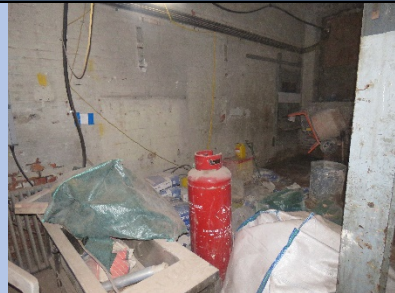
| Room Ref. | Element | Description / Item | Condition | Action | Photographs | | |
|---|---|---|---|---|---|---|---|
| Unit G 0.2 | Walls | Painted brick, minor holes. | Fair | <p>Enabling works</p> <ul style="list-style-type: none"> <li>Remove flaking paint.</li> <li>Fill holes with salvaged red brick and mortar.</li> </ul> <p>Proposed works</p> <ul style="list-style-type: none"> <li>Existing walls stripped back to masonry</li> <li>Existing exposed steel columns and beams to be painted with intumescent paint as NBS:M61/120.</li> </ul> | | | |

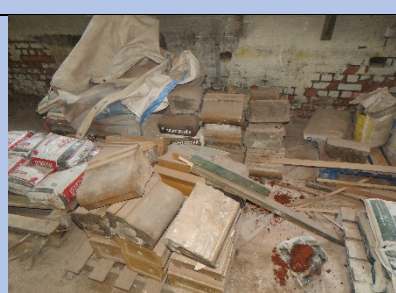
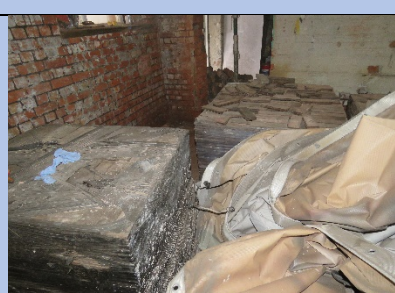
| Room Ref. | Element | Description / Item | Condition | Action | Photographs | | |
|---|---|---|---|---|---|---|---|
| | Misc. | Historic hook fixing to beam. Radiators. General construction materials and salvaged materials. | | <ul style="list-style-type: none"> <li>Retain hook to beam (check fixing to beam and replace with new fixings if required).</li> <li>Remove all construction and kitchen unit waste.</li> <li>Catalogue all salvaged / stored materials</li> </ul> | | | |

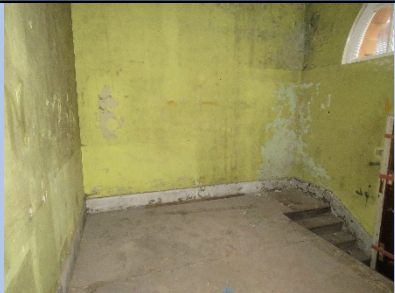
| Room Ref. | Element | Description / Item | Condition | Action | Photographs | | |
|---|---|---|---|---|---|---|--|
| 0.20 | Walls | Plaster on brick with paint finish. | Fair | Proposed work <ul style="list-style-type: none"> <li>Remove plaster finishes back to masonry</li> </ul> | | | |

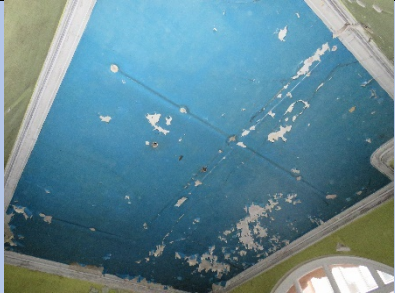
| Room Ref. | Element | Description / Item | Condition | Action | Photographs | | |
|---|---|---|---|---|---|---|--|
| | Ceiling | Plaster on lath with paint finish. Cornice survives | Fair | <ul style="list-style-type: none"> <li>Hammer test remaining plaster and remove any bossed plaster.</li> <li>Remove flaking paint.</li> </ul> <hr/> Proposed work <ul style="list-style-type: none"> <li>Repairs to existing lath and plaster ceiling as per M20/587.</li> <li>Treat ceiling with intumescent paint as per Z12/212.</li> </ul> | | | |

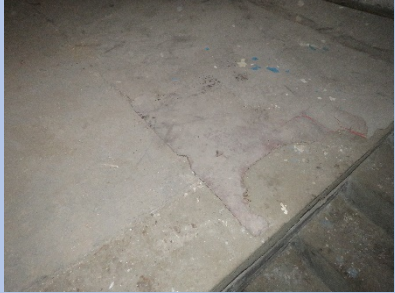
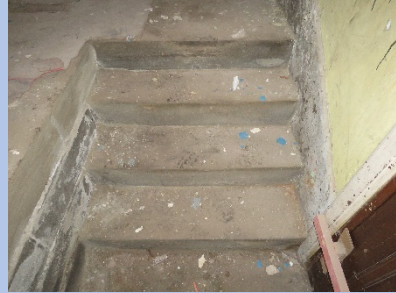
| Room Ref. | Element | Description / Item | Condition | Action | Photographs | | |
|---|---|---|---|---|---|---|--|
| | Floor | Concrete floor | Fair | <ul style="list-style-type: none"> <li>Remove all boarding and debris.</li> </ul> <hr/> Proposed work <ul style="list-style-type: none"> <li>Provide vinyl floor covering.</li> </ul> | | | |

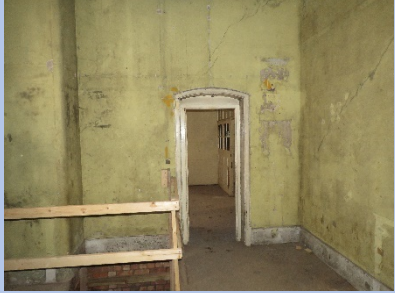
| Room Ref. | Element | Description / Item | Condition | Action | Photographs | | |
|---|---|---|---|---|---|---|--|
| | Joinery | schedule<br>Door architrave.<br>Skirting | | Proposed work <ul style="list-style-type: none"> <li>Skirting to be removed.</li> <li>Door and architrave to be removed, set aside for reuse.</li> </ul> | | | |

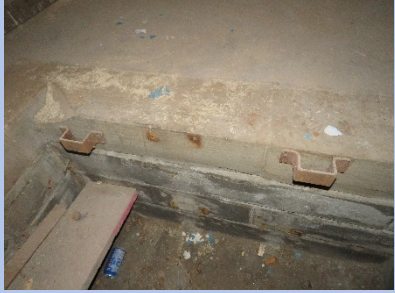
| Room Ref. | Element | Description / Item | Condition | Action | Photographs | | |
|---|---|---|---|---|---|---|--|
| | Misc. | Brackets for edge protection. | | <ul style="list-style-type: none"> <li>Remove fixing to edge of concrete slab.</li> </ul> | | | |

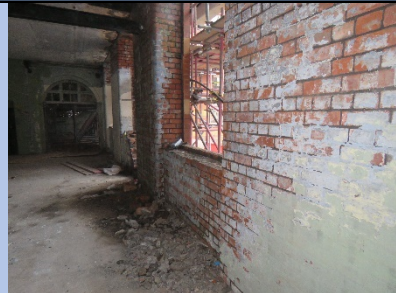
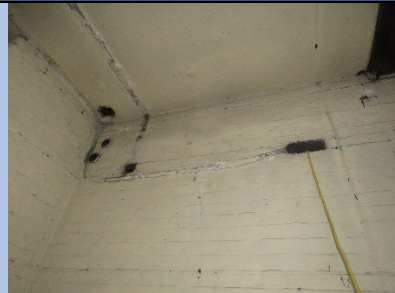
| Room Ref. | Element | Description / Item | Condition | Action | Photographs | | |
|---|---|---|---|---|---|---|---|
| 0.25<br>(hotel recep.) | Walls | Paint on brick.<br>Minor holes to brick. | Fair | Enabling works <ul style="list-style-type: none"> <li>Fill holes to brick with salvaged red brick and mortar.</li> </ul> Proposed works <ul style="list-style-type: none"> <li>Existing walls stripped back to masonry (level of stripping back to be agreed)</li> <li>New black metal crittal style external entrance screen to courtyard and street entrance to be supplied and installed. Refer to Purcell drawing 3205 &amp; 3208.</li> <li>Reclaimed masonry wall to form working fireplace recess.</li> <li>New fire rated black metal crittal style door to be supplied and installed to lift lobby. Refer to Purcell drawing 3208.</li> <li>Existing timber sliding doors refurbished and rehung</li> </ul> | | | |

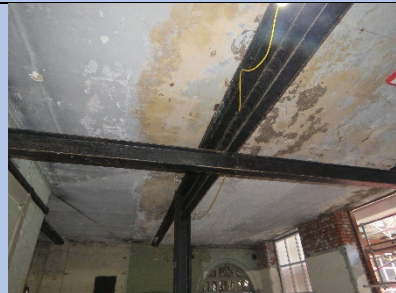
| Room Ref. | Element | Description / Item | Condition | Action | Photographs | | |
|---|---|---|---|---|---|---|---|
| | Ceiling | Plaster on concrete with paint finish.<br>Steel beams. | Fair | Enabling works <ul style="list-style-type: none"> <li>Hammer test remaining plaster and remove any bossed plaster.</li> <li>Remove flaking paint.</li> <li>De-rusted areas corroded steelwork.</li> </ul> Proposed works <ul style="list-style-type: none"> <li>Existing lath and plaster ceiling repaired to non-visual grade, to achieve required fire separation.</li> <li>Existing ceiling to receive coating of intumescent paint spec tbc.</li> <li>Steel beams to receive intumescent paint NBS:M61/120.</li> <li>Provide new suspended ceiling refer to (Ceiling type CT10 refer to drawing 2251)</li> </ul> | | | |

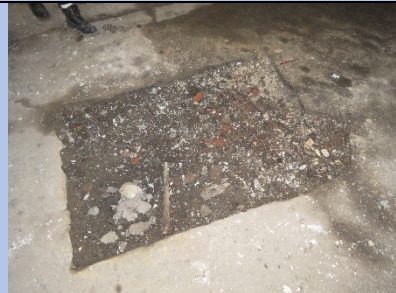
| Room Ref. | Element | Description / Item | Condition | Action | Photographs | | |
|---|---|---|---|---|---|---|---|
| | Floor | Exposed concrete floor with minor area dug out. | Poor | Enabling works <ul style="list-style-type: none"> <li>Clear all debris.</li> </ul> Proposed works <ul style="list-style-type: none"> <li>Install reclaimed parquet floor on resilient layer NBS:M10/295A with inset timber block border detail to reception desk location. Architect to confirm reception desk dimensions and exact location.</li> </ul> | | | |

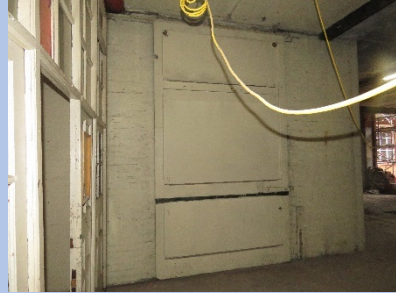
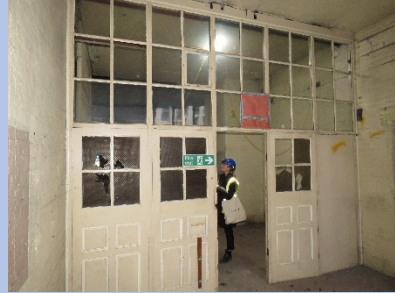
| Room Ref. | Element | Description / Item | Condition | Action | Photographs | | |
|---|---|---|---|---|---|---|---|
| | Joinery | Door architrave.<br>Timber partition<br>Large sliding timber doors. | | <ul style="list-style-type: none"> <li>Remove redundant timber door.</li> </ul> <p><i>NOTE: Access not available at time of survey</i></p> | | | |

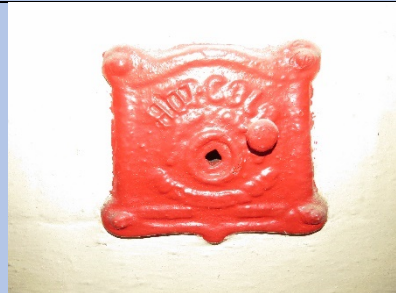
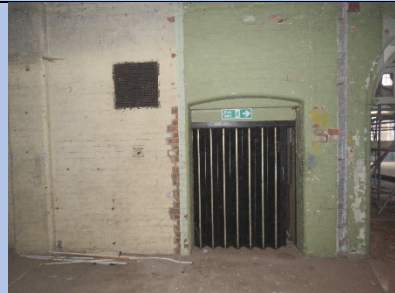
| Room Ref. | Element | Description / Item | Condition | Action | Photographs | | |
|---|---|---|---|---|---|---|---|
| | Misc. | Wall vent<br>Radiator<br>Ventilation control plate.<br>Lift door. | | <ul style="list-style-type: none"> <li>Retain wall vent and control plate and clean.</li> <li>Record radiator and relocate to heritage store.</li> <li>Retain lift door.</li> </ul> | | | |

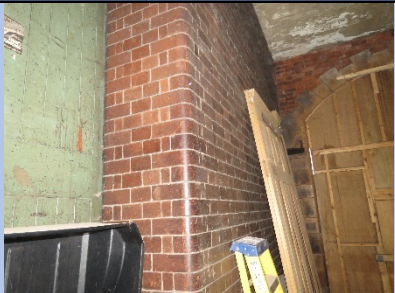
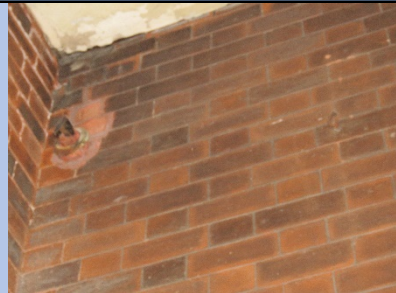
| Room Ref. | Element | Description / Item | Condition | Action | Photographs | | |
|---|---|---|---|---|---|---|--|
| 0.26 | Walls | Glazed brown brick.<br>Terracotta to external doorway. | Fair | <p>Enabling works</p> <ul style="list-style-type: none"> <li>Remove flaking paint.</li> <li>Full holes to brick with salvaged red brick and mortar.</li> <li>Clean and protect brick</li> </ul> <p>Proposed works</p> <ul style="list-style-type: none"> <li>Existing walls stripped back to masonry (level of stripping back to be agreed).</li> <li>New black metal crittal style external entrance screen to courtyard and street entrance to be supplied and installed. Refer to Purcell drawing 3205 &amp; 3208.</li> <li>New fire rated black metal crittal style door to lift lobby to be supplied and installed. Refer to Purcell drawing 3208.</li> </ul> | | | |

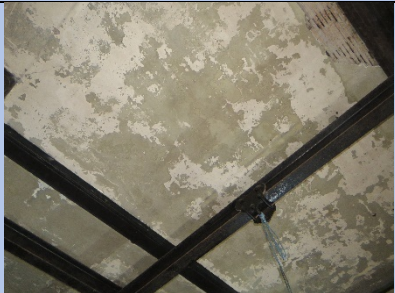
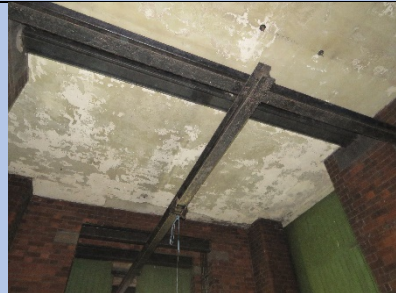
| Room Ref. | Element | Description / Item | Condition | Action | Photographs | | |
|---|---|---|---|---|---|---|--|
| | Ceiling | Plaster on concrete with paint finish.<br>Steel beams. | Fair | <p>Enabling works</p> <ul style="list-style-type: none"> <li>Hammer test remaining plaster and remove any bossed plaster.</li> <li>Remove flaking paint.</li> <li>De-rusted areas corroded steelwork.</li> </ul> <p>Proposed works</p> <ul style="list-style-type: none"> <li>Existing lath and plaster ceiling repaired to non-visual grade, to achieve required fire separation.</li> <li>Existing ceiling to receive coating of intumescent paint spec tbc.</li> <li>Steel beams to receive intumescent paint NBS:M61/120.</li> <li>Provide new suspended ceiling refer to (Ceiling type CT10 refer to drawing 2251)? ALLIED LONDON COMMENT: Specification to be checked with Purcell prior to works commencing.</li> </ul> | | | |

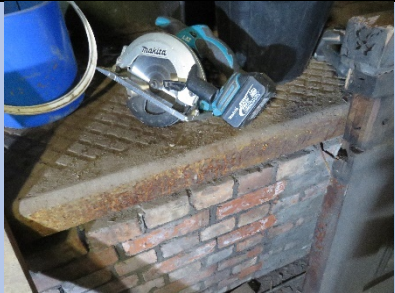
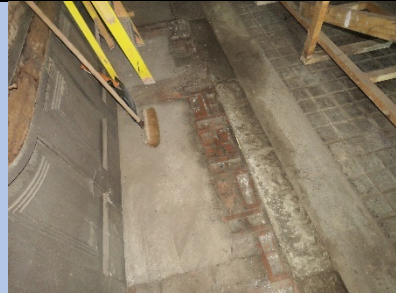
| Room Ref. | Element | Description / Item | Condition | Action | Photographs | | |
|---|---|---|---|---|---|---|--|
| | Floor | Concrete sets.<br>Cast steel pavement lights filled with concrete.<br>Stone kerb.<br>Red brick.<br>Metal ledges. | Fair / Poor | <p>Enabling works</p> <ul style="list-style-type: none"> <li>Remove all debris, clean and protect.</li> </ul> <p>Proposed works</p> <ul style="list-style-type: none"> <li>Reclaimed timber block parquet laid on resilient layer</li> </ul> | | | |
